Inspection Photos

API: 011-06036

Operator: OXY USA INC

Inspection Date: 9/6/2023

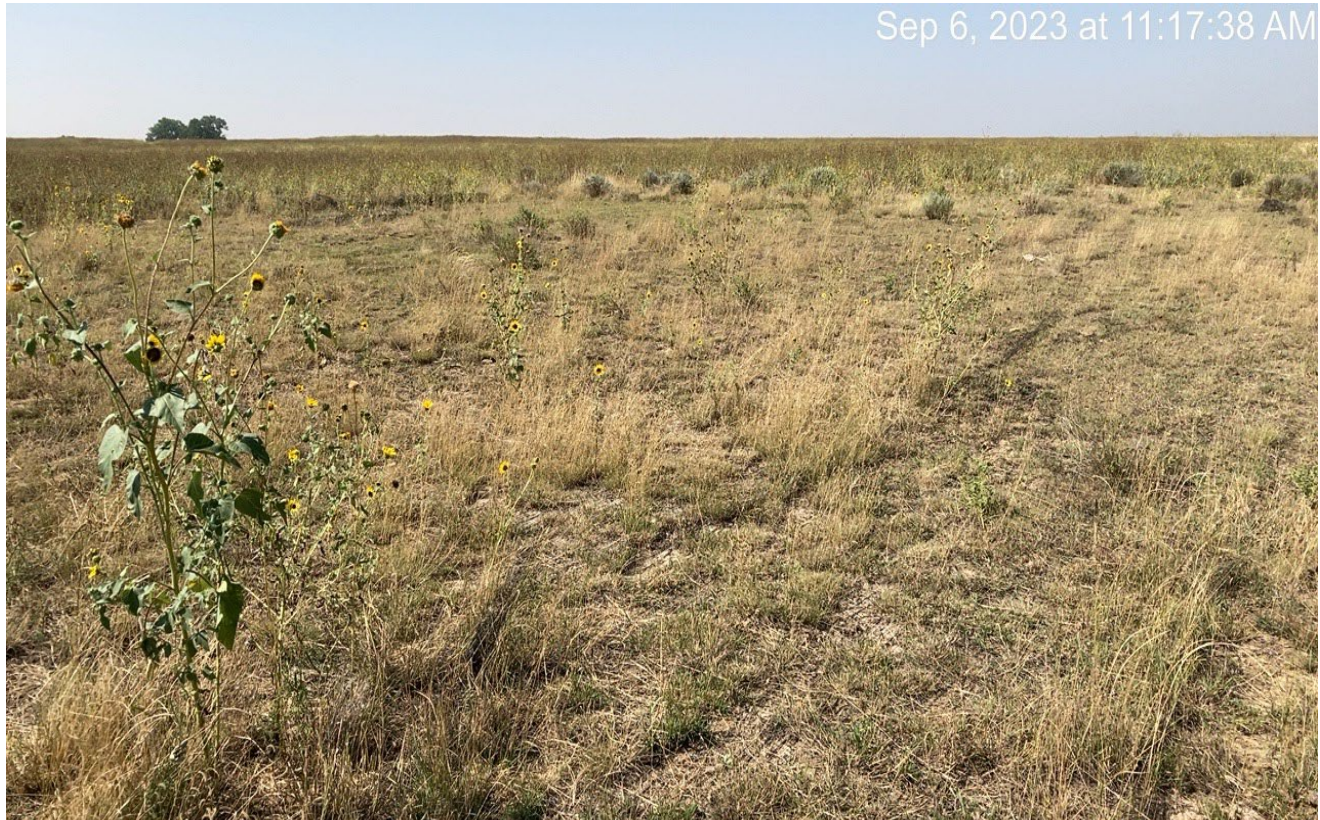
Photo 1. Facing southwest at the location. Perennial vegetation has re-established at the location.

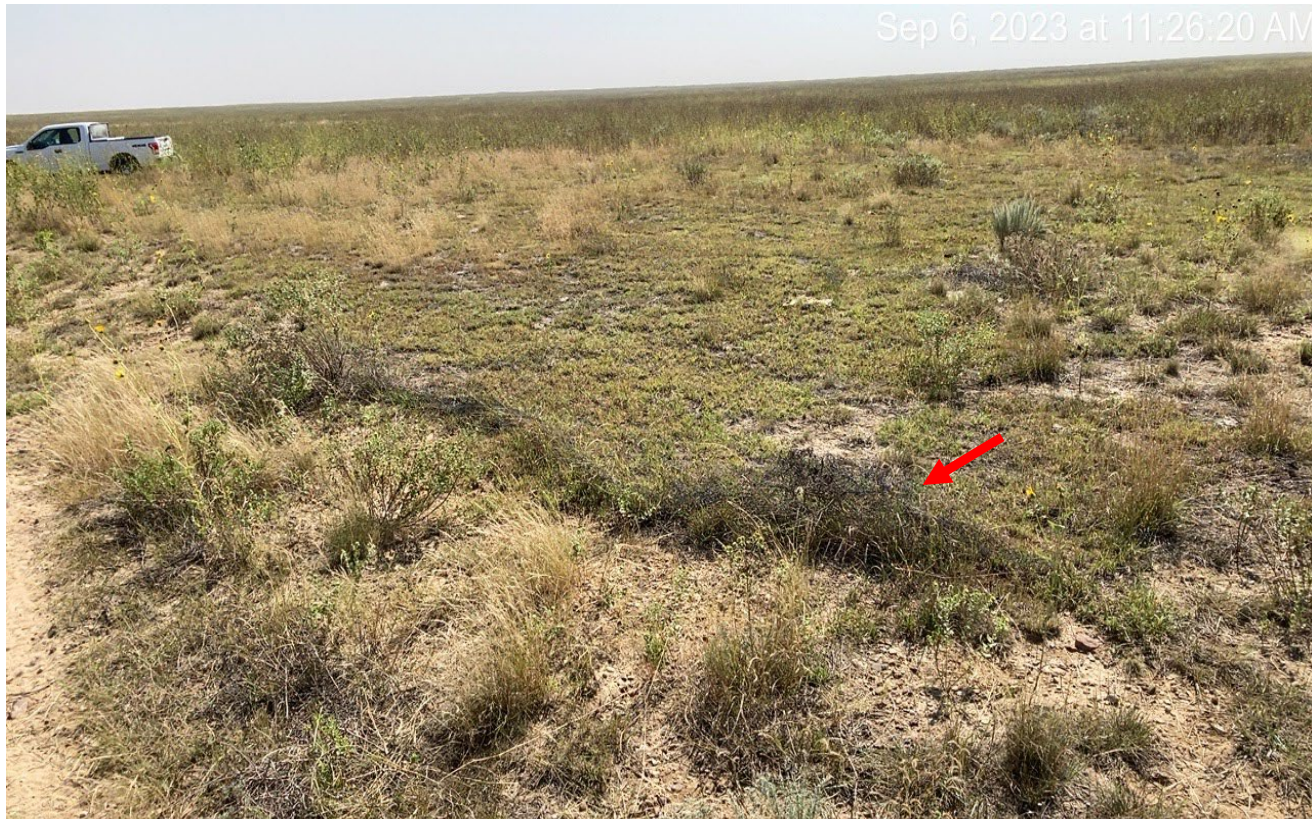
Photo 2. Facing southeast at the location. Perennial vegetation has re-established at the location. There is bunched up netting from the straw blanket that needs to be removed.

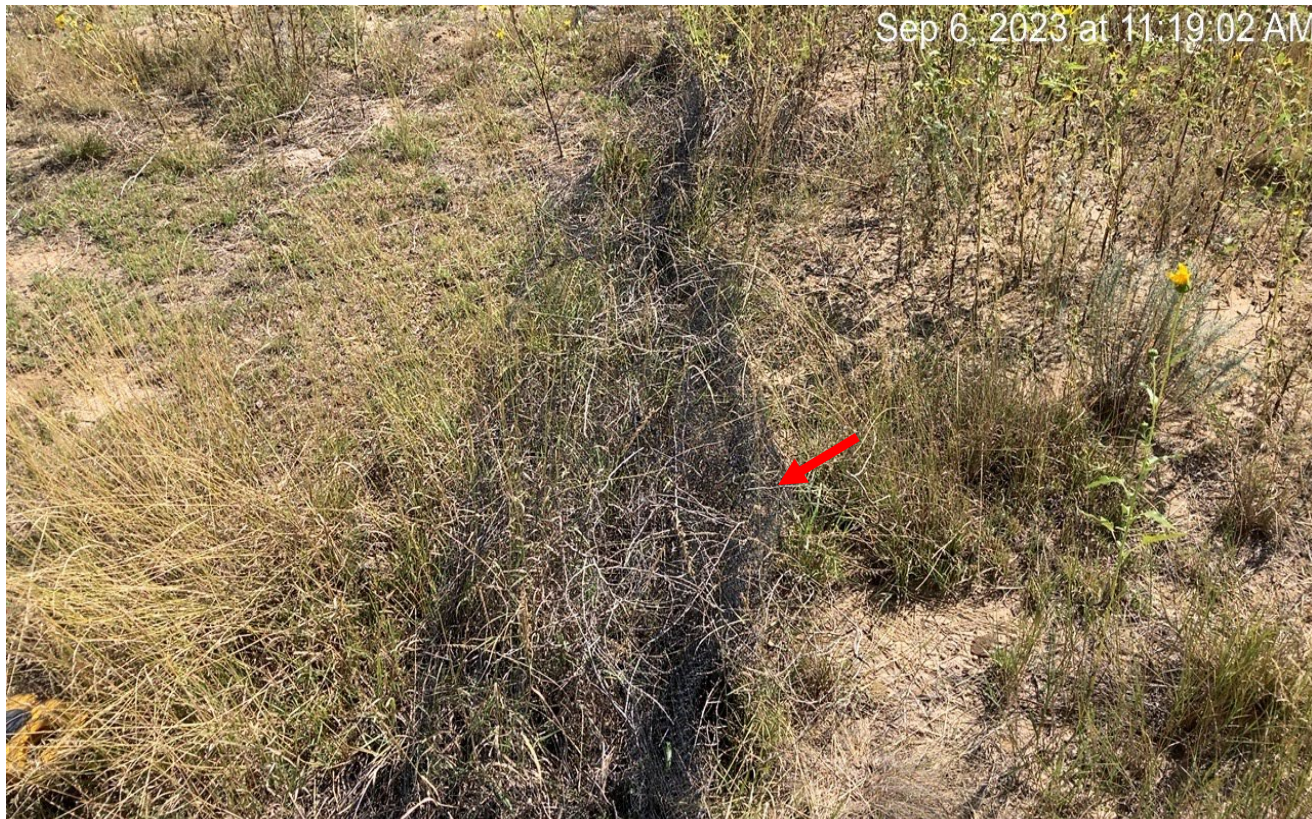
Photo 3. Southwest corner of the location. There is bunched up netting from the straw blanket that needs to be removed.

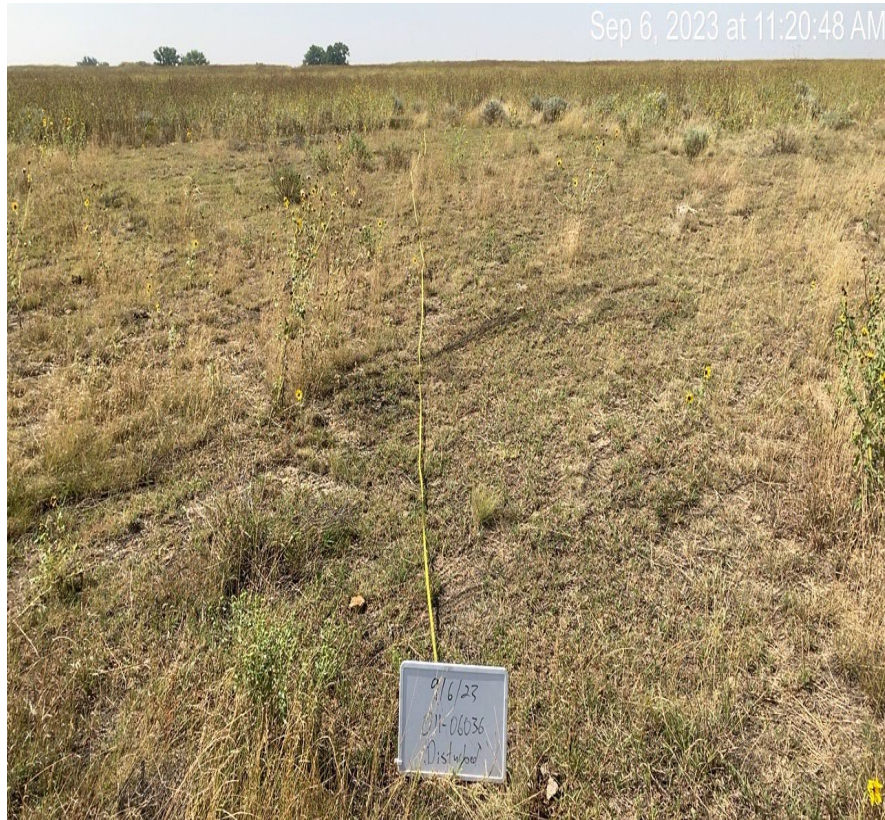
Photo 4. Facing southwest at the disturbed location.

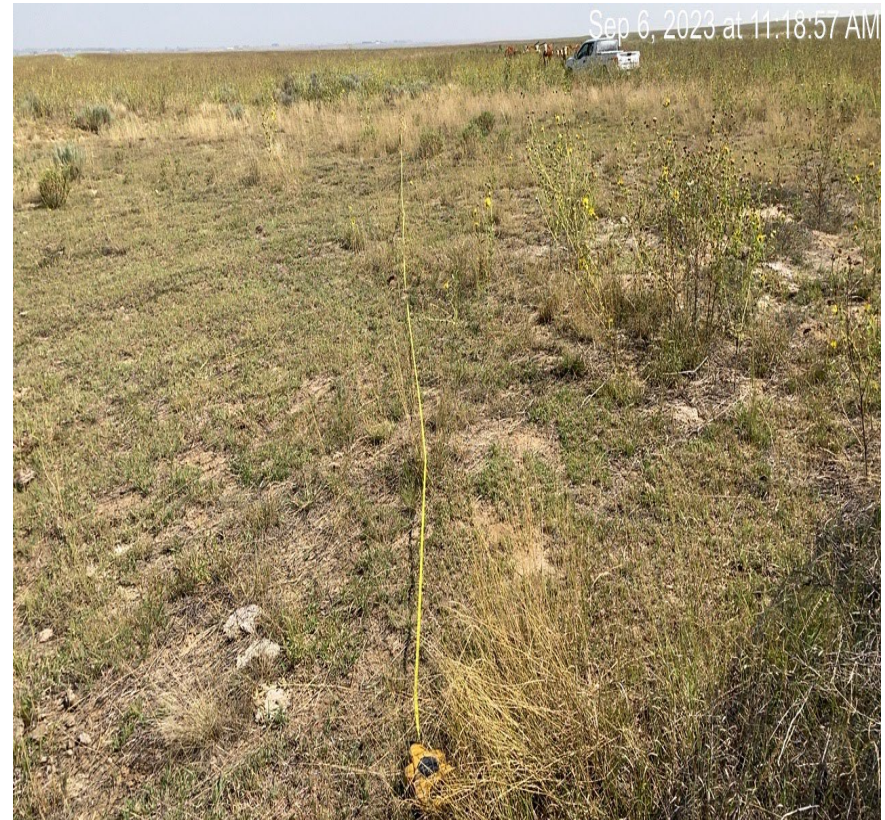
Photo 5. Facing northeast at the disturbed location.

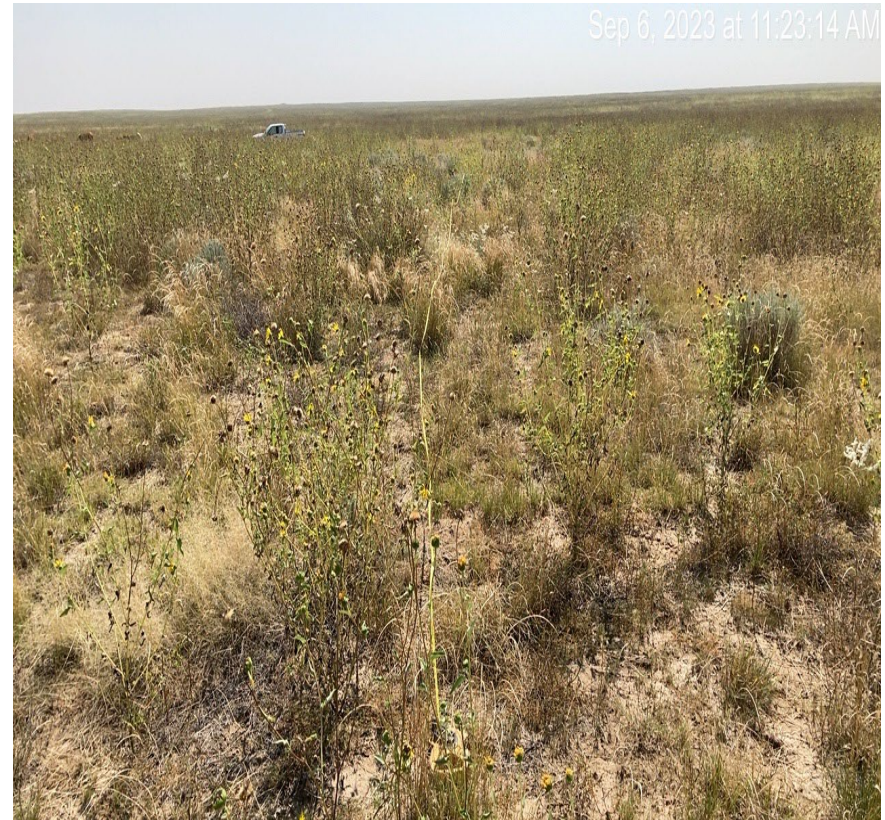
Photo 7. Facing southeast at the reference area. .
