Inspection Photos

Location Name: VISION ENERGY LLC, SOUTH SHALE RIDGE-68S98W/14NENE

Location ID: 312598

Date: 9/6/2023

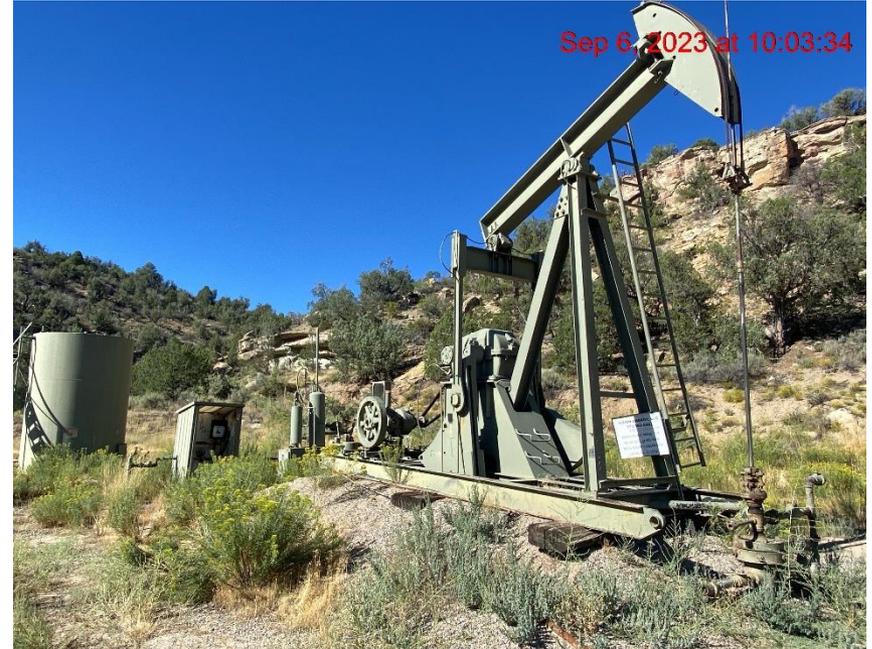
Wellhead/Weeds – Photo #06239

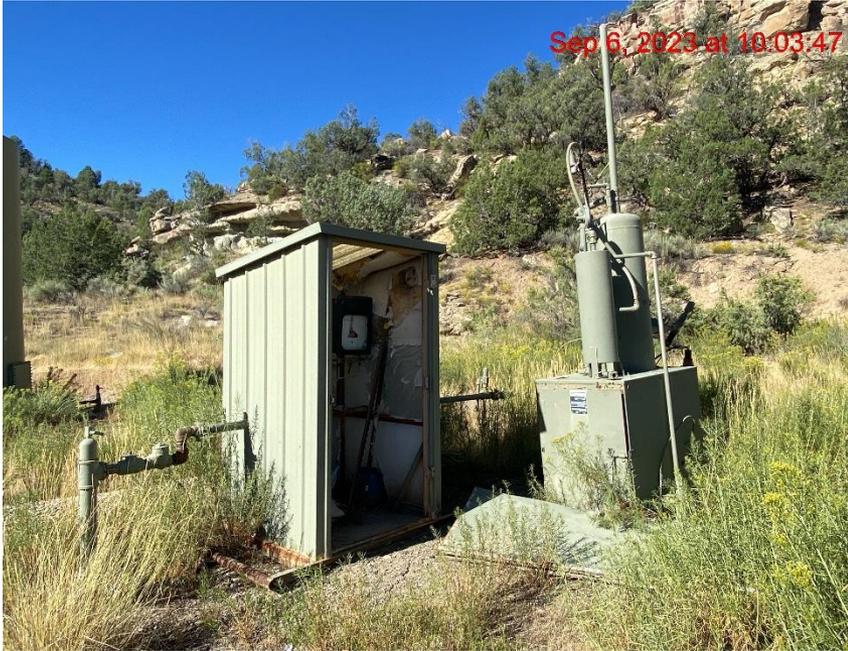
Separator/Gas Meter/Weeds – Photo #06240

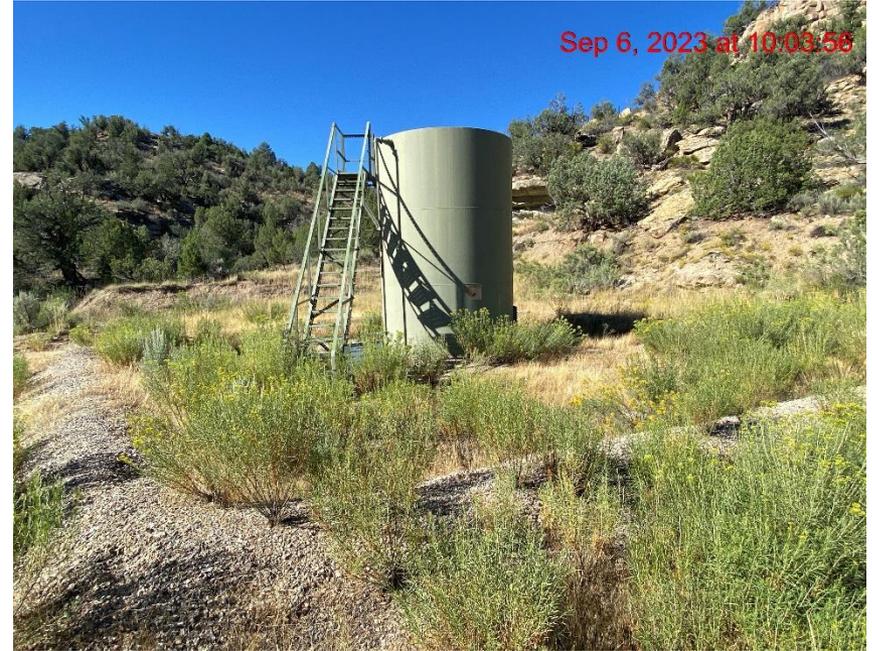
Tank Battery/Weeds – Photo #06241

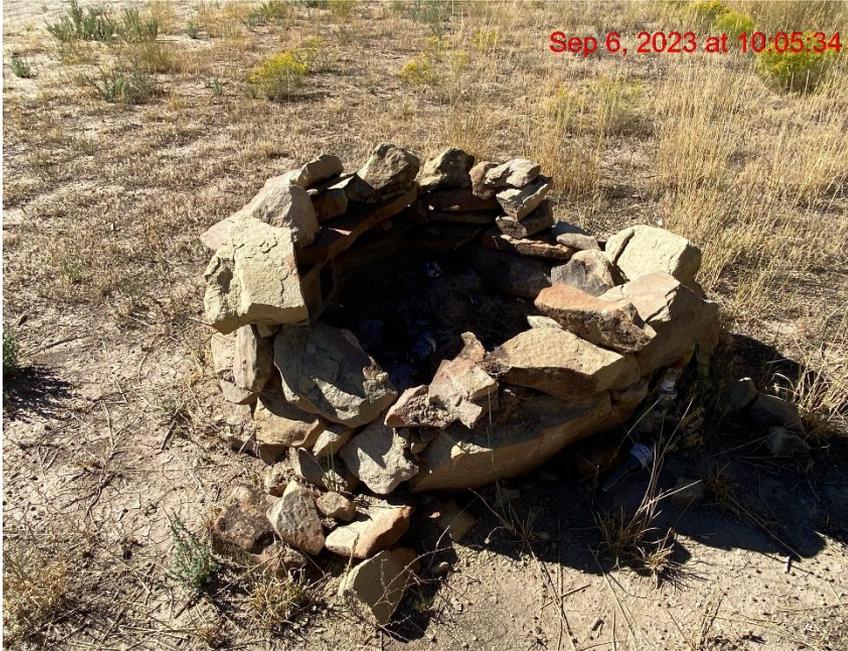
Trash/Debris – Photo #06246

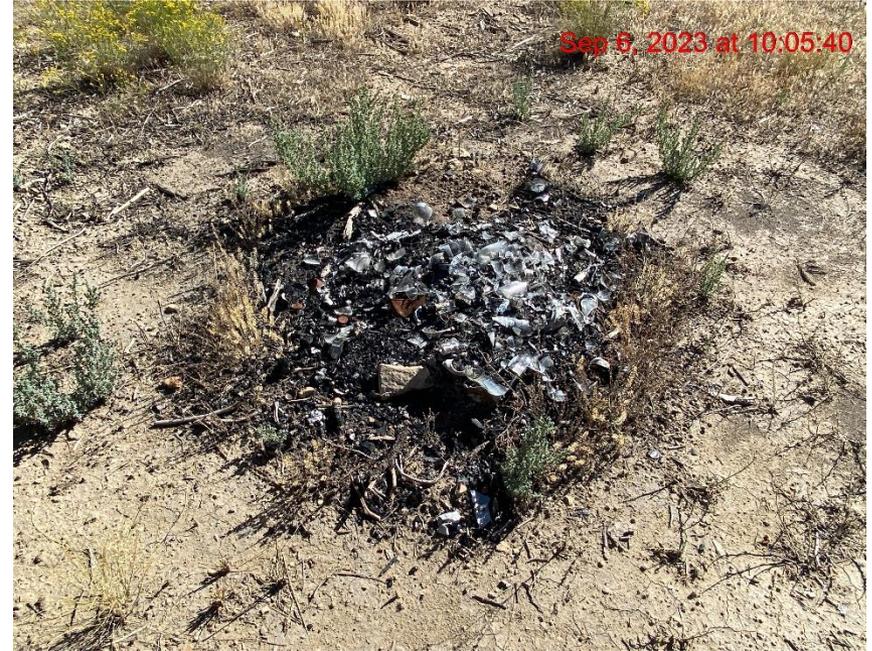
Trash/Debris – Photo #06247

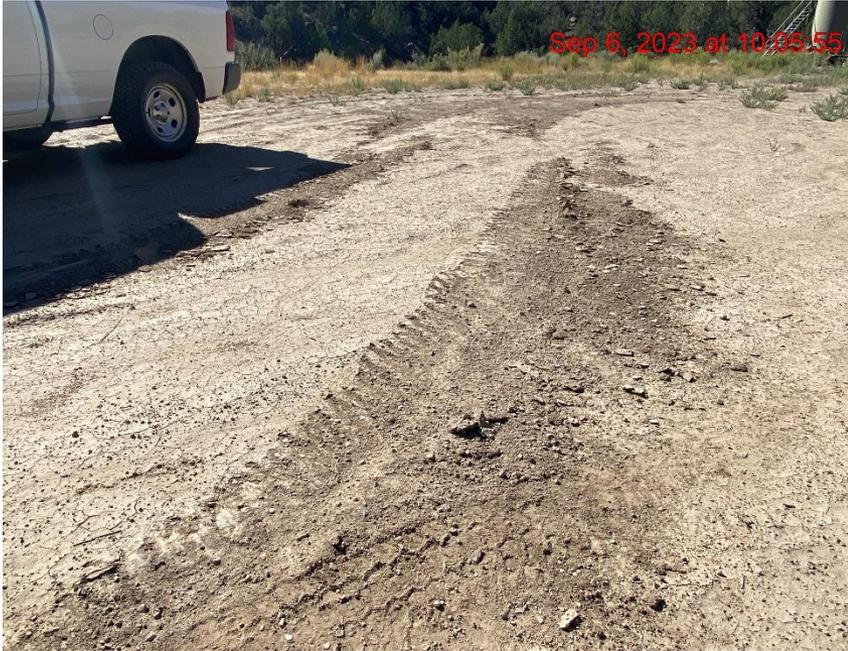
Location Lacks Stabilization – Photo #06248

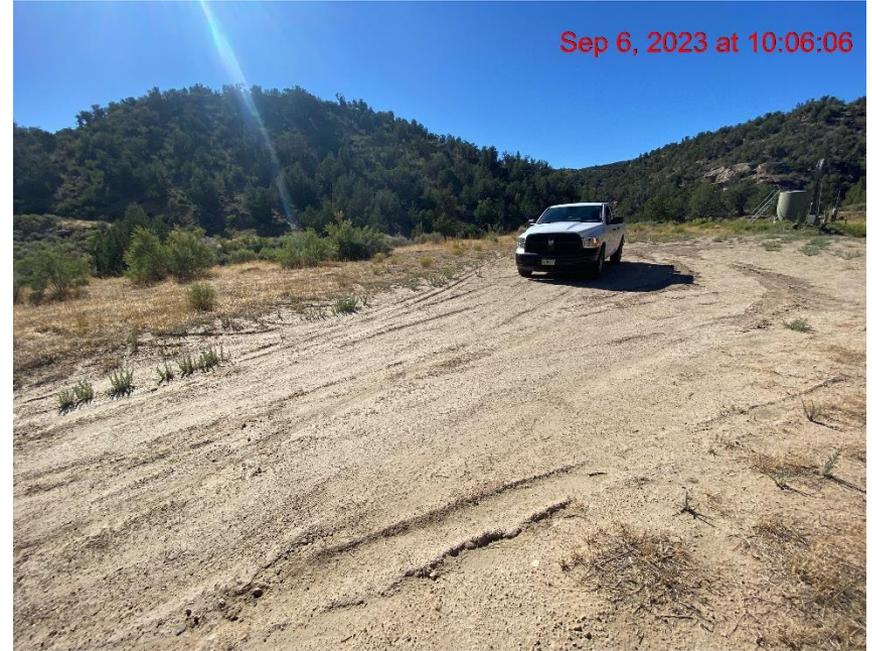
Insufficient Vehicle Tracking BMPs at Location Entrance/Exit – Photo #06249

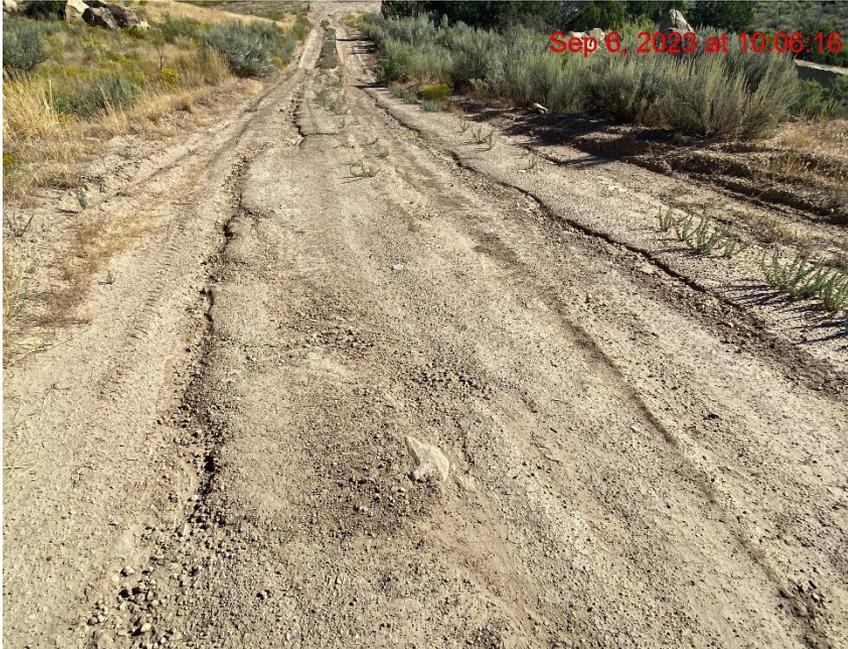
**Insufficient Erosion Control/Rill Erosion on Access Road –
Photo #06250**
