Final Reclamation and Stormwater Inspection

Date: 09/05/2023

Operator: SCHNEIDER ENERGY SERVICES - 76840

Location ID: 394686

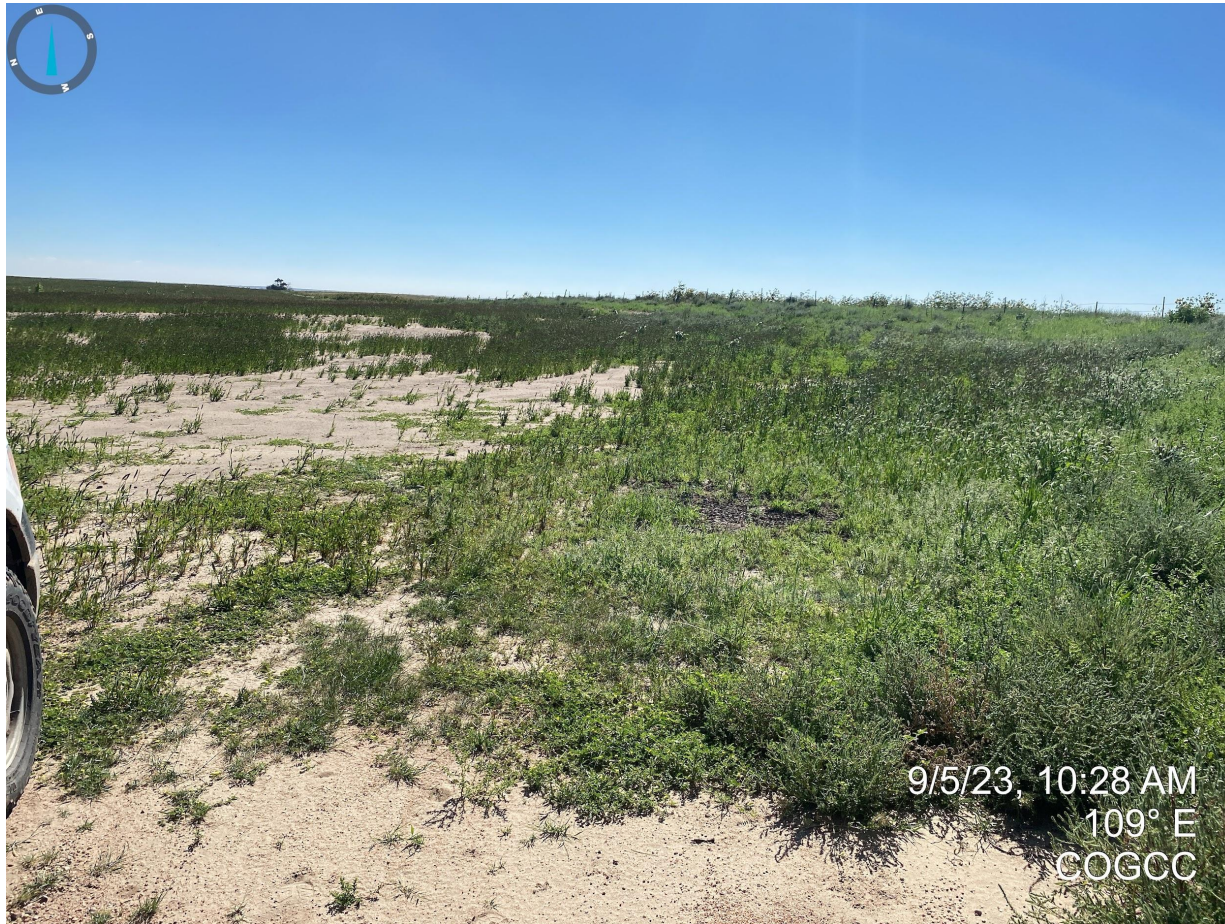
Photo 1. Taken from the entrance to the former location. It does not appear the former access road has been reclaimed with evidence of bare/exposed soils and undesirable vegetation. Additional reclamation activities are required for the former access road.

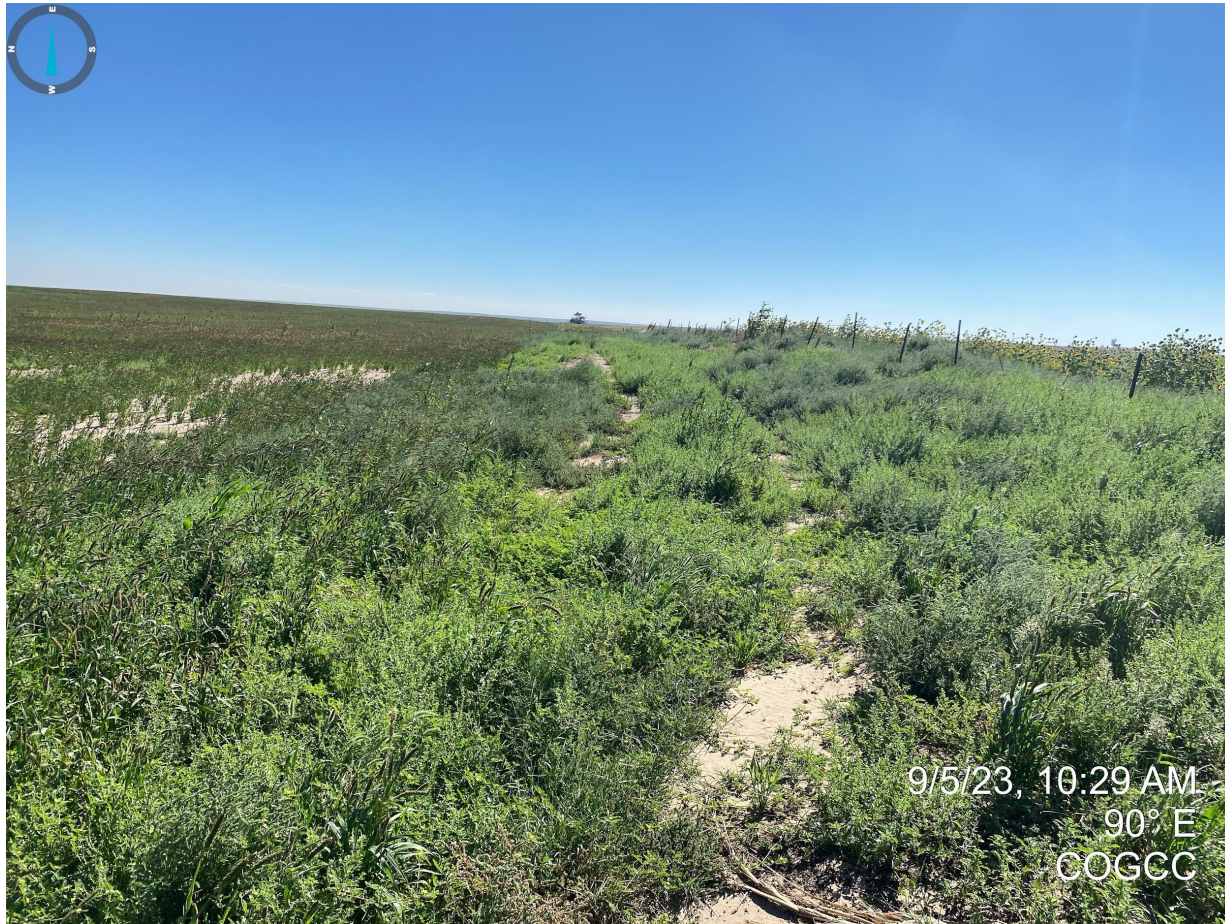
Photo 2. Taken from the former access road. See comments in Photo 1.

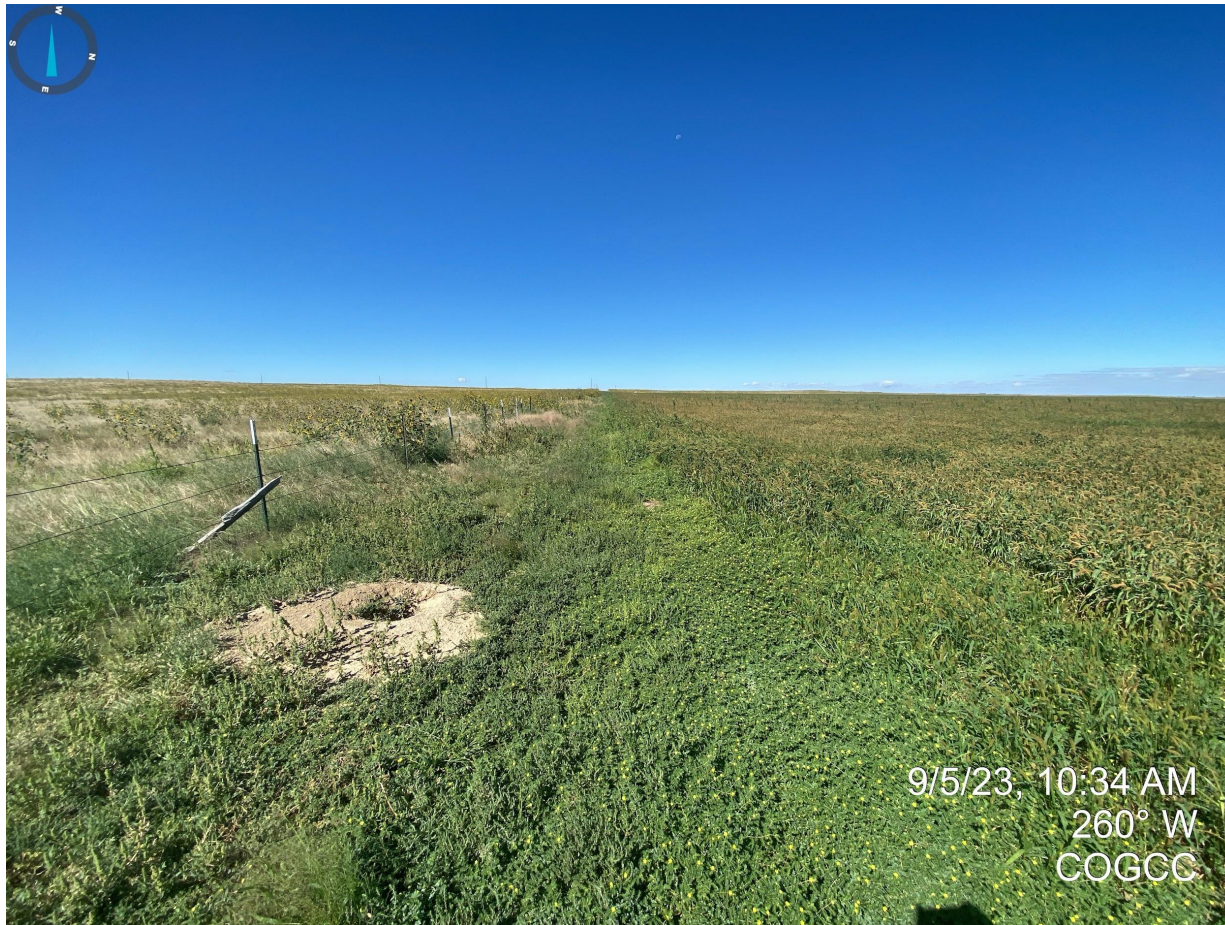
Photo 3. Facing west from the easternmost point of the access road; see comments in Photo 1.

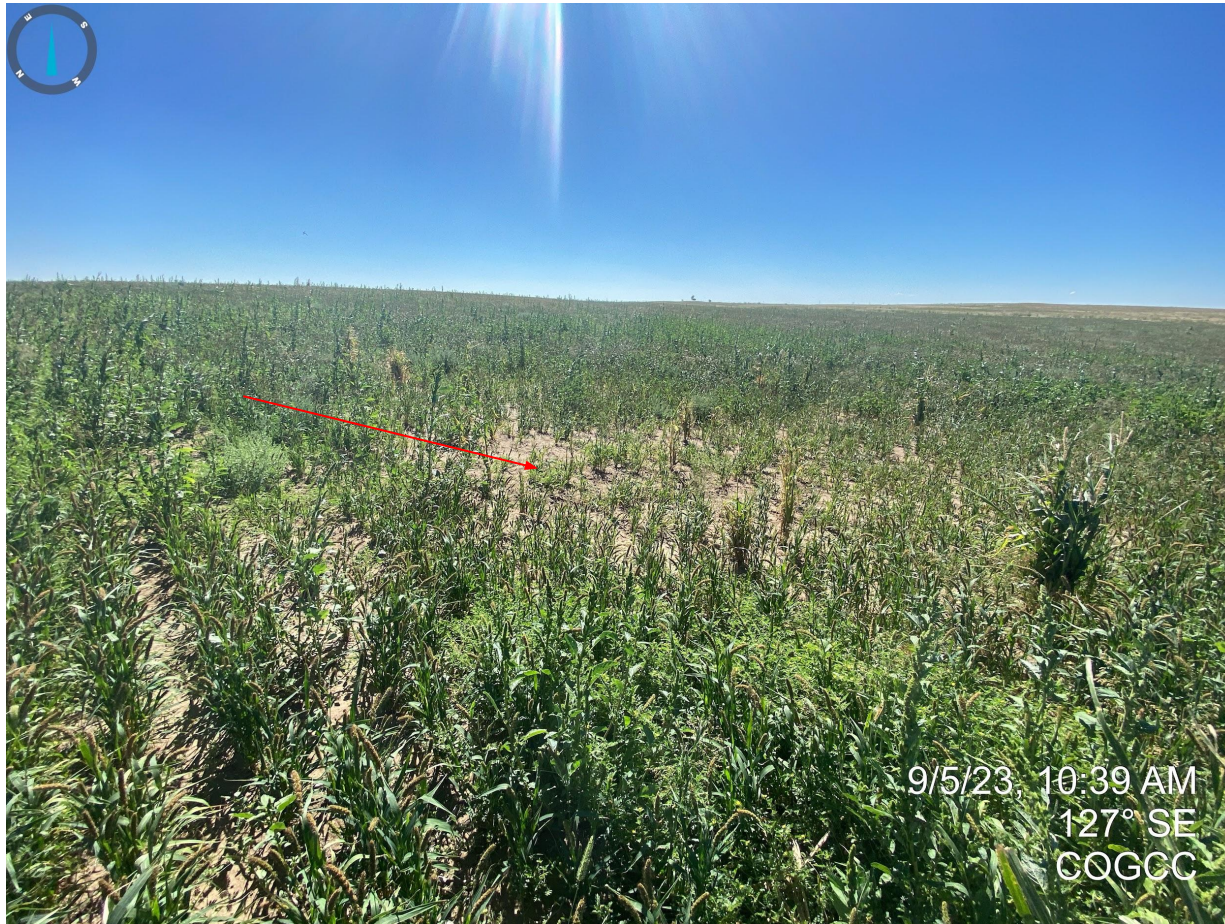
Photo 4. Taken from the former location, near the well. Non-uniform vegetative cover resulting in stunted crop growth and areas of bare/exposed soils.

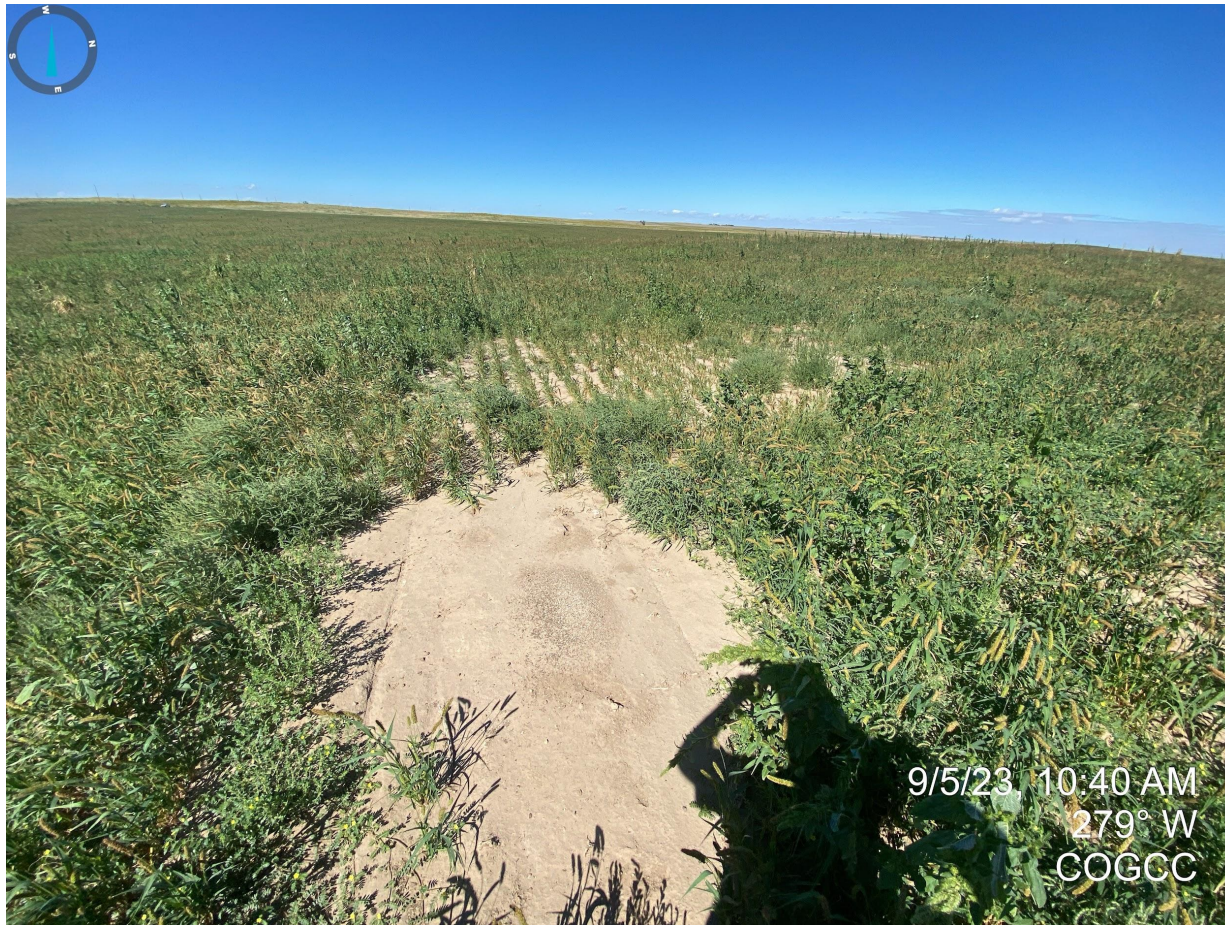
Photo 5. Bare/exposed soils and undesirable vegetation (e.g. russian thistle and kochia) observed throughout the reclaimed area.

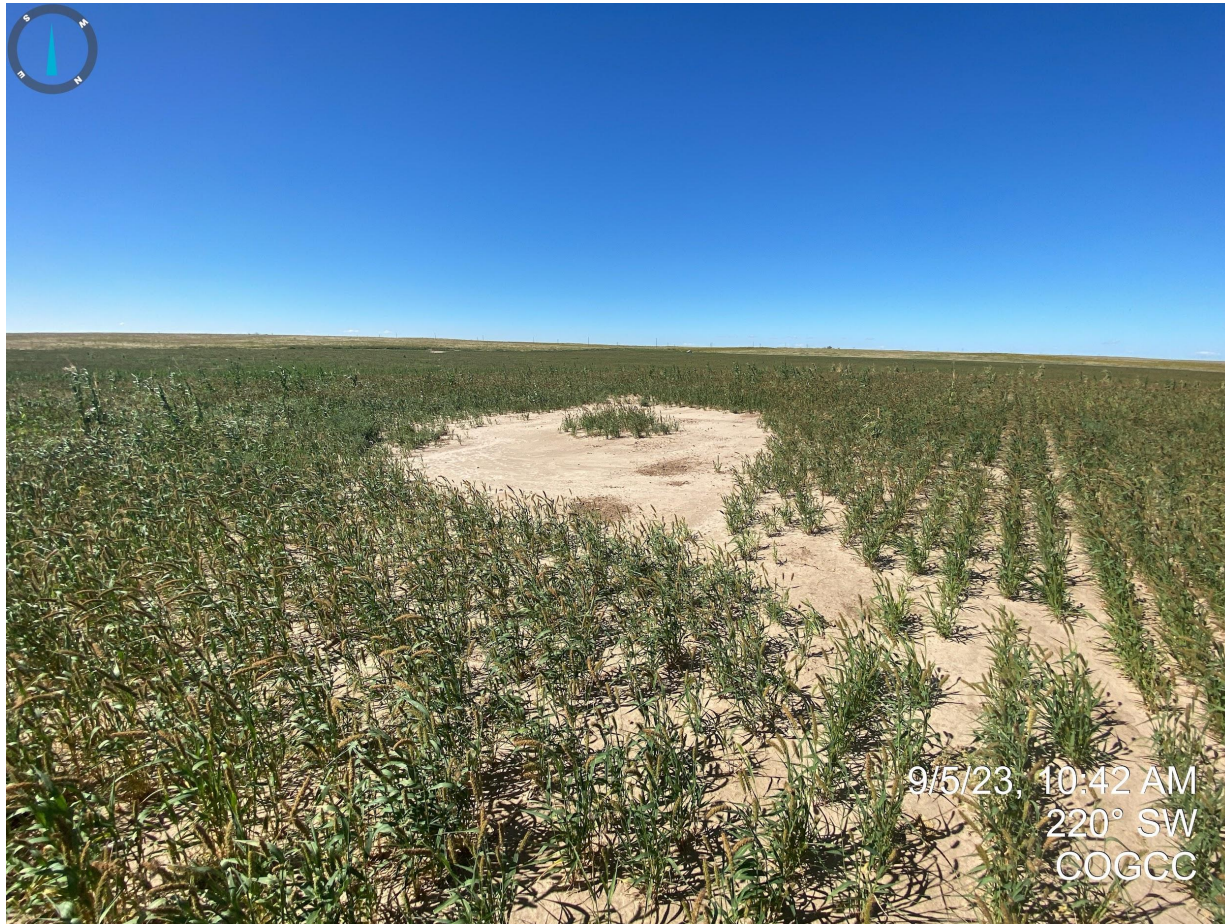
Photo 6. See comments in Photos 4 & 5.

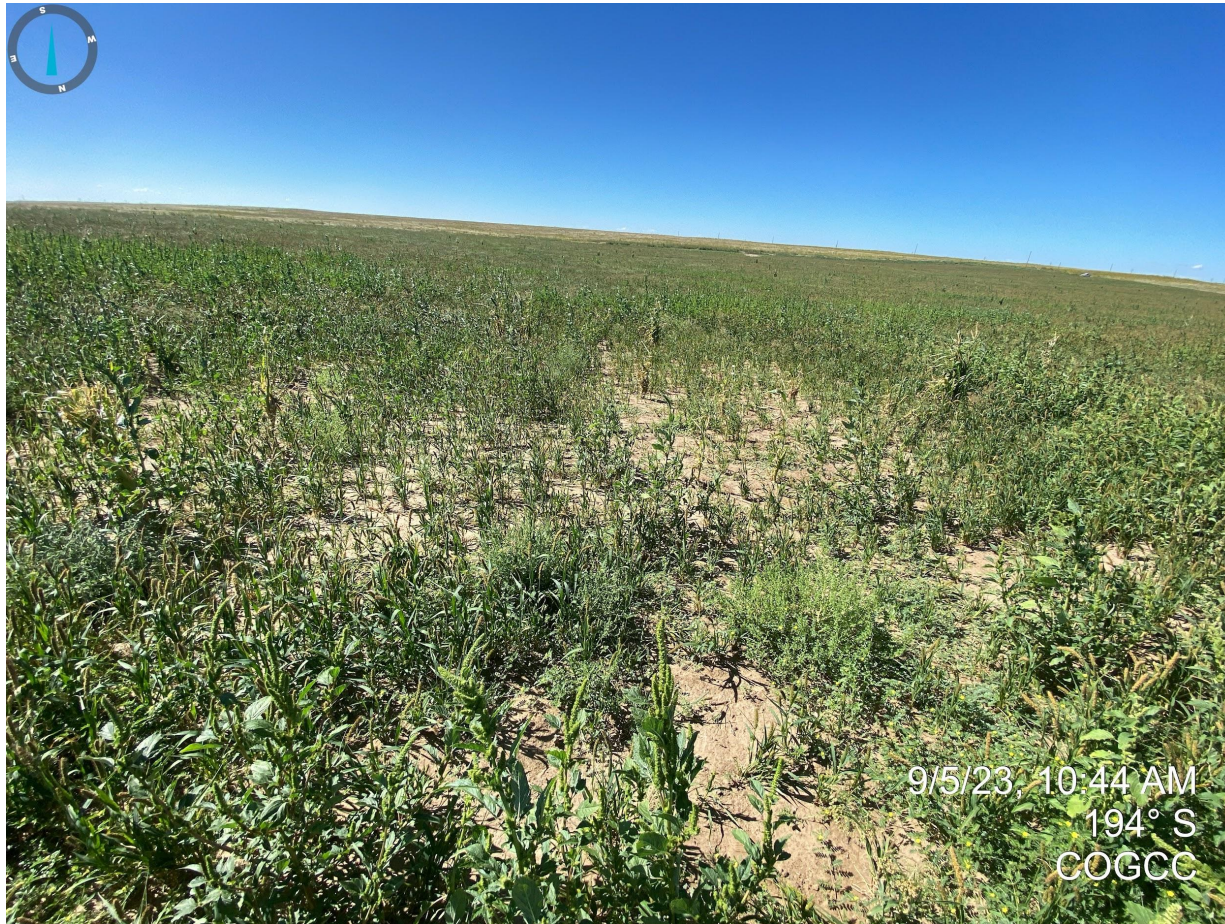
Photo 7. See comments in Photos 4 & 5.

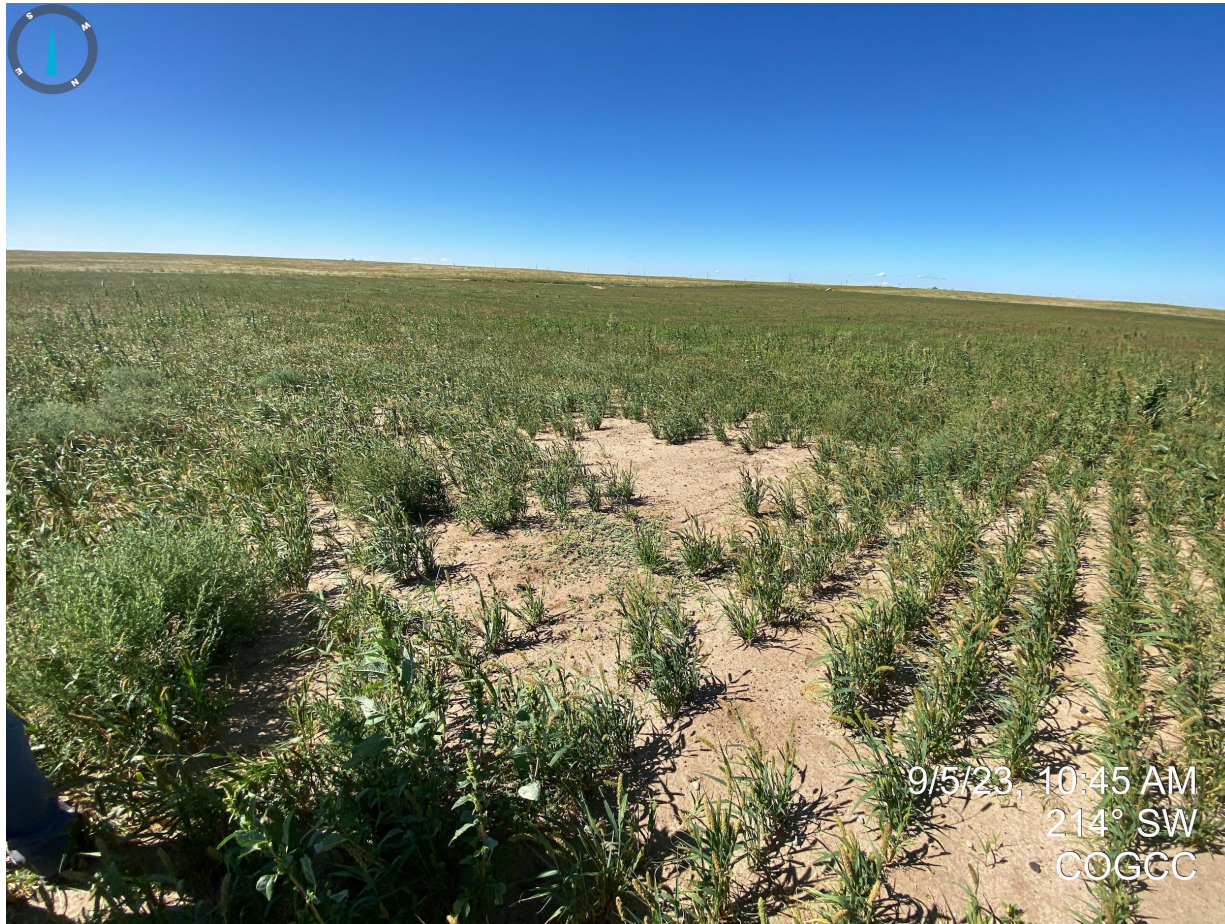
Photo 8. Taken near the former pit location; see comments in Photos 4 & 5.

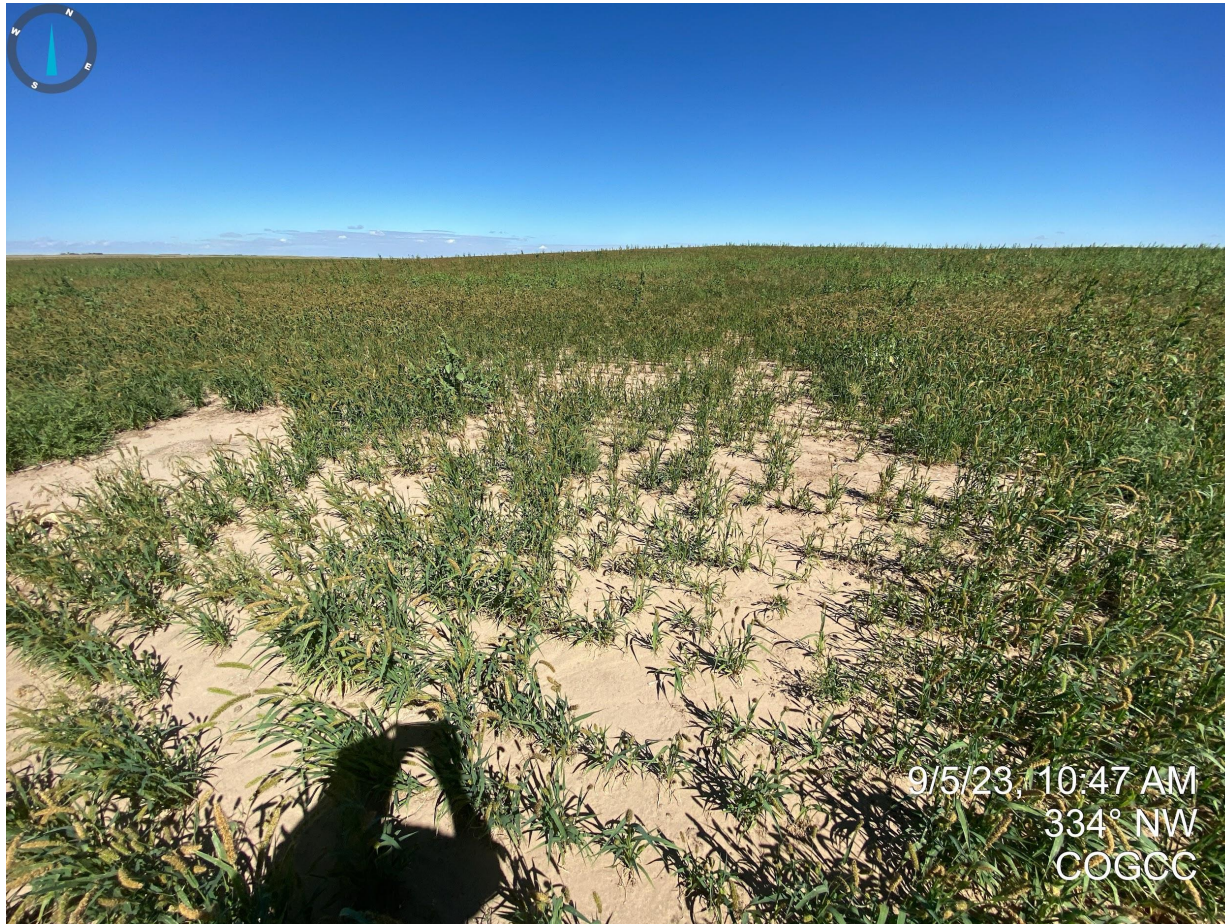
Photo 9. See comments in Photos 4 & 5.

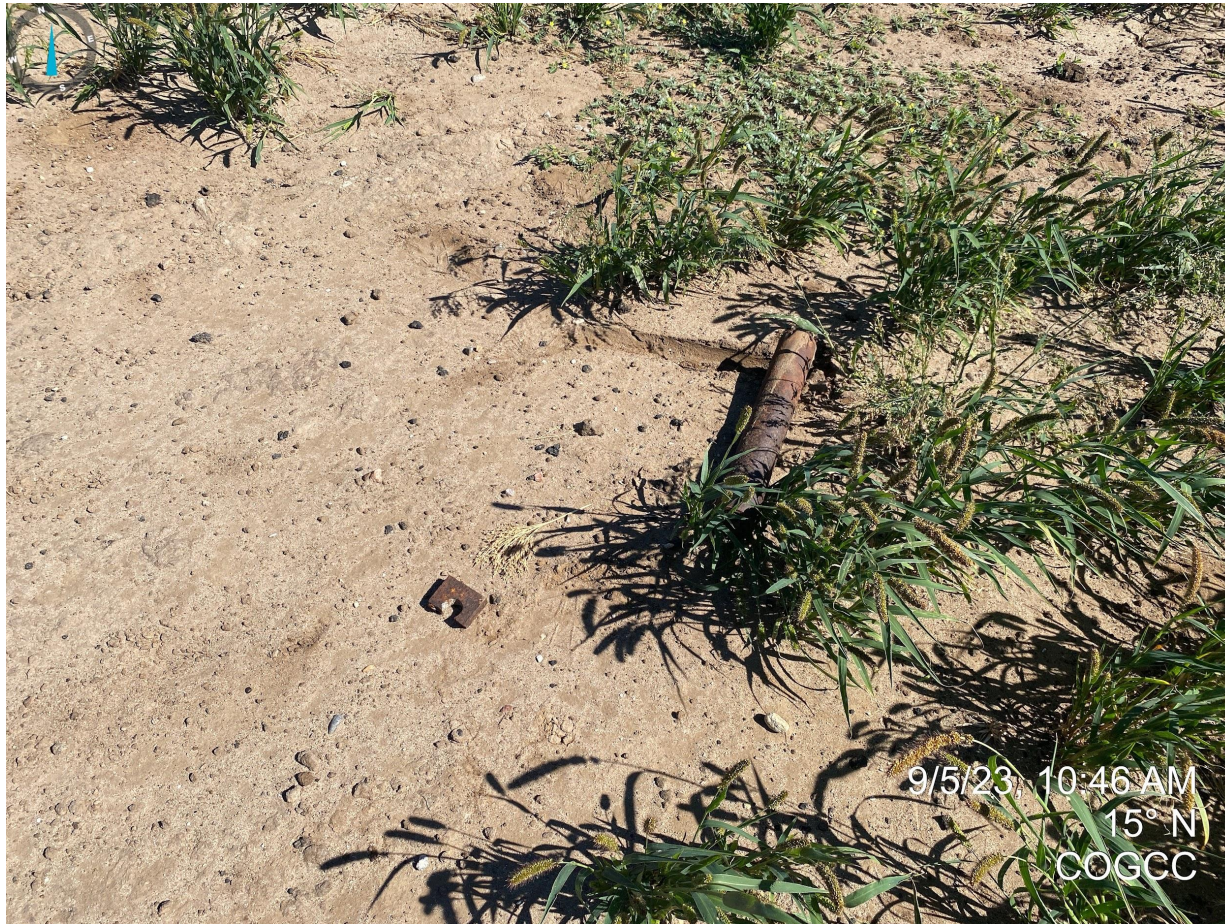
Photo 10. Debris remains on location.

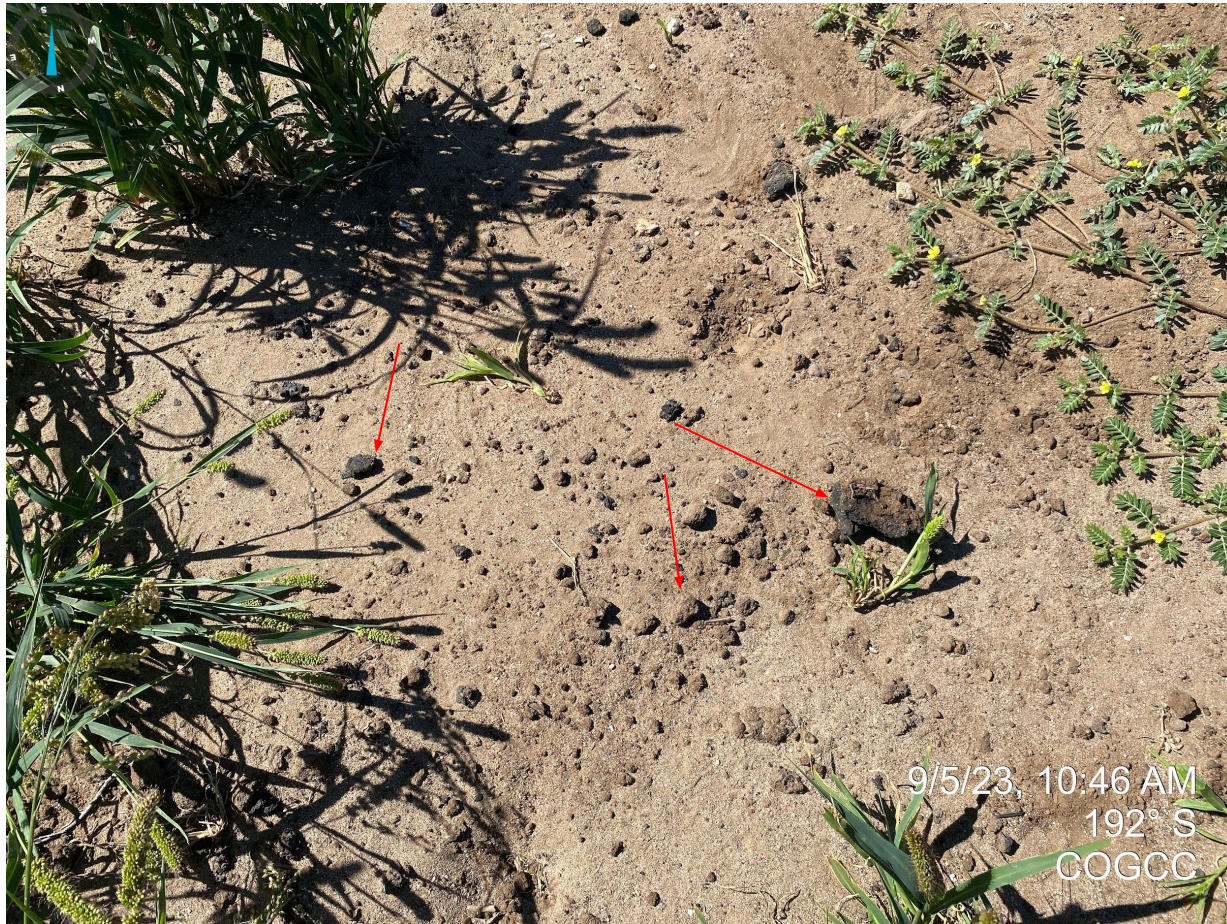
Photo 11. Stained soils (w/hydrocarbon odors) observed near the former pit location.
