Final Reclamation and Stormwater Inspection

Operator: SCHNEIDER ENERGY SERVICES INC - 76840

Location ID: 395432

Inspection Document #: 708200538

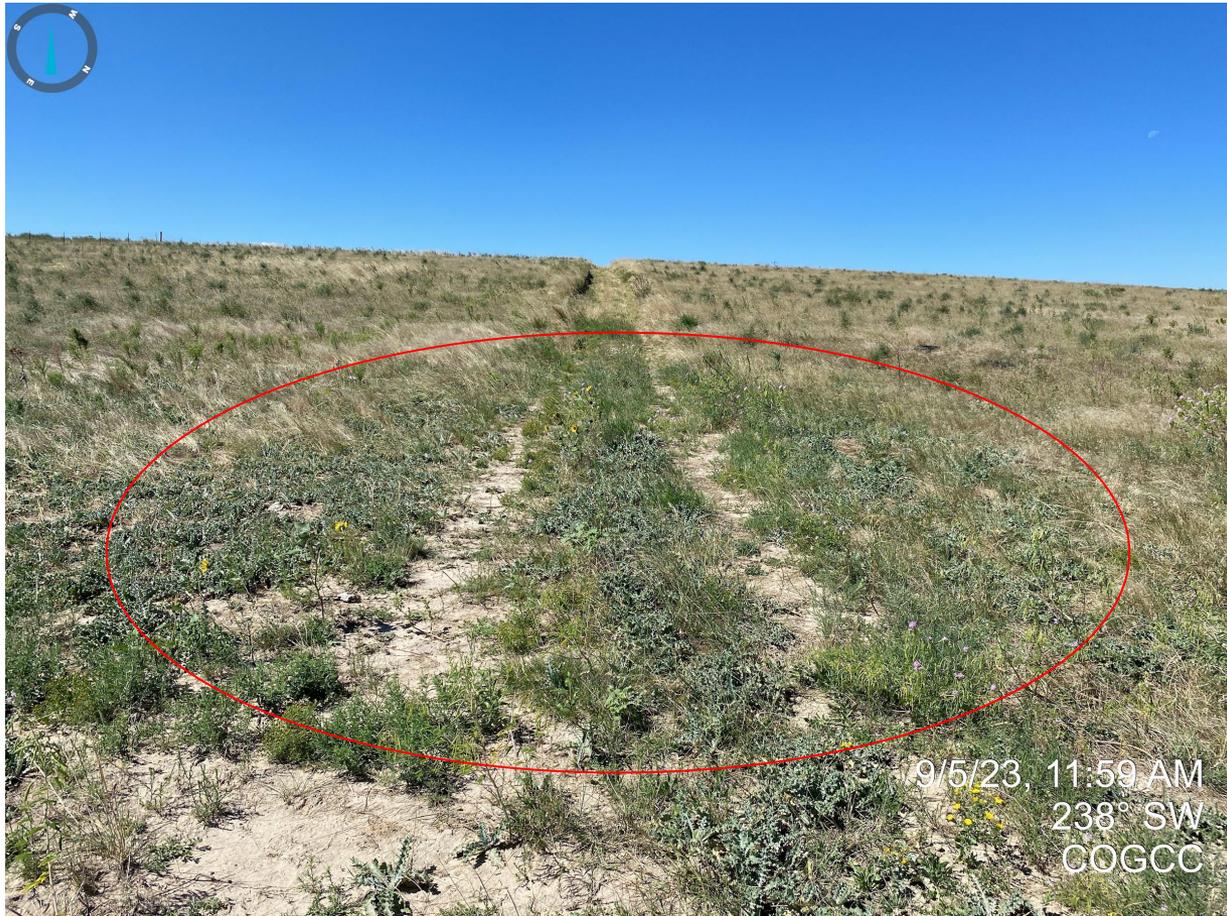
Photo 1. Taken from the access road. Evidence of CO List B Noxious weed (scotch thistle) observed within lease road

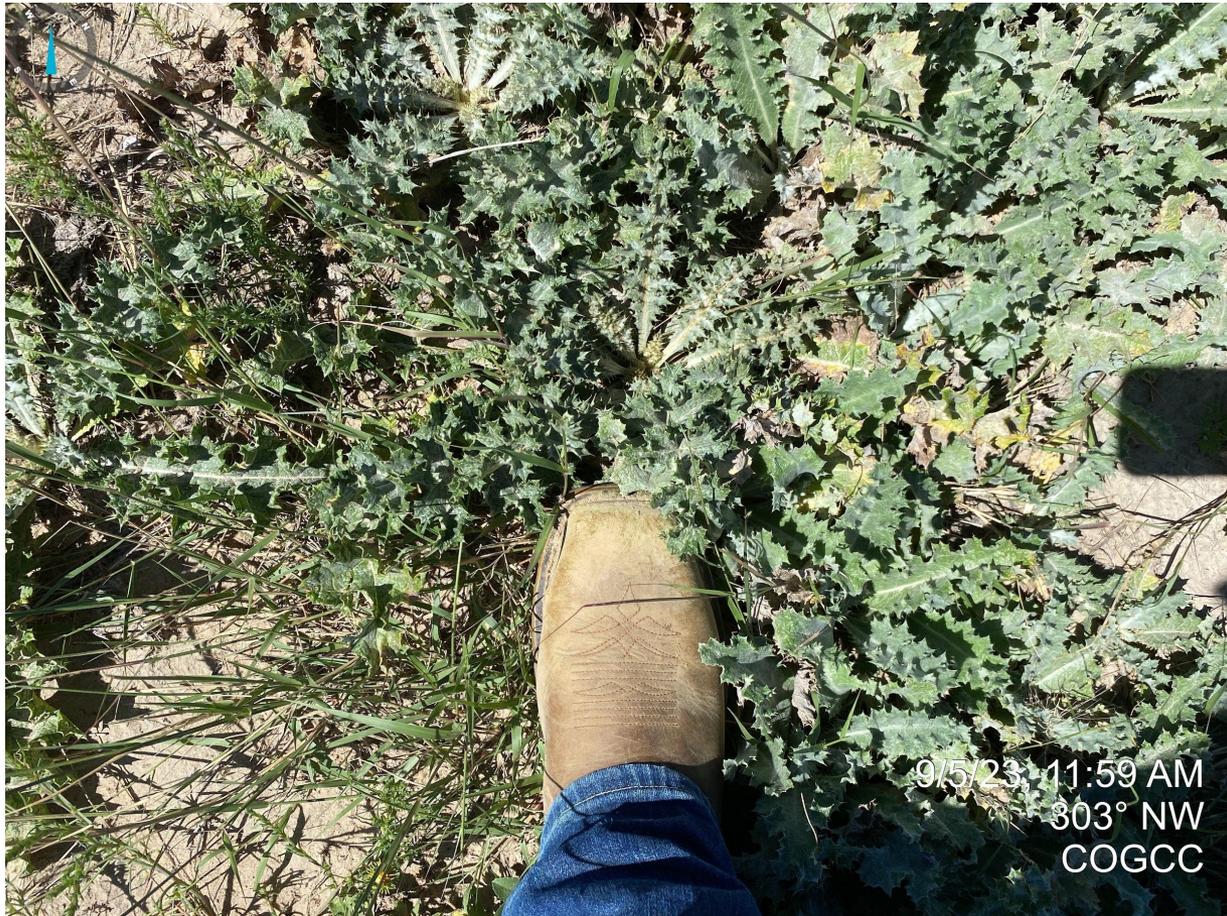
Photo 2. Close up of Scotch thistle; see comments in Photo 1.

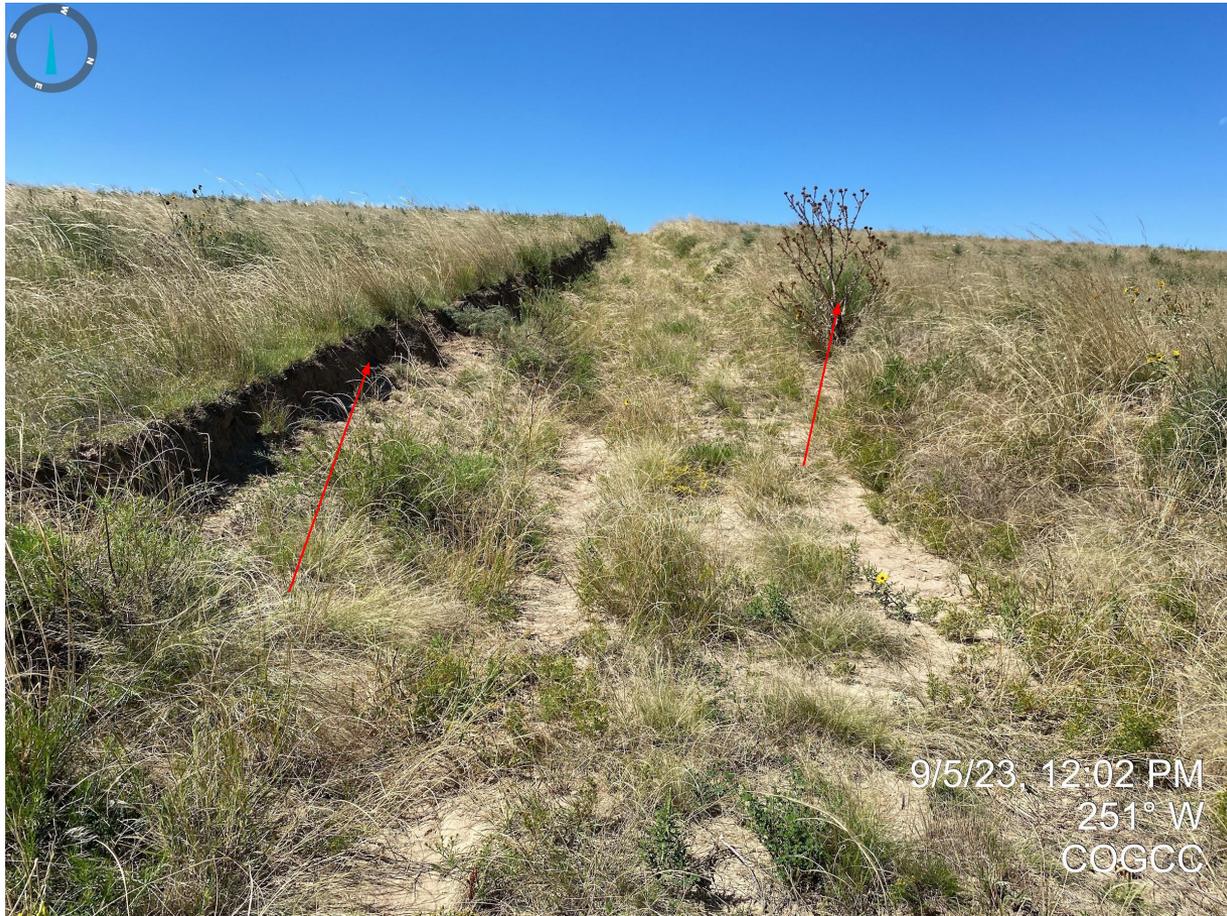
Photo 3. The former access road does not appear to have been reclaimed with evidence of contouring issues. Also pictured, Scotch thistle.

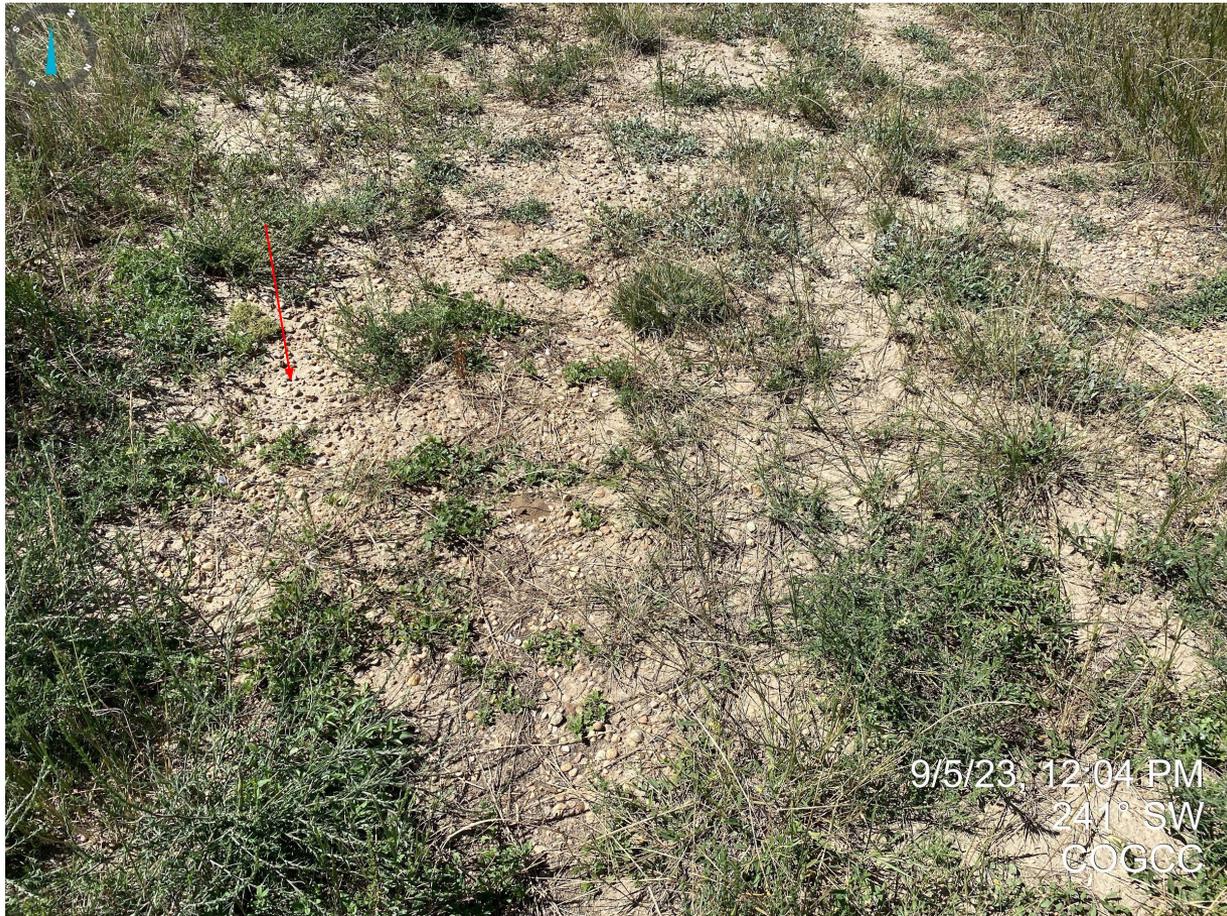
Photo 4. Road base/gravel remains throughout portions of the location and will need to be removed.

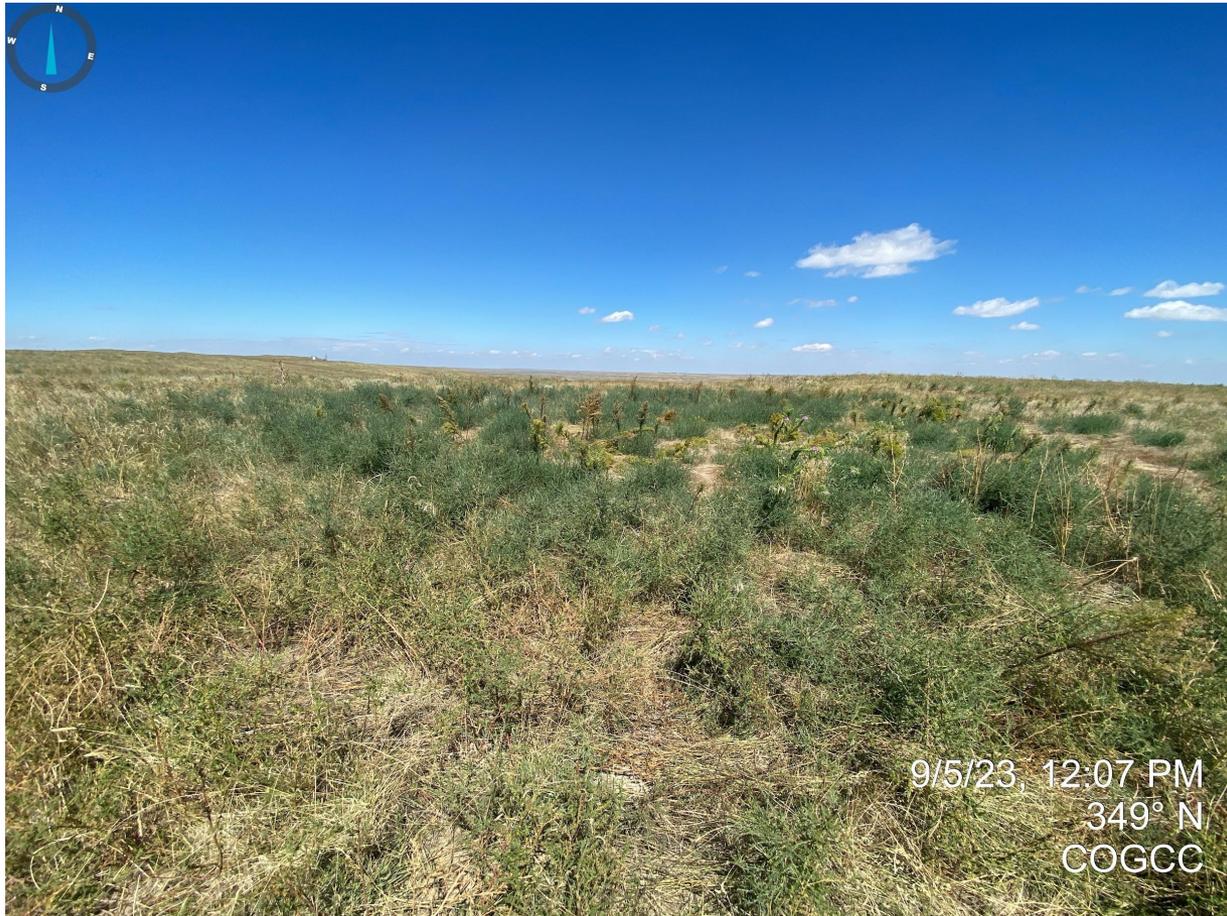
Photo 5. Area south of the access road. Undesirable vegetation (e.g. russian thistle and kochia; and CO List C Noxious weed- cheatgrass) was observed to be growing throughout.

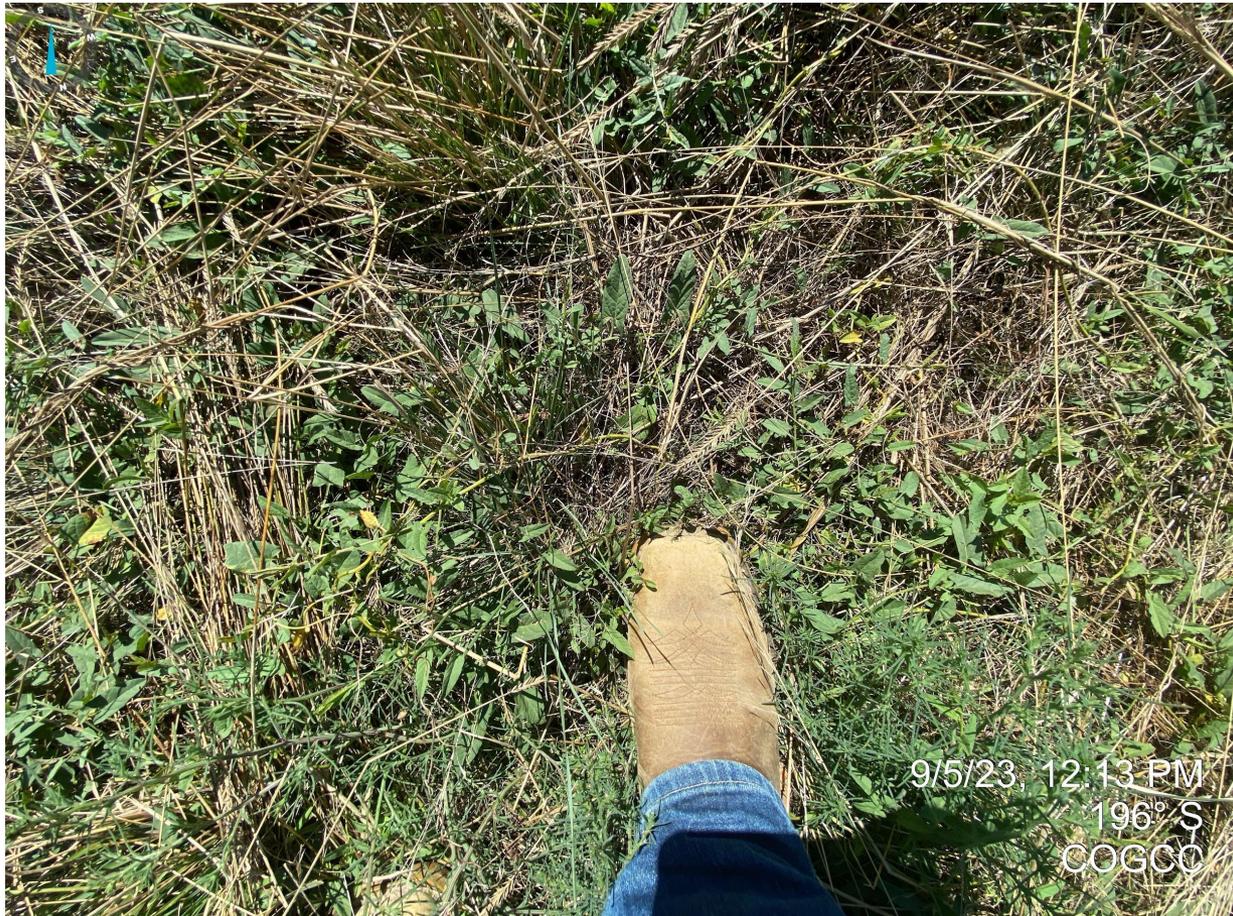
Photo 6. Close up photo of Colorado List C Noxious weed- Field bindweed.

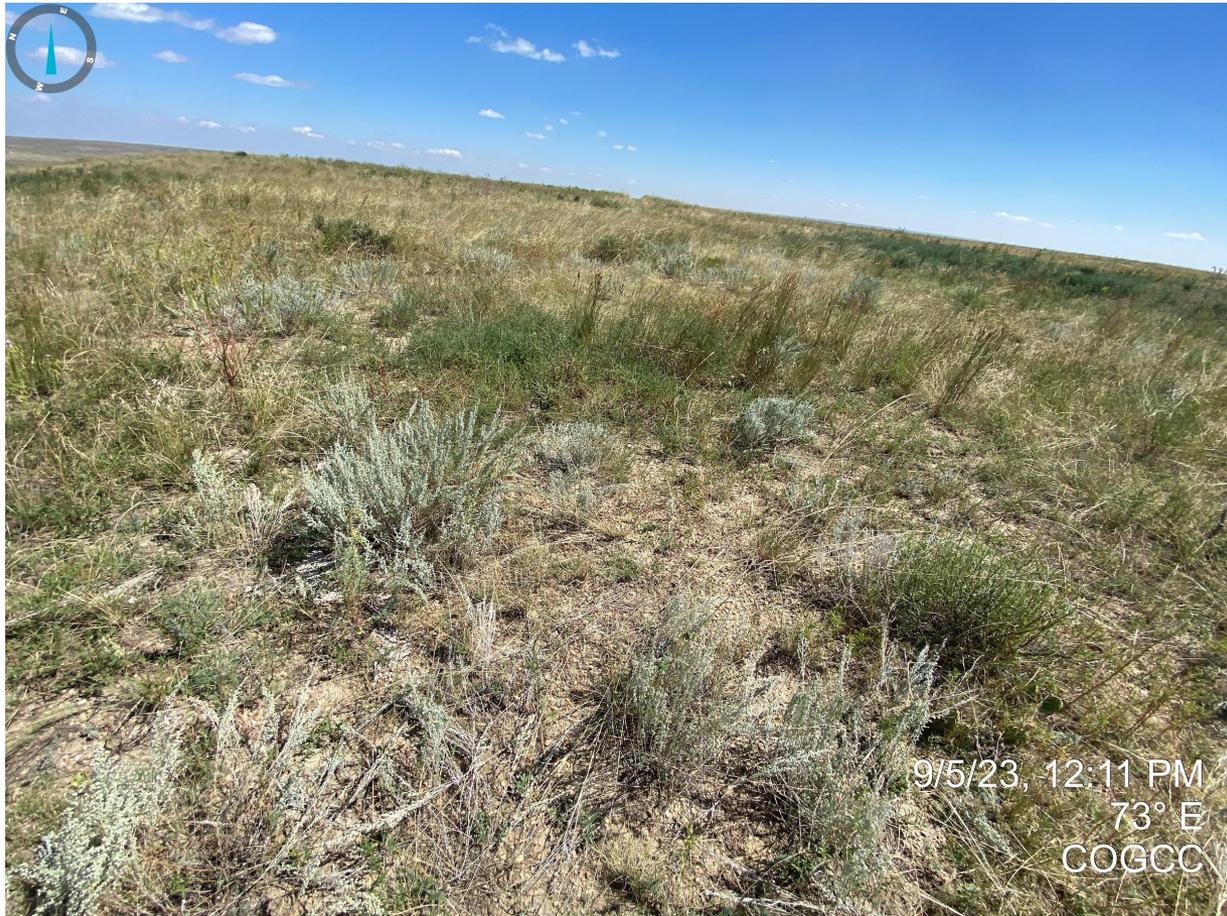
Photo 7. Area north of access road; Some desirable perennial vegetation was observed within the former pit area as well as areas of non-uniform vegetative cover and road base/gravel were evident.
