# Final Reclamation and Stormwater Inspection

Operator: SCHNEIDER ENERGY SERVICES INC- 76840

Location ID: 313840

Inspection Document #: 708200539

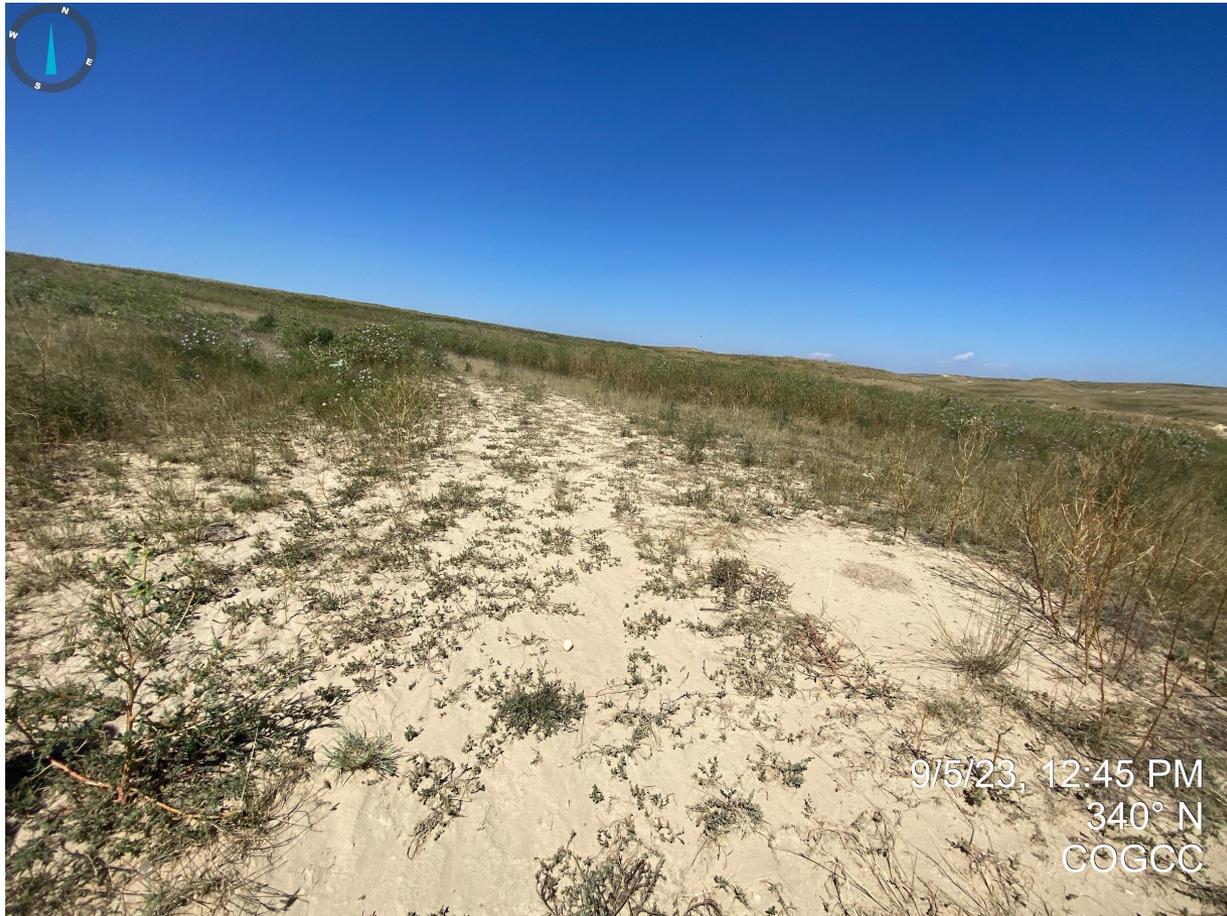
**Photo 1.** The access road entrance requires additional reclamation activities as bare/exposed soils and undesirable vegetation were evident during this inspection.

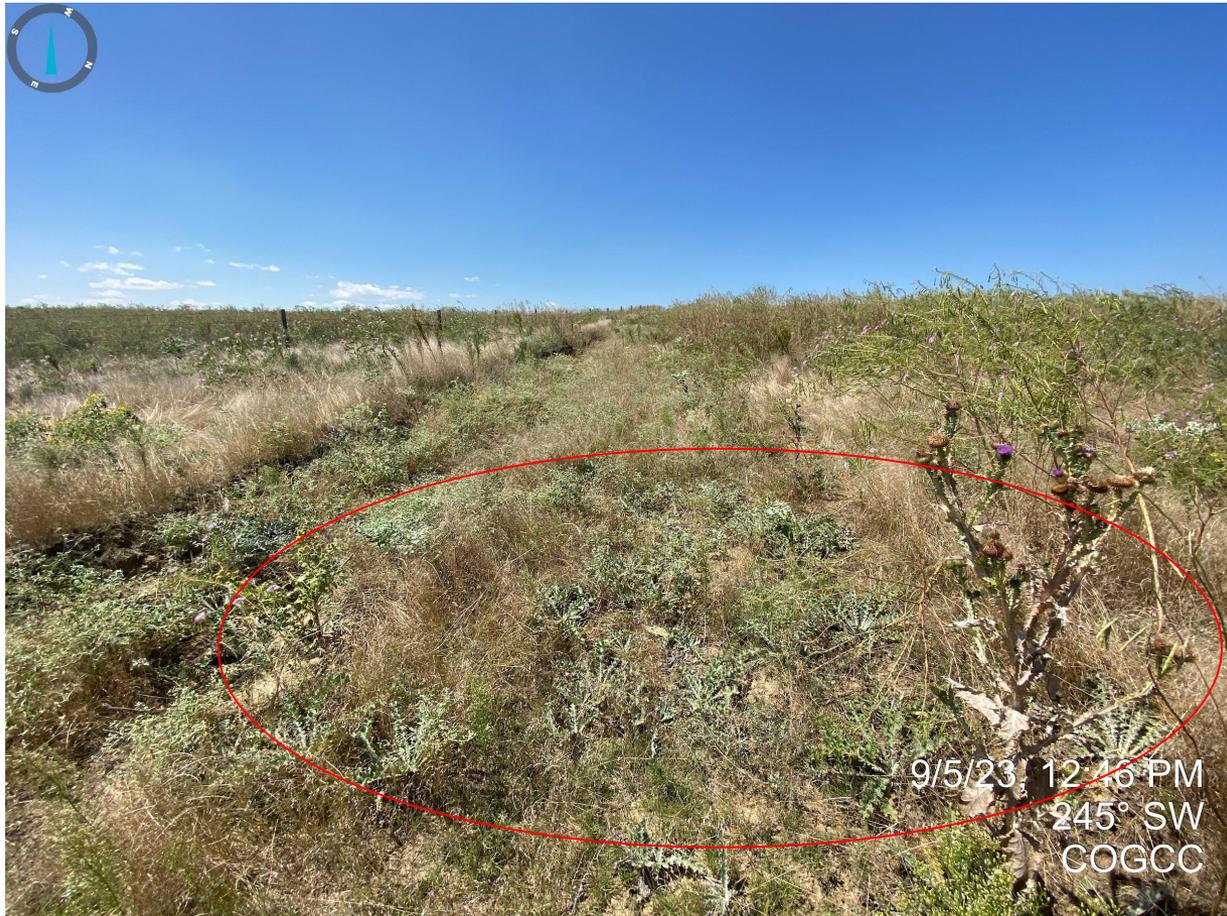
**Photo 2.** Colorado List B Noxious Weed- Scotch Thistle observed to be growing along the former access road; this weed species requires active and immediate management to prevent spread onto adjacent lands.

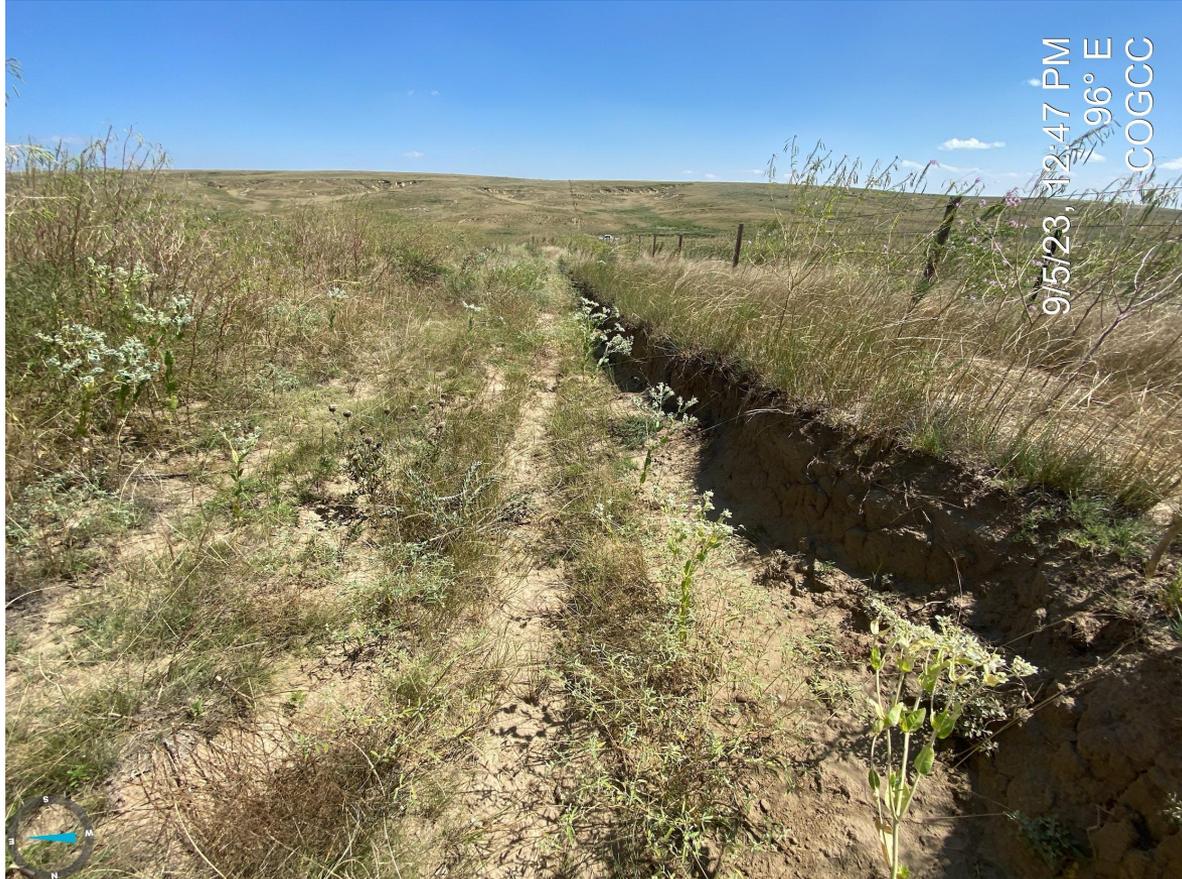
**Photo 4.** The former access road requires additional contouring and grading; cut banks illustrated.

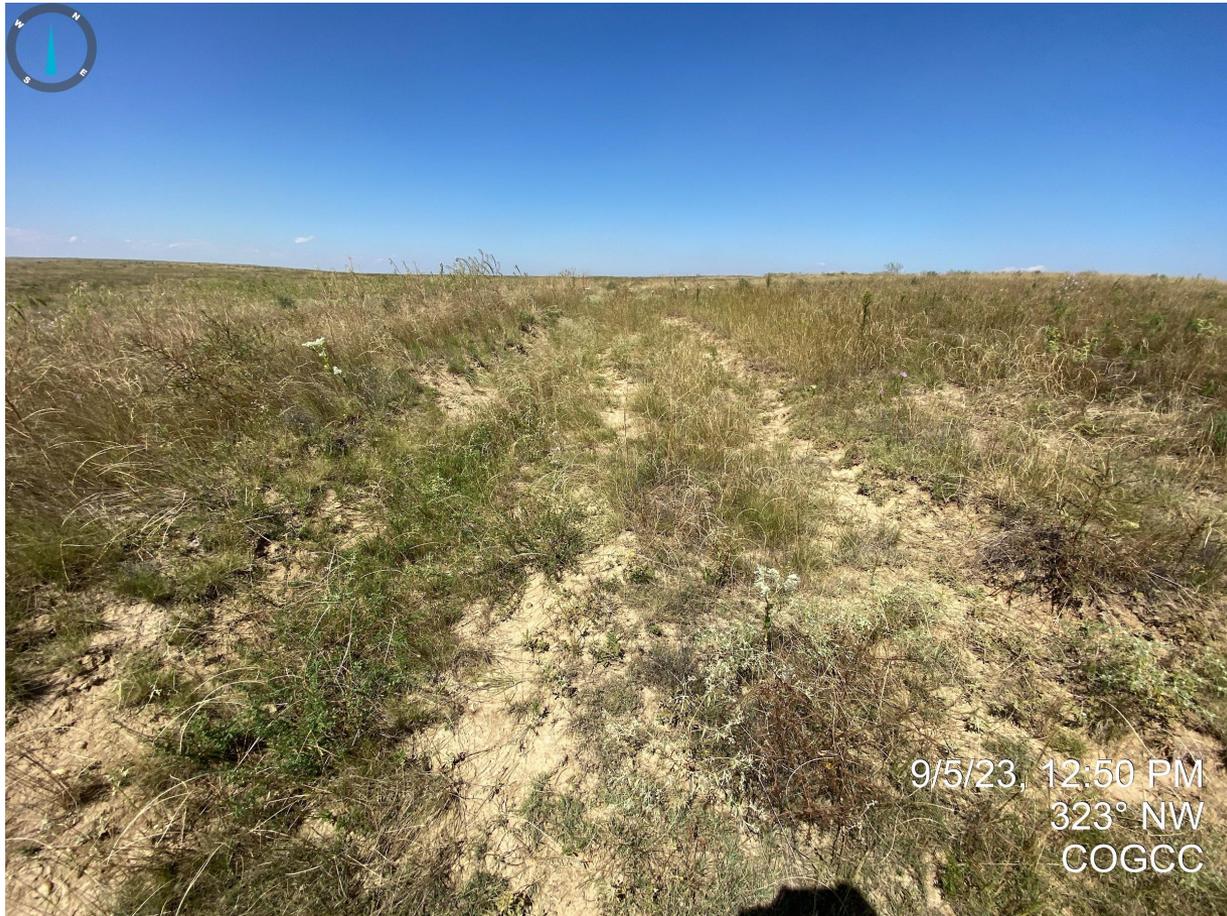
**Photo 4.** Access road south of the location; see comments in Photo 3.

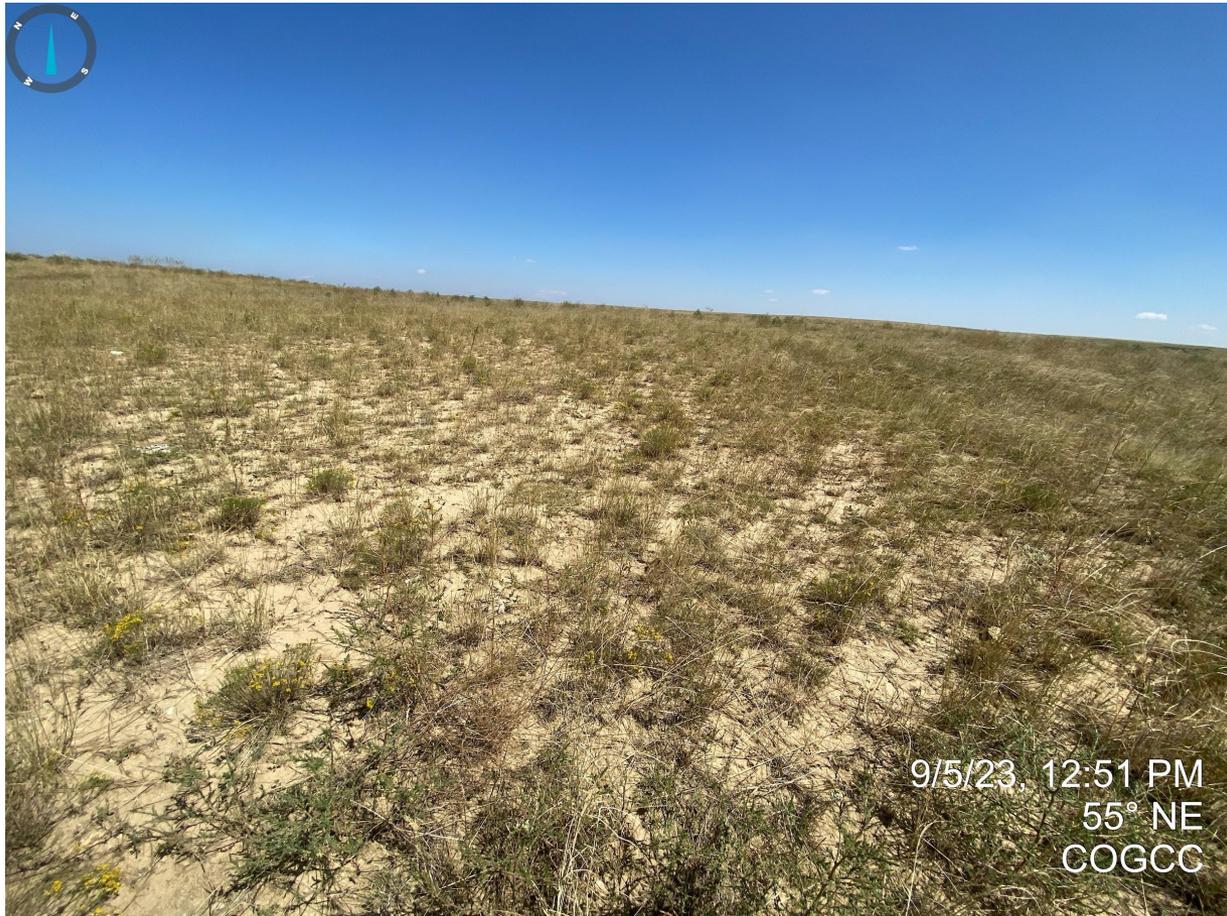
**Photo 5.** The former tank battery area is not progressing towards Rule 1004 regulations and standards as illustrated by non-uniform vegetation cover resulting areas of bare/exposed soils.

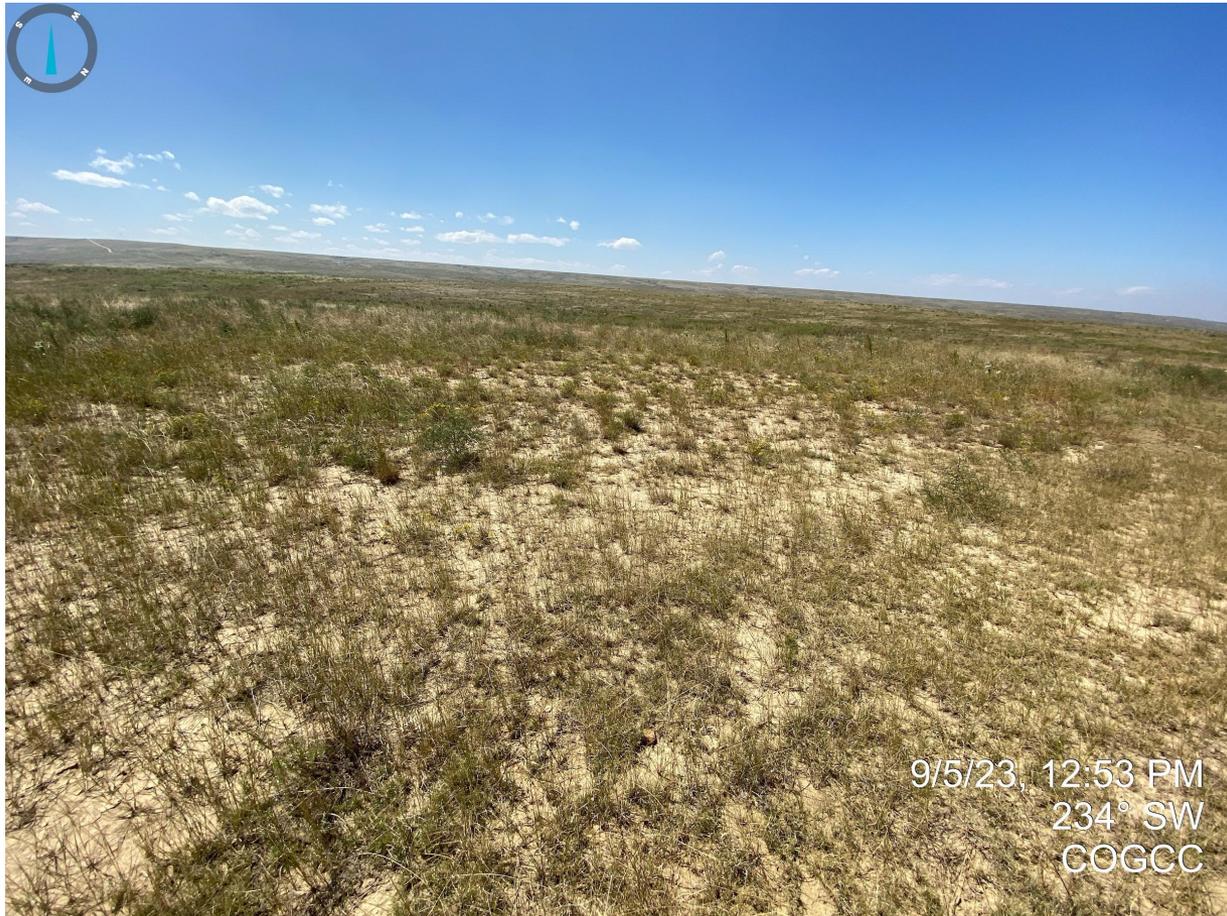
**Photo 6.** Taken from the northern portion of the location; see comments in Photo 5.

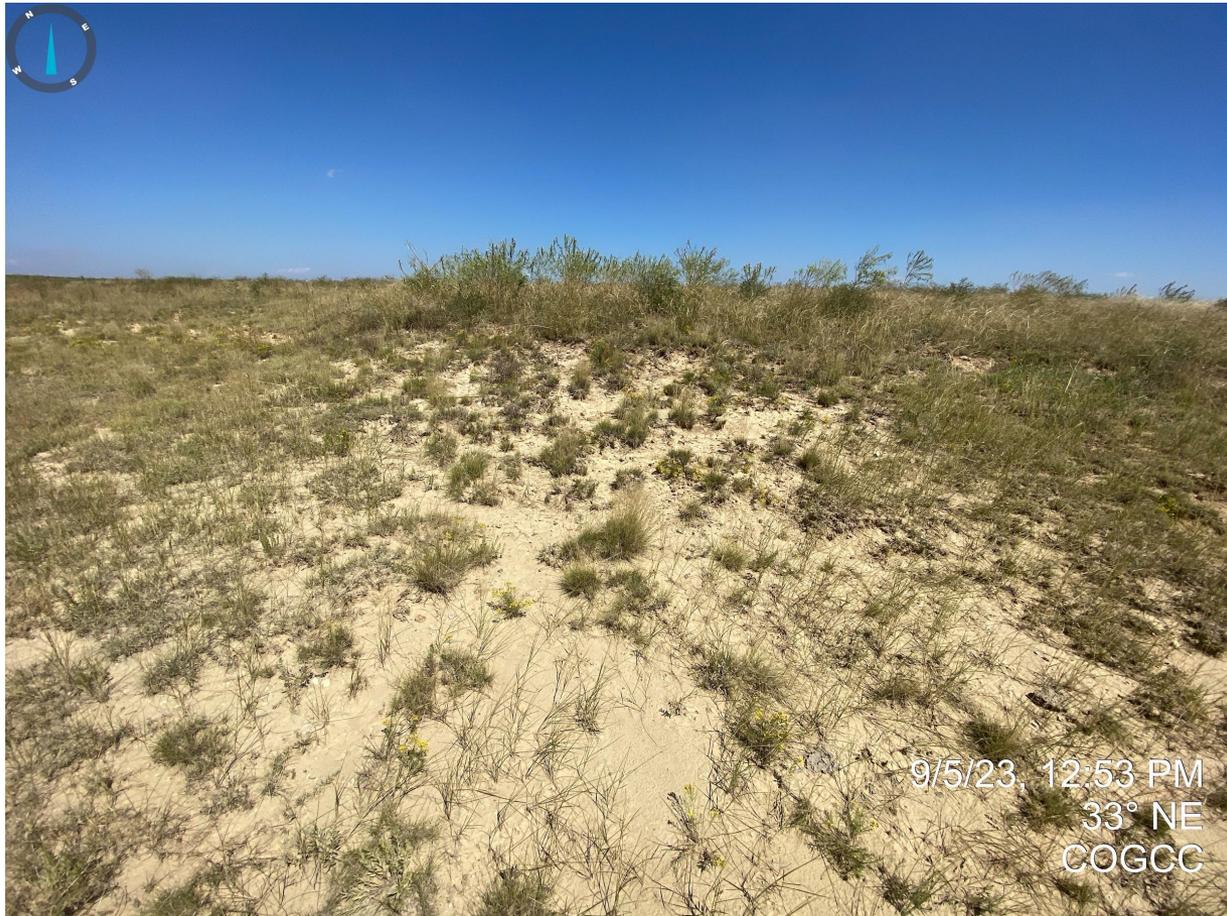
**Photo 7.** Taken from the northern portion of the location. The cut banks are predominantly bare/exposed soils and require additional contouring within the former wellhead area.

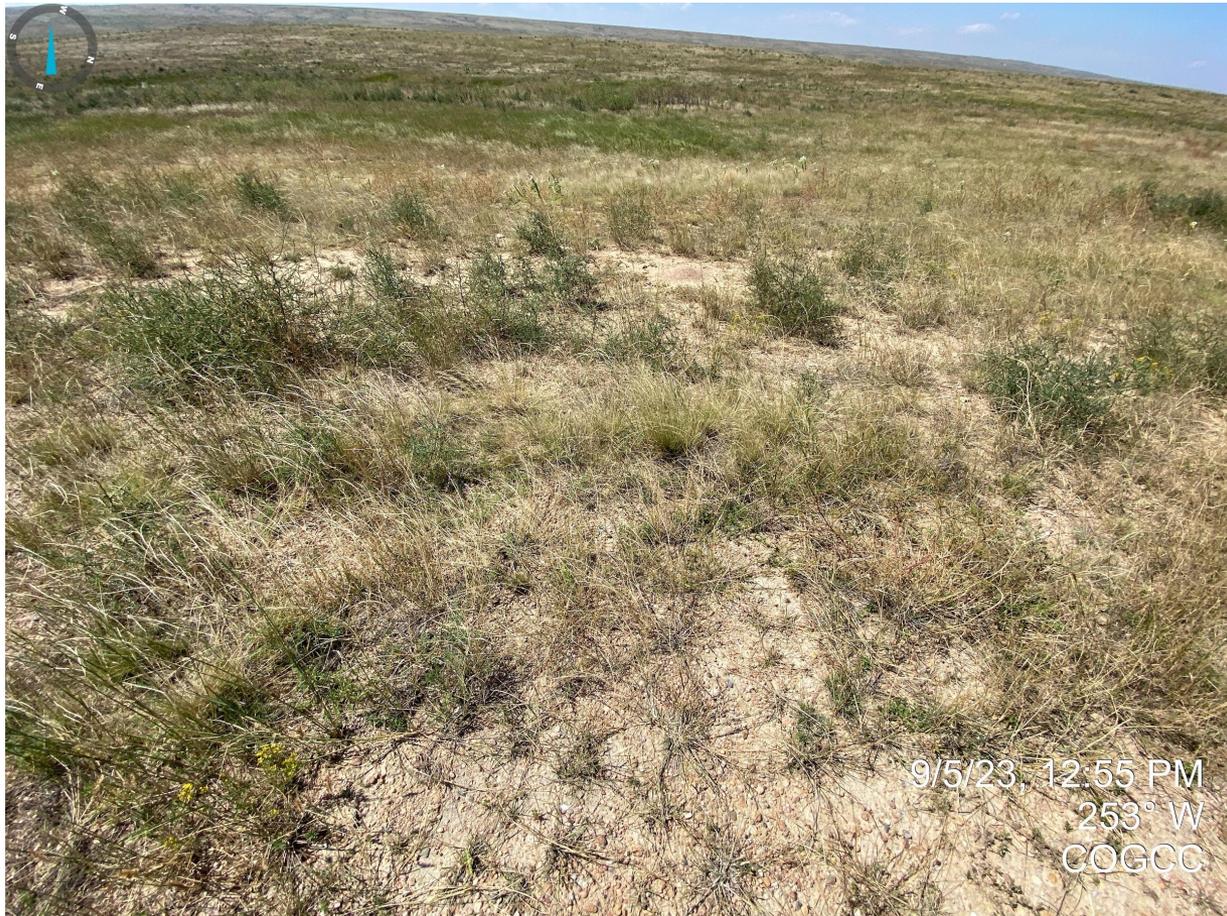
**Photo 8.** Taken west of the former wellhead. Non-uniform vegetative cover and the presence of undesirable vegetation (e.g. russian thistle) pictured.

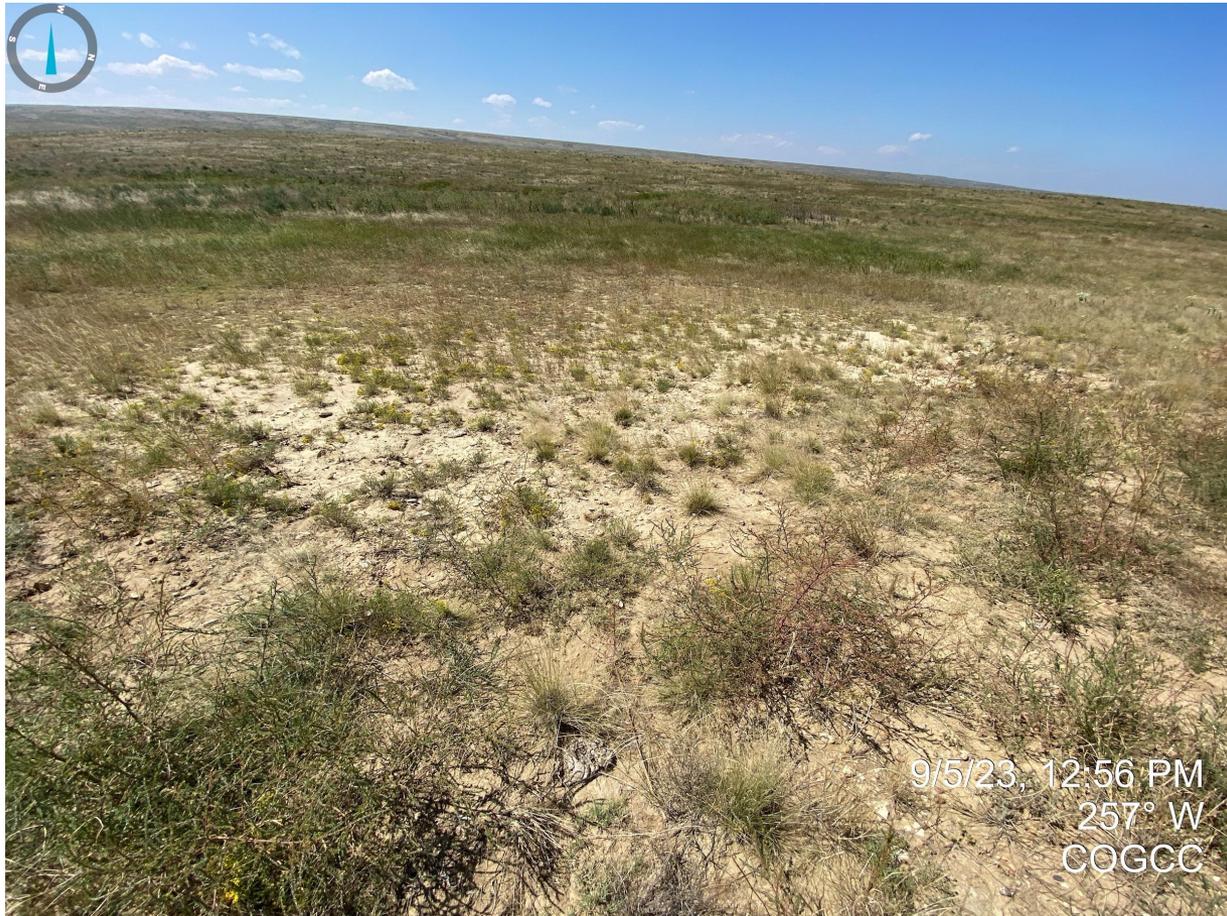
**Photo 9.** Taken near the former pit location. See comments in Photo 8.

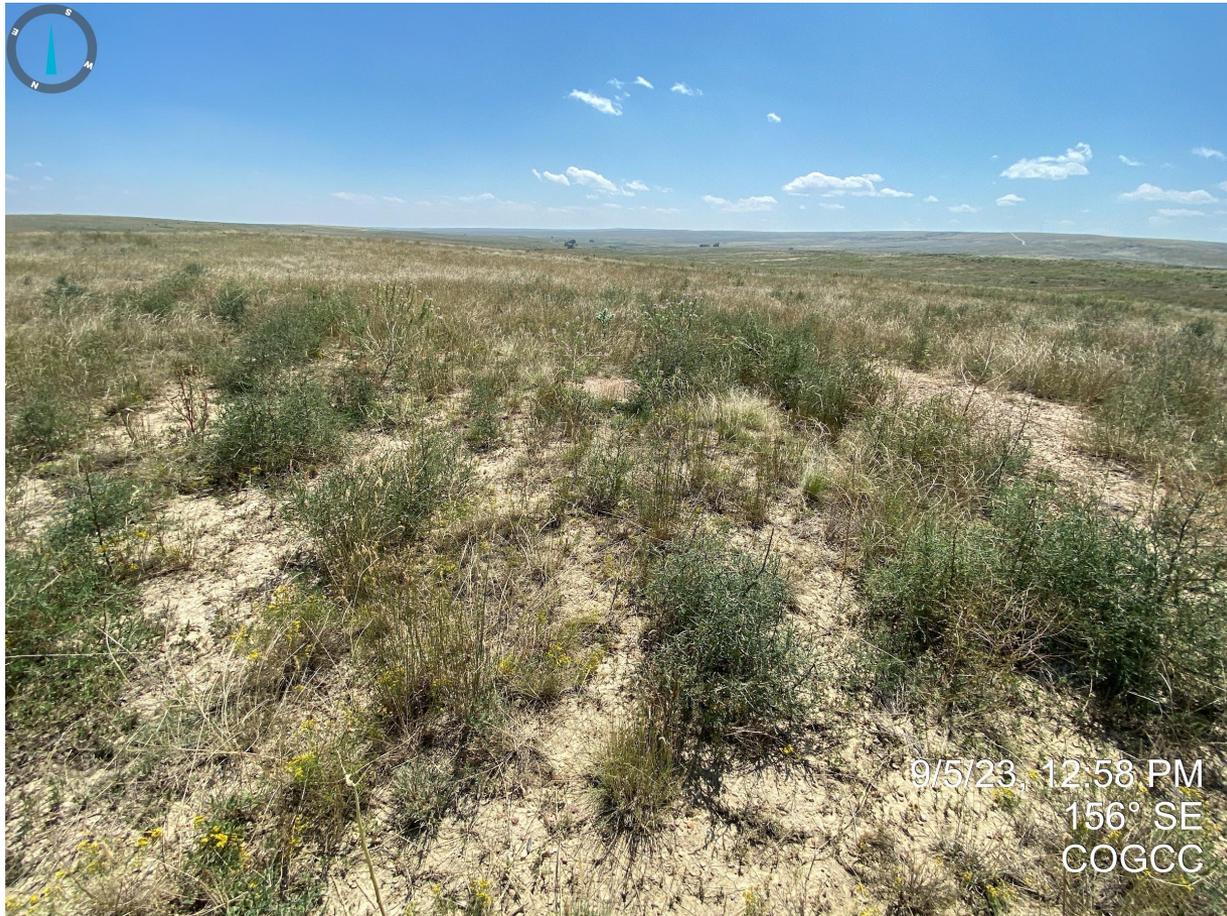
**Photo 10.** Facing towards the former pit location; see comments in Photo 8.

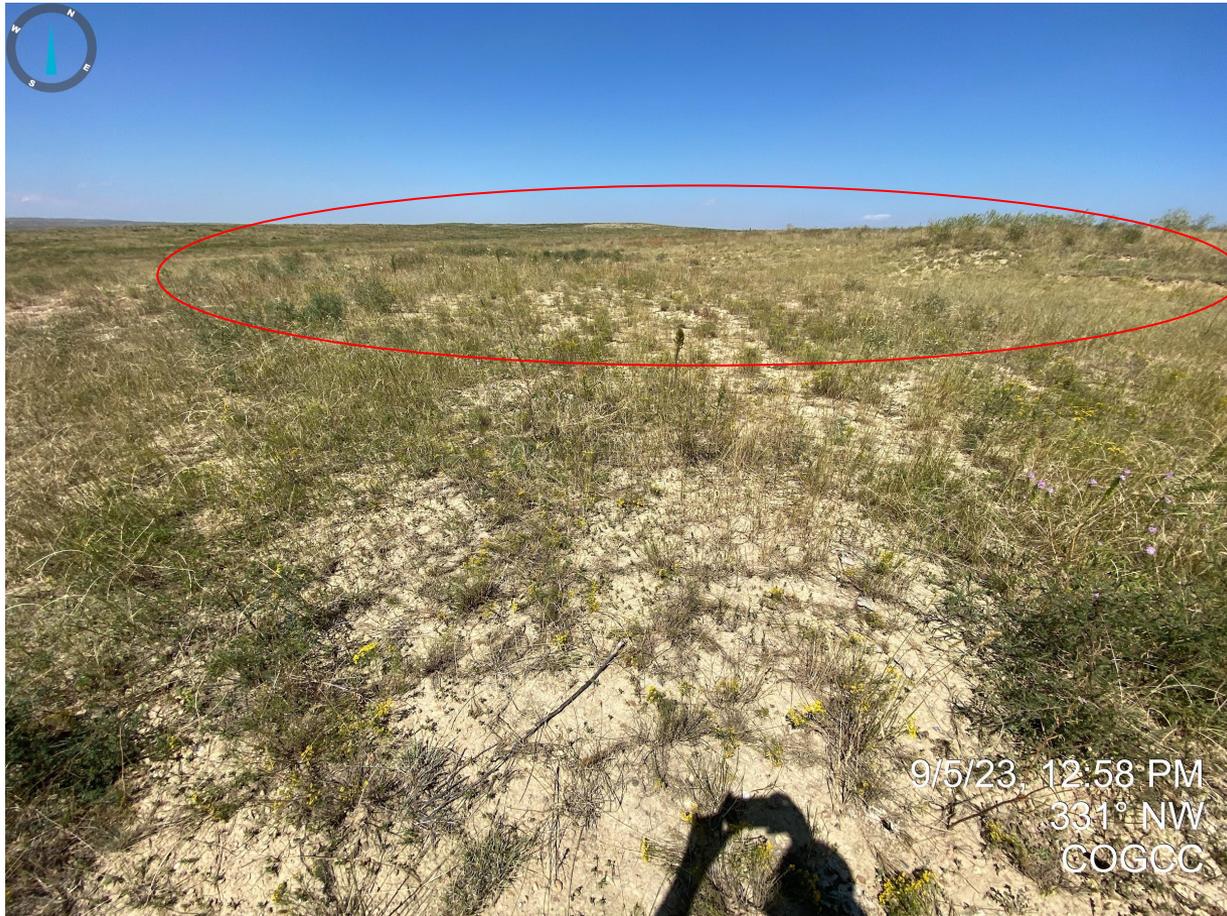
**Photo 11.** Taken from the center portion of the location. Photo illustrates additional recontouring activities that are required around the former wellhead location.

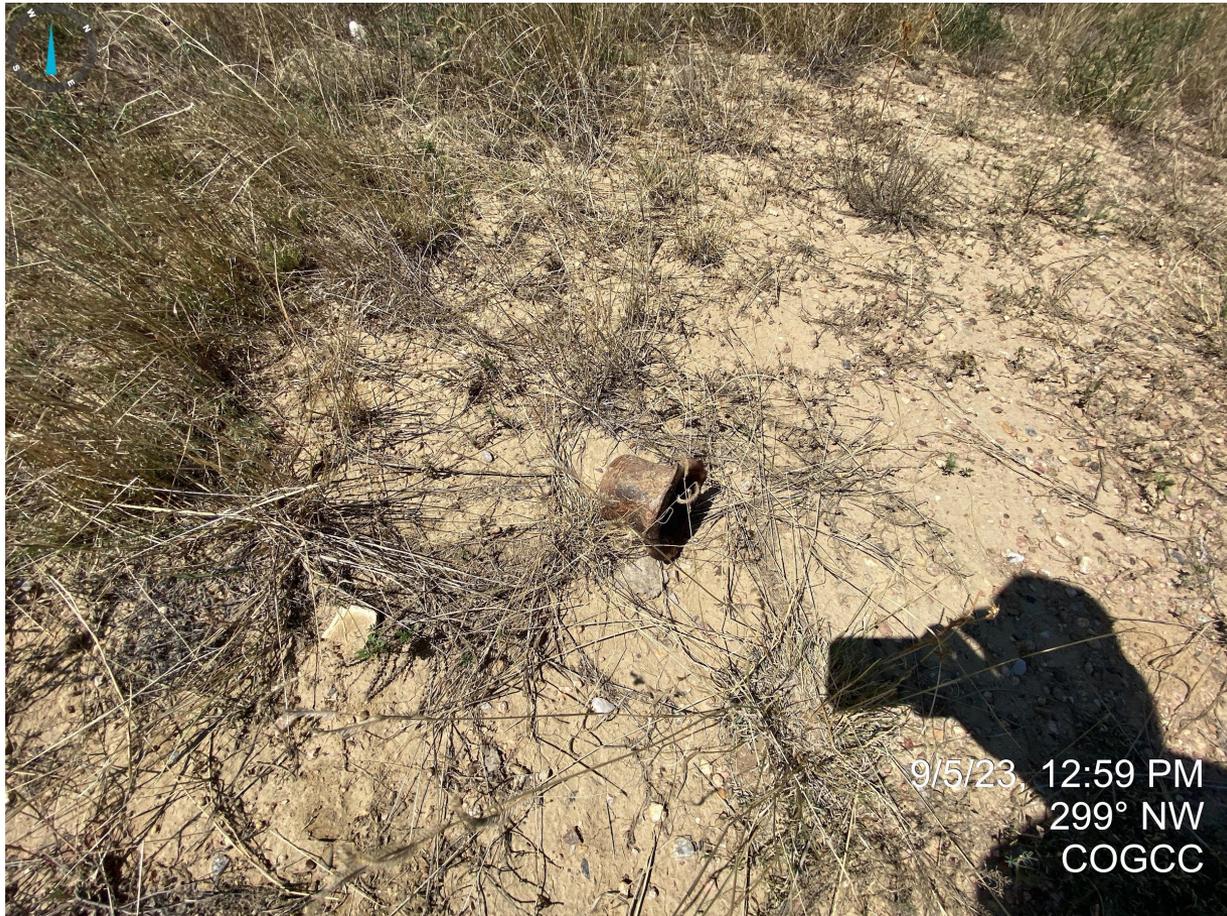
**Photo 12.** Debris left on location (e.g. metal pipe and road base/gravel).
