Storm Water Management and Erosion control
Location Name: TEP Rocky Mountain LLC CLOUGH 128 Pad
Location # 322493

**Location Overview: Location is within High Priority/Density
Habitat areas & Bald Eagle Roost site.**
Section/Township/Range: 23 6S94W

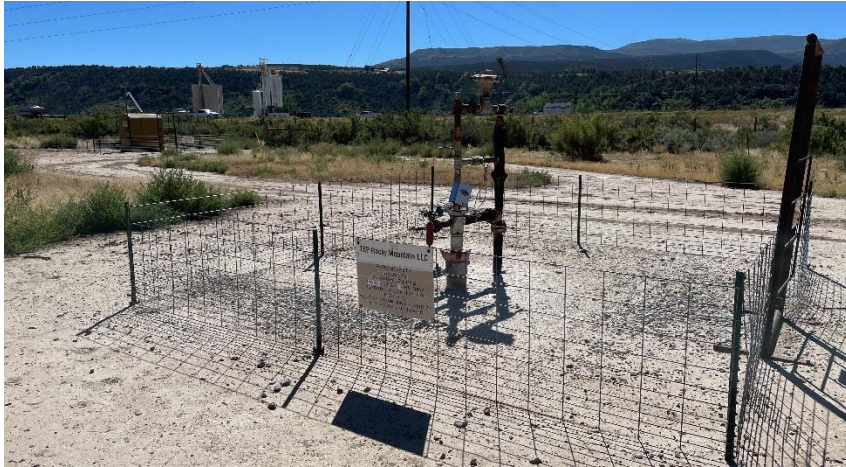
North West corner of location.

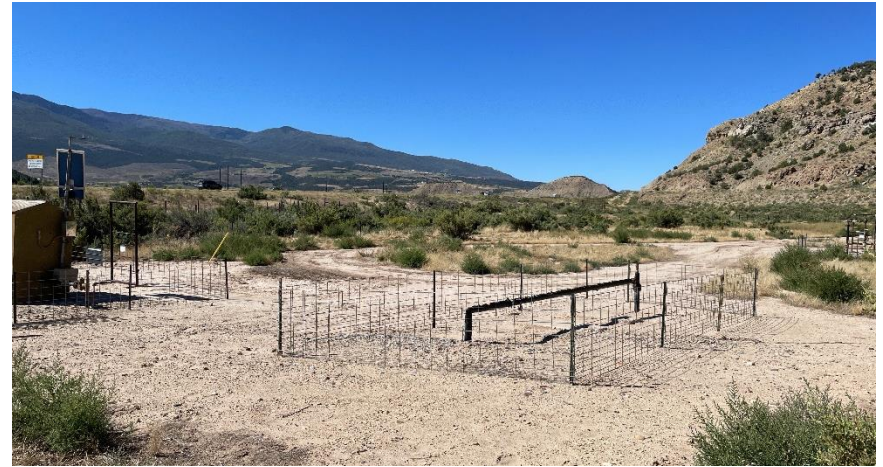
North East corner of location.

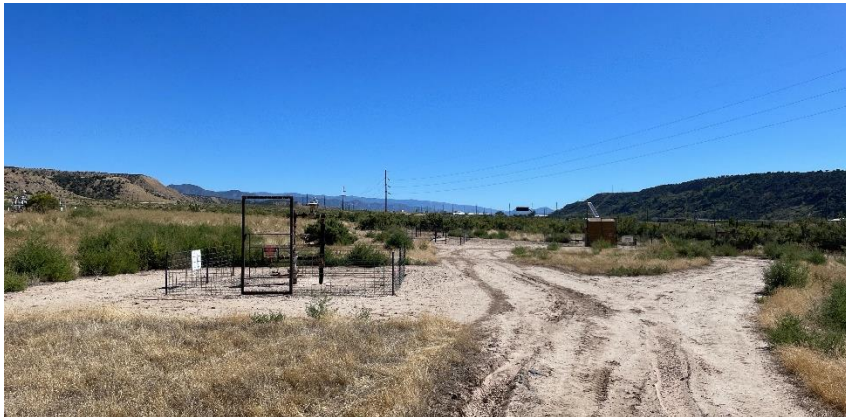
South West corner of location.

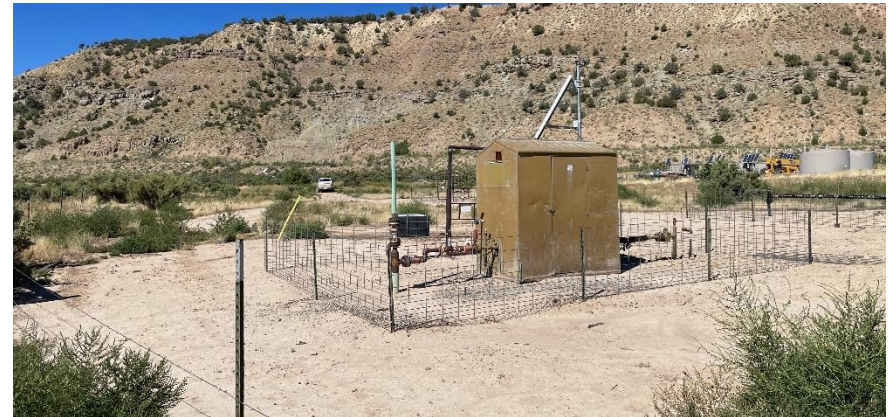
South East corner of location.

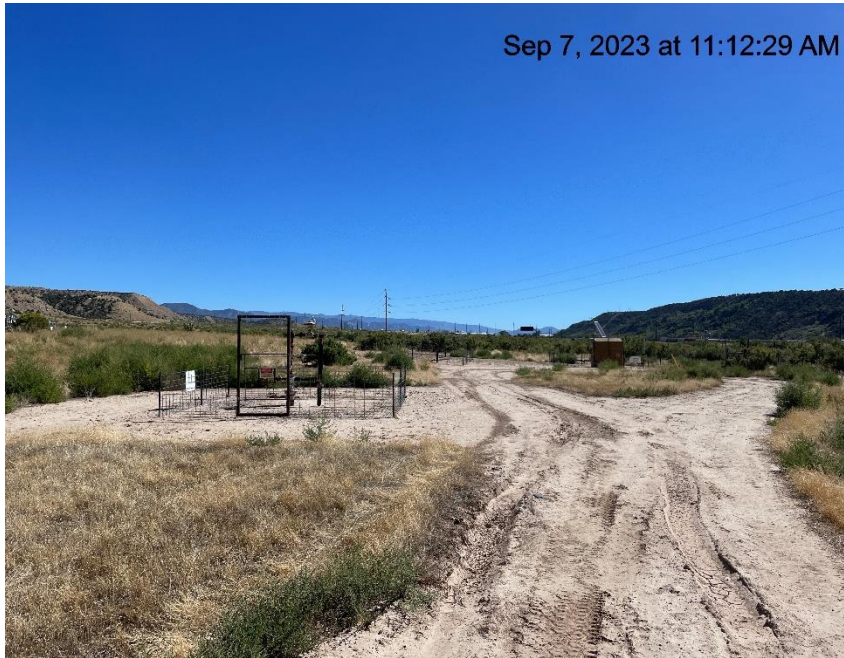
**Photo # 8590 Lack of stabilization/compaction on spur road
& location**

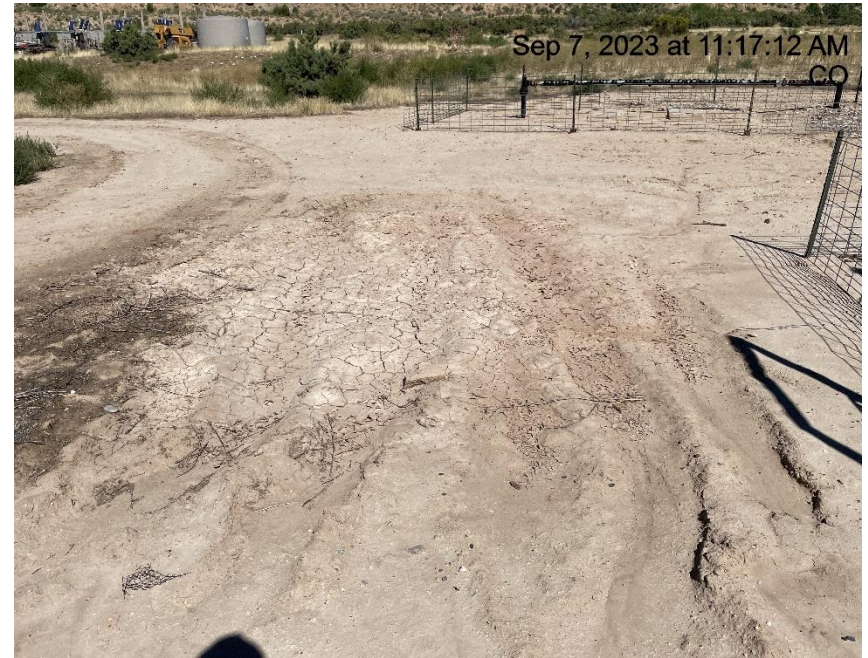
Photo # 8599 Lack of stabilization/compaction on location

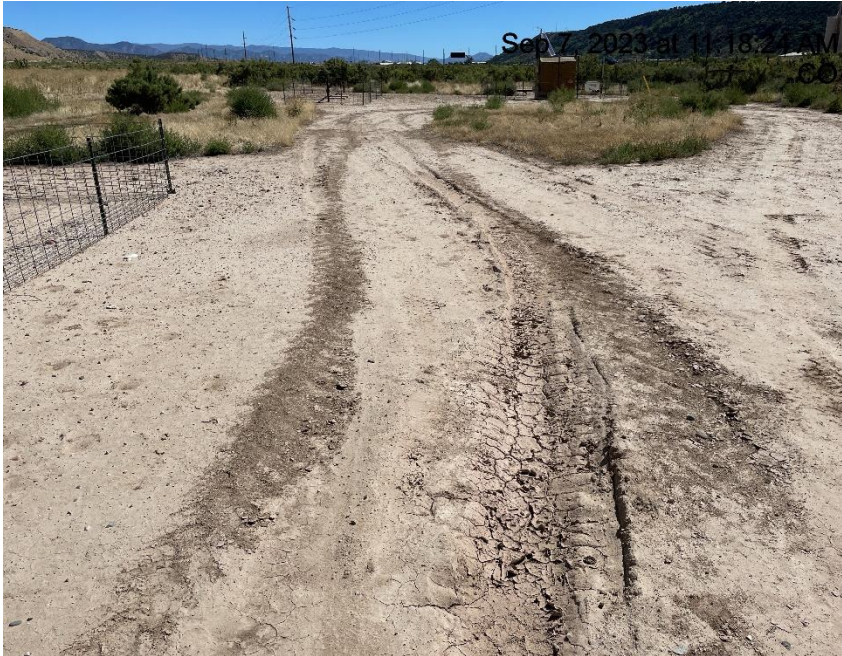
Photo # 8603 Lack of stabilization/compaction on location

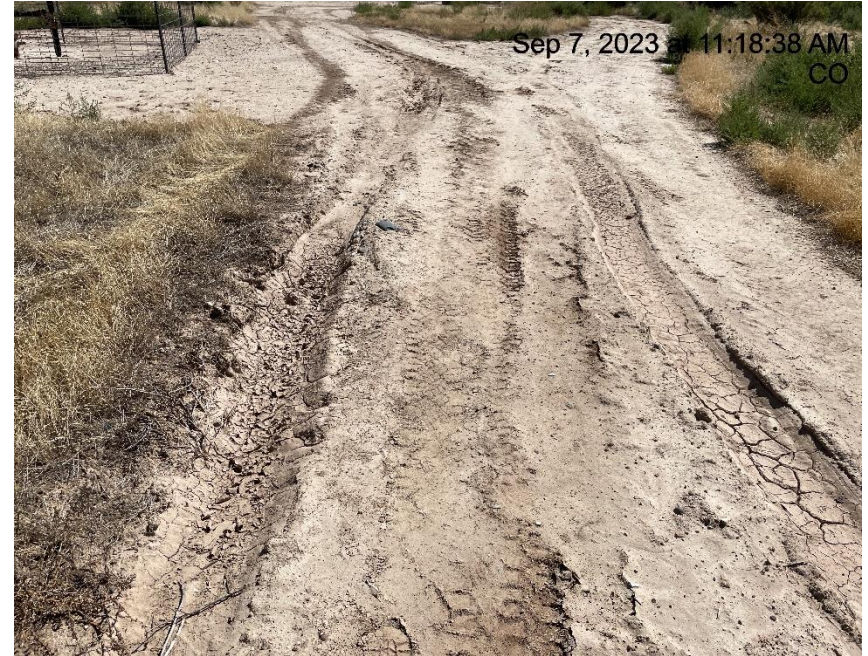
Photo # 8604 Lack of stabilization/compaction on spur road & location

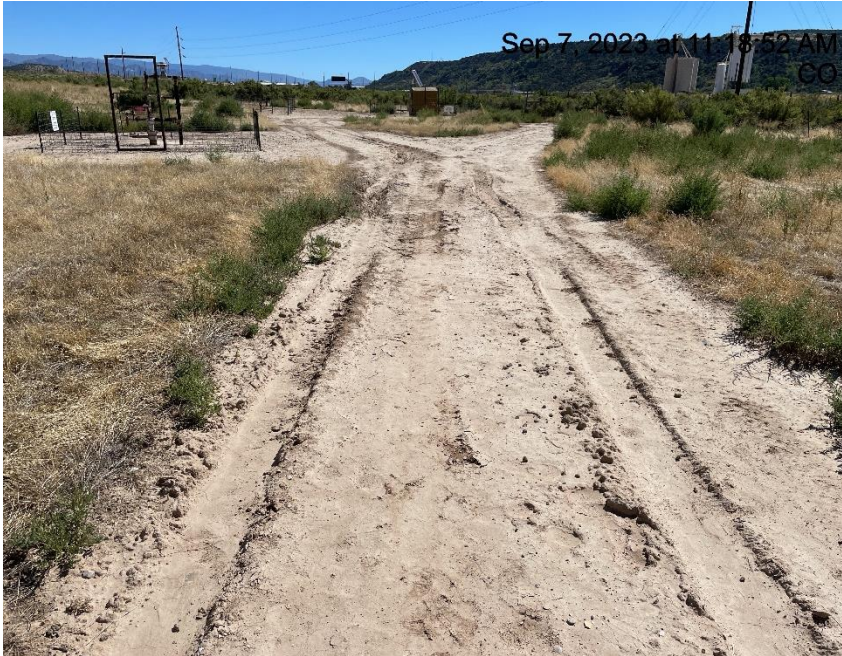
Photo # 8605 Lack of stabilization/compaction on spur road

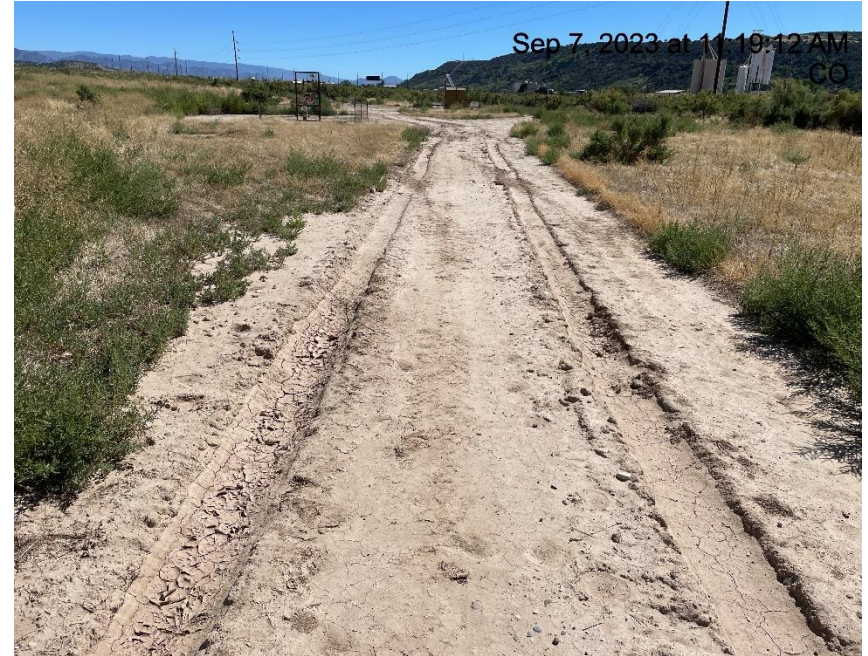
Photo # 8606 Lack of stabilization/compaction on spur road

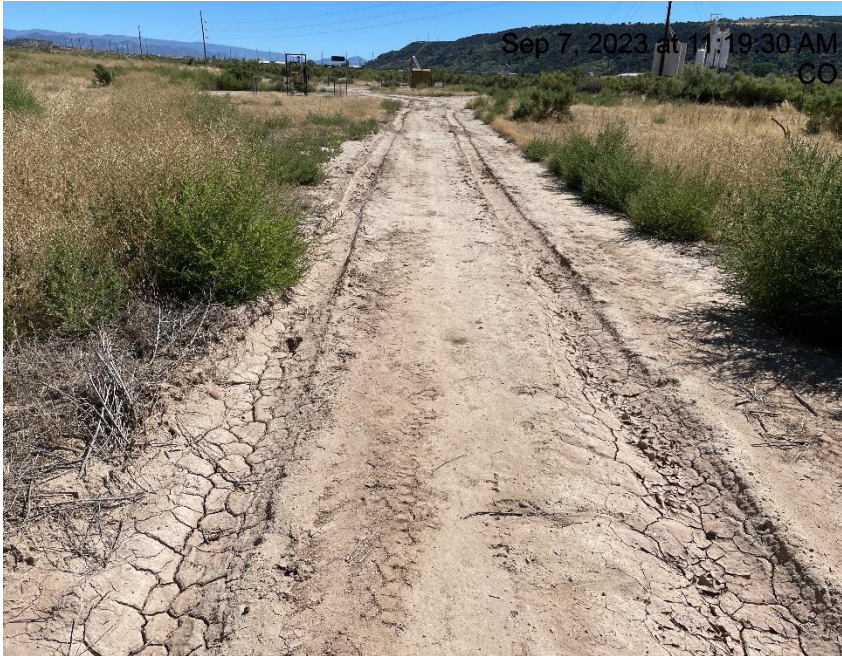
Photo # 8607 Lack of stabilization/compaction on spur road

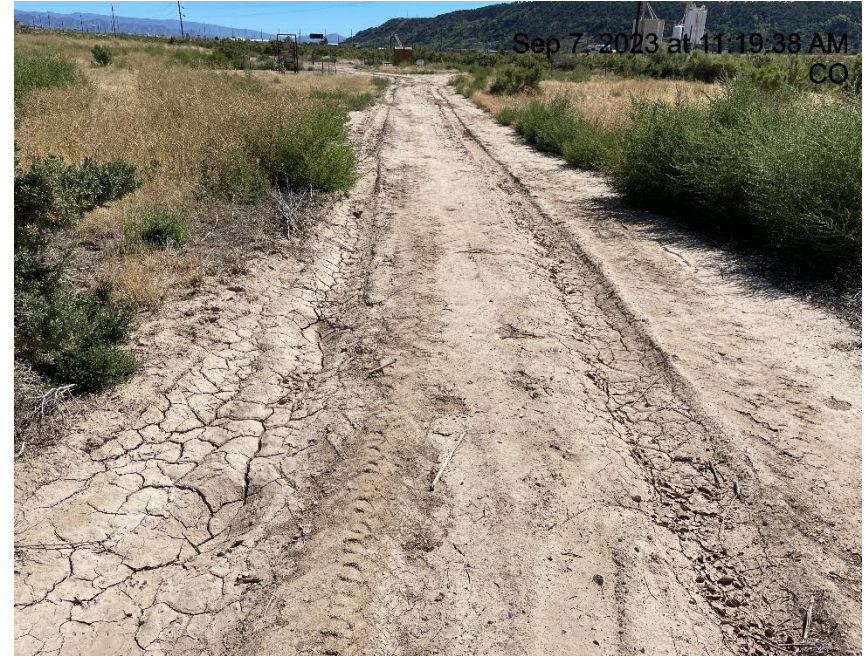
Photo # 8608 Lack of stabilization/compaction on spur road

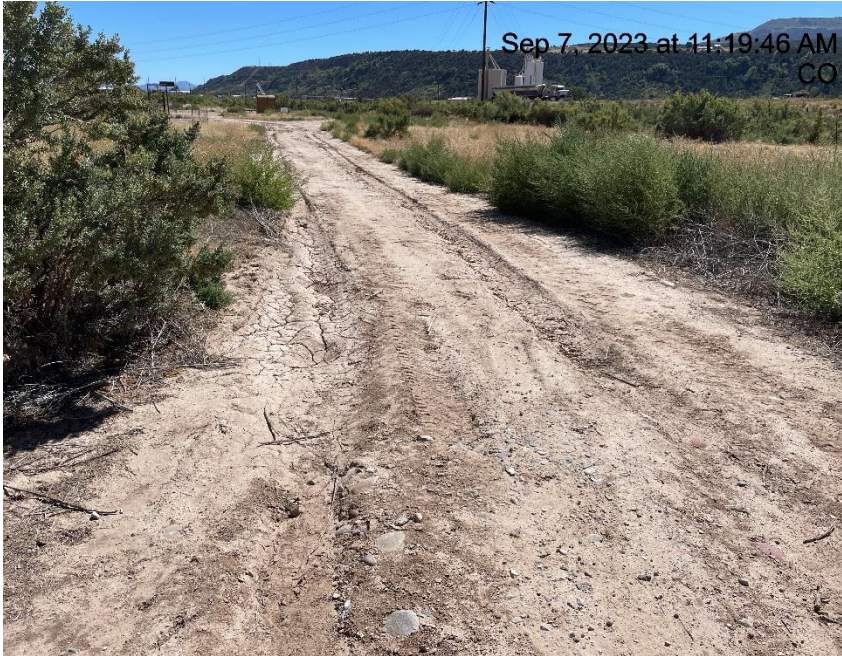
Photo # 8609 Lack of stabilization/compaction on spur road

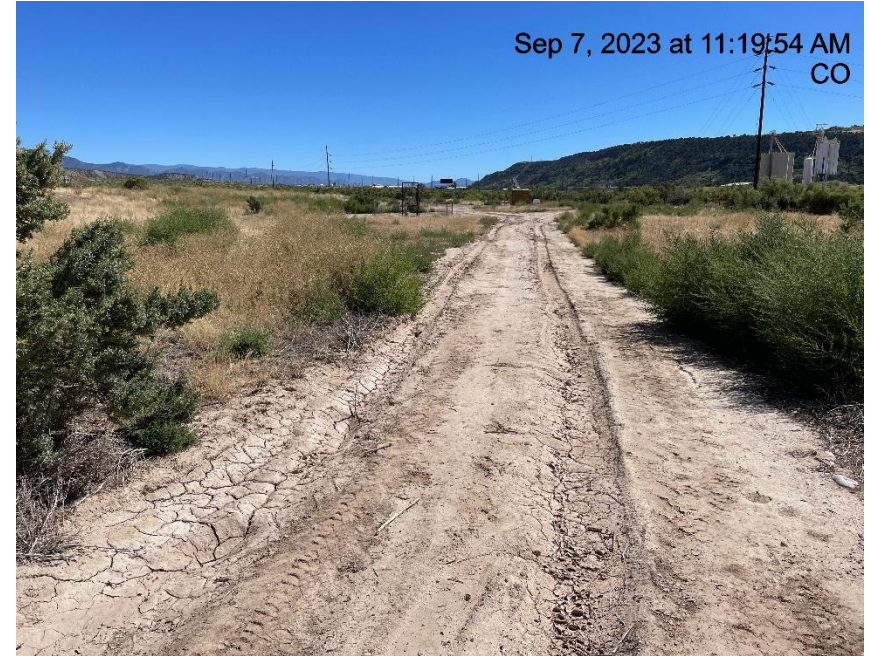
Photo # 8610 Lack of stabilization/compaction on spur road
