Storm Water Management and Erosion control
Location Name: MUSTANG RESOURCES LLC CLOUGH 27-11-6S-94W Pad
Location ID: 430758

Location Overview: Location is within High Priority Habitat area & Bald Eagle Nest & Roost sites & within close proximity to NSO/Density Habitat areas.

Section/Township/Range: 27 6S94W

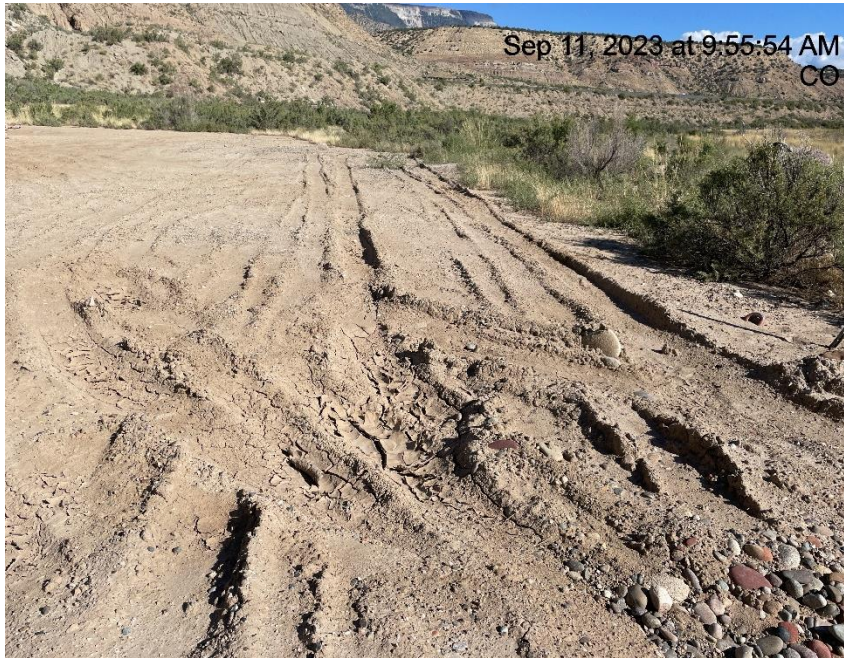
Photo # 8712 Lack of stabilization/compaction on location

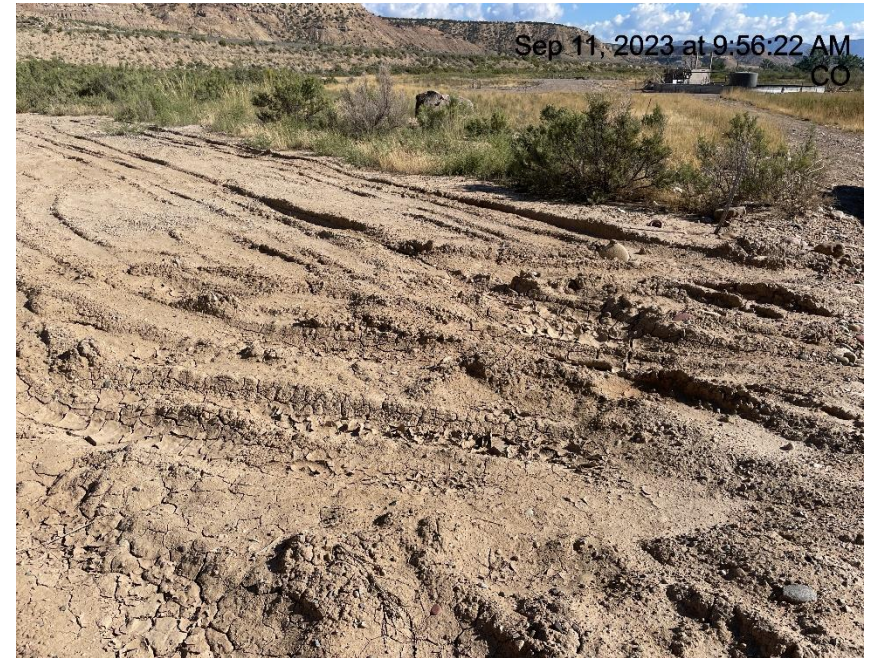
Photo # 8715 Lack of stabilization/compaction on location

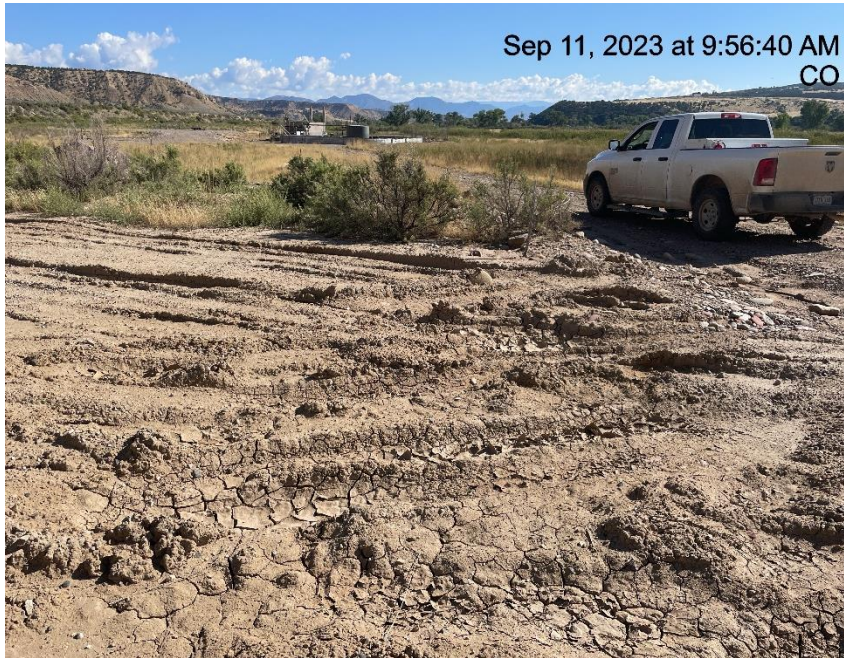
Photo # 8717 Lack of stabilization/compaction on location

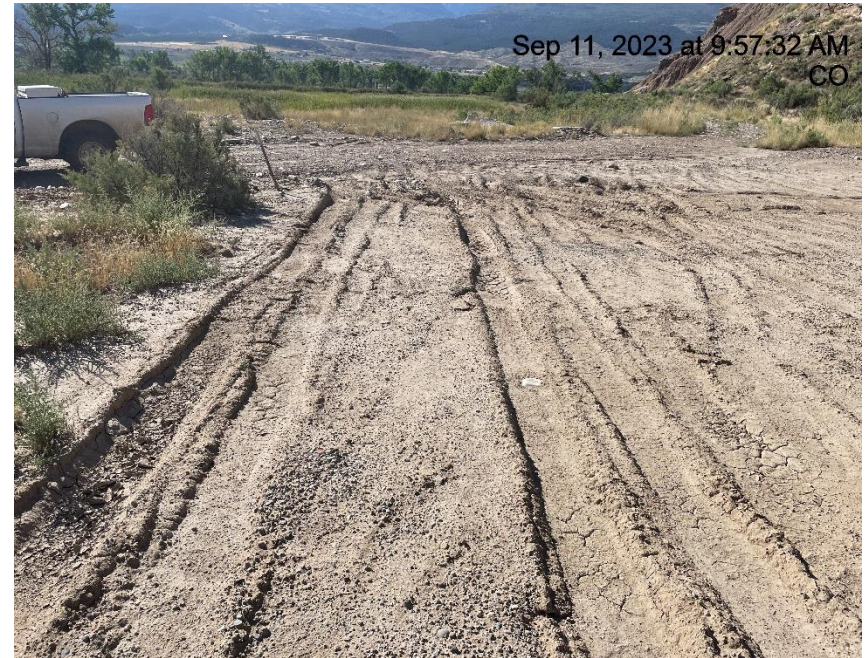
Photo # 8722 Lack of stabilization/compaction on location

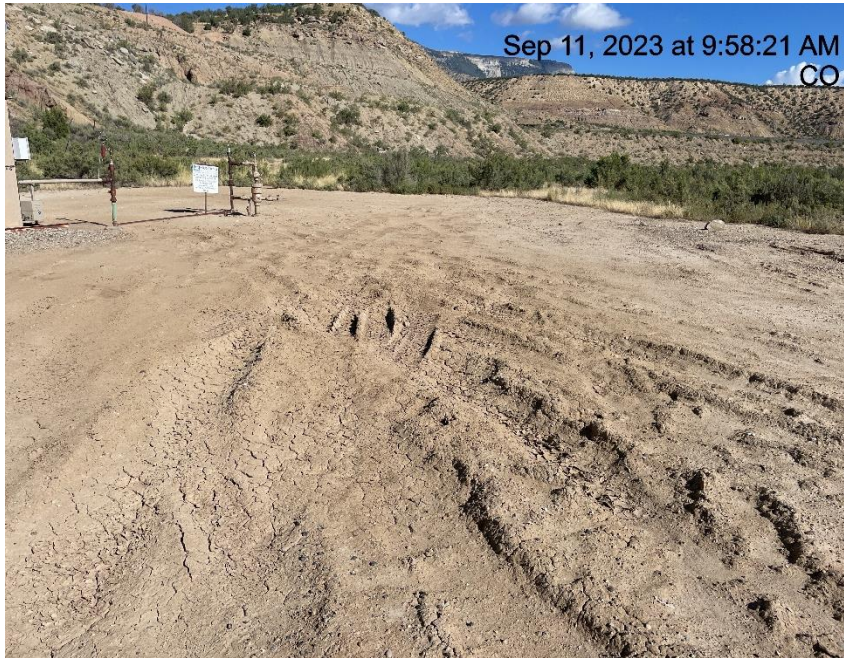
Photo # 8723 Lack of stabilization/compaction on location

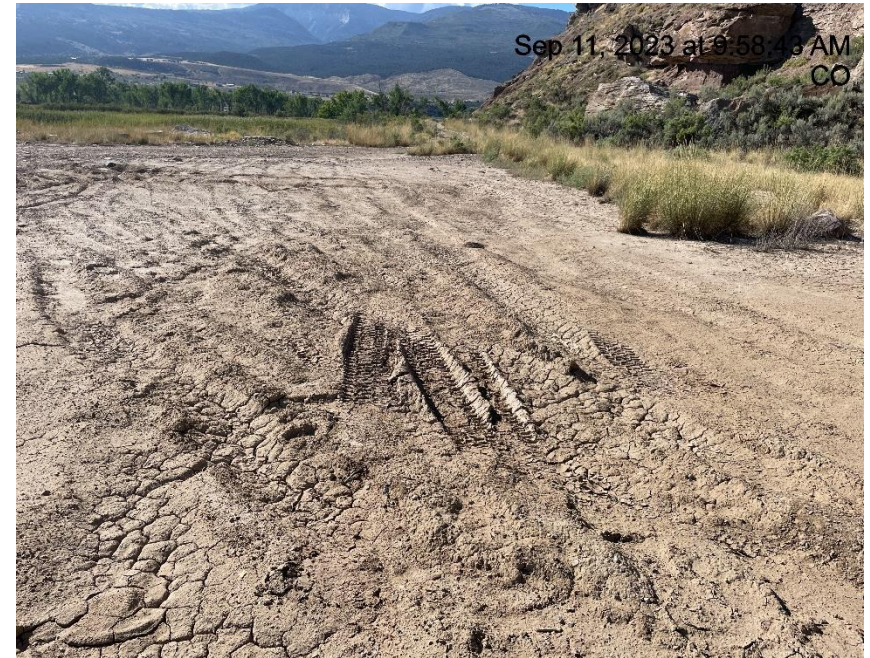
Photo # 8725 Lack of stabilization/compaction on location
