# Inspection Photos

API: 011-06099

Operator: PONCHO PRODUCTION COMPANY

Inspection Date: 9/6/2023

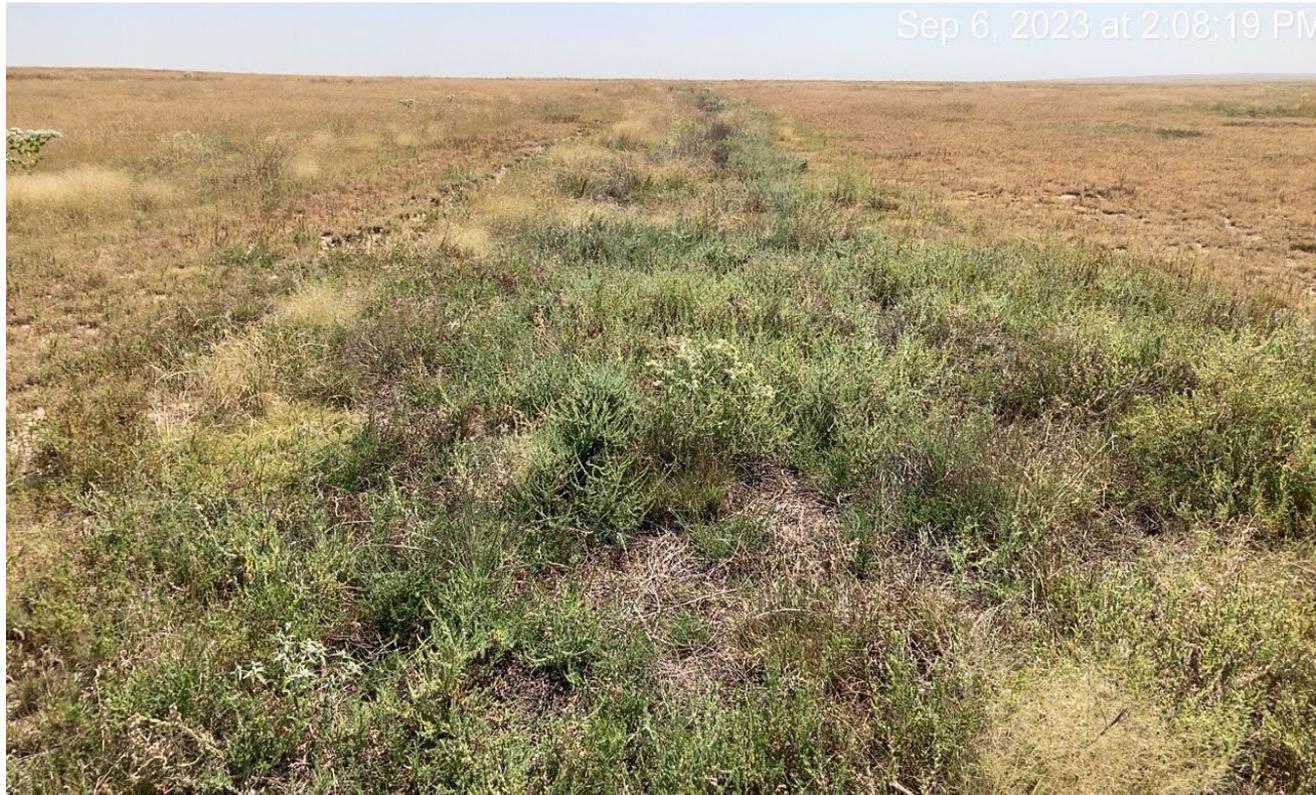
**Photo 1.** Facing southwest along the former access road. The road has not been reclaimed and consists of undesirable weed such as Kochia and Russian thistle.

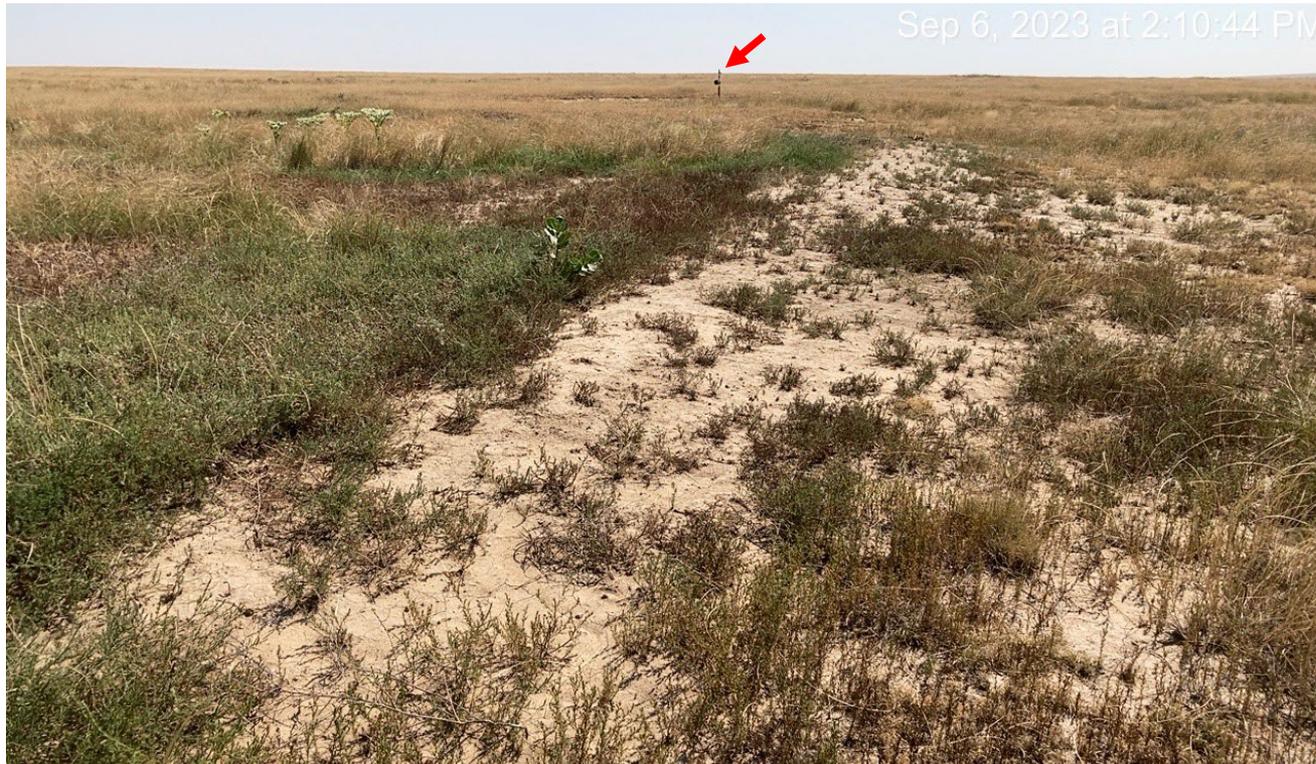
**Photo 2.** Facing south toward the location which has not been reclaimed. There are undesirable weeds throughout the location and areas bare vegetation. There is equipment that remains at the south side of the location shown at red arrow.

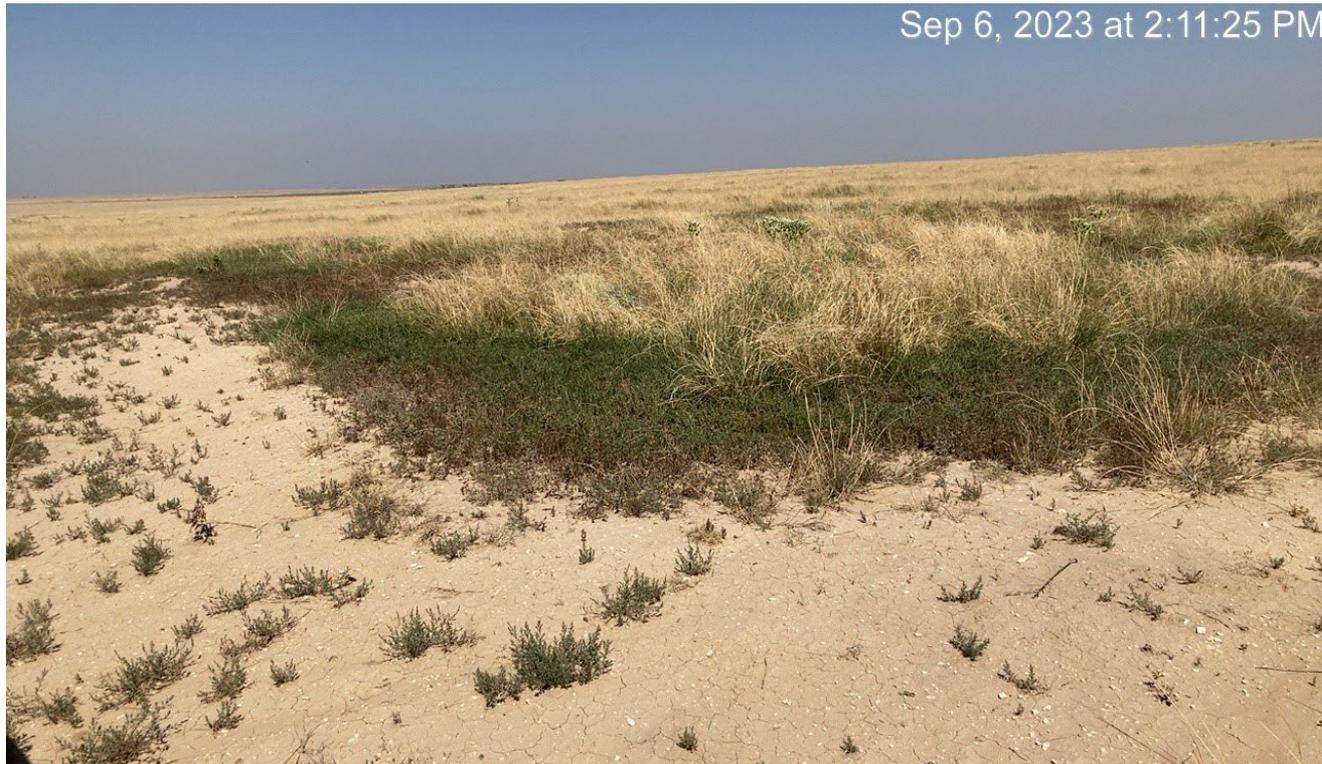
**Photo 3.** Facing northeast. This area appears to be the former tank battery site. There are likely soil issues preventing vegetation growth within this area.

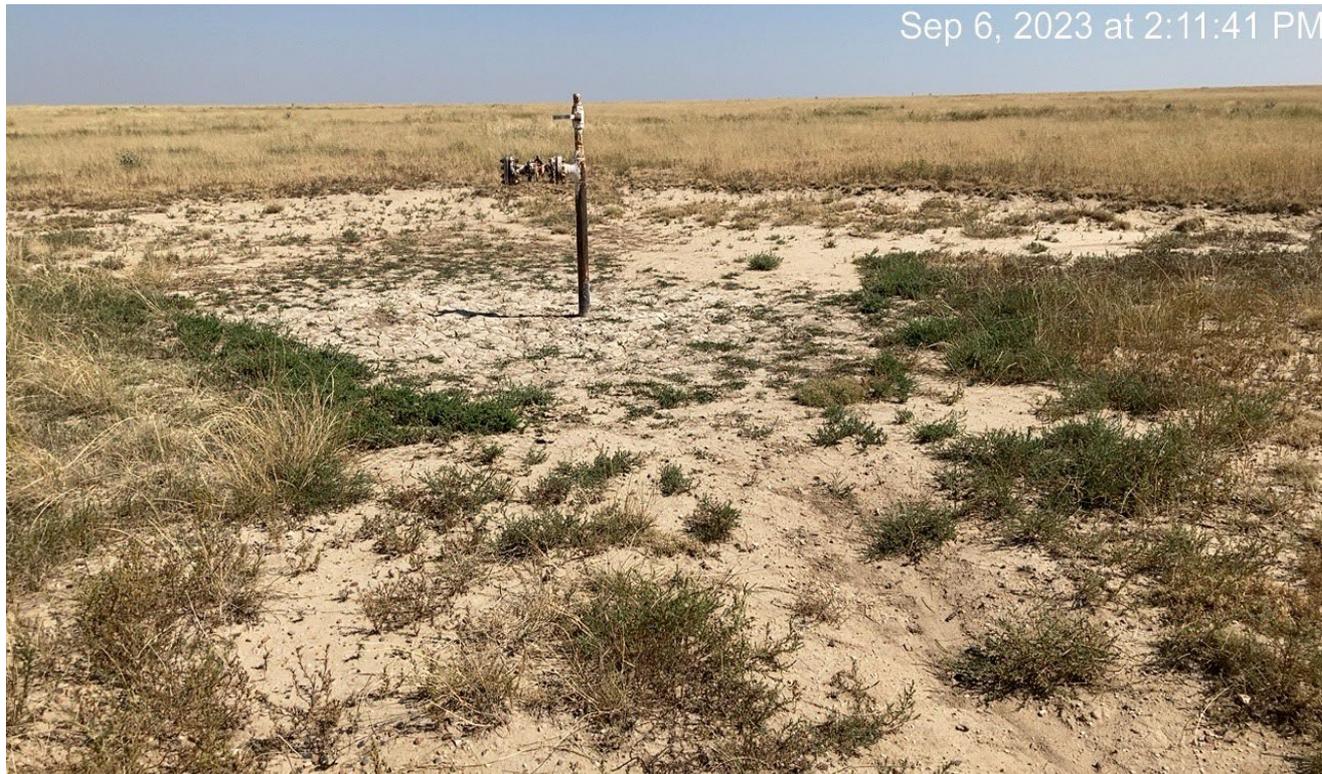
**Photo 4.** Facing southeast at the south side of the location. There is an abandoned pipe riser that has not been removed. The area around the riser is mostly bare of vegetation and has not been reclaimed. Previous corrective action was not completed.

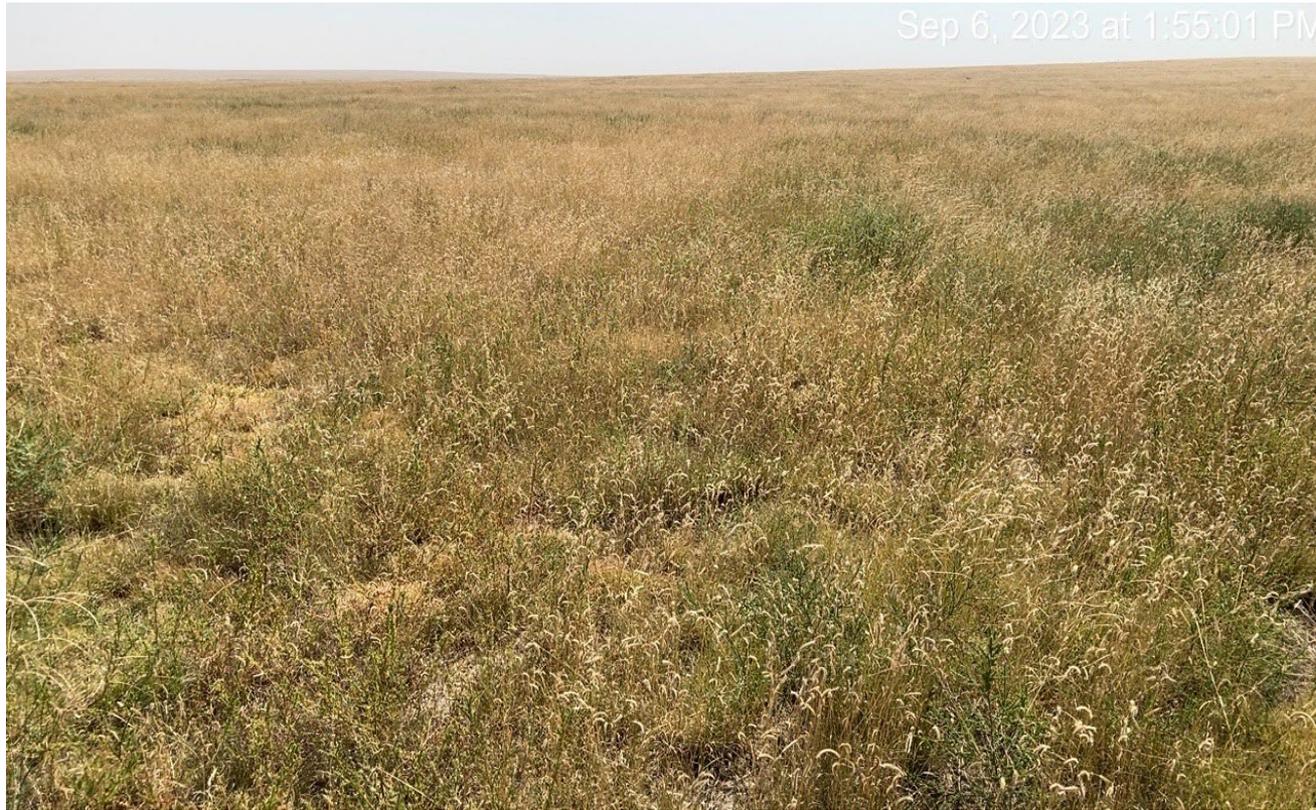
**Photo 5.** Facing south at the surrounding undisturbed reference area which shows a uniform vegetation cover consisting of Blue grama, Sand dropseed, Prairie threeawn among other species.
