Inspection Photos
Location Name: CAERUS PICEANCE LLC O18 Pad
Location #: 311604

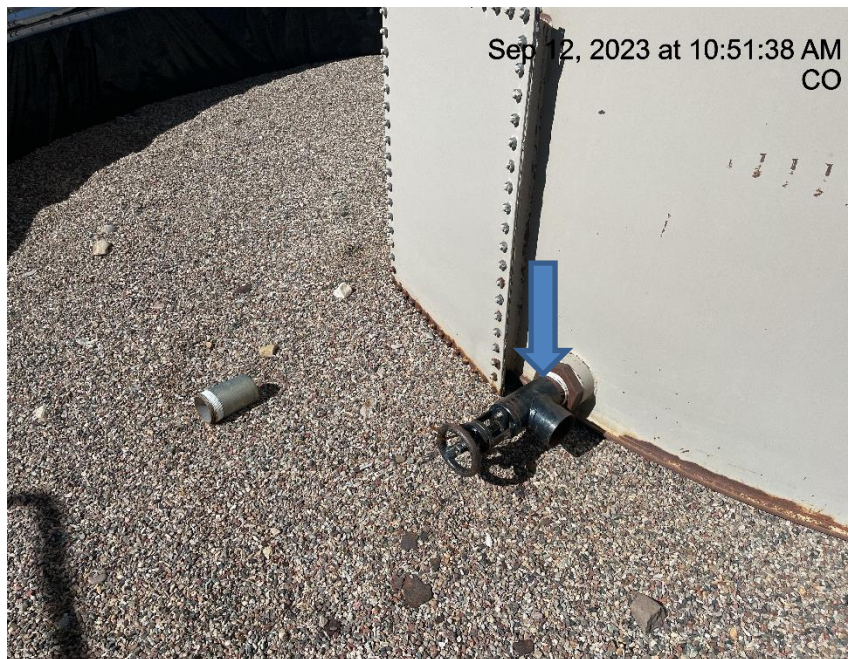
Photo # 8851 Open ended load line

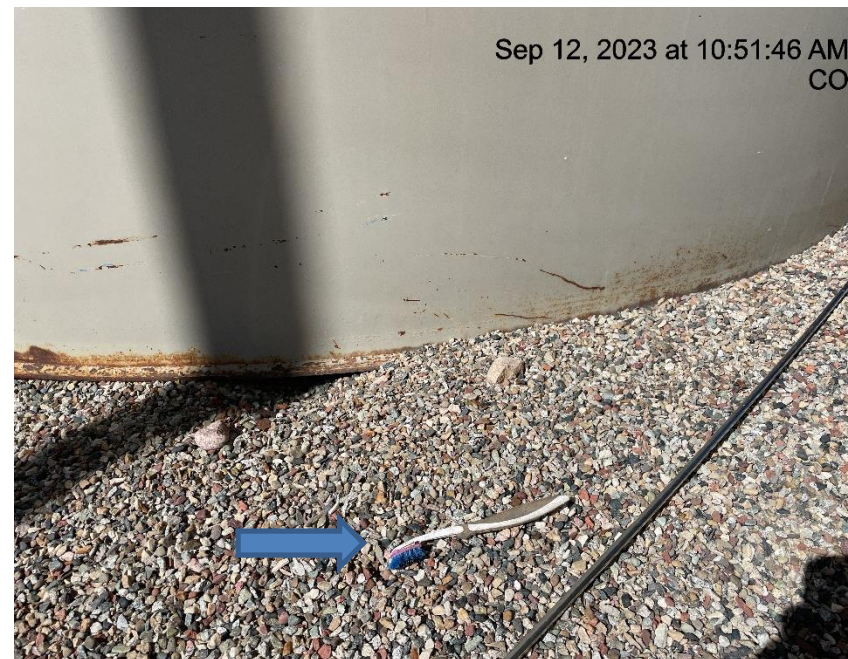
Photo # 8852 Debris

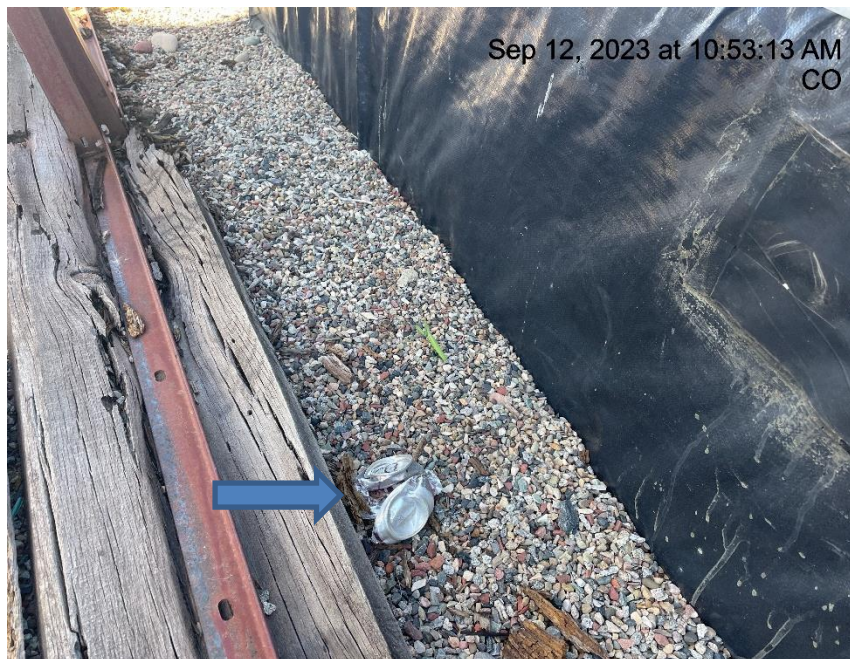
Photo # 8859 Debris

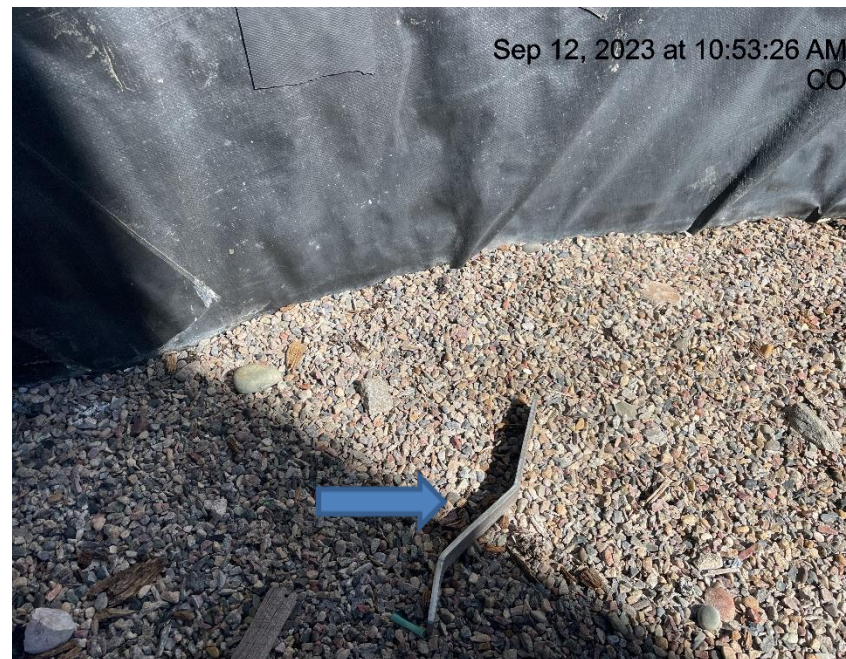
Photo # 8860 Debris

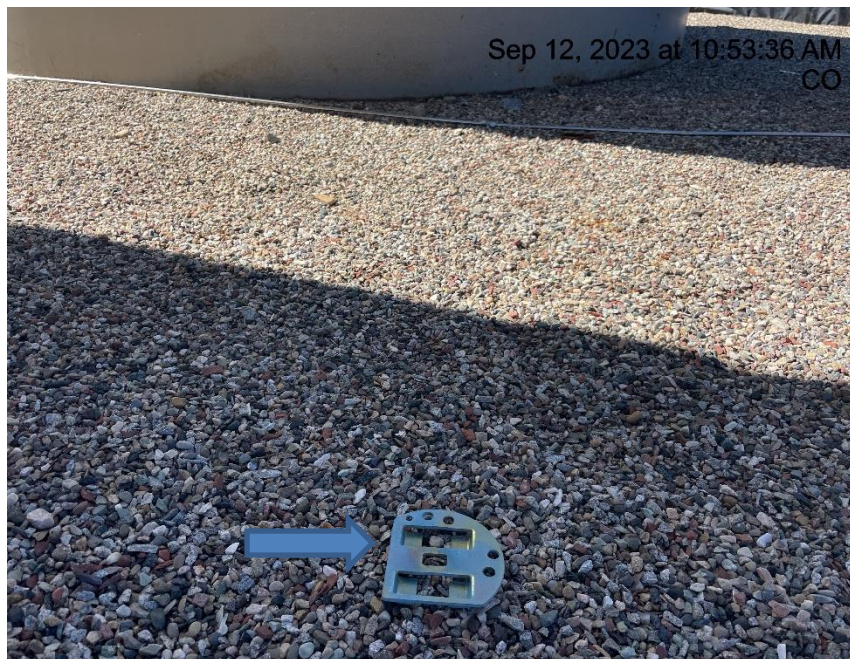
Photo # 8861 Debris

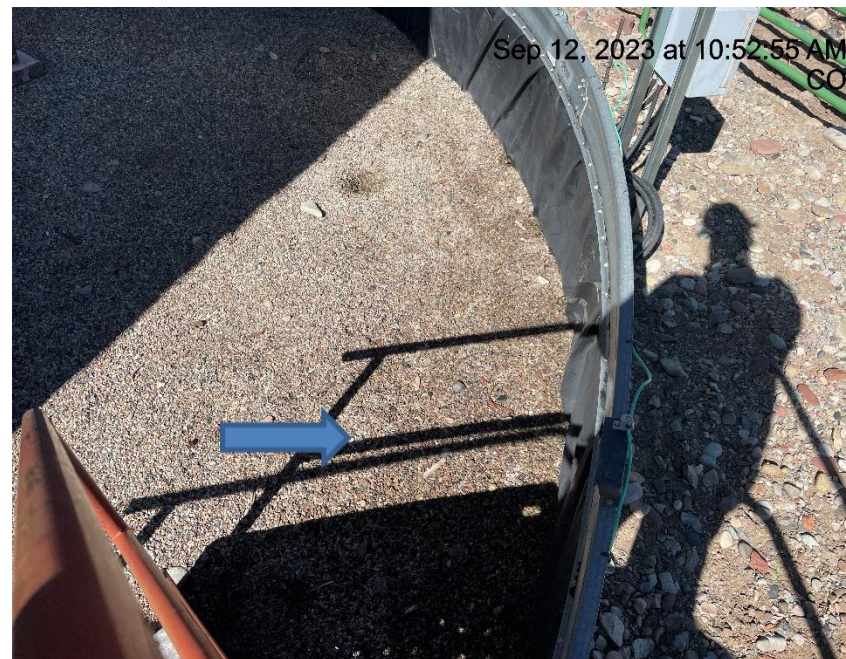
Photo # 8857 Stained gravel

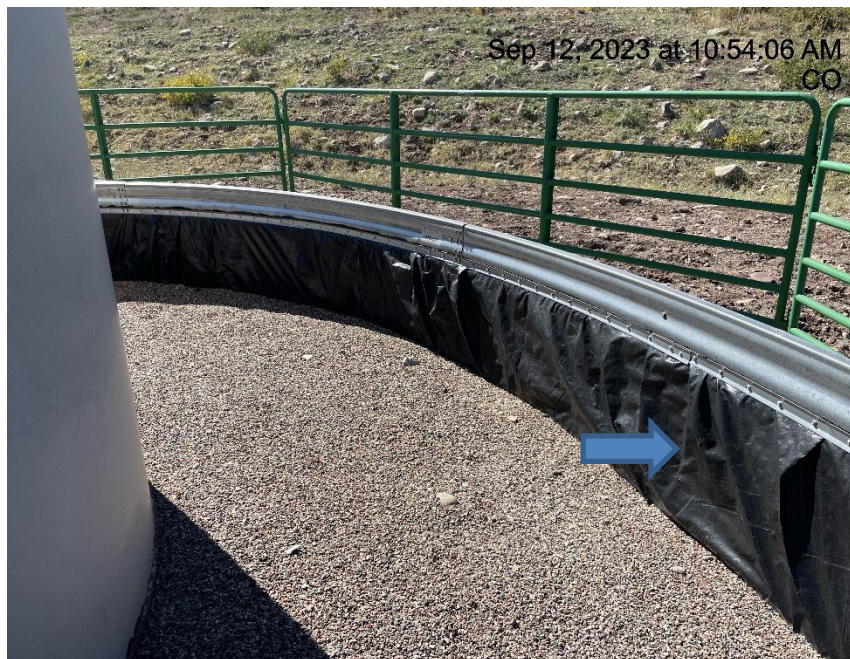
Photo # 8862 Hole in secondary containment liner/liner needs maintenance

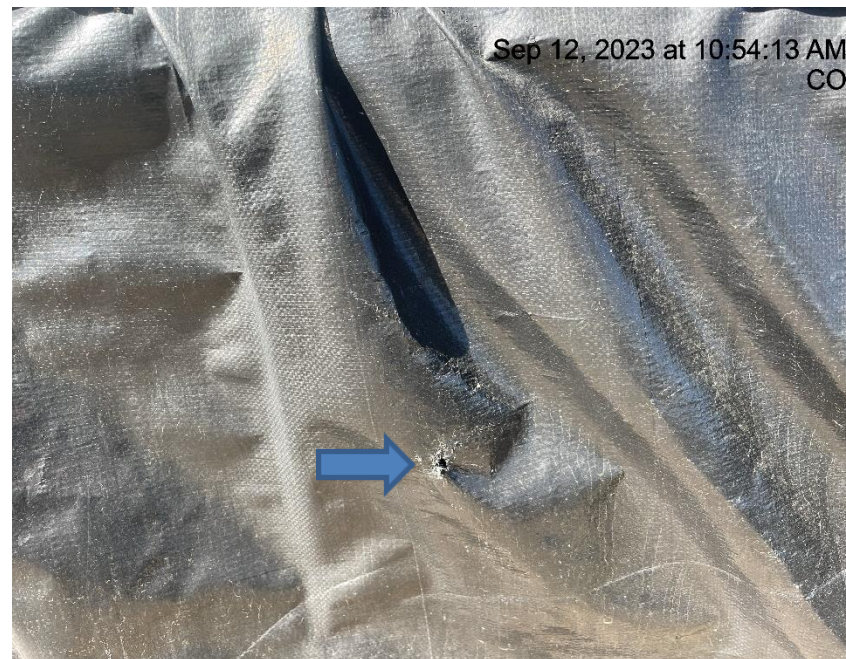
Photo # 8863 Hole in secondary containment liner/liner needs maintenance

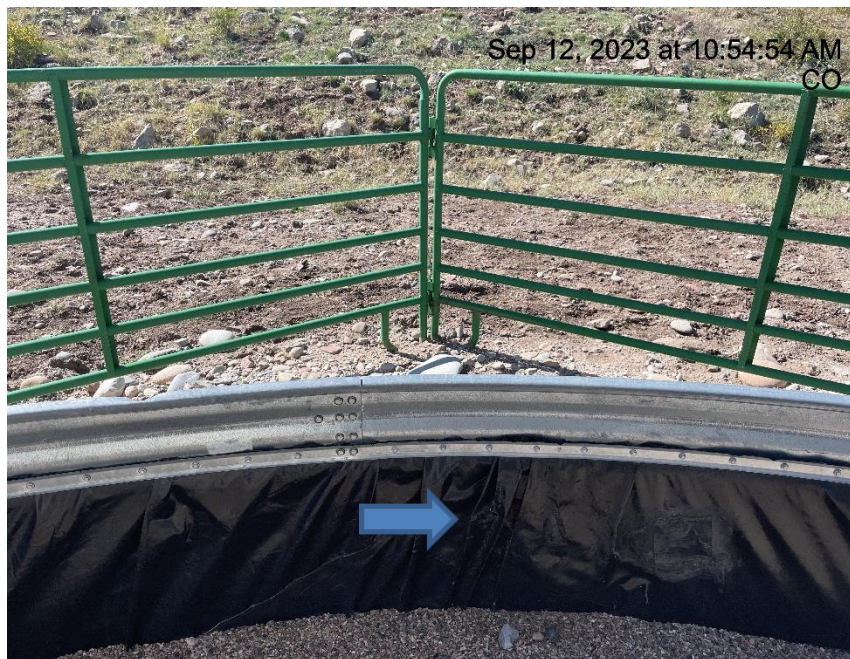
Photo # 8865 Hole in secondary containment liner/liner needs maintenance

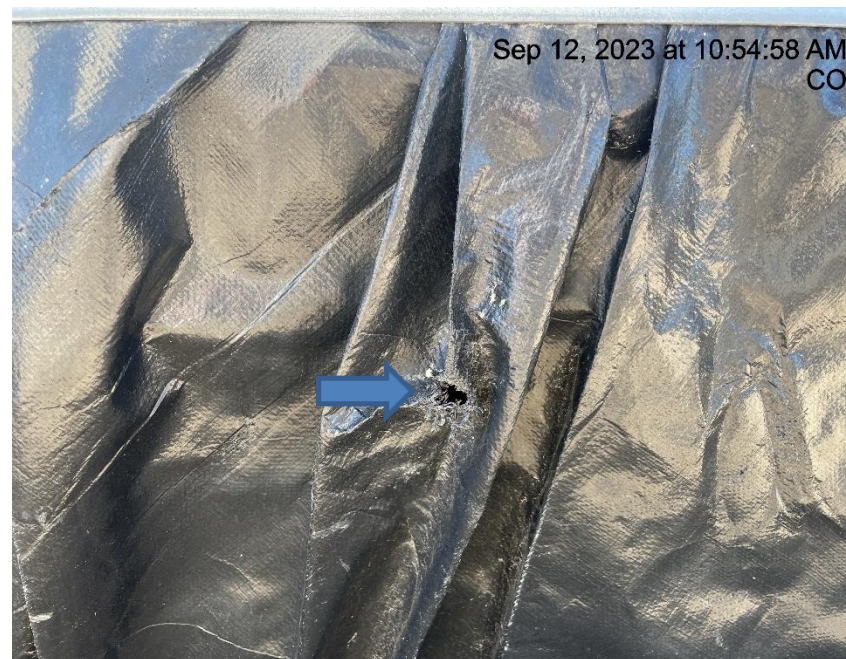
Photo # 8866 Hole in secondary containment liner/liner needs maintenance

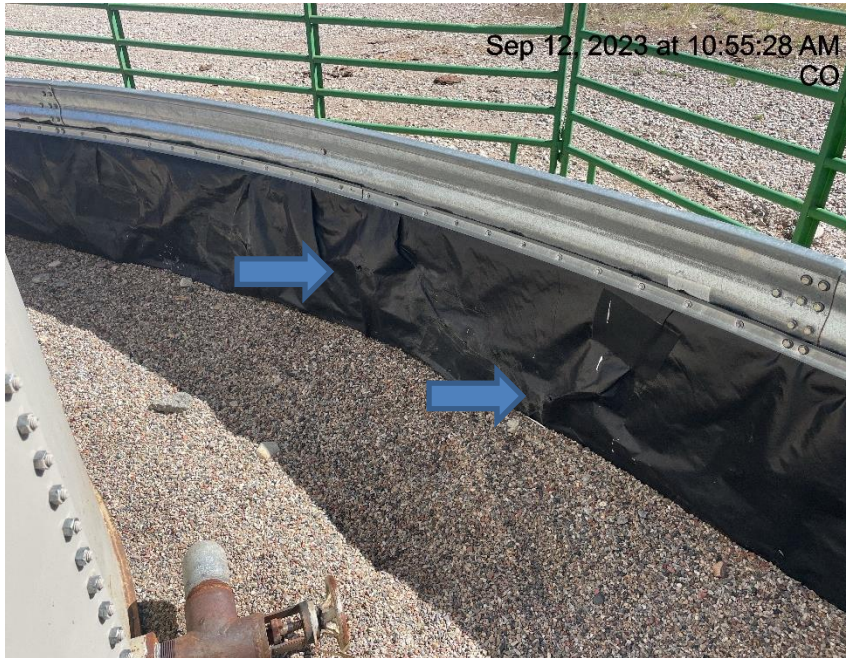
Photo # 8867 Holes in secondary containment liner/liner needs maintenance

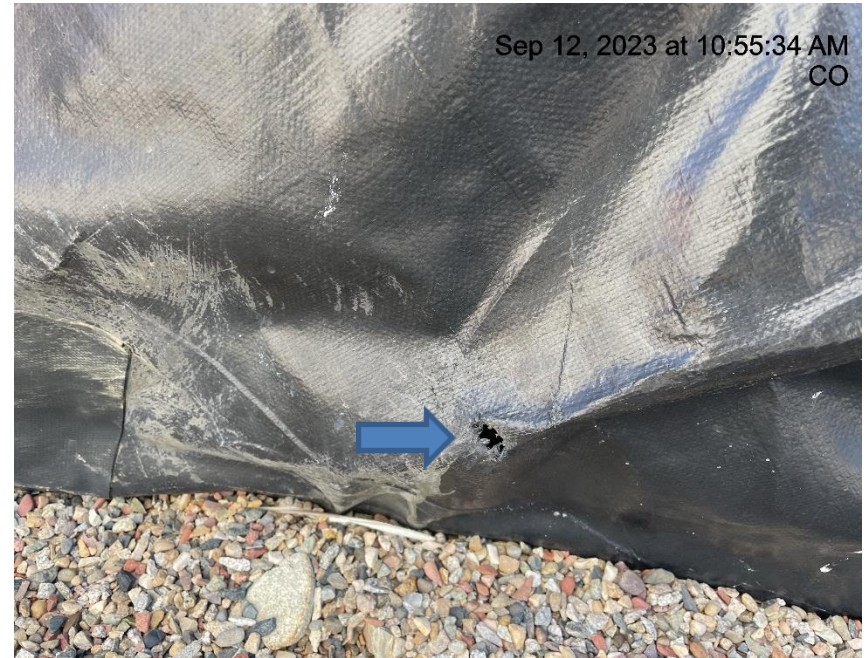
Photo # 8868 Hole in secondary containment liner/liner needs maintenance

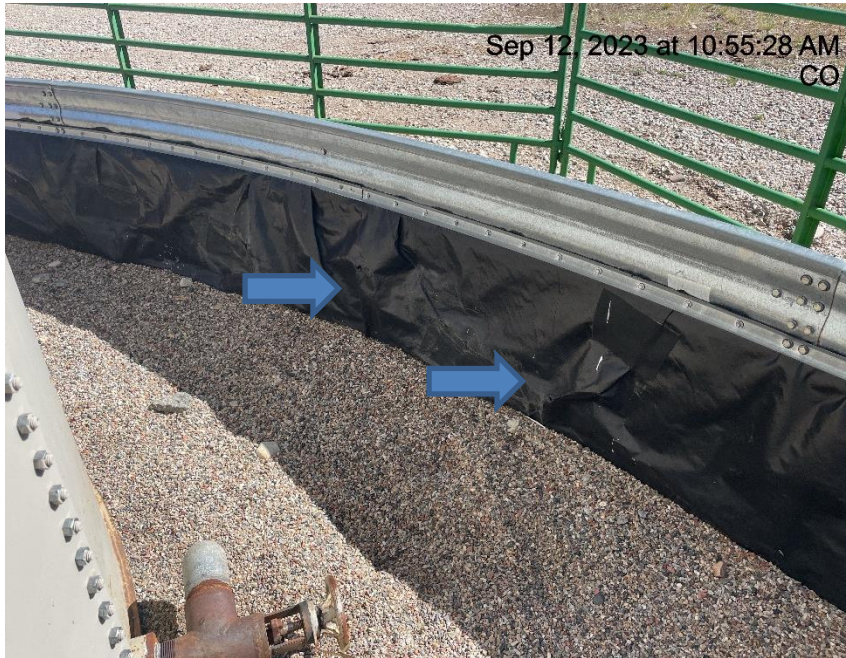
Photo # 8867 Holes in secondary containment liner/liner needs maintenance

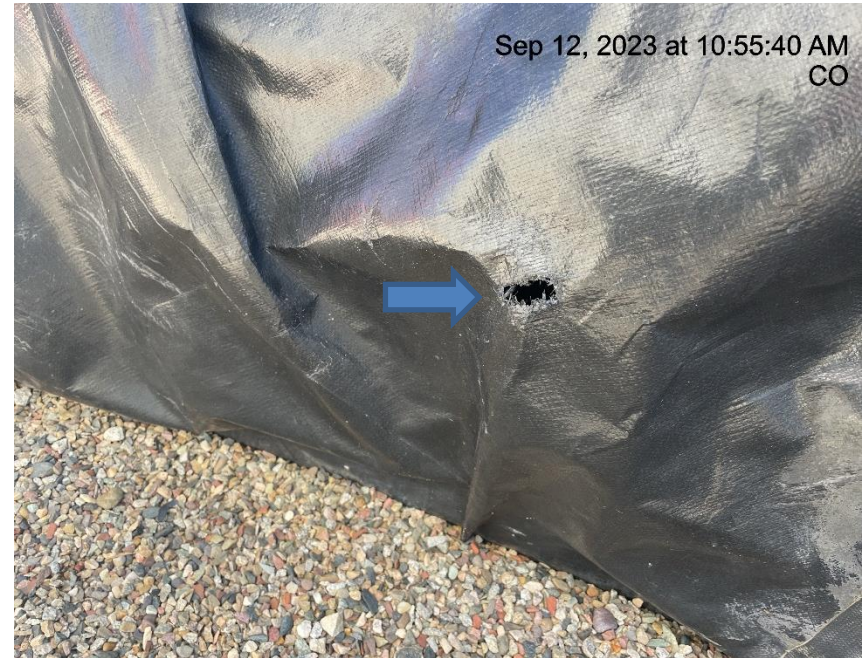
Photo # 8869 Hole in secondary containment liner/liner needs maintenance

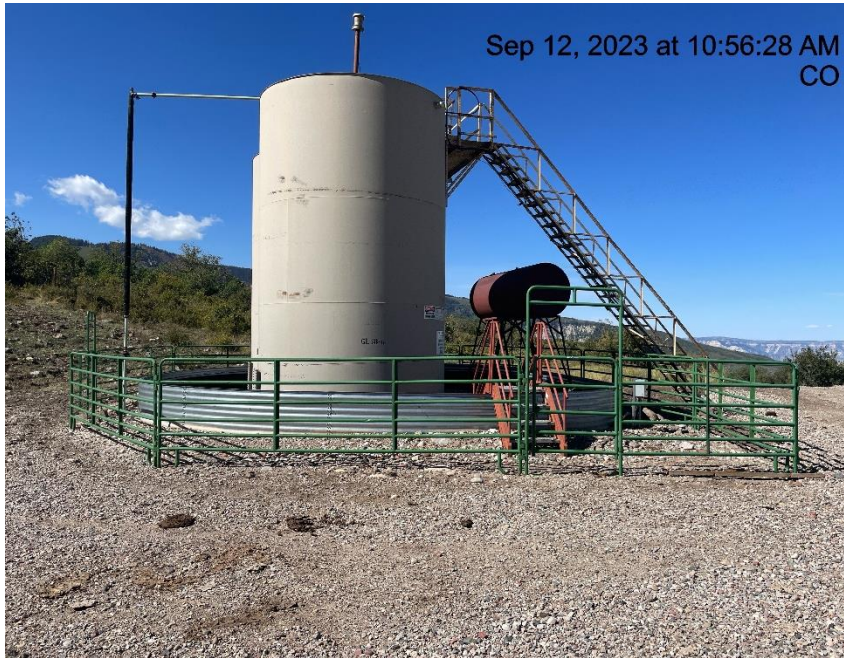
Photo # 8870 Tank battery lacks required signage

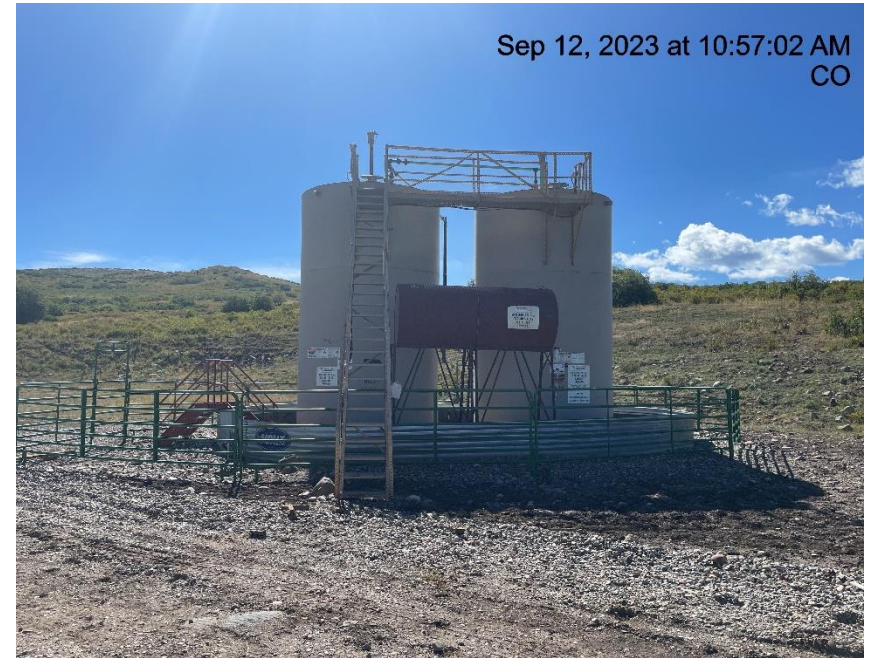
Photo # 8871 Tank battery lacks required signage

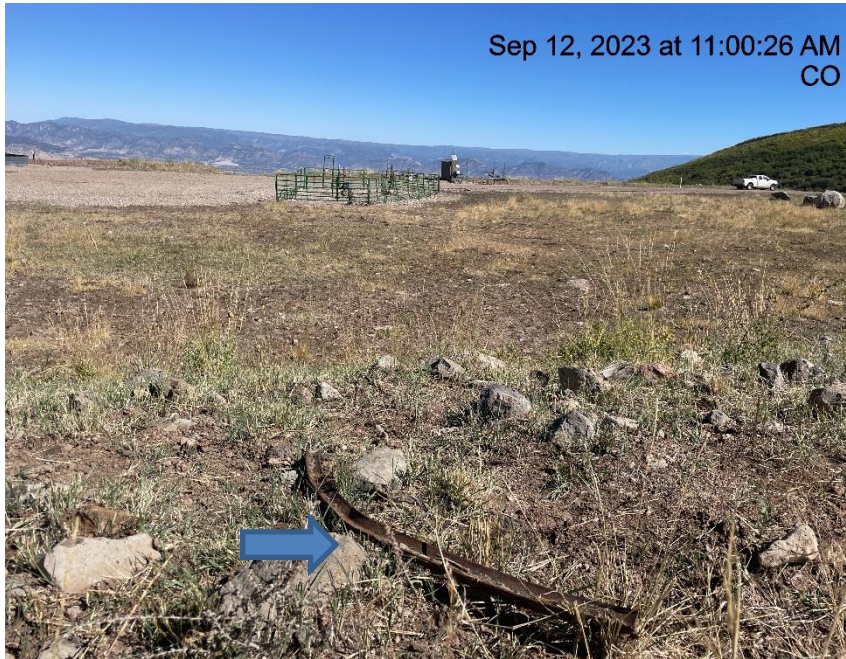
Photo # 8877 Debris

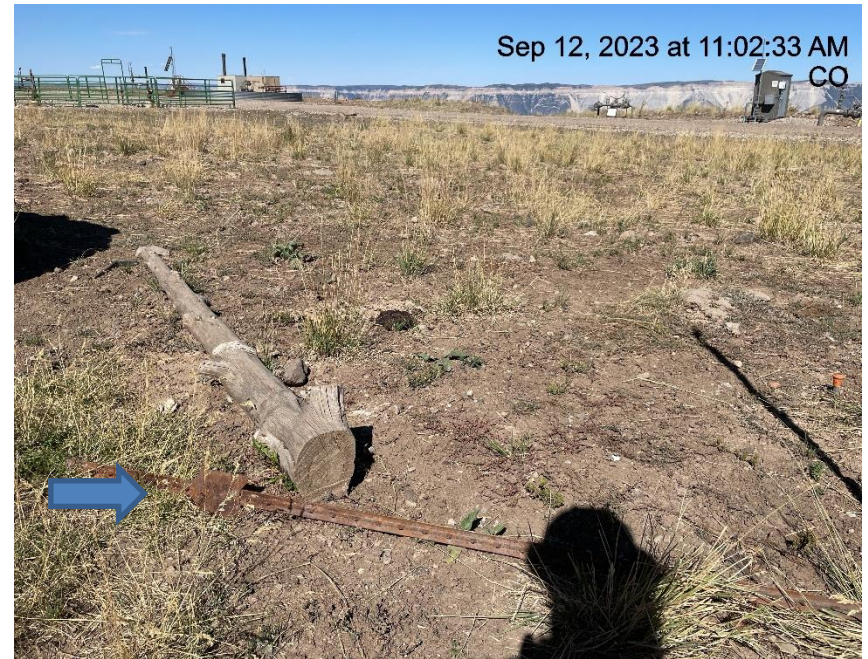
Photo # 8879 Debris

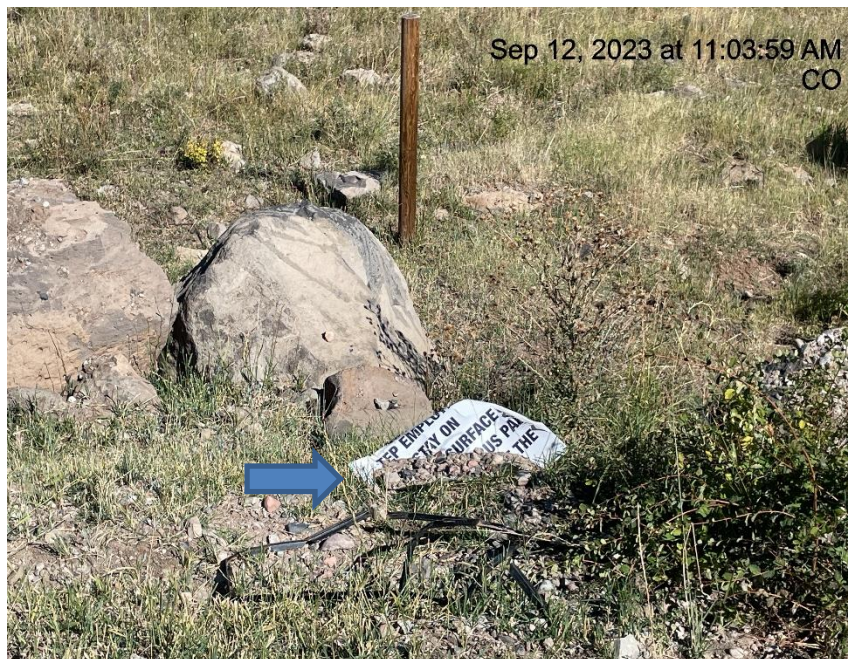
Photo # 8884 Debris
