# Inspection Photos

Loc: 418506

Operator: OXY USA INC

Inspection Date: 9/13/2023

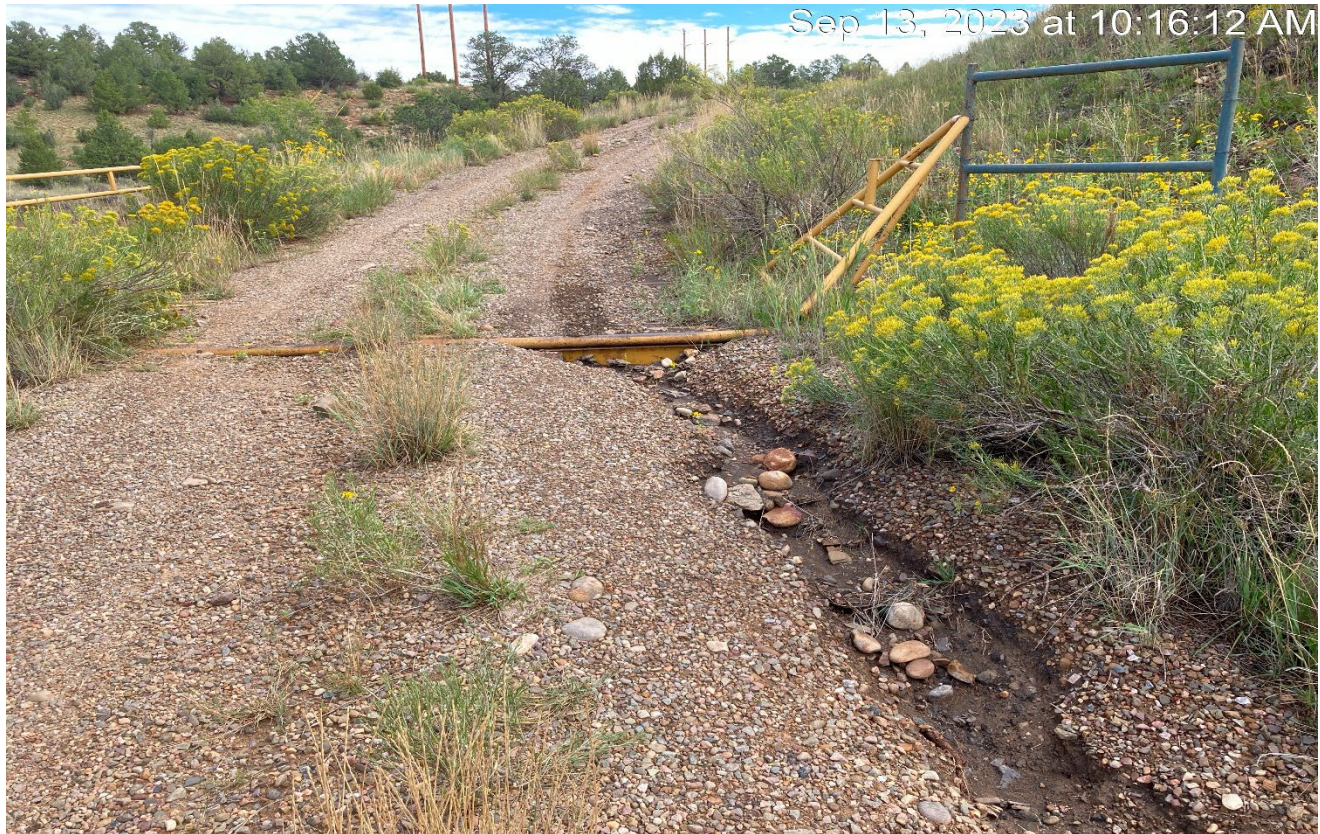
**Photo 1.** Facing east along the access road. The cattle guard is filled in with sediment and erosion is occurring at this area.

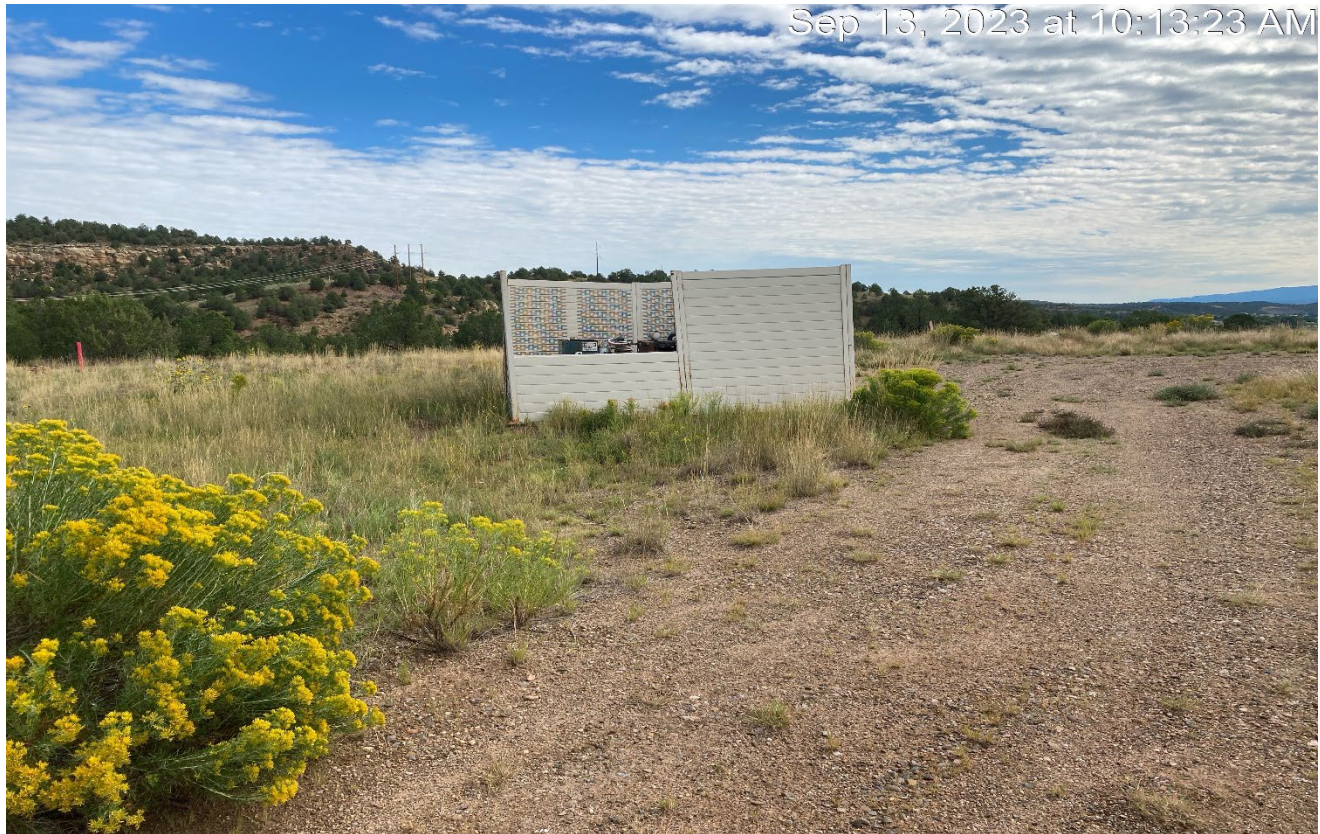
**Photo 2.** Facing east at the location..

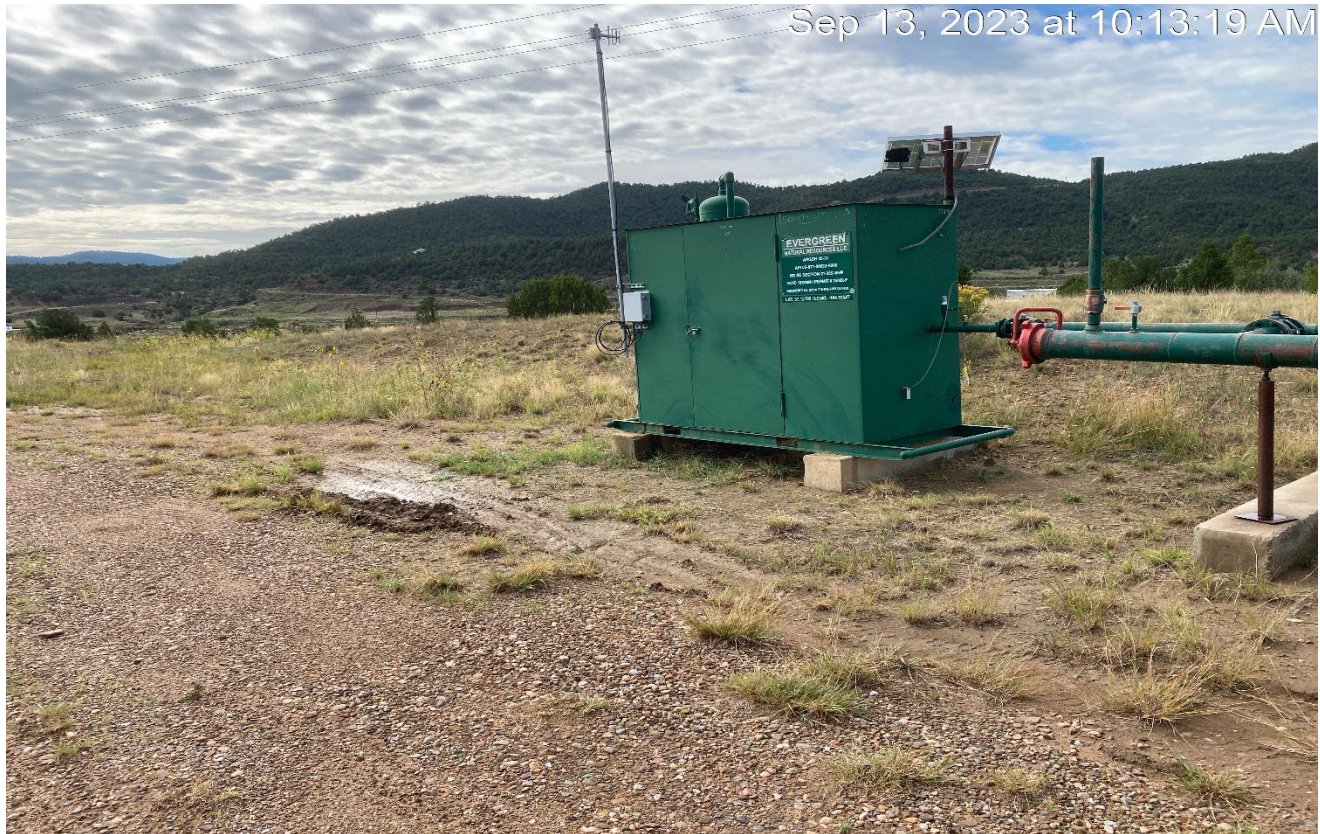
**Photo 3.** Well sign is posted at the meter shed.

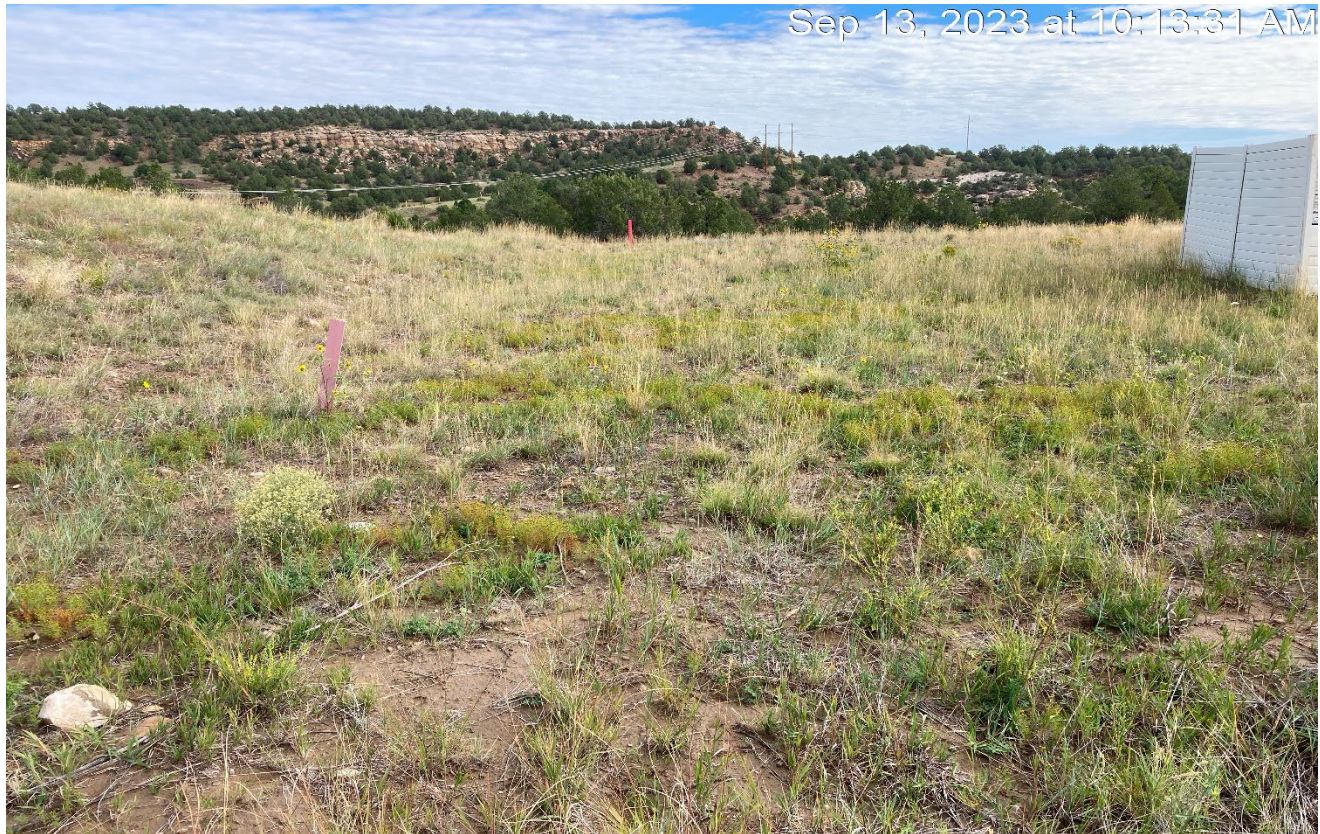
**Photo 4.** Facing northeast toward the interim reclamation area cut slope.

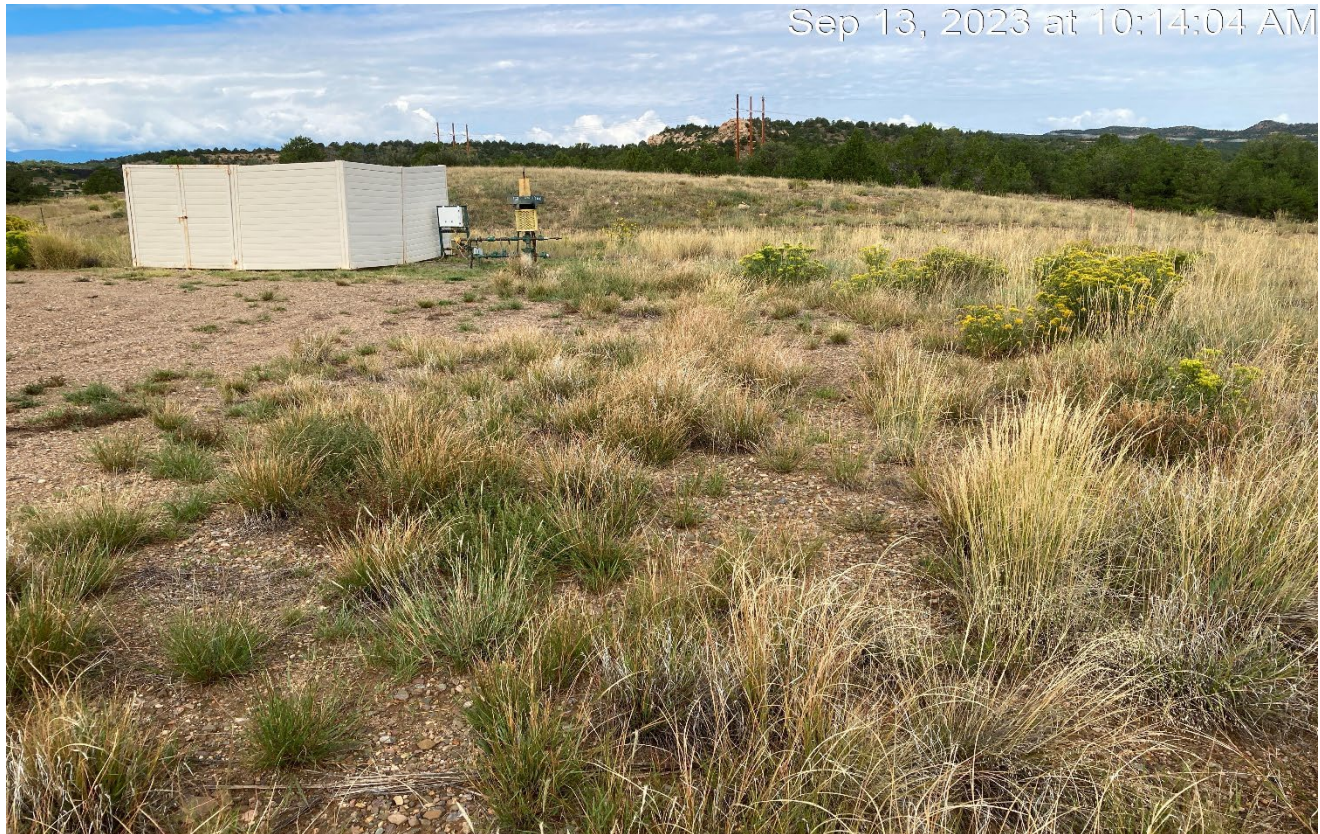
**Photo 5.** Facing northwest toward the interim reclamation area. Perennial vegetation is progressing.
