Storm Water Management and Erosion control
Location Name: TEP ROCKY MOUNTAIN LLC MOBIL GV 11-33 Pad
Location ID: 323824

Location Overview: Location is within High Priority/Density/Black Bear Habitat areas & Bald Eagle Roost Site & in close proximity to NSO Habitat area. Location is within Rule 411a Surface Water Intermediate Buffer. Location is approximately 434 yards from the Colorado River.

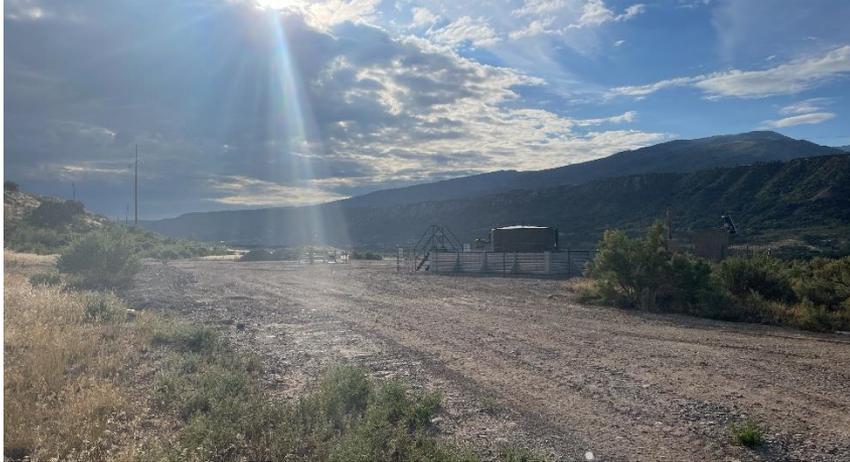
North West corner of location.

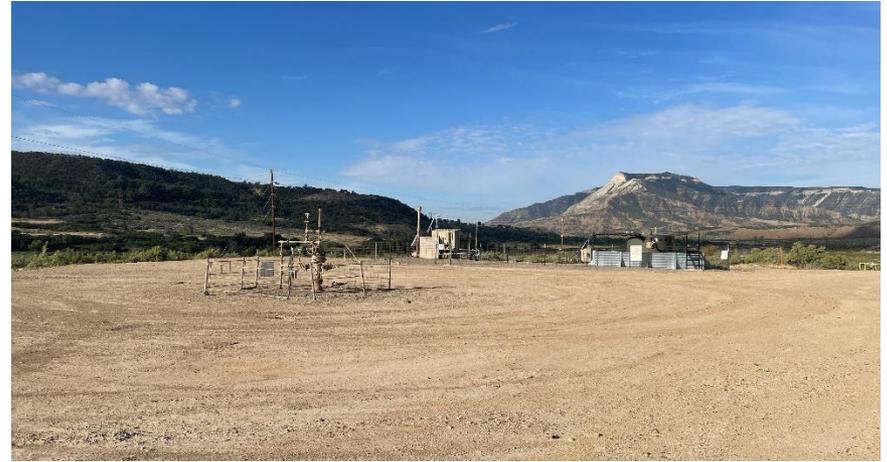
North East corner of location.

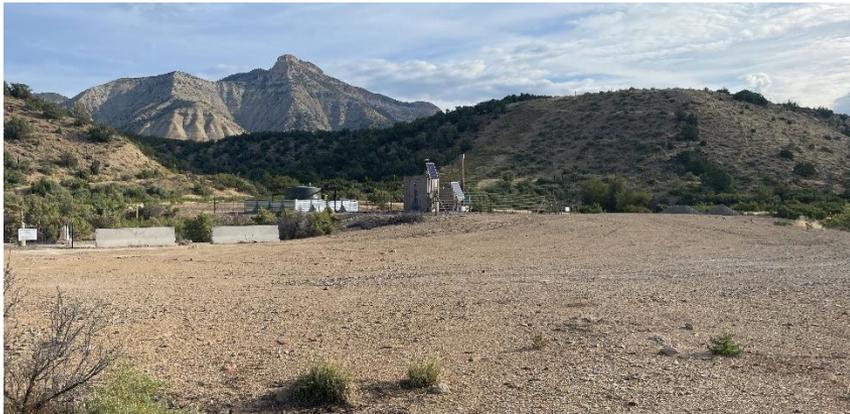
South West corner of location.

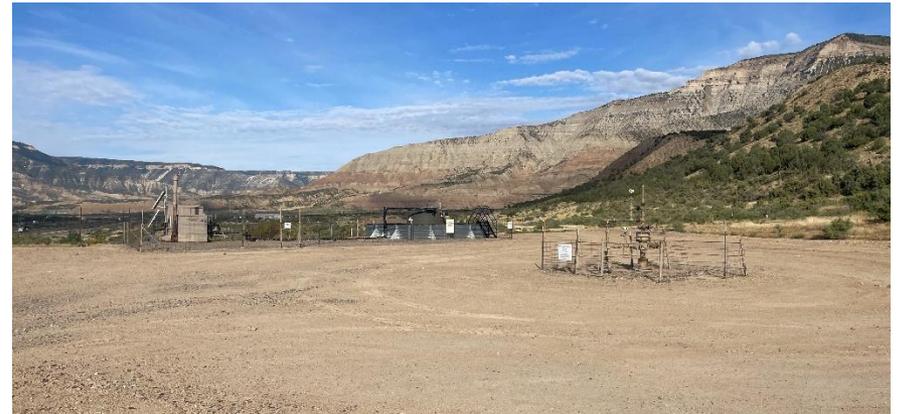
South East corner of location.

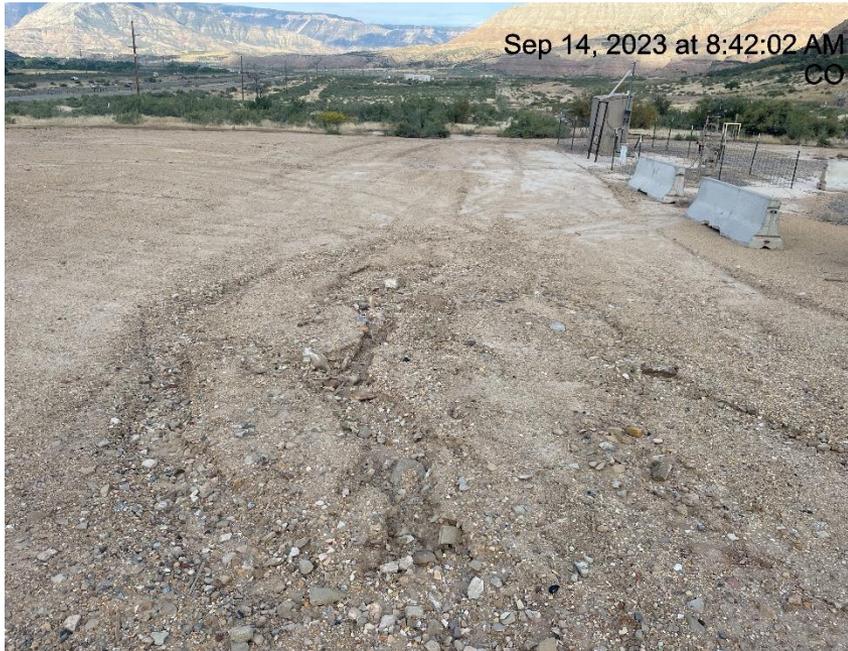
Photo # Erosion & transport of sediment

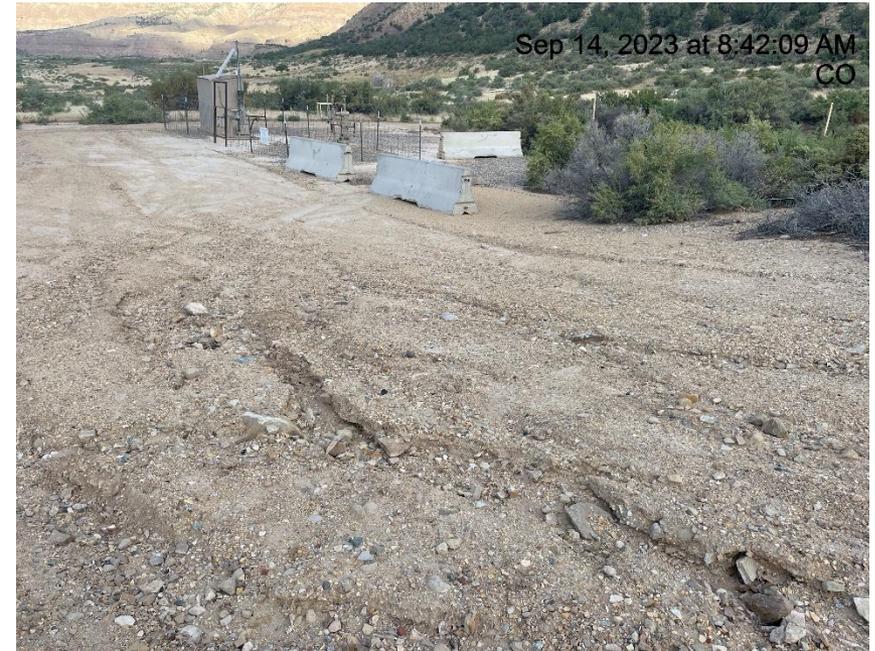
Photo # Erosion & transport of sediment

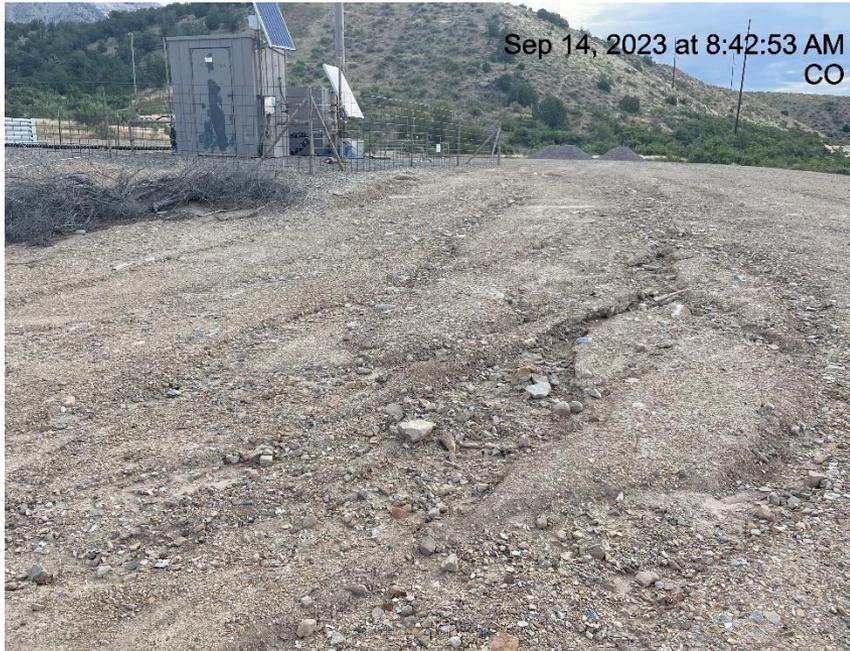
Photo # 9127 Erosion & transport of sediment

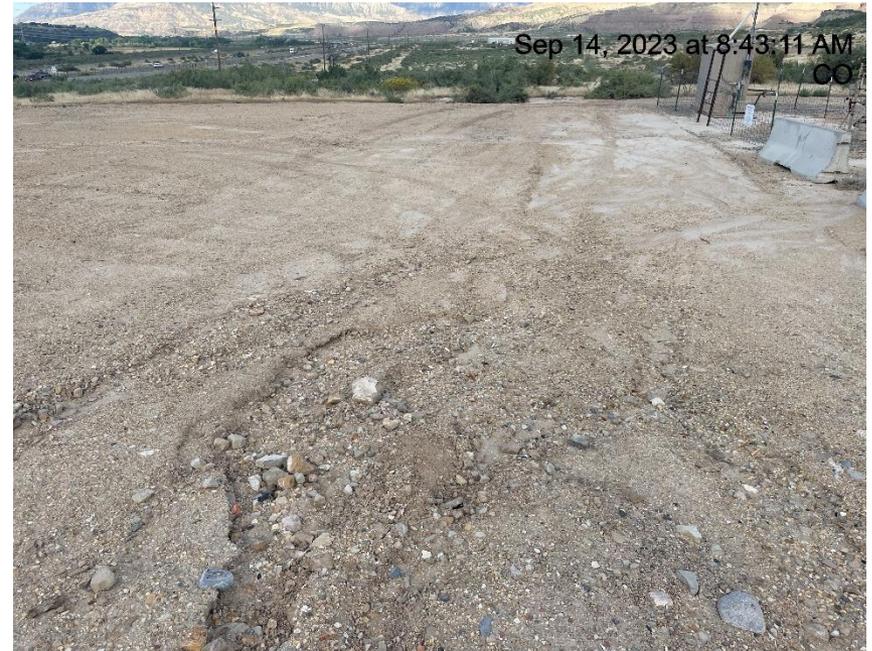
Photo # 9128 Erosion & transport of sediment

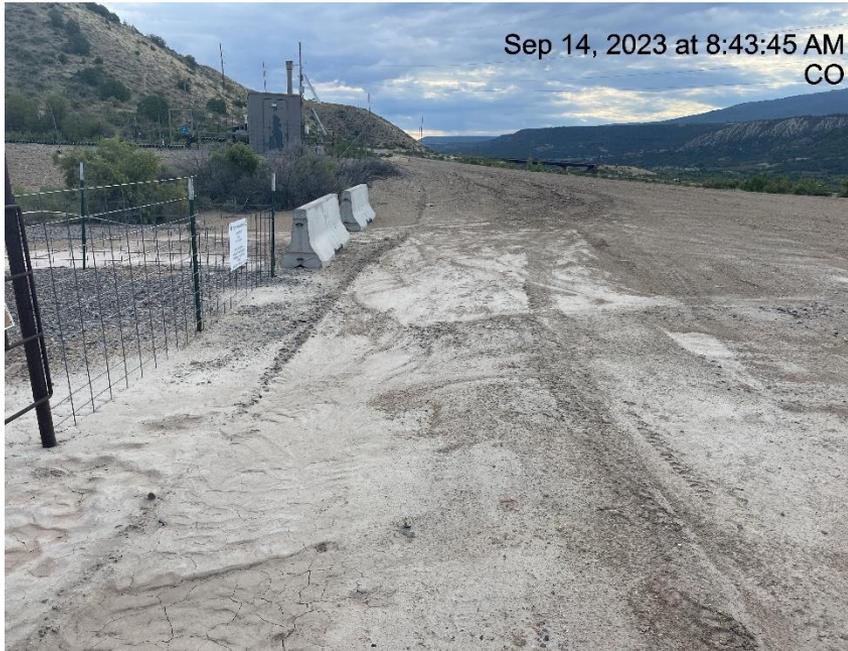
Photo # 9131 Erosion & transport of sediment

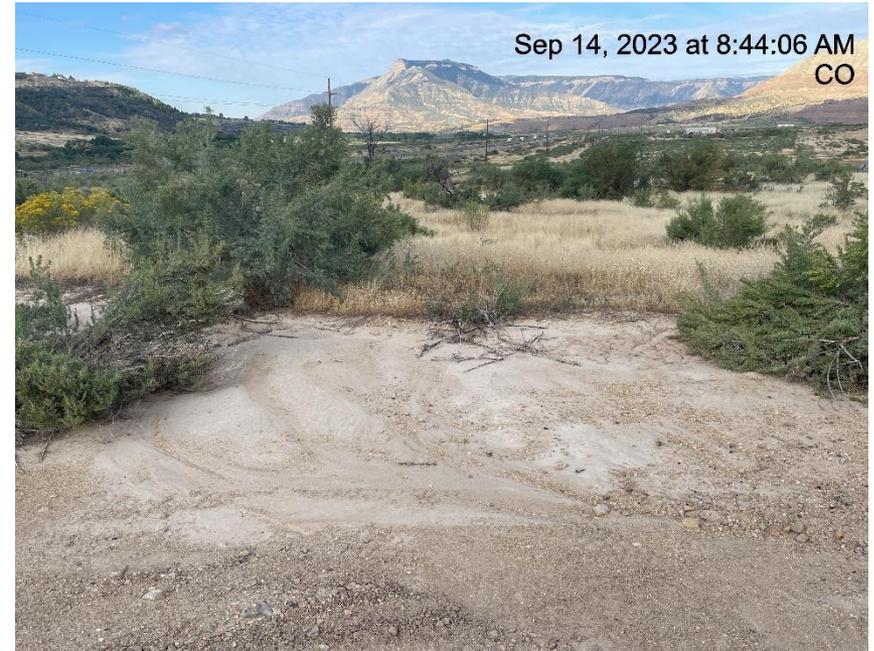
Photo # 9132 Erosion & transport of sediment off location into a vegetated area/choking off vegetation/insufficient BMP's .

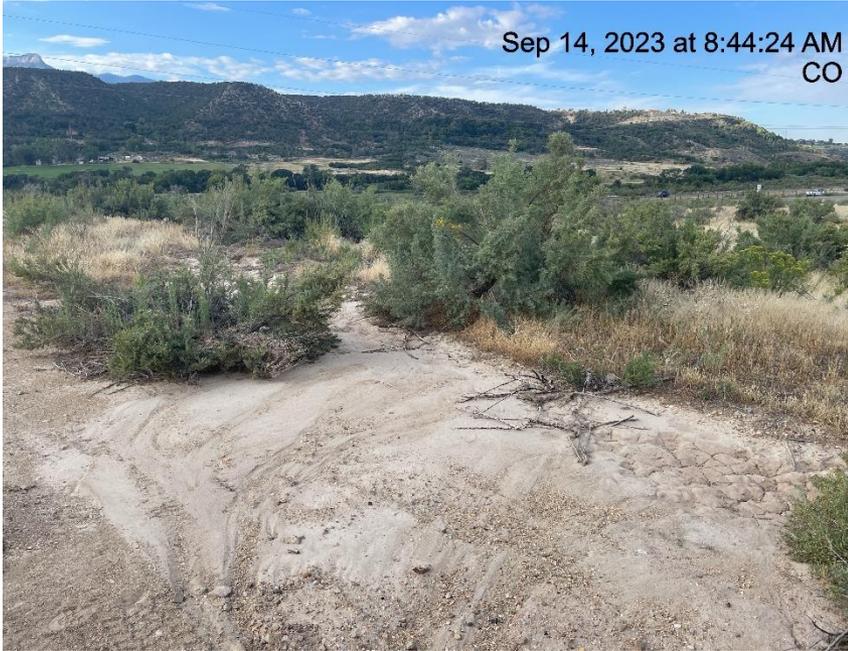
Photo # 9134 Erosion & transport of sediment off location into a vegetated area/choking off vegetation/insufficient BMP's .

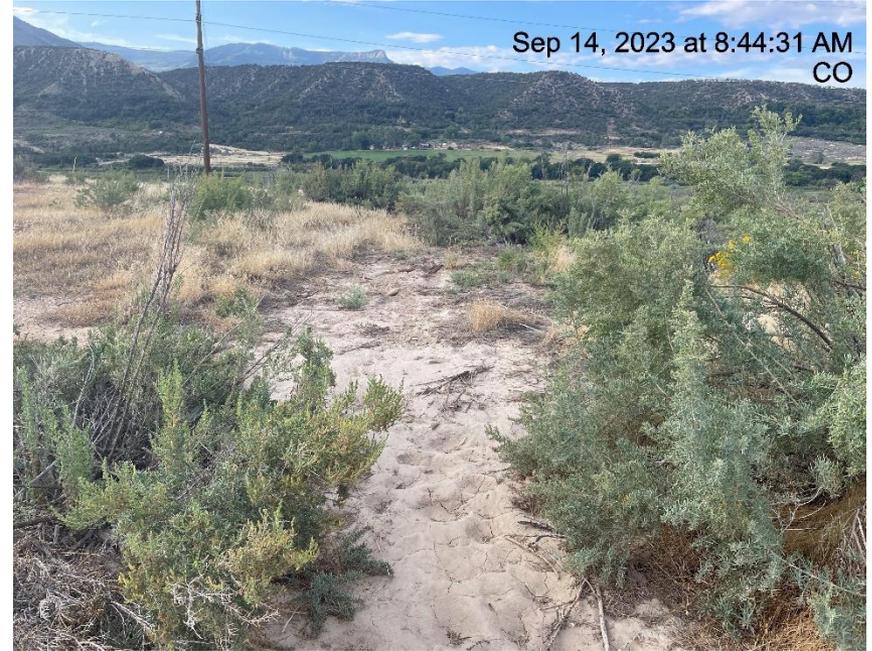
Photo # 9135 Erosion & transport of sediment off location into a vegetated area/choking off vegetation/insufficient BMP's .

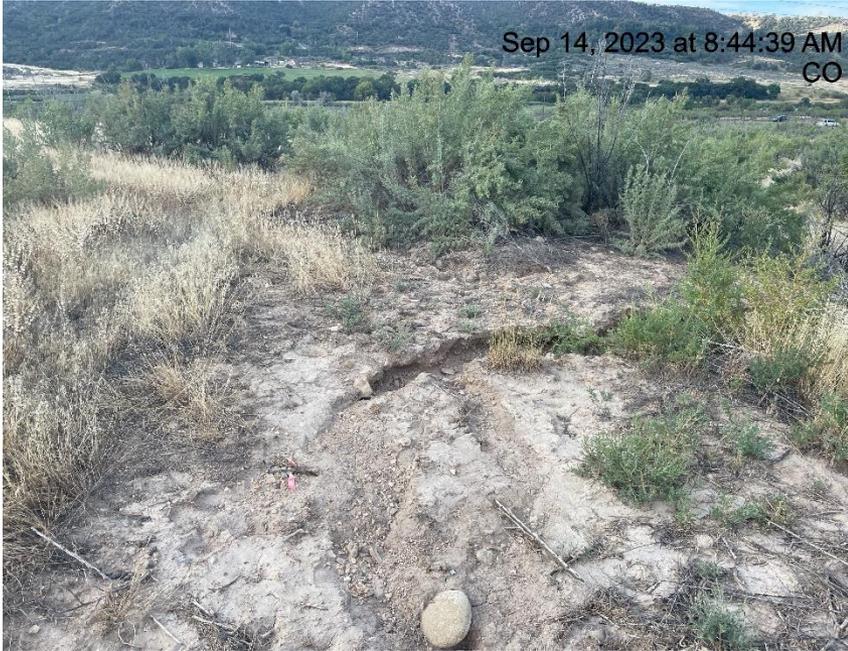
Photo # 9136 Erosion & transport of sediment off location into a vegetated area/choking off vegetation/insufficient BMP's .

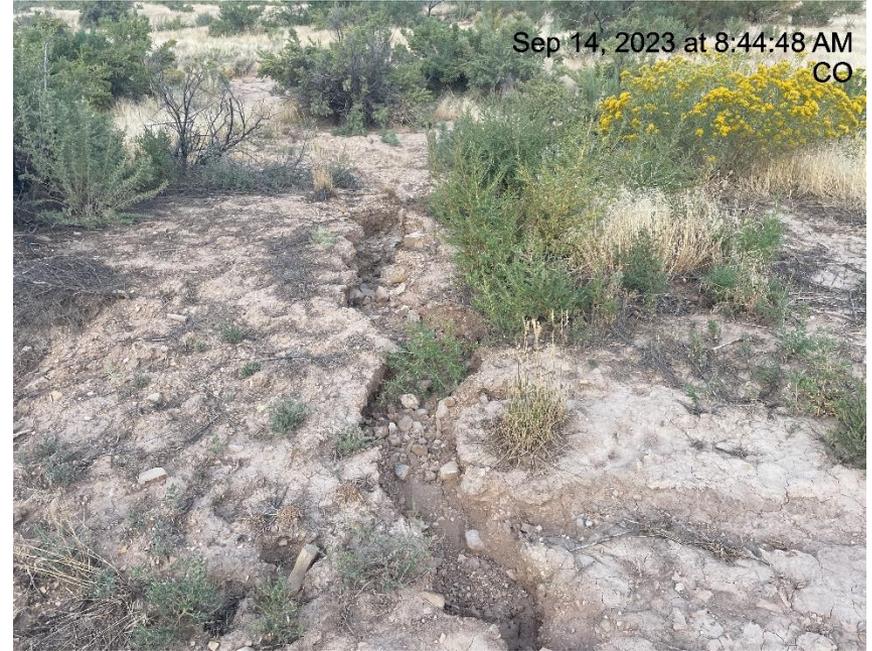
Photo # 9137 Erosion & transport of sediment off location into a vegetated area/choking off vegetation/insufficient BMP's .

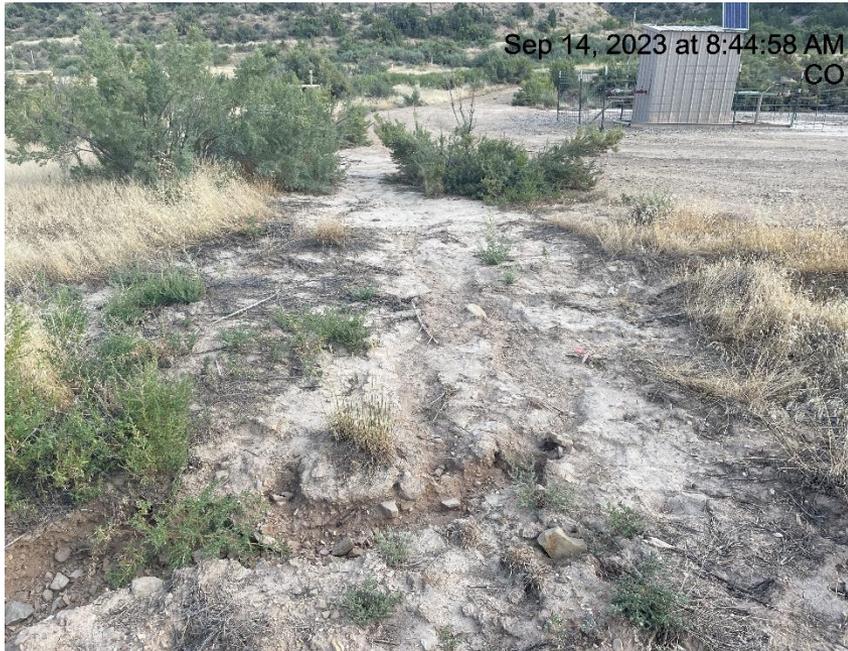
Photo # 9138 Erosion & transport of sediment off location into a vegetated area/choking off vegetation/insufficient BMP's .

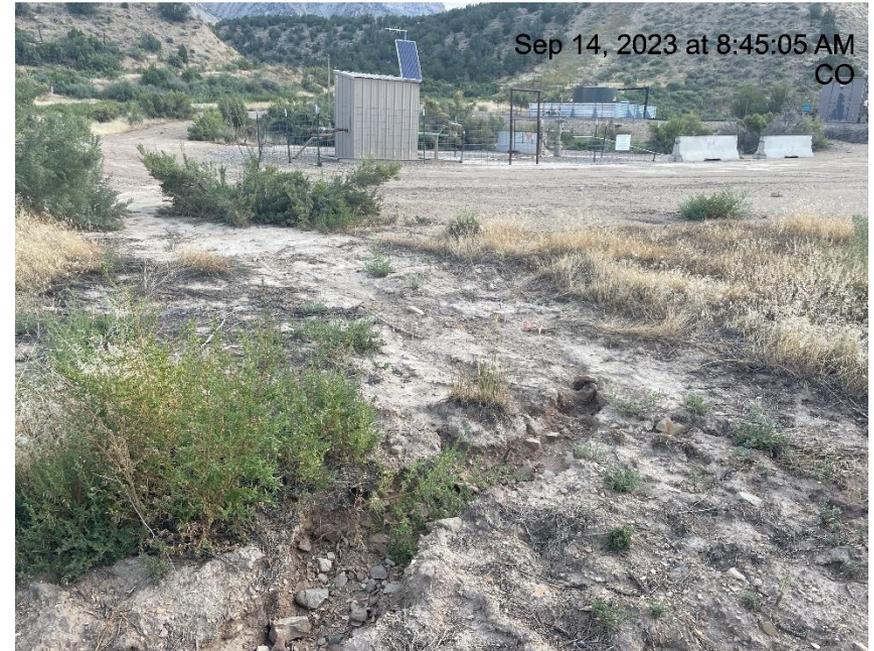
Photo # Erosion & transport of sediment off location into a vegetated area/choking off vegetation/insufficient BMP's .

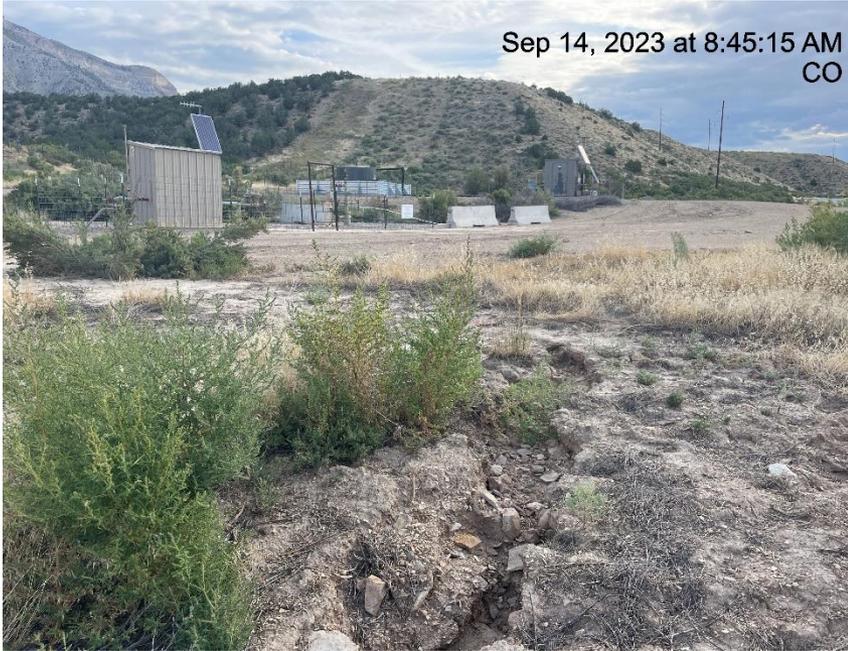
Photo # 9140 Erosion & transport of sediment off location into a vegetated area/choking off vegetation/insufficient BMP's .

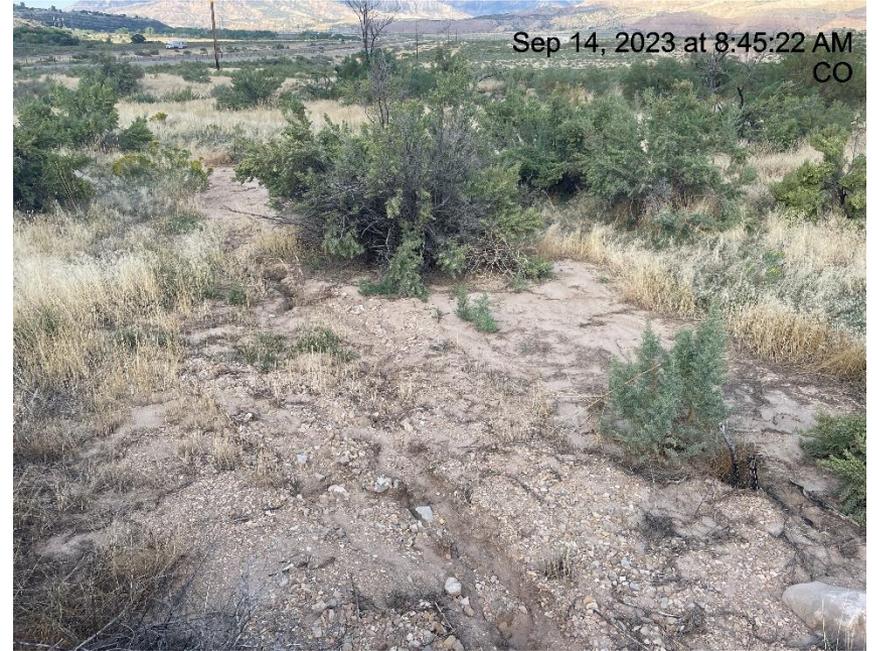
Photo # 9141 Erosion & transport of sediment off location into a vegetated area/choking off vegetation/insufficient BMP's .

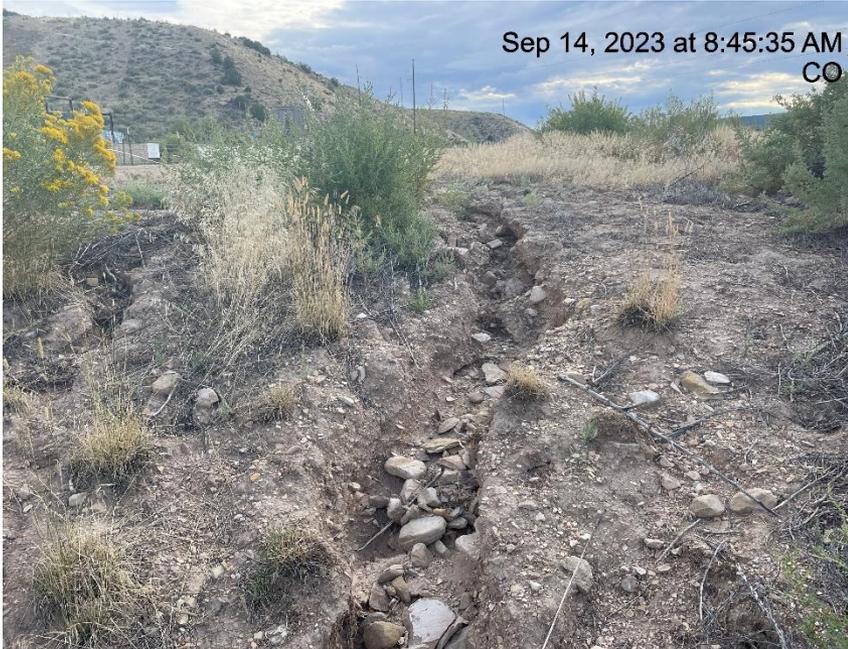
Photo # 9142 Erosion & transport of sediment off location into a vegetated area/choking off vegetation/insufficient BMP's .

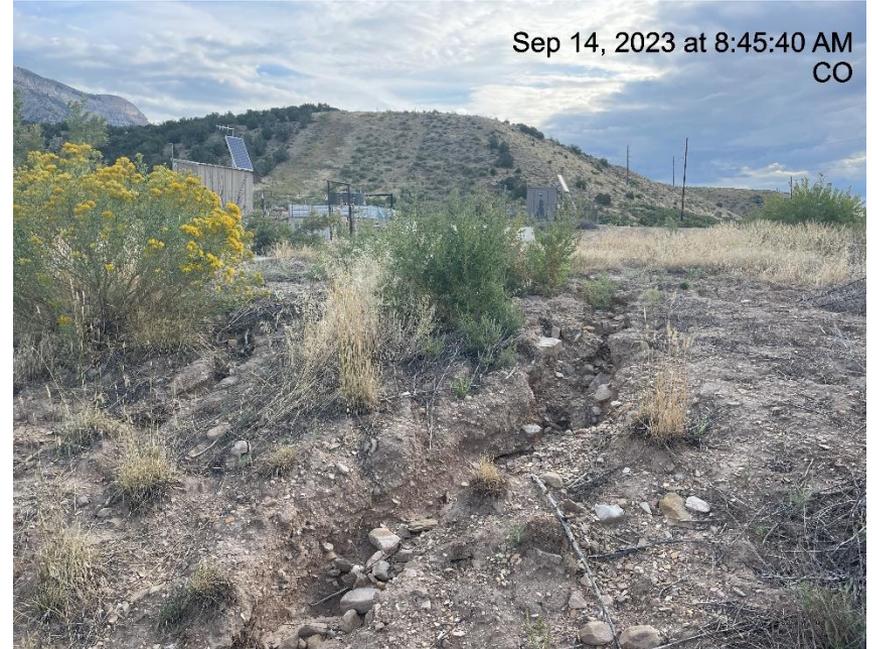
Photo # 9143 Erosion & transport of sediment off location into a vegetated area/choking off vegetation/insufficient BMP's .

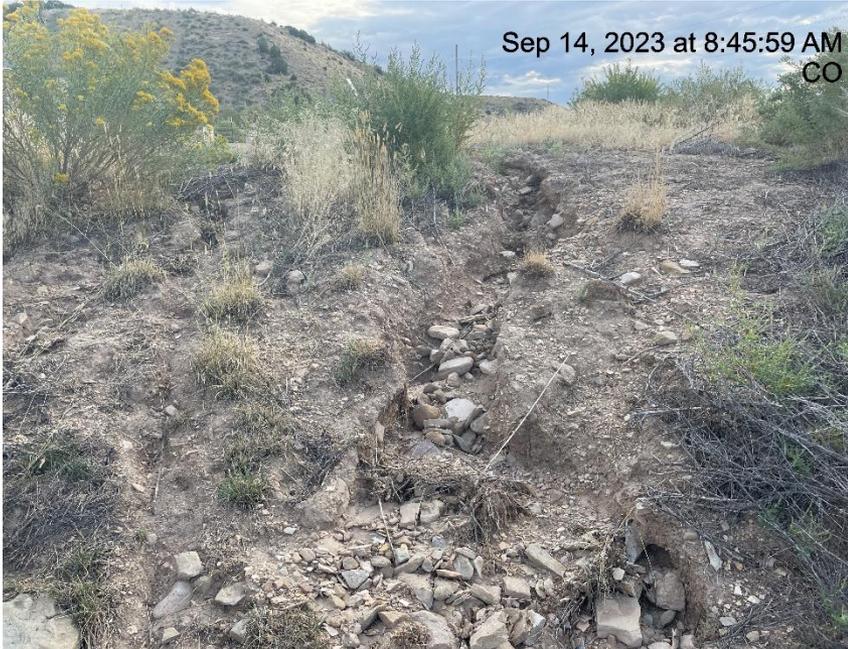
Photo # 9147 Erosion & transport of sediment off location into a vegetated area/choking off vegetation/insufficient BMP's .

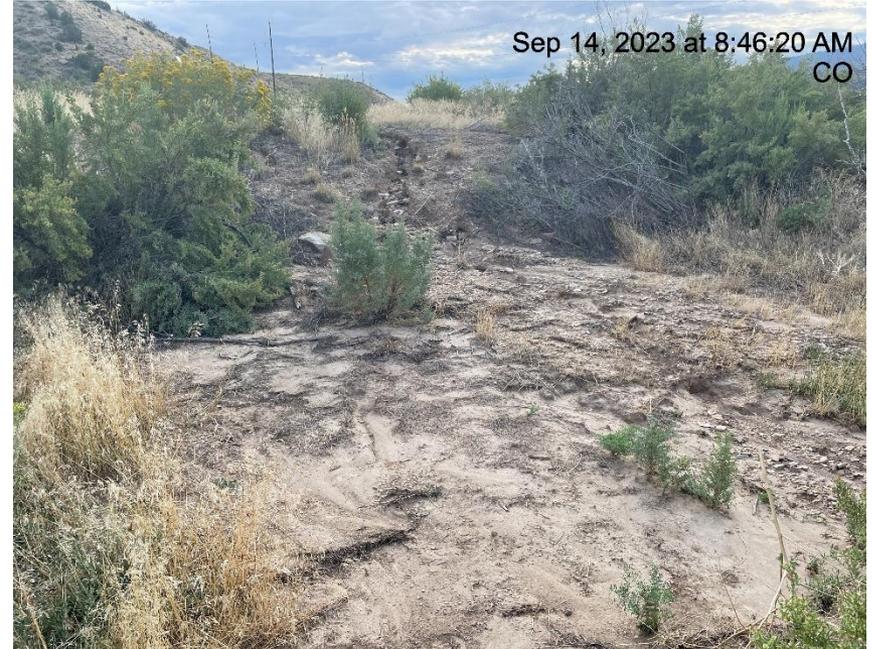
Photo # 9151 Erosion & transport of sediment off location into a vegetated area/choking off vegetation/insufficient BMP's .

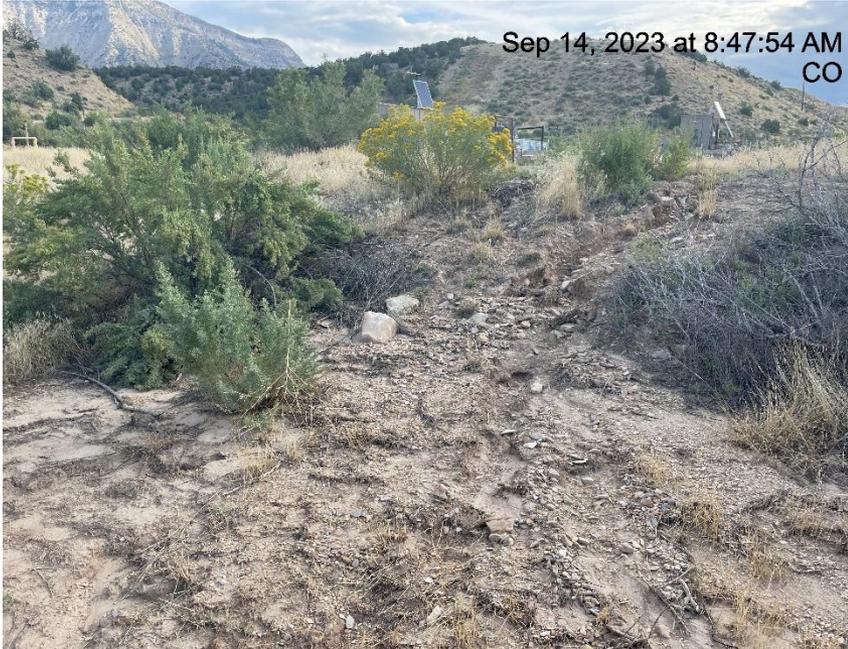
Photo # 9159 Erosion & transport of sediment off location into a vegetated area/choking off vegetation/insufficient BMP's .

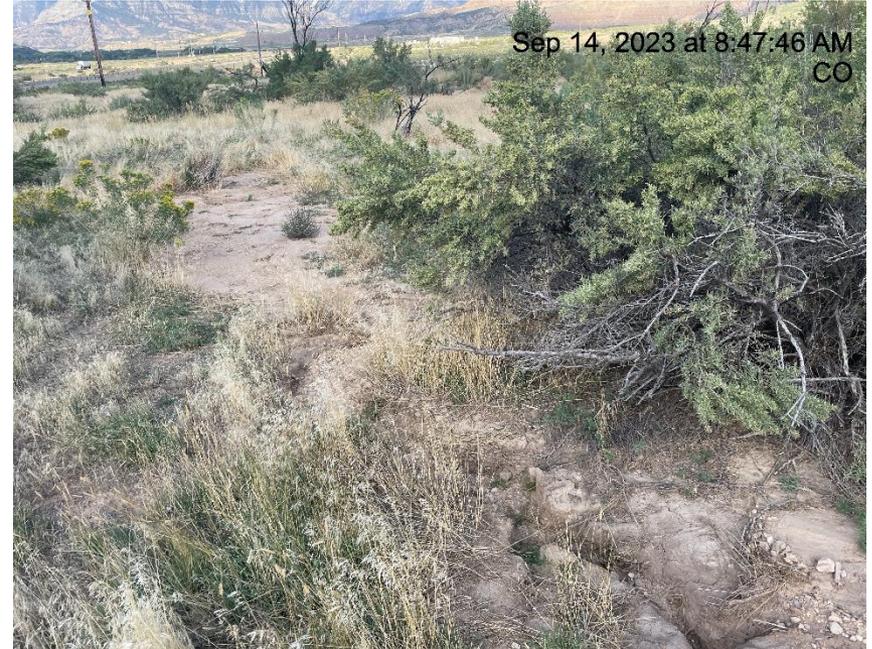
Photo # 9161 Erosion & transport of sediment off location into a vegetated area/choking off vegetation/insufficient BMP's .

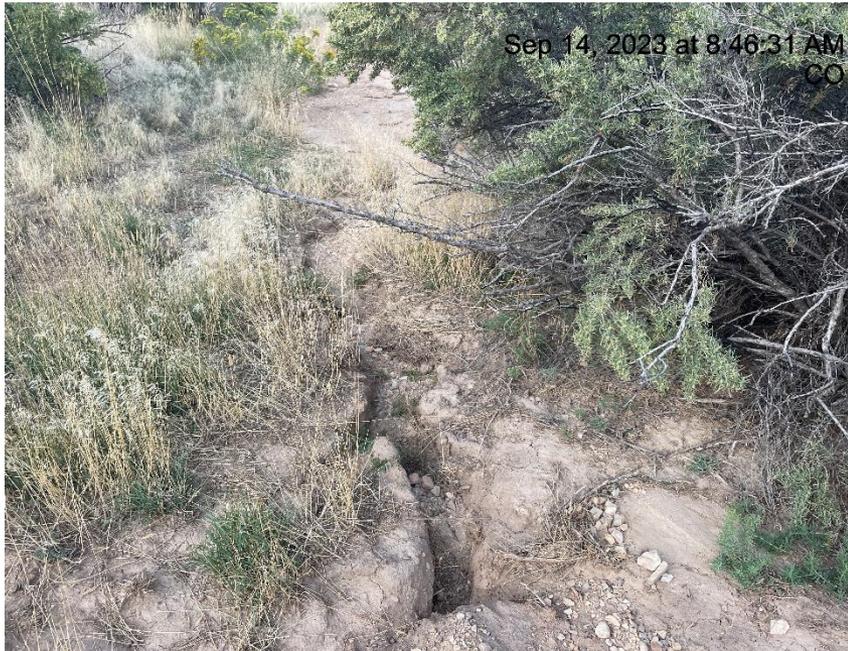
Photo # 9152 Erosion & transport of sediment off location into a vegetated area/choking off vegetation/insufficient BMP's .

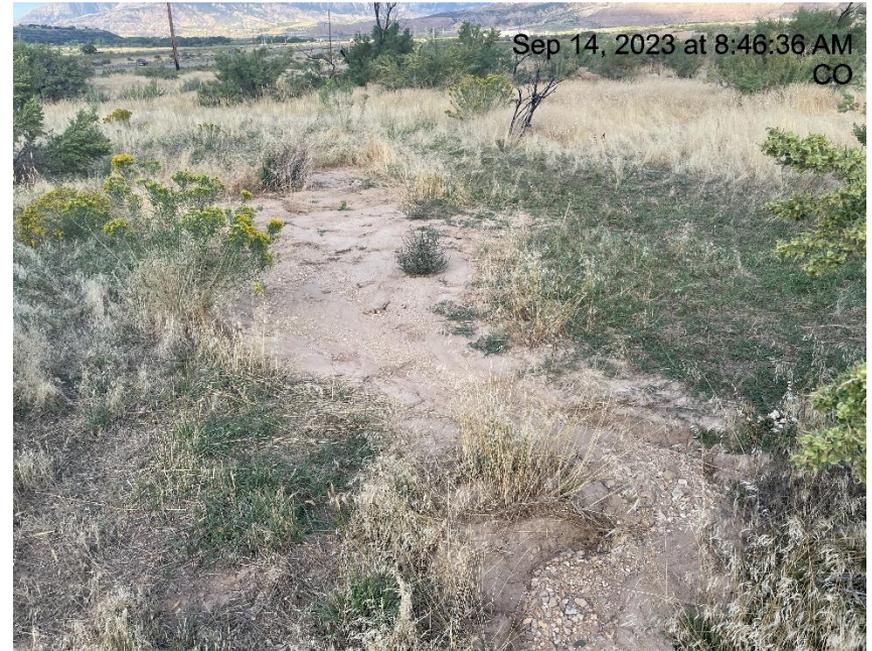
Photo # 9153 Erosion & transport of sediment off location into a vegetated area/choking off vegetation/insufficient BMP's .

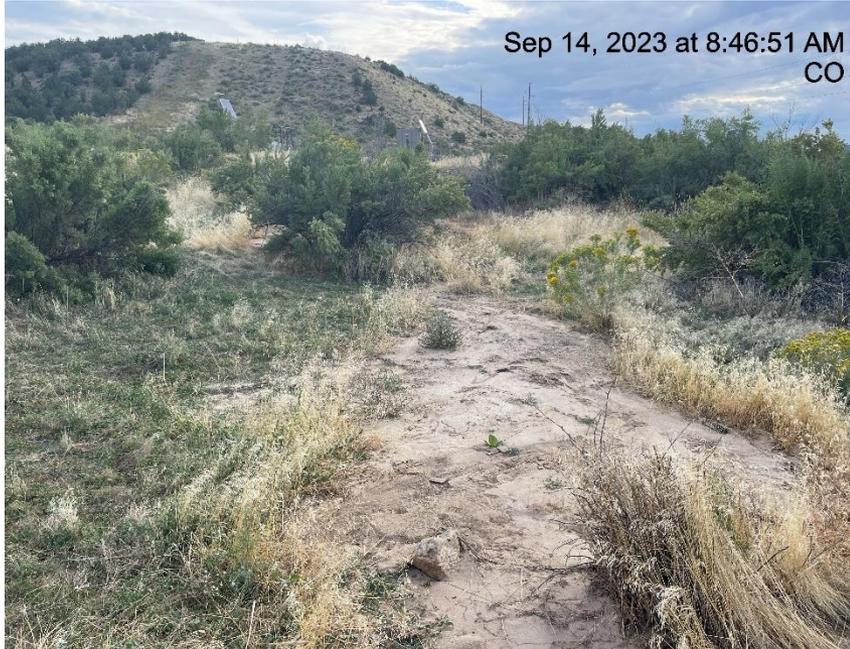
Photo # 9154 Erosion & transport of sediment off location into a vegetated area/choking off vegetation/insufficient BMP's .

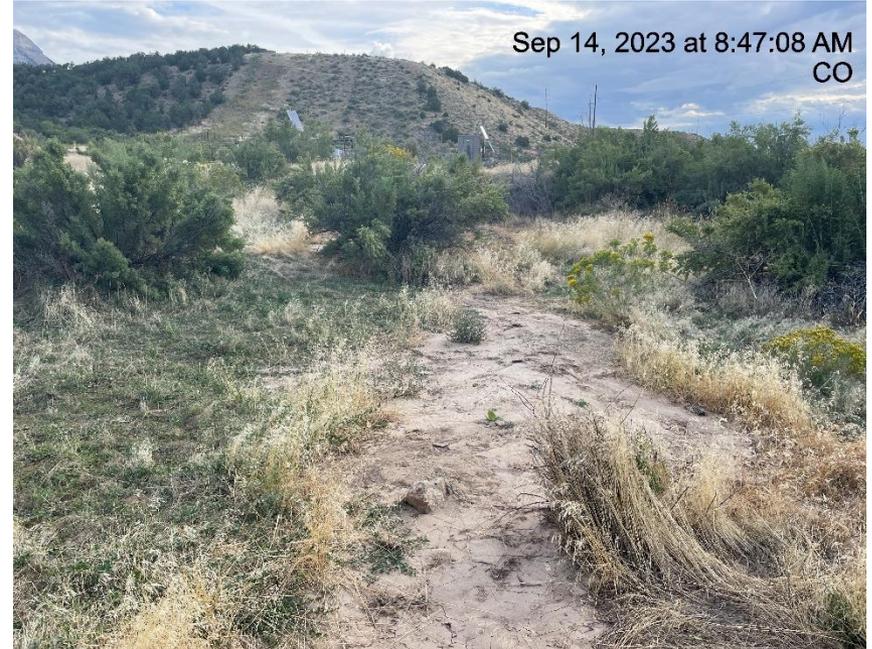
Photo # 9155 Erosion & transport of sediment off location into a vegetated area/choking off vegetation/insufficient BMP's .
