Inspection Photos

Loc: 309313

Operator: XTO ENERGY INC

Inspection Date: 9/18/2023

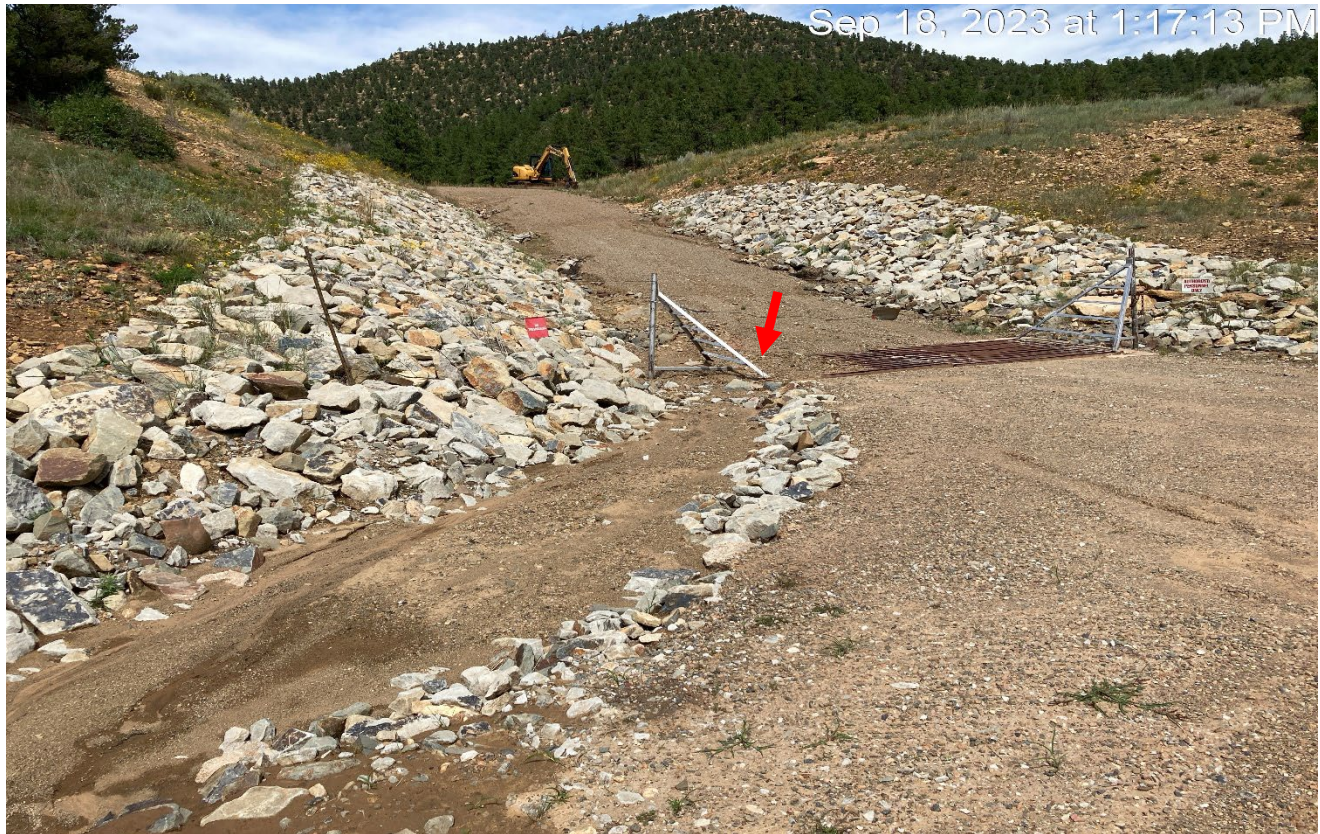
Photo 1. Facing north at the beginning of the access road. There is sediment deposition at the cattleguard and roadside from recent rainstorms..

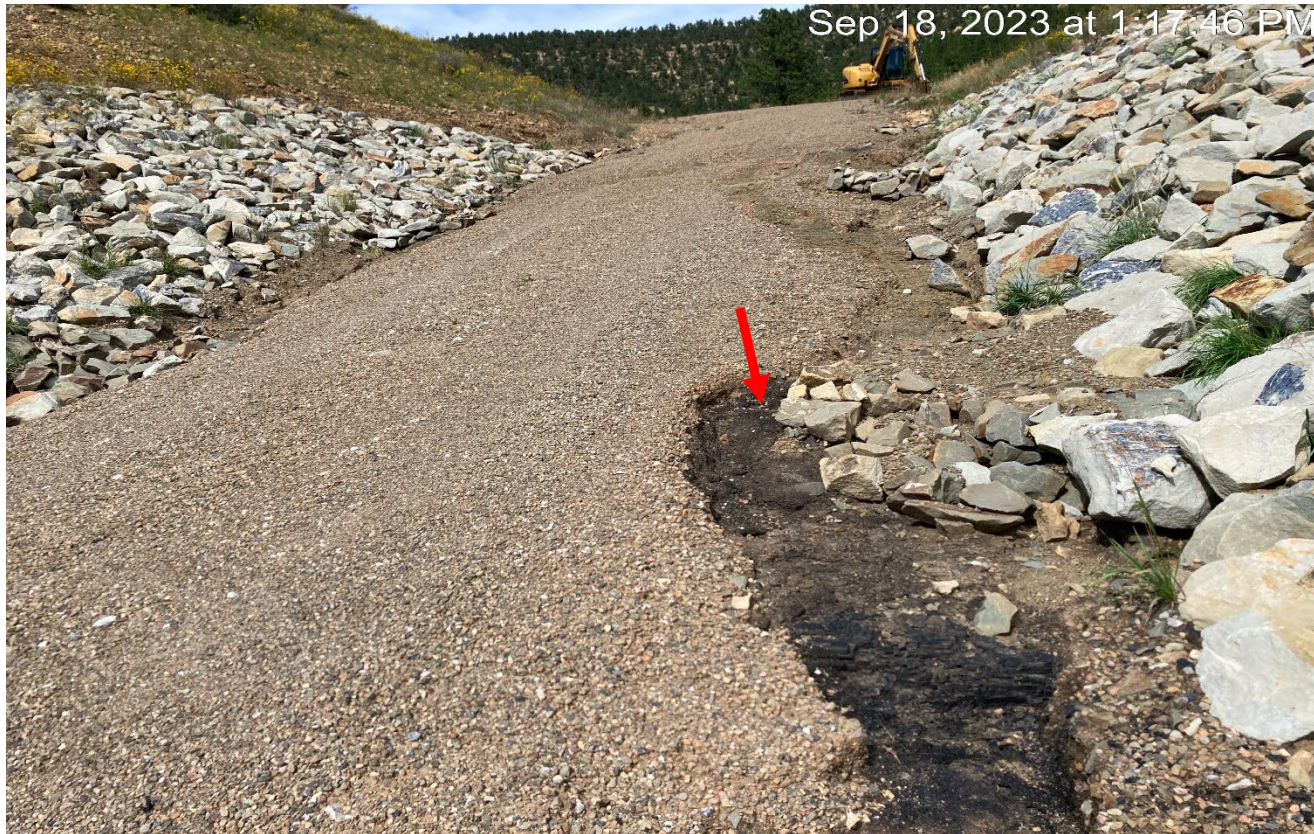
Photo 2. Facing north along the access road. Stormwater has washed around the rock checkdams shown at red arrow.

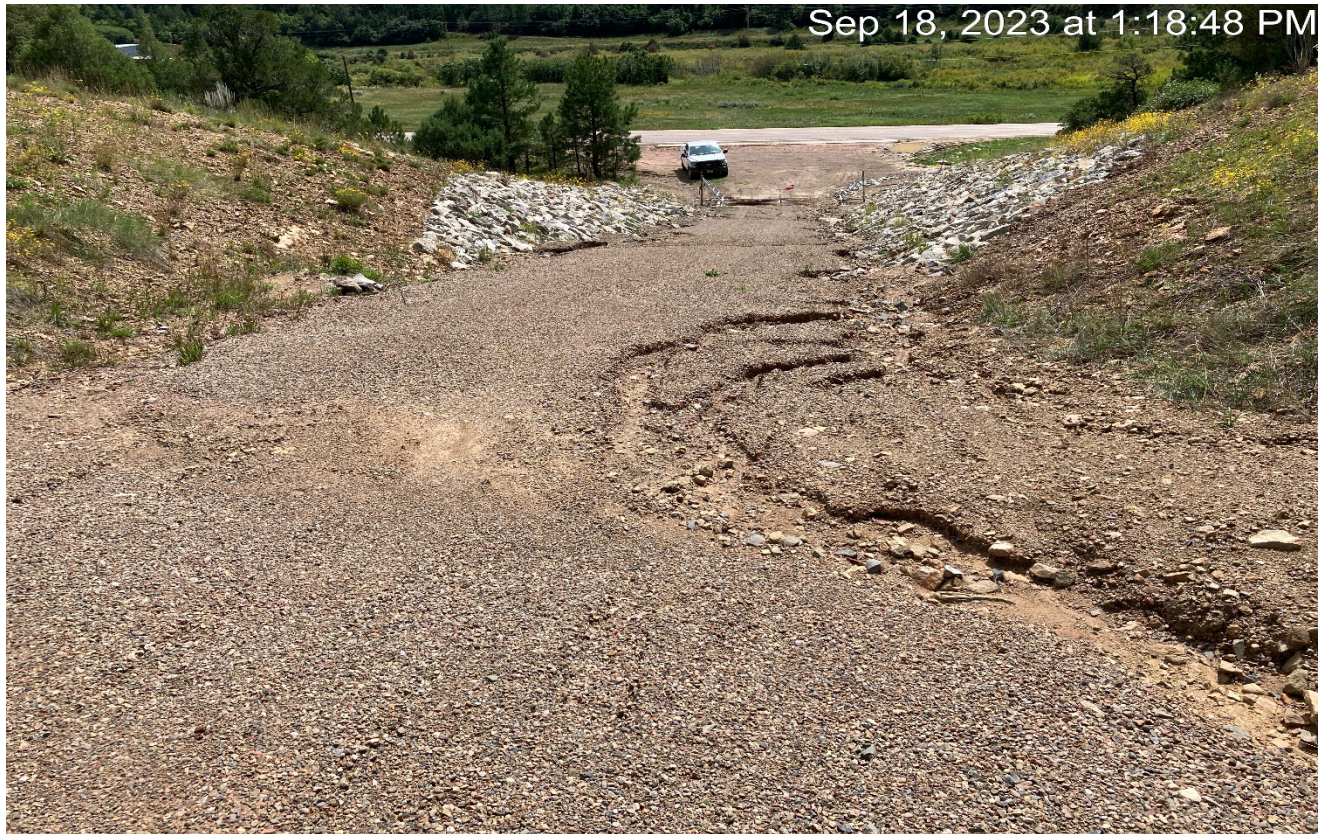
Photo 3. Facing back south at the access road. There is erosion along the road from recent rain storms.

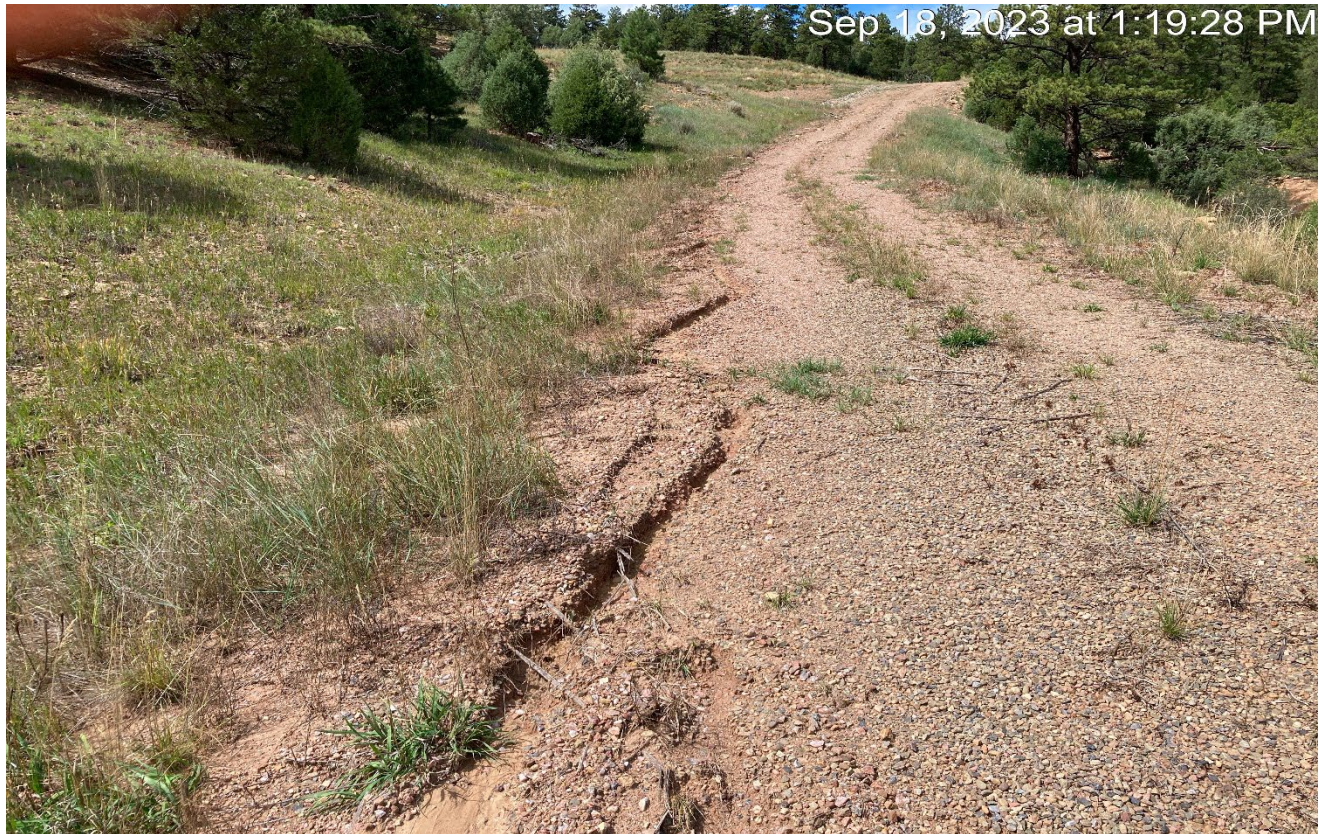
Photo 4. Facing northwest along the access road. There is an erosion channel along the road beginning to develop. BMP's such as a water bar may help direct stormwater off the road.

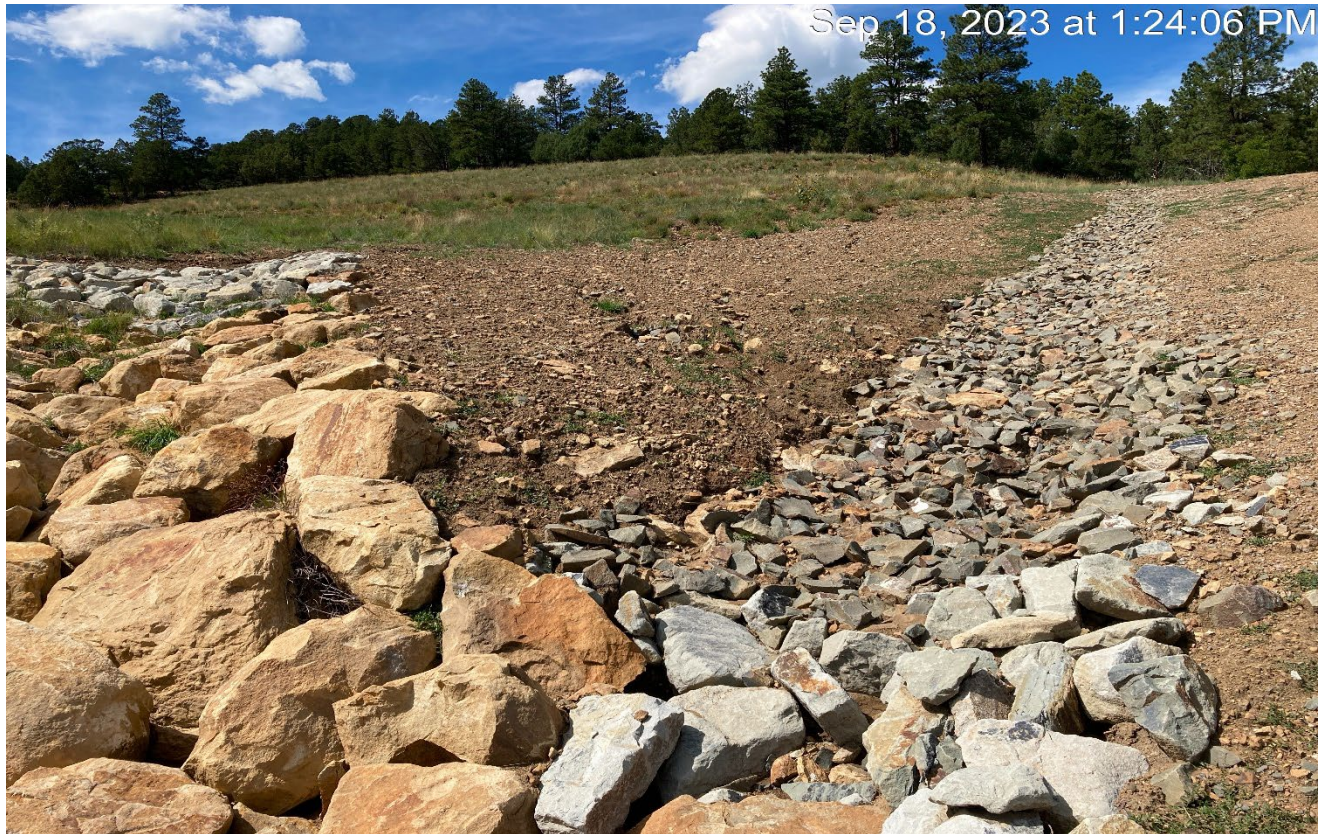
Photo 5. Facing northwest toward the location. Additional rock rip rap was installed in this area.

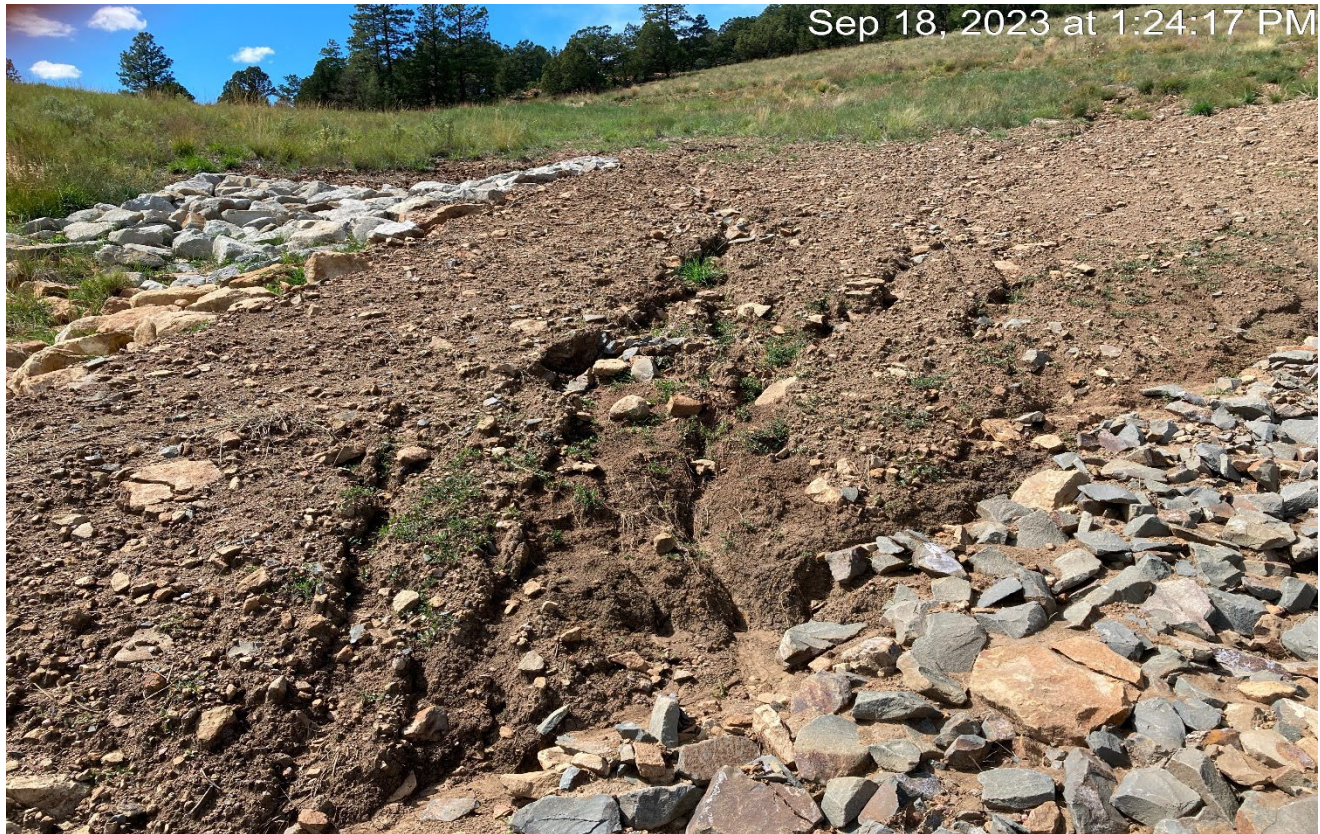
Photo 6. Facing northwest. There is erosion beginning to occur in this area bare of vegetation. Additional BMPs should be installed until vegetation establishes.

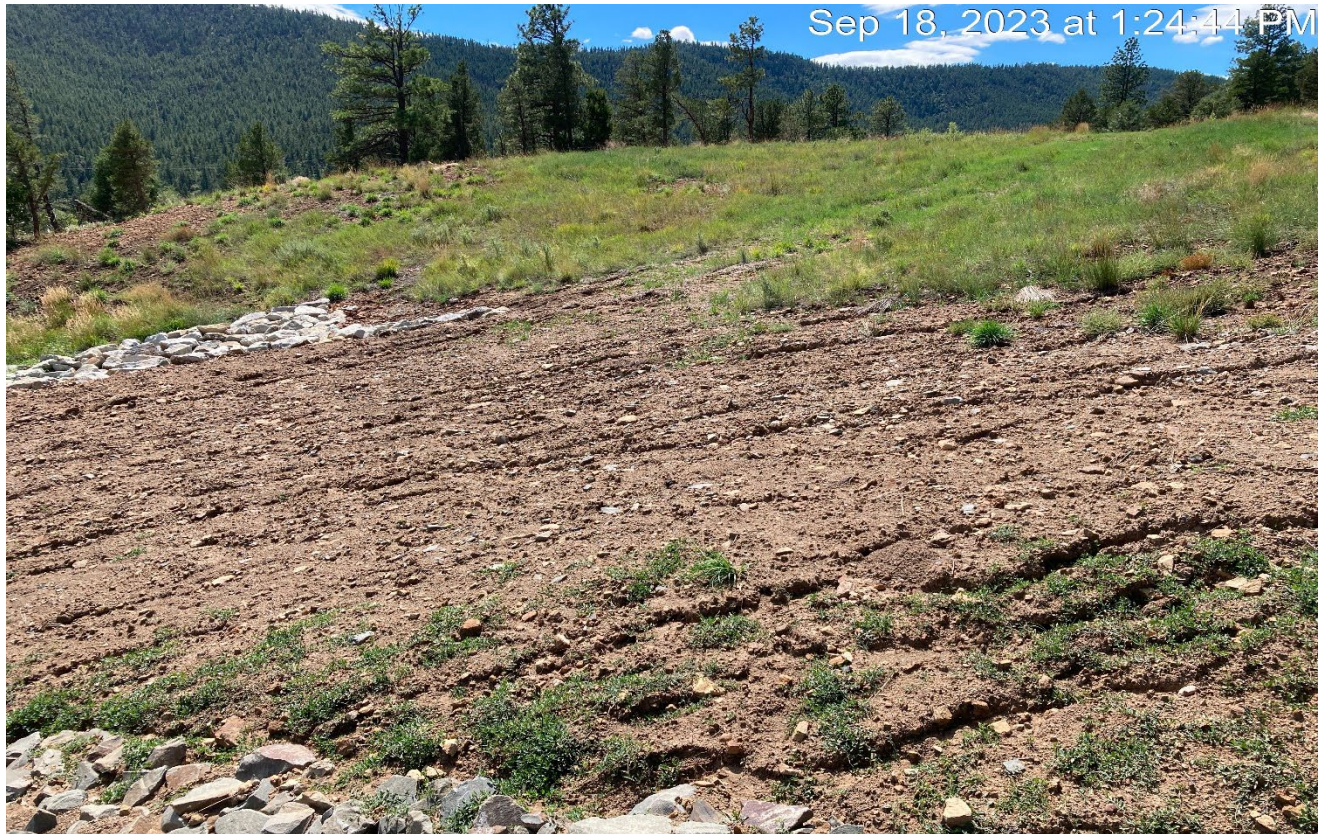
Photo 7. Facing southwest. There is erosion beginning to occur in this area bare of vegetation. Additional BMPs should be installed until vegetation establishes.

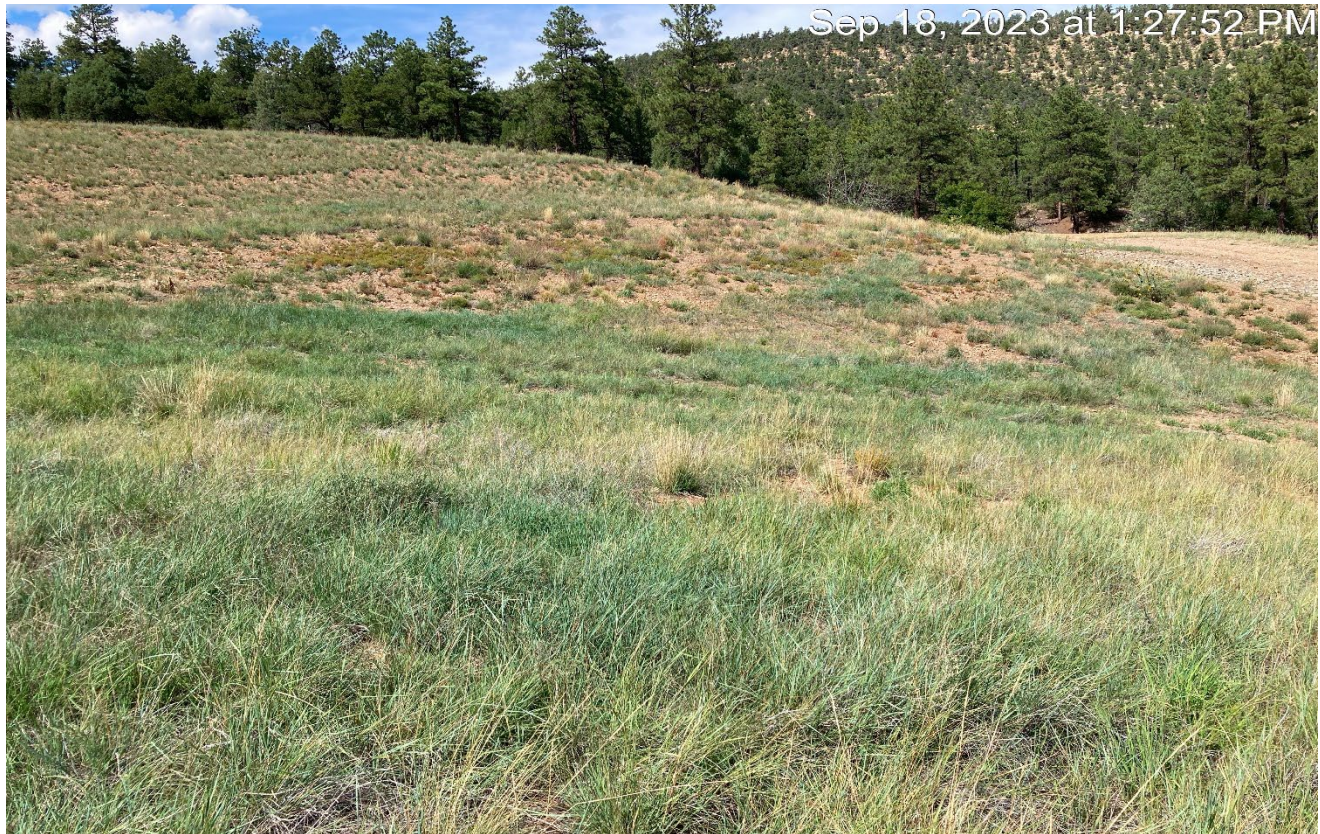
Photo 8. South side of the location facing north. Overall vegetation appears to be progressing.

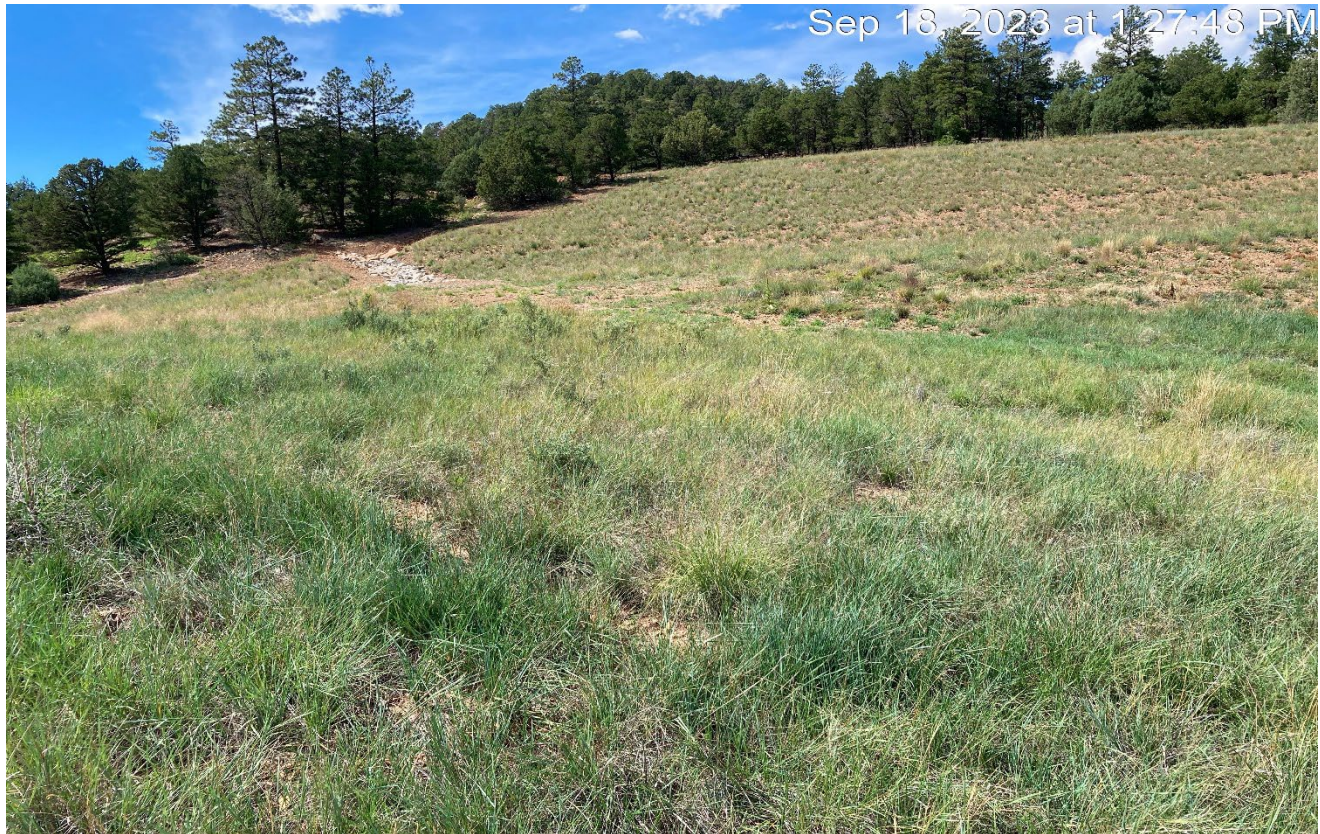
Photo 9. South side of the location facing northwest. Overall vegetation appears to be progressing.

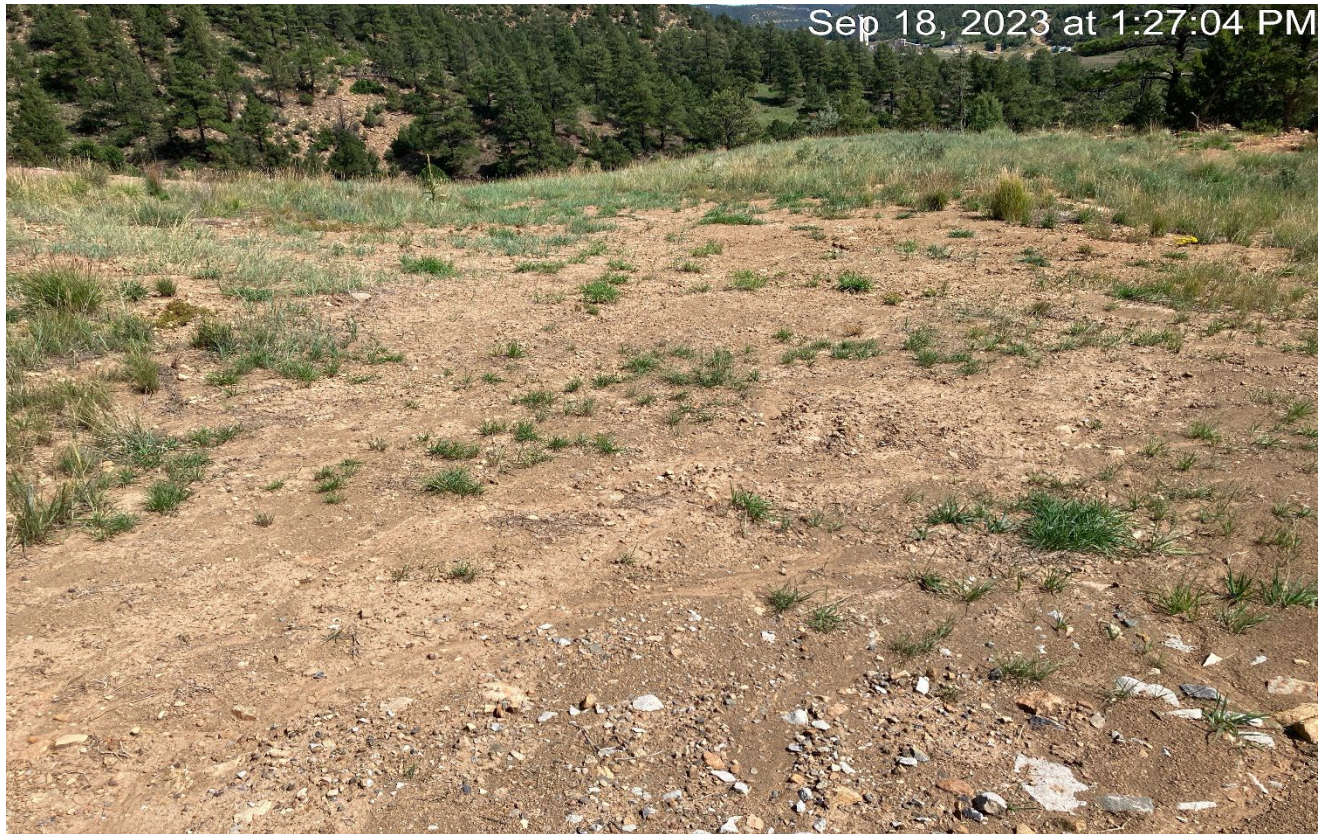
Photo 10. Center of the location facing east. This area was disturbed and will need to re-establish perennial vegetation.

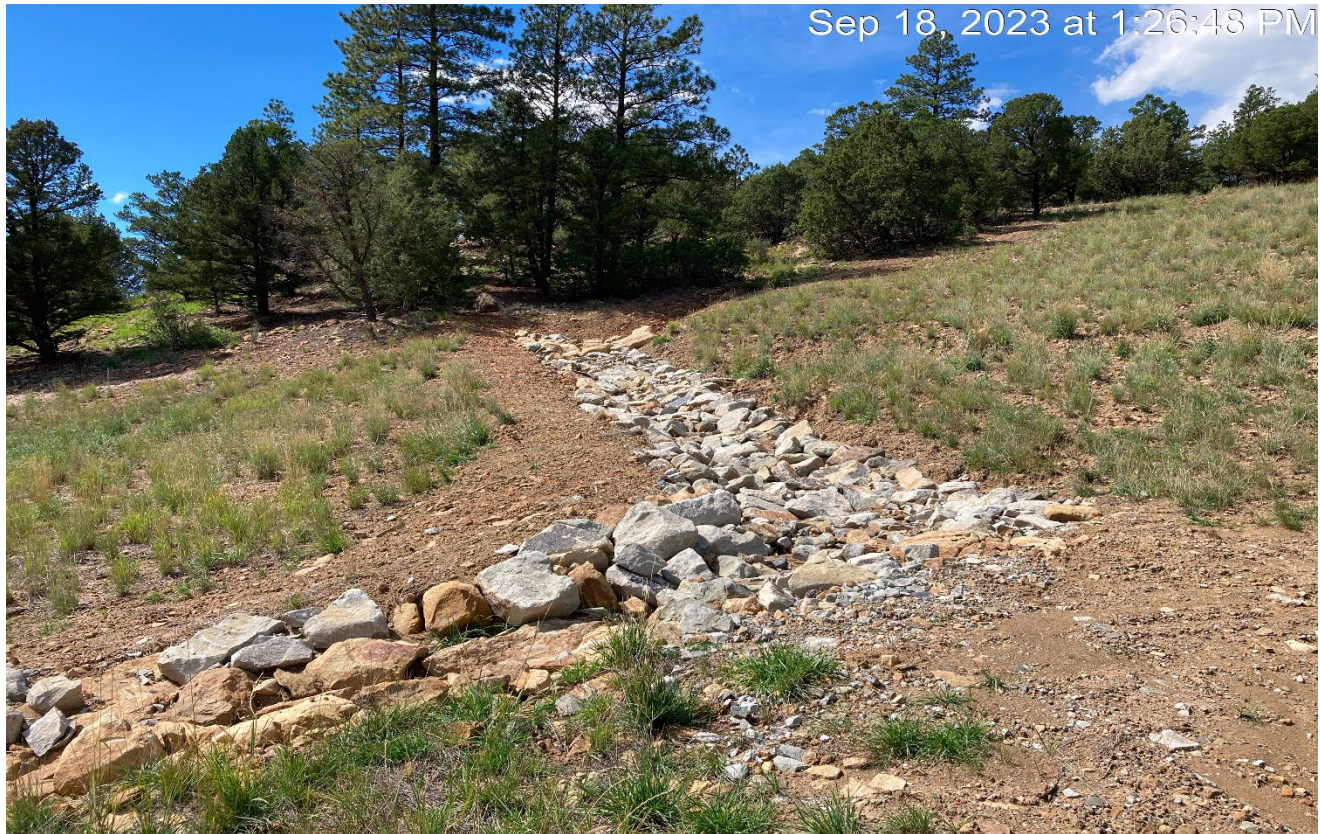
Photo 11. Facing northwest toward the west side of the location. Additional rock rip/rap was installed in this area.
