## Inspection Photos

Location Name: TEP ROCKY MOUNTAIN LLC YOUBERG RWF 33-23 Pad

Location ID: 383326

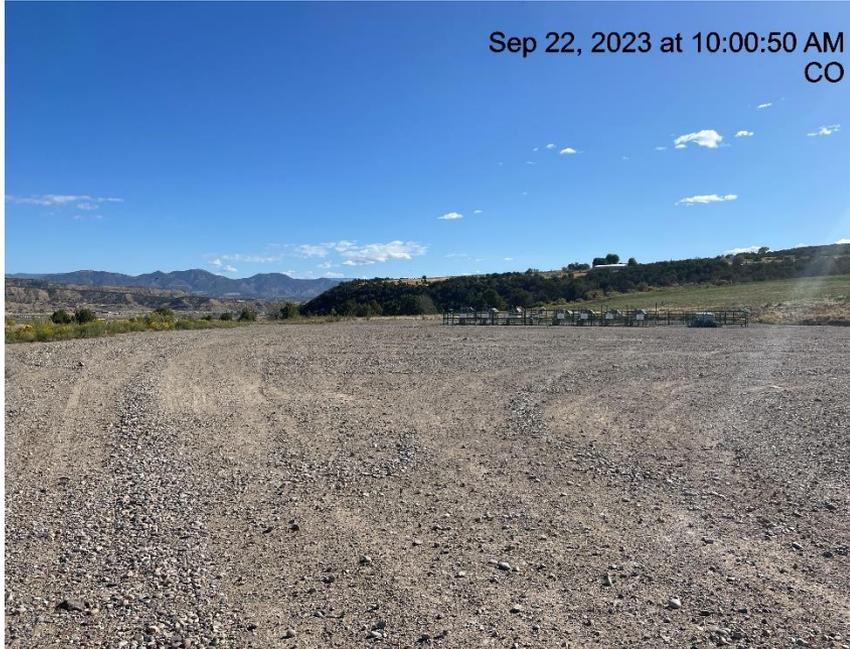
Photo # 144 From entrance to location

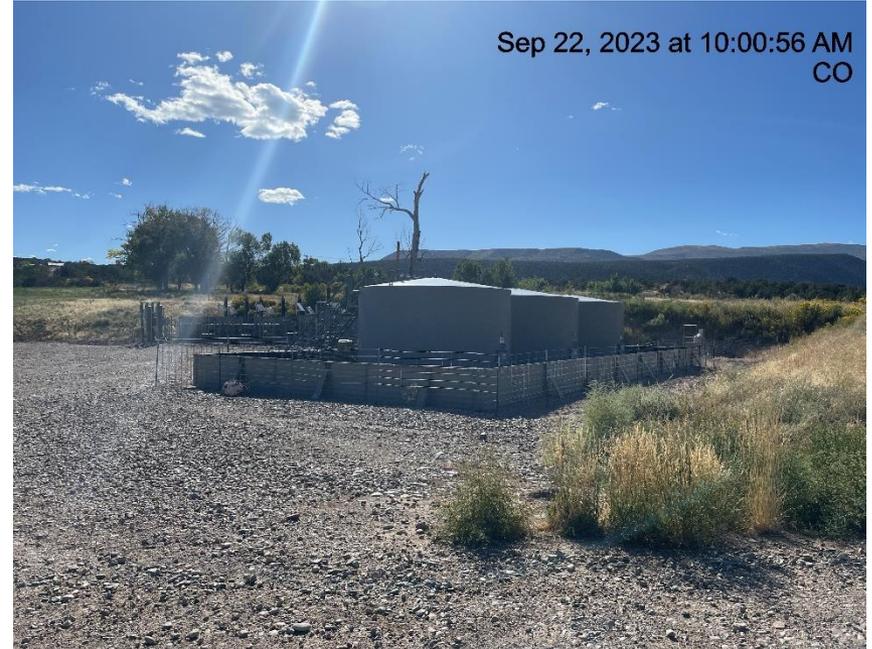
Photo # 145 From entrance to location

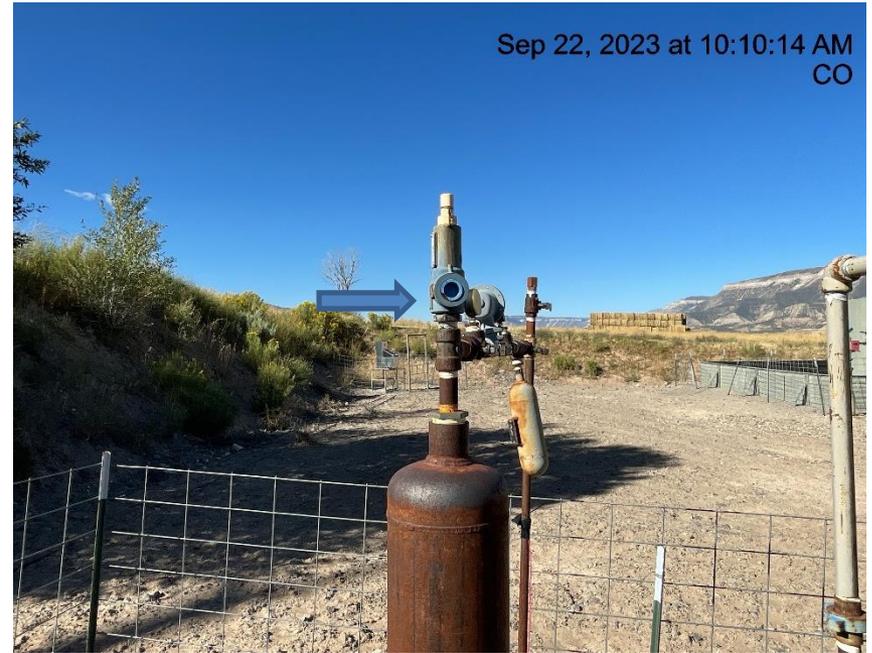
Photo # 163 PRV has plastic in relief port & no vent line

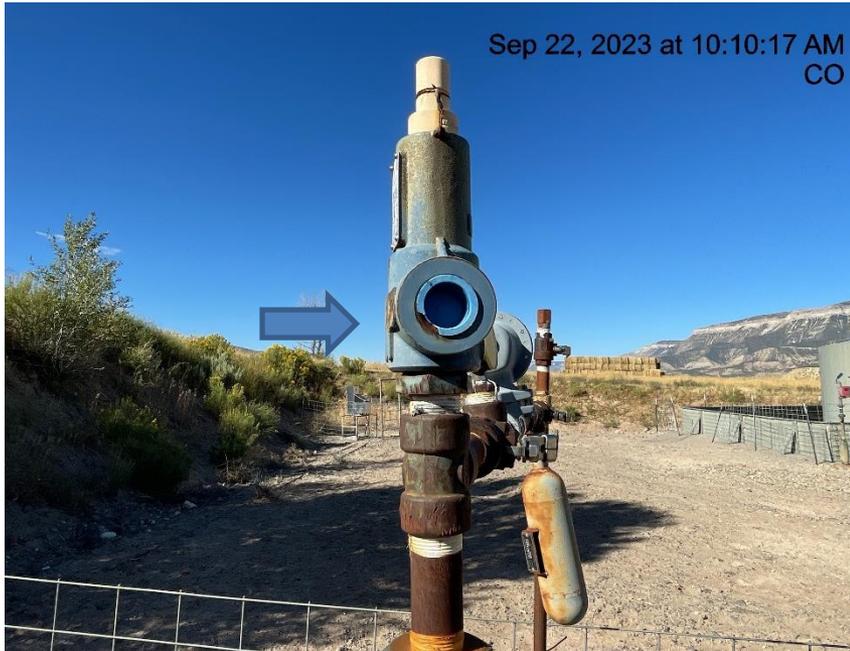
Photo # 164 PRV has plastic in relief port & no vent line

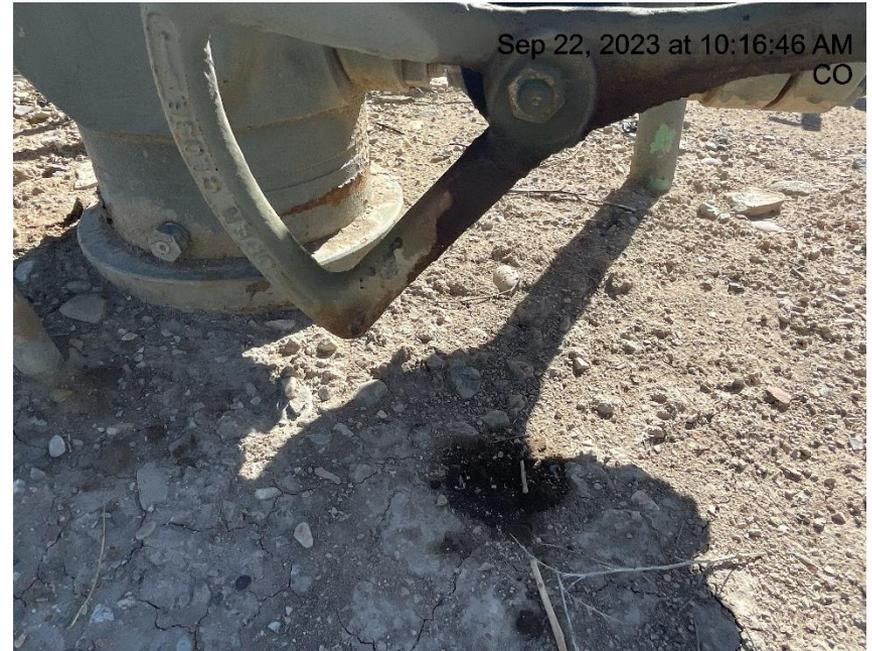
Photo # 169 Stained soils & gravel

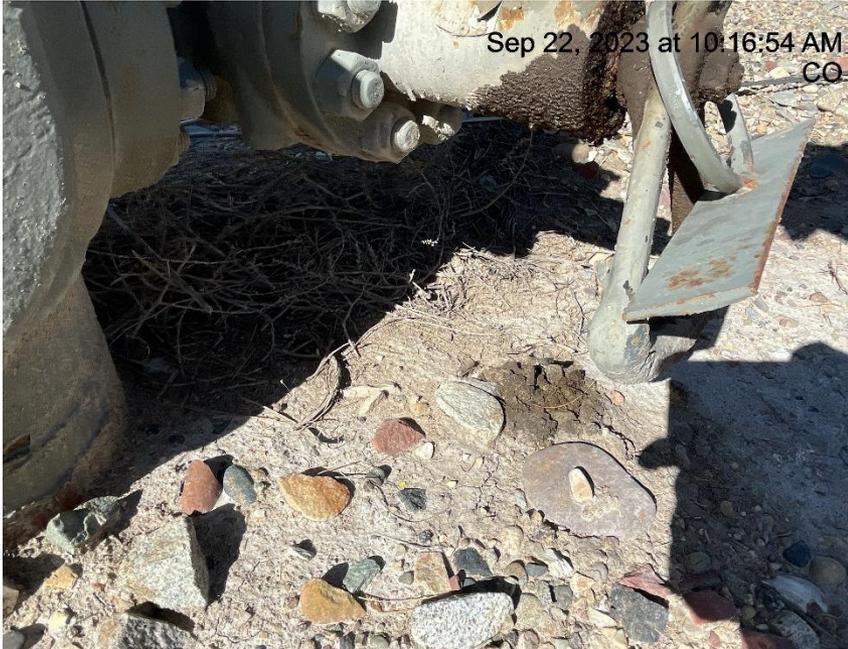
Photo # 170 Stained soils & gravel

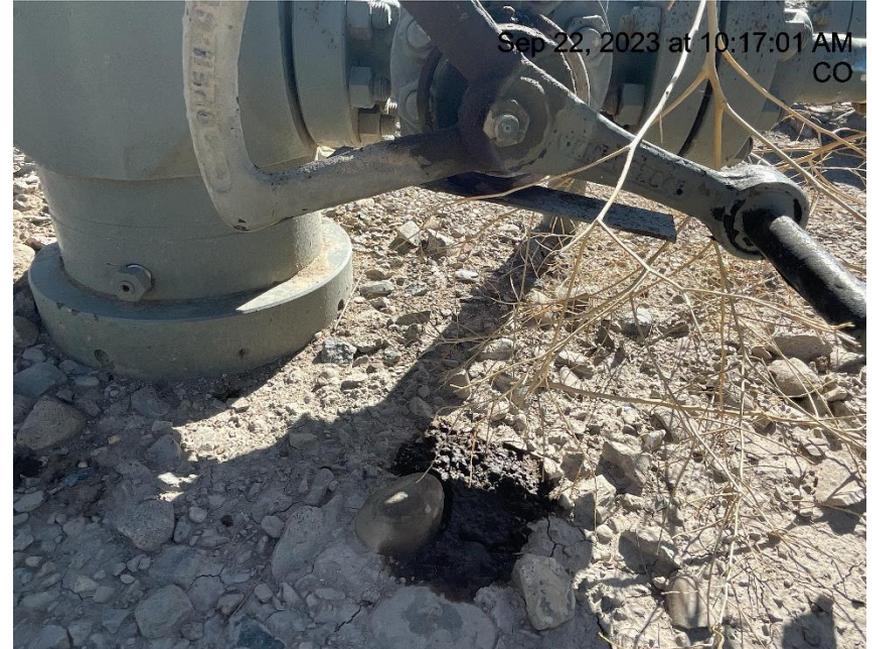
Photo # 171 Stained soils & gravel

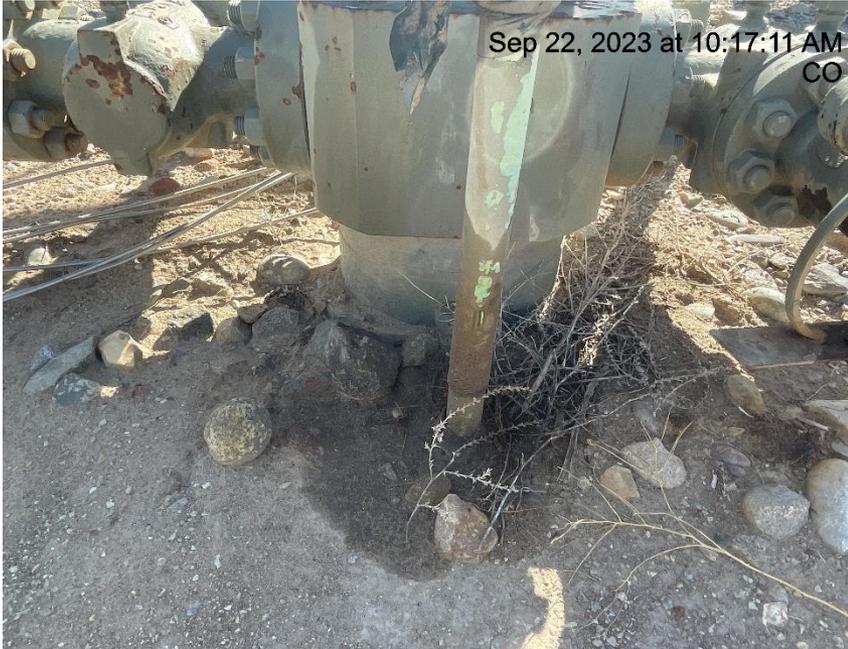
Photo # 172 Stained soils & gravel

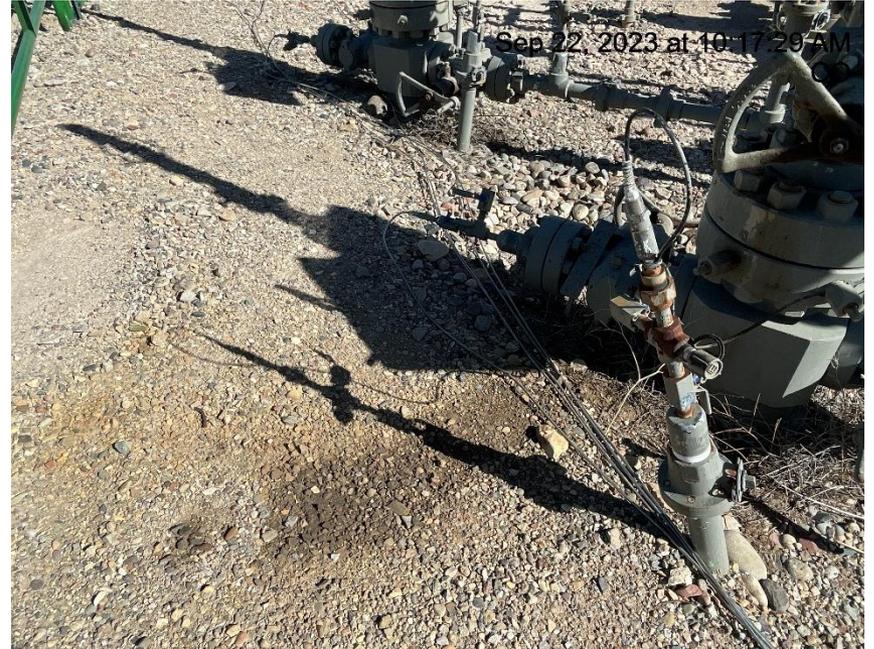
Photo # 174 Stained soils & gravel

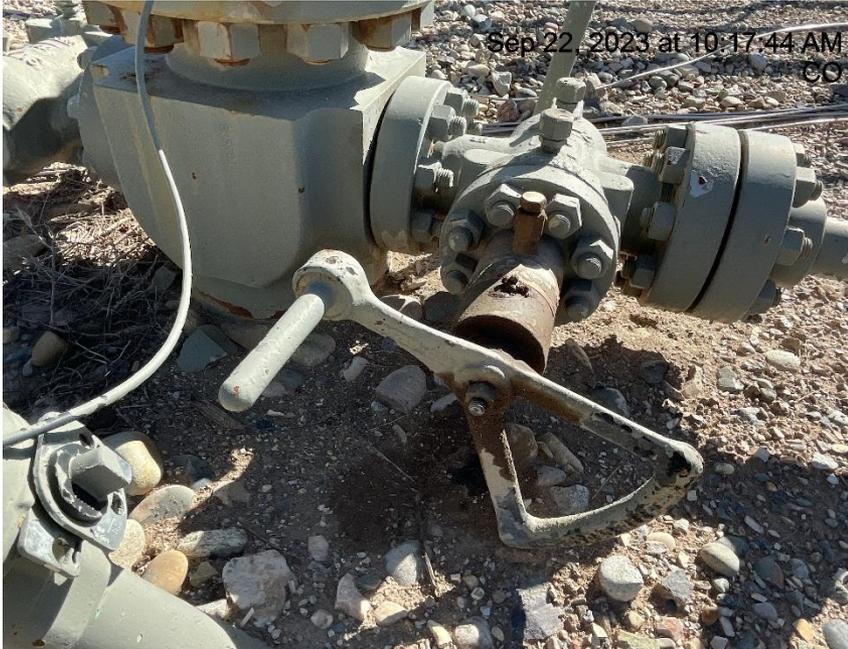
Photo # 176 Stained soils & gravel

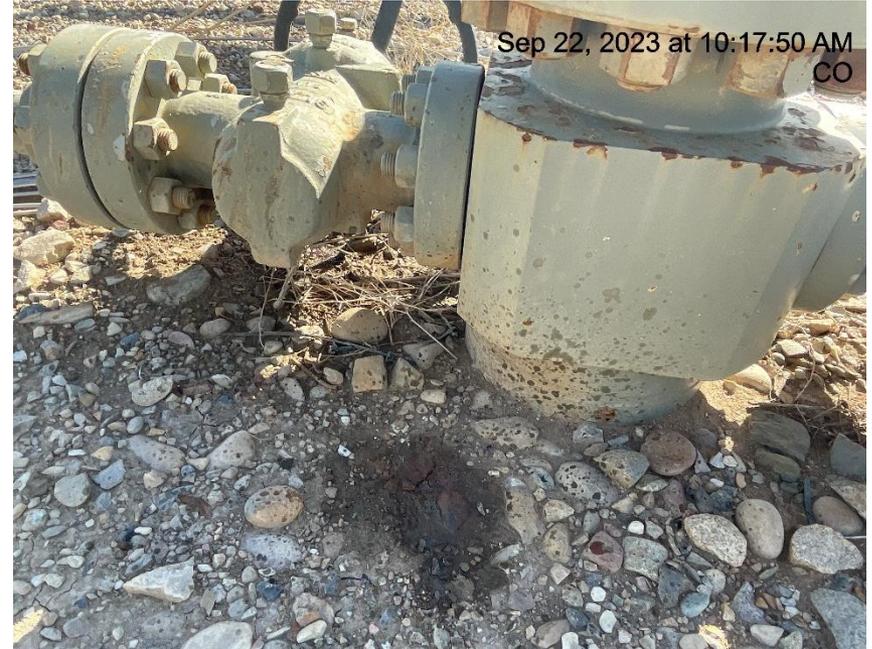
Photo # 177 Stained soils & gravel

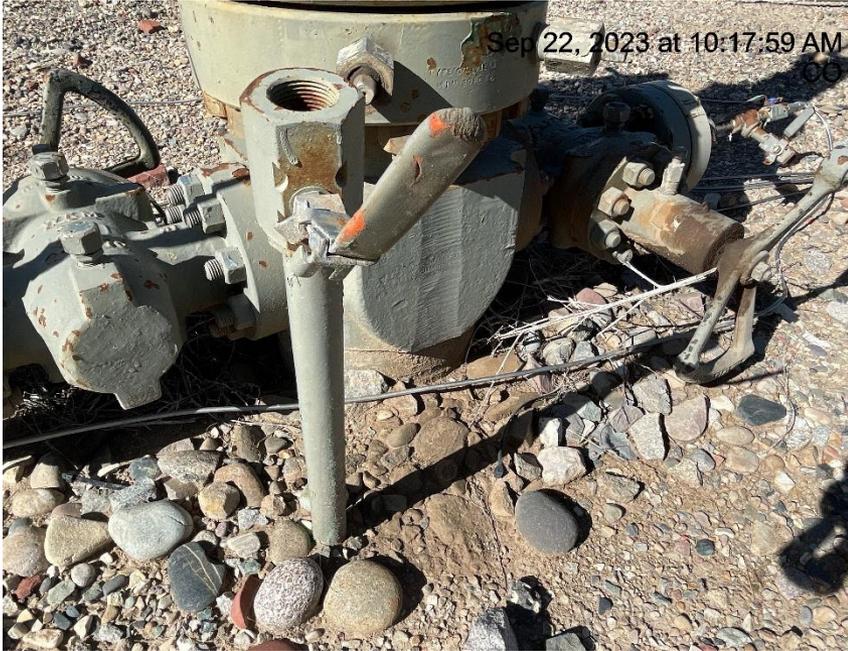
Photo # 178 Stained soils & gravel

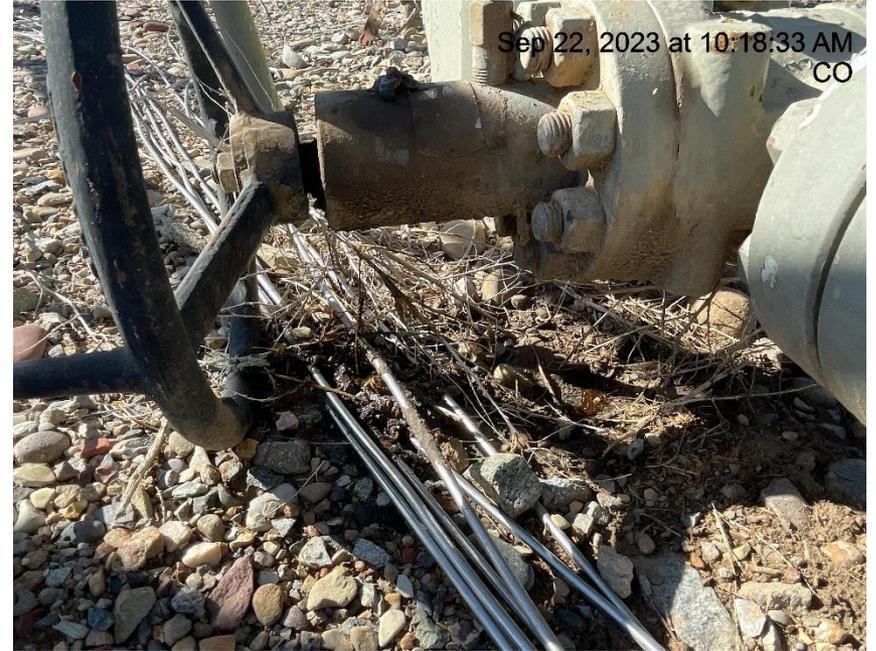
Photo # 182 Stained soils & gravel
