Inspection Photos

Location Name: MUSTANG RESOURCES LLC MEAD 23-44-6S-94W Pad

Location ID: 323783

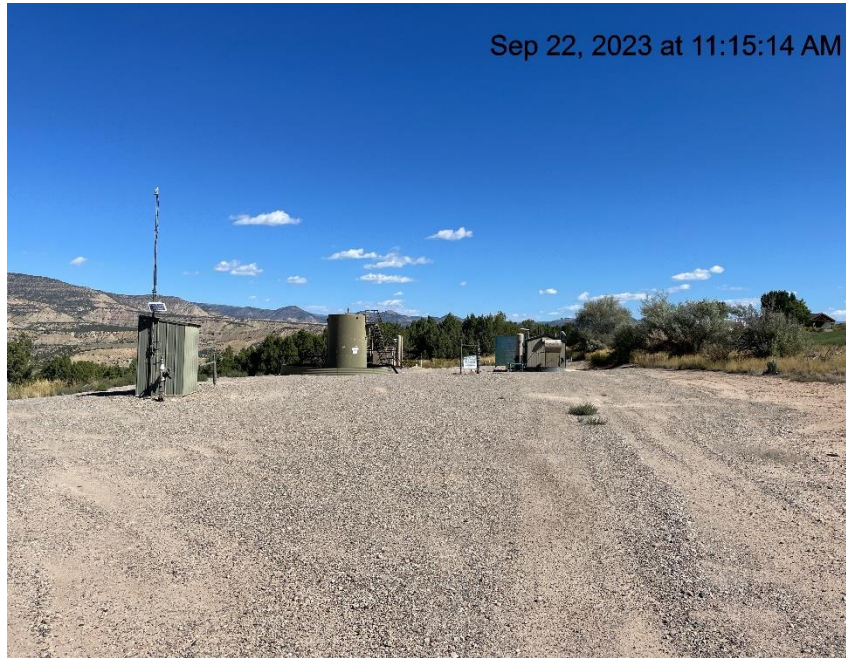
Photo # 265 From entrance to location

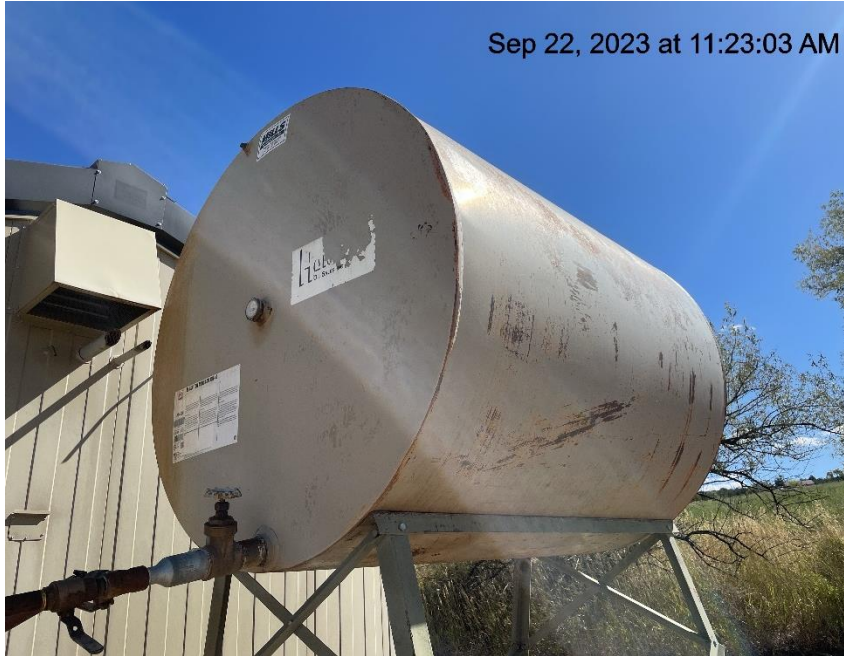
Photo # 276 Tank not properly labeled/missing required information

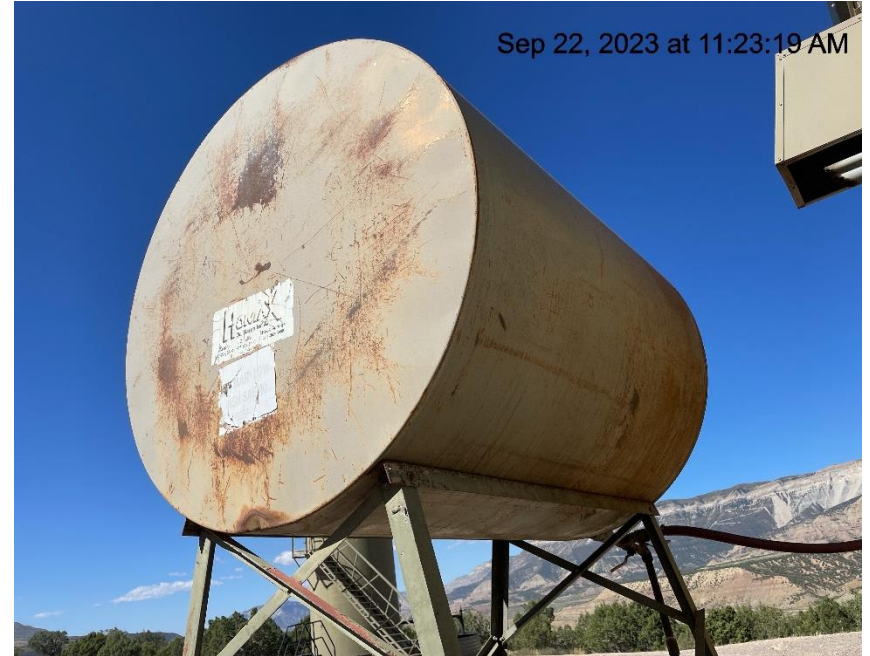
Photo # 277 Tank not properly labeled/missing required information

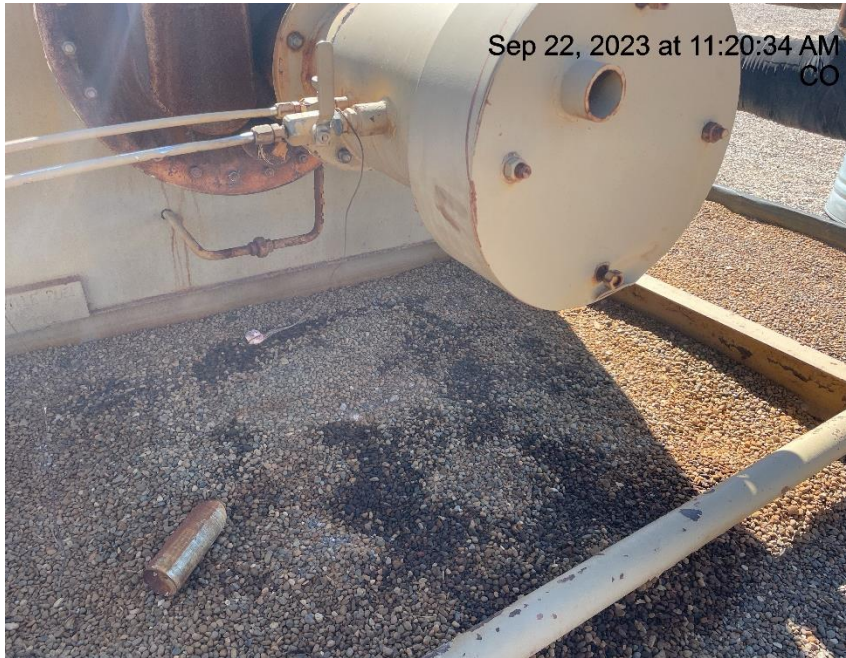
Photo # 273 Stained gravel

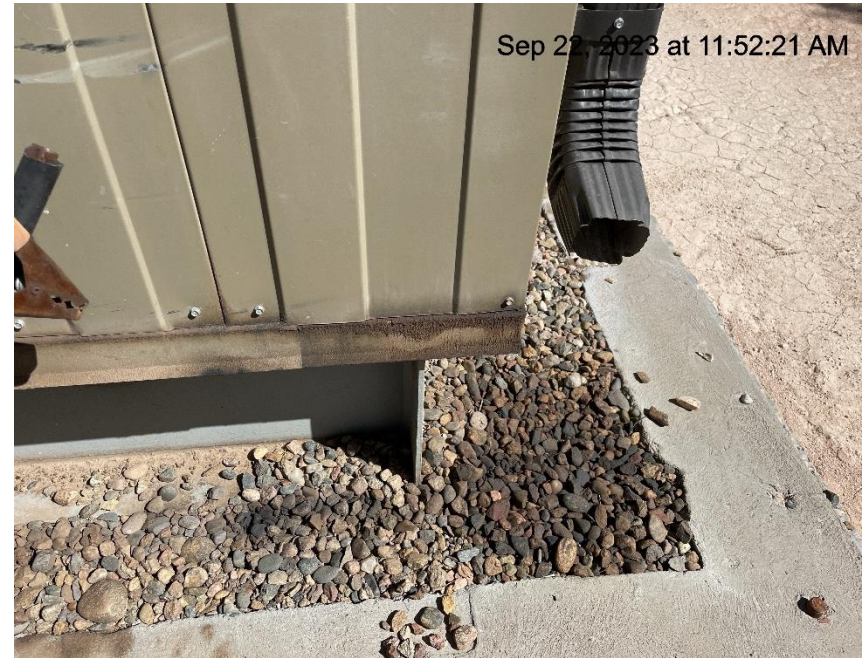
Photo # 400 Stained soils & gravel

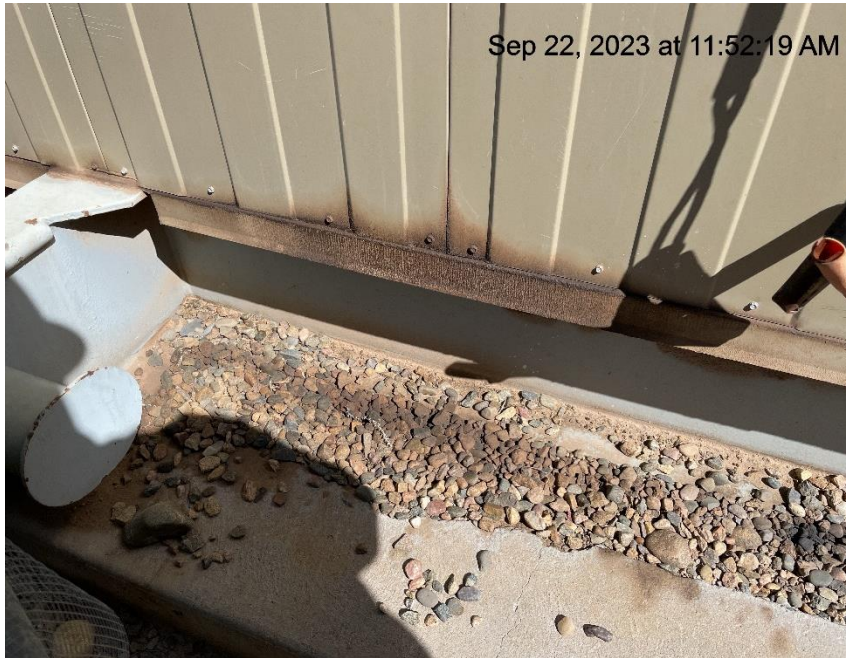
Photo # 401 Stained soils & gravel

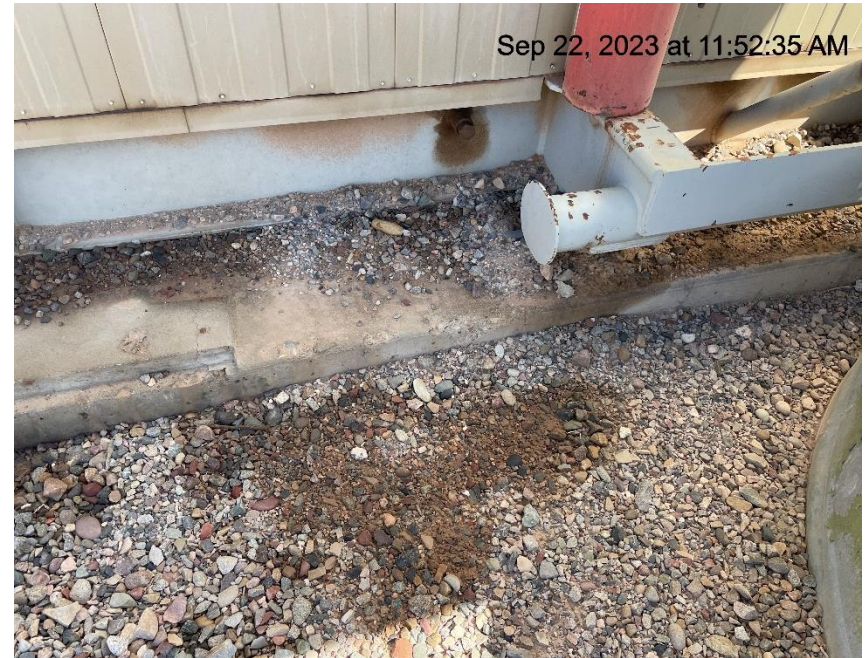
Photo # 404 Stained soils & gravel

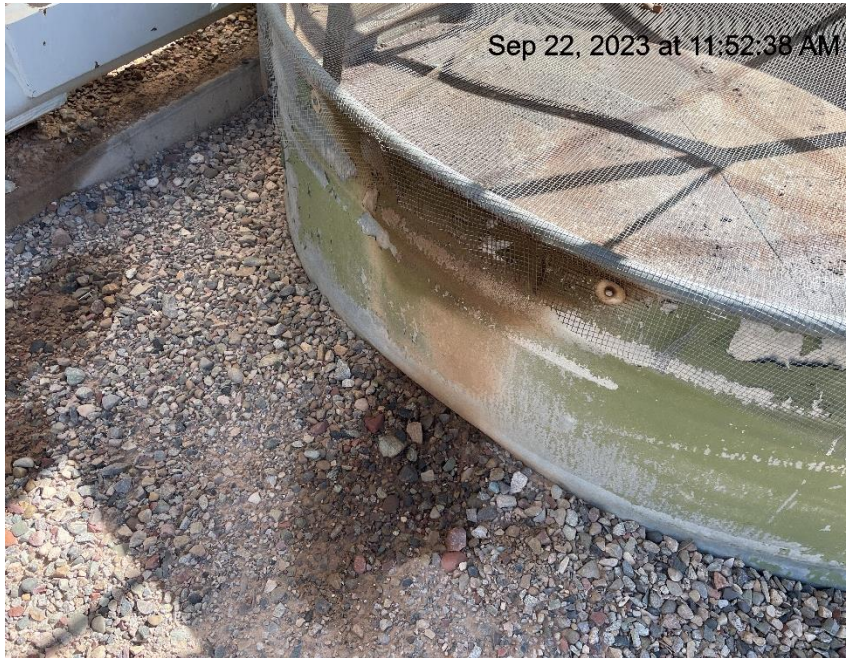
Photo # 405 Stained soils & gravel

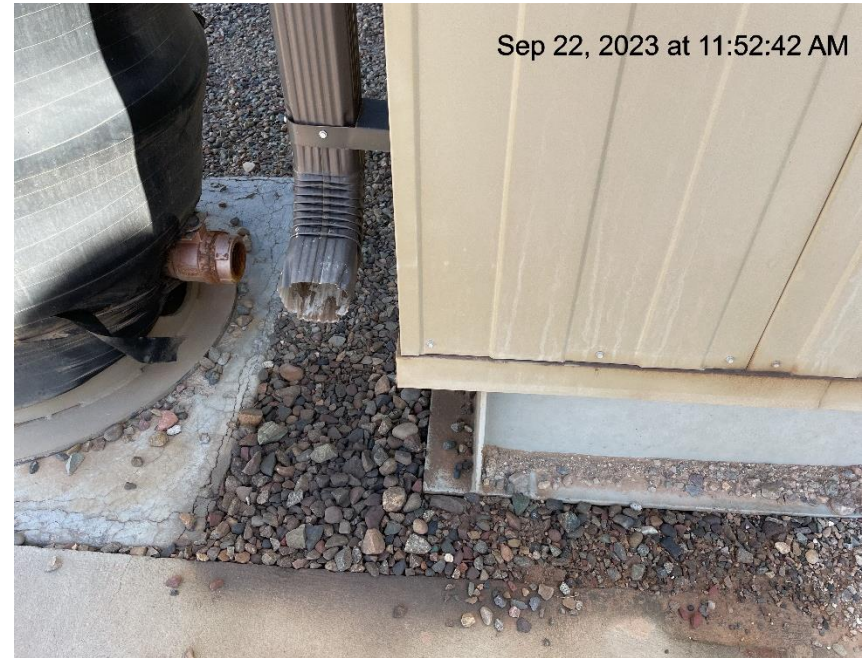
Photo # 406 Stained soils & gravel

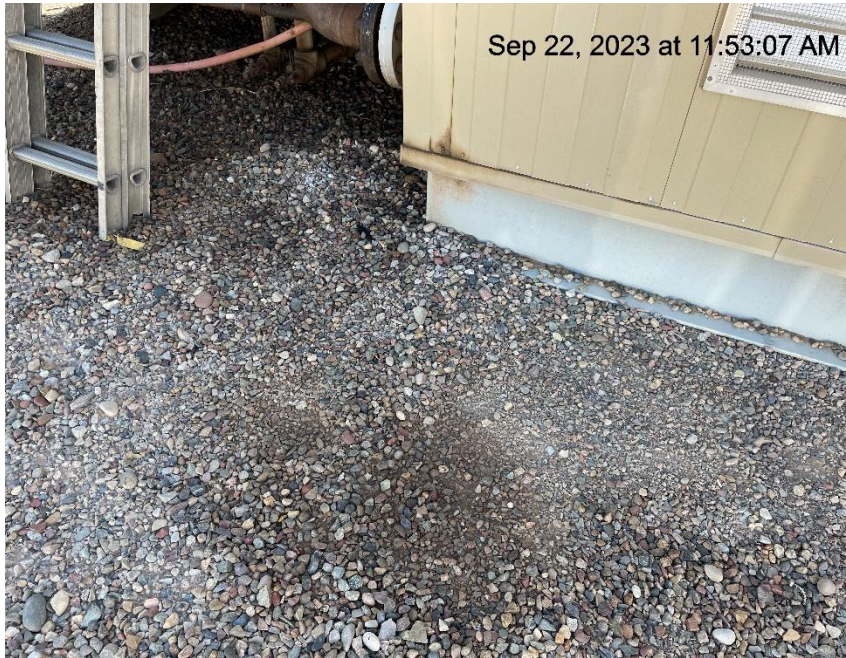
Photo # 410 Stained soils & gravel

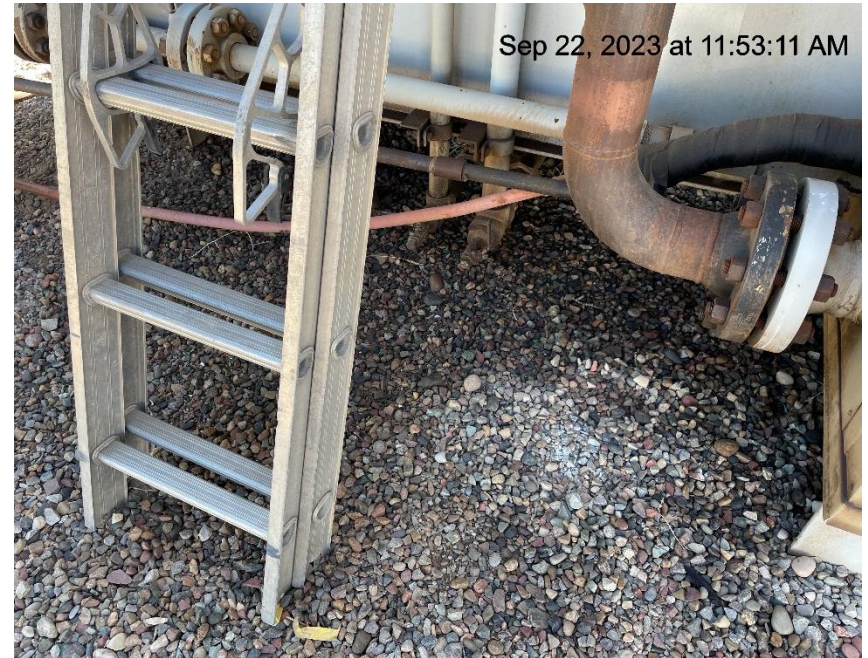
Photo # 411 Stained soils & gravel

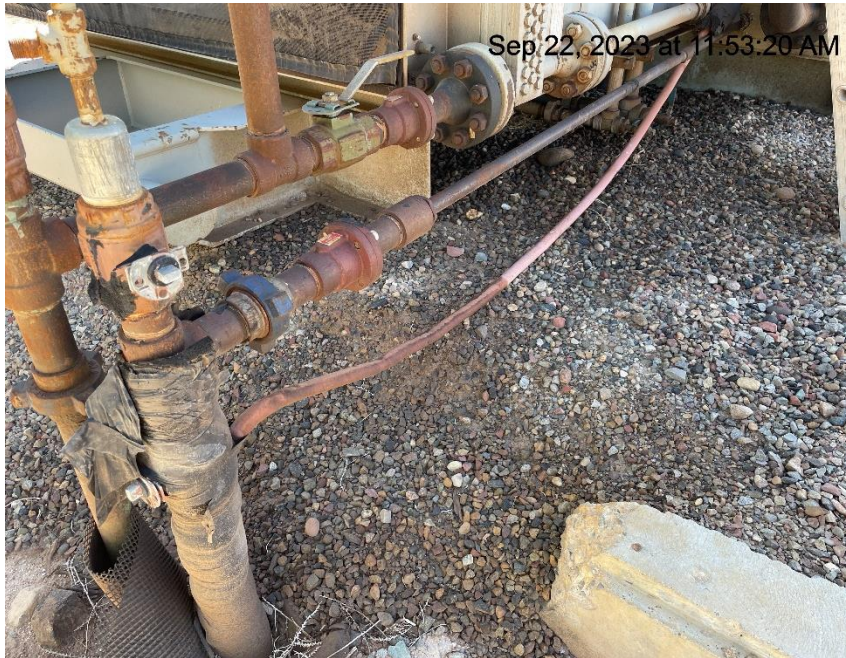
Photo # 412 Stained soils & gravel

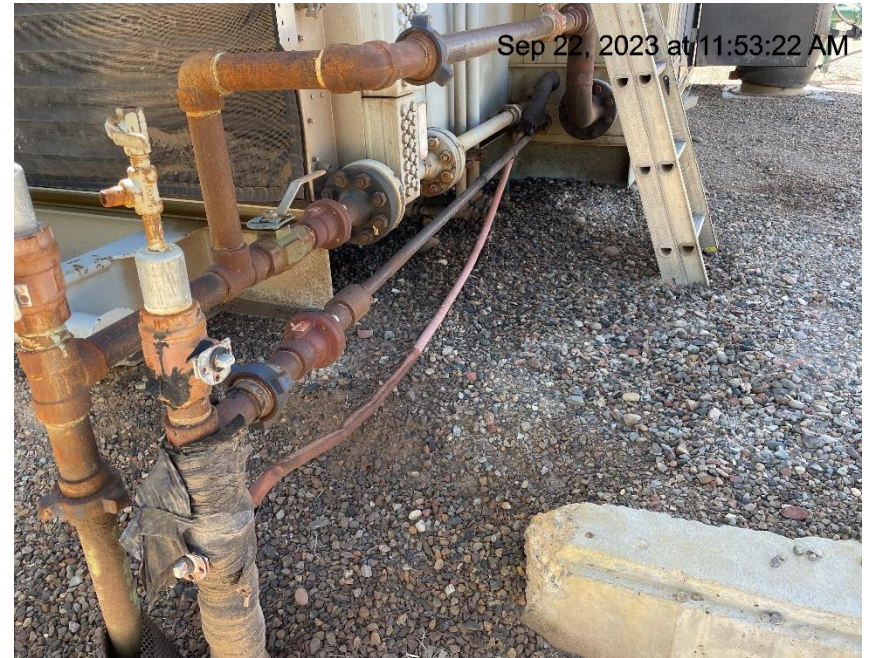
Photo # 414 Stained soils & gravel

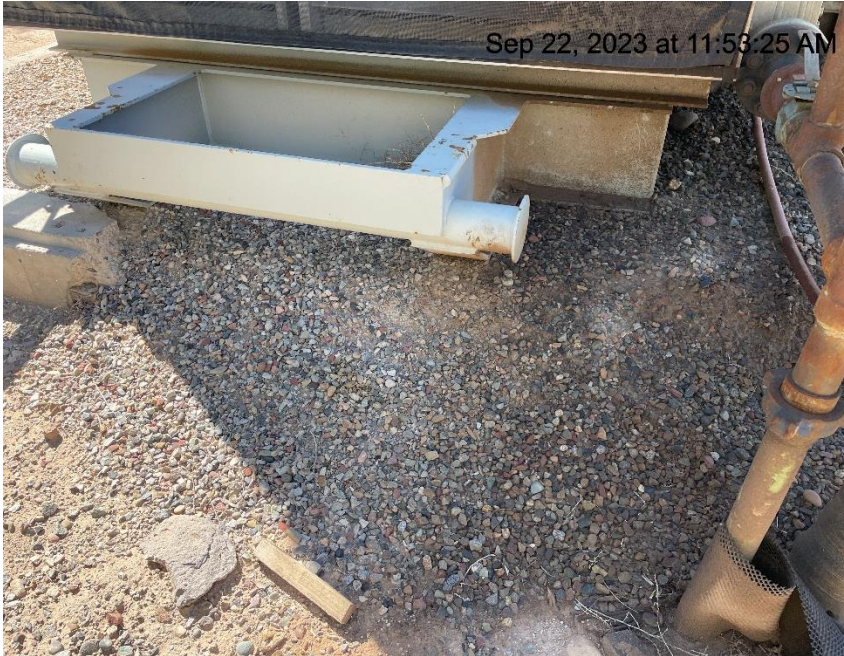
Photo # 415 Stained soils & gravel

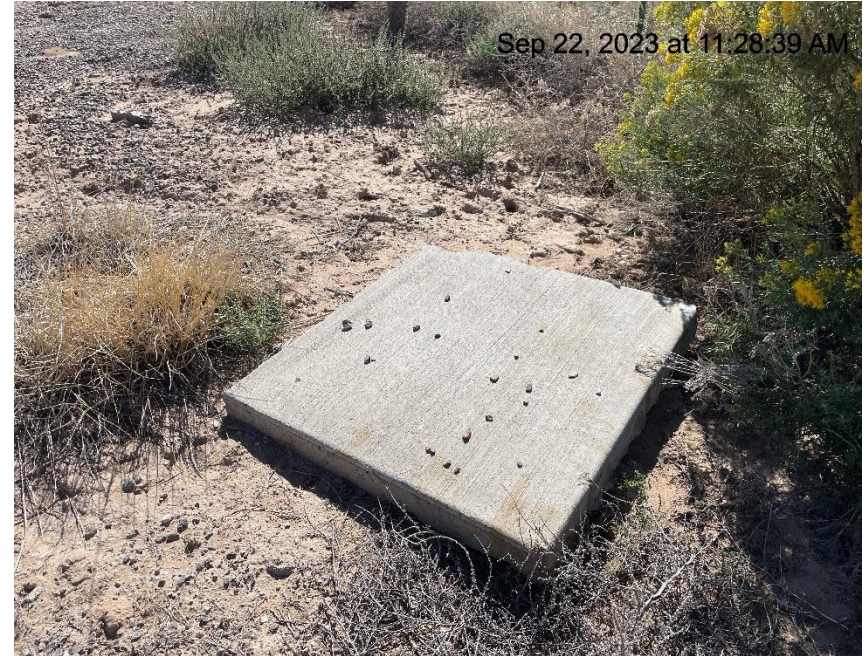
Photo # 284 Debris
