Storm Water Management and Erosion control

Location Name: MUSTANG RESOURCES LLC MEAD 23-44-6S-94W Pad

Location ID: 323783

COLORADO
Energy & Carbon Management
Commission
Department of Natural Resources

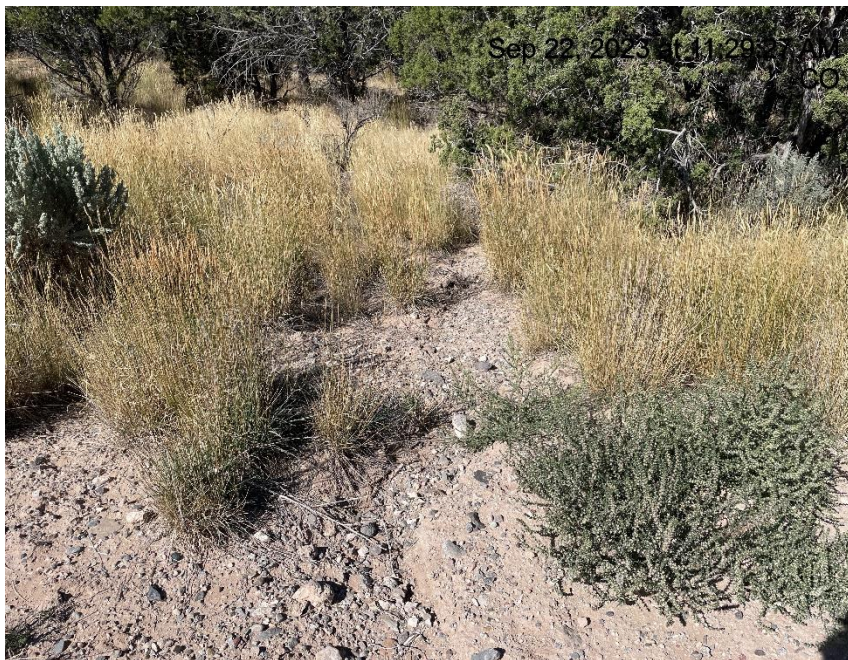
Photo # 289 Erosion & transport of sediment off location & into a vegetated area (W/NW area of location)

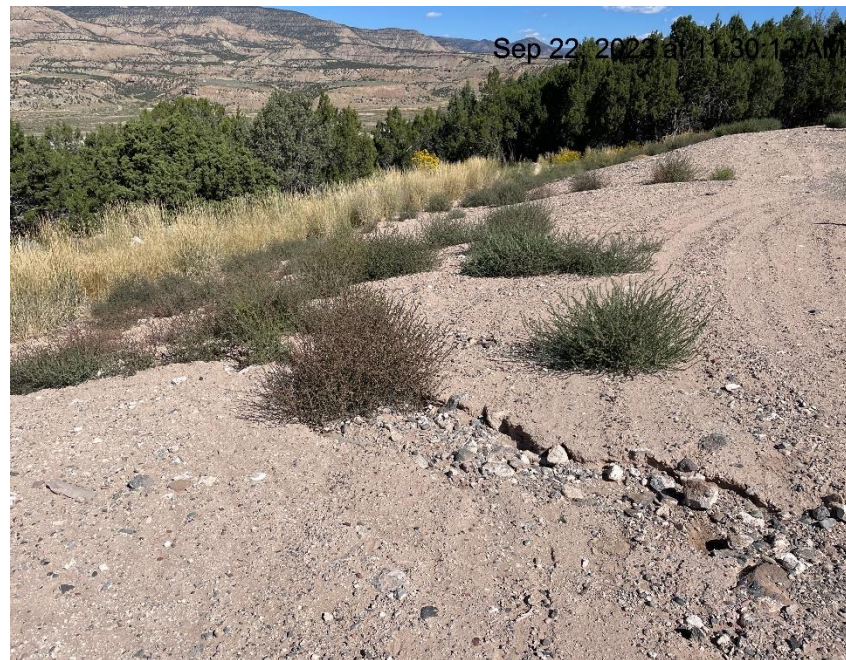
Photo # 292 Erosion & transport of sediment off location & into a vegetated area (W/NW area of location)

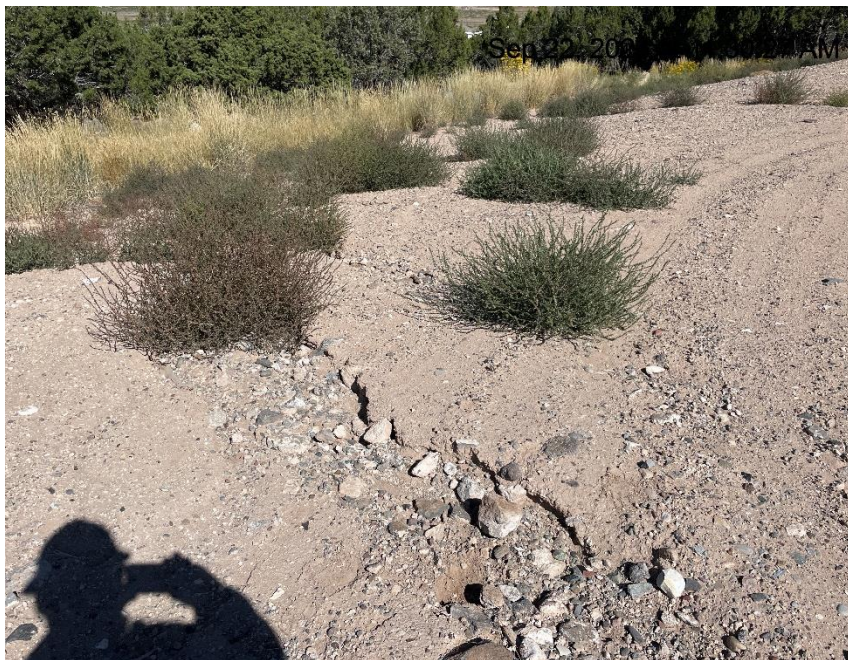
Photo # 294 Erosion & transport of sediment off location & into a vegetated area (W/NW area of location)

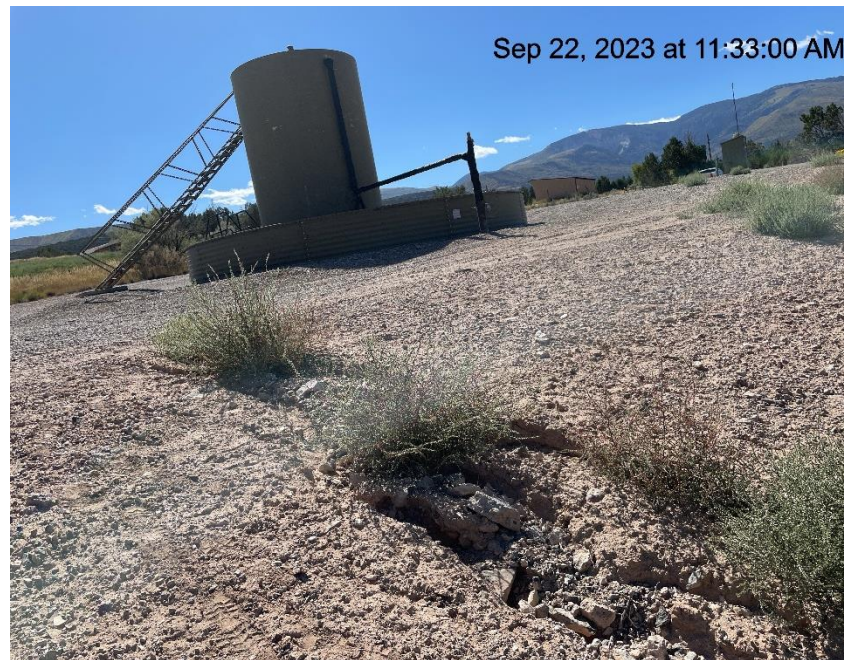
Photo # 312 Erosion & transport of sediment

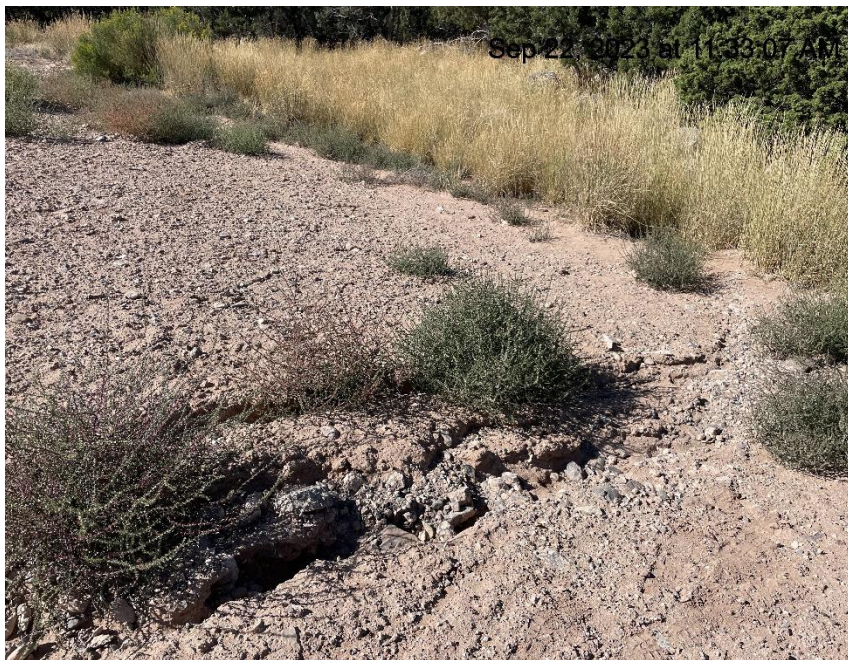
Photo # 314 Erosion & transport of sediment off location & into a vegetated area (W/NW area of location)

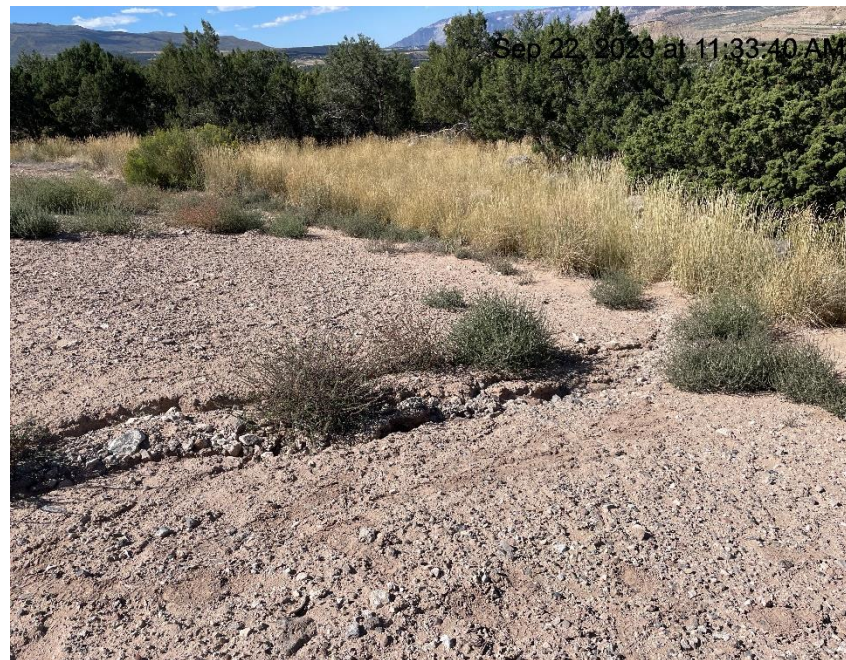
Photo # 317 Erosion & transport of sediment off location & into a vegetated area (W/NW area of location)

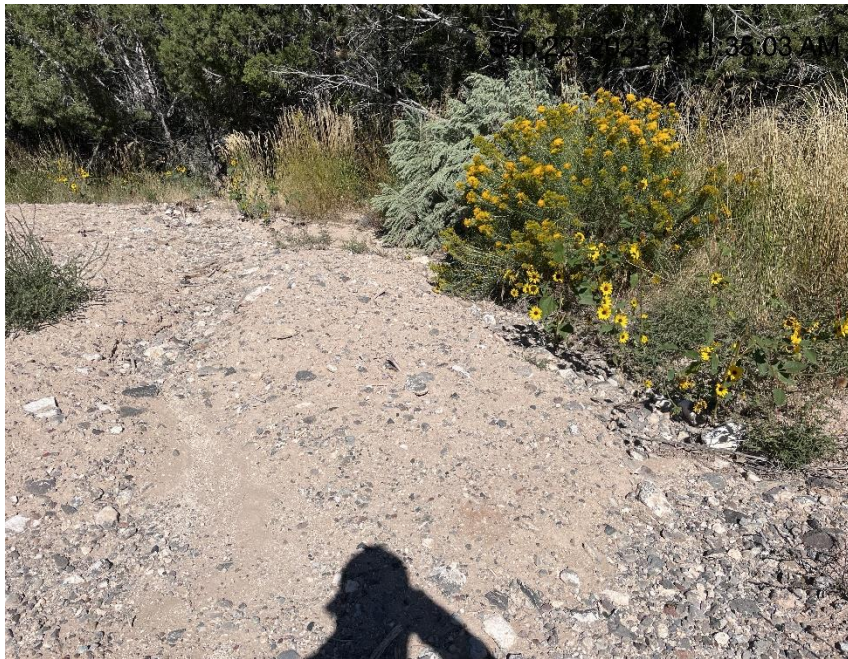
Photo # 320 Erosion & transport of sediment off location & into a vegetated area (NW corner of location)

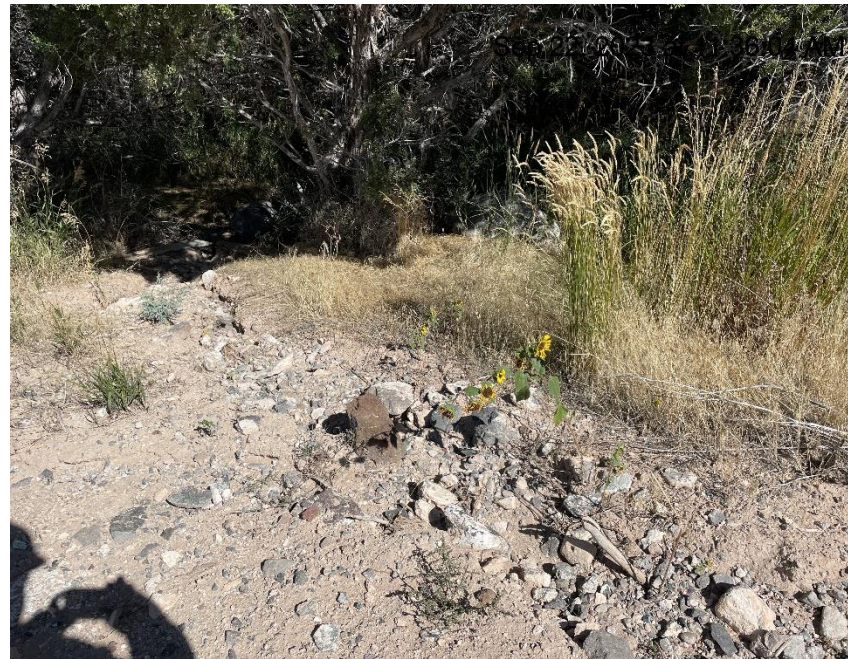
Photo # 332 Erosion & transport of sediment off location & into a vegetated area (NW corner of location)

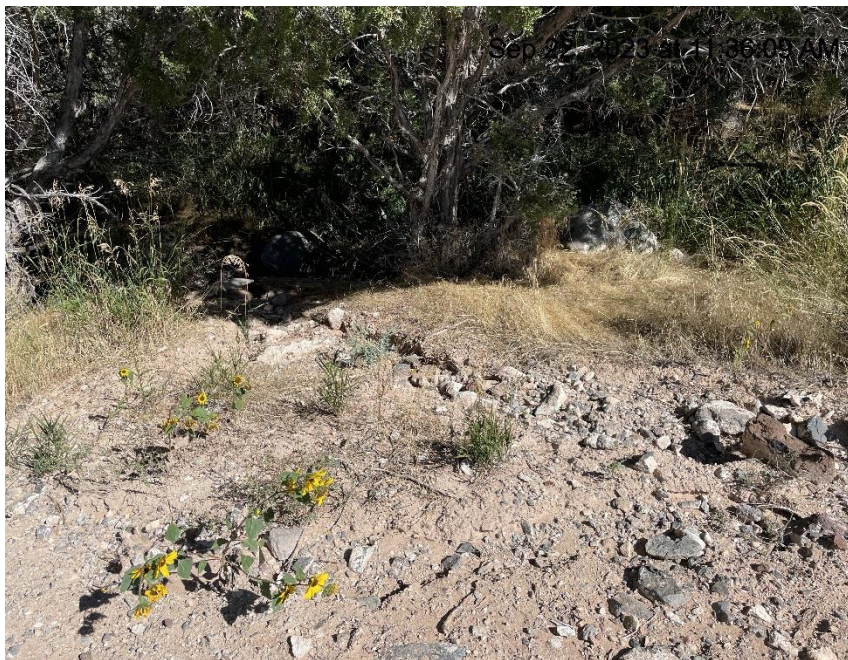
Photo # 333 Erosion & transport of sediment off location & into a vegetated area (NW corner of location)

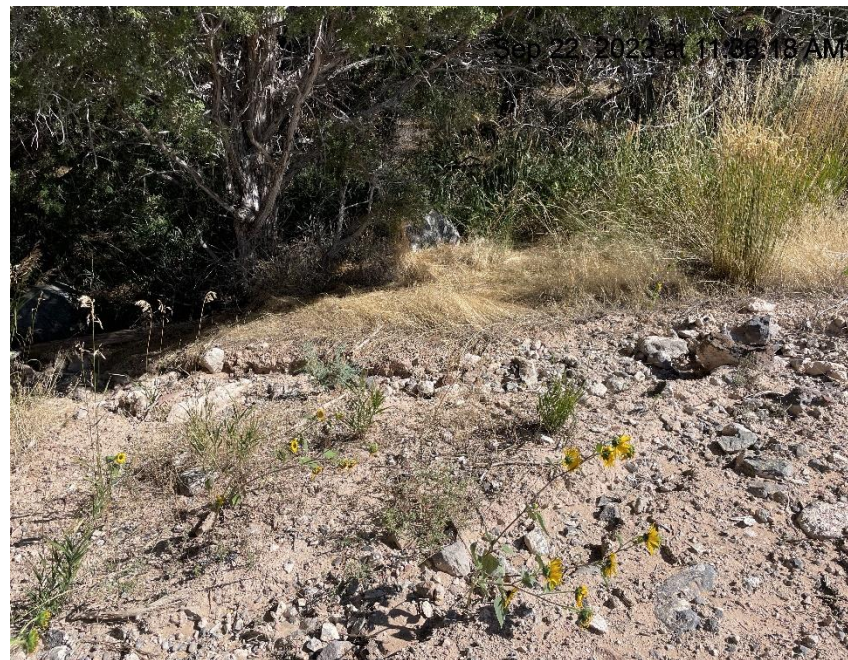
Photo # 335 Erosion & transport of sediment off location & into a vegetated area (NW corner of location)

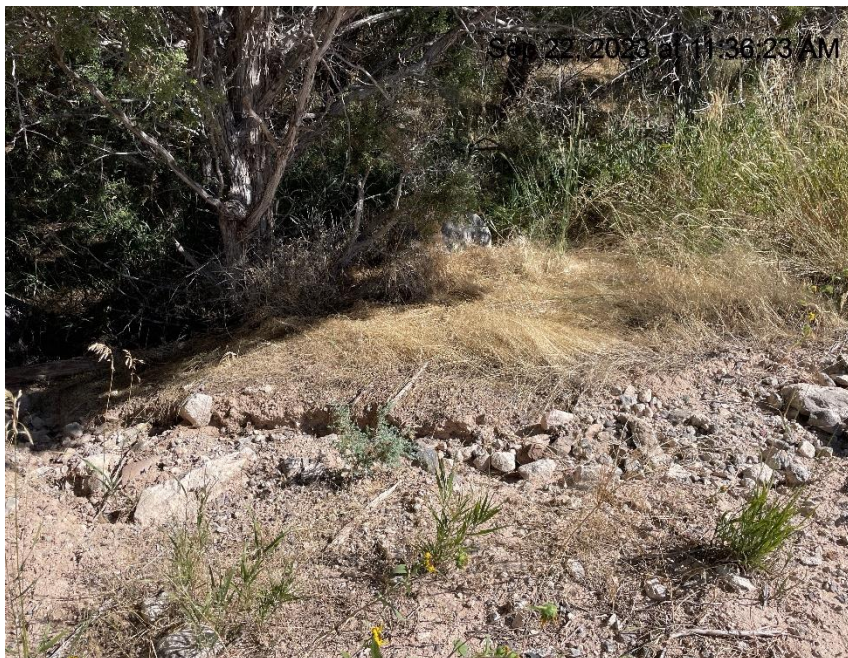
Photo # 337 Erosion & transport of sediment off location & into a vegetated area

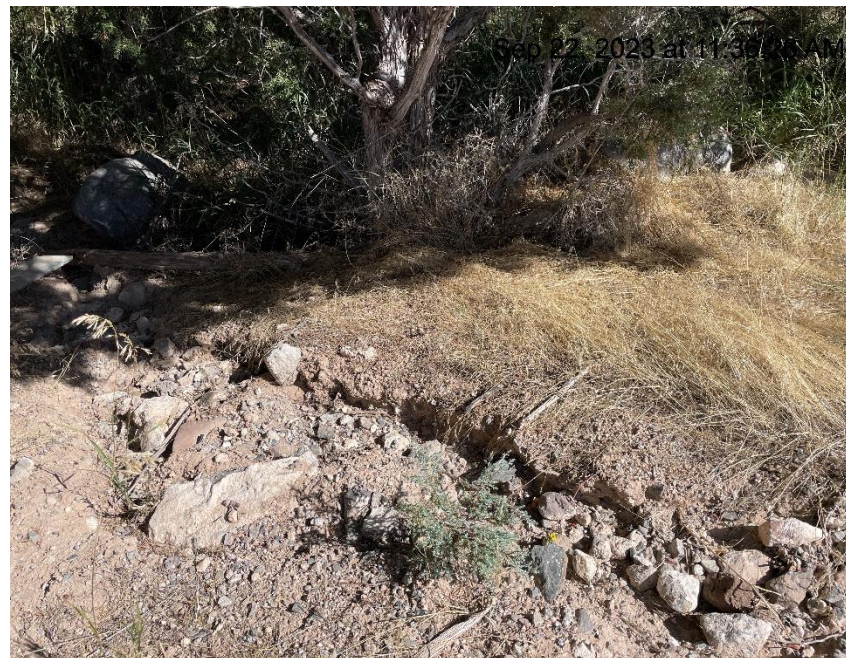
Photo # 338 Erosion & transport of sediment off location & into a vegetated area

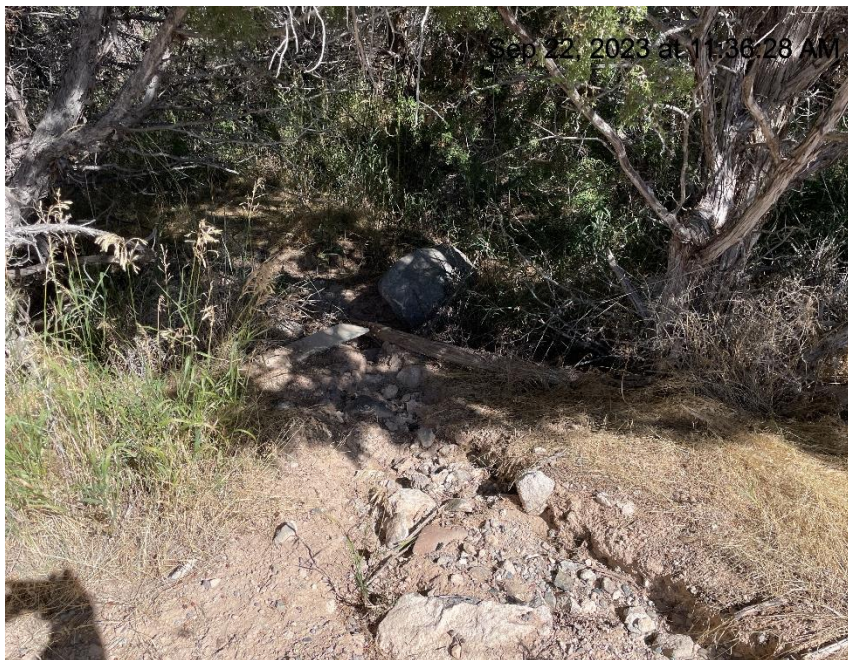
Photo # 339 Erosion & transport of sediment off location & into a vegetated area

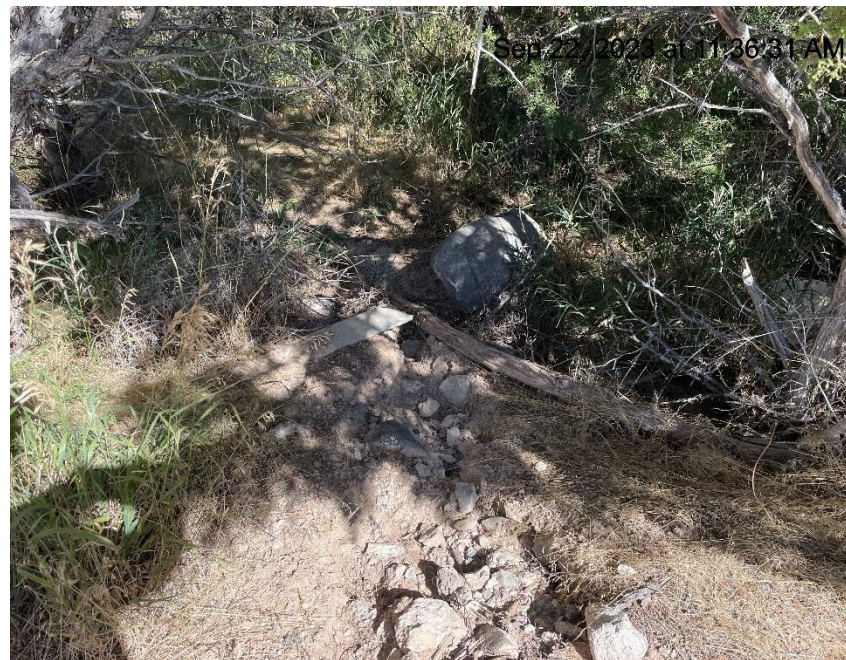
Photo # 340 Erosion & transport of sediment off location & into a vegetated area

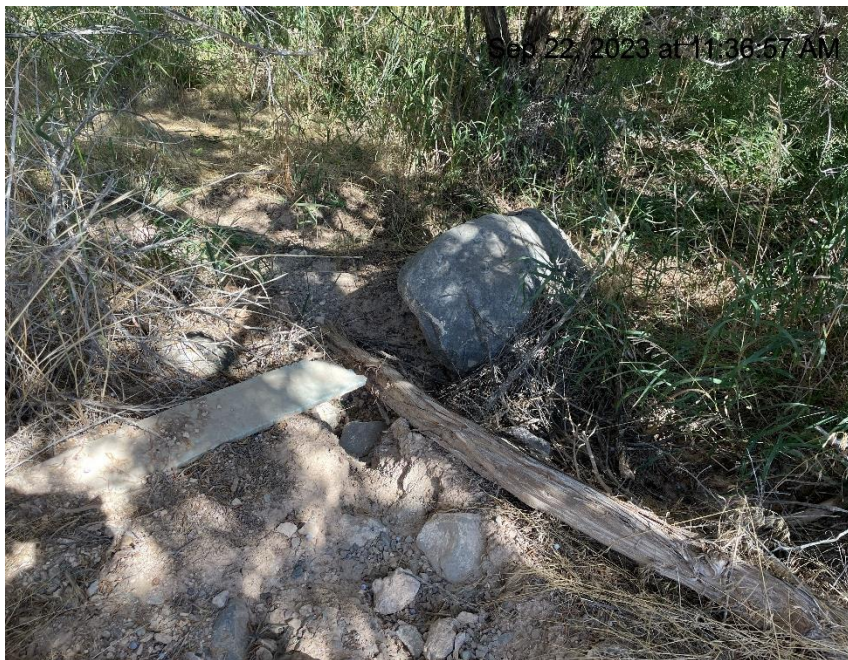
Photo # 343 Erosion & transport of sediment off location & into a vegetated area

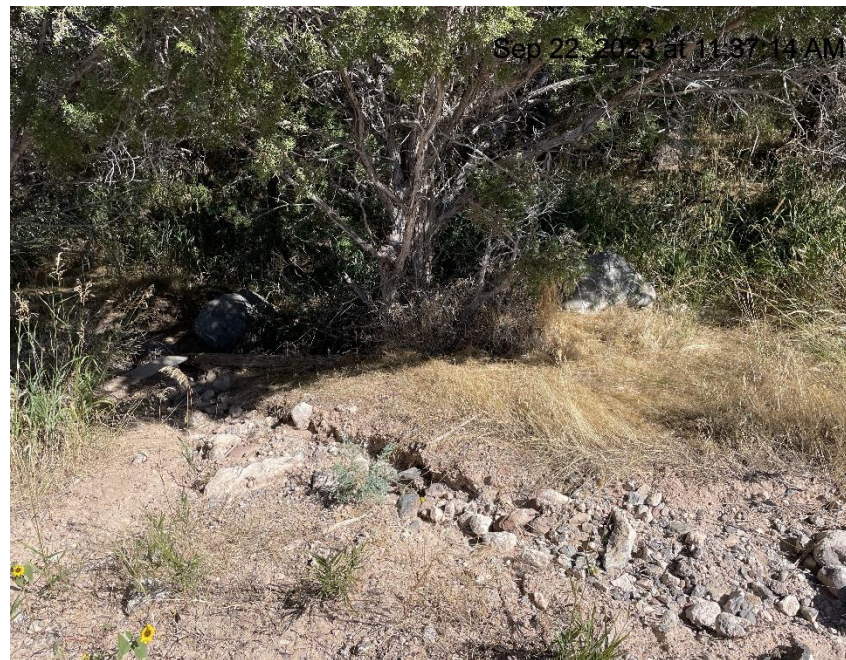
Photo # 346 Erosion & transport of sediment off location & into a vegetated area

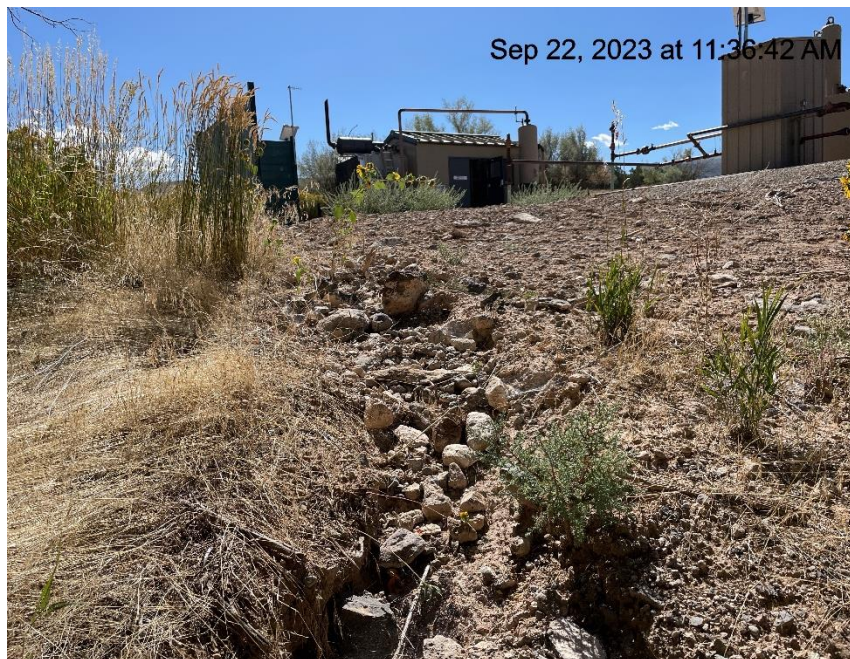
Photo # 341 Erosion & transport of sediment off location & into a vegetated area

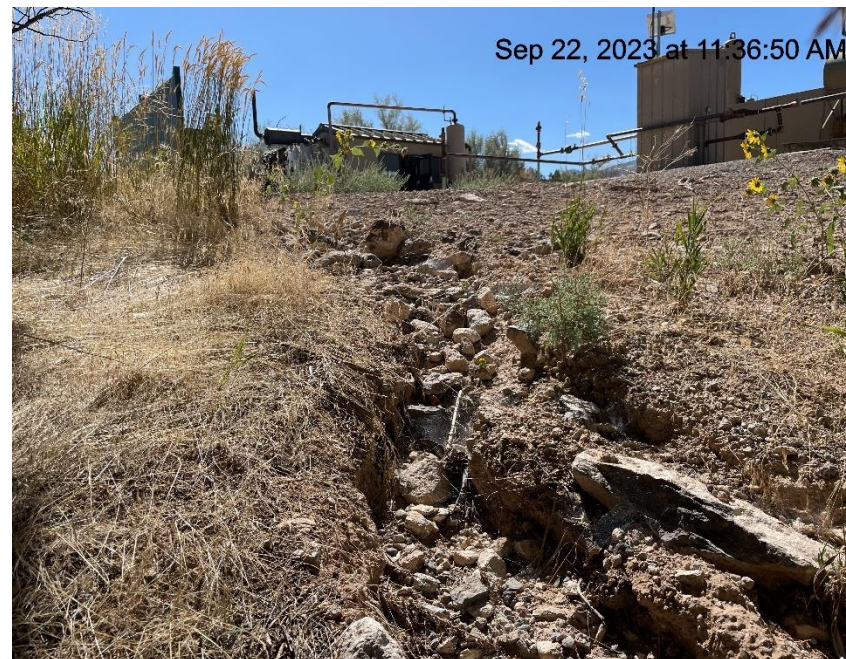
Photo # 342 Erosion & transport of sediment off location & into a vegetated area

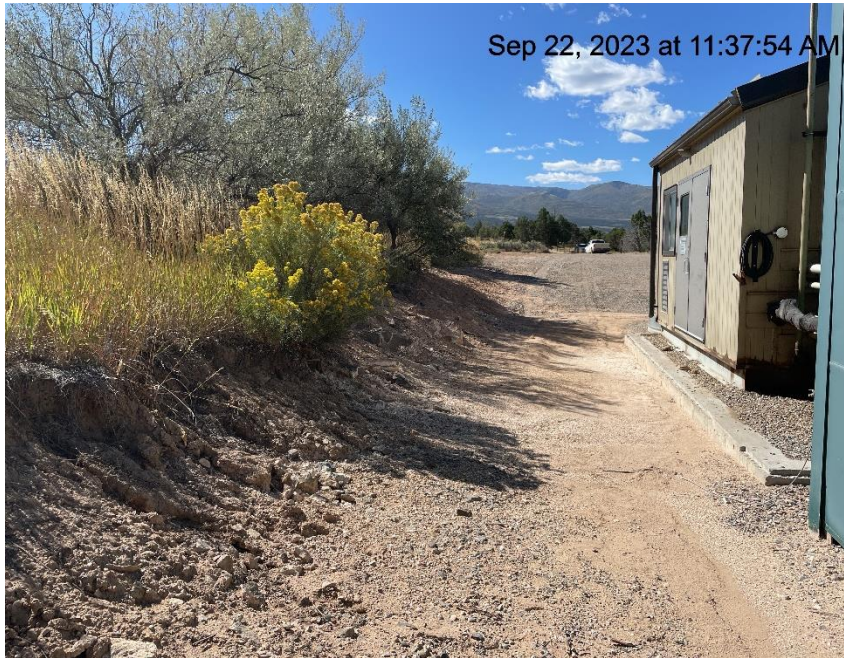
**Photo # 348 Lack of stabilization & erosion on slope
/transport of sediment onto location/insufficient BMP's**

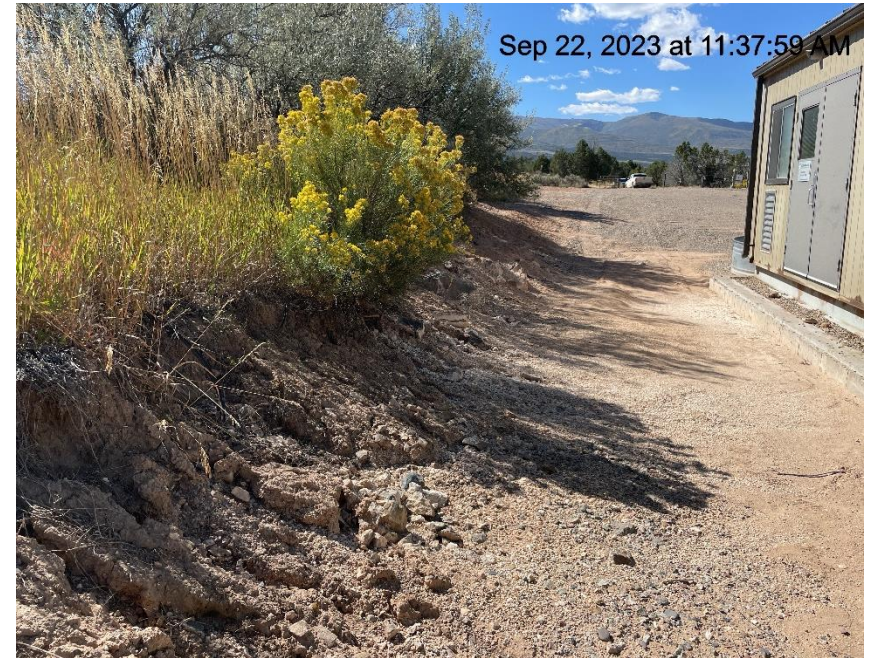
**Photo # 349 Lack of stabilization & erosion on slope
/transport of sediment onto location/insufficient BMP's**

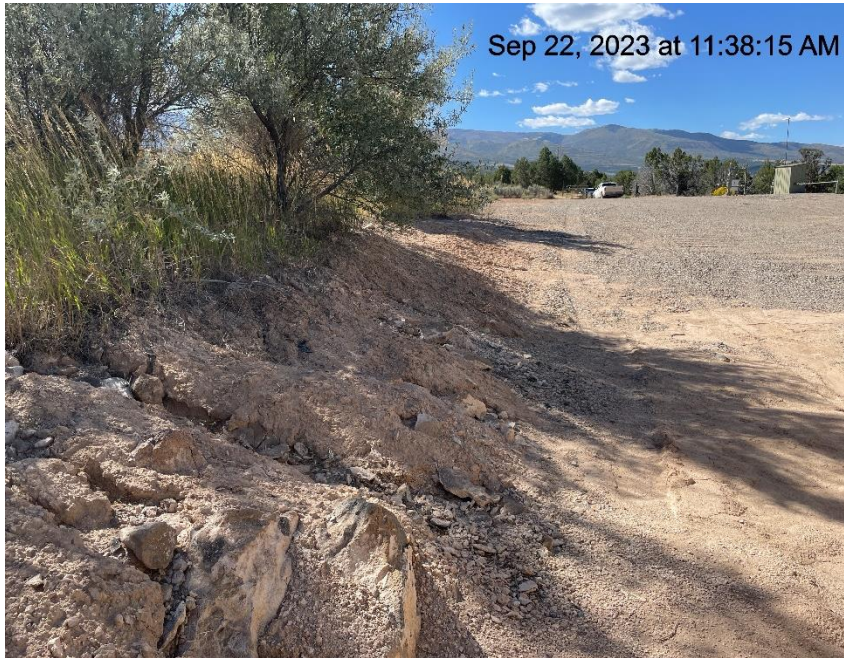
**Photo # 352 Erosion & transport of sediment onto location/
insufficient BMP's**

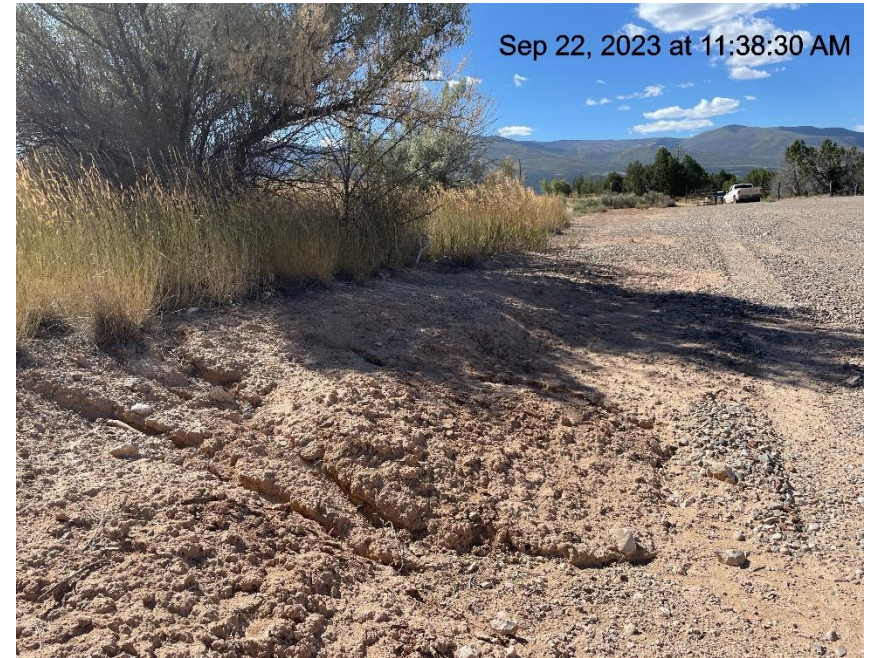
**Photo # 355 Erosion & transport of sediment onto location/
insufficient BMP's**

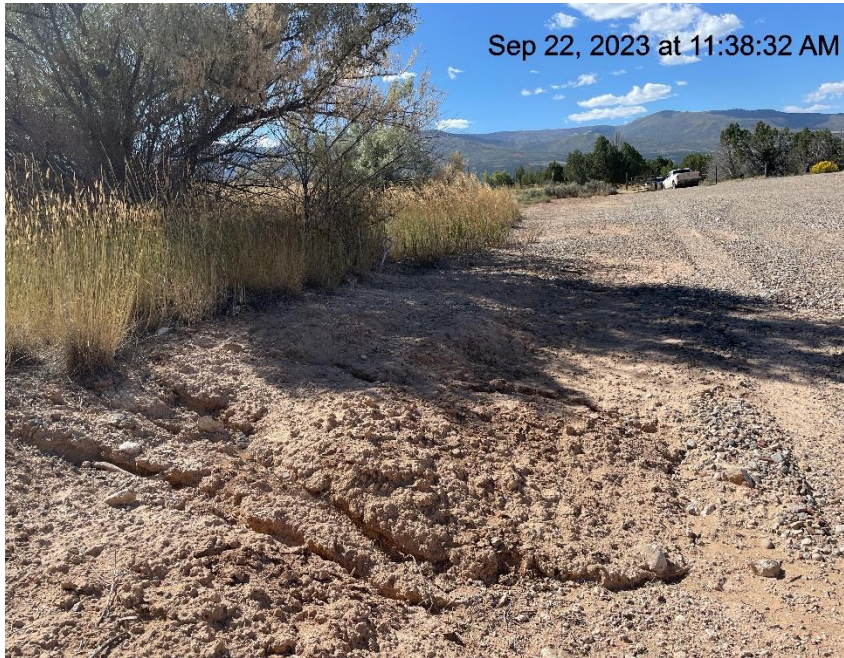
**Photo # 356 Erosion & transport of sediment onto location/
insufficient BMP's**

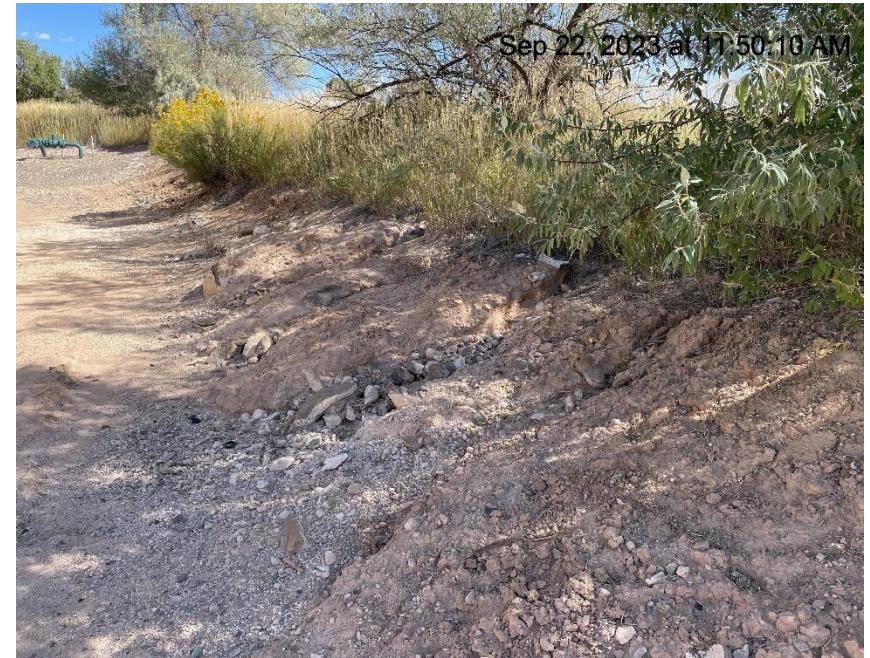
**Photo # 363 Erosion & transport of sediment onto location/
insufficient BMP's**

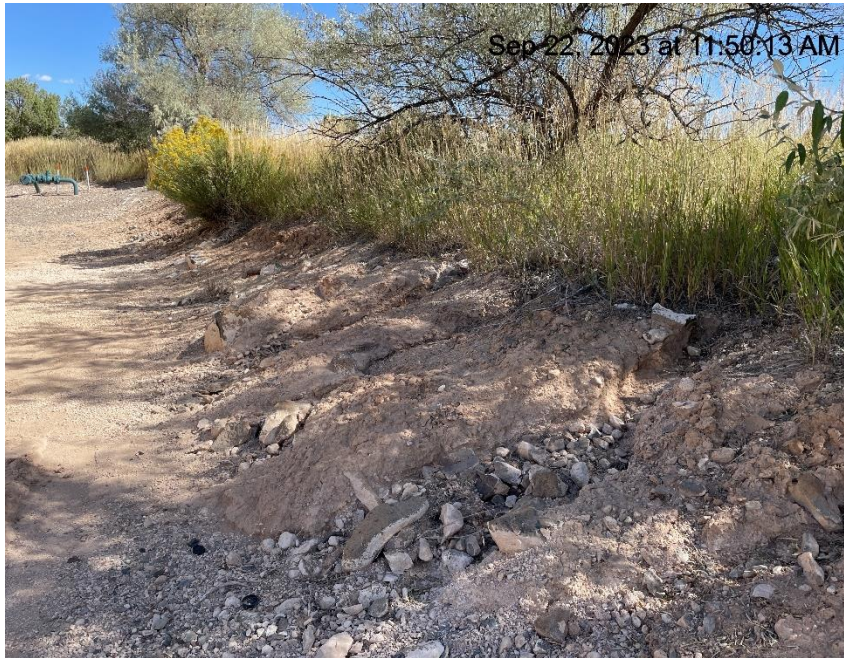
**Photo # 364 Erosion & transport of sediment onto location/
insufficient BMP's**

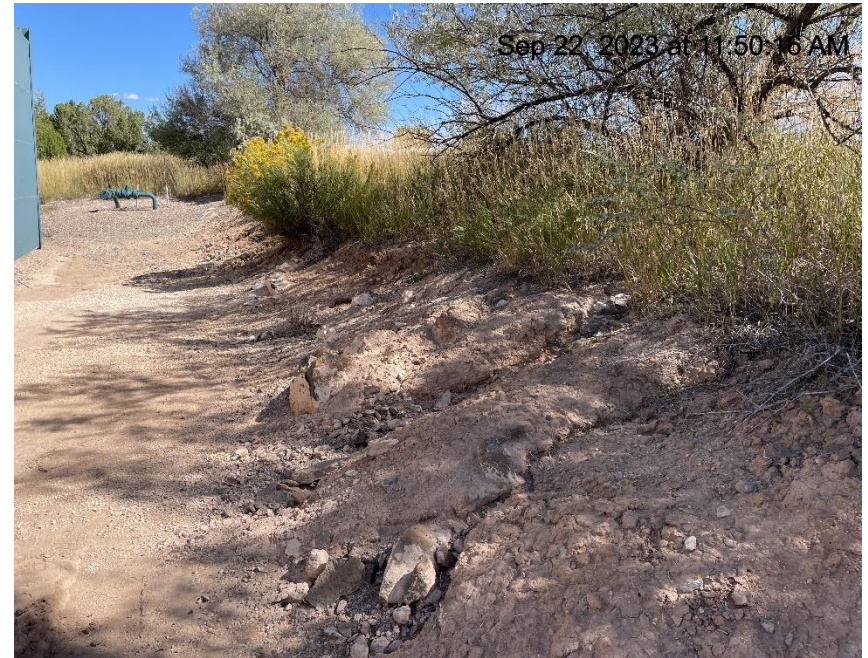
**Photo # 365 Erosion & transport of sediment onto location/
insufficient BMP's**

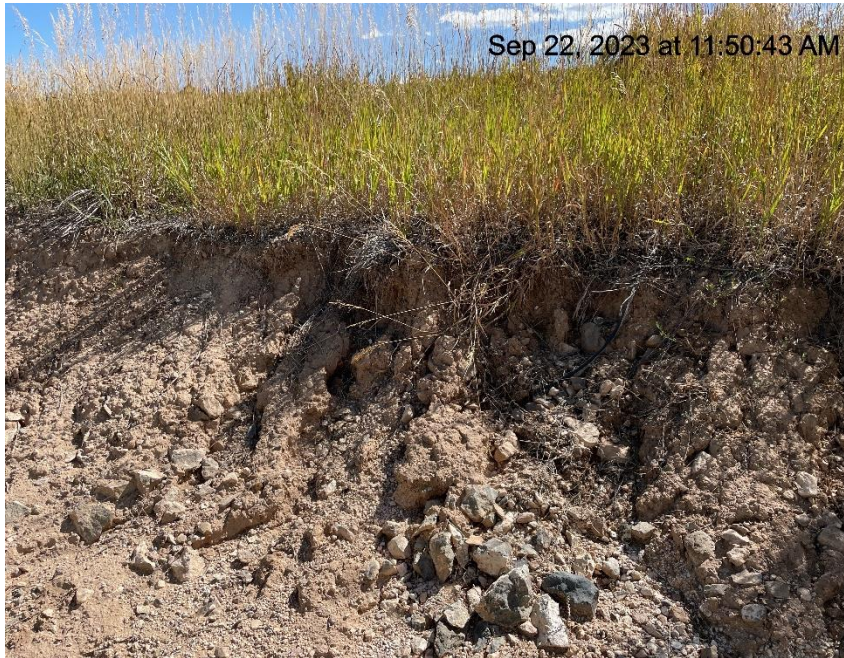
**Photo # 373 Lack of stabilization & erosion on slope
/transport of sediment onto location/insufficient BMP's**

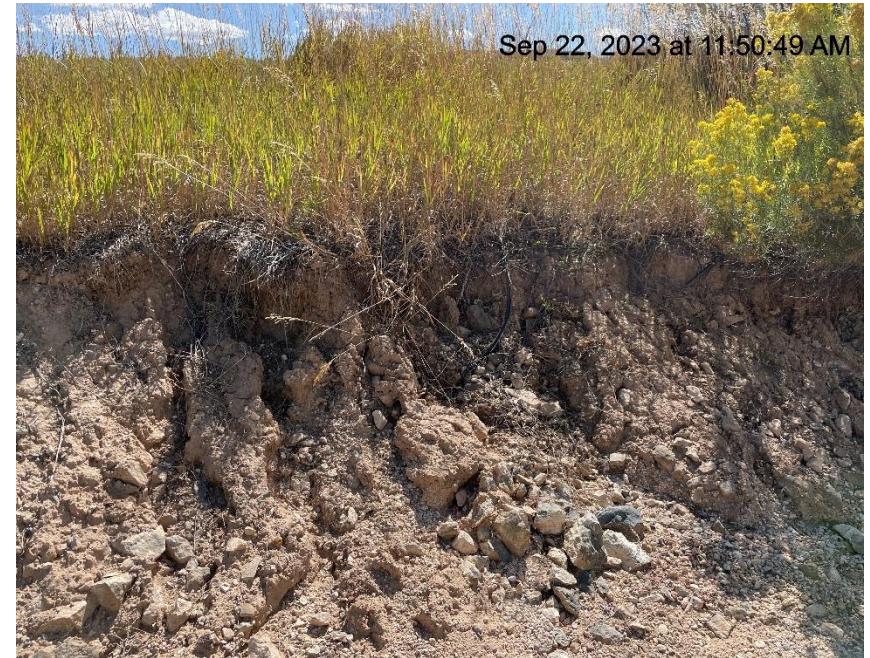
**Photo # 375 Lack of stabilization & erosion on slope
/transport of sediment onto location/insufficient BMP's**

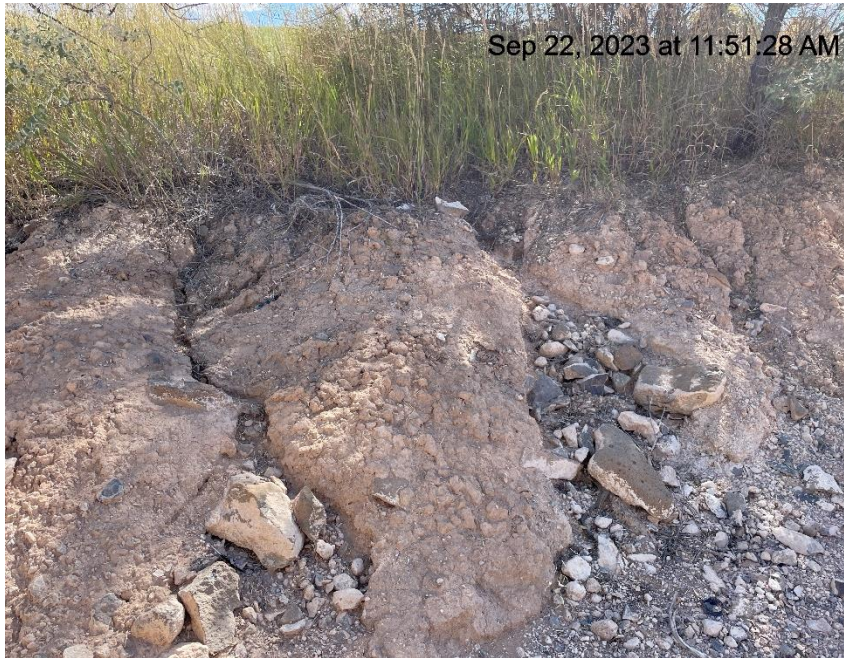
**Photo # 386 Erosion & transport of sediment onto location/
insufficient BMP's**

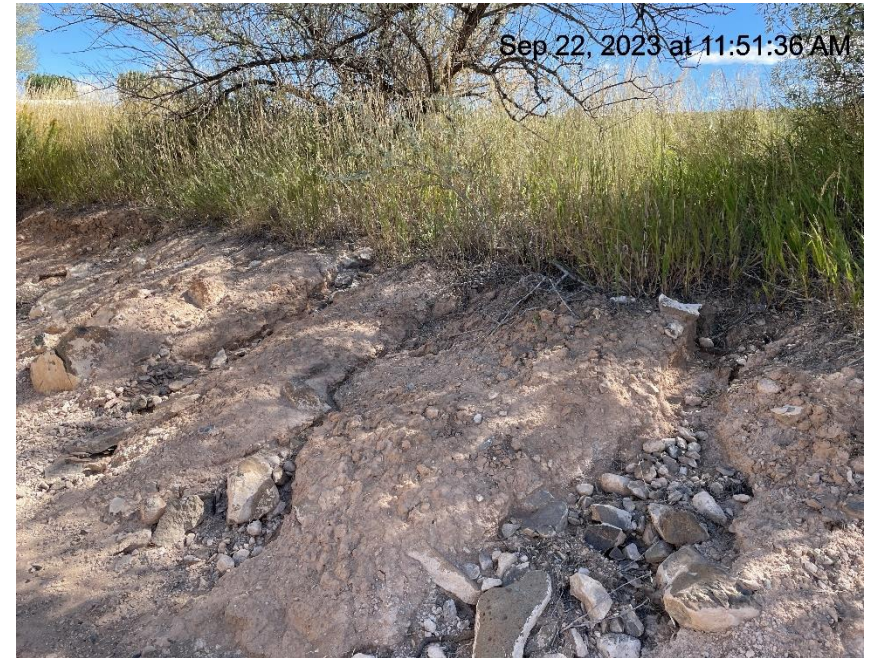
**Photo # 388 Erosion & transport of sediment onto location/
insufficient BMP's**

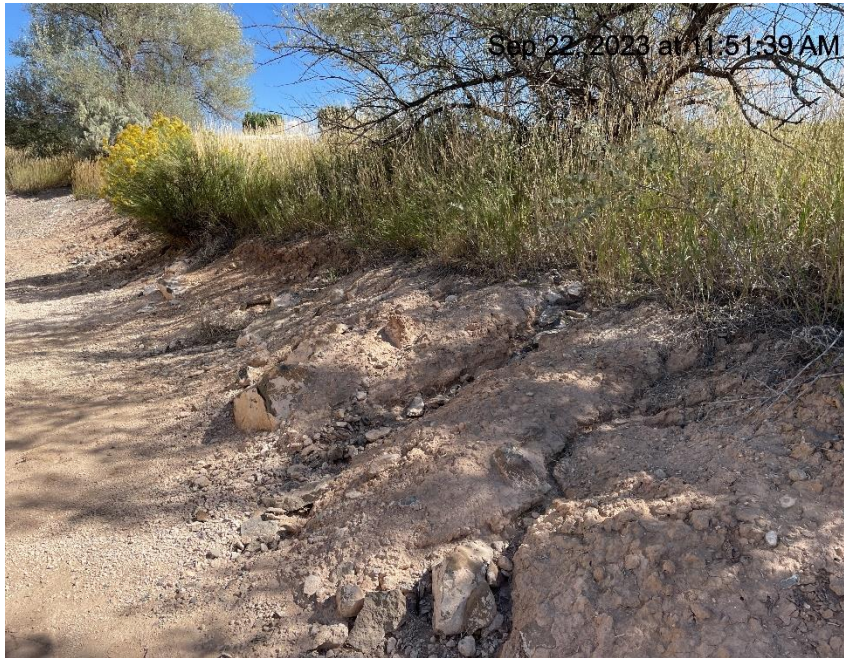
**Photo # 389 Erosion & transport of sediment onto location/
insufficient BMP's**

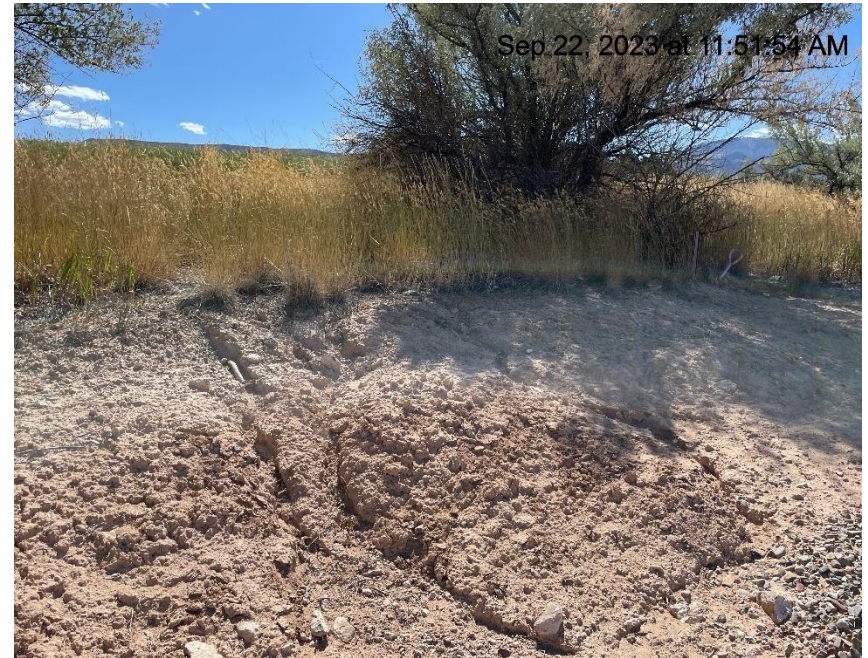
**Photo # 392 Erosion & transport of sediment onto location/
insufficient BMP's**

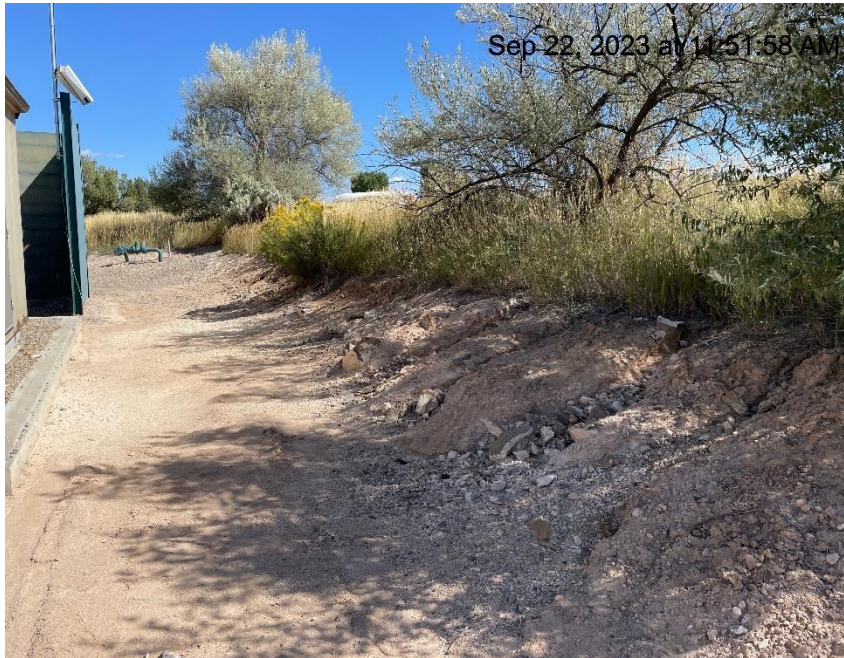
**Photo # 393 Erosion & transport of sediment onto location/
insufficient BMP's**

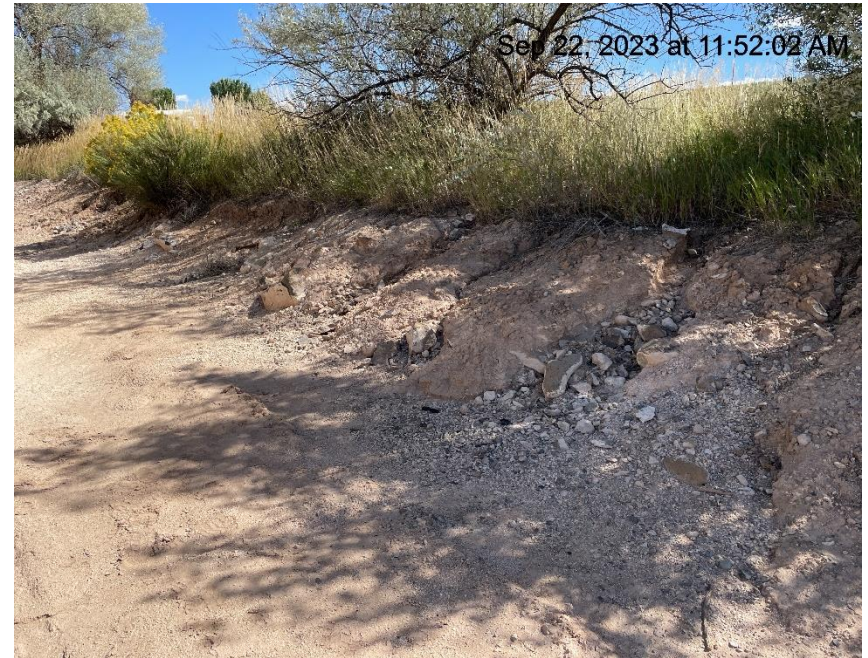
**Photo # 394 Erosion & transport of sediment onto location/
insufficient BMP's**

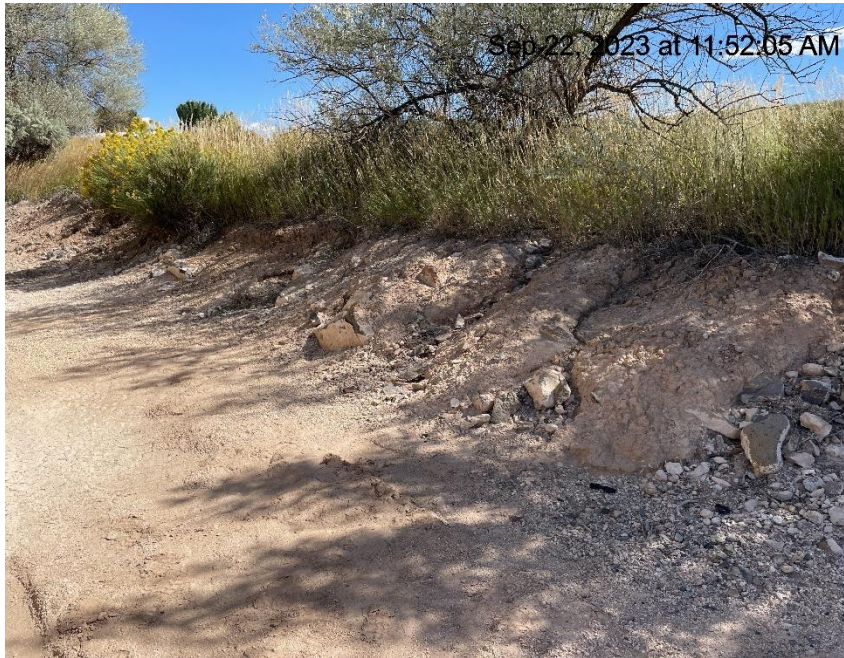
**Photo # 395 Erosion & transport of sediment onto location/
insufficient BMP's**

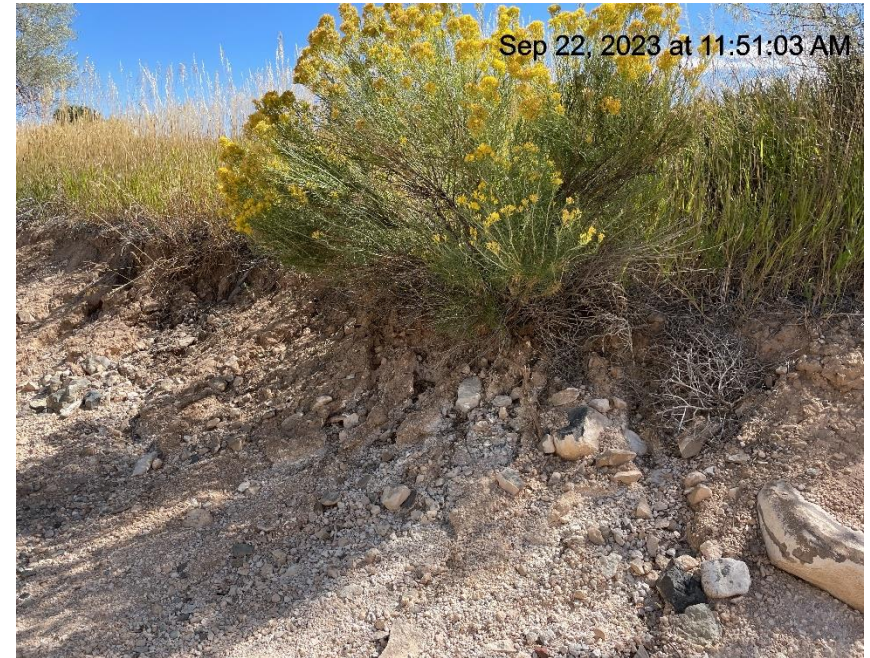
**Photo # 378 Lack of stabilization & erosion on slope
/transport of sediment onto location/insufficient BMP's**
