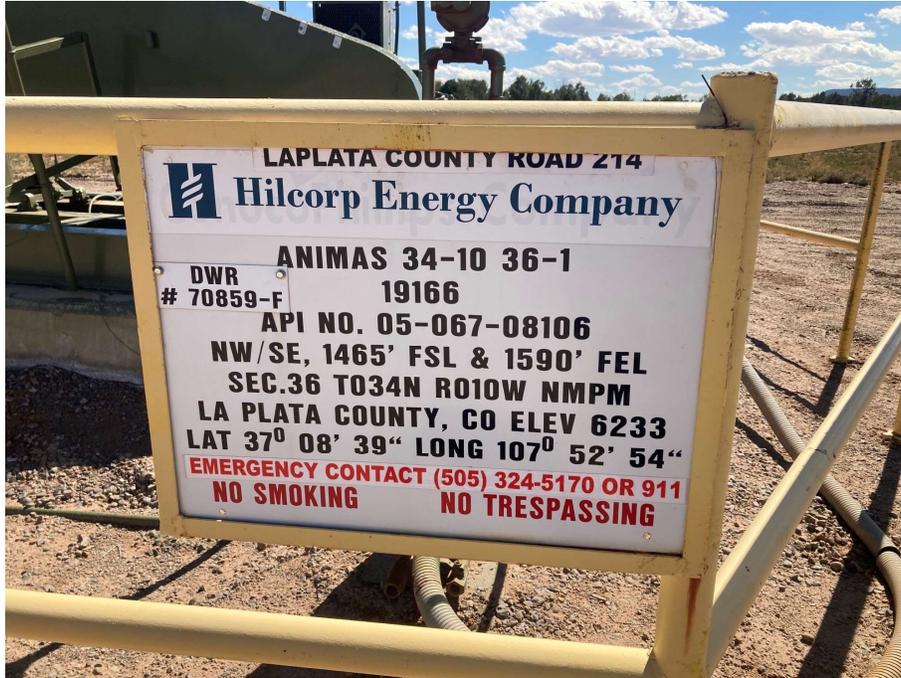
Comment: Metal signs posted on wellhead/pumpjack fenced enclosure. The ANIMAS 34-10 36-1 is not signed.

Corrective Action: Moved fenced enclosure back around Animas 34-10 36-1 to satisfy the signage and unused equipment (pipe fence) section of the INC.

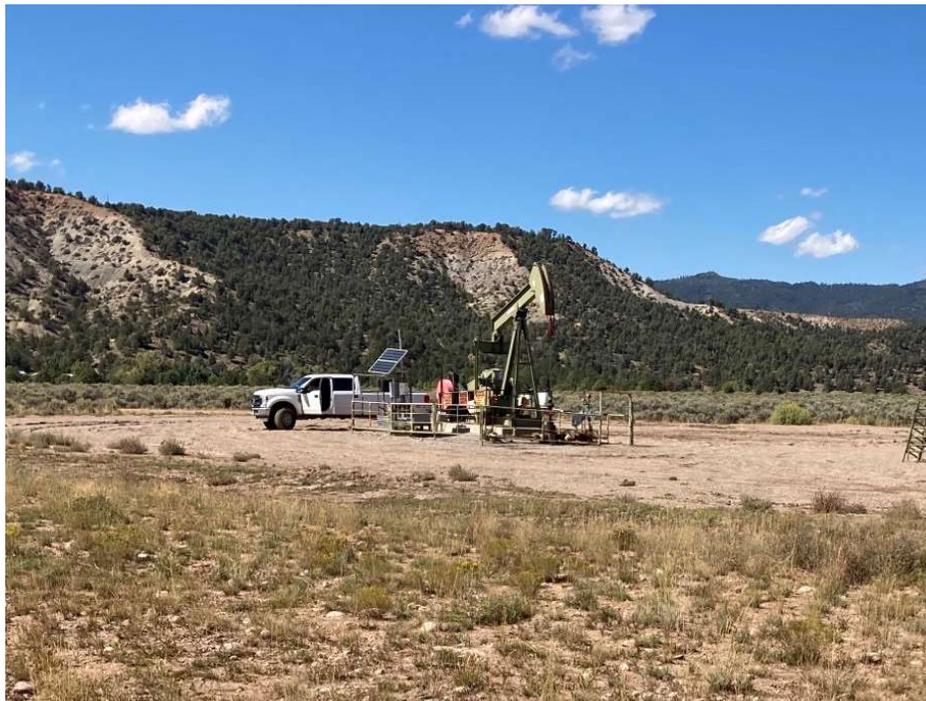
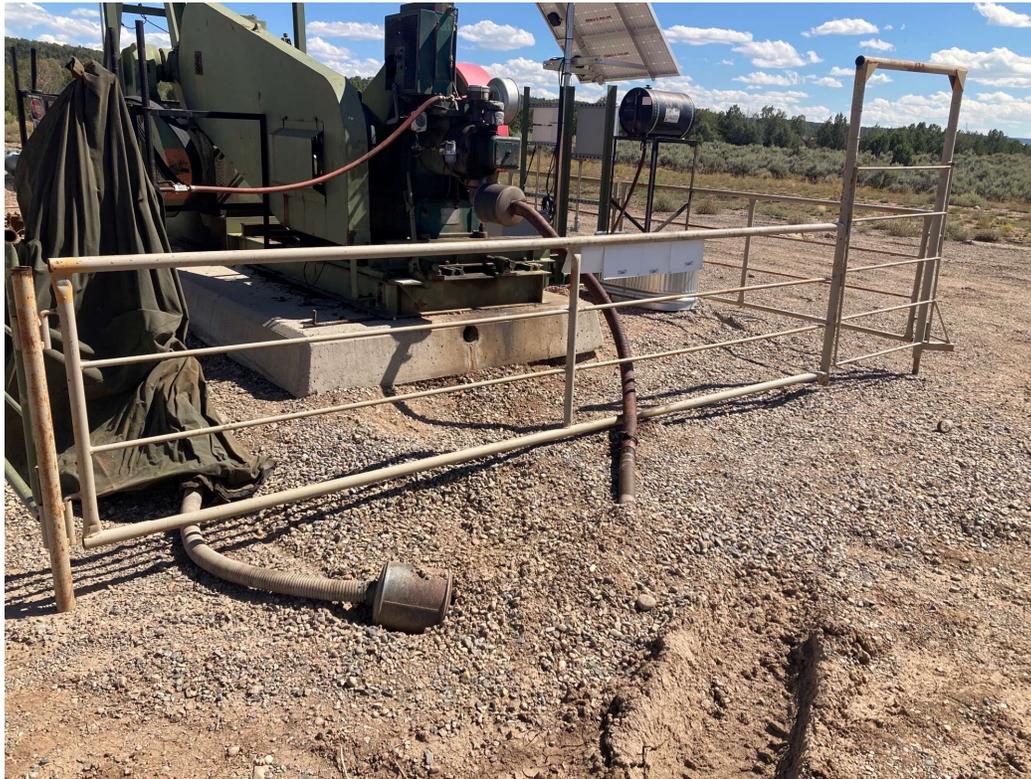
Comment: Disconnected chemical container positioned approximately 10 feet from wellhead at the ANIMAS 34-10 36-2A. See Photos #4 & #5. Muffler hose and manifold parts on ground beside prime mover at the ANIMAS 34-10 36-2A. See Photo #3.

Corrective Action: Removed chemical trailer and reconnected muffler on Animas 34-10 #36-2A to satisfy unused equipment section of the INC.

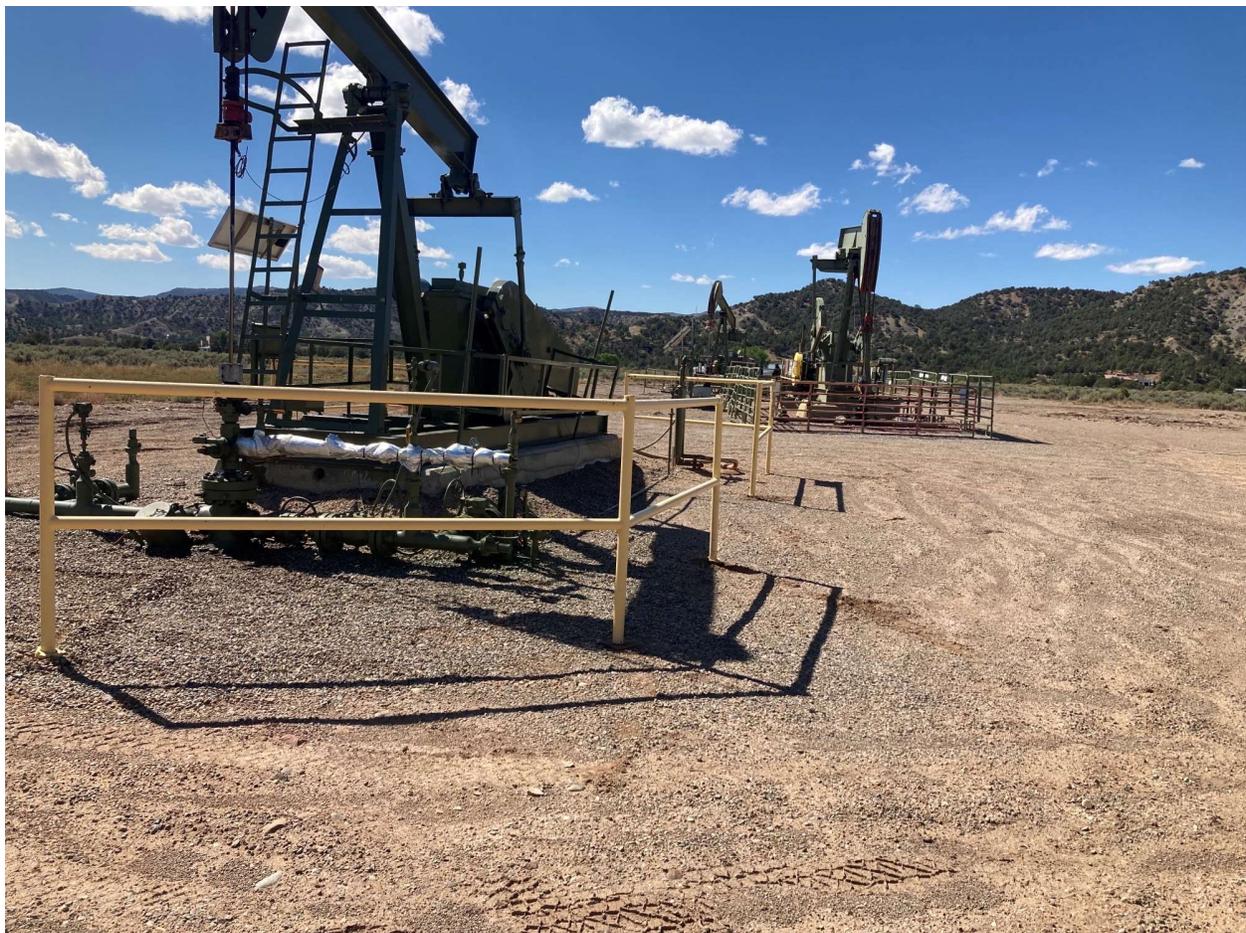
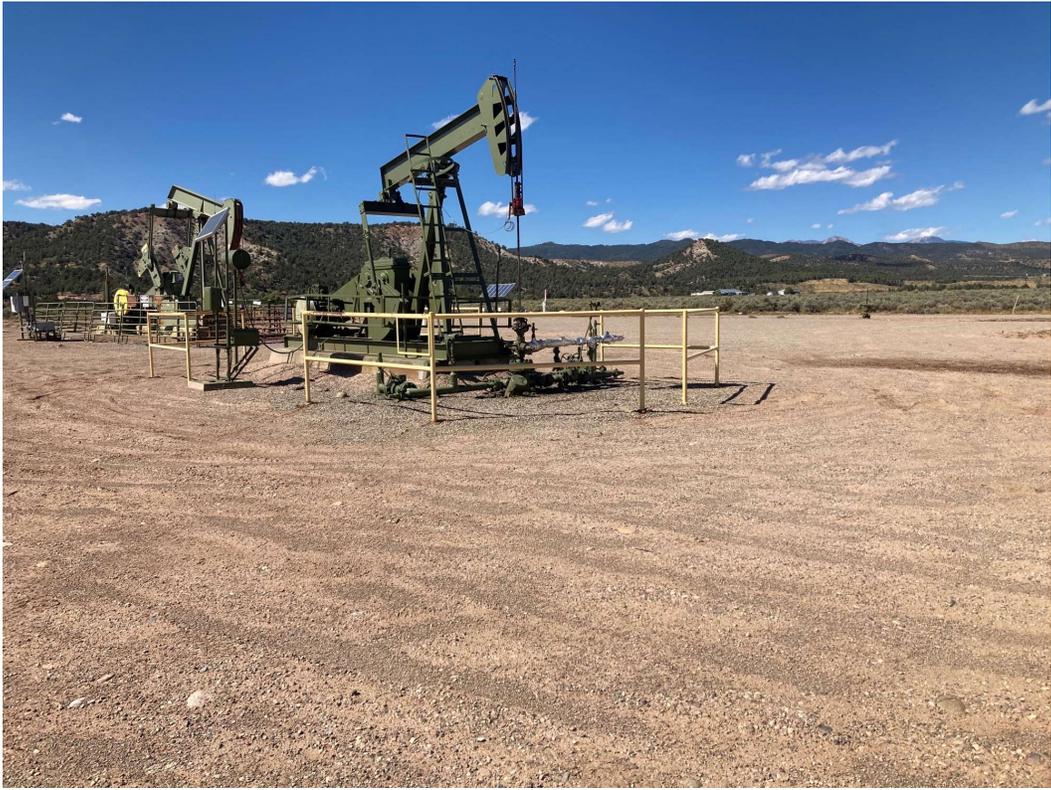
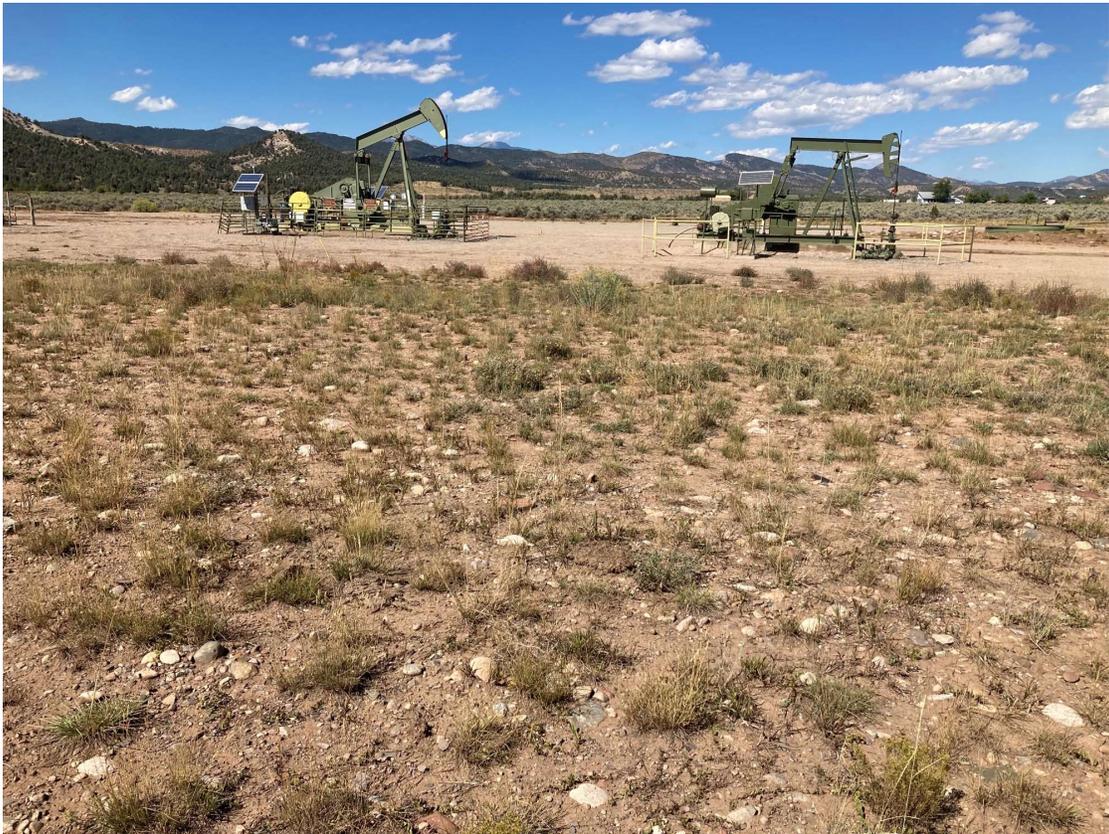
Comment: Sections of pipe rail fencing placed along the edge of the location. See Photos #6 & #7.

Corrective Action: Moved fenced enclosure back around Animas 34-10 36-1 to satisfy the signage and unused equipment (pipe fence) section of the INC.

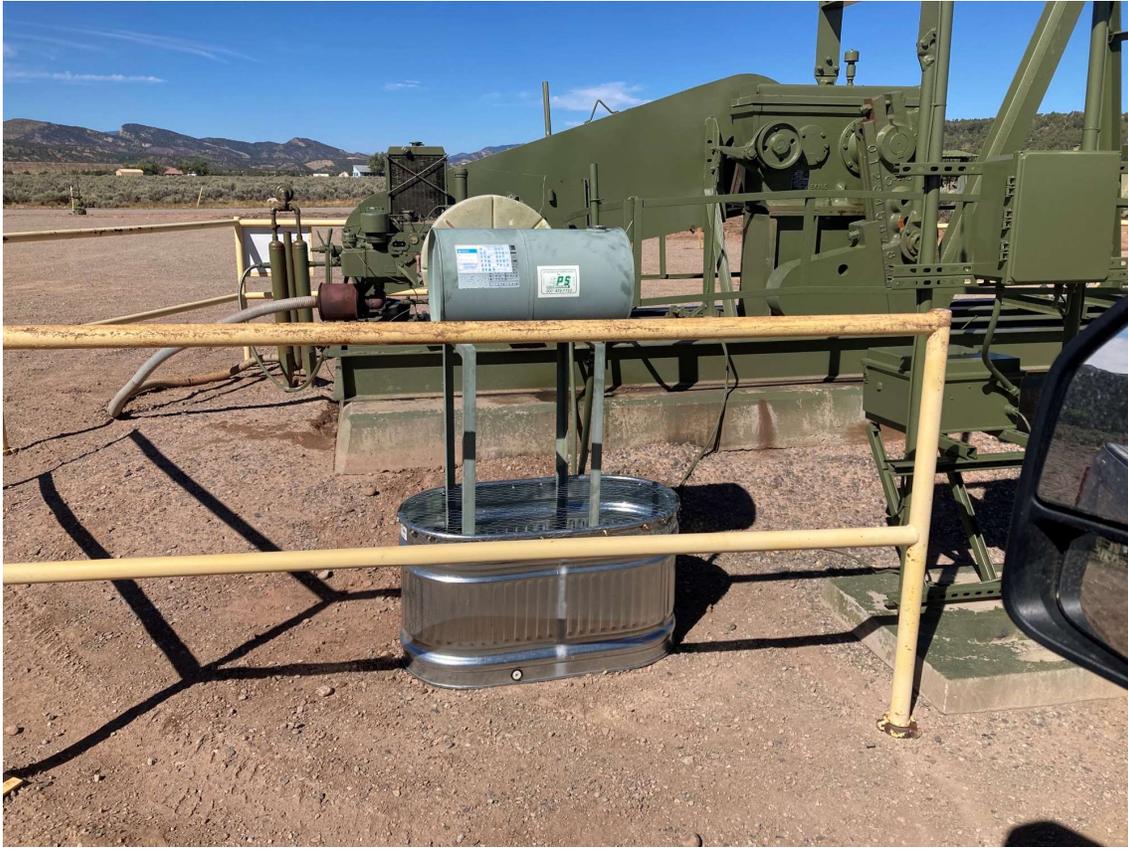
Comment: Lube oil container not in spill prevention at the 2A wellhead.

Corrective Action: Installed Spill containment to satisfy that section of the INC.

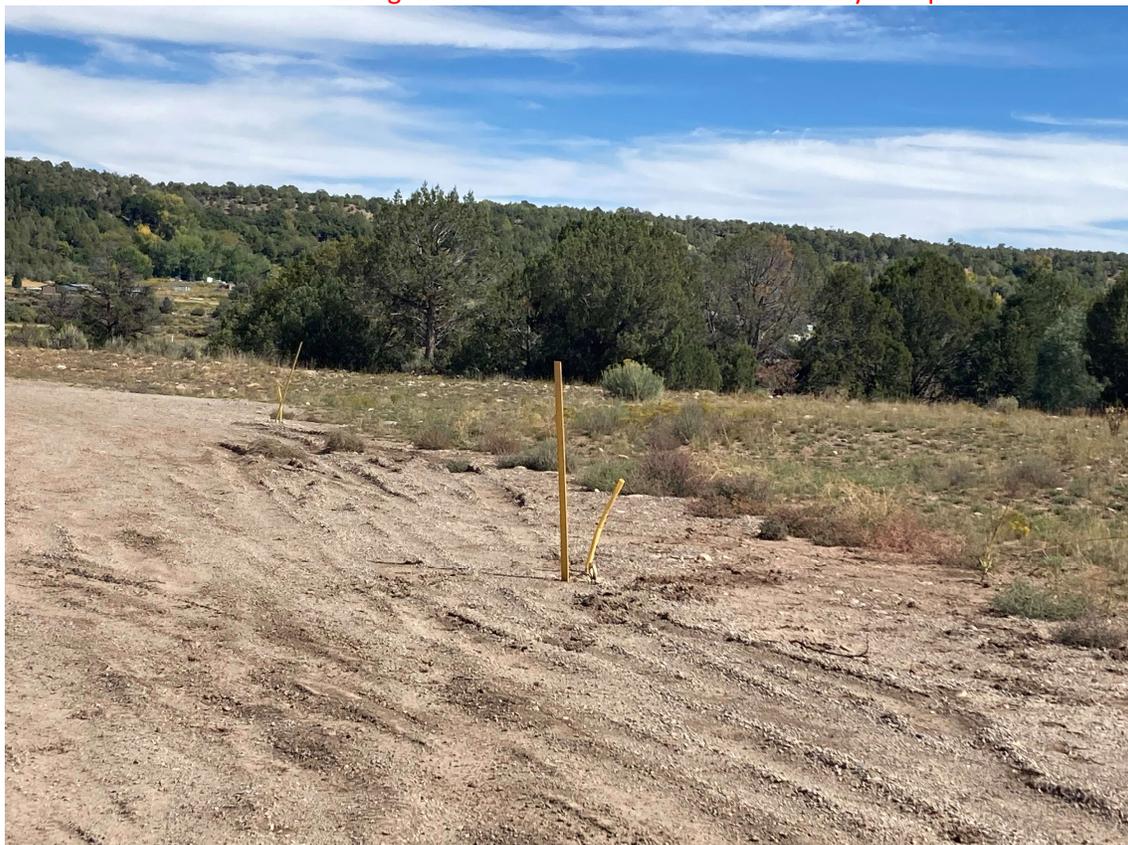
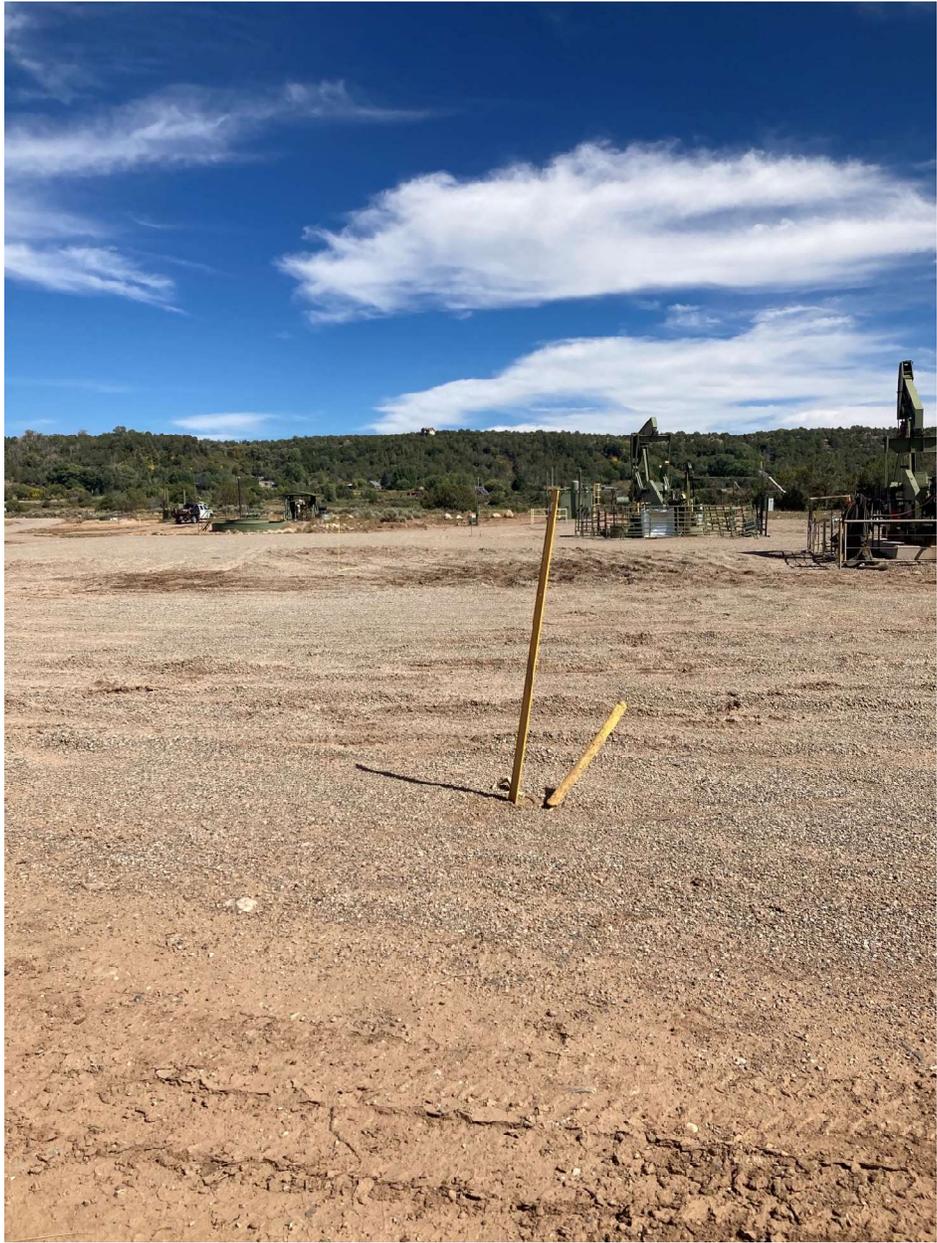
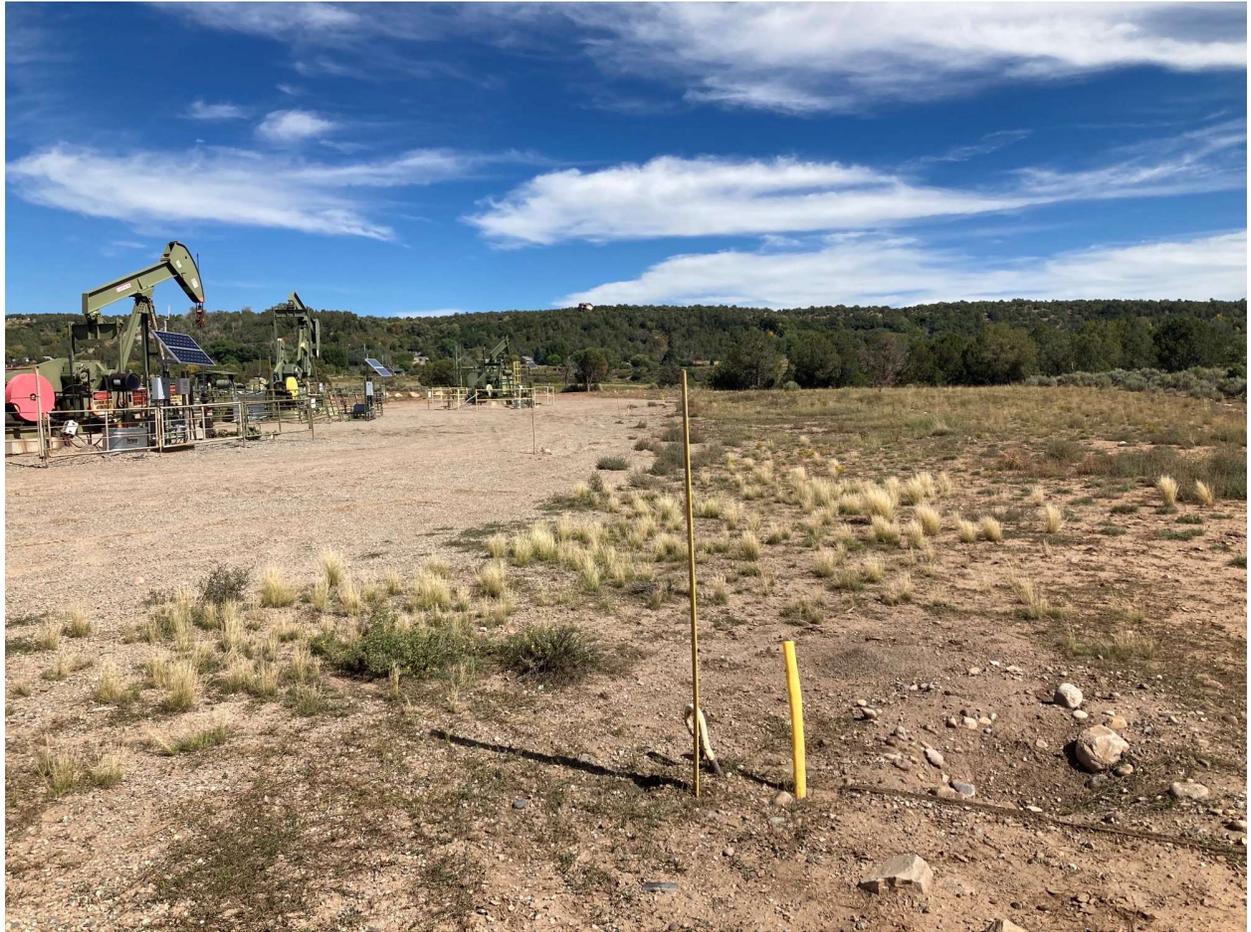
Comment: Several guy anchors unmarked or marker is broken on the ground.

Corrective Action: Installed Markers on the rig anchors across all 3 locations to satisfy that part of the INC.
