WELL NAME: HILL RANCH 36-11, API #: 071-09531, INSP. # 695108675

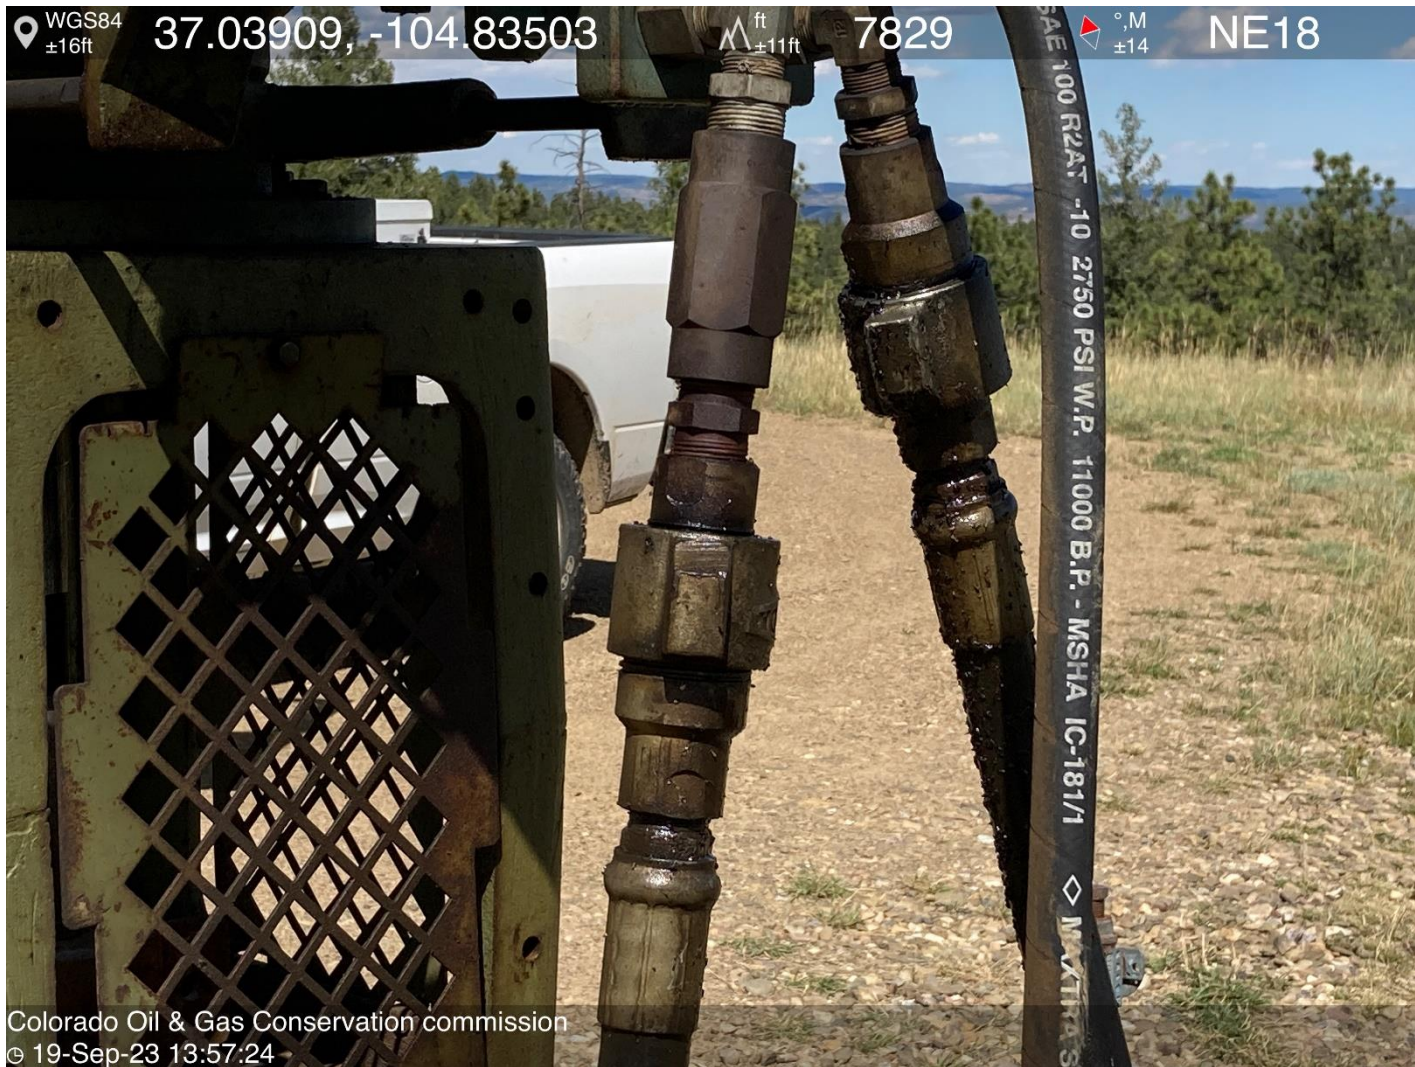
**PHOTO 4: QUICK CONNECTIONS ON DYDRO HOSES ARE LEAKING. Conduct maintenance on equipment, cleanup stained material and review self inspection processes. COMPLY WITH RULE 1002,(2).D. CA DATE 9-30-2023.**

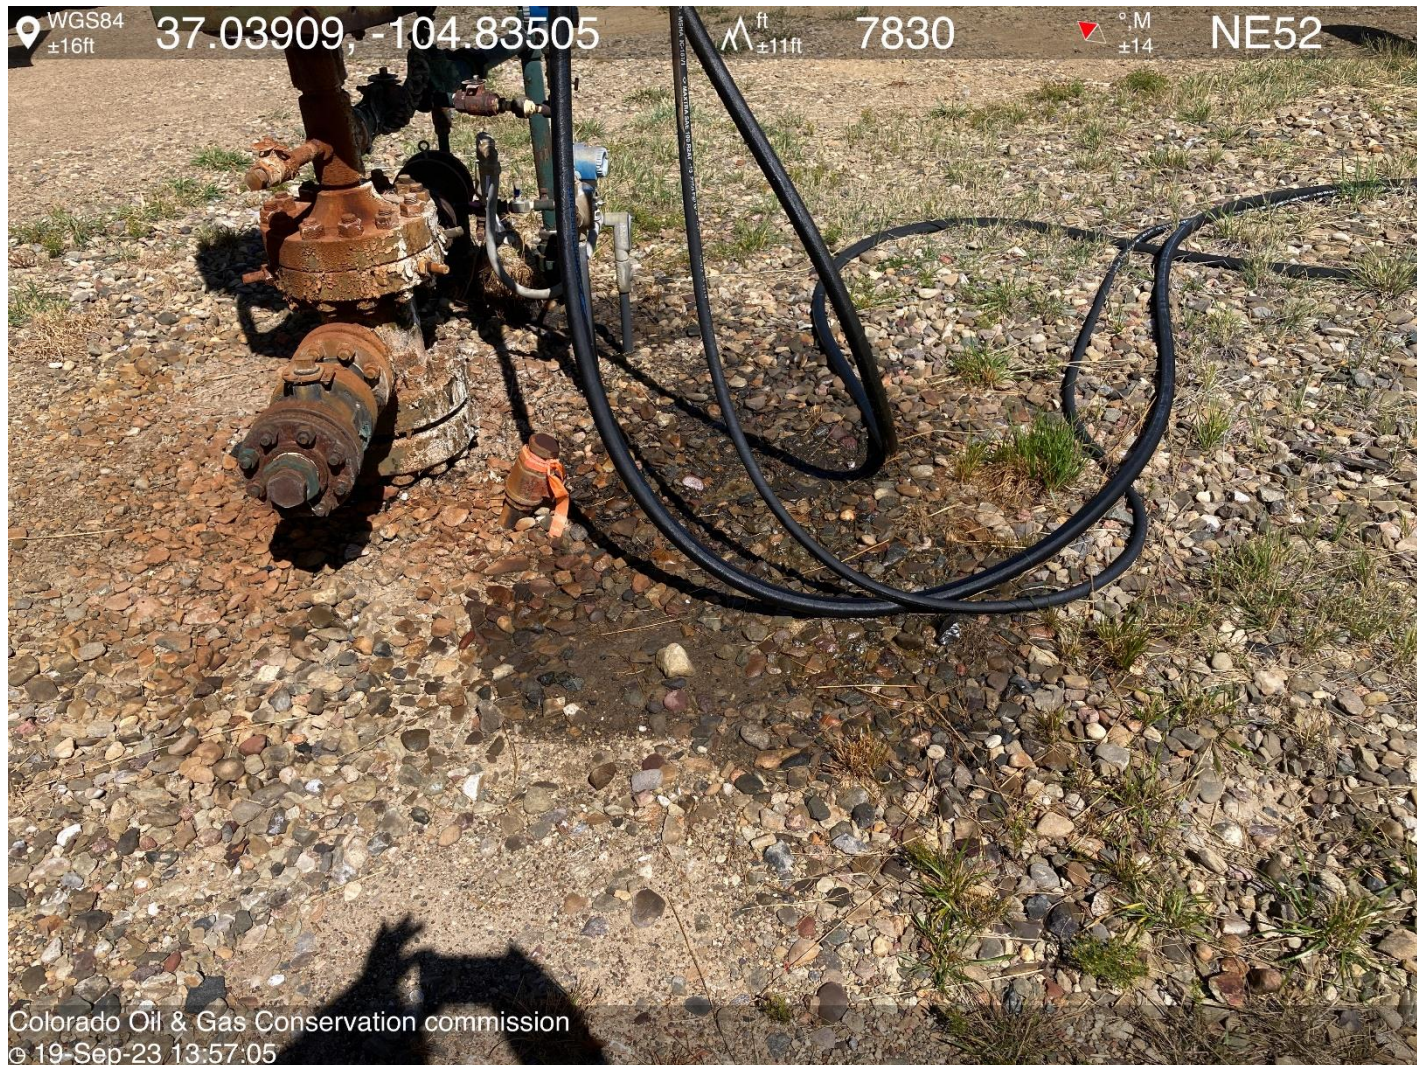
**PHOTO 5: AREA OF IMPACTED SOIL UNDER DYDRO QUICK CONNECT HOSED. Conduct maintenance on equipment, cleanup stained material and review self inspection processes. COMPLY WITH RULE 1002,(2).D. CA DATE 9-30-2023.**

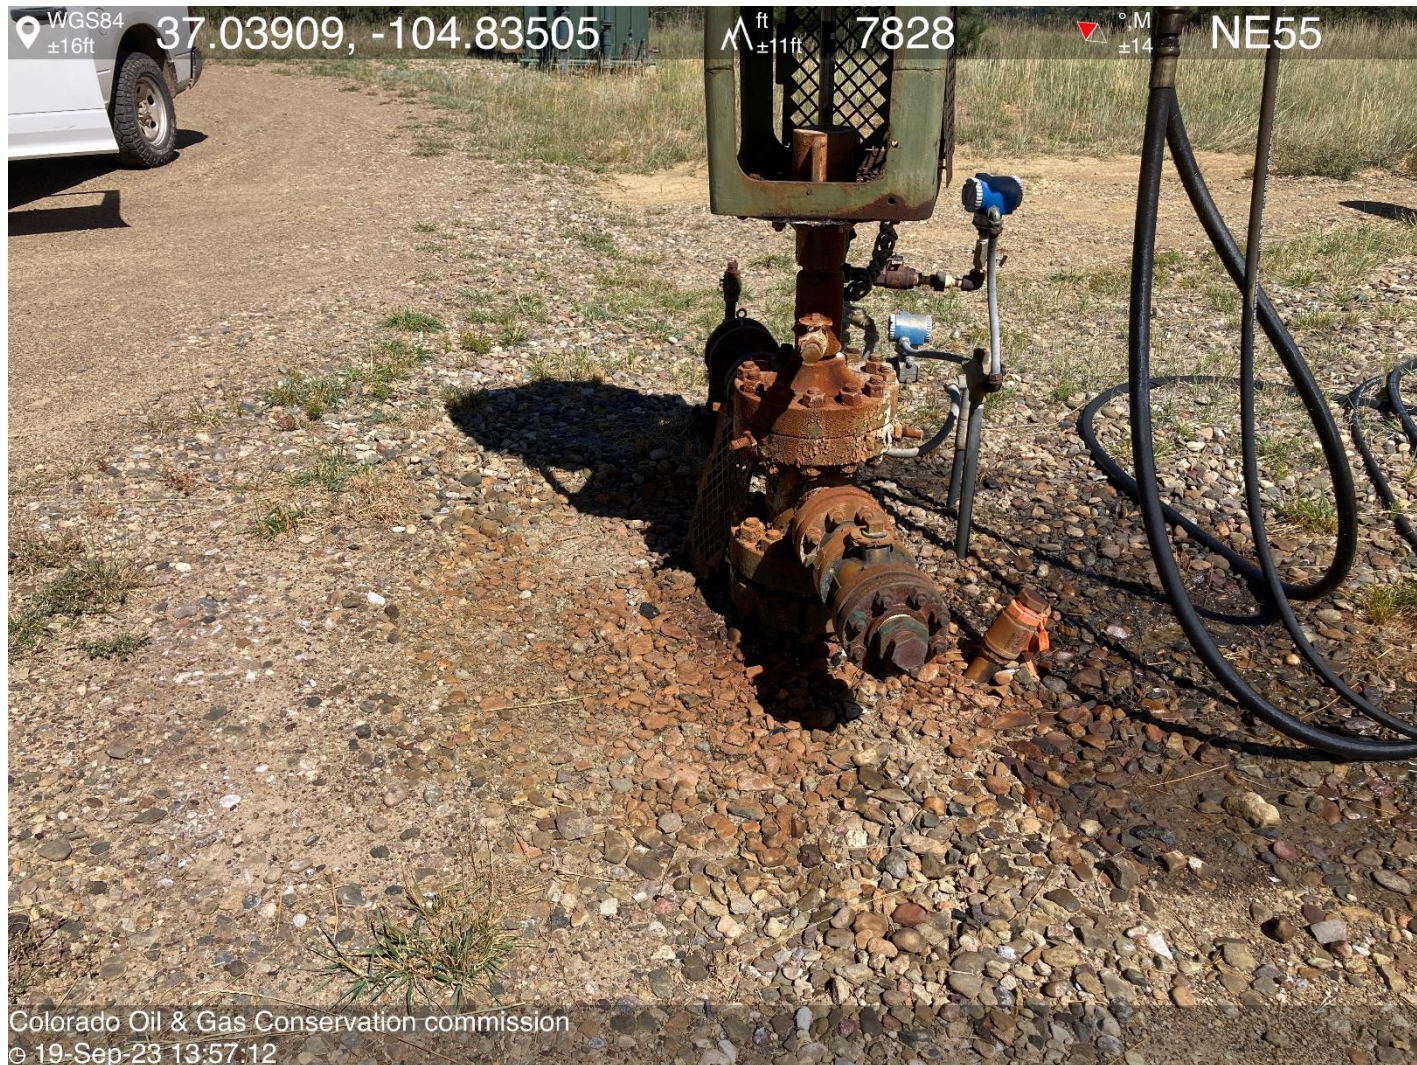
**PHOTO 6: RUST COLORED IMPACTED SOIL APPEARS TO BE FROM ROD PACKING LEAKING OVER MULTIPLE EVENTS. Conduct maintenance on equipment, cleanup stained material and review self inspection processes. COMPLY WITH RULE 1002,(2).D. CA DATE 9-30-2023.**
