Inspection Photos

Location Name: MUSTANG RESOURCES LLC YOUNBERG 23-24-6S-94W Pad

Location ID: 323785

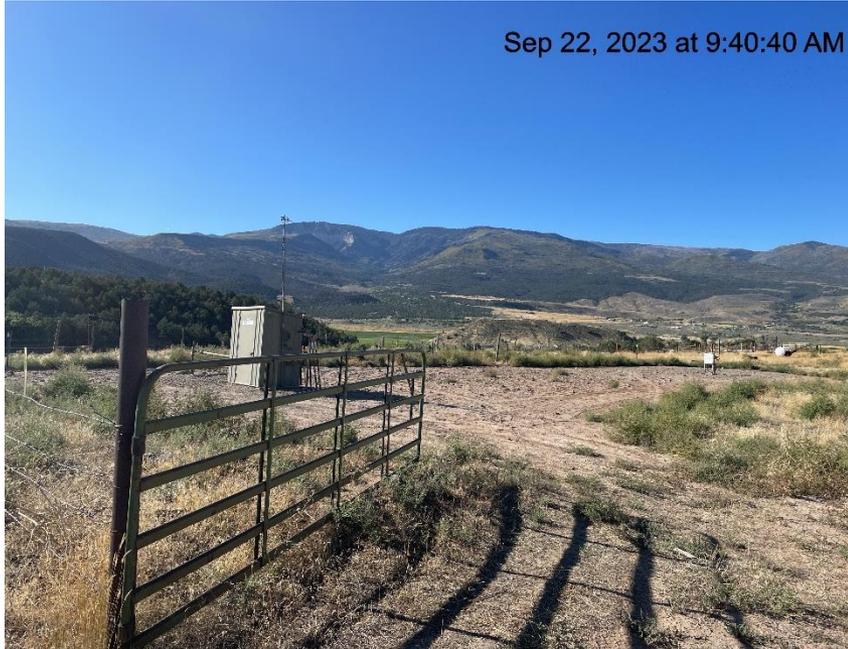
Photo # 120 From entrance to location

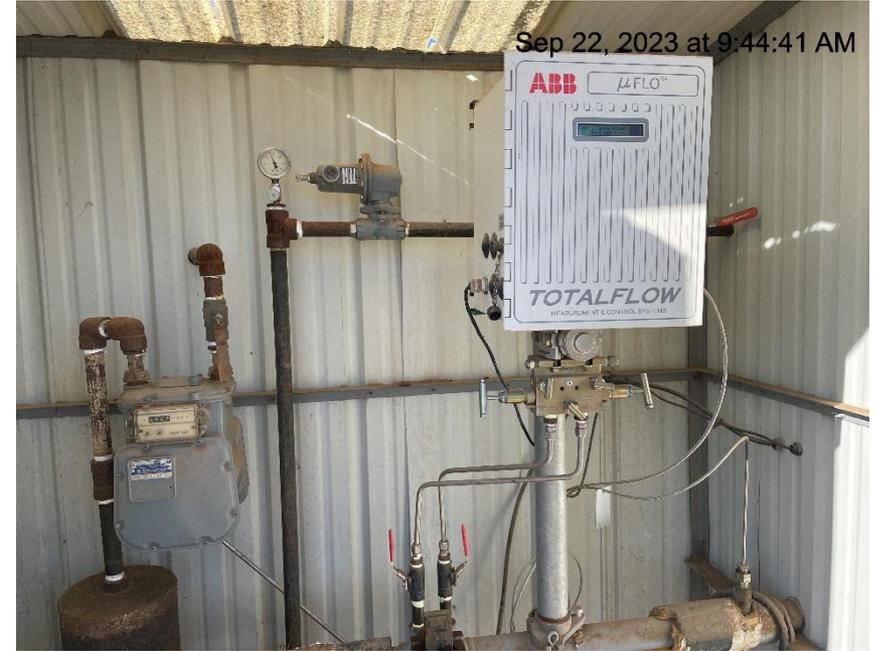
Photo # 123 Meter calibration info not conspicuously posted

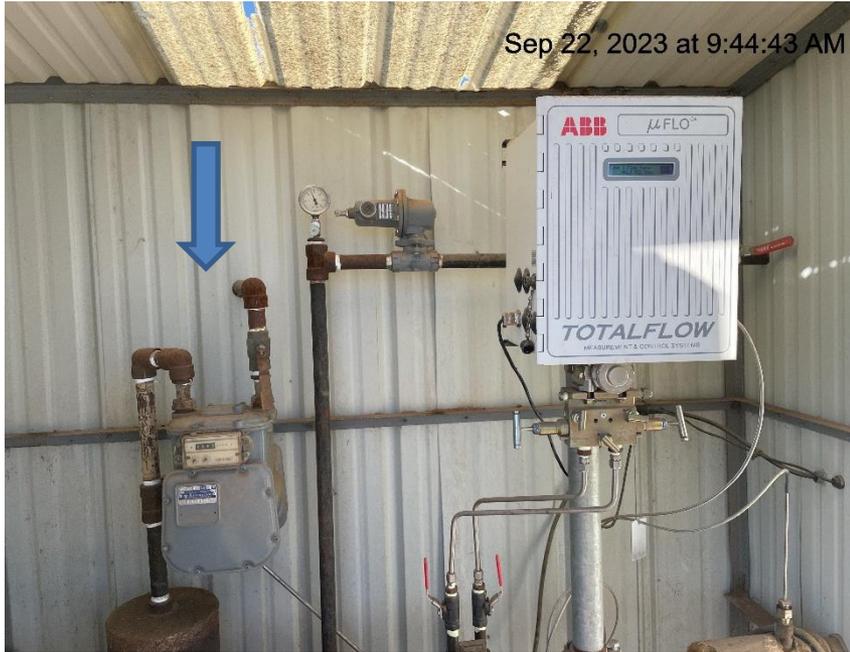
Photo # 124 Unregistered domestic tap

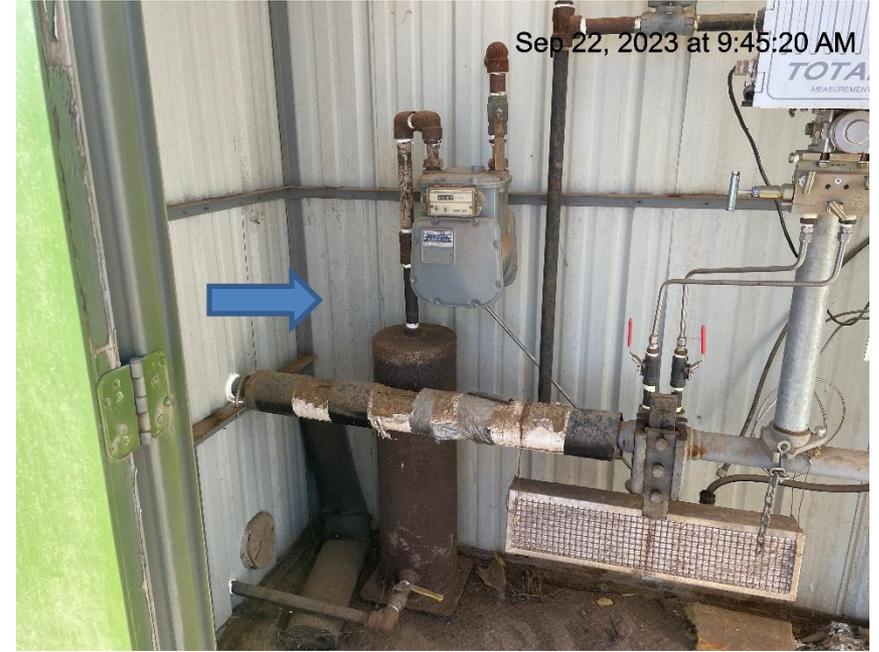
Photo # 125 Unregistered domestic tap

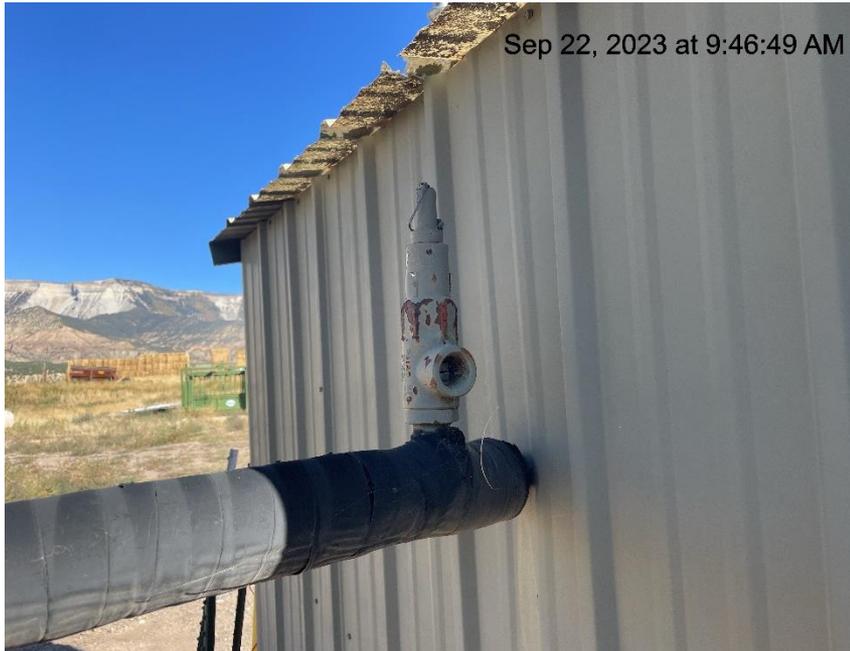
Photo # 126 PRV lacks vent line

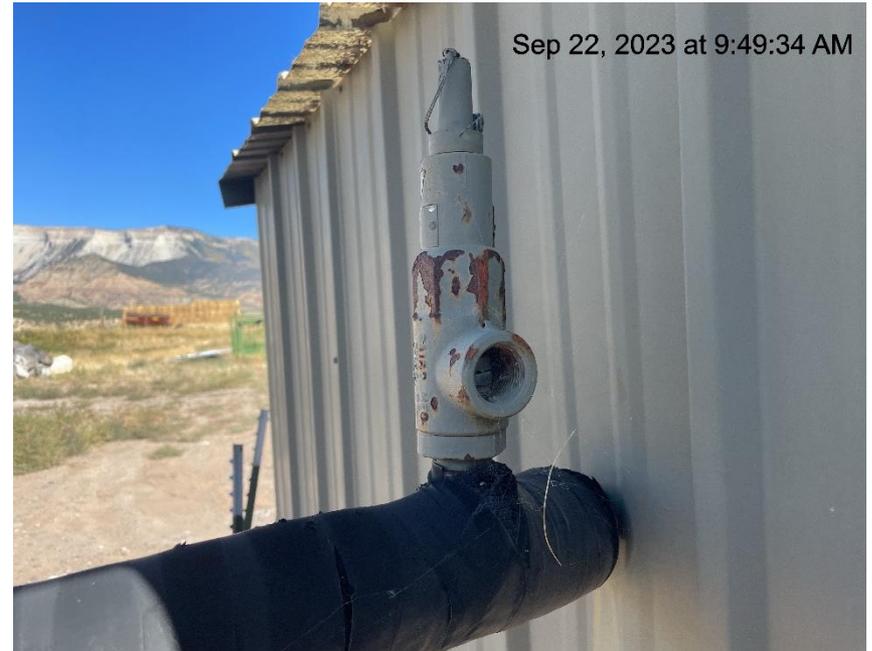
Photo # 127 PRV lacks vent line
