Inspection Photos

Location Name: MUSTANG RESOURCES LLC LOUTHAN 34-32-6S-94W Pad

Location ID: 323819

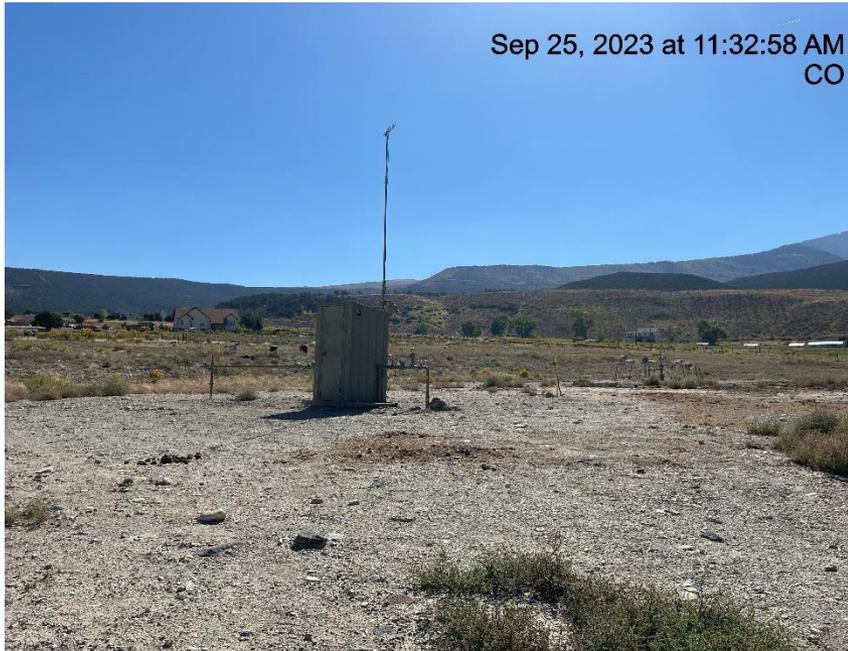
Photo # 639 From entrance to location

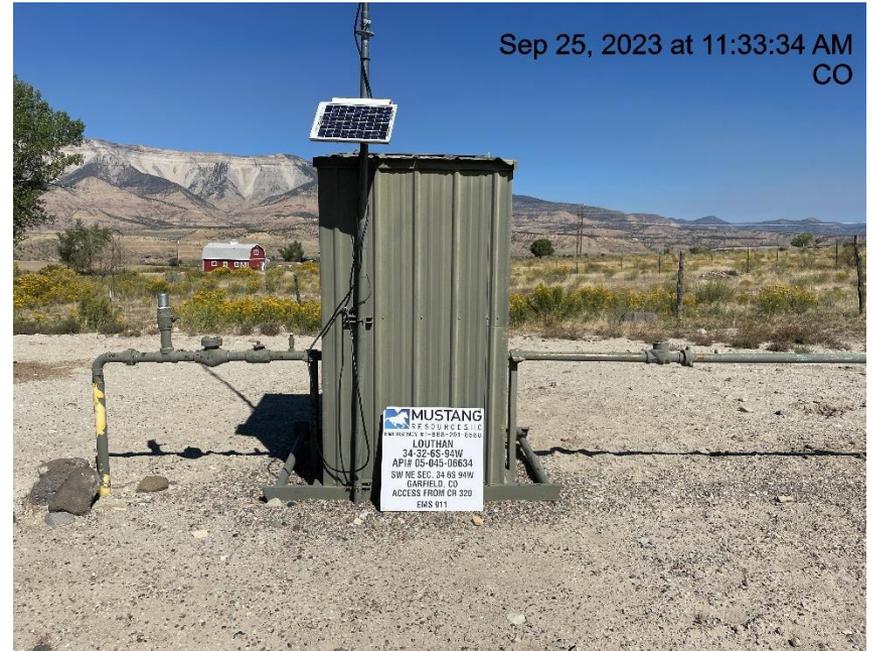
Photo # 640 Location

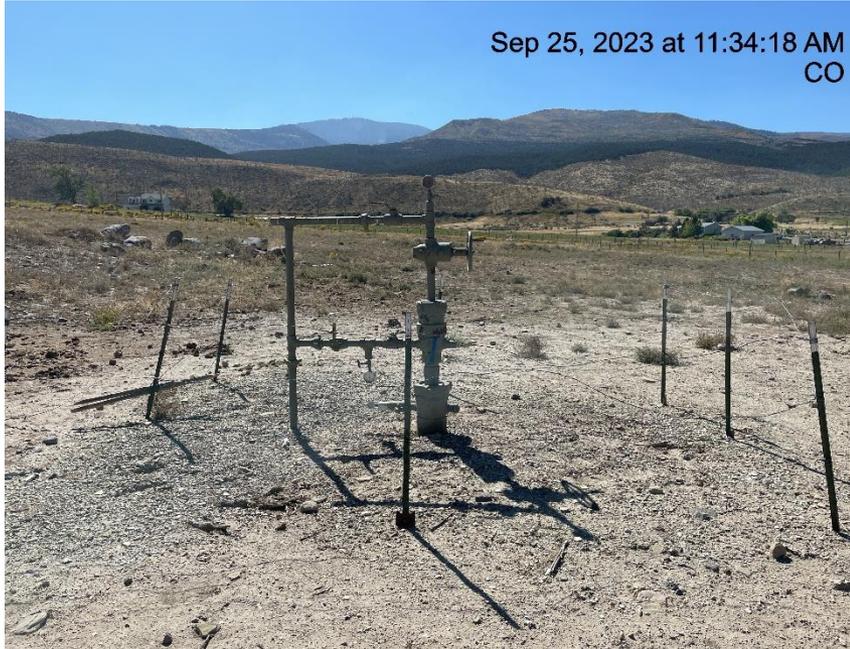
Photo # 641 Location

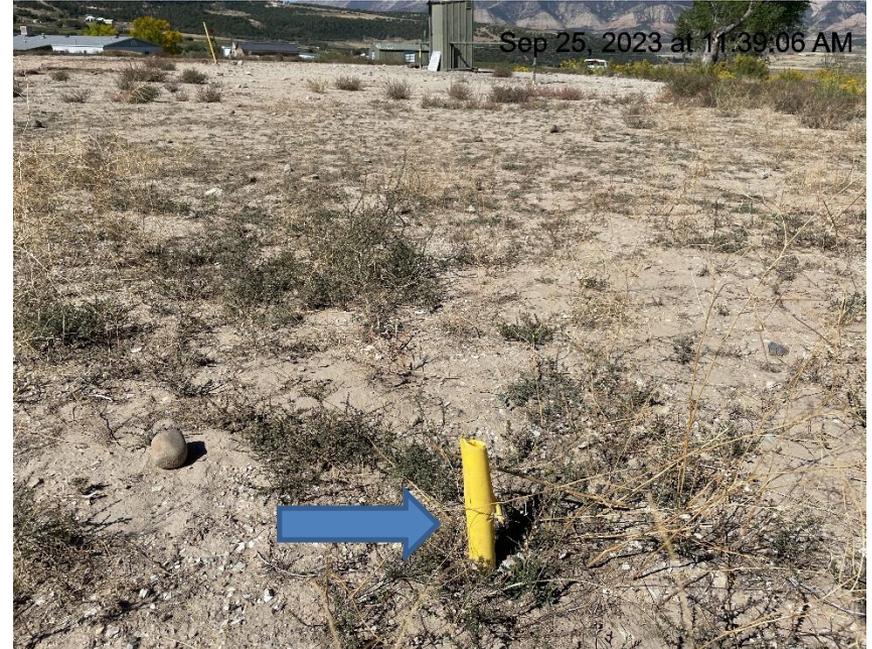
Photo # 642 Improperly marked deadman

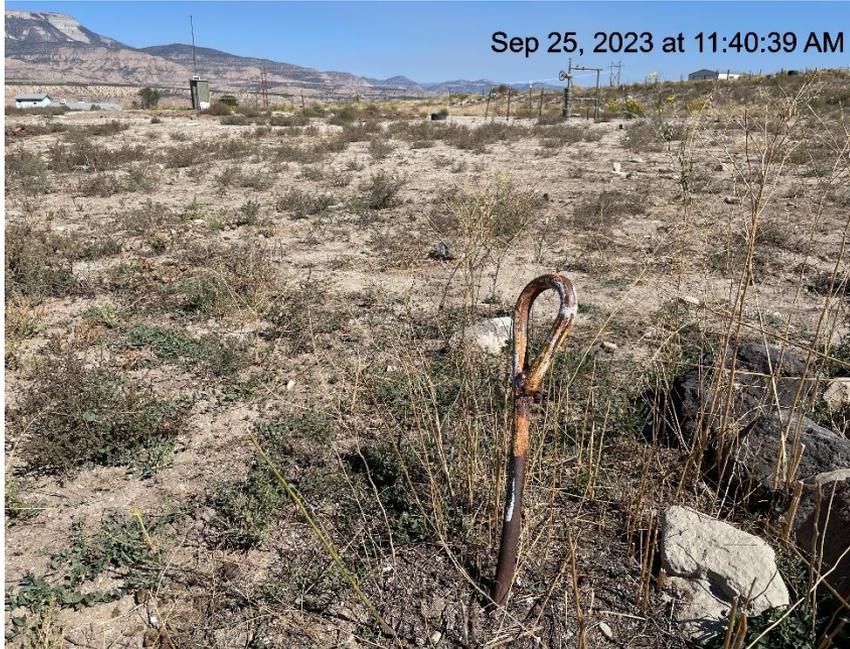
Photo # 643 Unmarked deadman

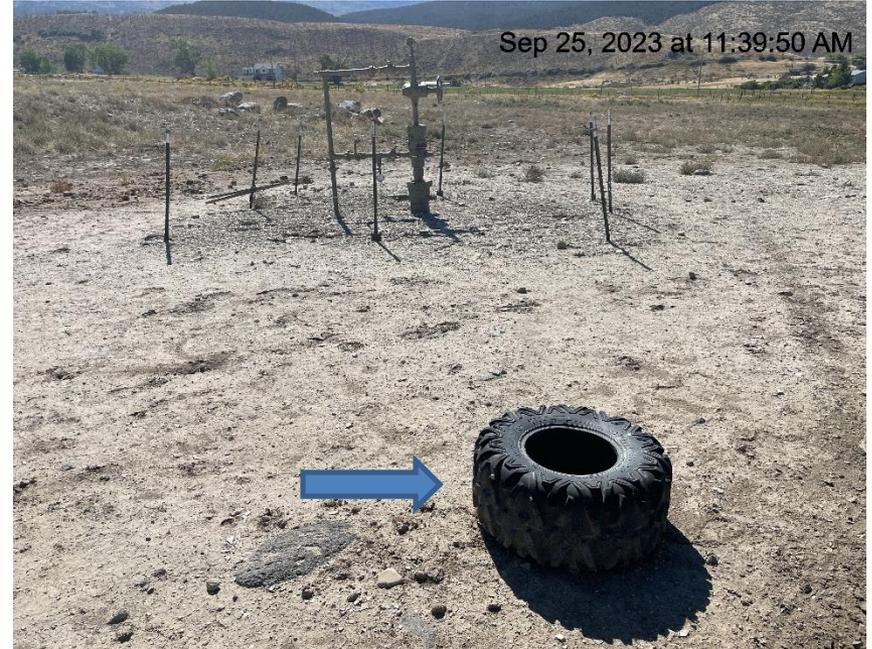
Photo # 644 Debris

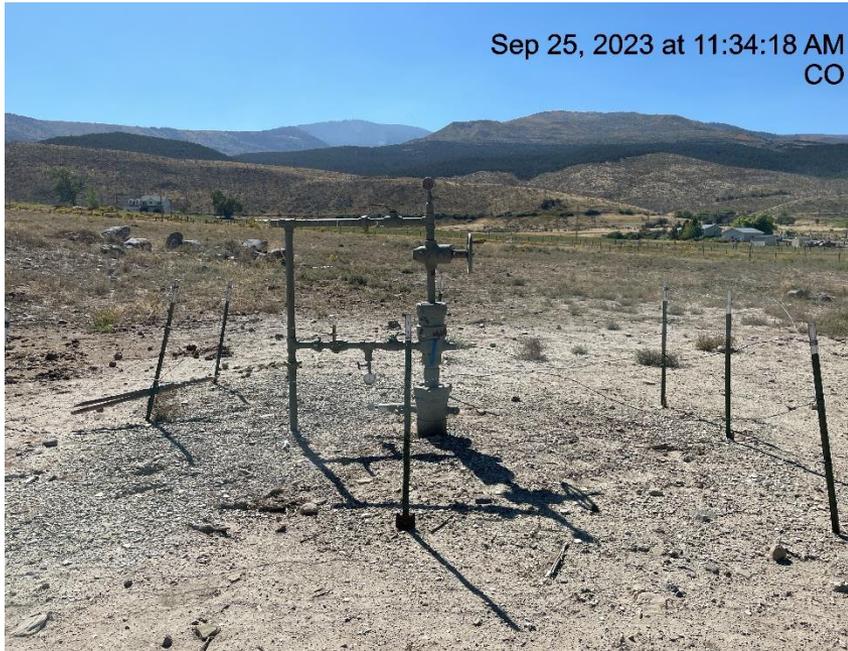
Photo # 641 No signage at wellhead
