HILL RANCH 36-10-67 (HILL RANCH 36-11) API# 05-071-09533 – OGRIS OPERATING  
COGCC OPERATOR NUMBER 10758 - DATE: SEPTEMBER 27, 2023  
CORRECTIVE ACTIONS COMPLETED REGARDING COGCC FIR DOCUMENT #695108675

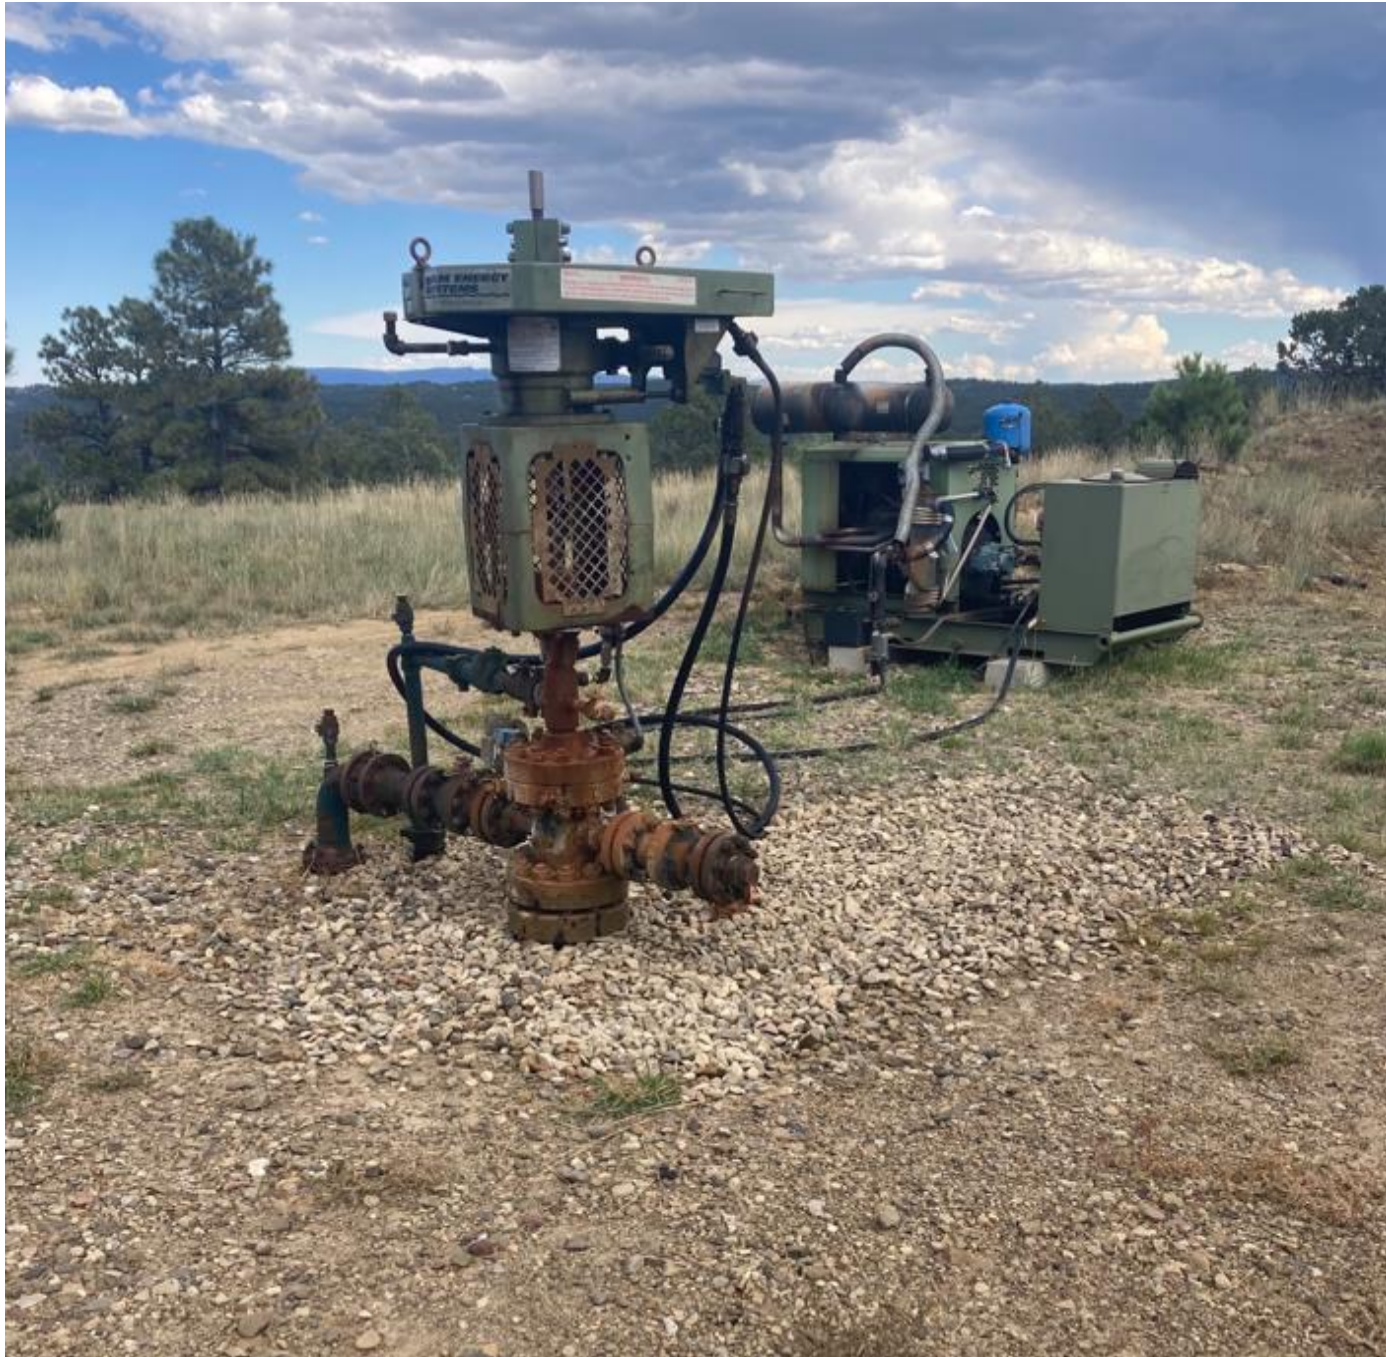
PHOTO 1: THE HYDRAULIC LEAK WAS REPAIRED AND EQUIPMENT MAINTENANCE HAS BEEN PERFORMED. ALL IMPACTED SOIL WAS REMOVED FROM THE LOCATION AND FRESH PAD MATERIAL ADDED AROUND THE WELLHEAD. THE SELF INSPECTION PROCESS HAS BEEN REVIEWED.

*NOTE: THE INSPECTION REPORTS THIS CORRECTIVE ACTION TO BE AT HILL RANCH 36-11 BUT UPON INVESTIGATION, THE LEAKING HYDRAULIC HOSES AND SOIL STAINS WERE DISCOVERED AT HILL RANCH 36-10-67.*
