# Construction and Stormwater Inspection

September 19, 2023

Operator: NOBLE ENERGY INC- #100322

Location ID: 483511

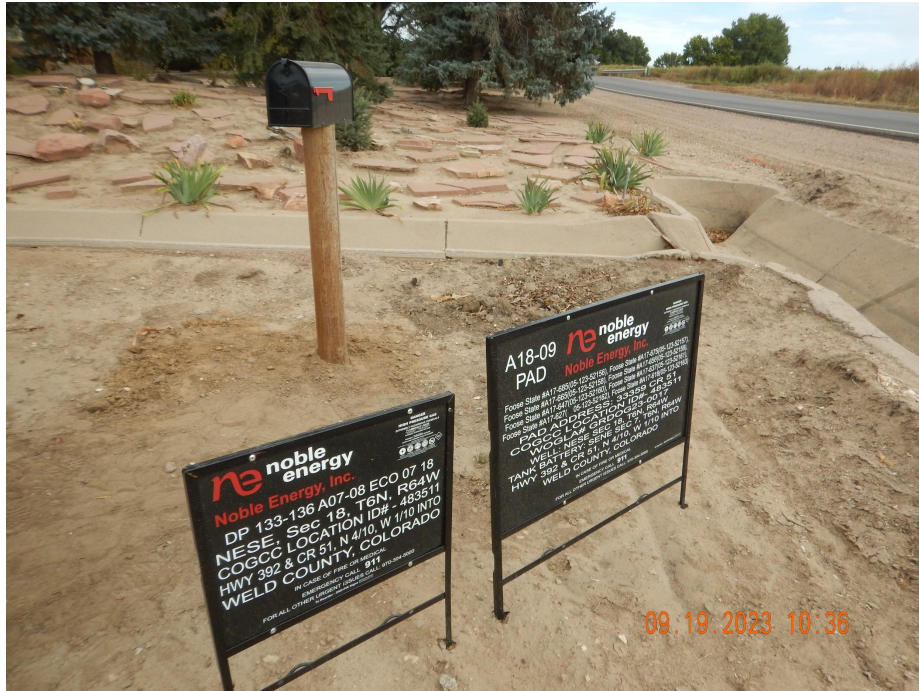
**Photo 1.** Photo taken from the location entrance off CR51, facing North. Photo illustrates a mailbox with permits to comply with Rule 406.c and Operator signage.

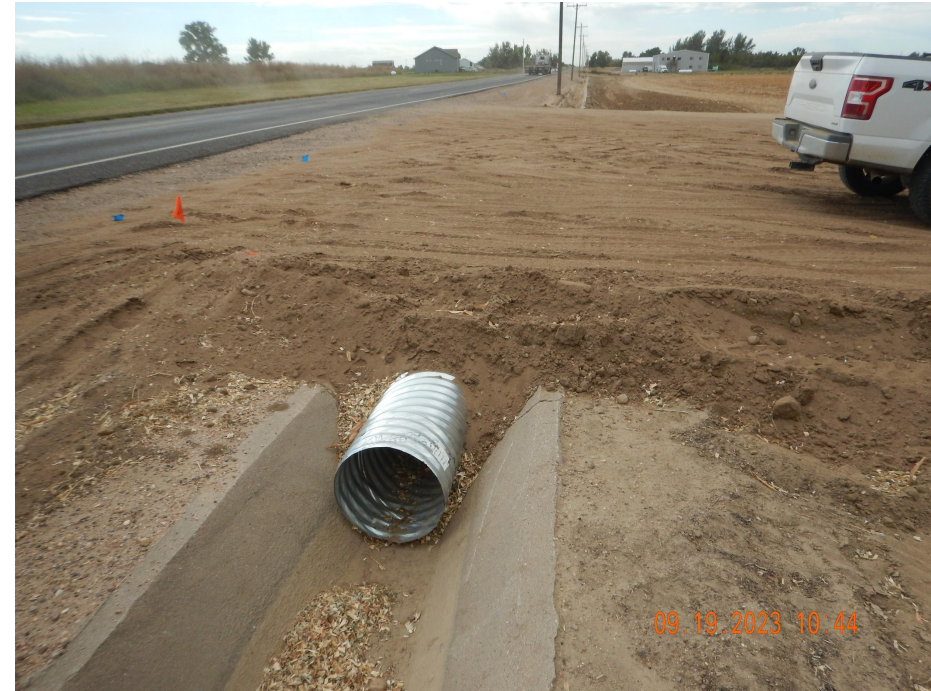
**Photo 2.** Photo taken from the location entrance, facing South. Photo illustrates culvert has been installed and BMP installation is in-process. Operator plans to install inlet and outlet protection devices. Operator also plans to install recycled asphalt at the location entrance and to install additional VTC devices.

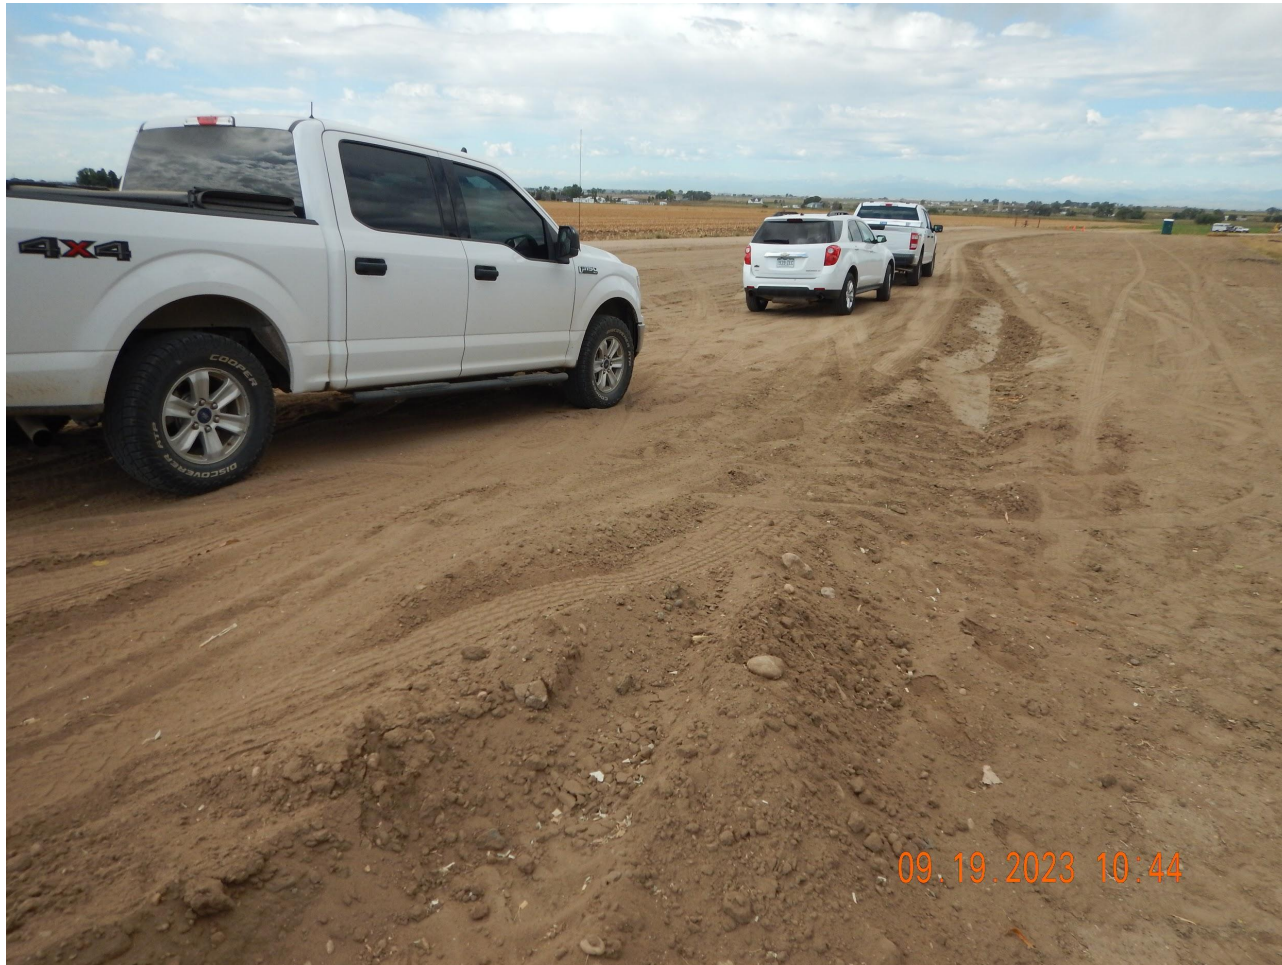
**Photo 3.** Photo taken from the location entrance off CR51, facing West. Photo illustrates the Operator is using a different access route than what was permitted. Refer to Photo 4.

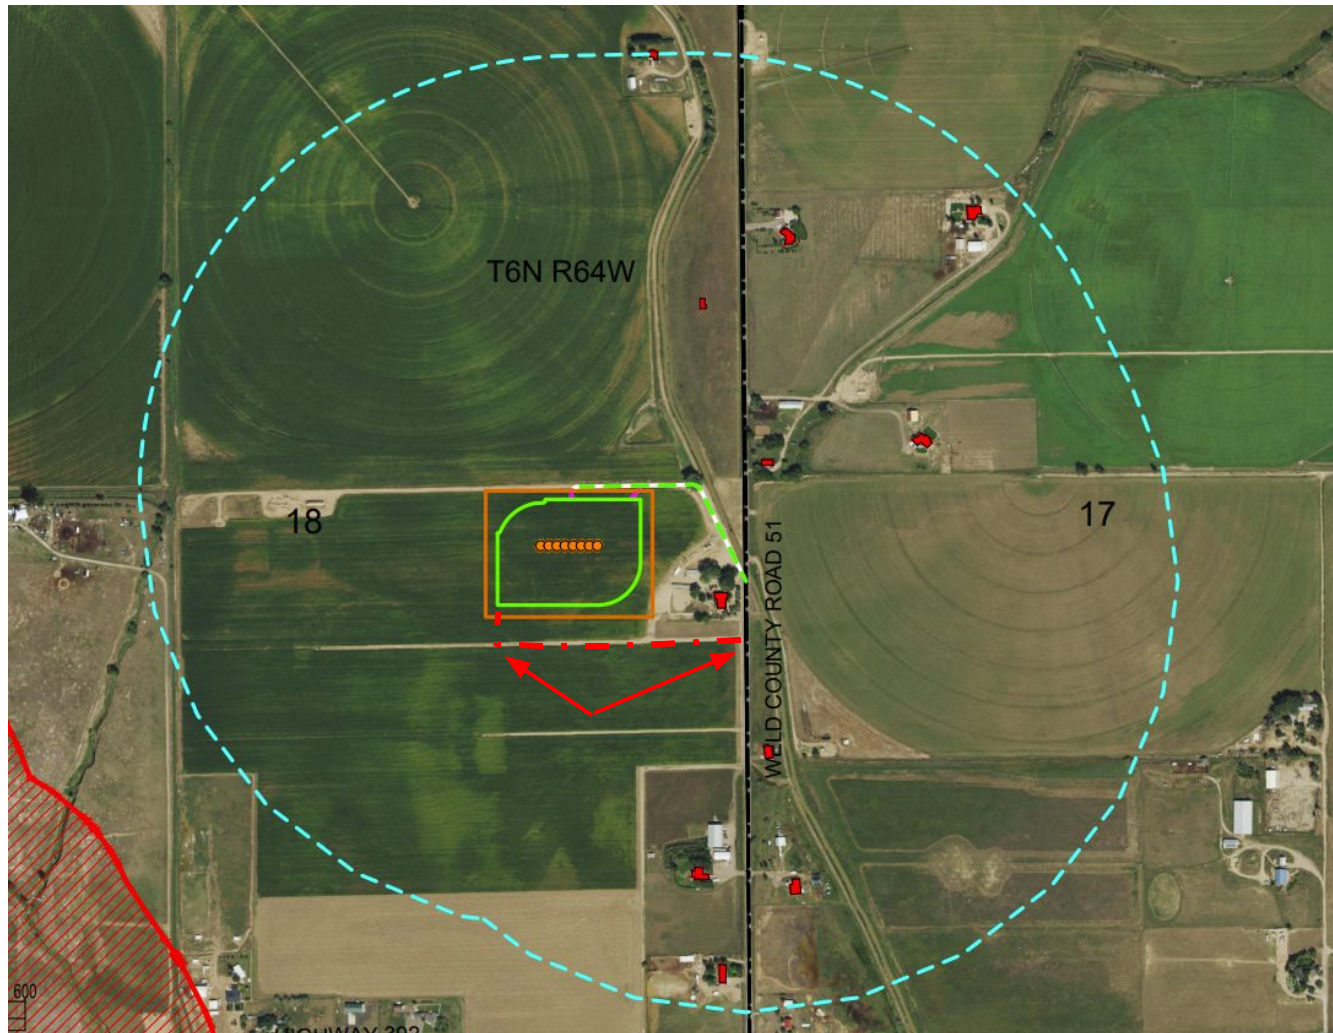
**Photo 4.** Photo taken of the permitted Access Road Map. Operator is no longer using the permitted access route and is using a southern access route (red dashed line and red arrows).

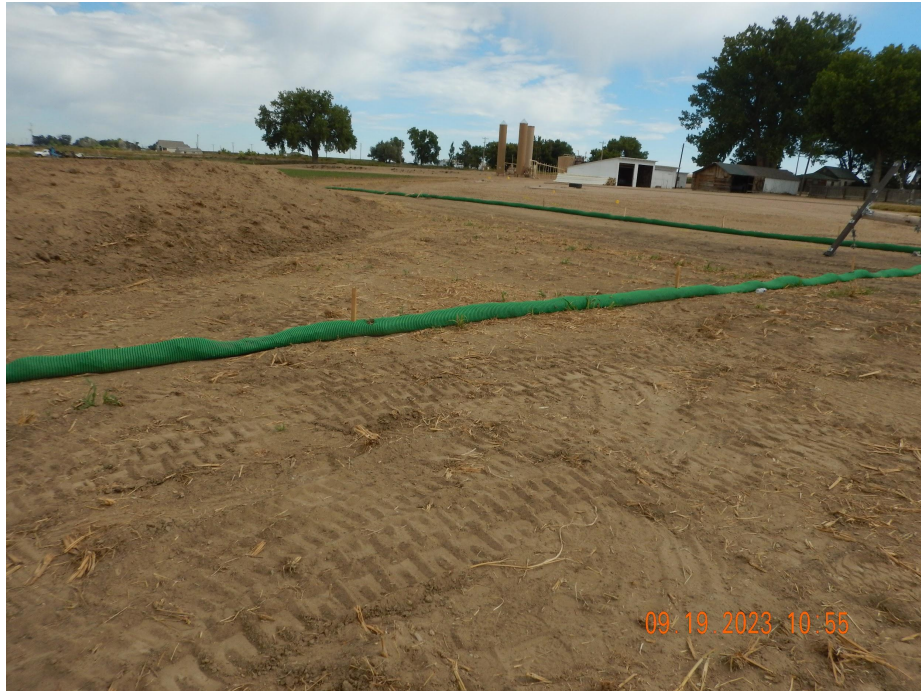
**Photo 5.** Photo taken from the southeastern perimeter of location, facing Northeast. Photo illustrates Operator has installed filterx wattles as an initial BMP around the perimeter of the location.

Note- vehicle traffic from contractors are driving the perimeter BMP. This was communicated to an Operator representative onsite.

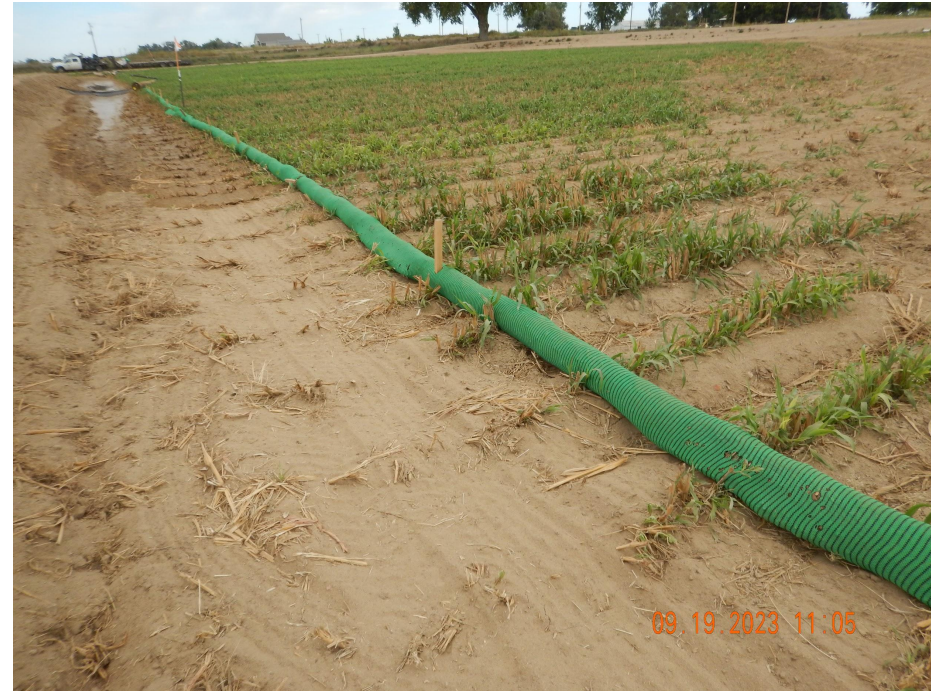
**Photo 6.** Photo taken from the eastern perimeter of location, facing Northeast. Photo illustrates Operator has improperly installed filterx wattles as an initial BMP intended for run-on protection.

Note- this was communicated to an Operator representative onsite who said these were planned to be reinstalled or an additional filterx wattle would be installed to the interior of the existing BMP.

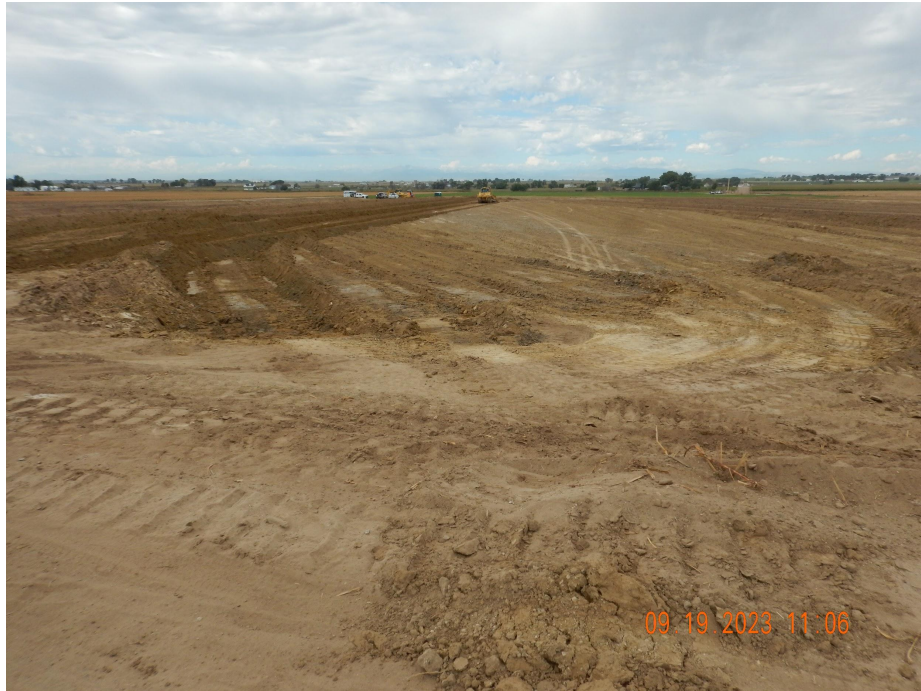
**Photo 7.** Photo taken from the eastern perimeter of location, facing West. Photo illustrates Operator is completing the cut/fill construction phase. Topsoil has been stockpiled along the southern, eastern and northern perimeter of the location.

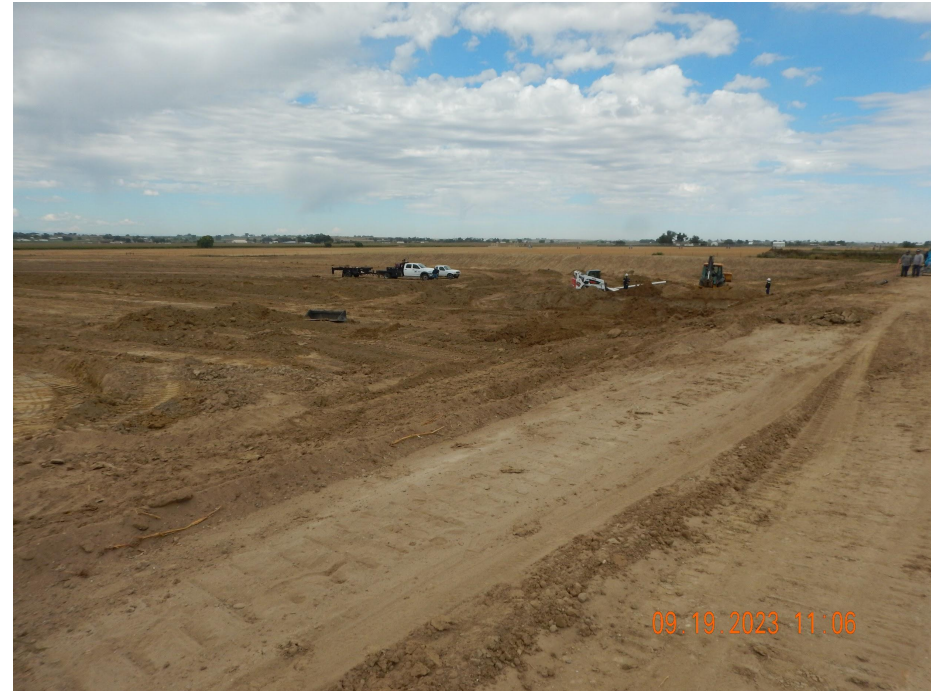
**Photo 8.** Photo taken from the eastern perimeter of location, facing Northwest. Photo illustrates Operator is repairing a clay line that was hit during construction.

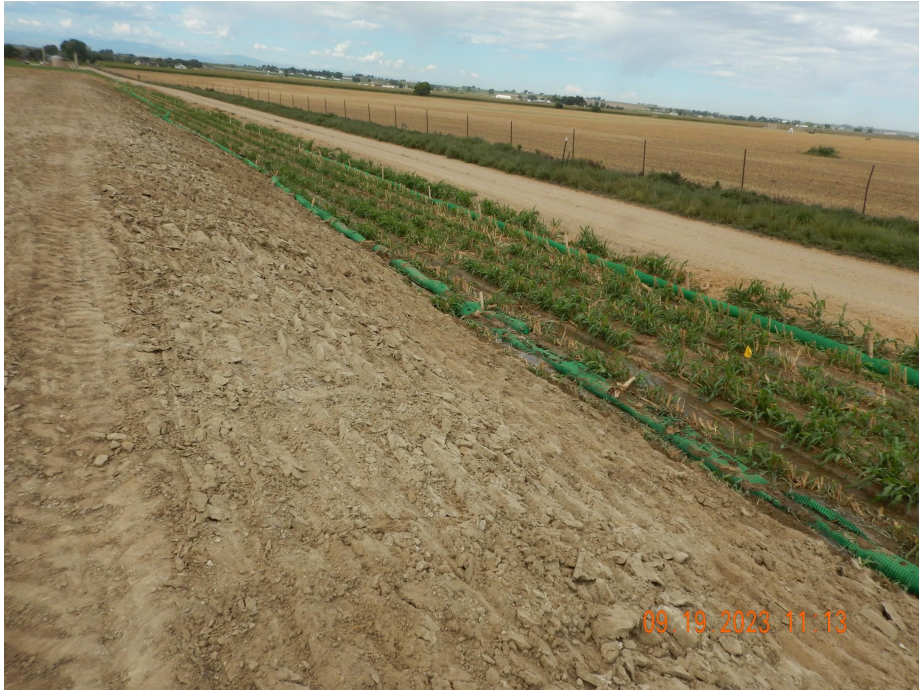
**Photo 9.** Photo taken from the northern perimeter of location, facing West. Photo illustrates a topsoil stockpile.

Note- the perimeter BMP along the toe of the stockpile was damaged but an additional perimeter BMP was installed to the outside.

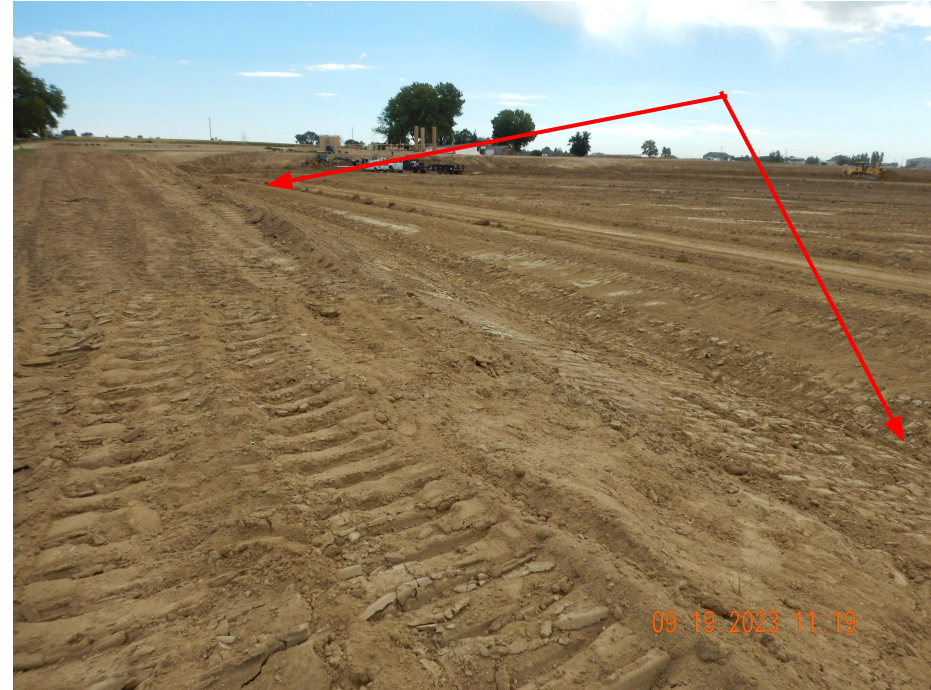
**Photo 10.** Photo taken from the northern perimeter of location, facing East. Photo illustrates a diversion ditch BMP installed along the perimeter of the working pad surface which is directed to detention pond.

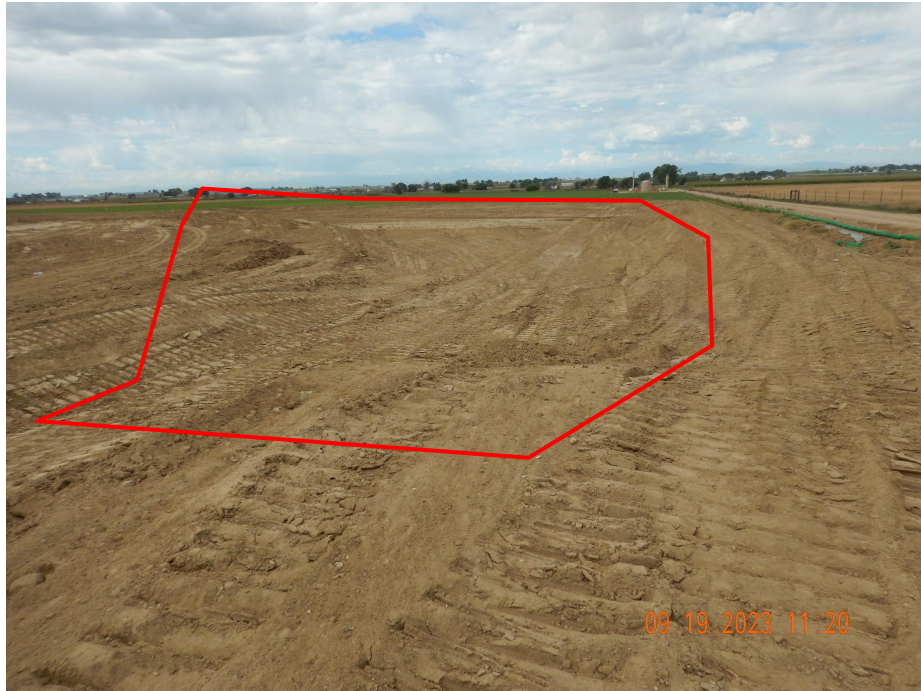
**Photo 11.** Photo taken from the northern perimeter of location, facing West. Photo illustrates the detention pond.

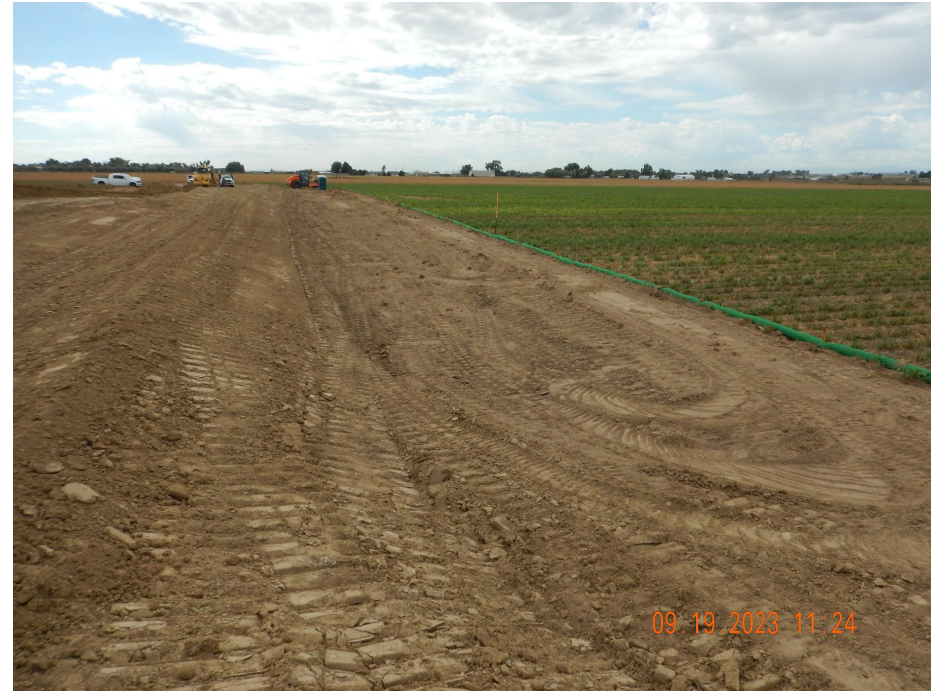
**Photo 12.** Photo taken from the western perimeter of location, facing South. Photo illustrates BMP areas which are still in process of construction.
