Storm Water Management and Erosion control

Location Name: TEP ROCKY MOUNTAIN LLC SAVAGE RMV 121-27 Pad

Location ID: 324140

Section/Township/Range: 27 6S94W

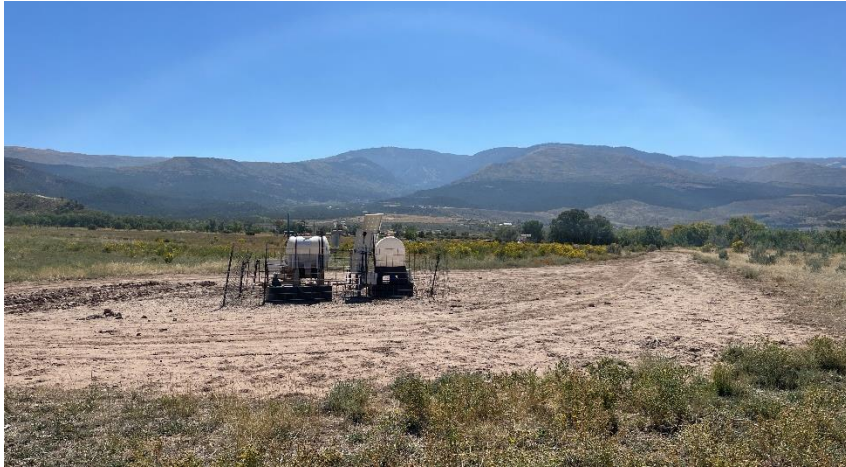
North West corner of location.

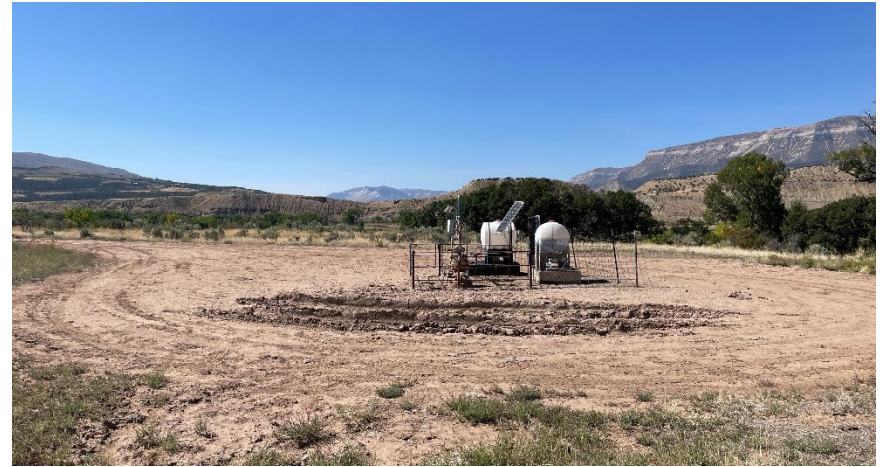
North East corner of location.

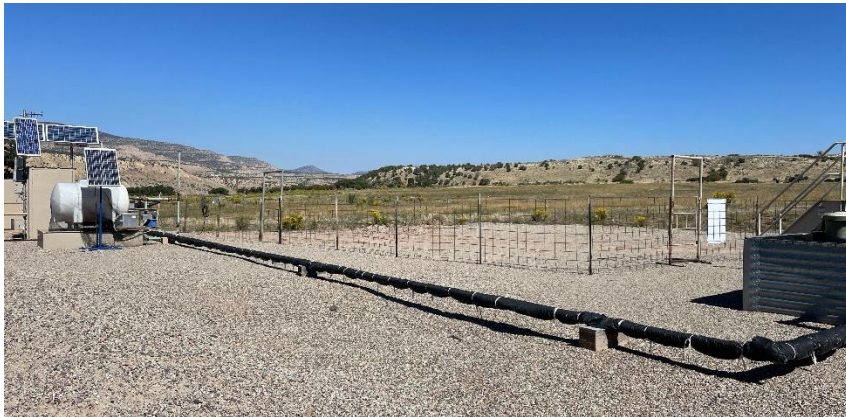
South West corner of location.

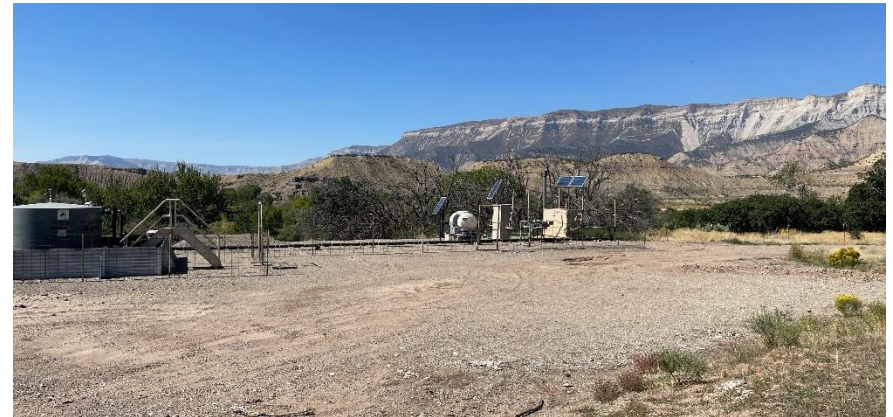
South East corner of location.

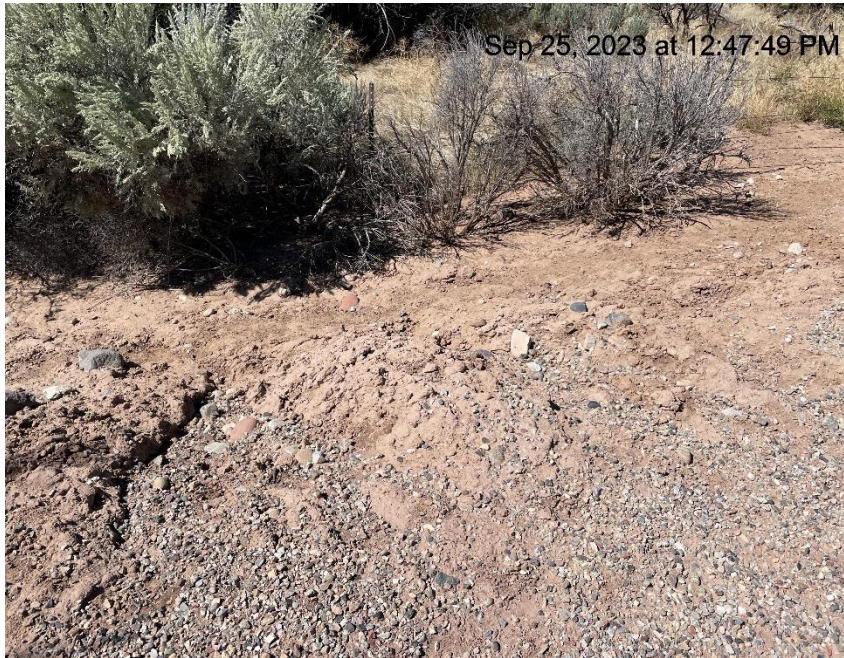
Photo # 768 Erosion on slope & transport of sediment off location/insufficient BMP's (S/SE area of location)

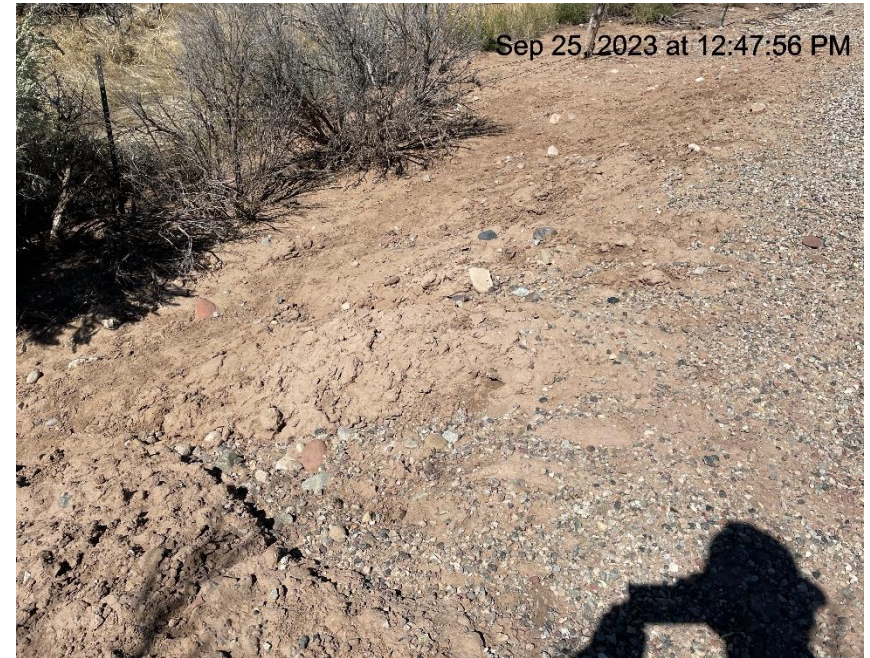
Photo # 769 Erosion on slope & transport of sediment off location/insufficient BMP's (S/SE area of location)

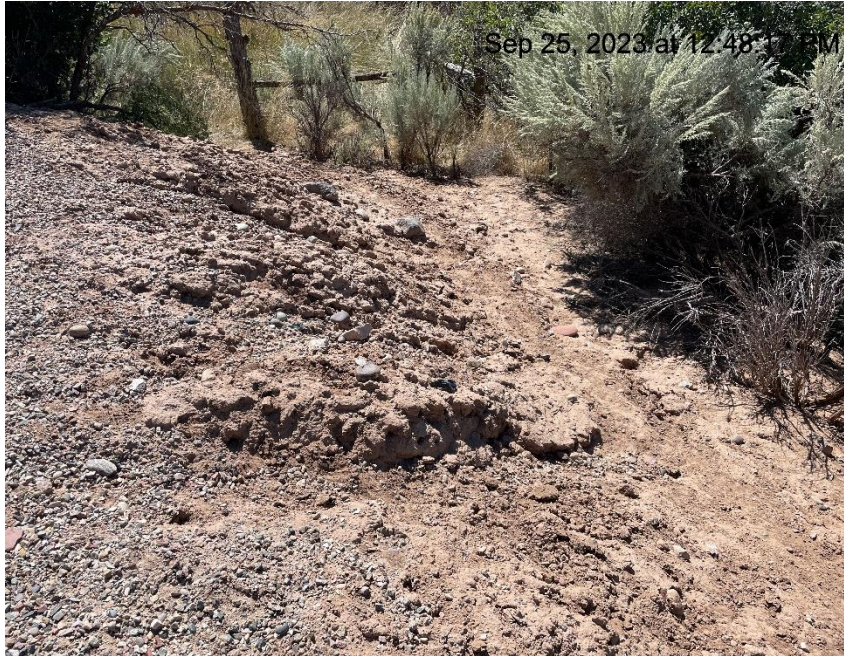
Photo # 770 Erosion on slope & transport of sediment off location/insufficient BMP's (S/SE area of location)

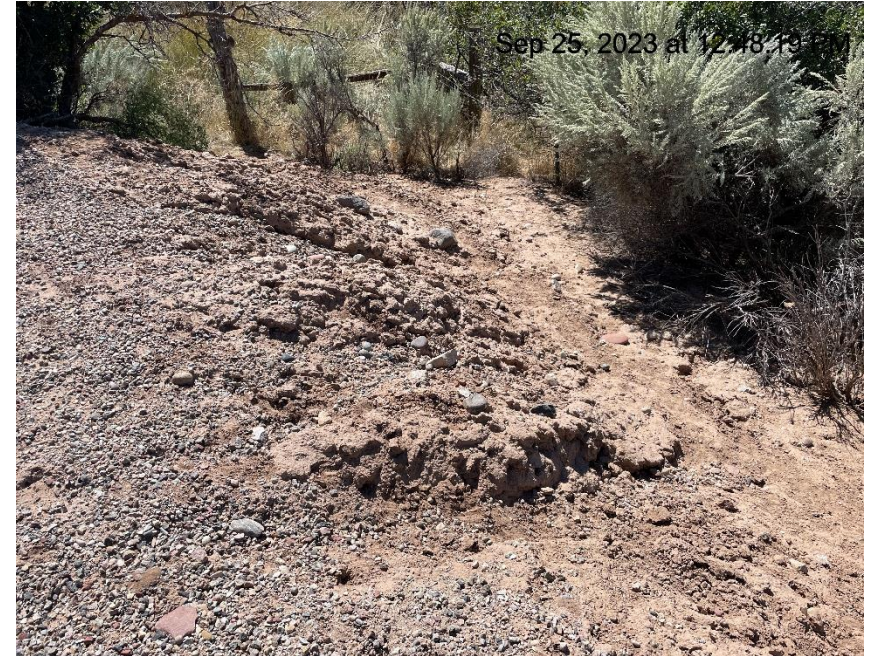
Photo # 771 Erosion on slope & transport of sediment off location/insufficient BMP's (S/SE area of location)

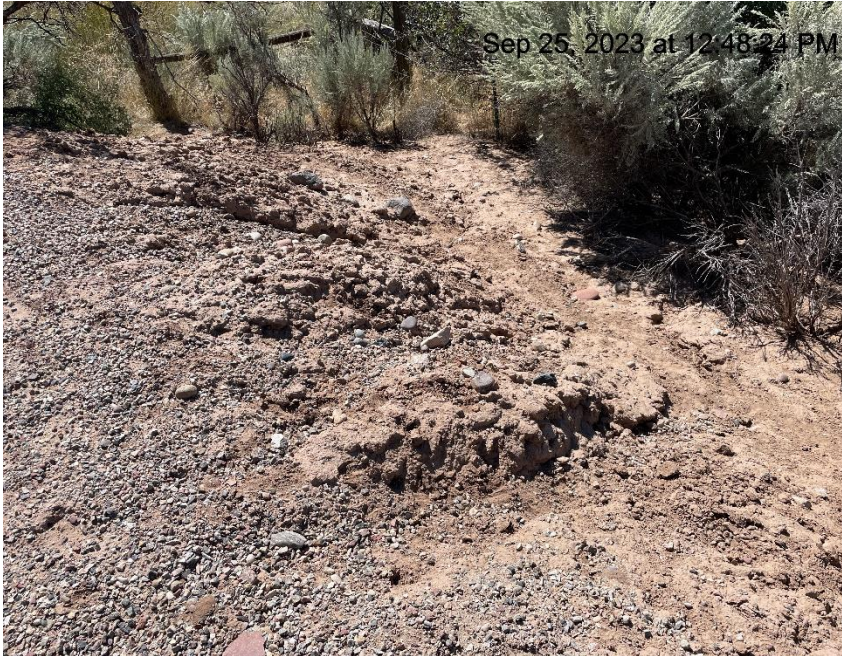
Photo # 772 Erosion on slope & transport of sediment off location/insufficient BMP's (S/SE area of location)

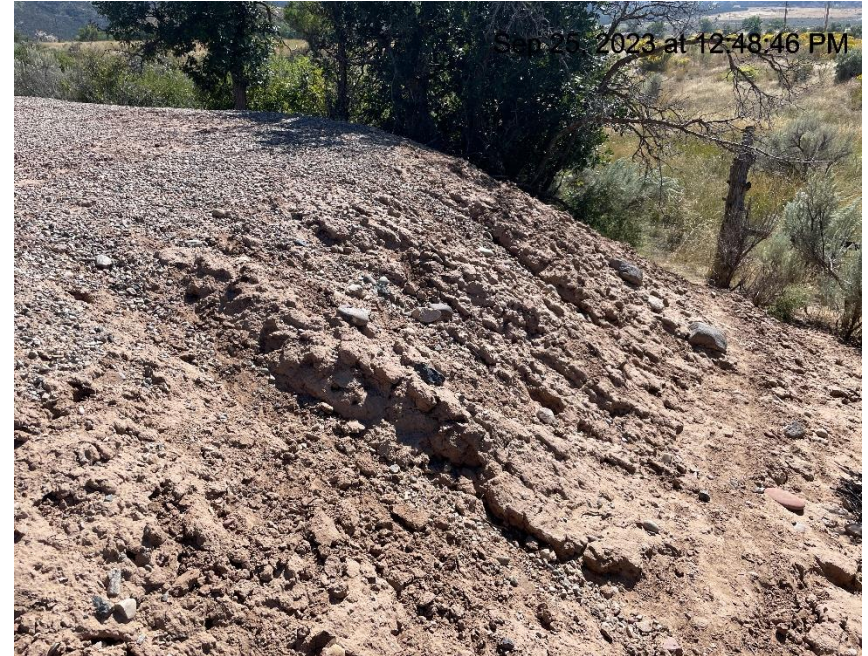
Photo # 773 Erosion on slope & transport of sediment off location/insufficient BMP's (S/SE area of location)

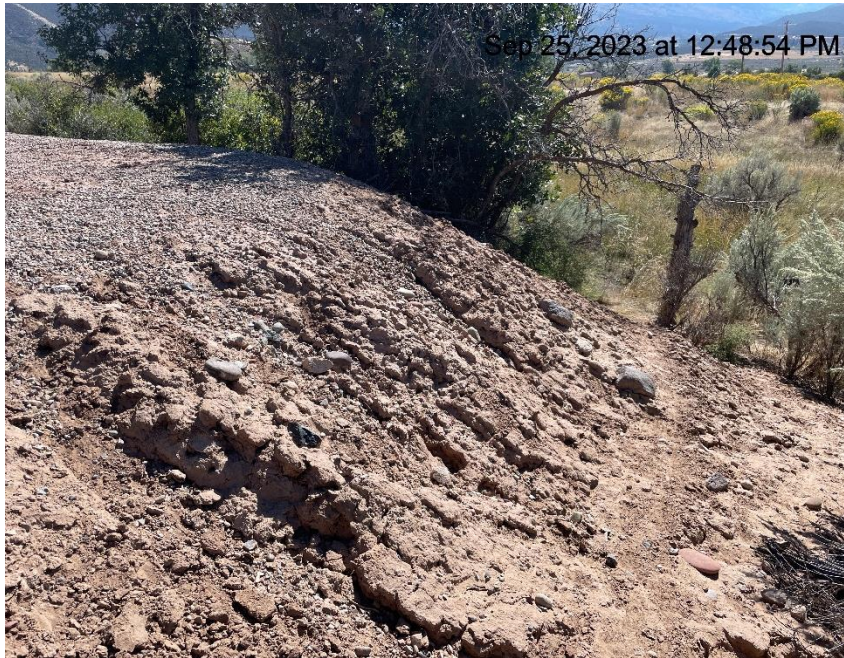
Photo # 774 Erosion on slope & transport of sediment off location/insufficient BMP's (S/SE area of location)

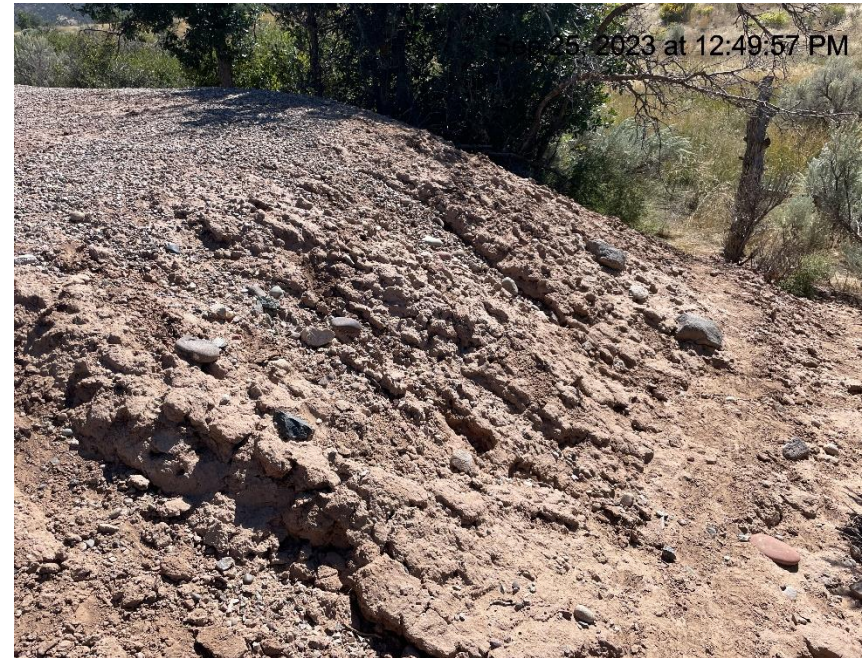
Photo # 775 Erosion on slope & transport of sediment off location/insufficient BMP's (S/SE area of location)

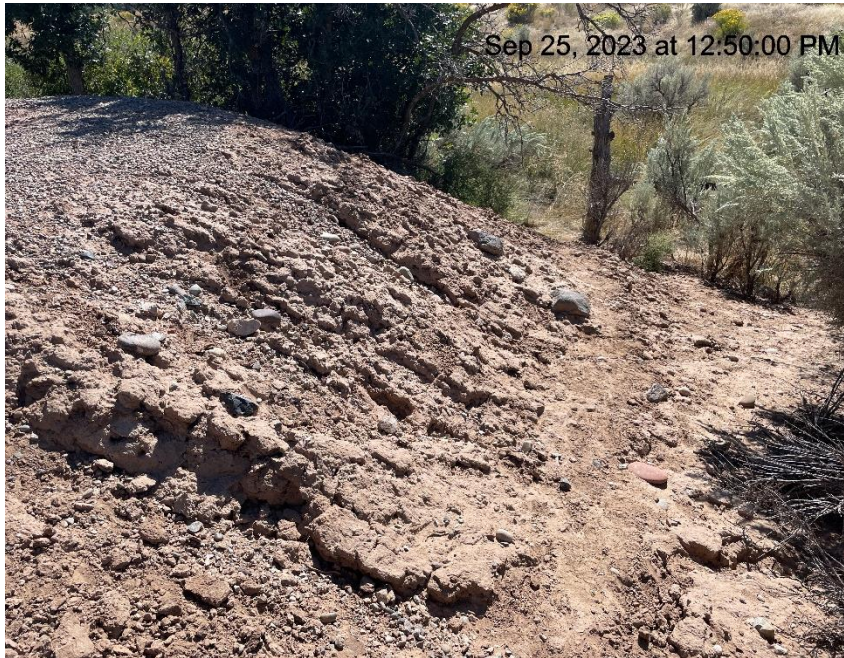
Photo # 776 Erosion on slope & transport of sediment off location/insufficient BMP's (S/SE area of location)

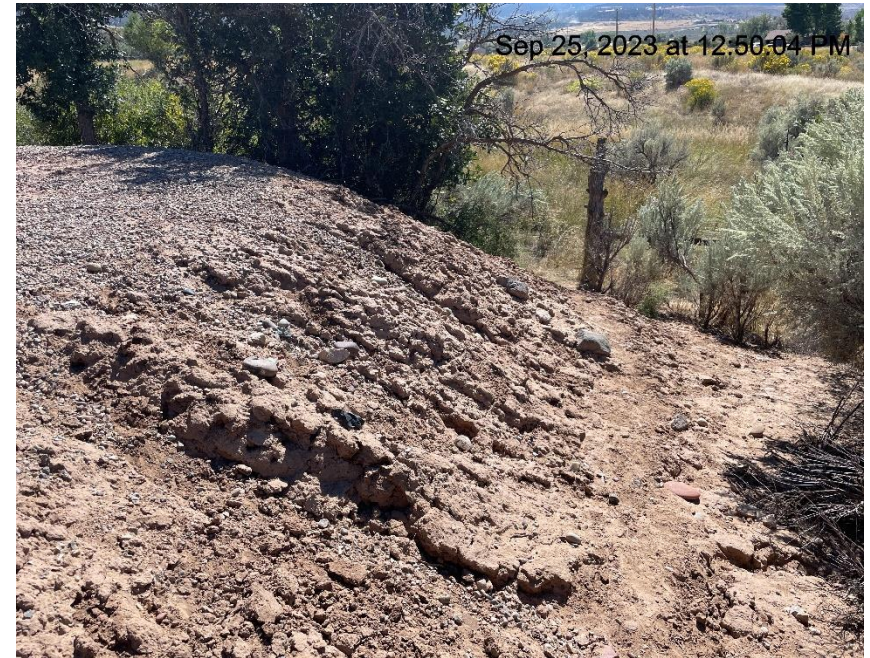
Photo # 777 Erosion on slope & transport of sediment off location/insufficient BMP's (S/SE area of location)

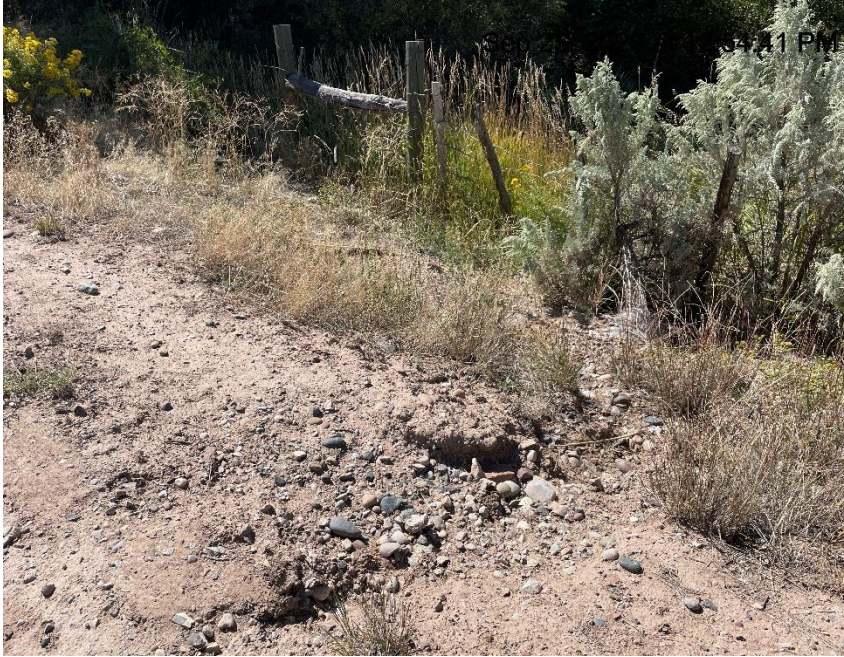
Photo # 778 Erosion & transport of sediment off lease road (on short portion of lease road between production equipment & wellheads, near culvert)

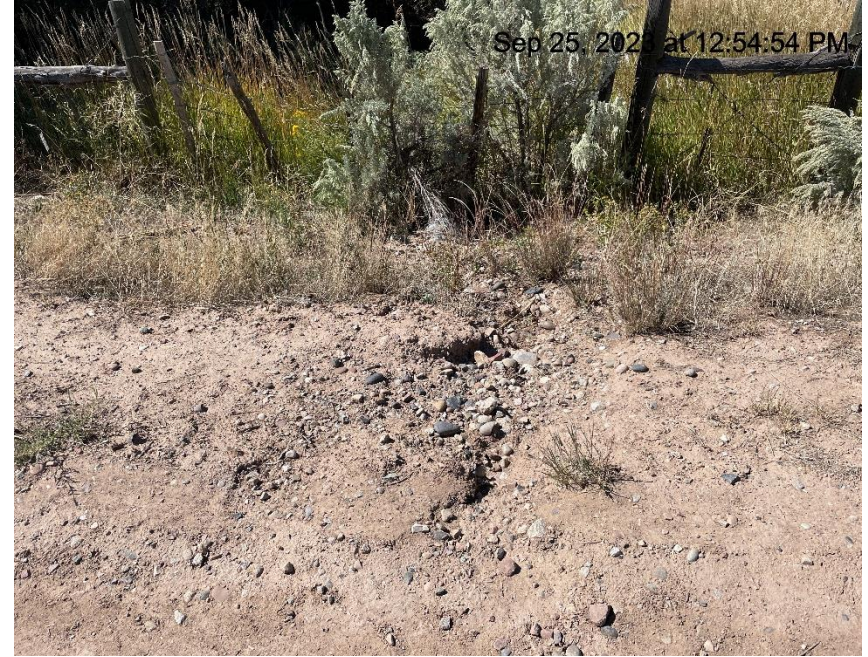
Photo # 779 Erosion & transport of sediment off lease road (on short portion of lease road between production equipment & wellheads, near culvert)

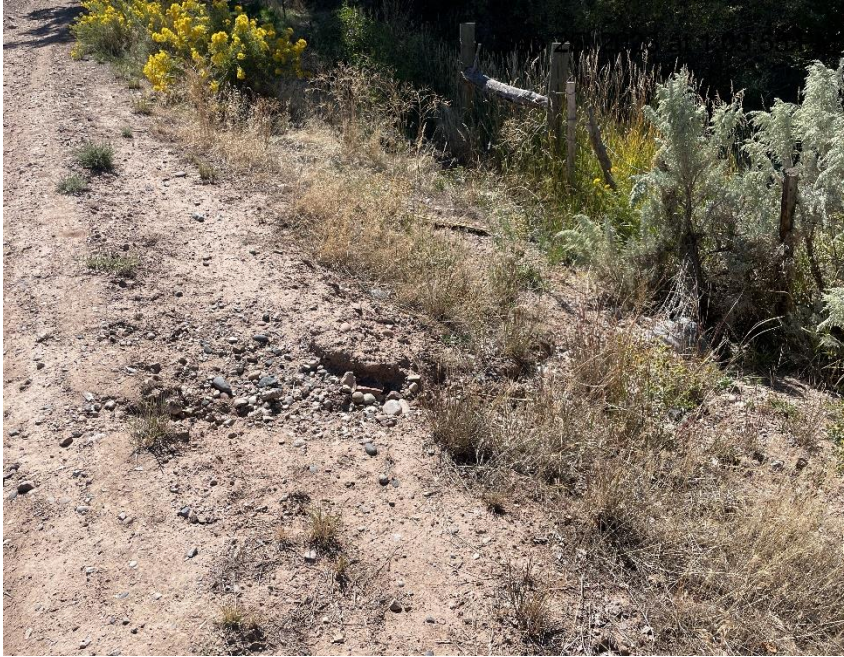
Photo # 780 Erosion & transport of sediment off lease road (on short portion of lease road between production equipment & wellheads, near culvert)

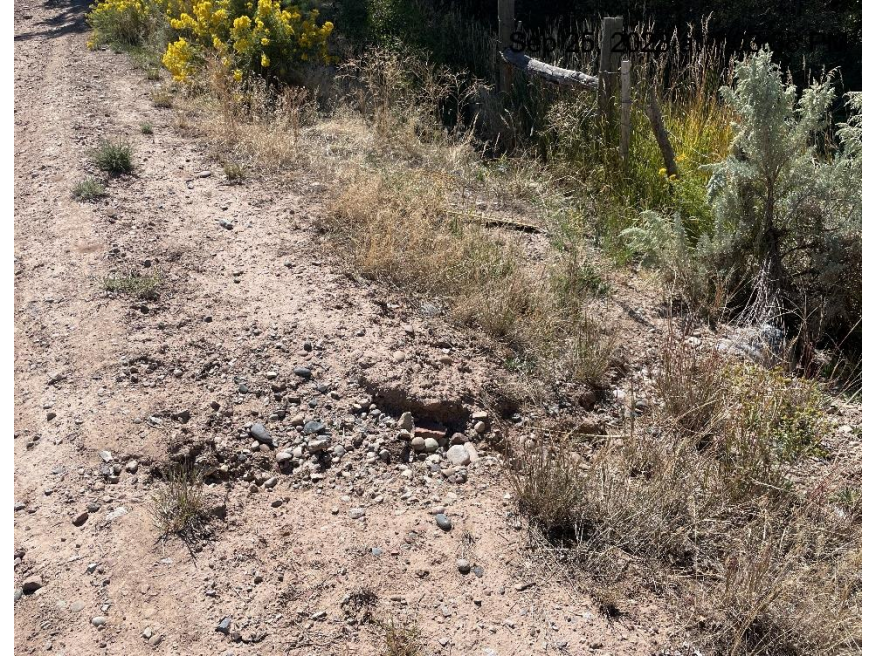
Photo # 781 Erosion & transport of sediment off lease road (on short portion of lease road between production equipment & wellheads, near culvert)

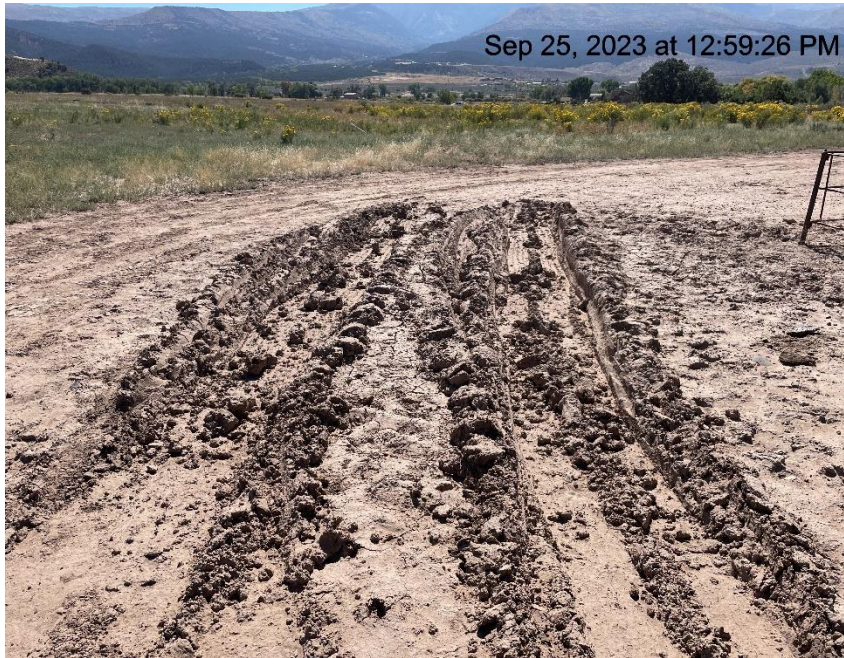
**Photo # 782 Lack of stabilization/compaction on location
/insufficient BMP's**

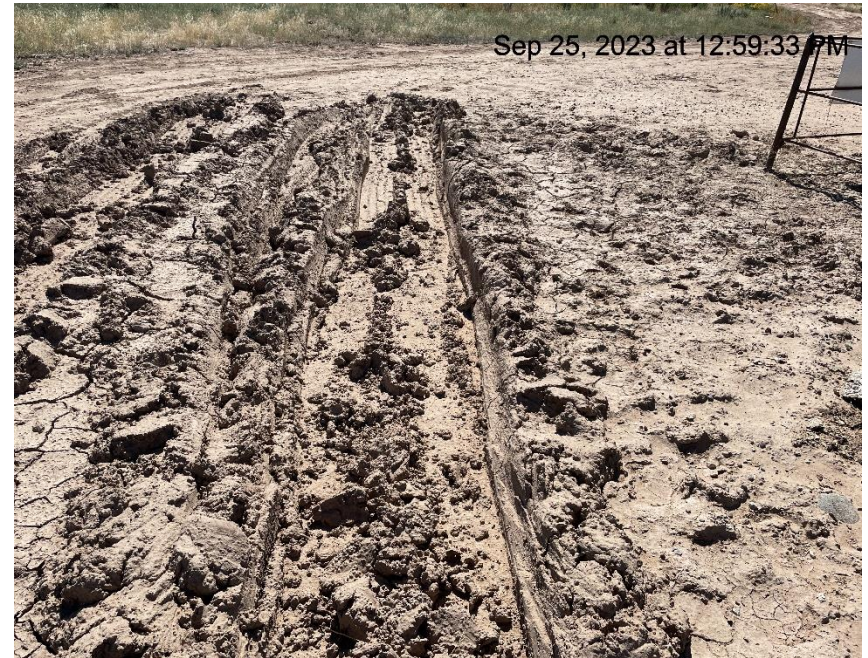
**Photo # 783 Lack of stabilization/compaction on location
/insufficient BMP's**

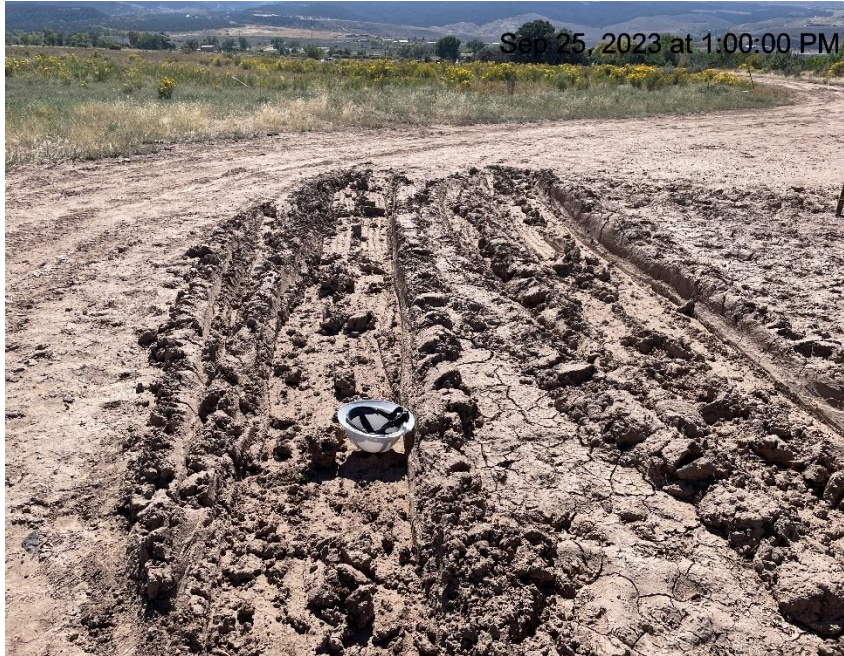
**Photo # 784 Lack of stabilization/compaction on location
/insufficient BMP's**

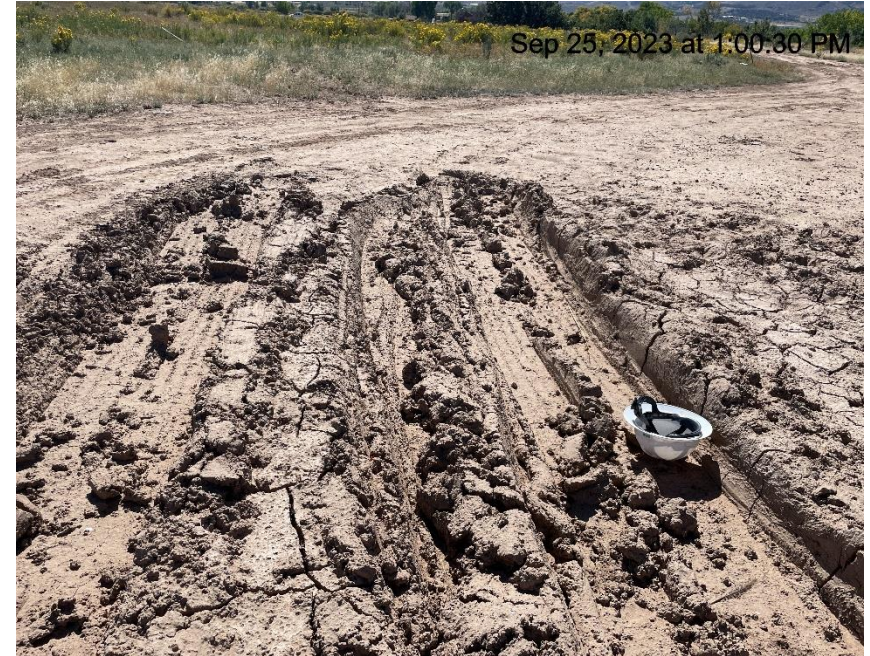
**Photo # 785 Lack of stabilization/compaction on location
/insufficient BMP's**

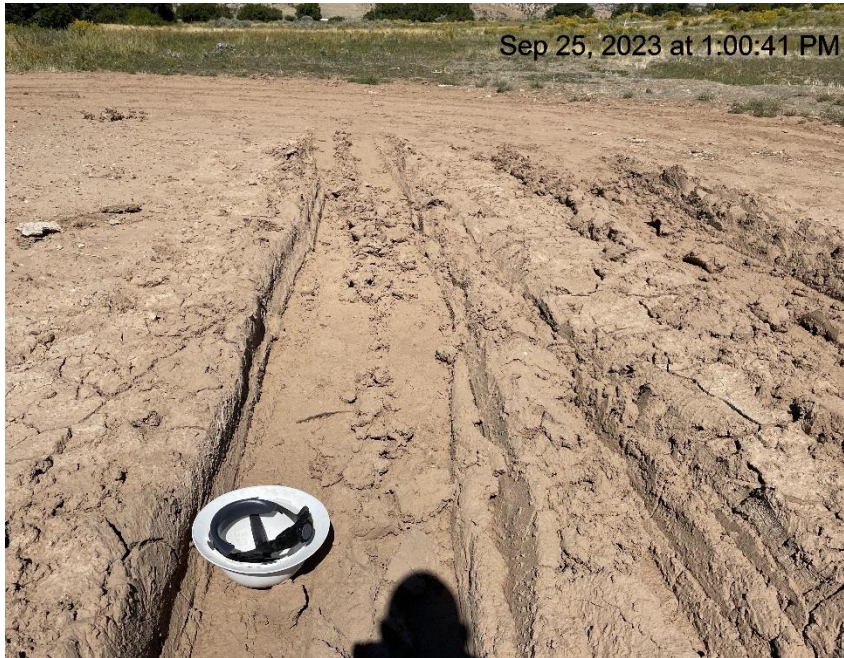
**Photo # 786 Lack of stabilization/compaction on location
/insufficient BMP's**

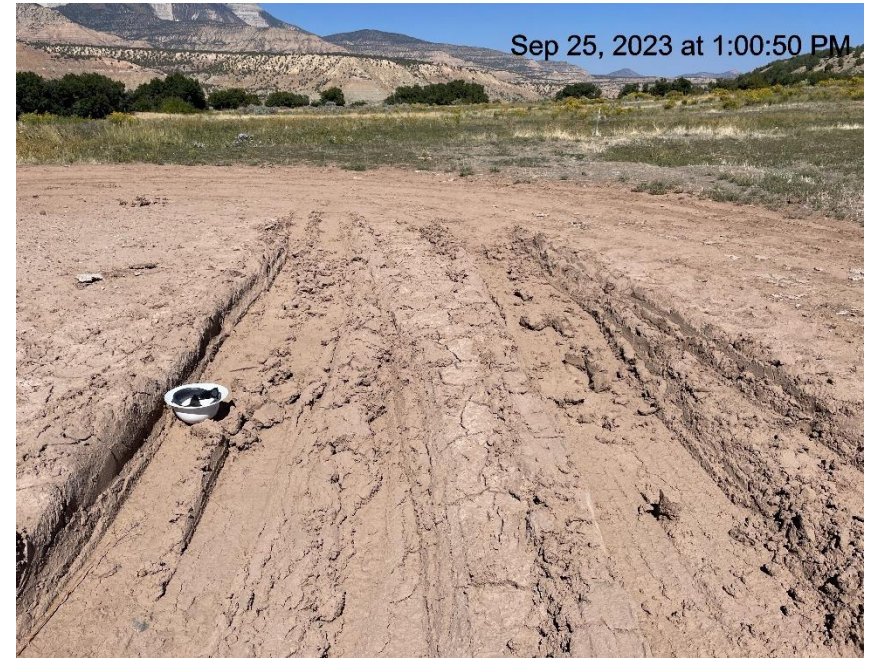
**Photo # 787 Lack of stabilization/compaction on location
/insufficient BMP's**

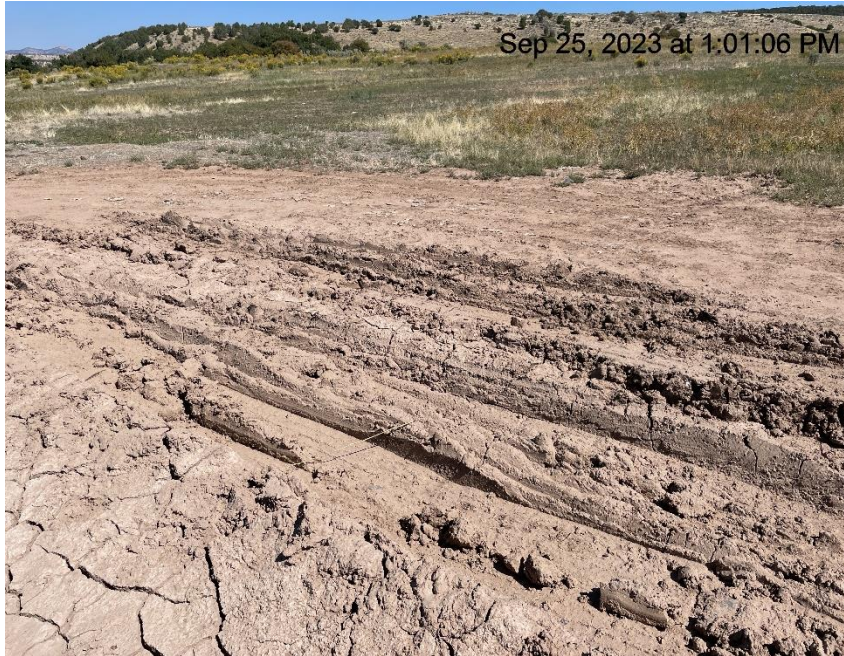
**Photo # 788 Lack of stabilization/compaction on location
/insufficient BMP's**

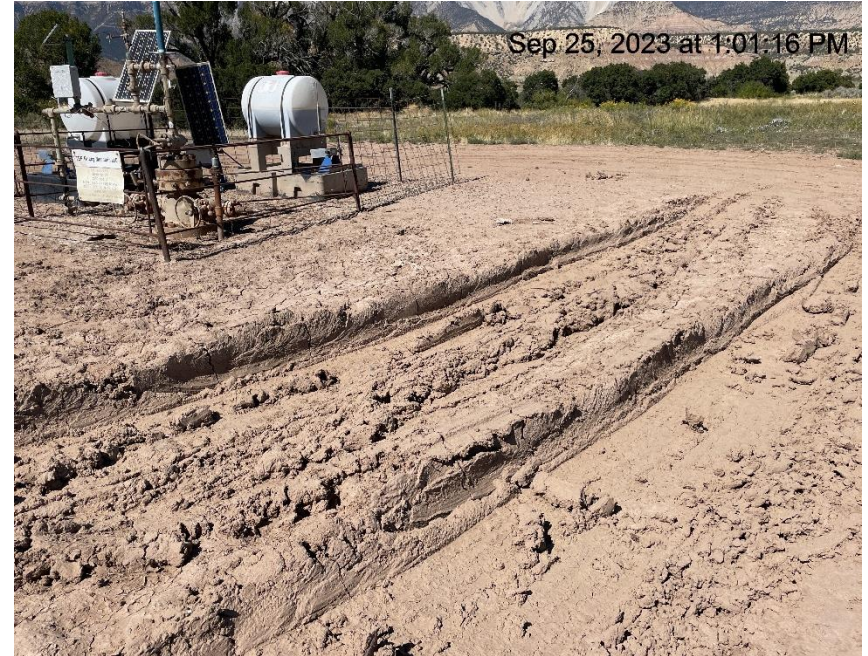
**Photo # 789 Lack of stabilization/compaction on location
/insufficient BMP's**

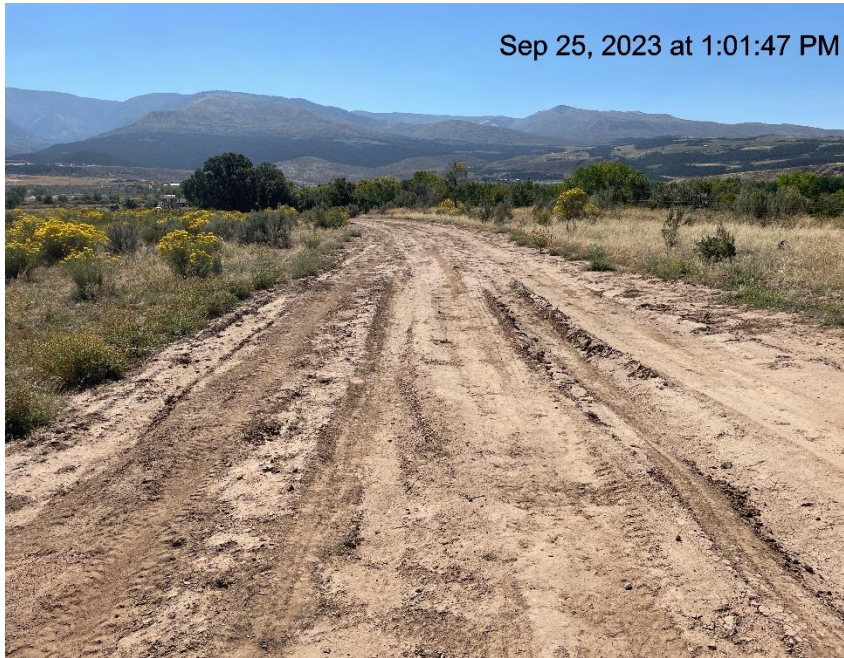
**Photo # 790 Lack of stabilization/compaction on lease road
/insufficient BMP's**

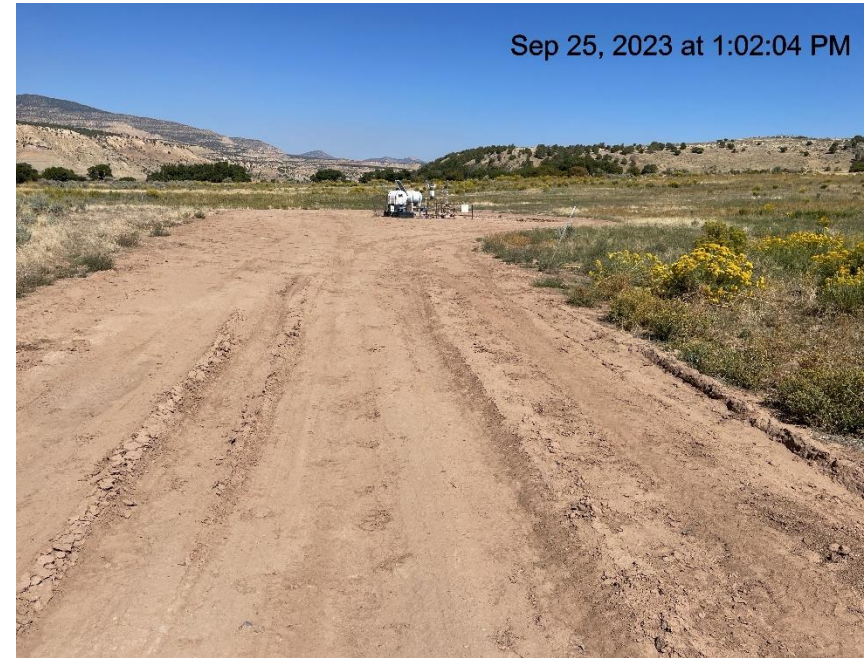
**Photo # 791 Lack of stabilization/compaction on lease road
/insufficient BMP's**

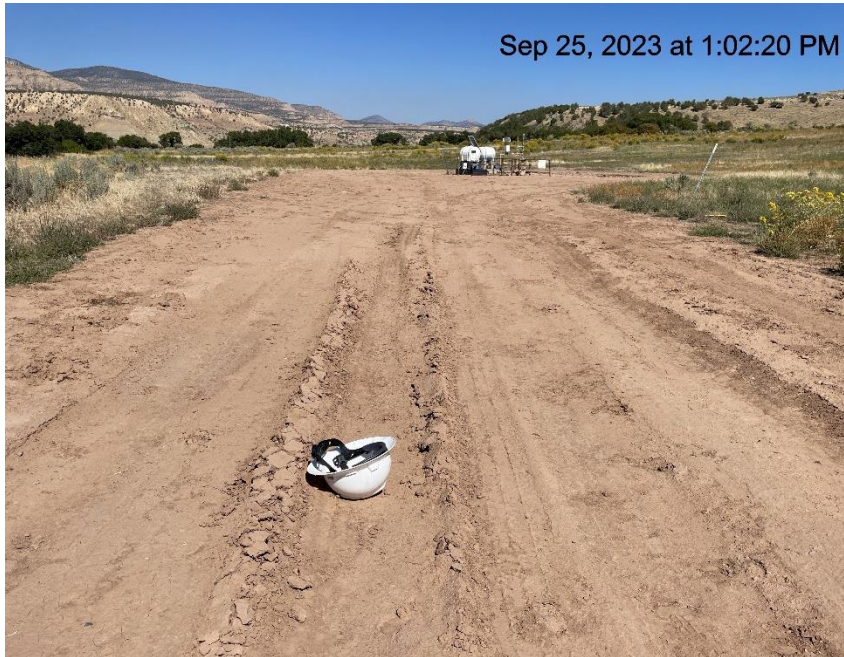
**Photo # 792 Lack of stabilization/compaction on lease road
/insufficient BMP's**

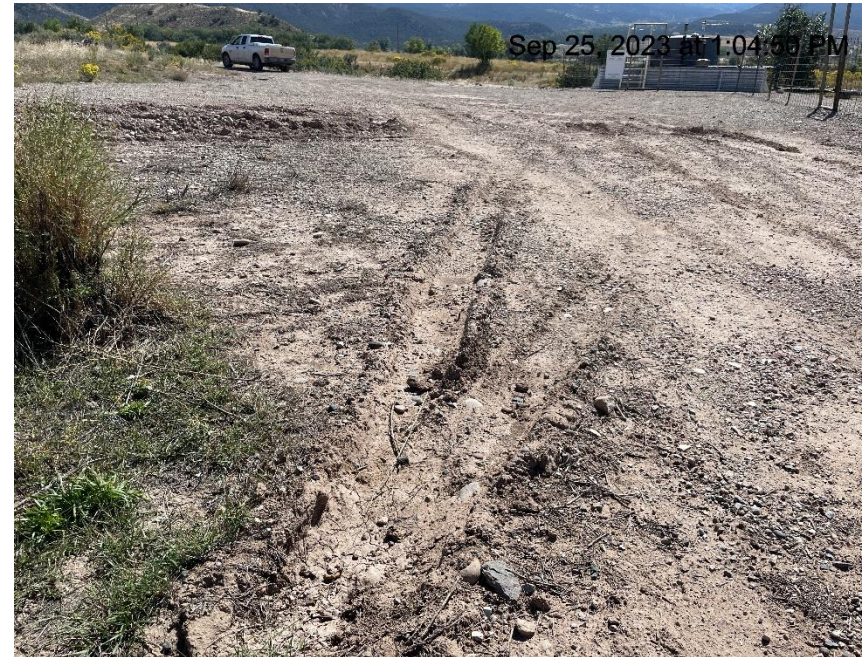
**Photo # 793 Lack of stabilization/compaction on location
/insufficient BMP's**

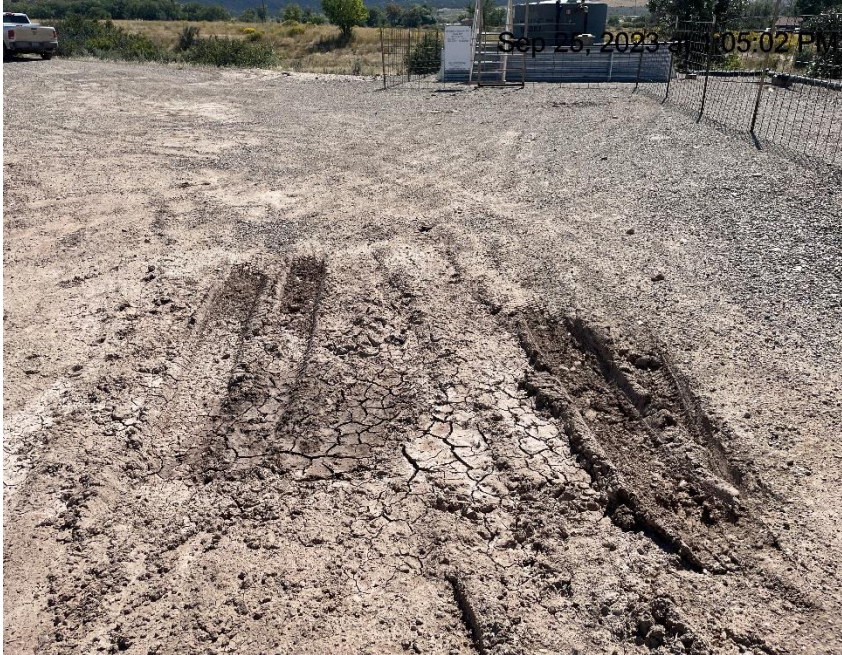
**Photo # 794 Lack of stabilization/compaction on location
/insufficient BMP's**

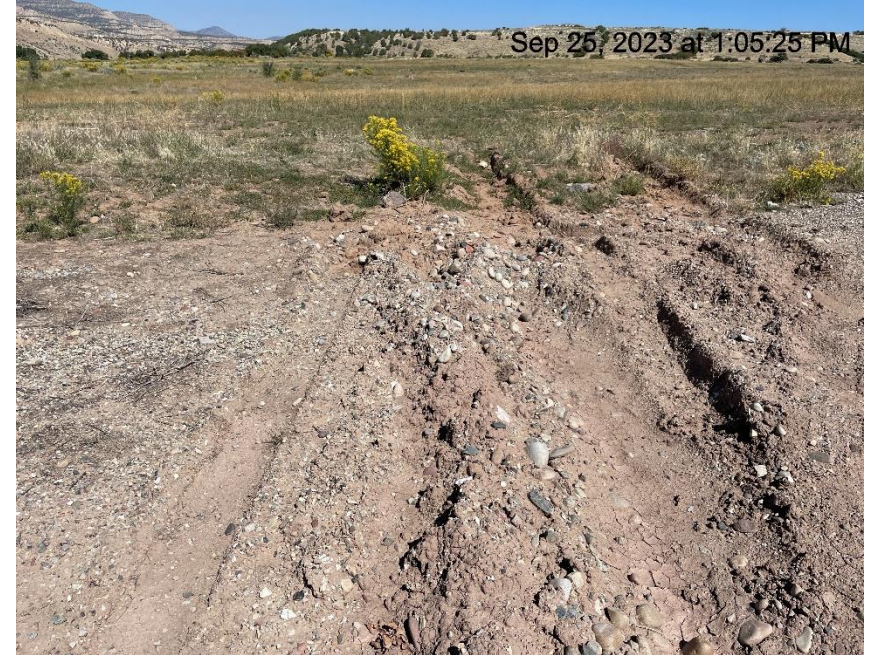
**Photo # 795 Lack of stabilization/compaction on location
/insufficient BMP's**

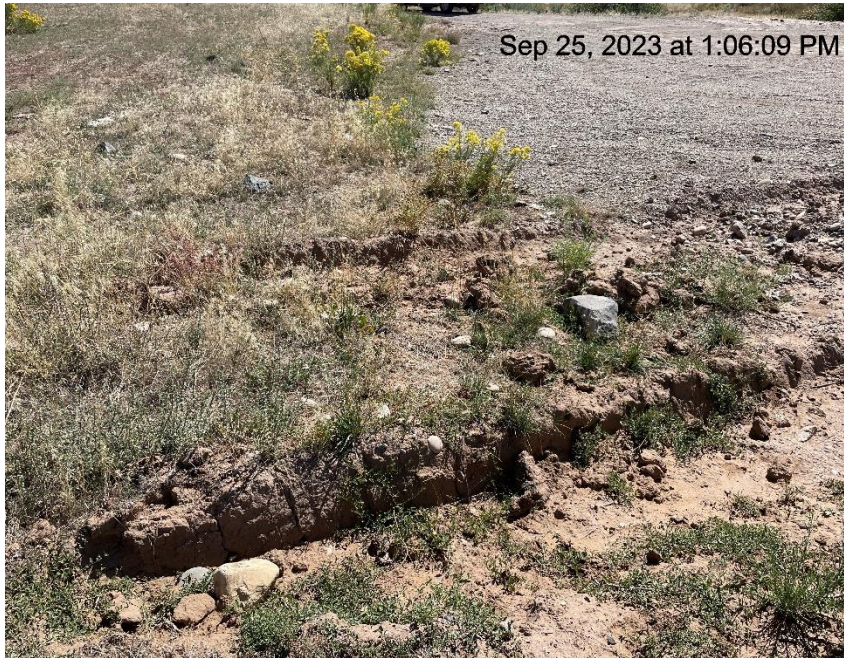
Photo # 796 Vehicle tracks traveling off the working pad area into the interim area

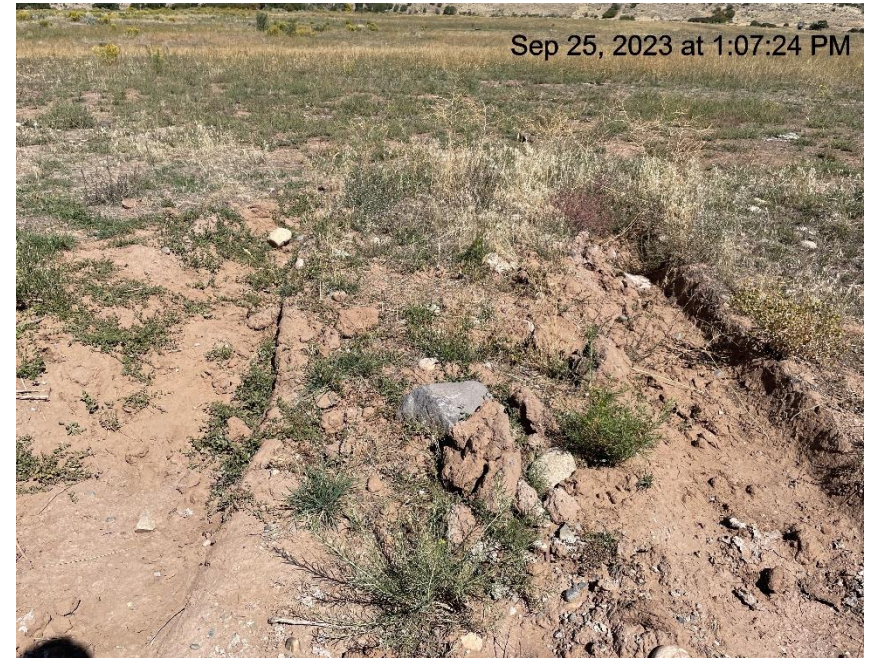
Photo # 797 Vehicle tracks traveling off the working pad area into the interim area

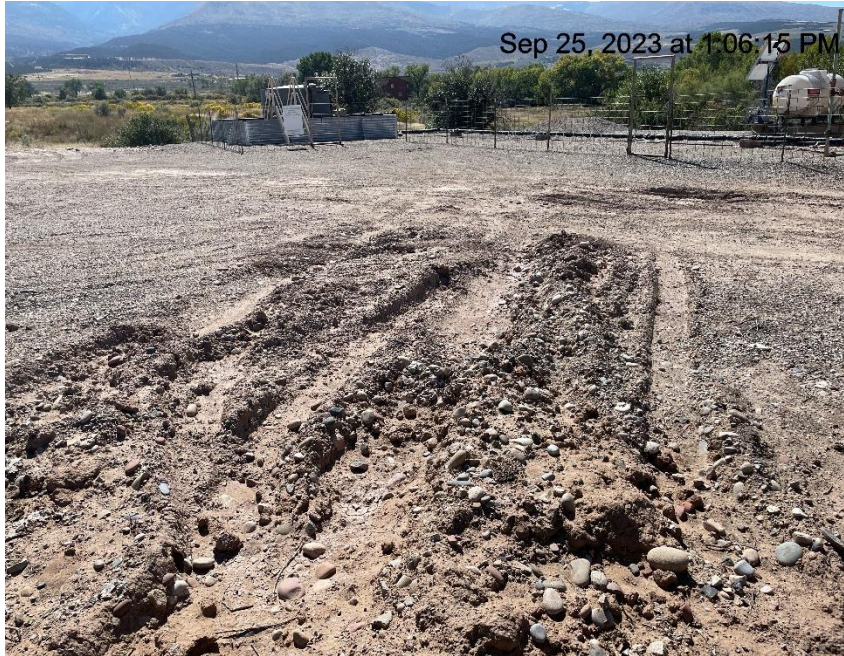
**Photo # 798 Lack of stabilization/compaction on location
/insufficient BMP's**

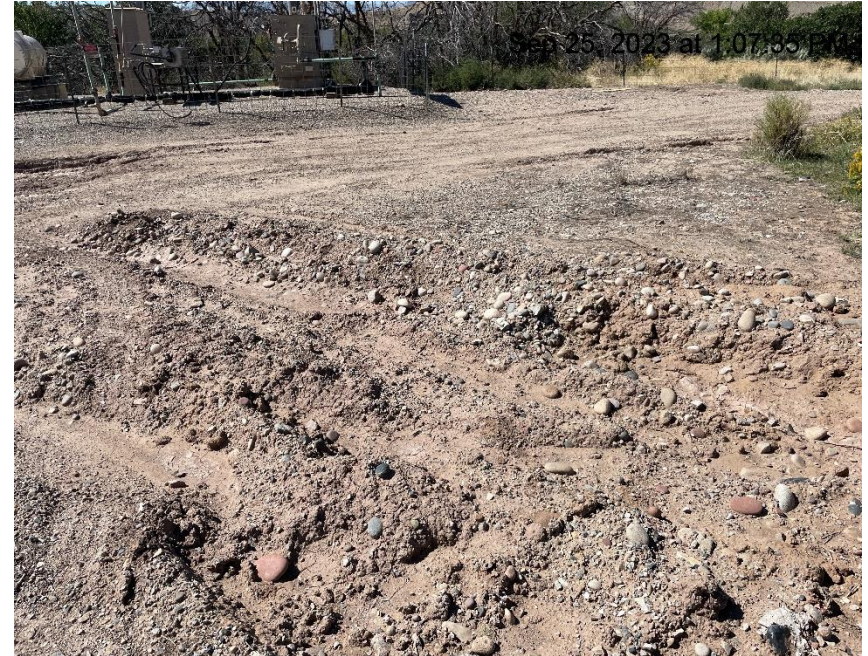
**Photo # 799 Lack of stabilization/compaction on location
/insufficient BMP's**

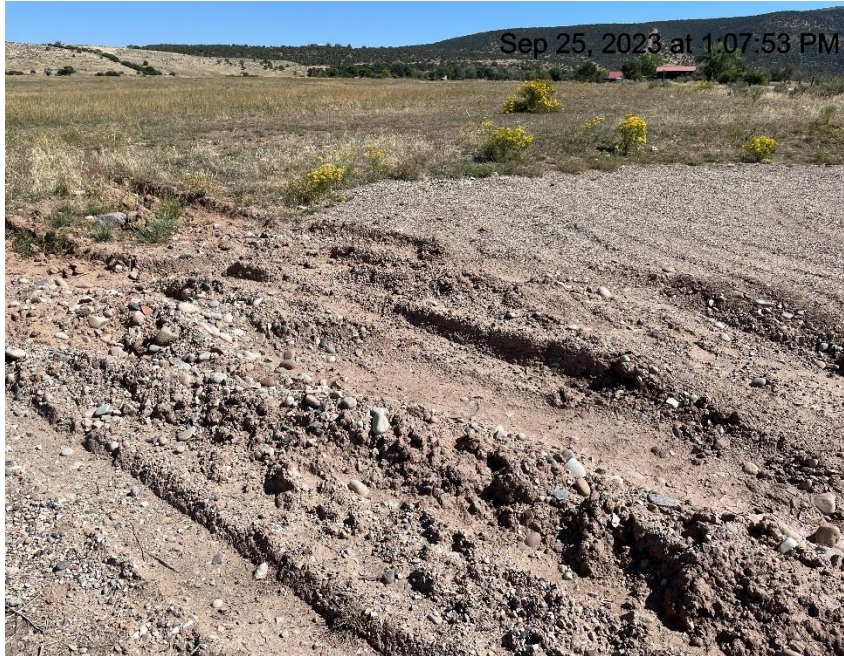
**Photo # 800 Lack of stabilization/compaction on location
/insufficient BMP's**

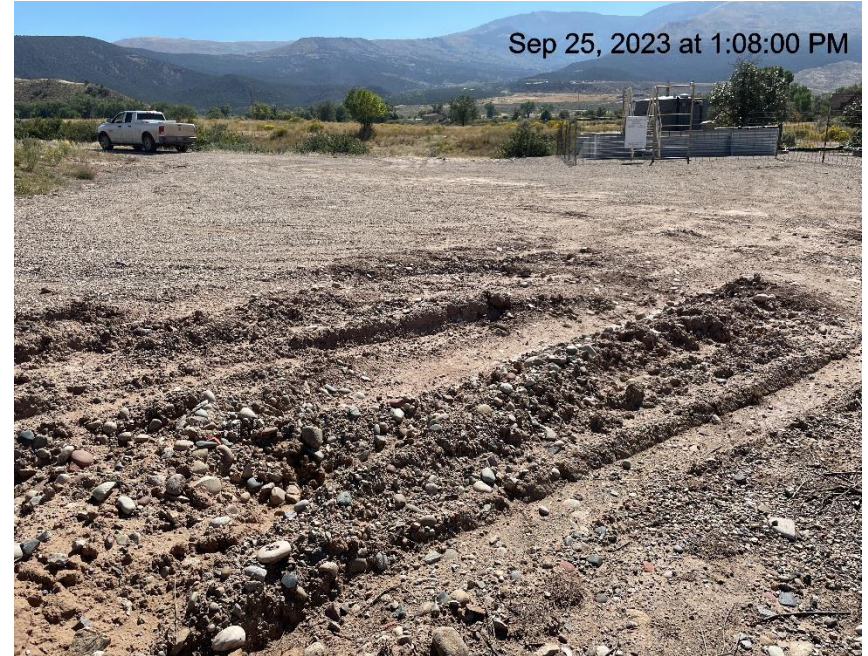
**Photo # 801 Lack of stabilization/compaction on location
/insufficient BMP's**
