## Inspection Photos

Location Name: CAERUS PICEANCE LLC FEDERAL 11-15A (RJ11) Pad

Location #: 324423

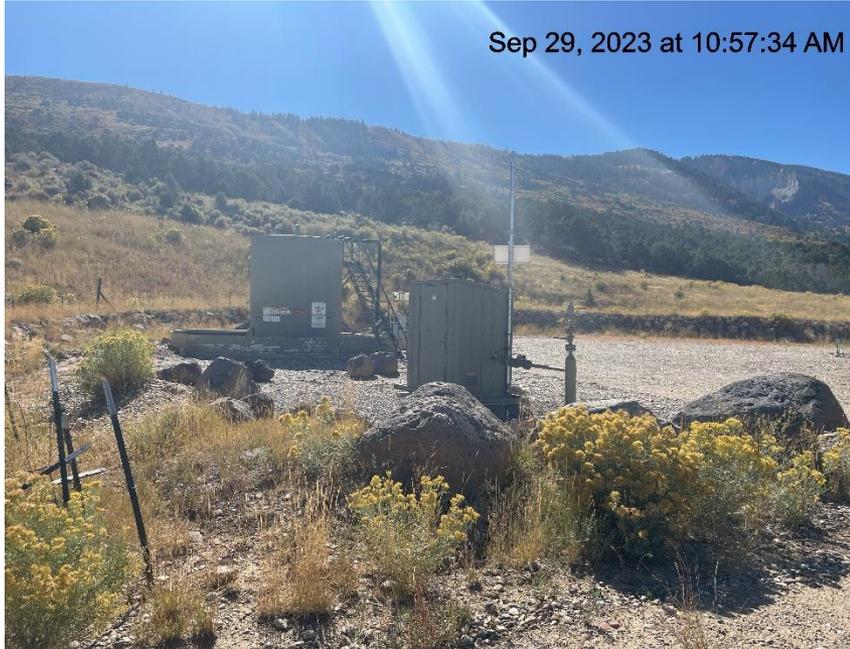
**Photo # 1031 From entrance to location**

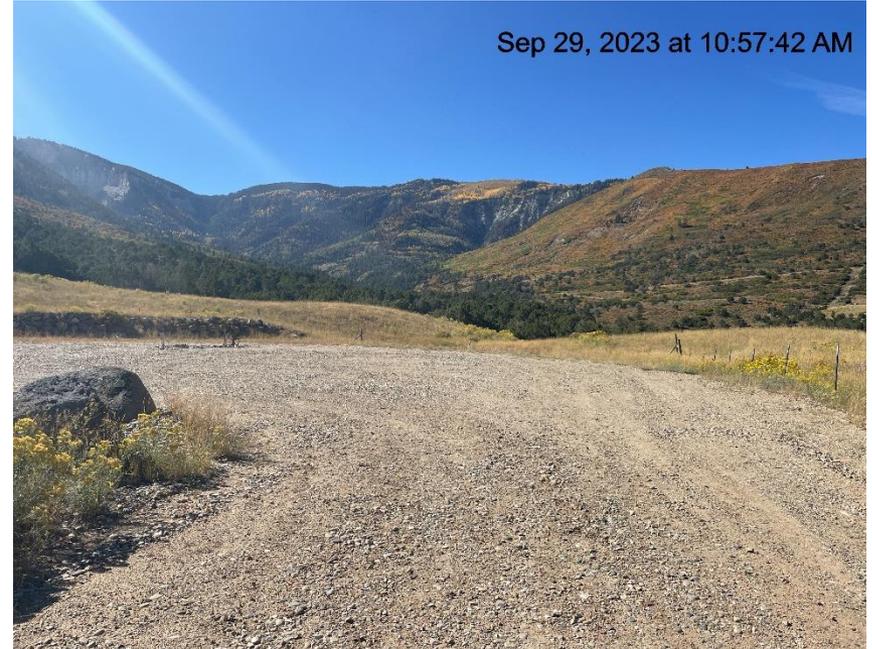
**Photo # 1032 From entrance to location**

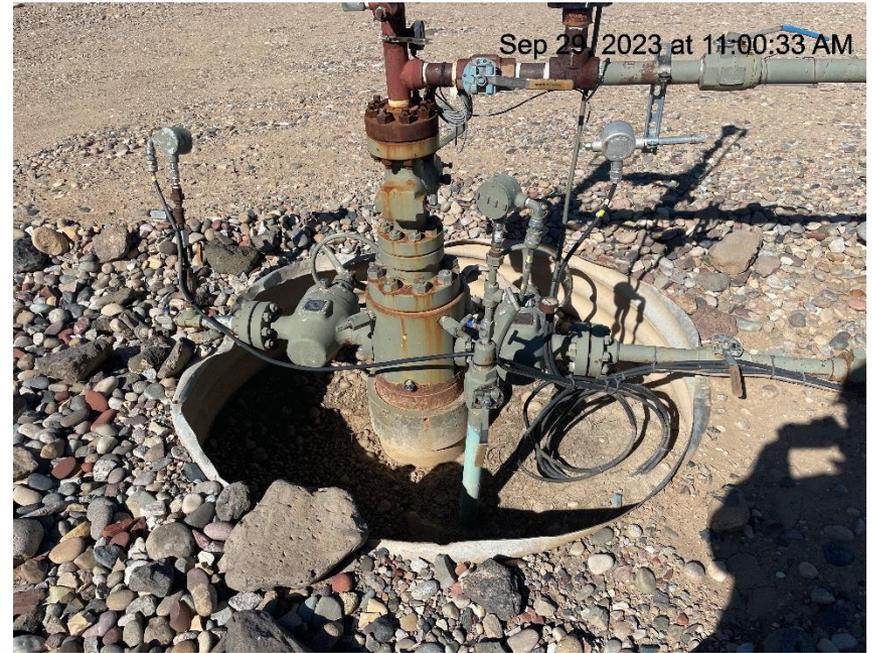
Photo # 1038 Cellar lacks wildlife egress

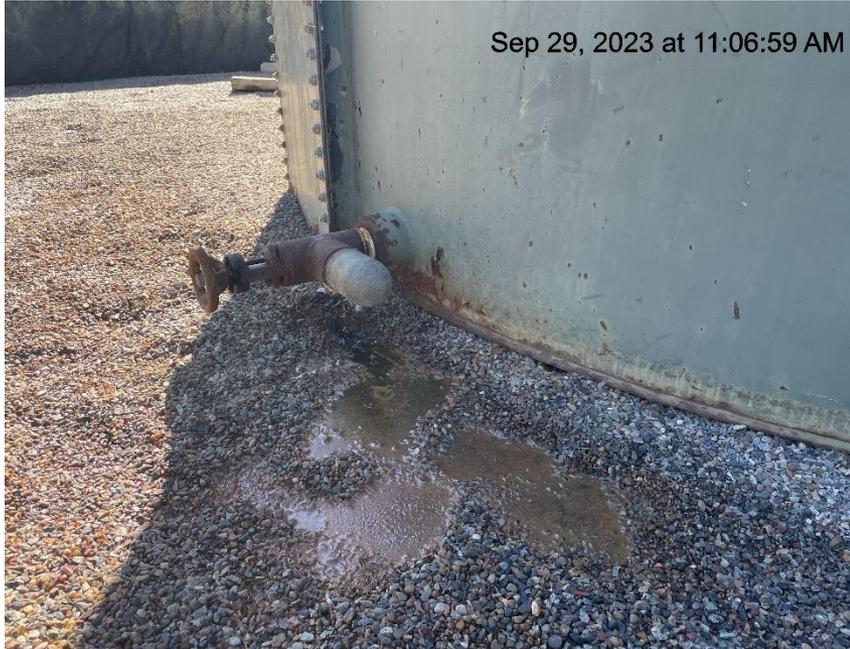
**Photo # 1039 Leaking valve on production tank/stained gravel**

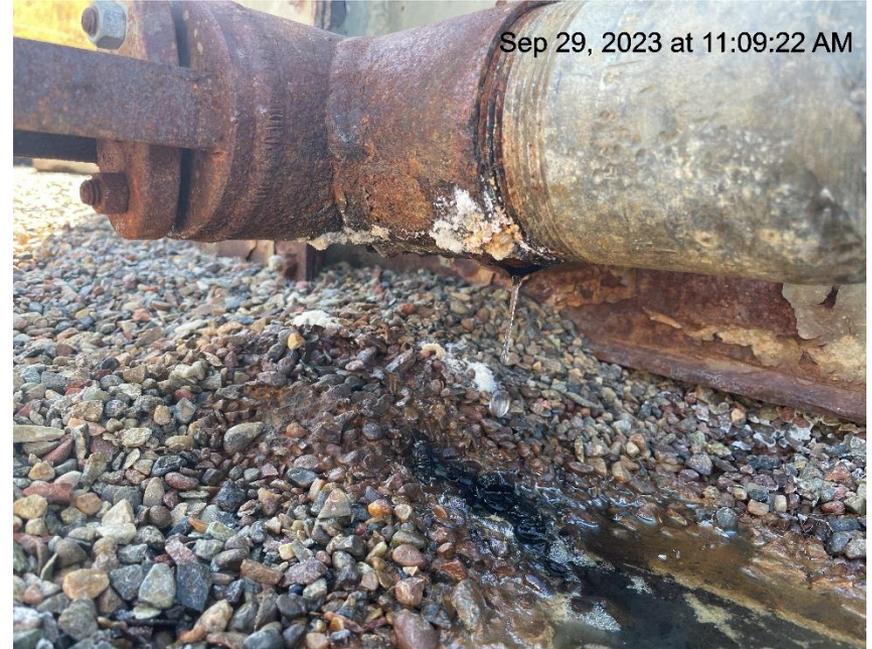
**Photo # 1040 Fluid leaking from valve**

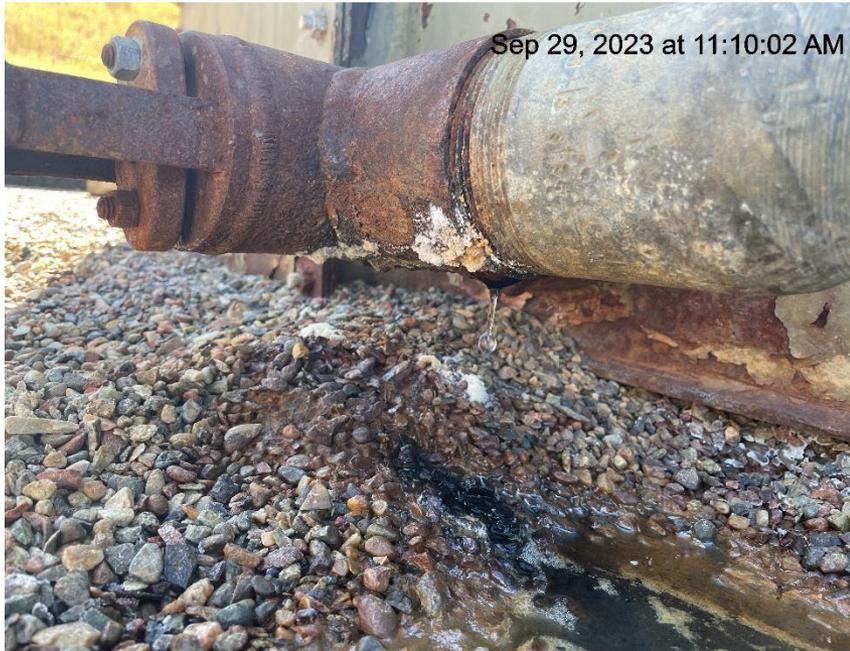
**Photo # 1041 Fluid leaking from valve**

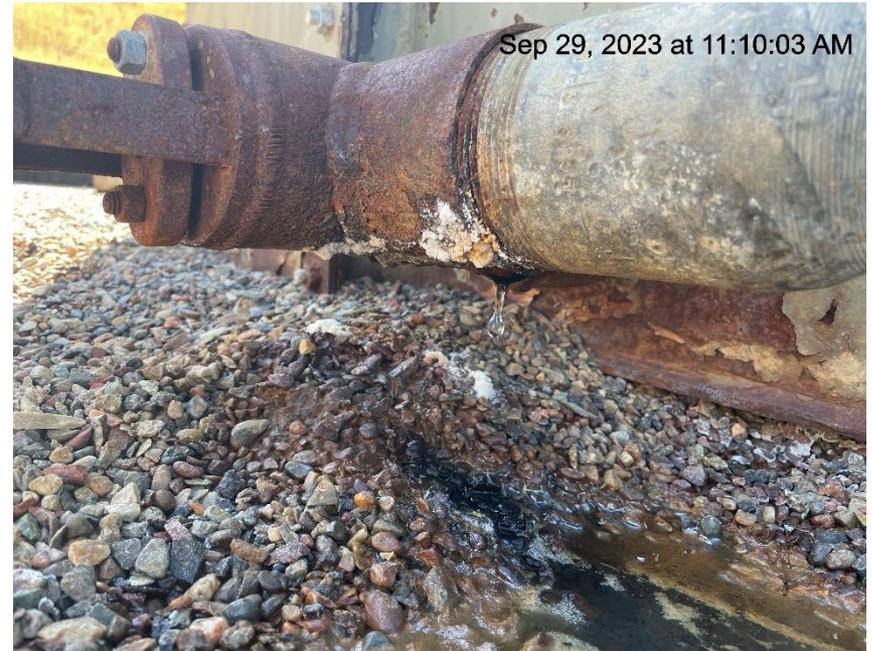
**Photo # 1042 Fluid leaking from valve**

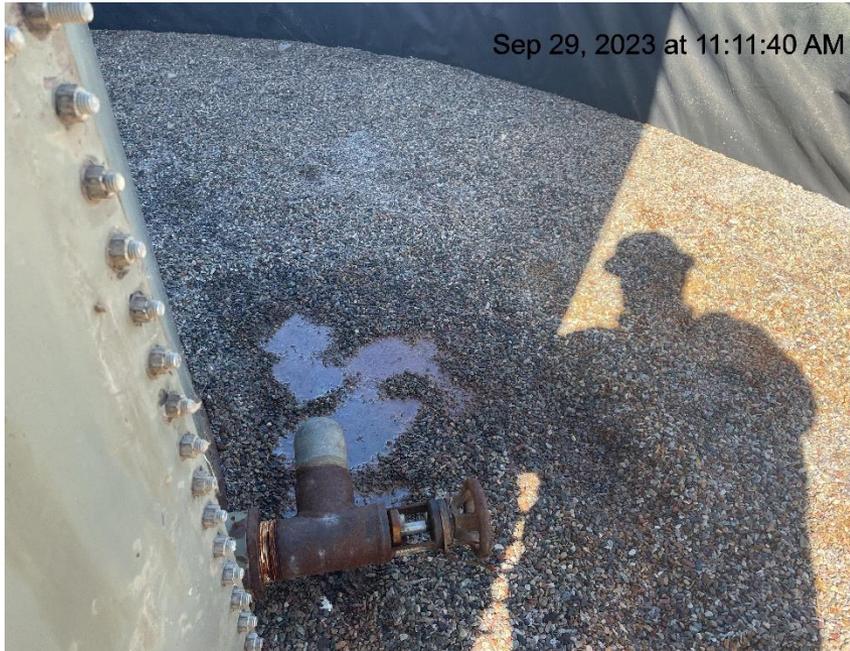
**Photo # 1043 Leaking valve on production tank/stained gravel**

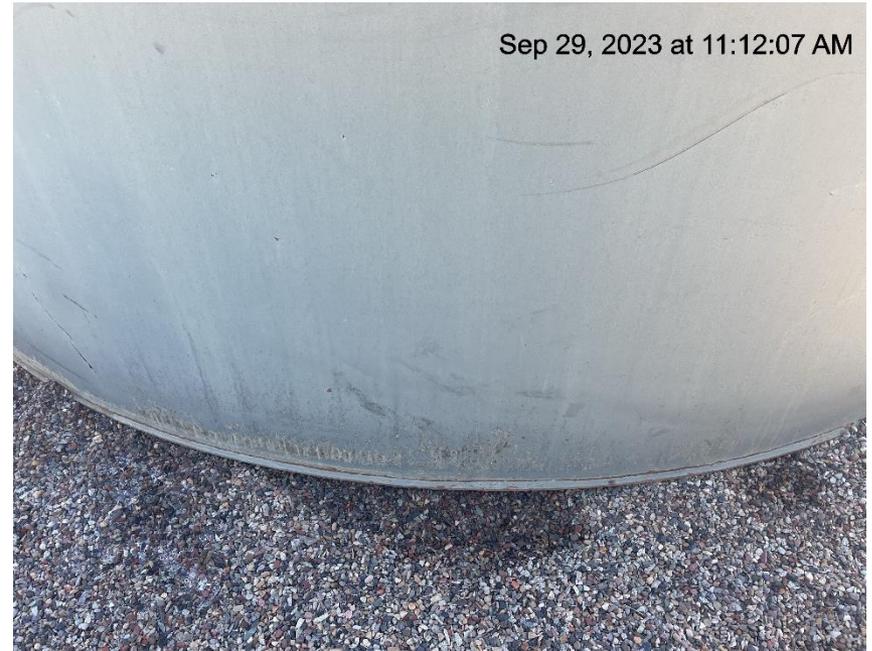
**Photo # 1044 Stained gravel**

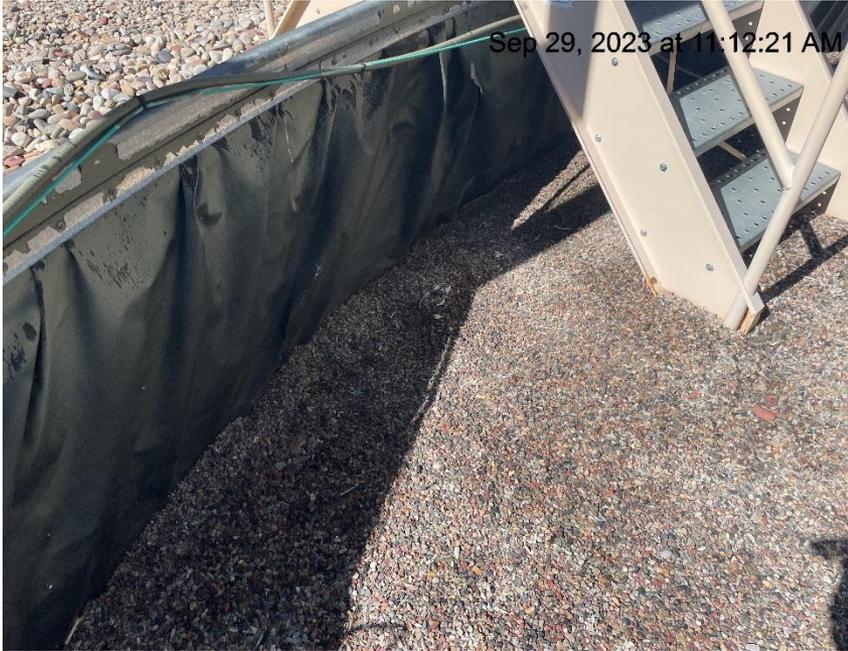
Photo # 1045 Stained gravel

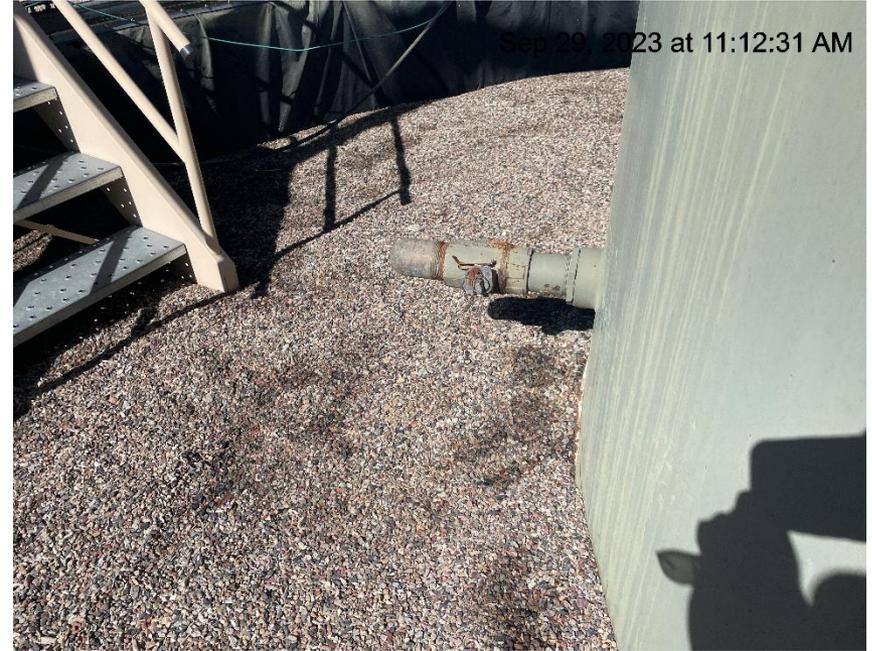
Photo # 1046 Stained gravel

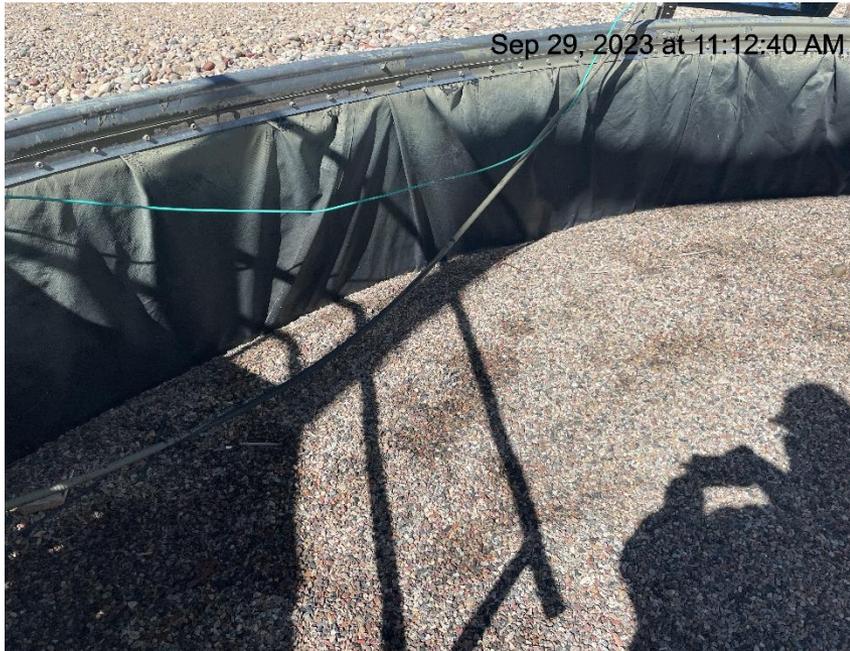
**Photo # 1047 Stained gravel**
