Inspection Photos

Location Name: CAERUS PICEANCE LLC SCARBER RO2 Pad

Location #: 334669

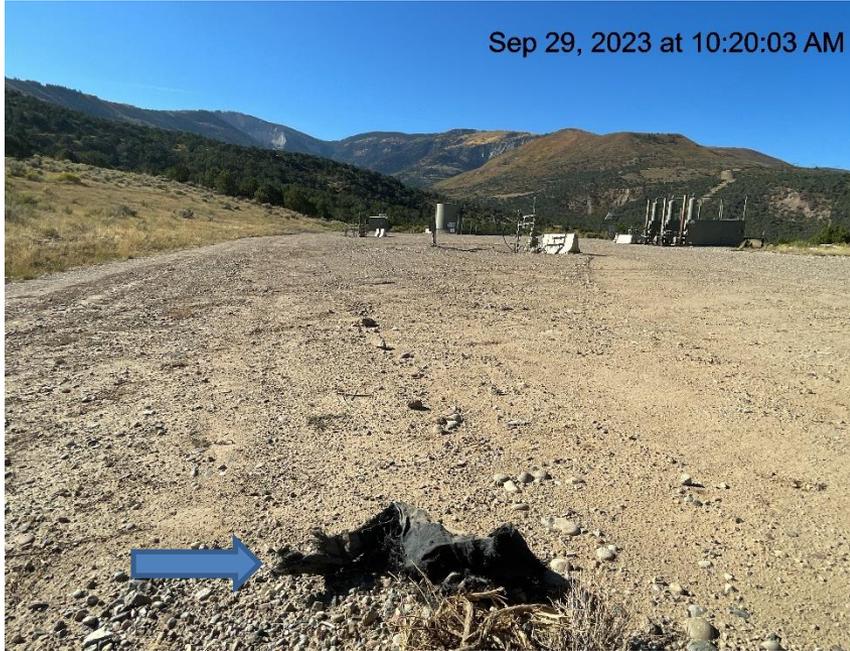
Photo # 971 Debris

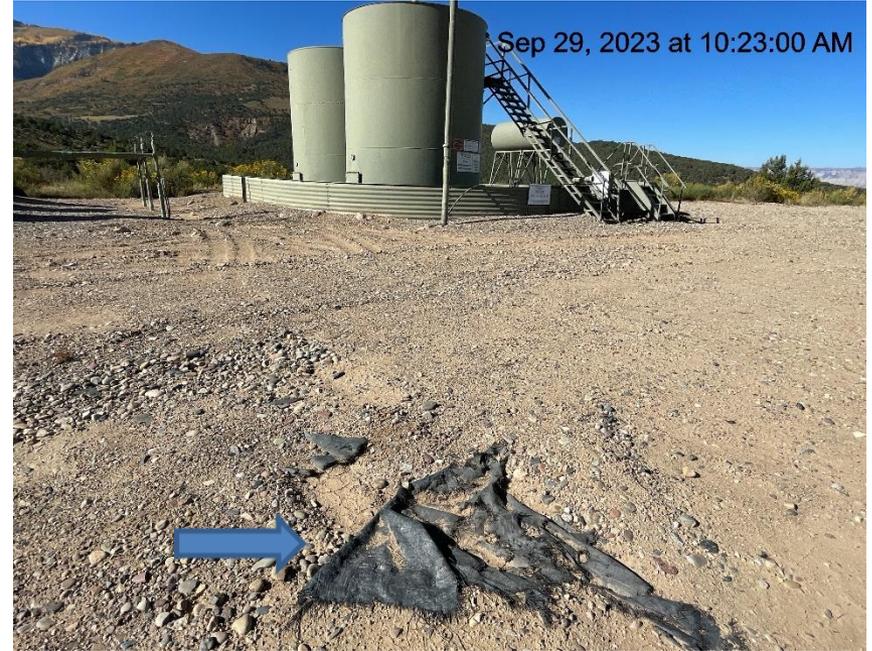
Photo # 972 Debris

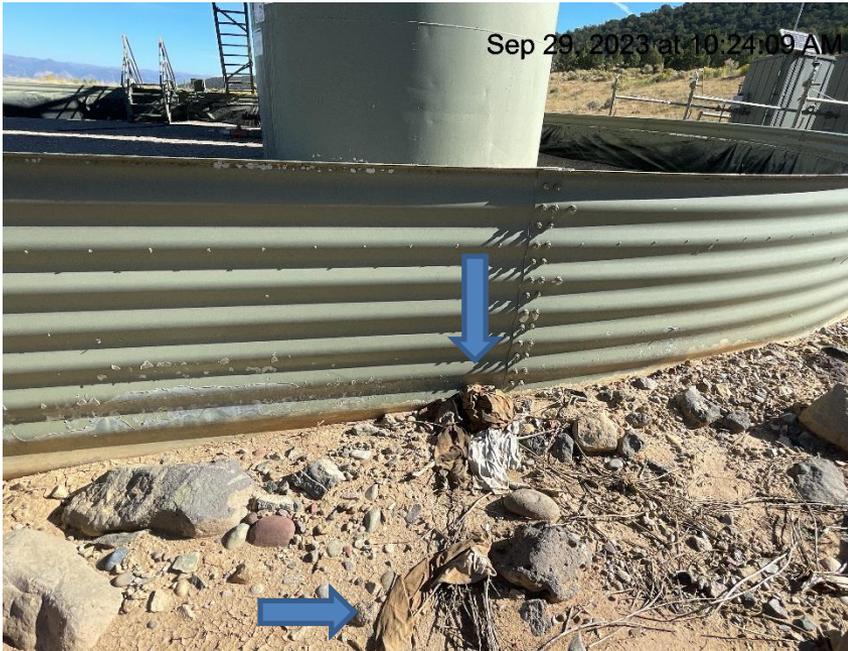
Photo # 973 Debris

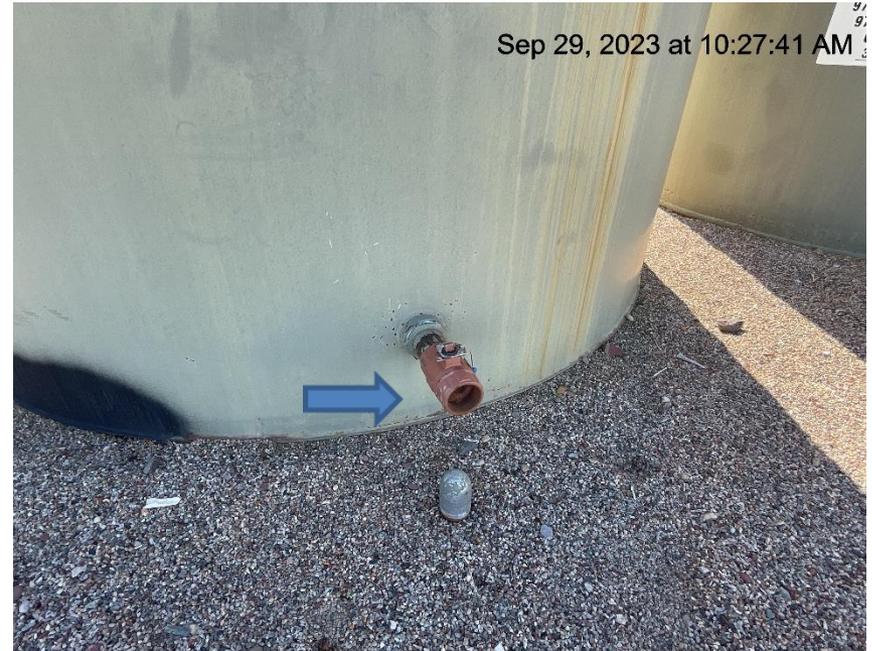
Photo # 974 Open ended load line

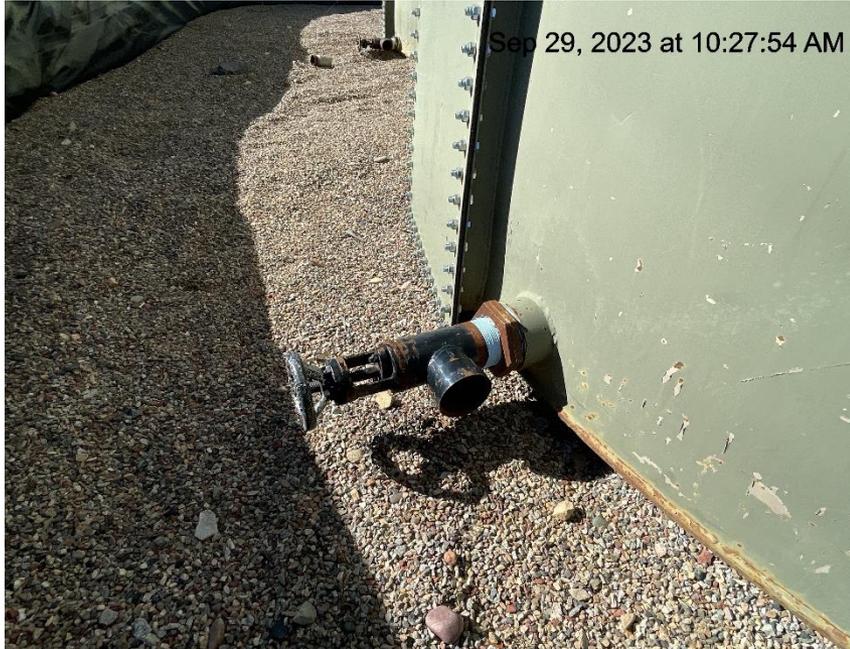
Photo # 975 Open ended load line

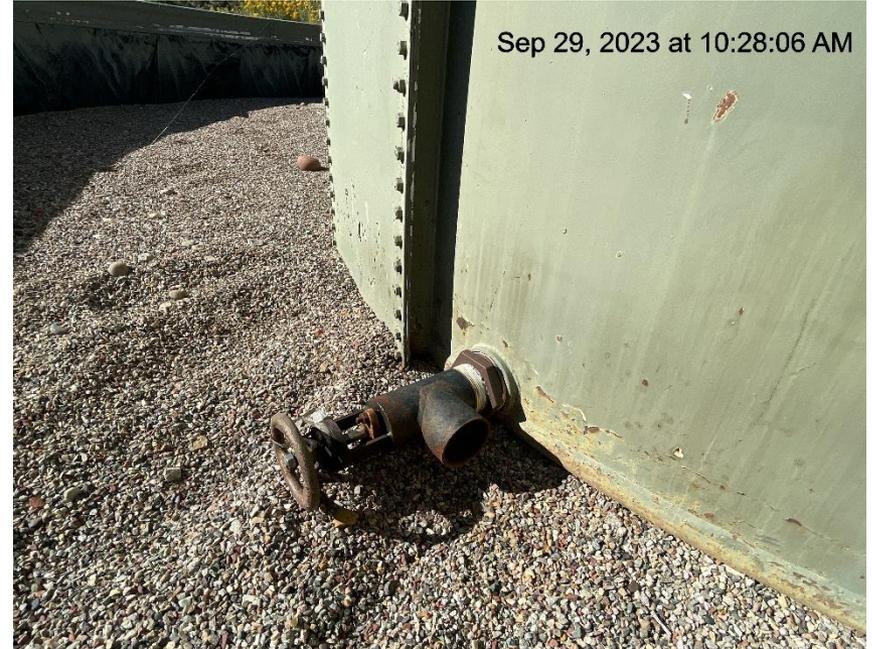
Photo # 976 Open ended load line

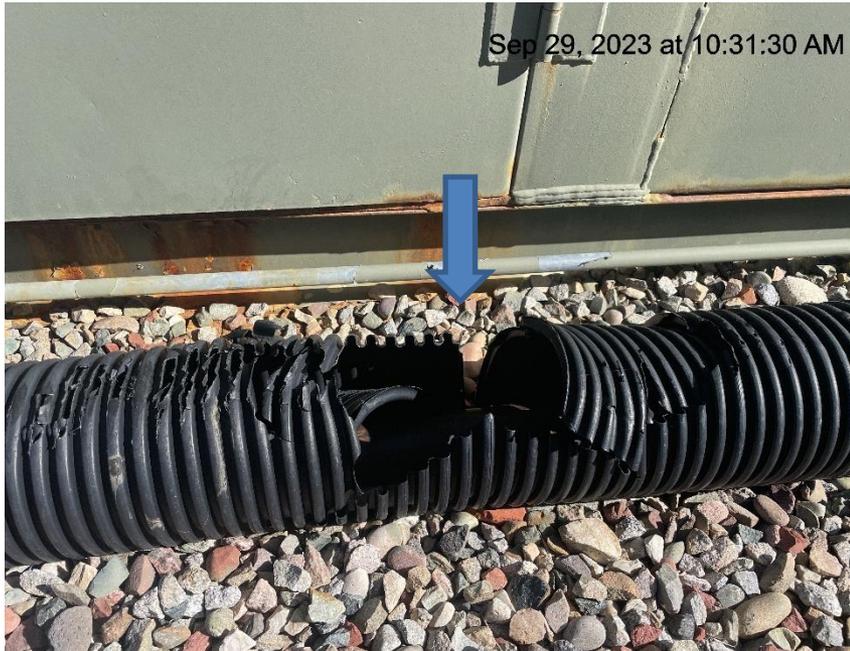
Photo # 977 Flowline heating insulation with a hole/wildlife hazard
