Inspection Photos
Location Name: Loehr Larry R 1
Location ID: 322864

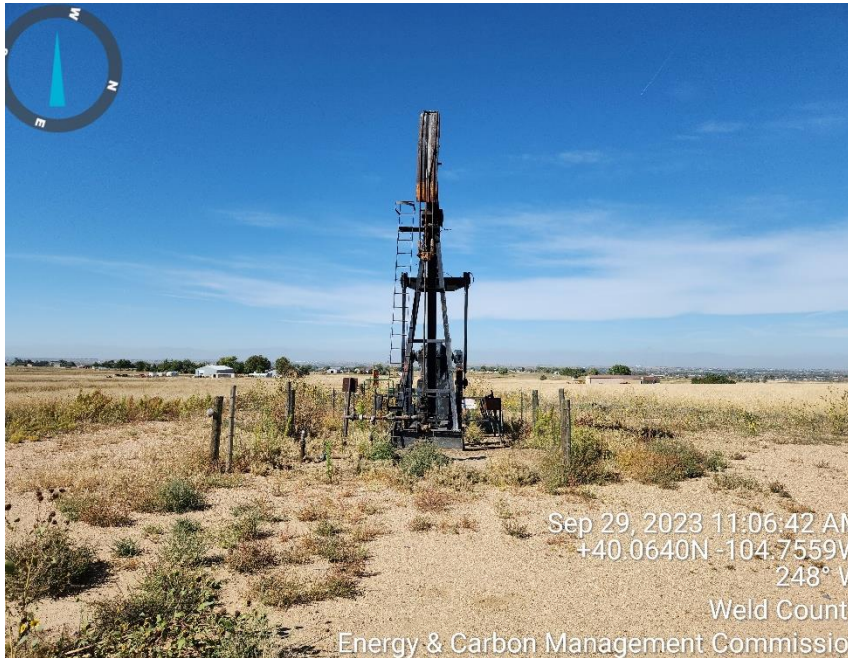
Photo 1 well head and equipment

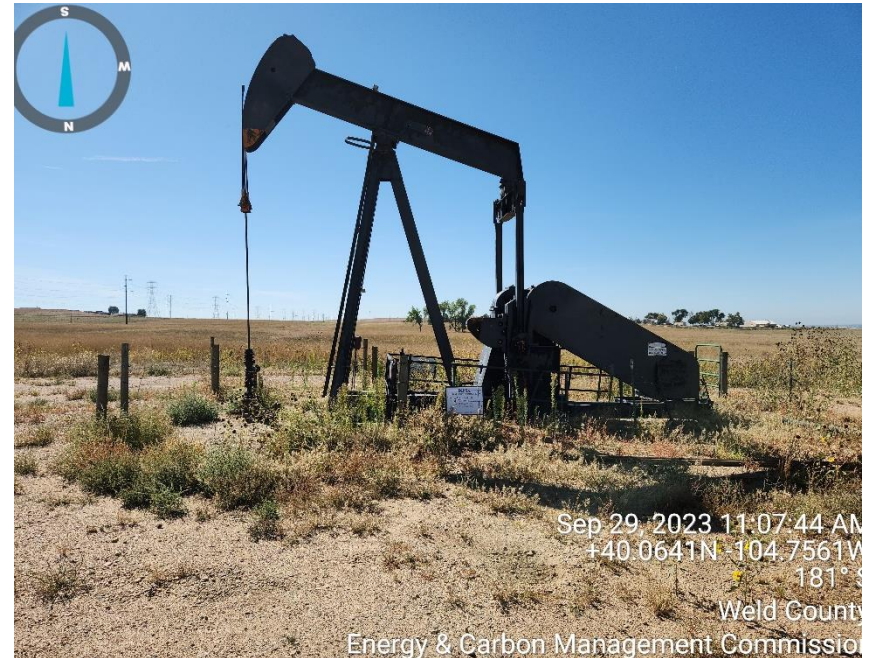
Photo 2 well head and equipment

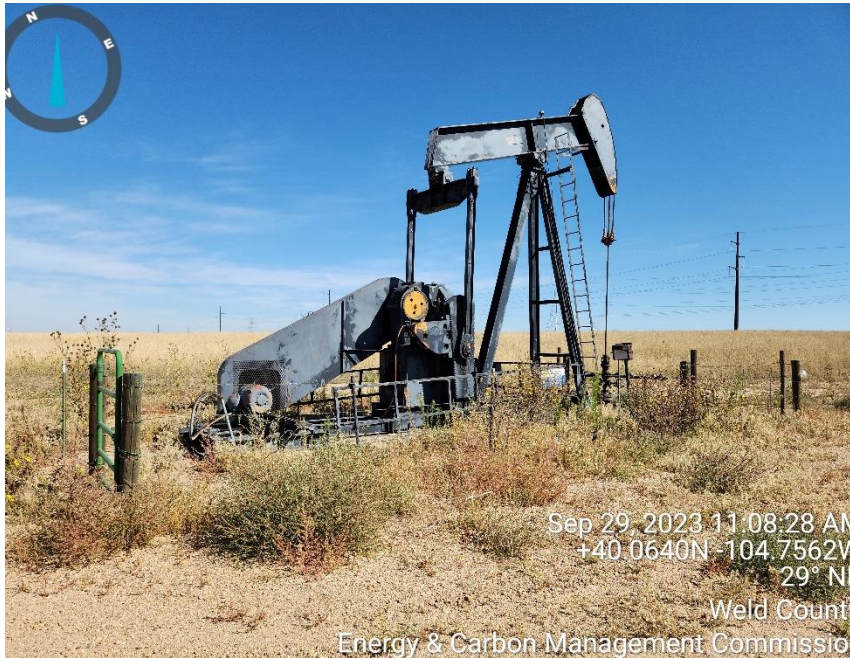
Photo 3 pumping unit

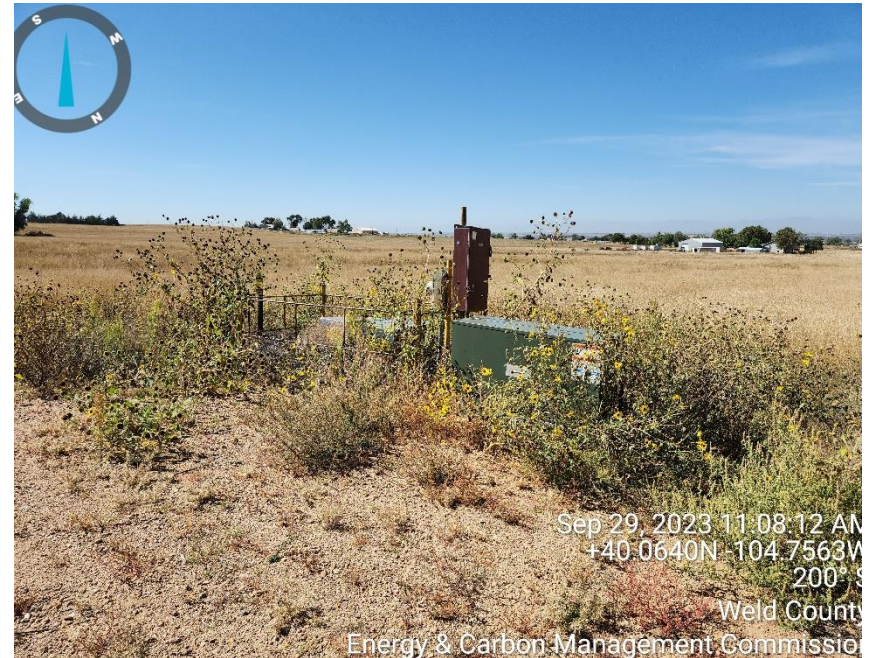
Photo 4 electrical panel

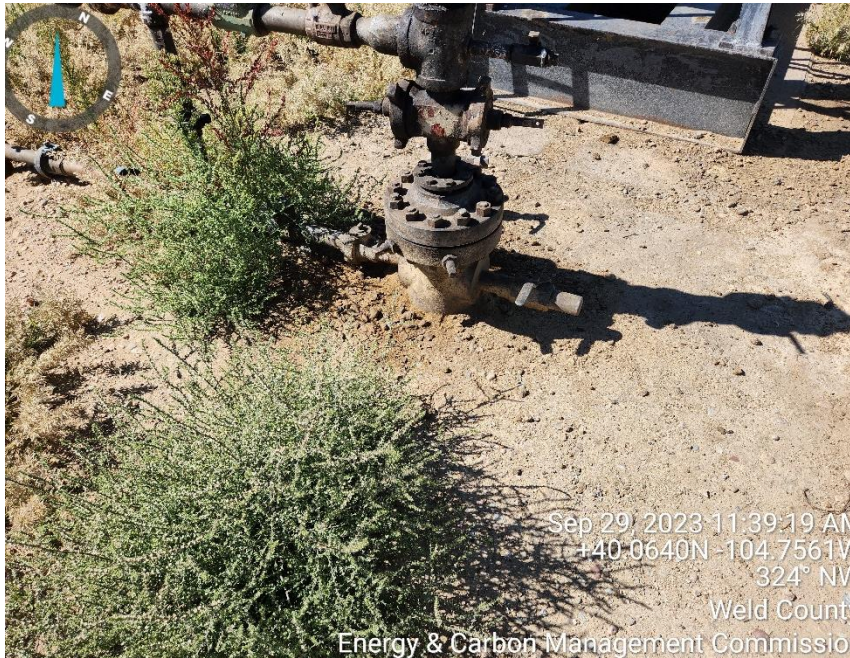
Photo 5 stained soil around well head

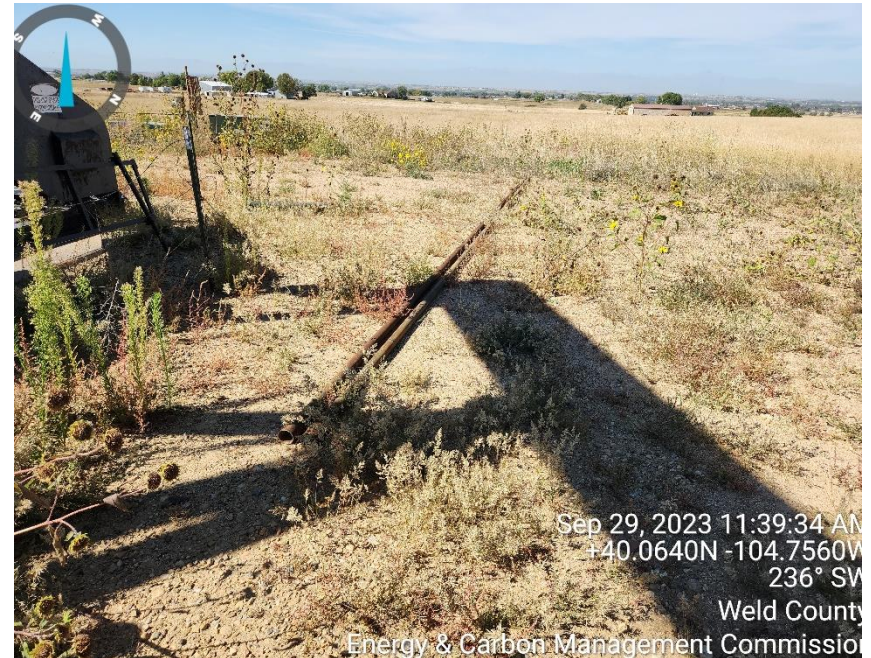
Photo 6 unused equipment

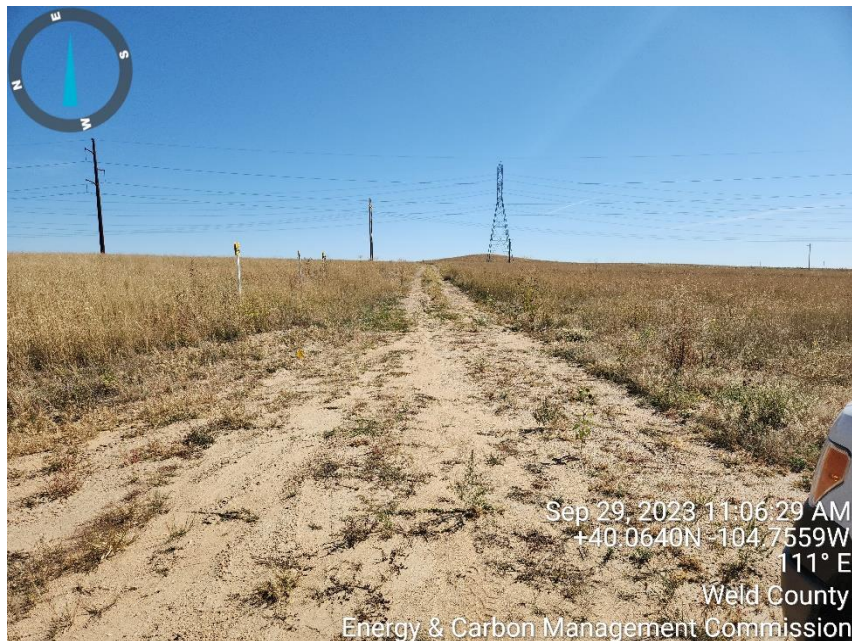
Photo 7 access road
