# Construction and Stormwater Inspection

September 28, 2023

Operator: KERR MCGEE OIL & GAS ONSHORE LP #47120

Location ID: 482983

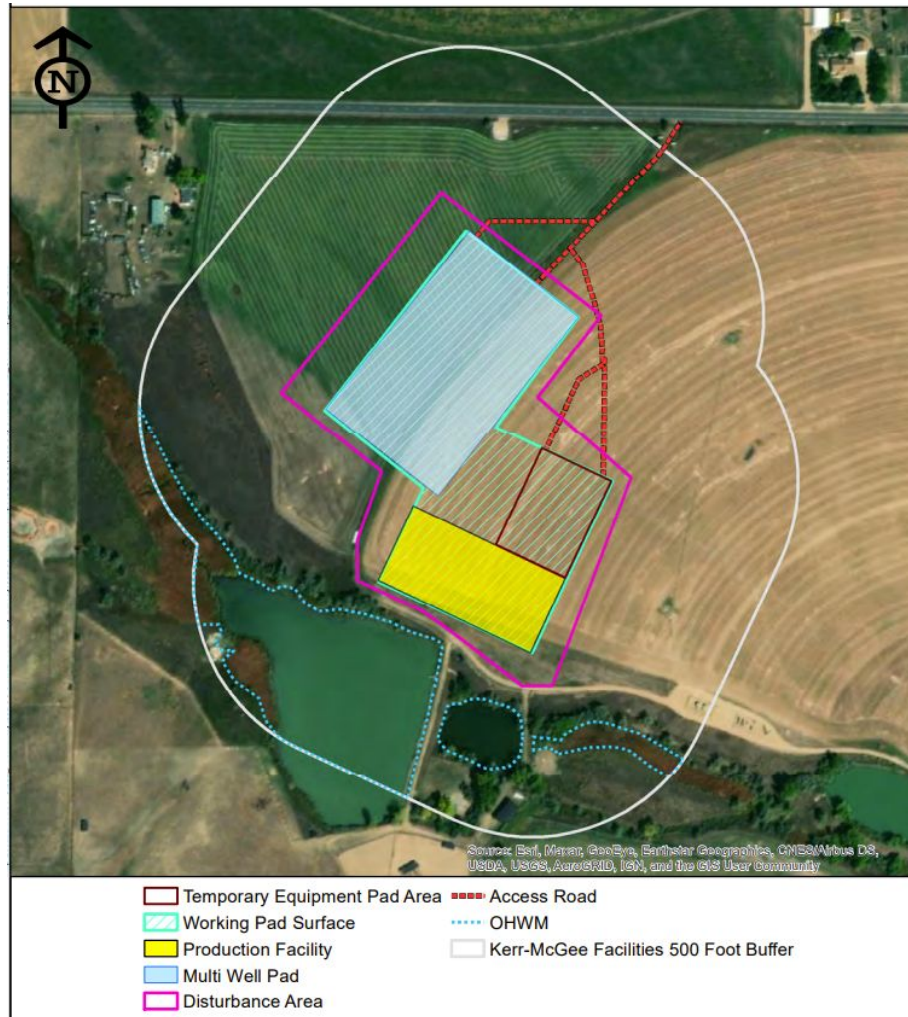
**Photo 1.** Figure 2 from the Wildlife Mitigation Plan is illustrated. At the time of this inspection, Operator has constructed the working pad surface and associated access road.

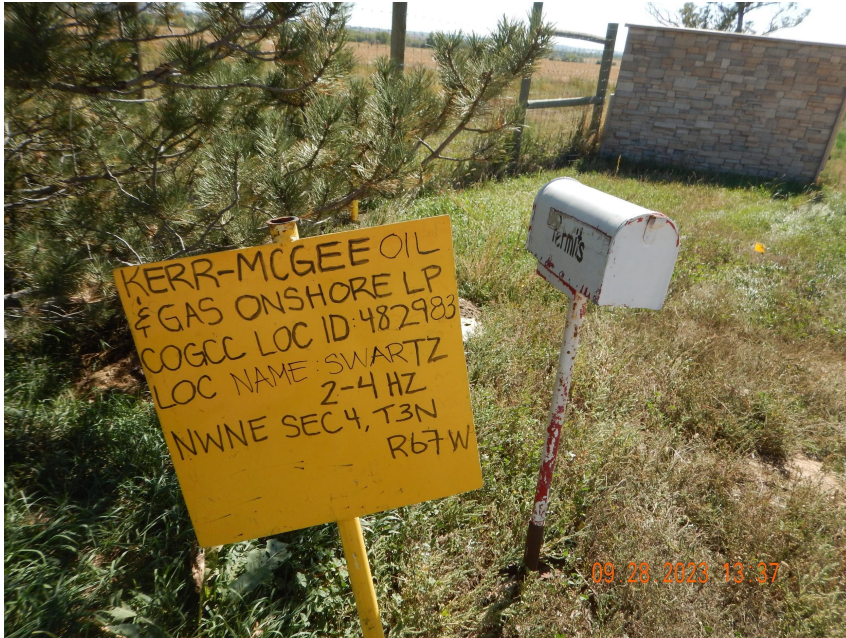
**Photo 2.** Photo taken from the entrance of location off CR38. Photo illustrates the Operator sign and mailbox with the required permits.

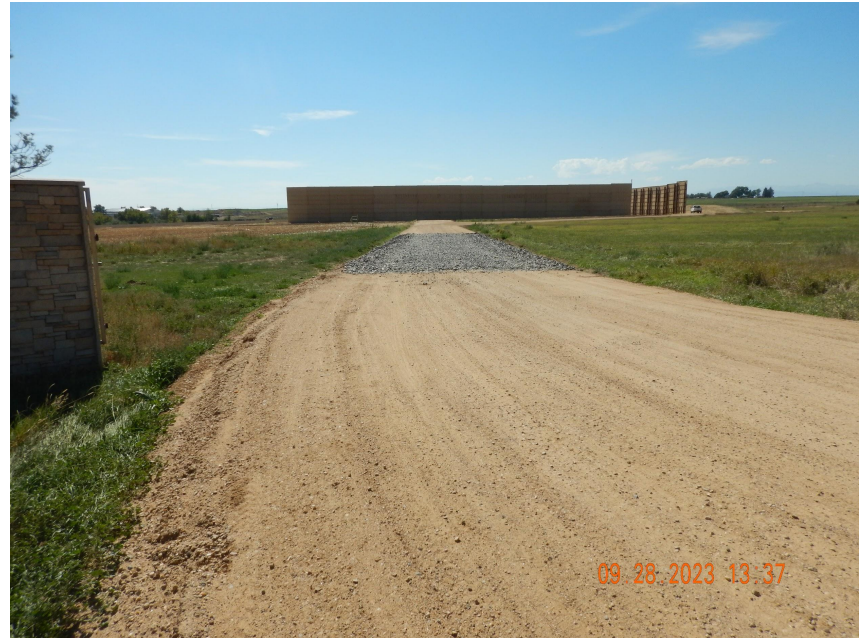
**Photo 3.** Photo taken from the entrance of location, facing South. Photo illustrates the Operator has installed a VTC device BMP which is in proper functioning at the of this inspection.

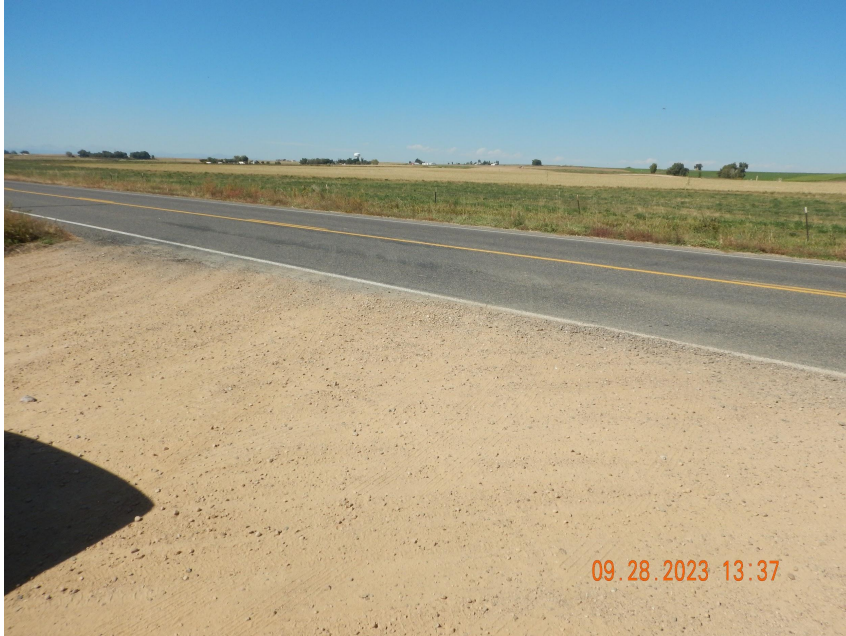
**Photo 4.** Photo taken from the entrance of location off CR38, facing West. Photo illustrates the current CR38 condition.

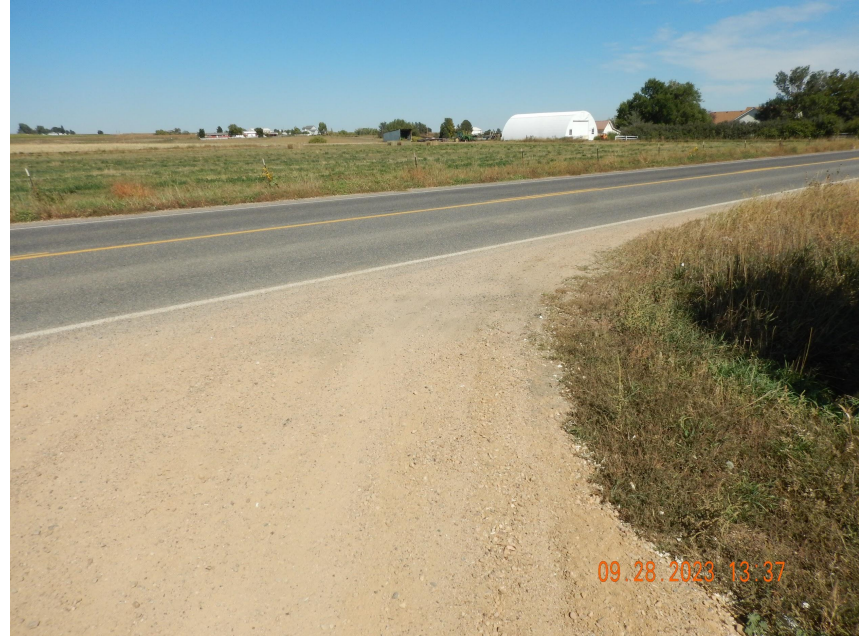
**Photo 5.** Photo taken from the entrance of location off CR38, facing East. See comments under Photo 4.

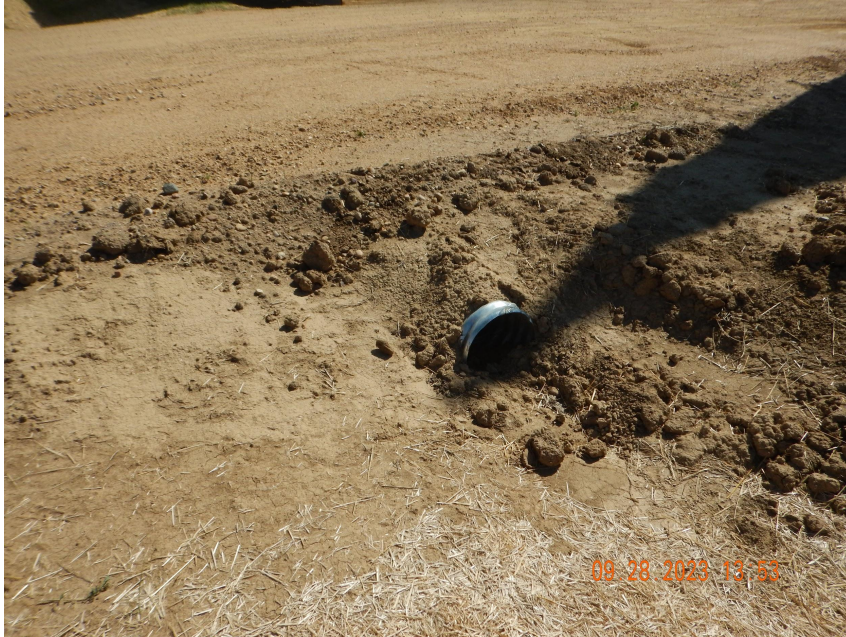
**Photo 6.** Photo taken from the northern perimeter of location and access road. Photo illustrates the culvert does not have any inlet or outlet protection.

Note- On 10/3/2023, Operator communicated that inlet and outlet protection was installed on 9/29/2023.

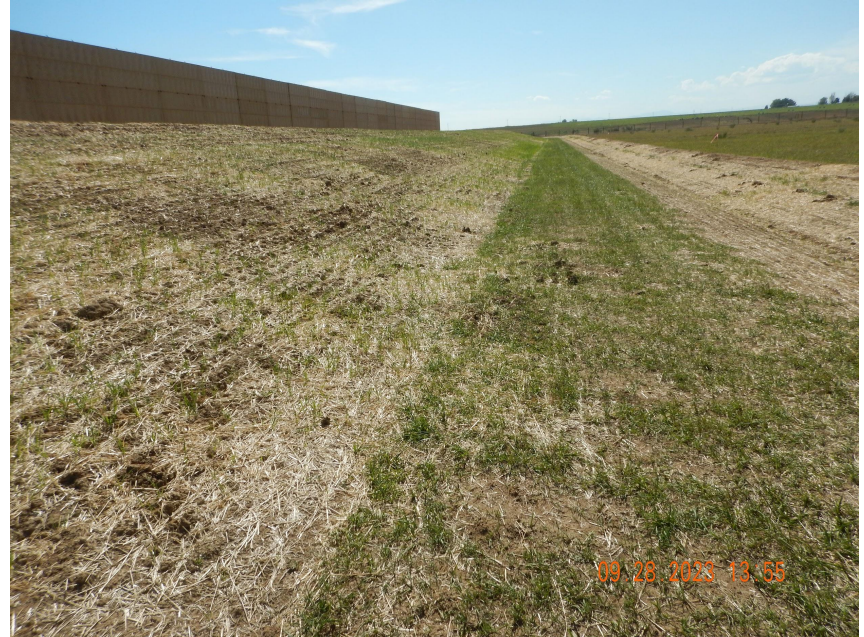
**Photo 7.** Photo taken from the northwestern perimeter of location, facing South. Photo illustrates the topsoil stockpile and stormwater BMPs areas have been seeded. Establishment of desirable vegetation was observed.

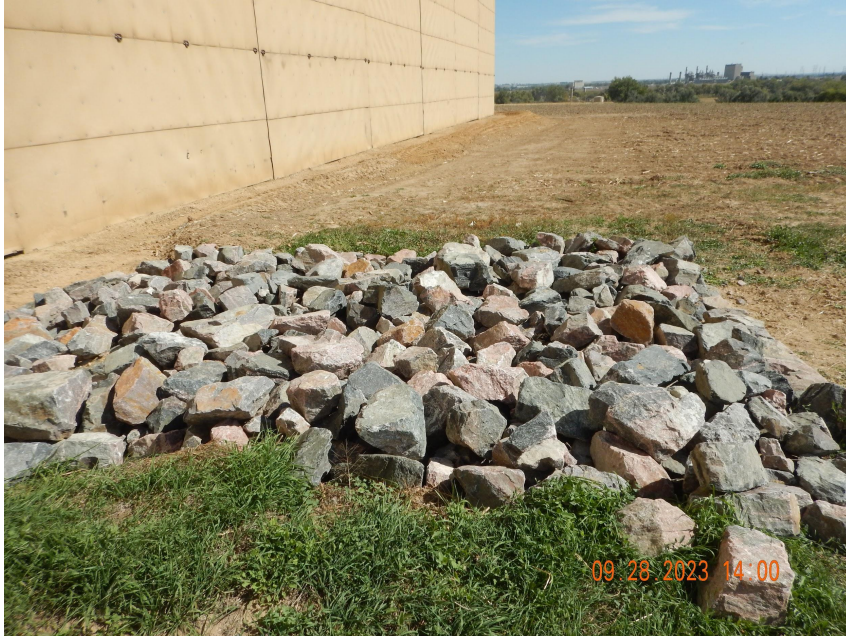
**Photo 8.** Photo taken from the southern perimeter of location, facing East. Photo illustrates a Weld County stormwater BMP.

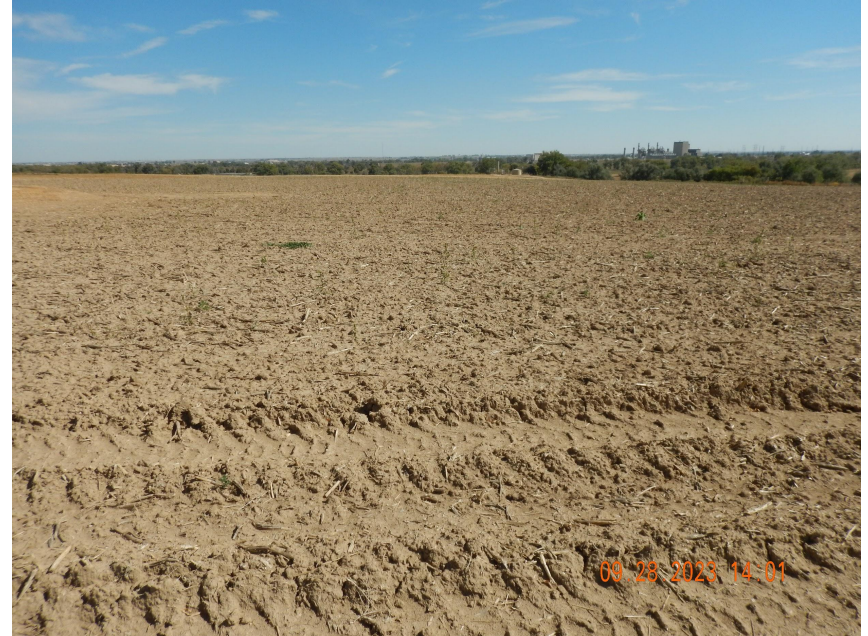
**Photo 9.** Photo taken from the southern perimeter of location, facing East. Photo illustrates the Production Facility has not yet been constructed.

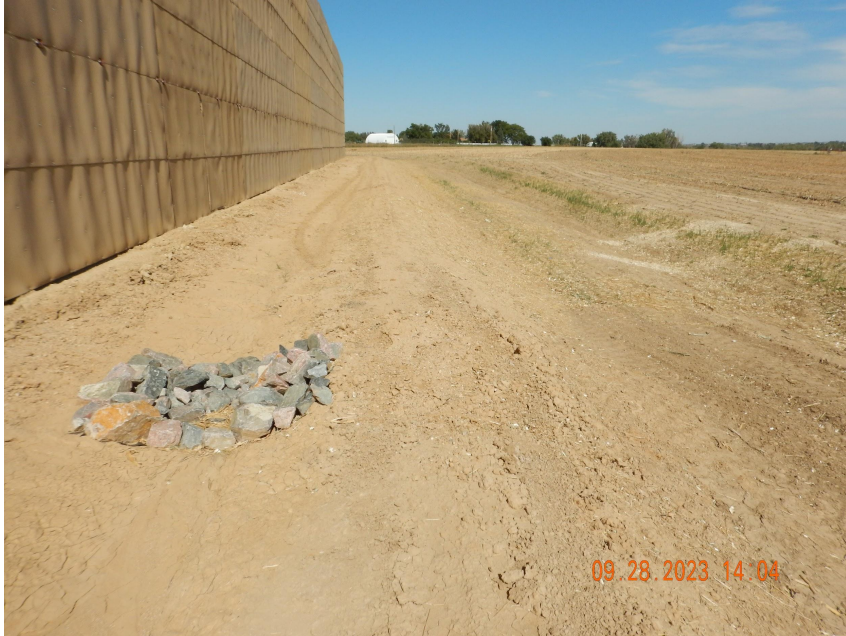
**Photo 10.** Photo taken from the eastern perimeter of location, facing North. Photo illustrates the eastern spillway per Weld County.

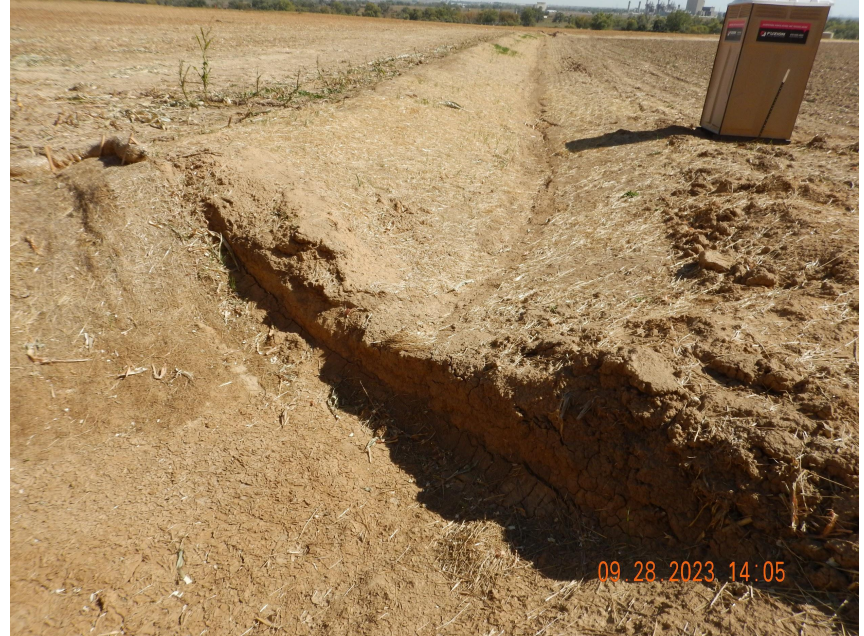
**Photo 11.** Photo taken from the eastern perimeter of location illustrating the 1:1 side slopes of the sediment trap which are not installed per good engineering practices.

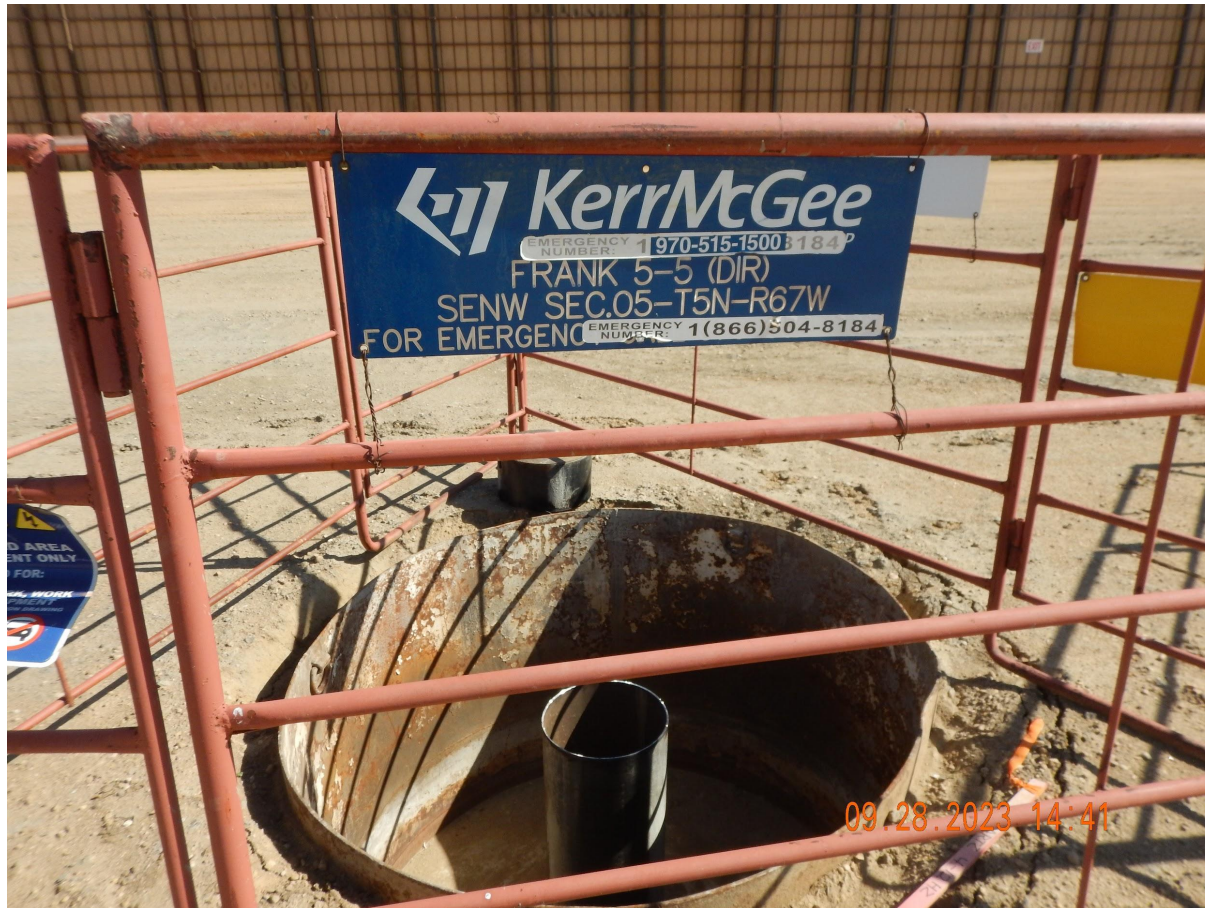
**Photo 12.** Photo illustrates there is no night cap on surface casing. Operator shall comply with Rule 406.e.(1) and follow their own BMP from the Wildlife Mitigation Plan.
