Storm Water Management and Erosion control
Location Name: CAERUS PICEANCE LLC F24W Pad
Location #: 334693

**Location Overview: Location is within High
Priority/Density/Black Bear Habitat areas & in close proximity
to NSO Habitat area. Location is approximately 349 yards
from West Mamm Creek.**

Section/Township/Range: 24 7S93W

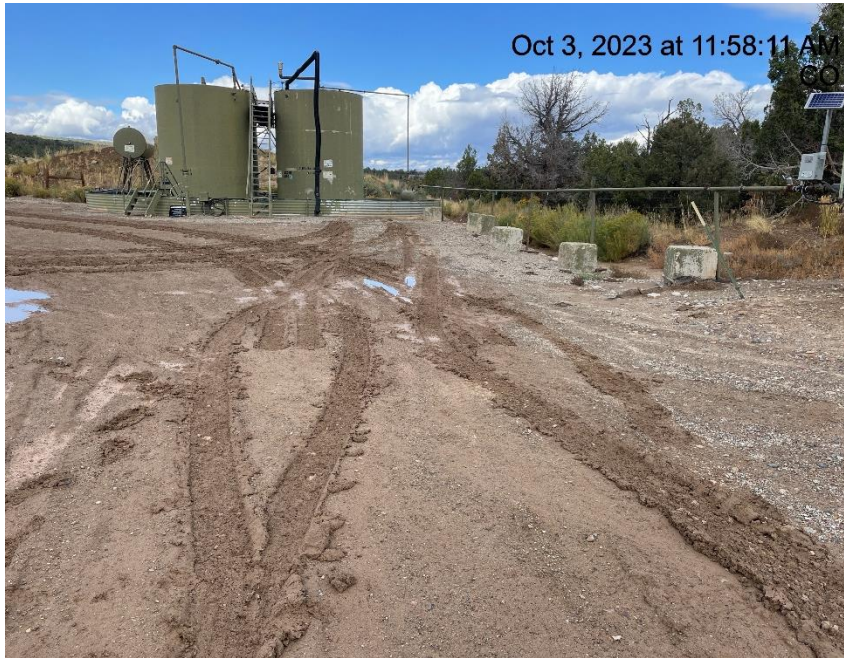
Photo # 1358 Lack of stabilization/compaction/insufficient BMP's

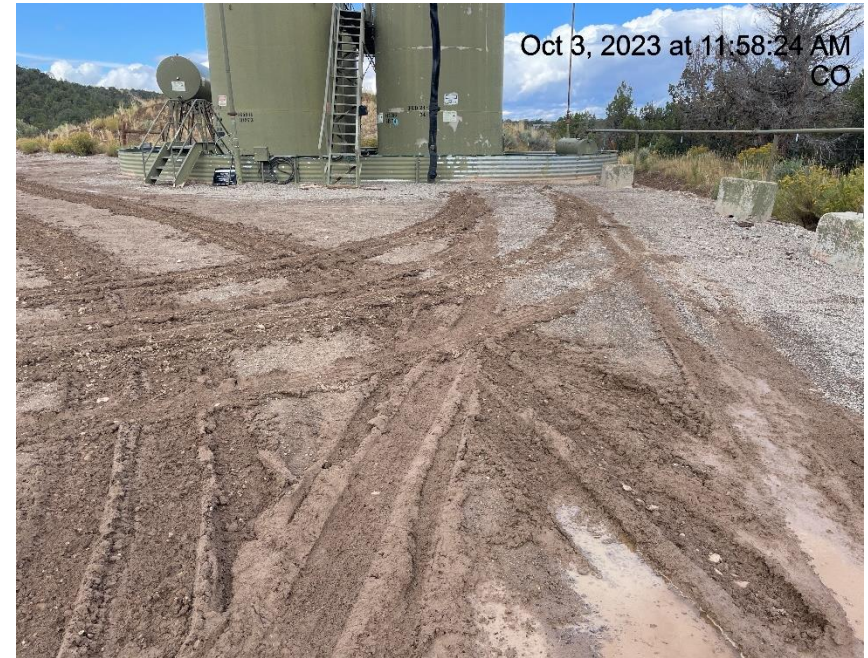
Photo # 1359 Lack of stabilization/compaction/insufficient BMP's

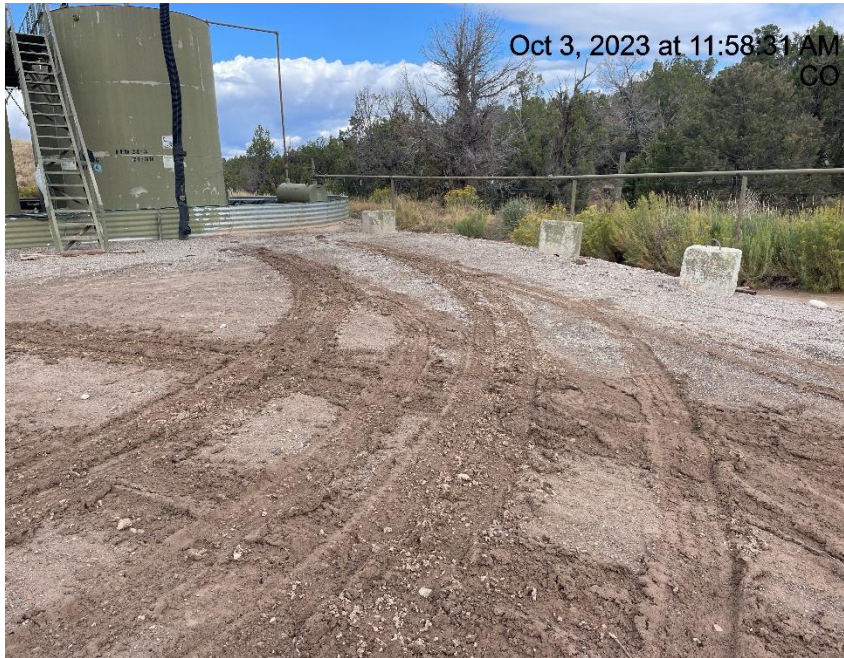
Photo # 1360 Lack of stabilization/compaction/insufficient BMP's

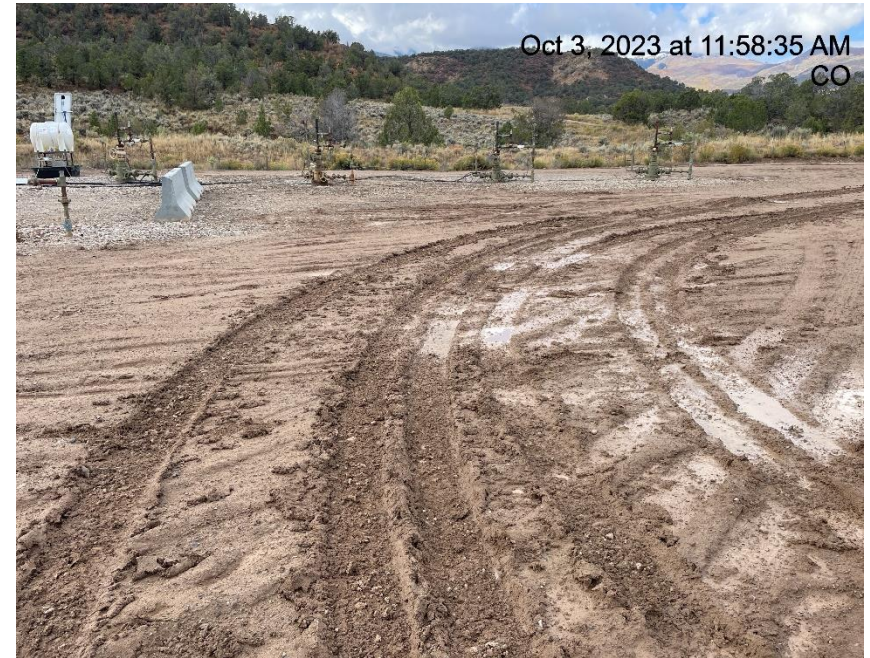
Photo # 1361 Lack of stabilization/compaction/insufficient BMP's

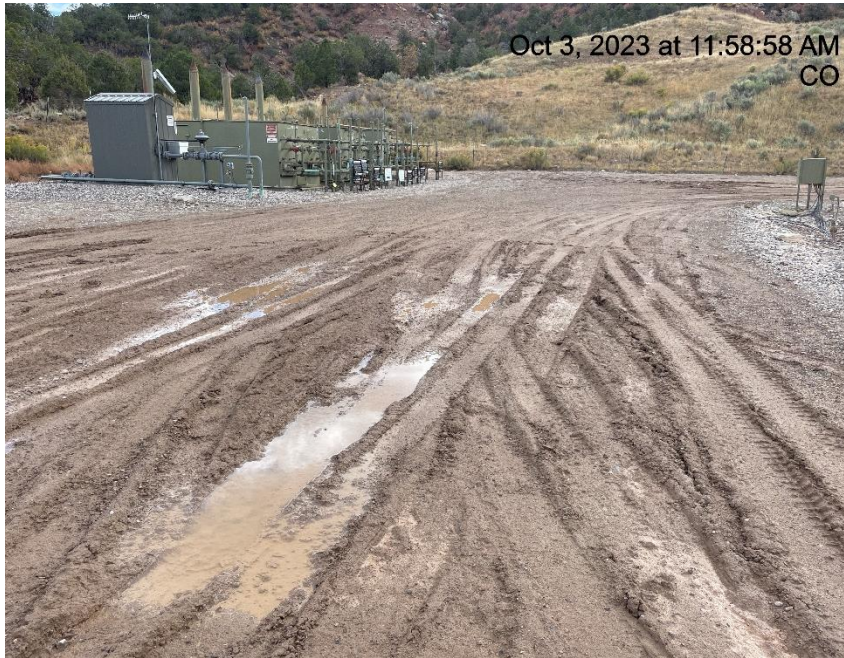
Photo # 1362 Lack of stabilization/compaction/insufficient BMP's

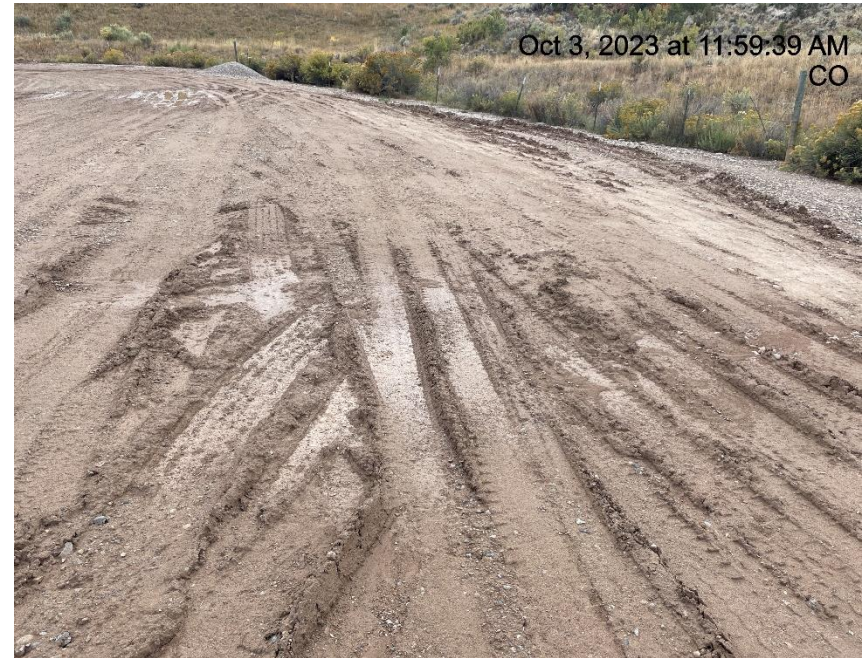
Photo # 1363 Lack of stabilization/compaction/insufficient BMP's

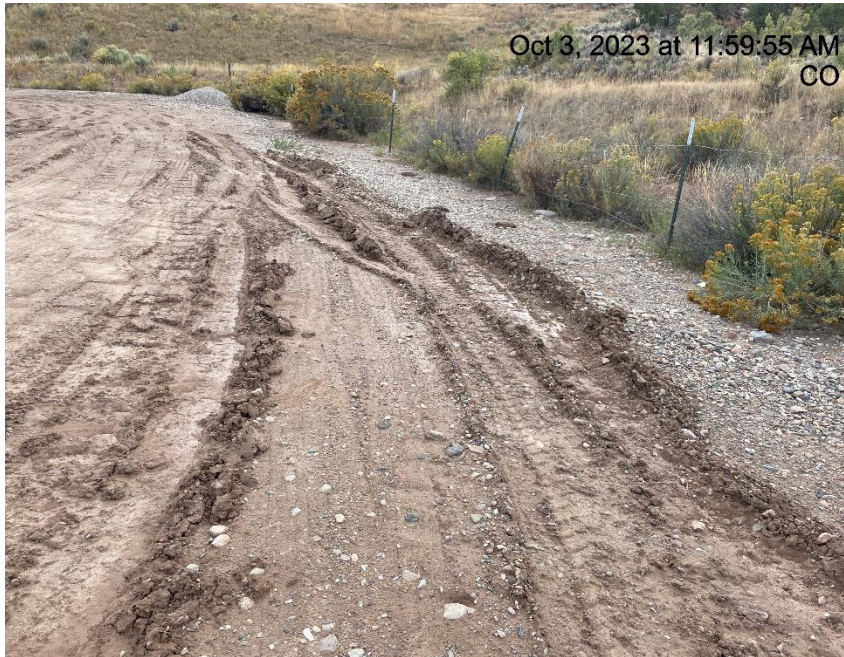
Photo # 1364 Lack of stabilization/compaction/insufficient BMP's

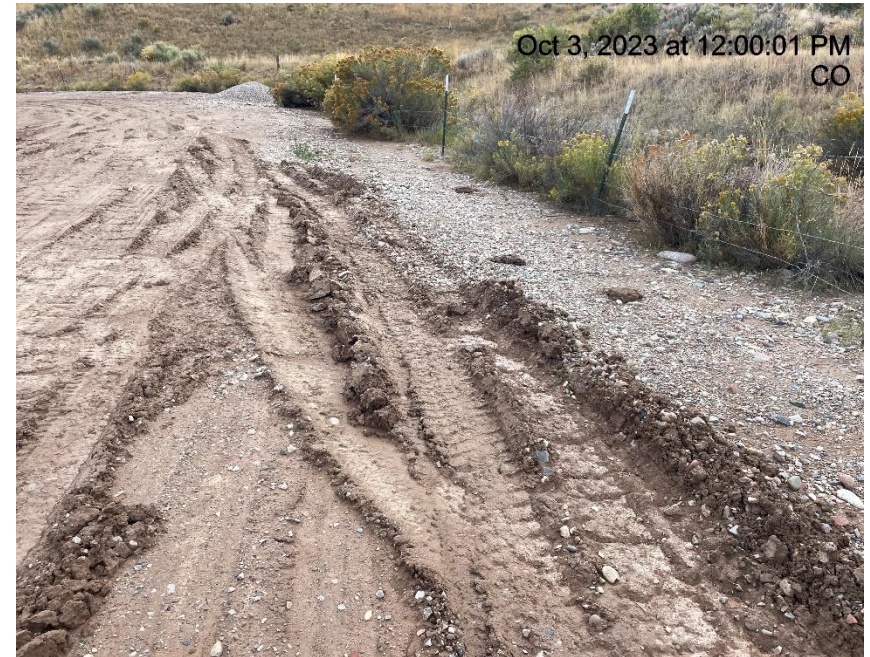
Photo # 1365 Lack of stabilization/compaction/insufficient BMP's

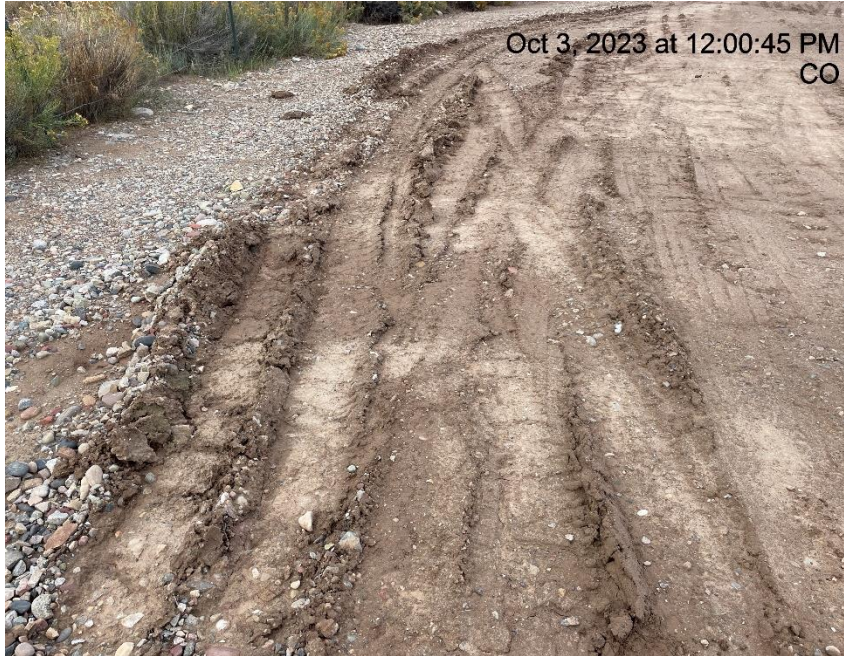
Photo # 1366 Lack of stabilization/compaction/insufficient BMP's

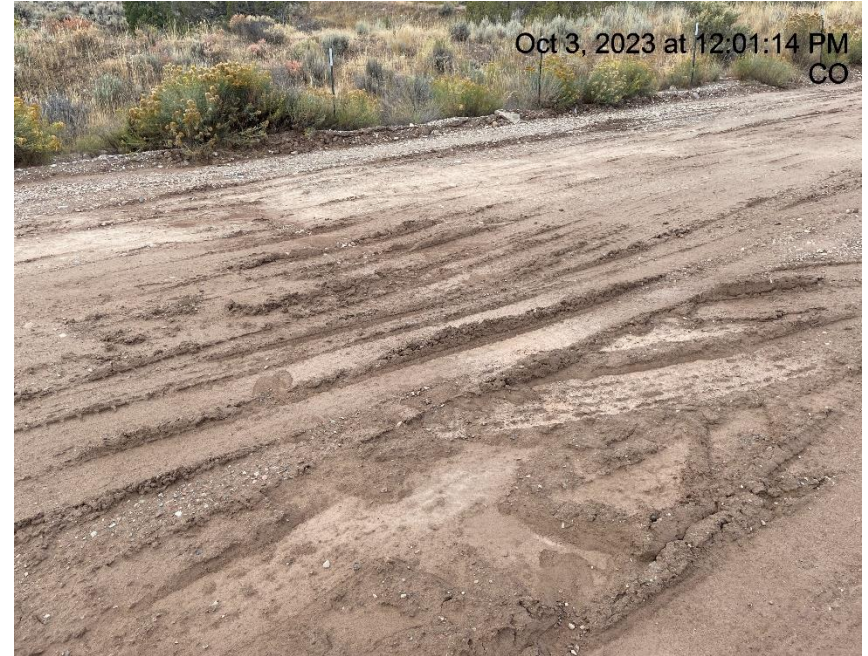
Photo # 1367 Lack of stabilization/compaction/insufficient BMP's

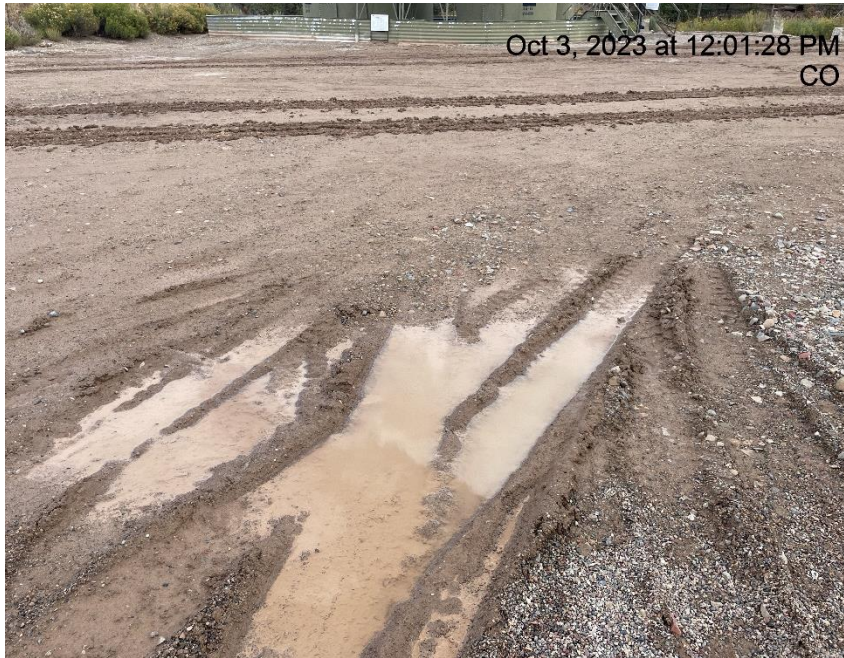
Photo # 1368 Lack of stabilization/compaction/insufficient BMP's

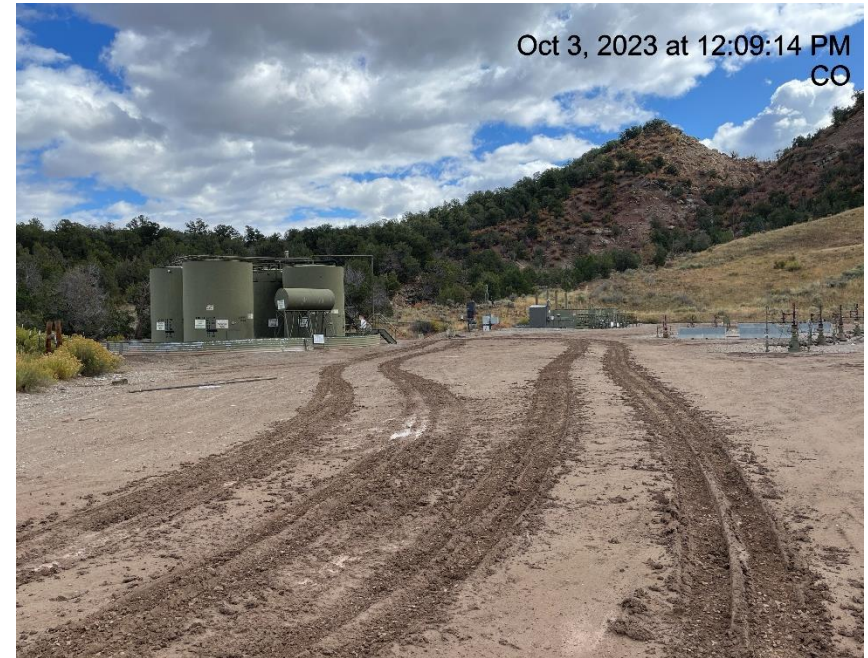
Photo # 1369 Lack of stabilization/compaction/insufficient BMP's

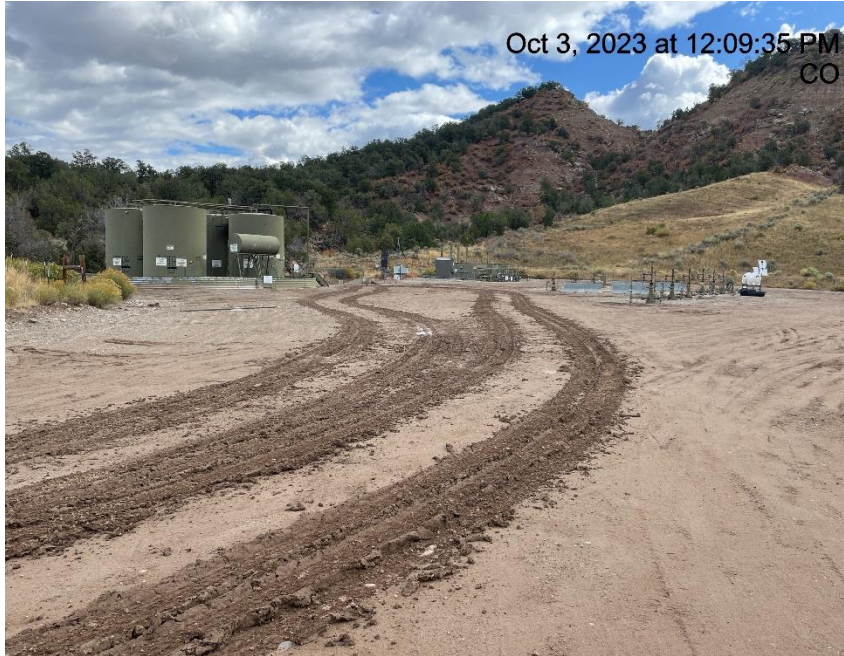
Photo # 1370 Lack of stabilization/compaction/insufficient BMP's

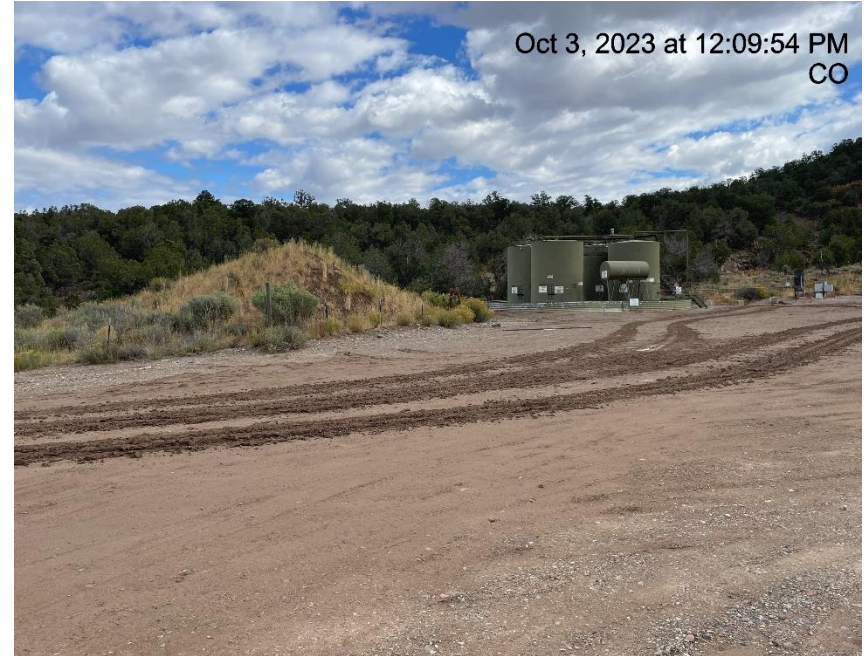
Photo # 1371 Lack of stabilization/compaction/insufficient BMP's

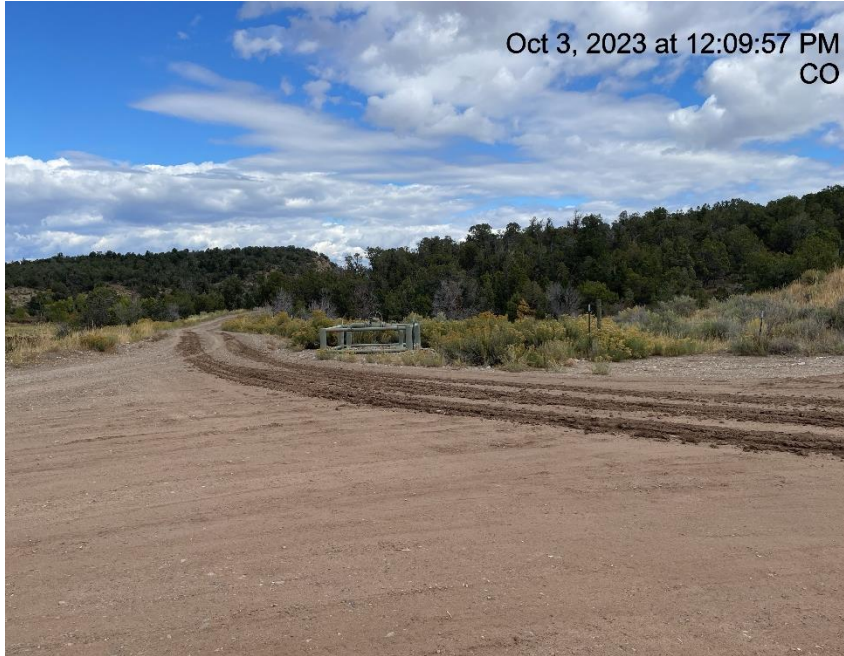
Photo # 1372 Vehicle tracking onto lease road/insufficient tracking BMP's

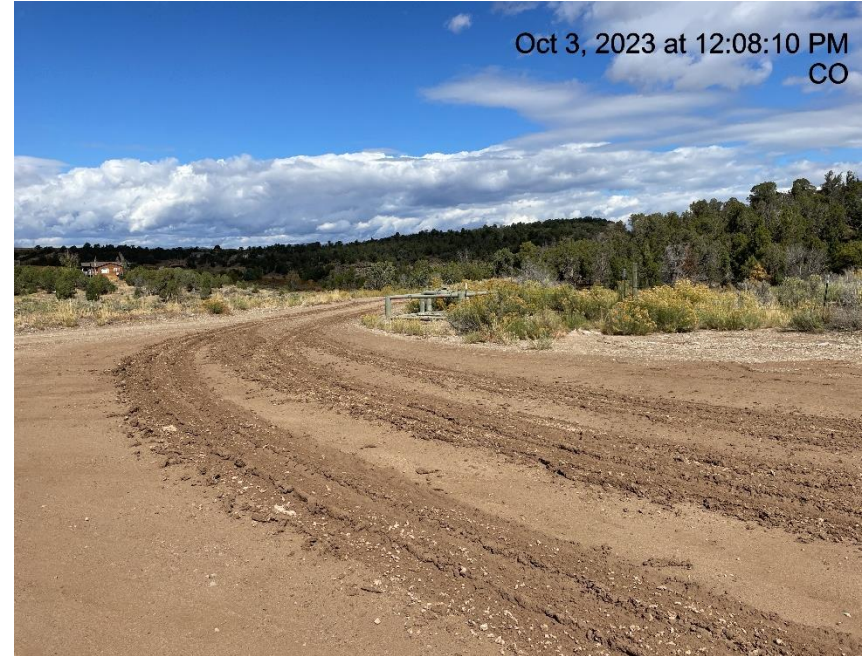
Photo # 1373 Vehicle tracking onto lease road/insufficient tracking BMP's

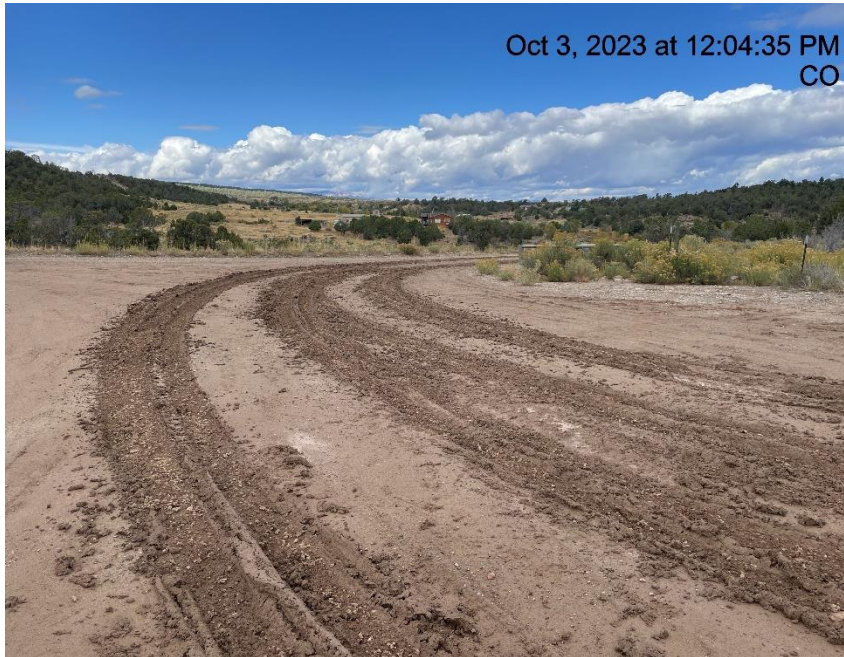
Photo # 1374 Vehicle tracking onto lease road/insufficient tracking BMP's

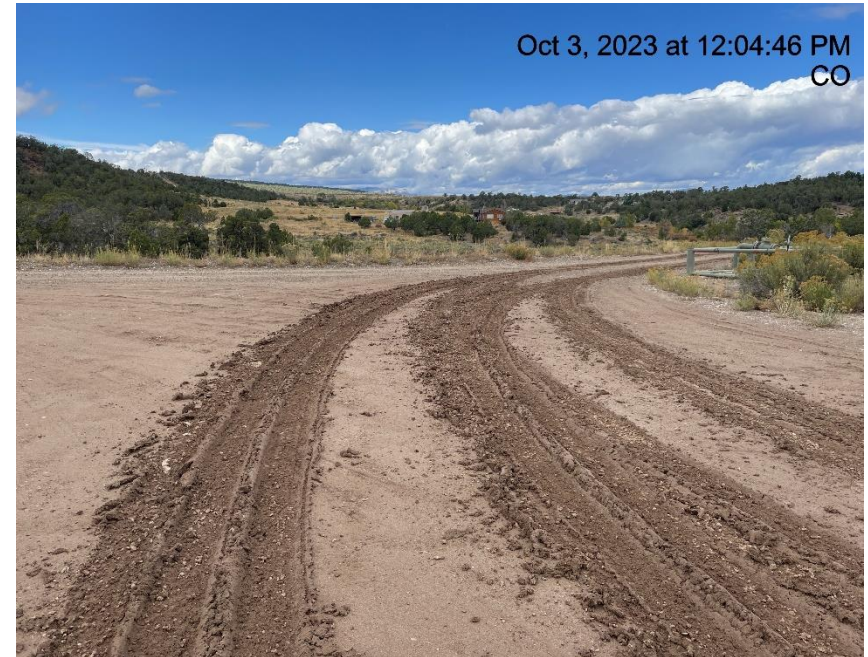
Photo # 1375 Vehicle tracking onto lease road/insufficient tracking BMP's

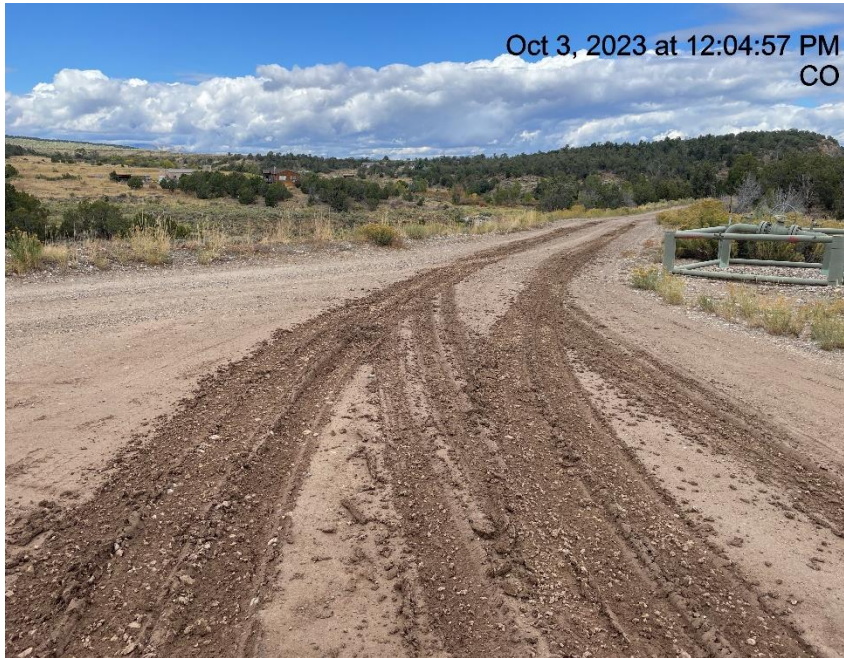
Photo # 1376 Vehicle tracking onto lease road/insufficient tracking BMP's

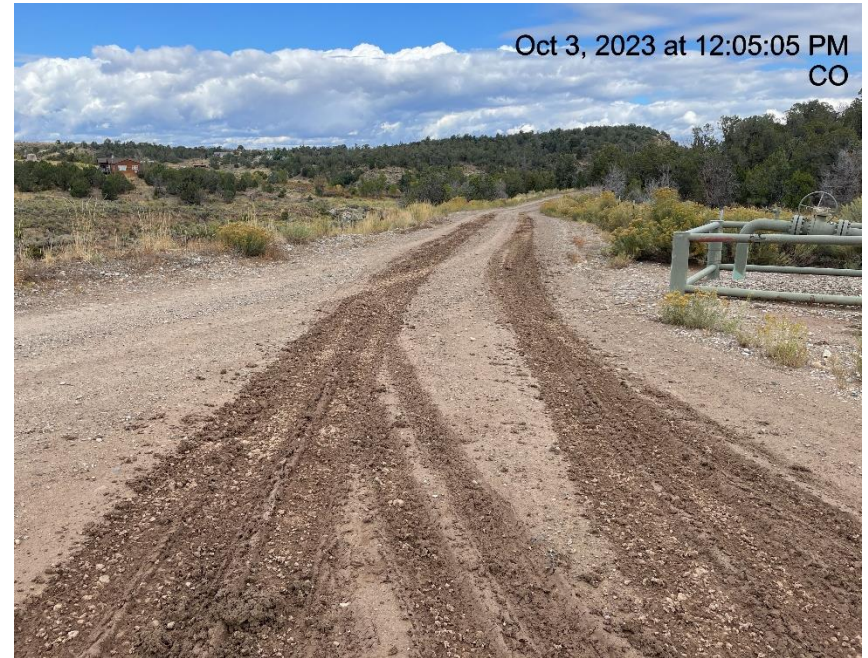
Photo # 1377 Vehicle tracking onto lease road/insufficient tracking BMP's

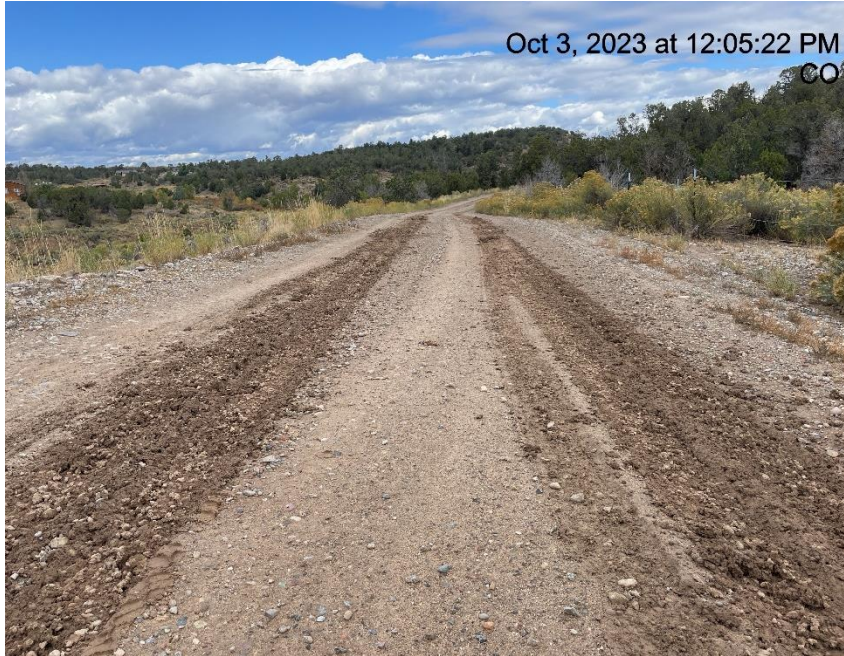
Photo # 1378 Vehicle tracking onto lease road/insufficient tracking BMP's

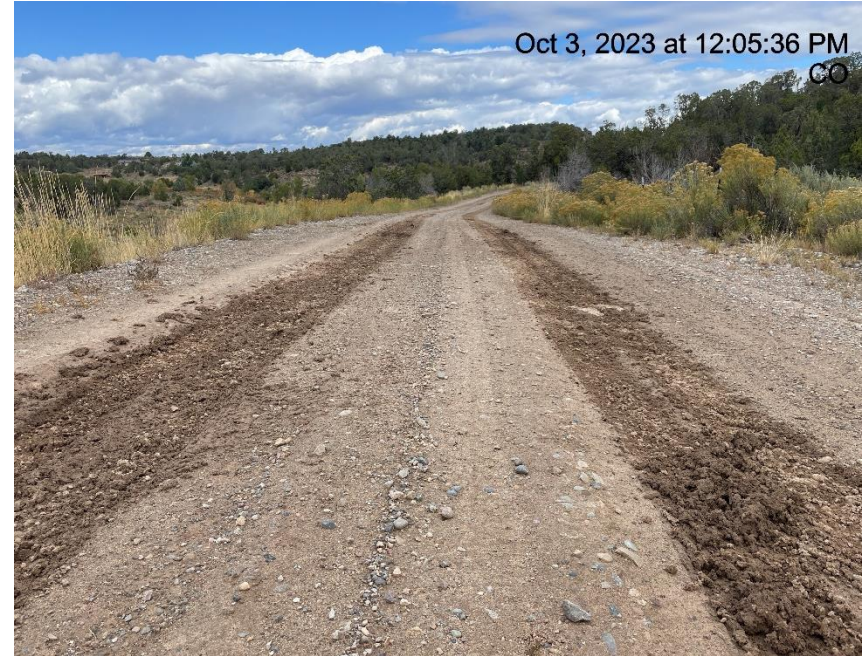
Photo # 1379 Vehicle tracking onto lease road/insufficient tracking BMP's

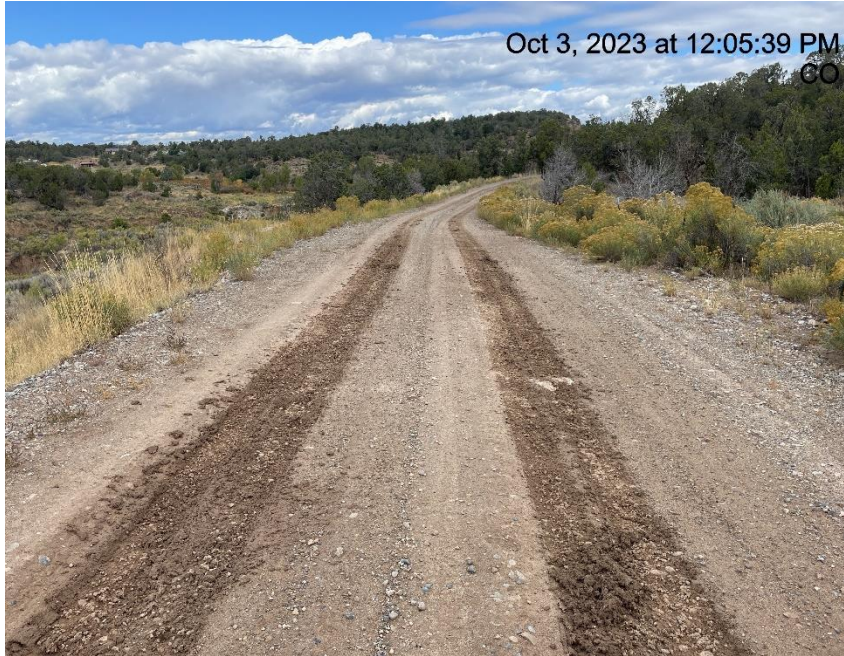
Photo # 1380 Vehicle tracking onto lease road/insufficient tracking BMP's

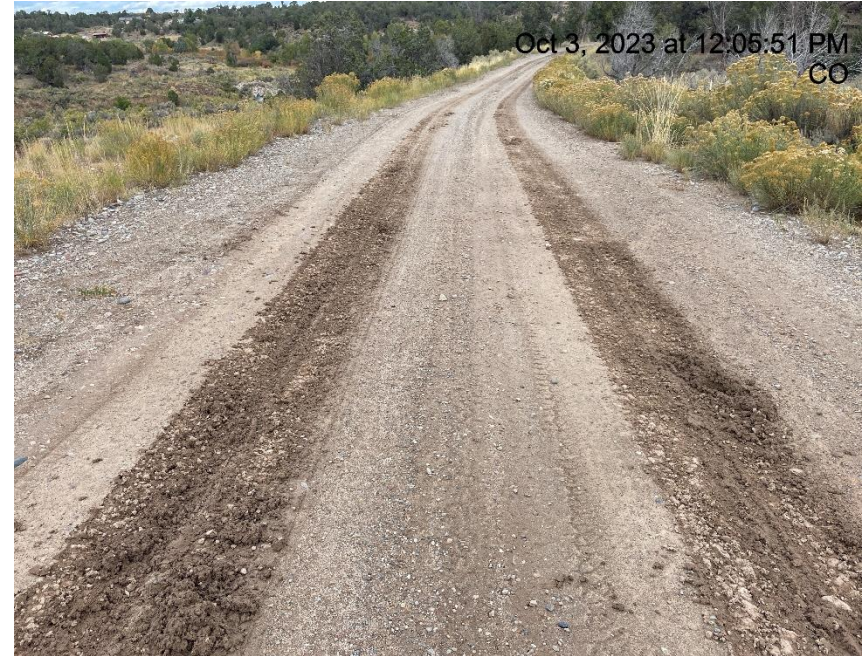
Photo # 1381 Vehicle tracking onto lease road/insufficient tracking BMP's

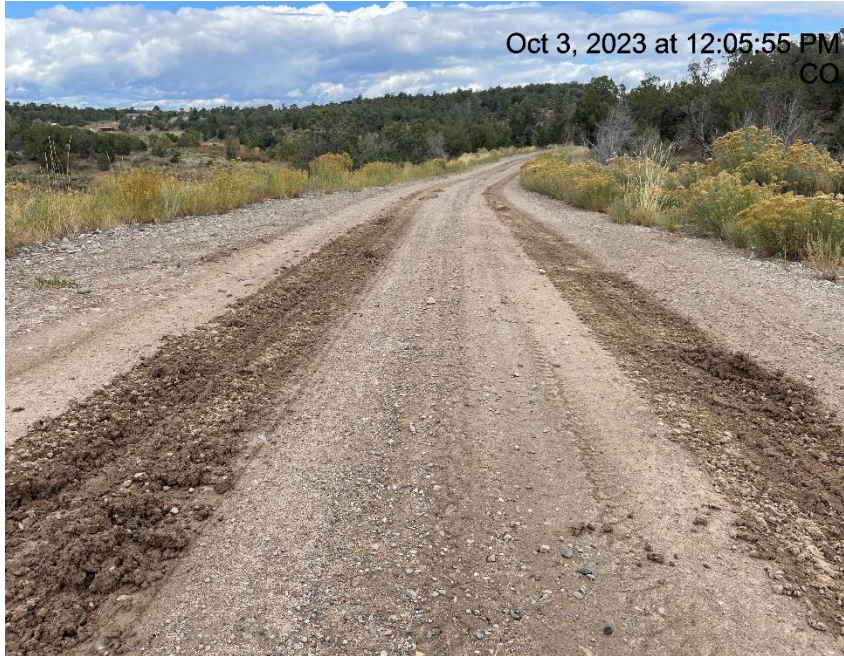
Photo # 1382 Vehicle tracking onto lease road/insufficient tracking BMP's

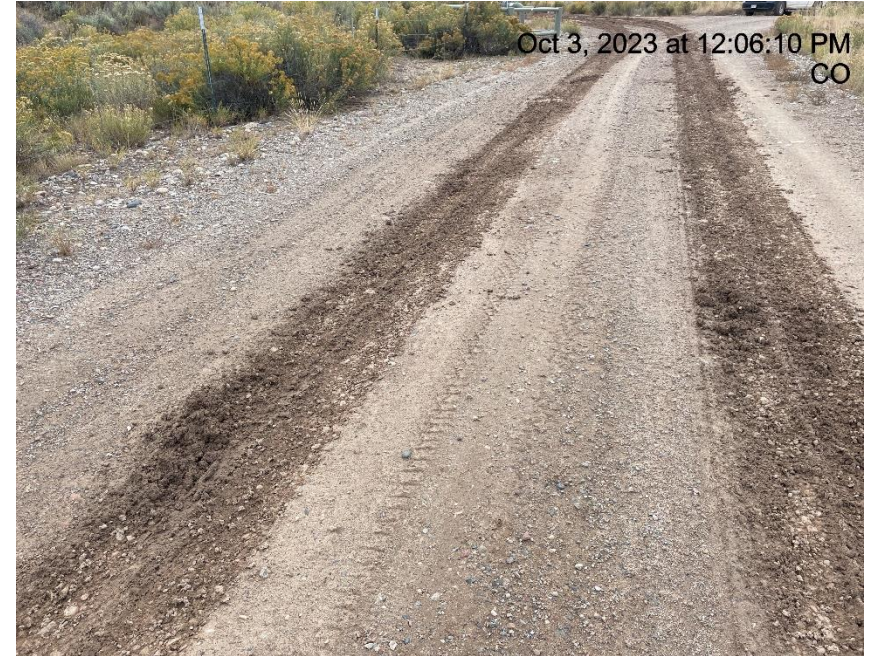
Photo # 1383 Vehicle tracking onto lease road/insufficient tracking BMP's

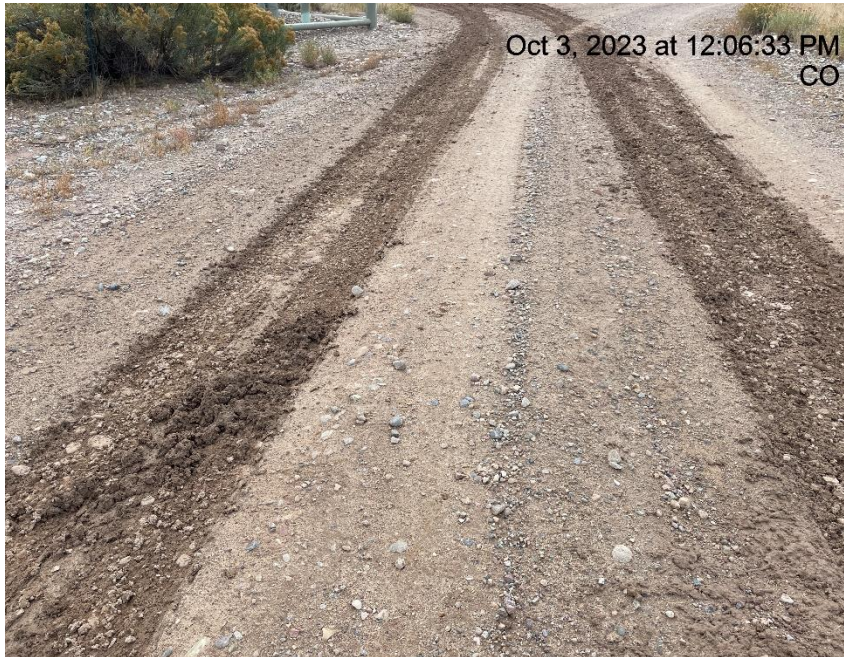
Photo # 1384 Vehicle tracking onto lease road/insufficient tracking BMP's

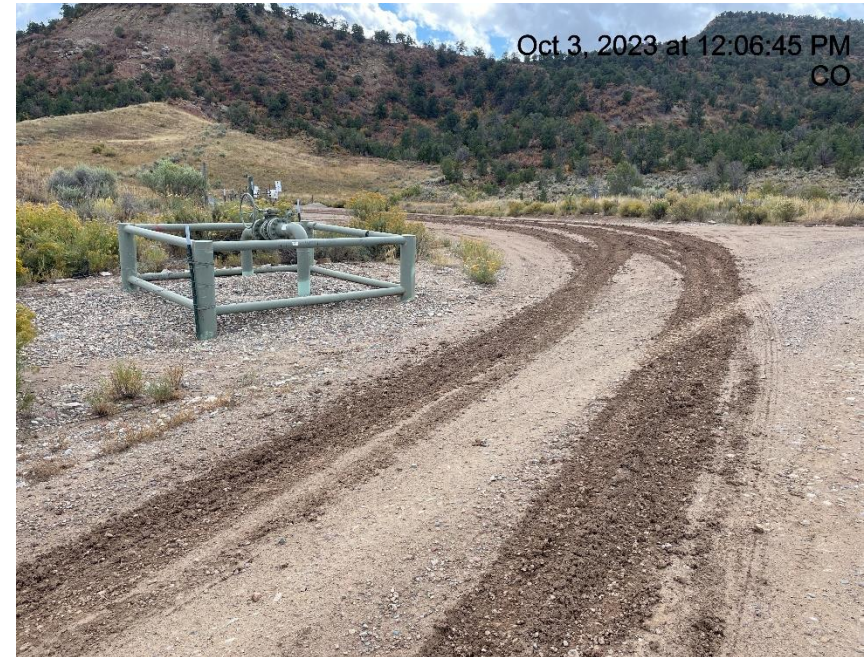
Photo # 1385 Vehicle tracking onto lease road/insufficient tracking BMP's

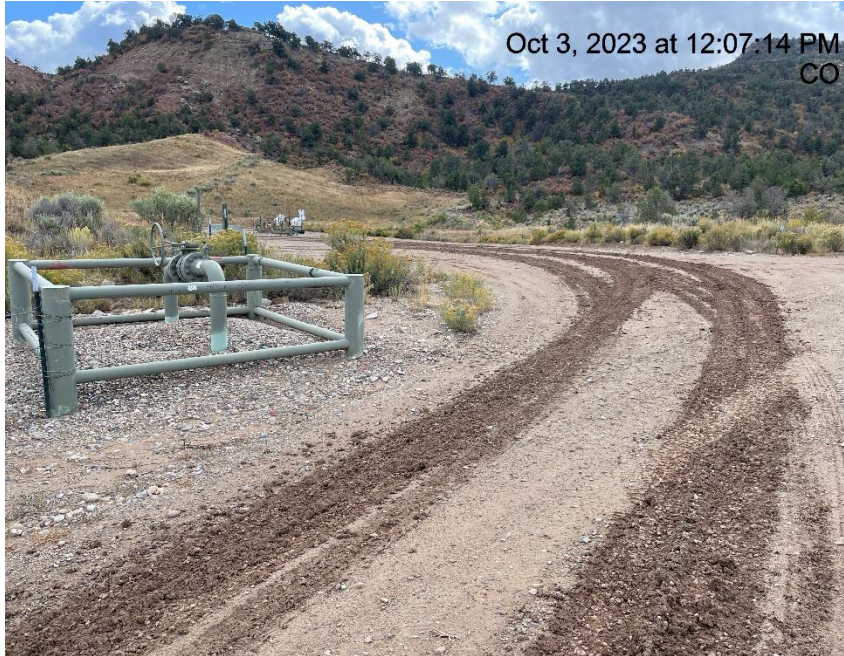
Photo # 1386 Vehicle tracking onto lease road/insufficient tracking BMP's

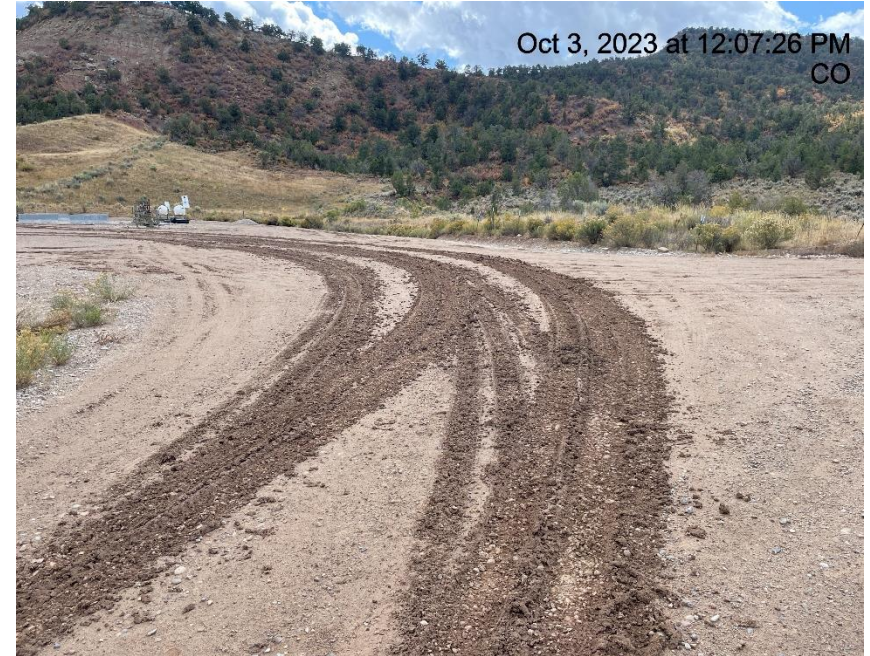
Photo # 1387 Vehicle tracking onto lease road/insufficient tracking BMP's

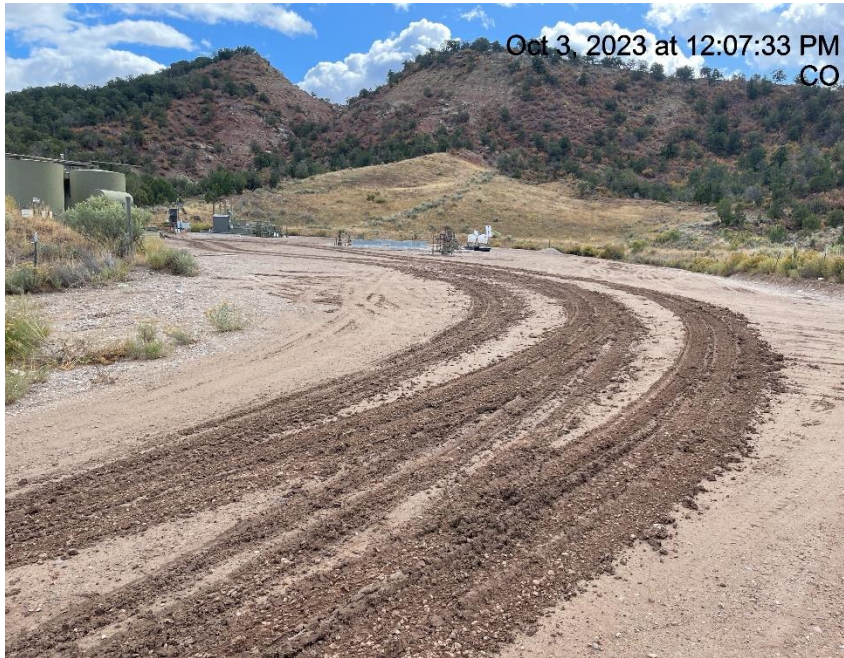
Photo # 1388 Vehicle tracking onto lease road/insufficient tracking BMP's

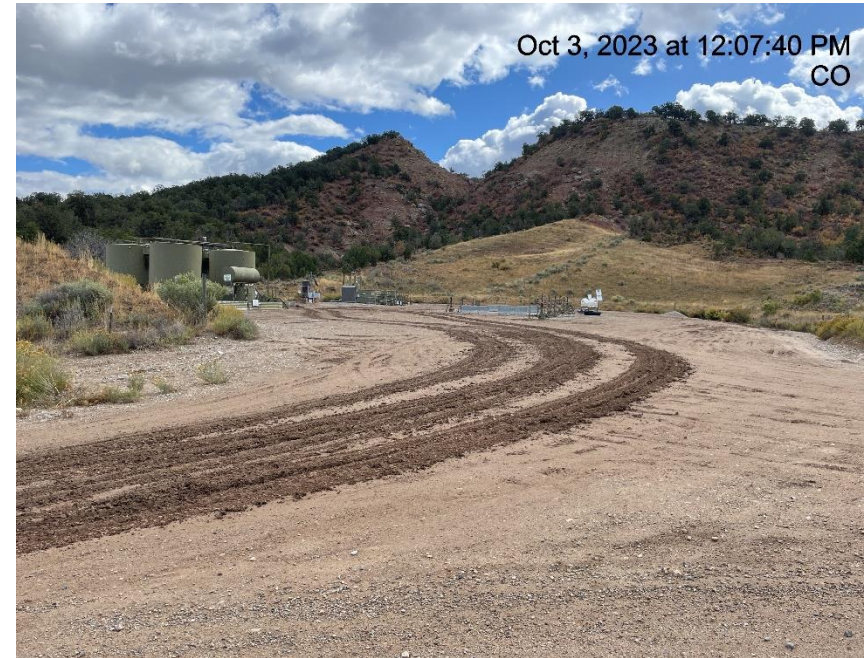
Photo # 1389 Vehicle tracking onto lease road/insufficient tracking BMP's

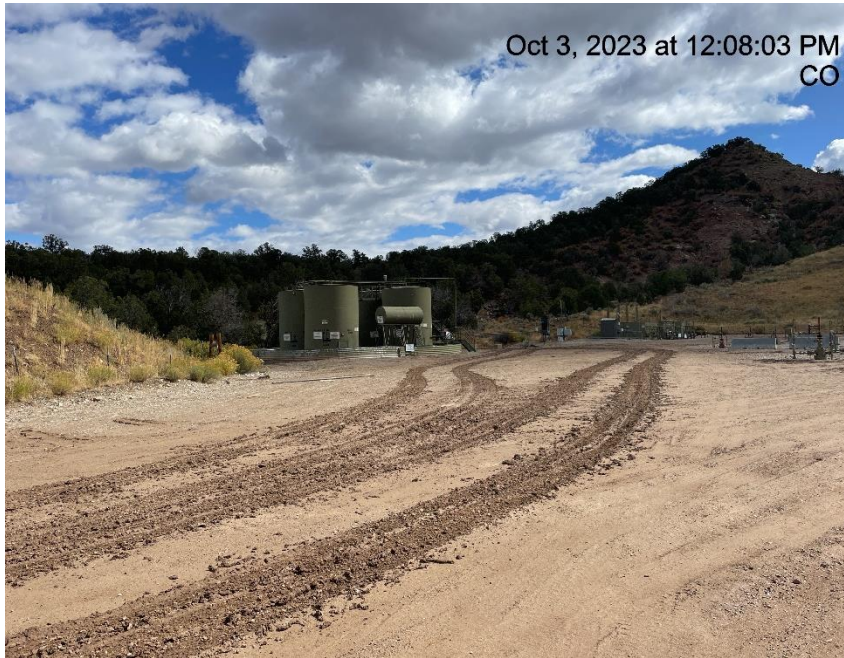
Photo # 1390 Vehicle tracking onto lease road/insufficient tracking BMP's

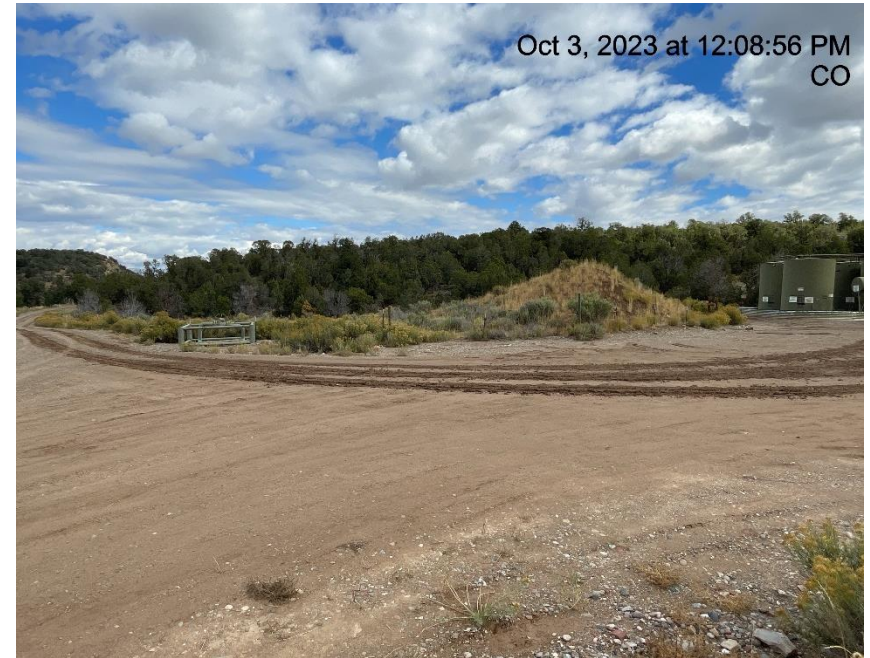
Photo # 1391 Vehicle tracking onto lease road/insufficient tracking BMP's

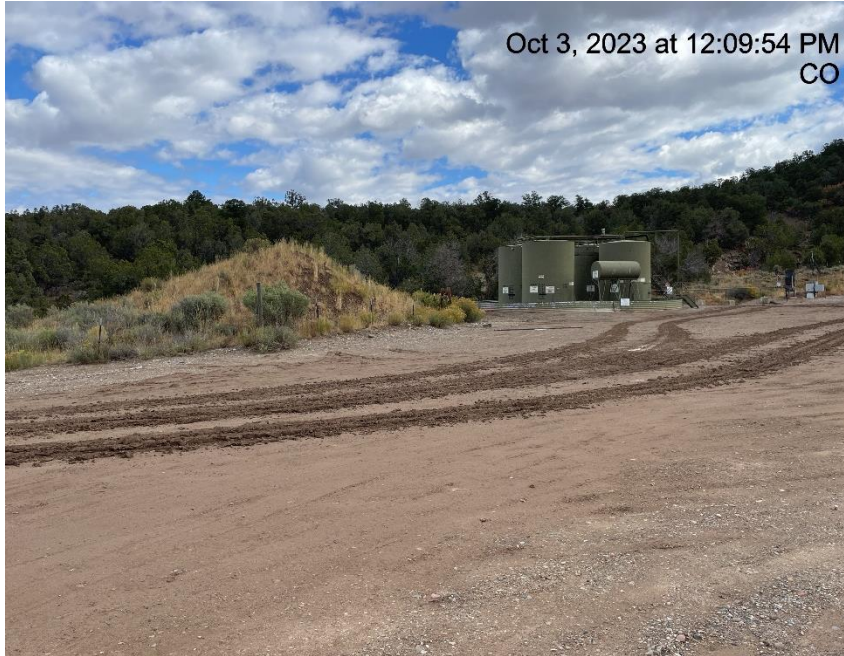
Photo # 1392 Vehicle tracking onto lease road/insufficient tracking BMP's

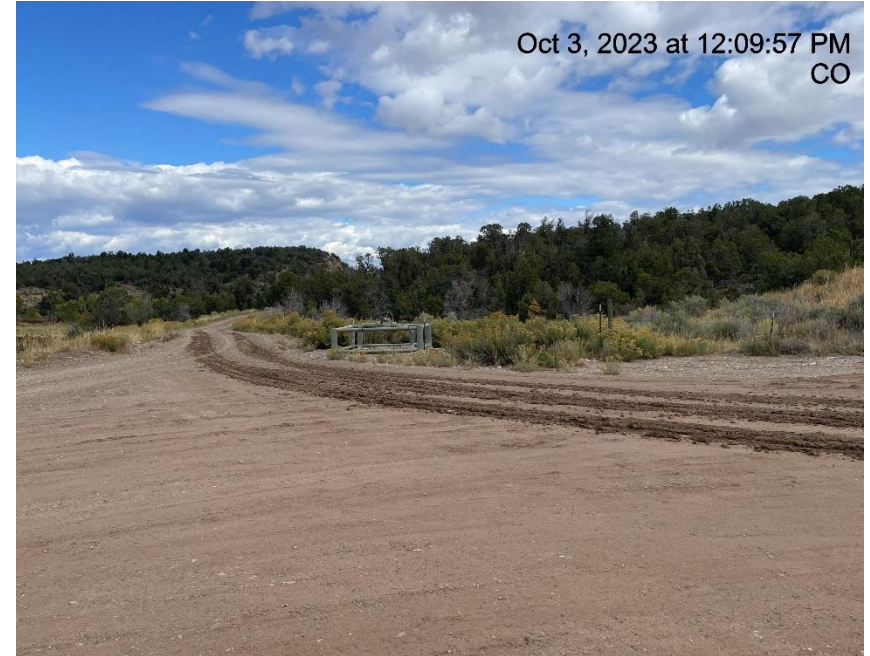
Photo # 1393 Vehicle tracking onto lease road/insufficient tracking BMP's
