Inspection Photos
Location Name: CAERUS PICEANCE LLC M34NE Pad
Location #: 334987

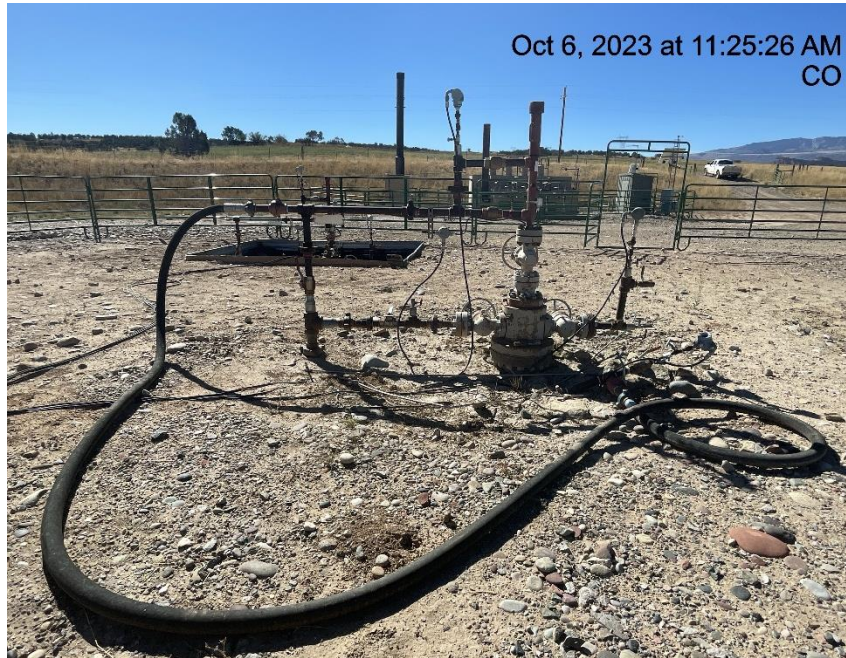
Photo # 1916 KELLY 34-13 well bradenhead connected to flowline

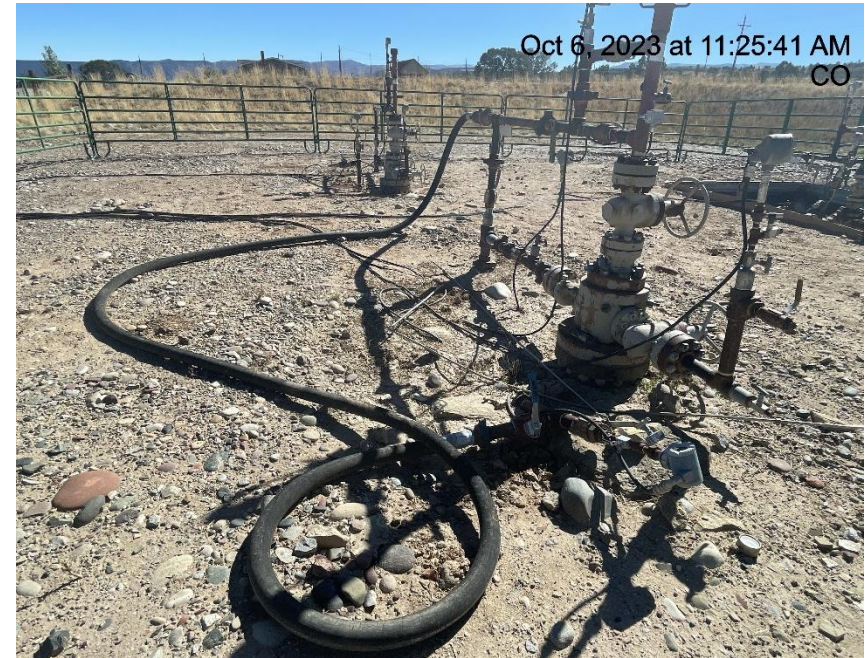
Photo # 1917 KELLY 34-13 well bradenhead connected to flowline

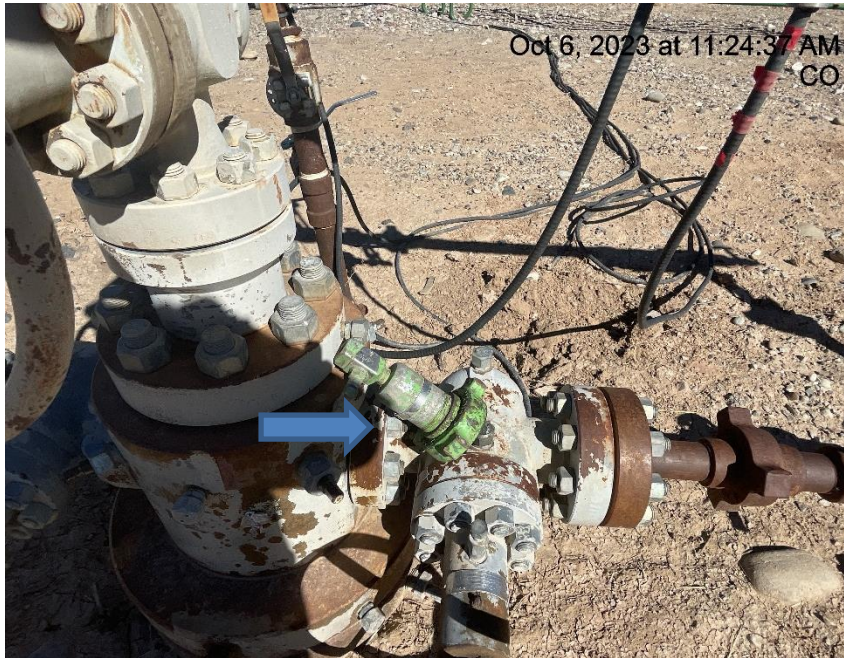
Photo # 1918 Debris

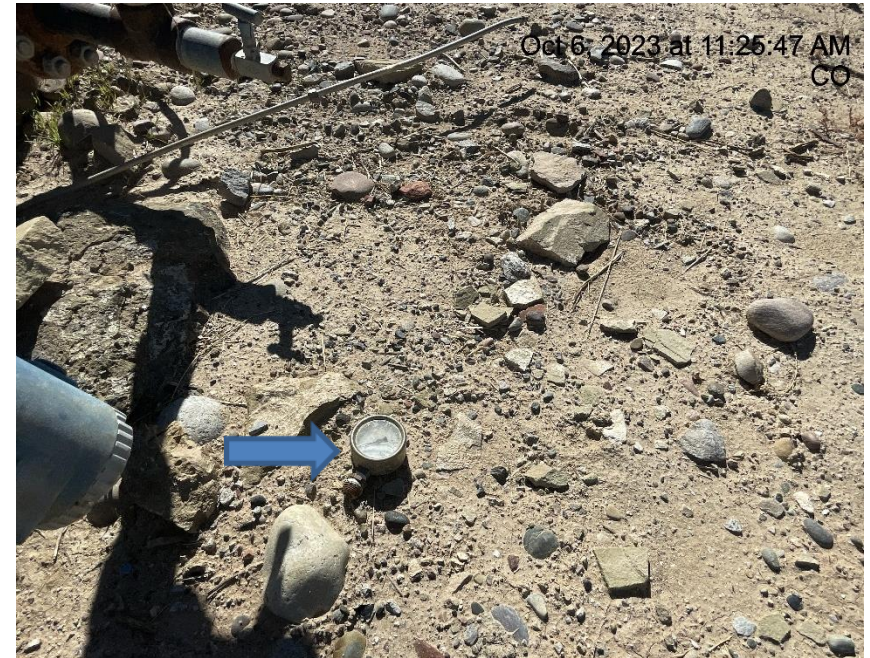
Photo # 1919 Debris

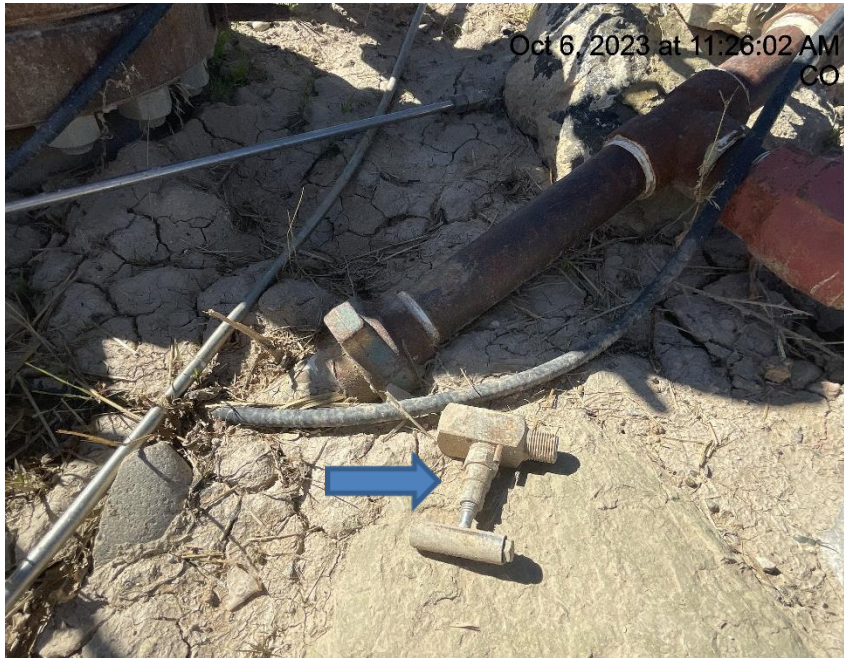
Photo # 1920 Debris

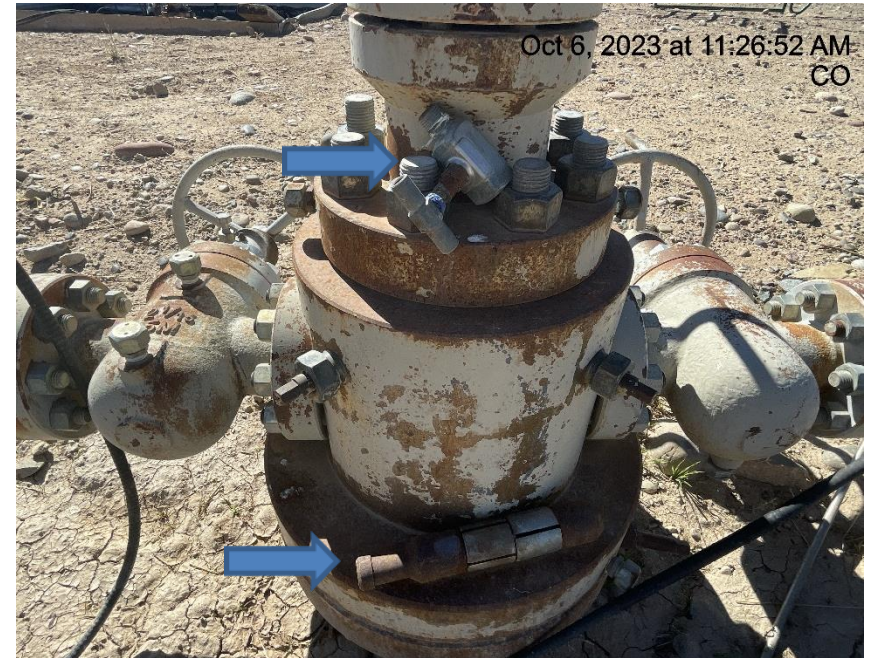
Photo # 1921 Debris

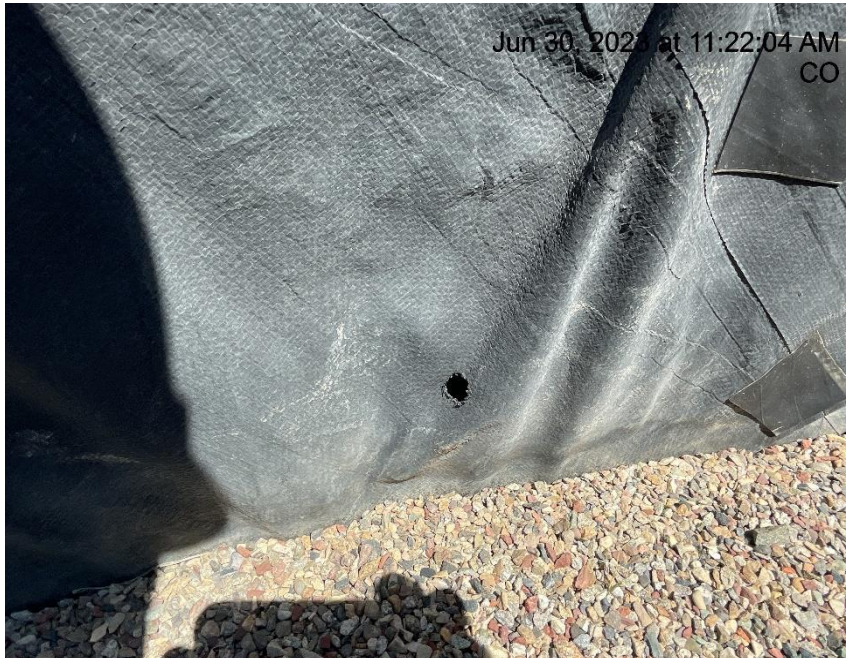
Photo # 2272 From inspection 708900904 conducted on 06/30/2023 Hole in secondary containment liner/liner needs maintenance

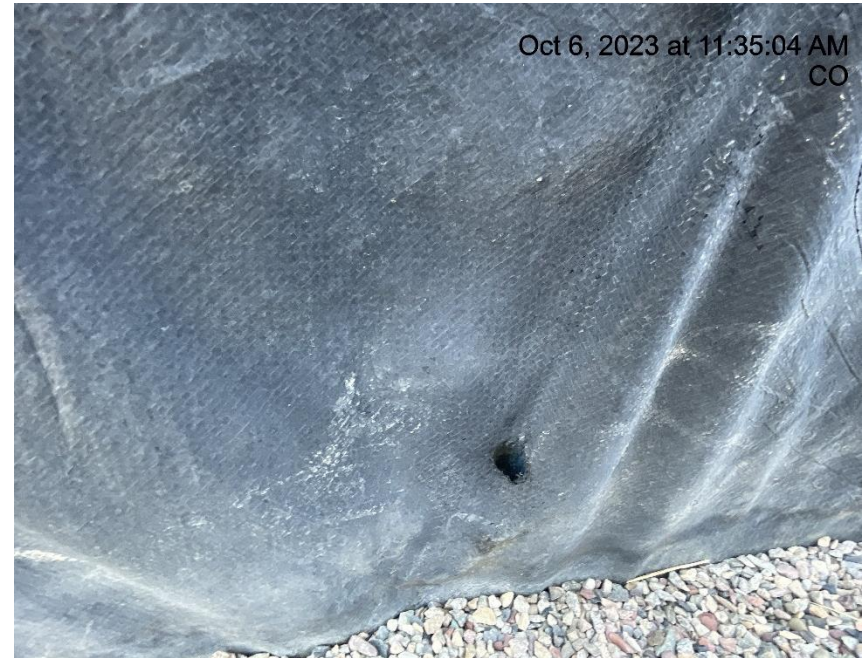
Photo # 1922 Hole in secondary containment liner/liner needs maintenance

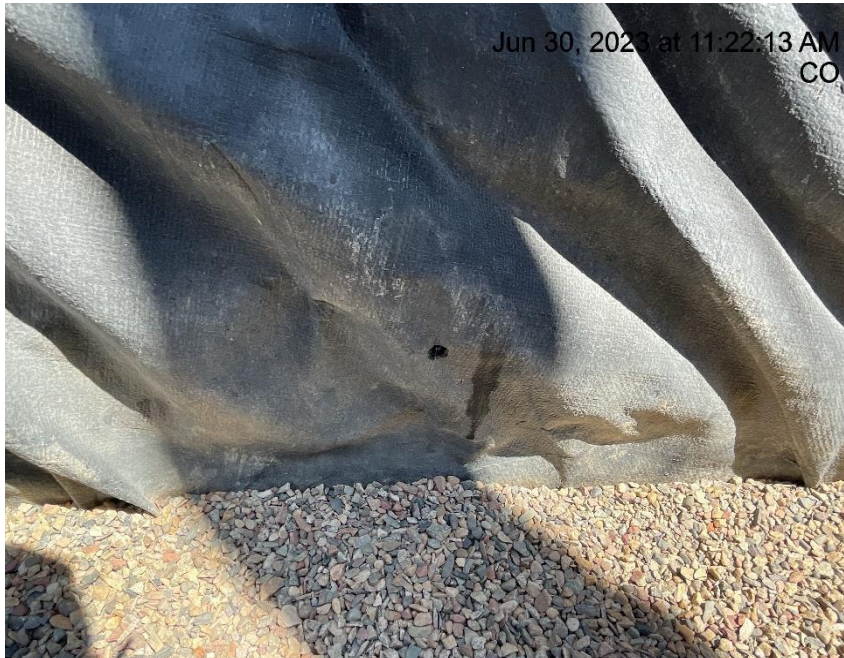
Photo # 2274 From inspection 708900904 conducted on 06/30/2023 Hole in secondary containment liner/liner needs maintenance

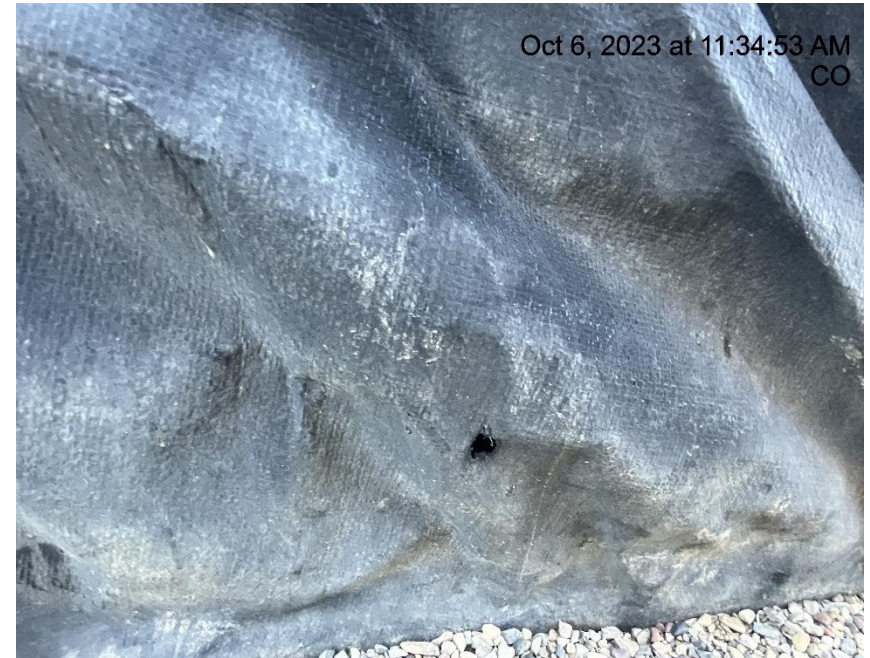
Photo # 1923 Hole in secondary containment liner/liner needs maintenance

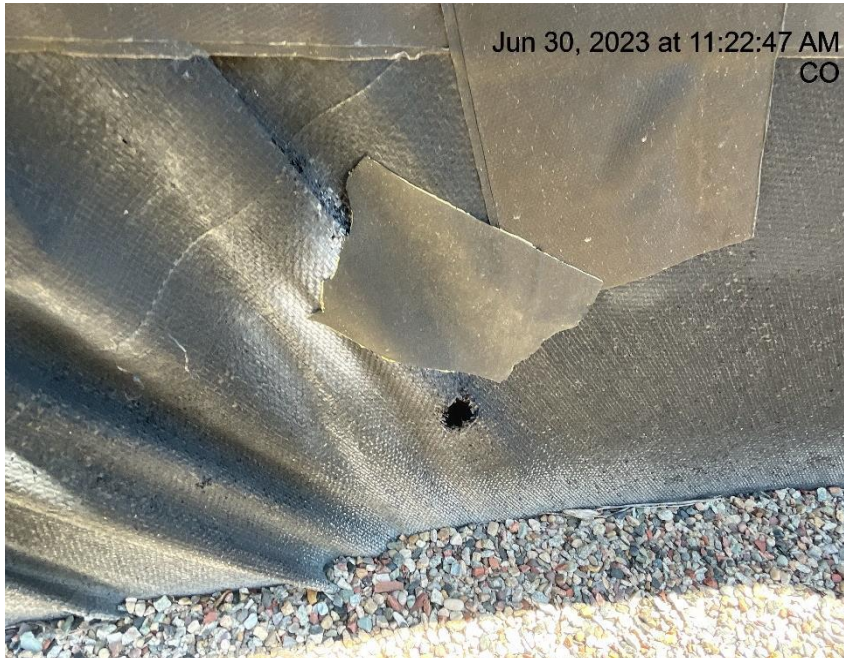
Photo # 2280 From inspection 708900904 conducted on 06/30/2023 Hole in secondary containment liner/liner needs maintenance

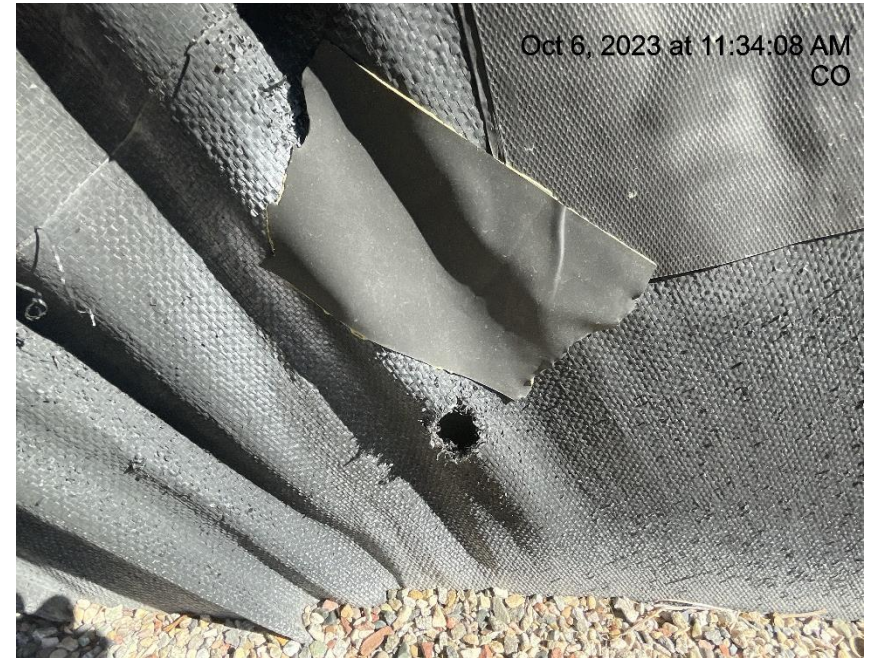
Photo # 1924 Hole in secondary containment liner/liner needs maintenance

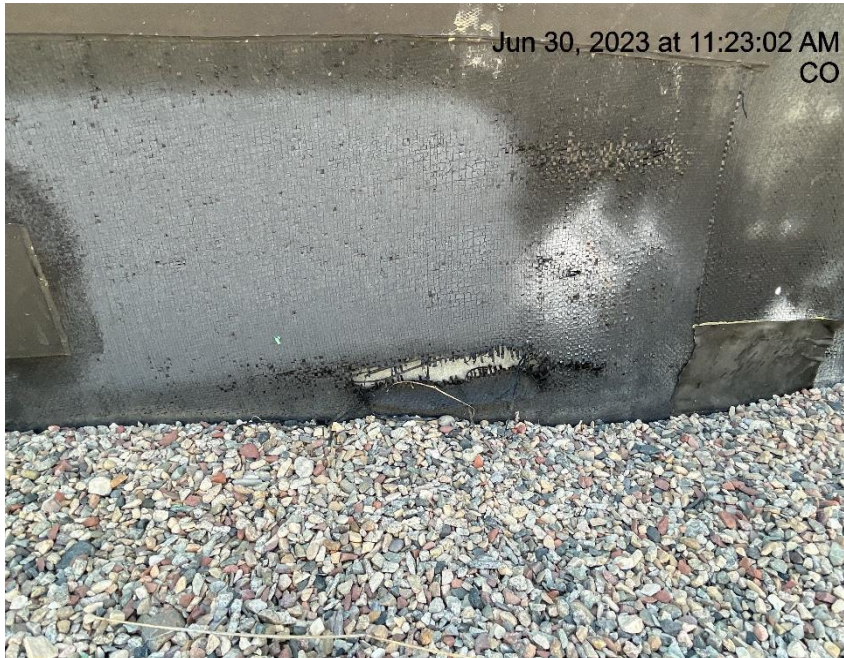
Photo # 2282 From inspection 708900904 conducted on 06/30/2023 Hole in secondary containment liner/liner needs maintenance

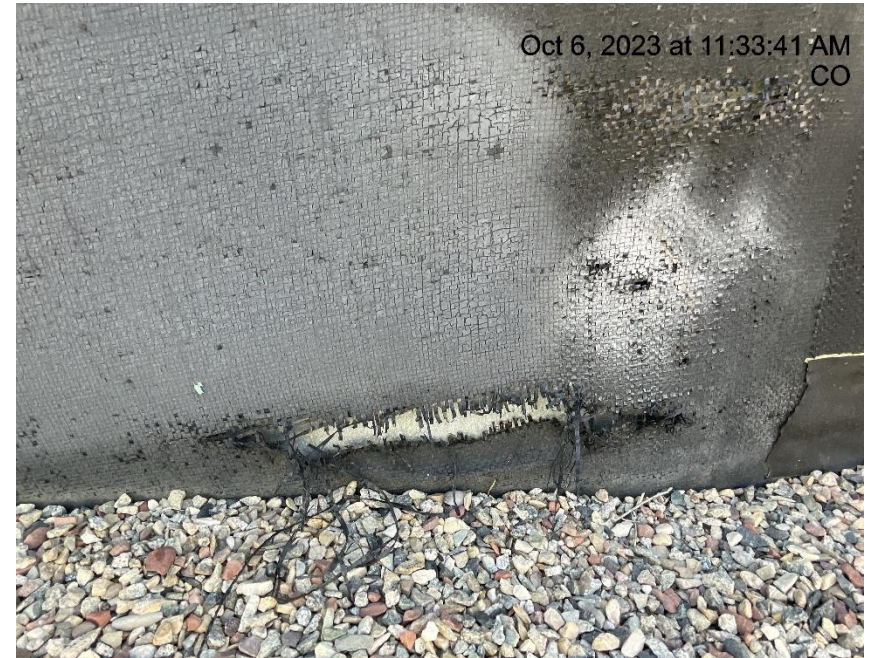
Photo # 1925 Hole in secondary containment liner/liner needs maintenance

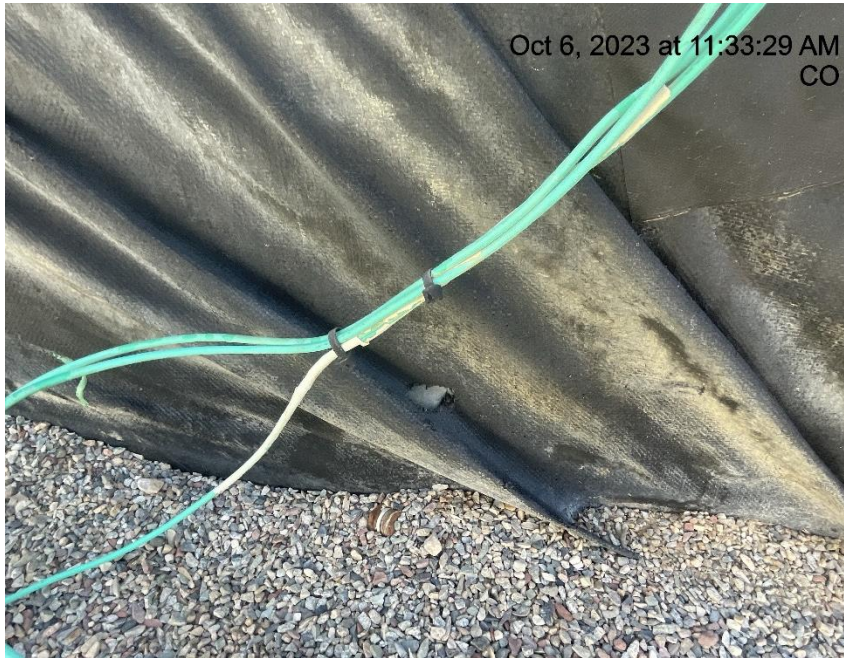
Photo # 1926 Hole in secondary containment liner/liner needs maintenance

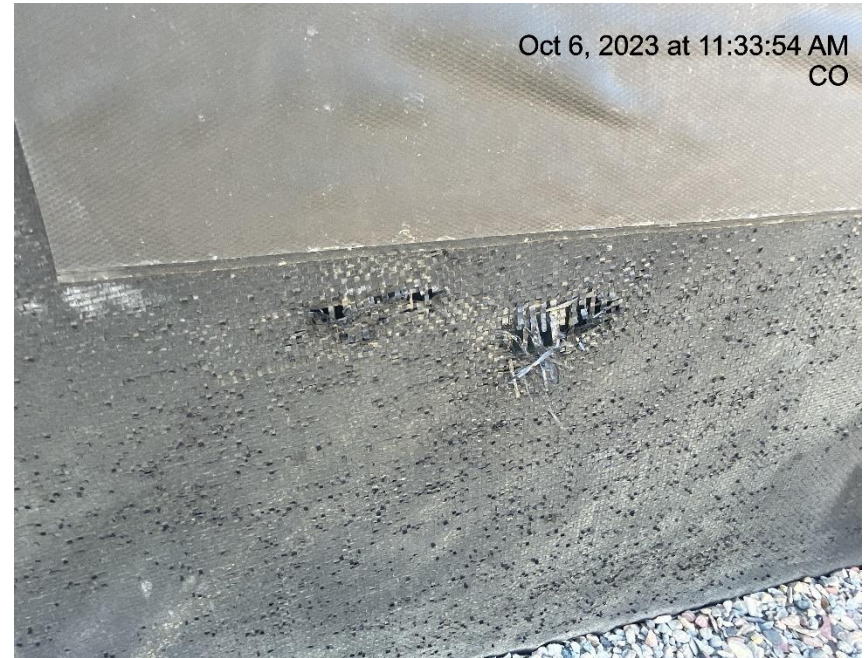
Photo # 1927 Hole in secondary containment liner/liner needs maintenance

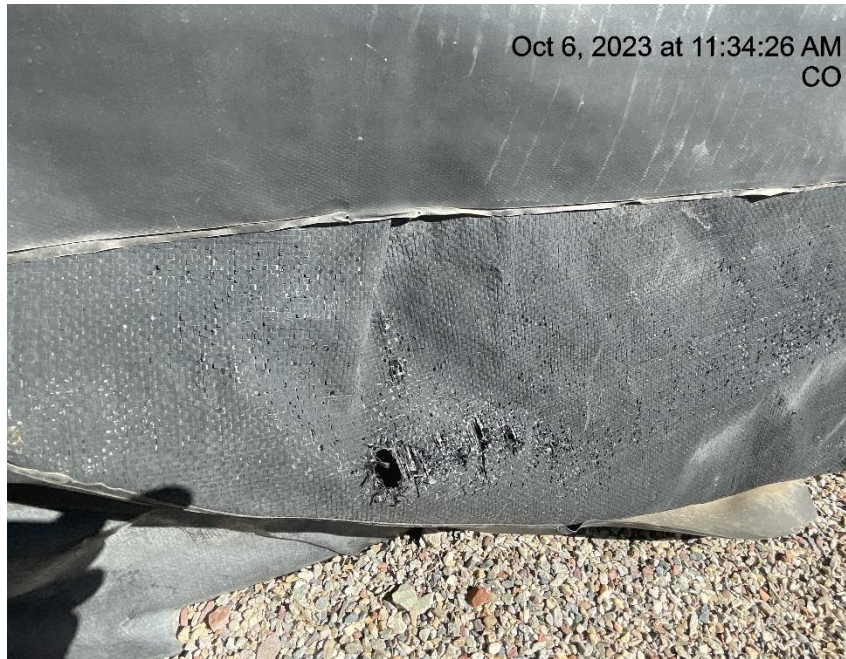
**Photo # 1928 Hole in secondary containment liner/liner
needs maintenance**

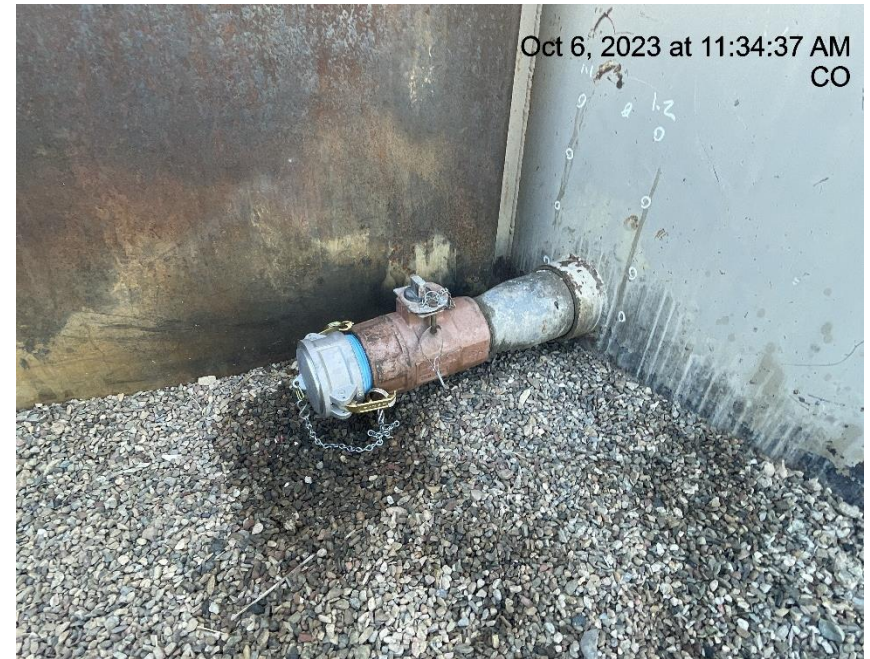
Photo # 1929 Stained gravel

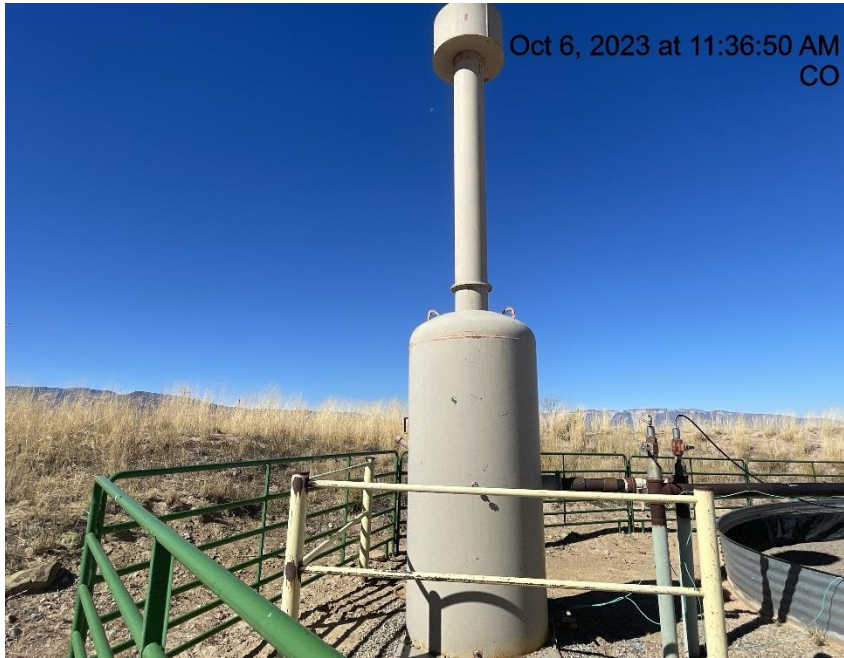
Photo # 1930 Unused equipment

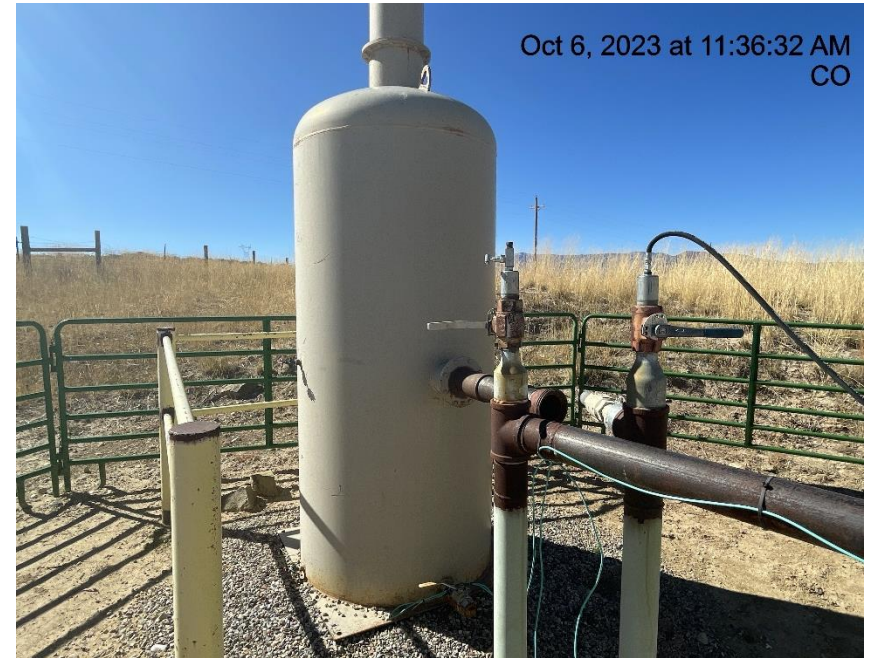
Photo # 1931 Unused equipment/ECD disconnected

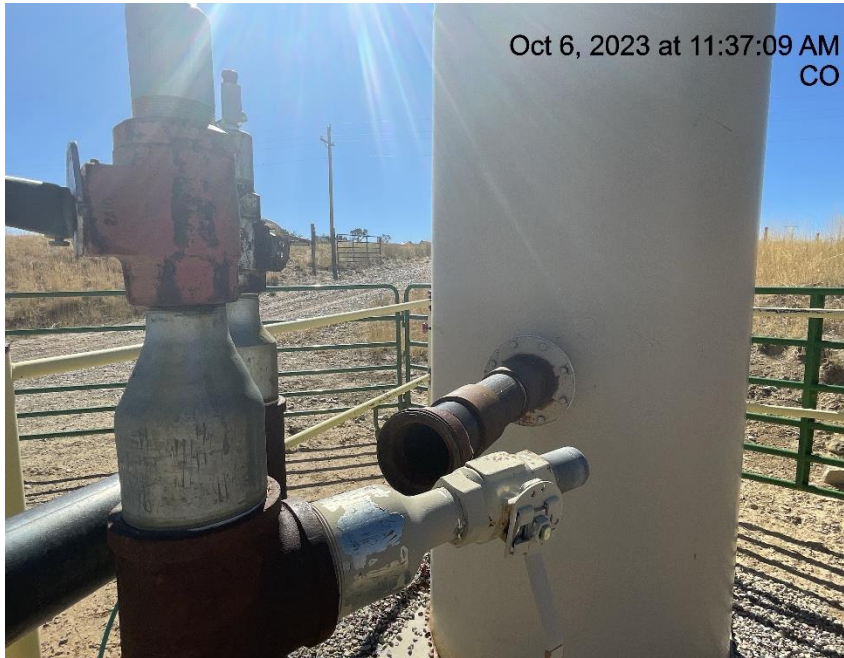
Photo # 1932 Unused equipment/ECD disconnected
