# Inspection Photos

Loc: 384227

Operator: WESTERN OPERATING COMPANY

Inspection Date: 10/5/2023

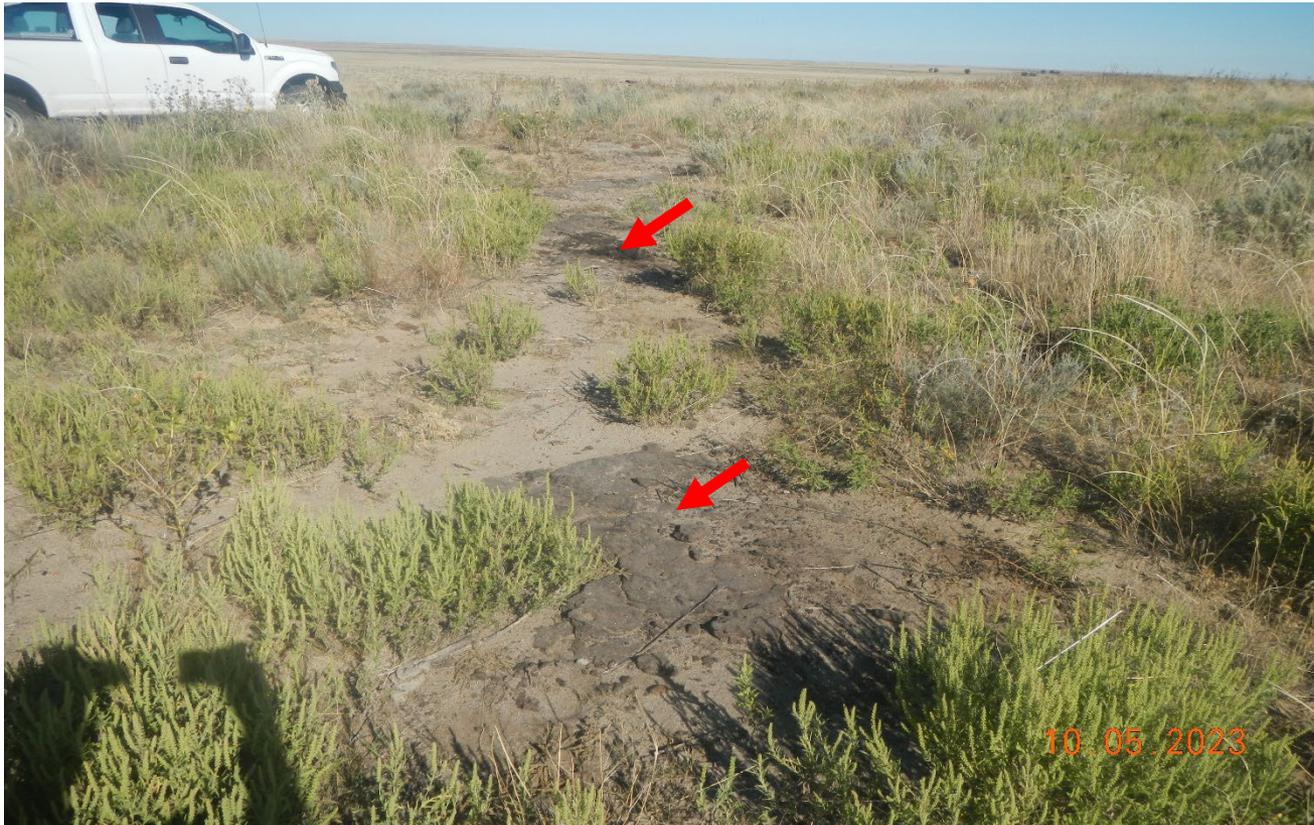
**Photo 1.** Facing northwest along the abandoned flowline near the location. There is oily sludge shown at red arrow that needs to be cleaned up. Lat/Long:-38.42686,-102.46158.

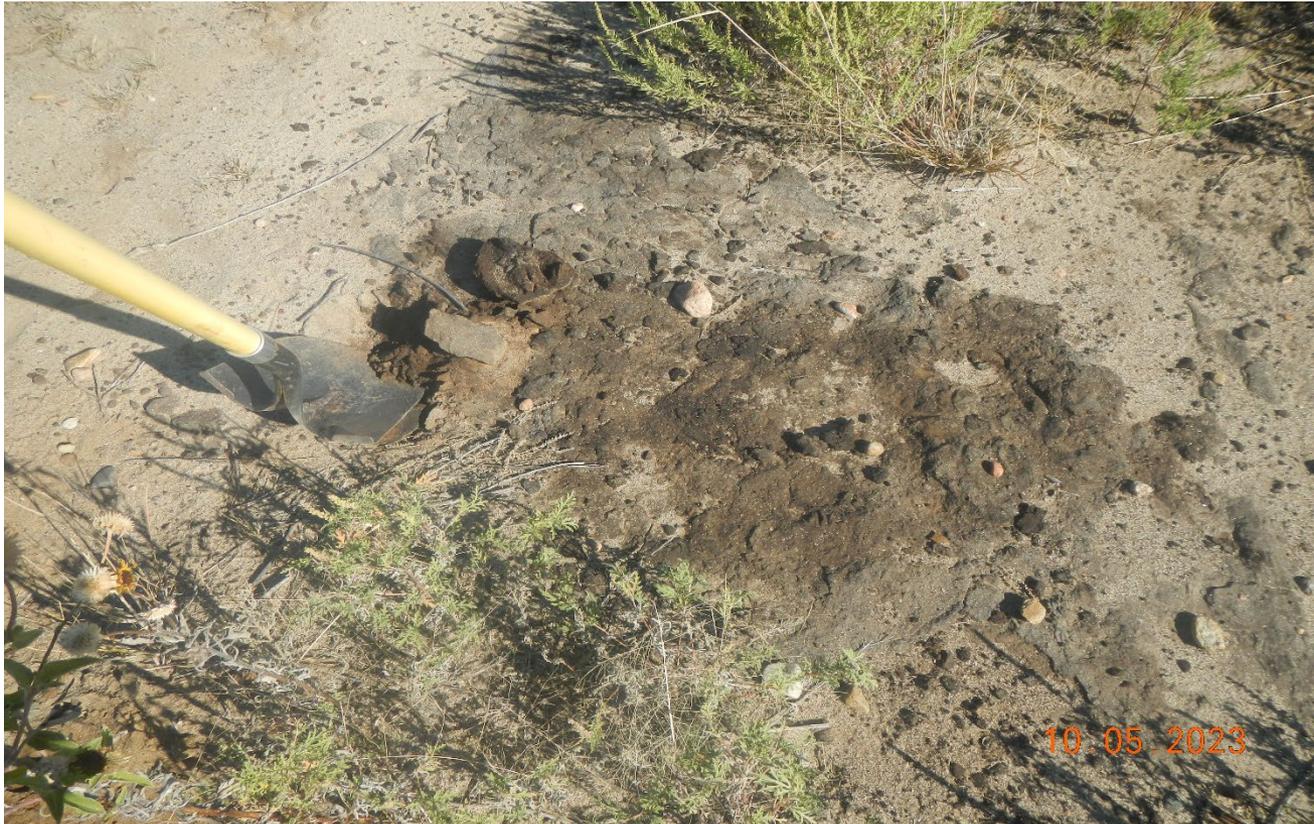
**Photo 2.** View of oily sludge shown at the surface. Lat/Long:38.42686,-102.46158.

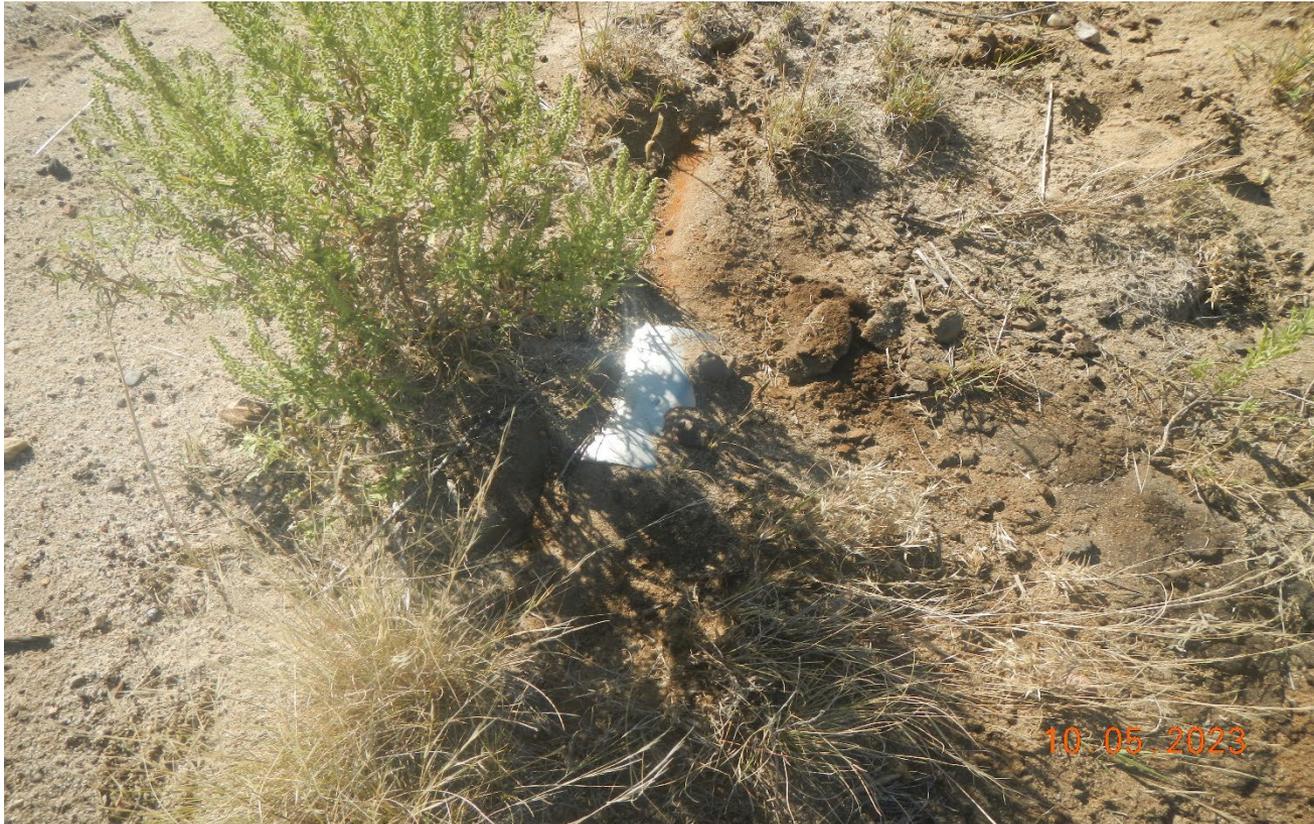
**Photo 3.** There is an exposed flowline at the surface that needs to be removed. .  
Lat/Long:38.42686,-102.46158.

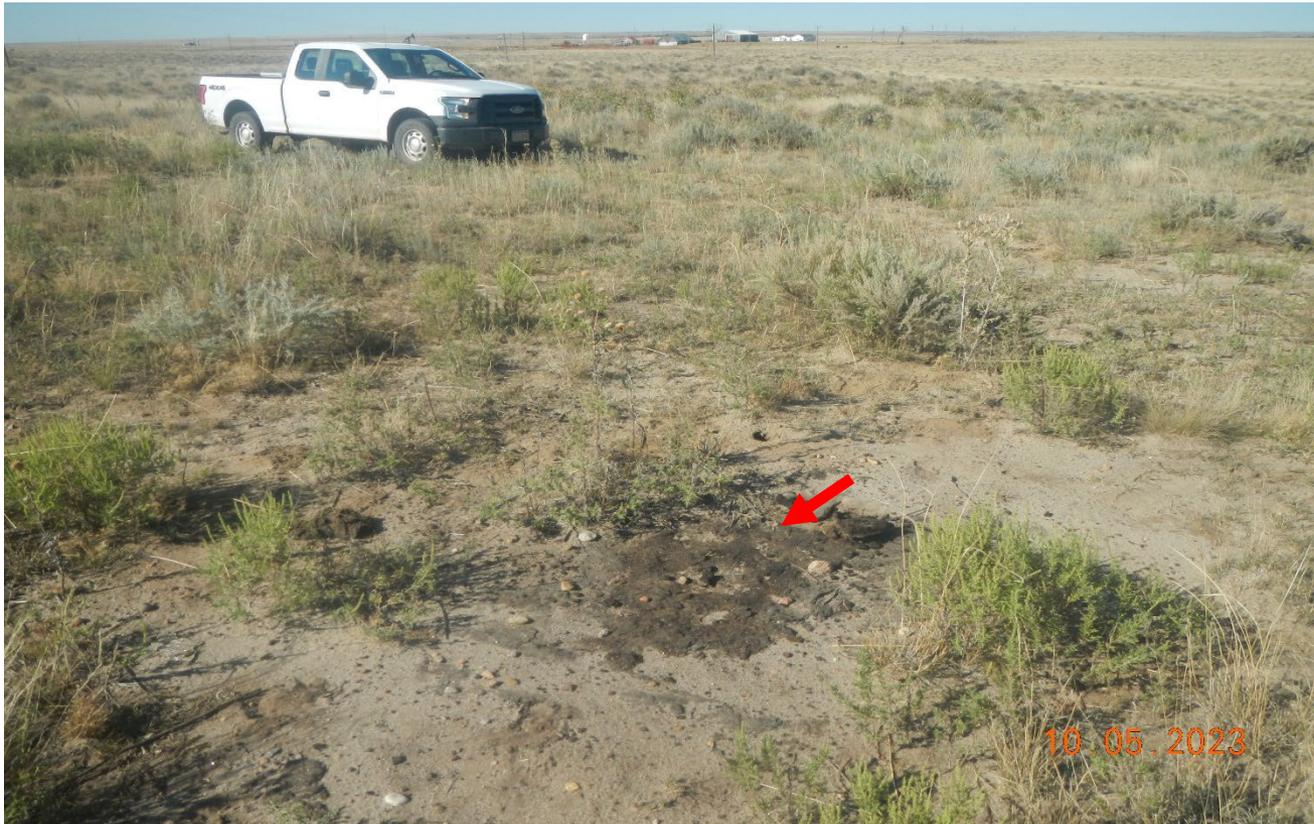
**Photo 4.** Facing southwest along the abandoned flowline near the location. There is oily sludge shown at red arrow that needs to be cleaned up. Lat/Long:-38.42686,-102.46158.

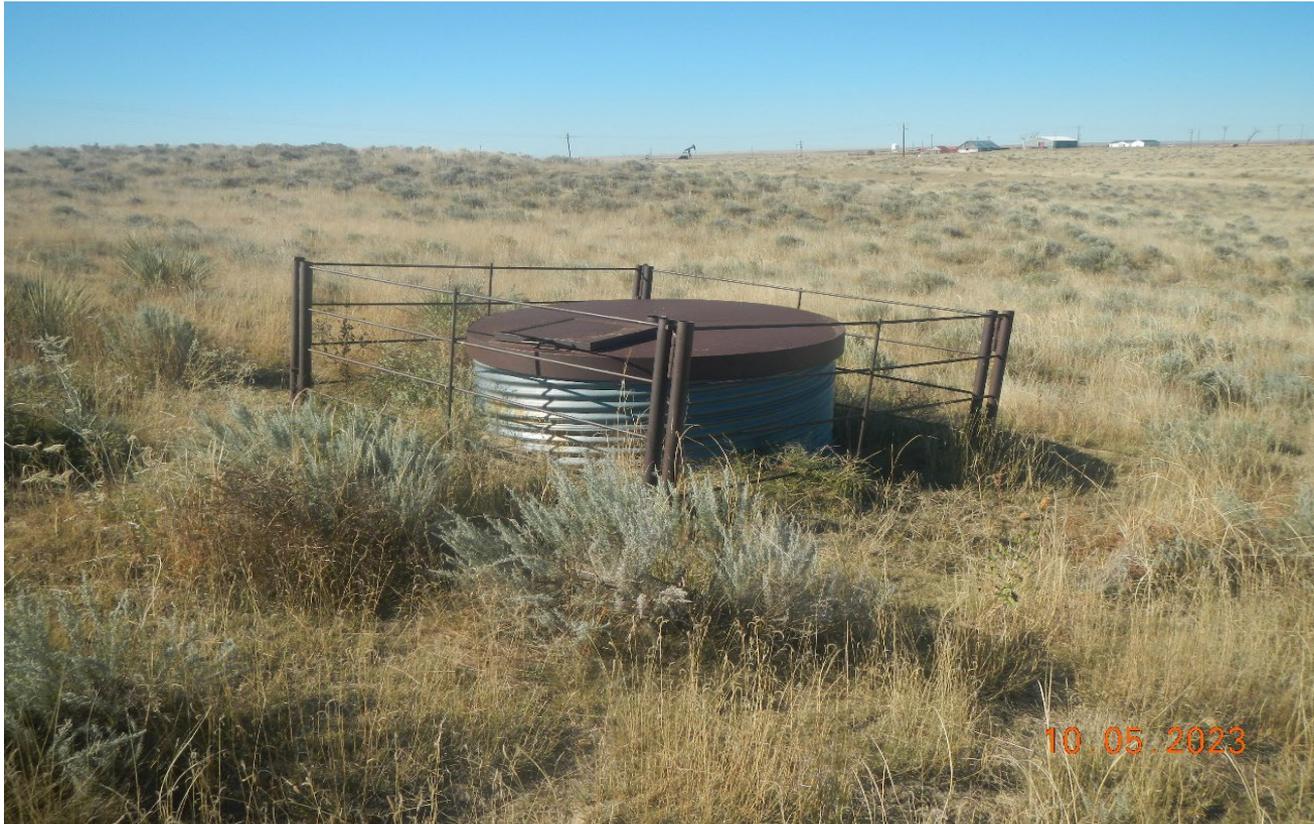
**Photo 5.** Facing southwest near the abandoned wellsite is abandoned flowline cellar that needs to be removed. Lat/Long:38.42706, -102.46211.

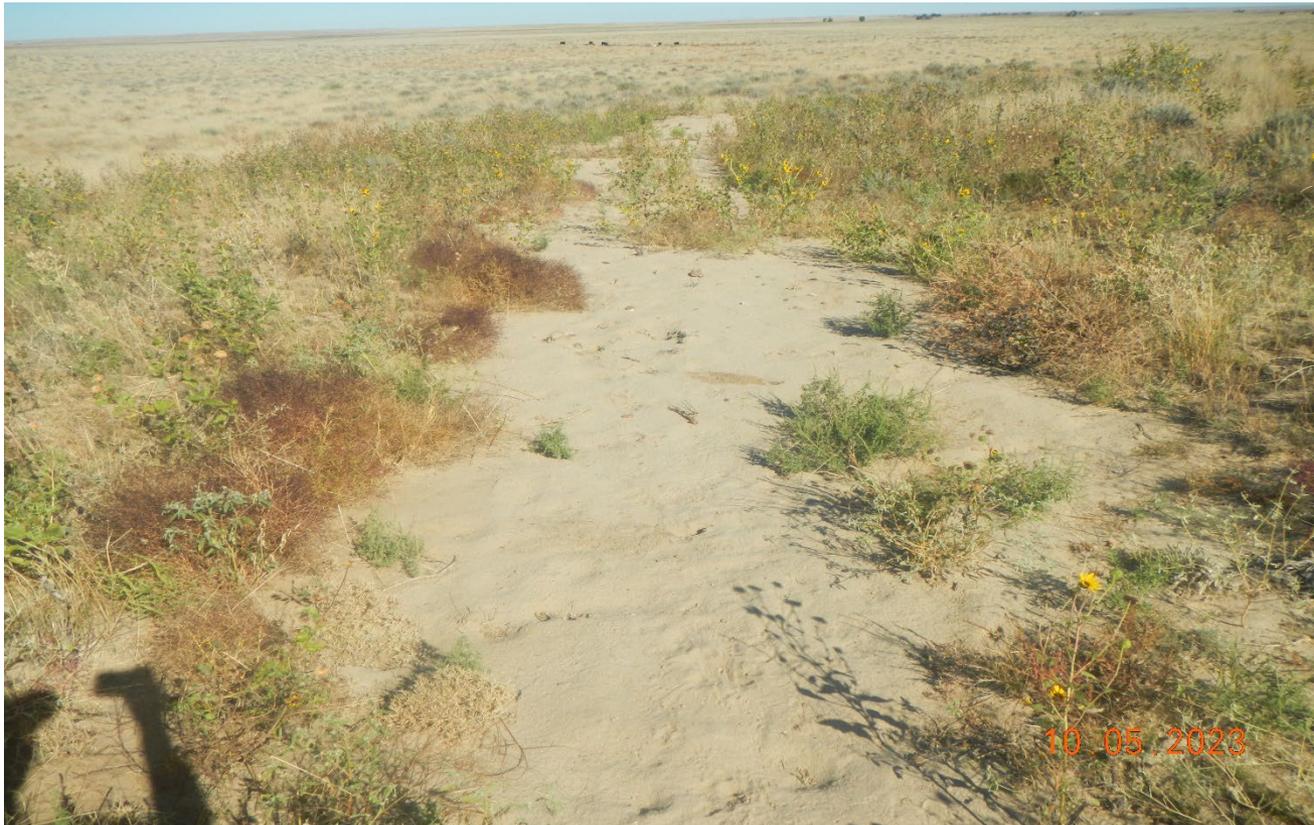
**Photo 6.** Facing north at the abandoned wellsite location. The sandy soils have not revegetated and need to be seeded and reclaimed.

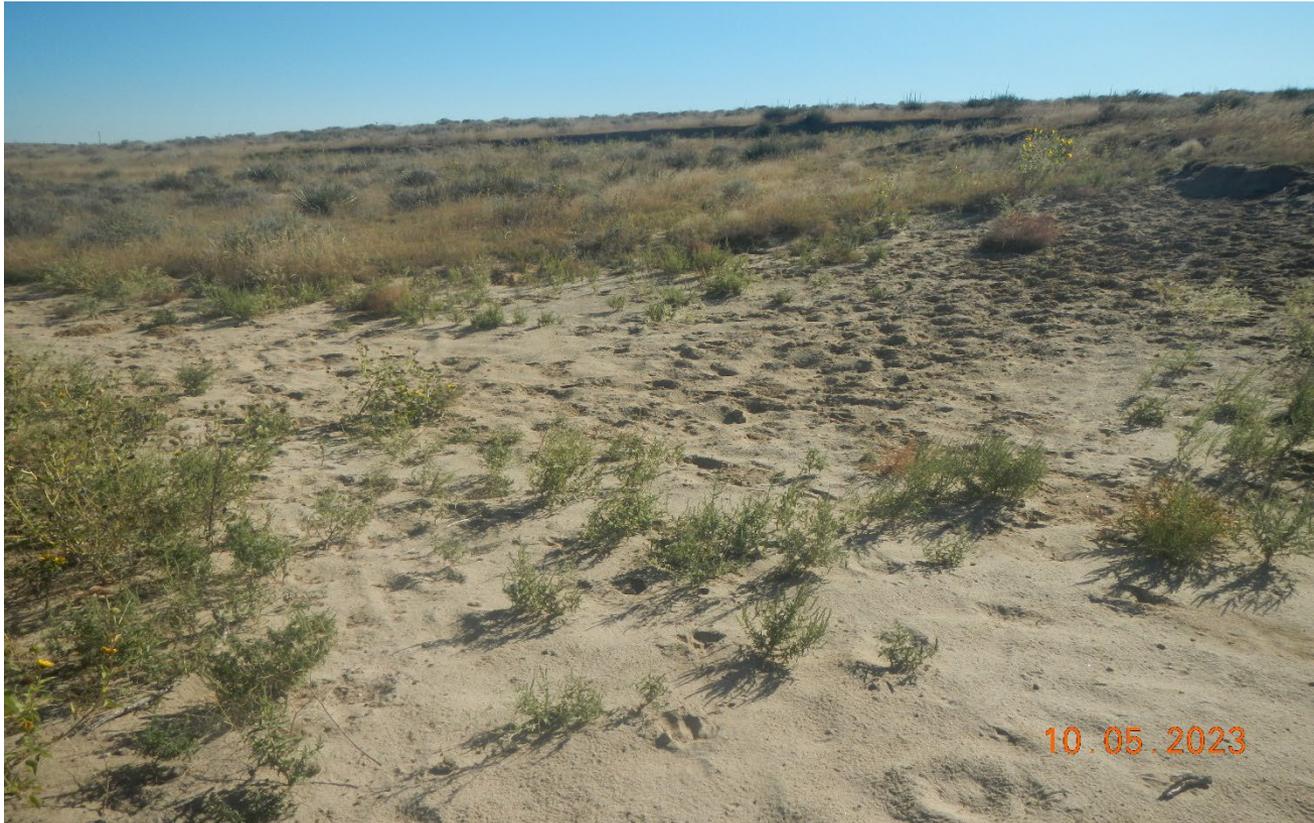
**Photo 7.** Facing east at the abandoned wellsite location. The sandy soils have not revegetated and need to be seeded and reclaimed.

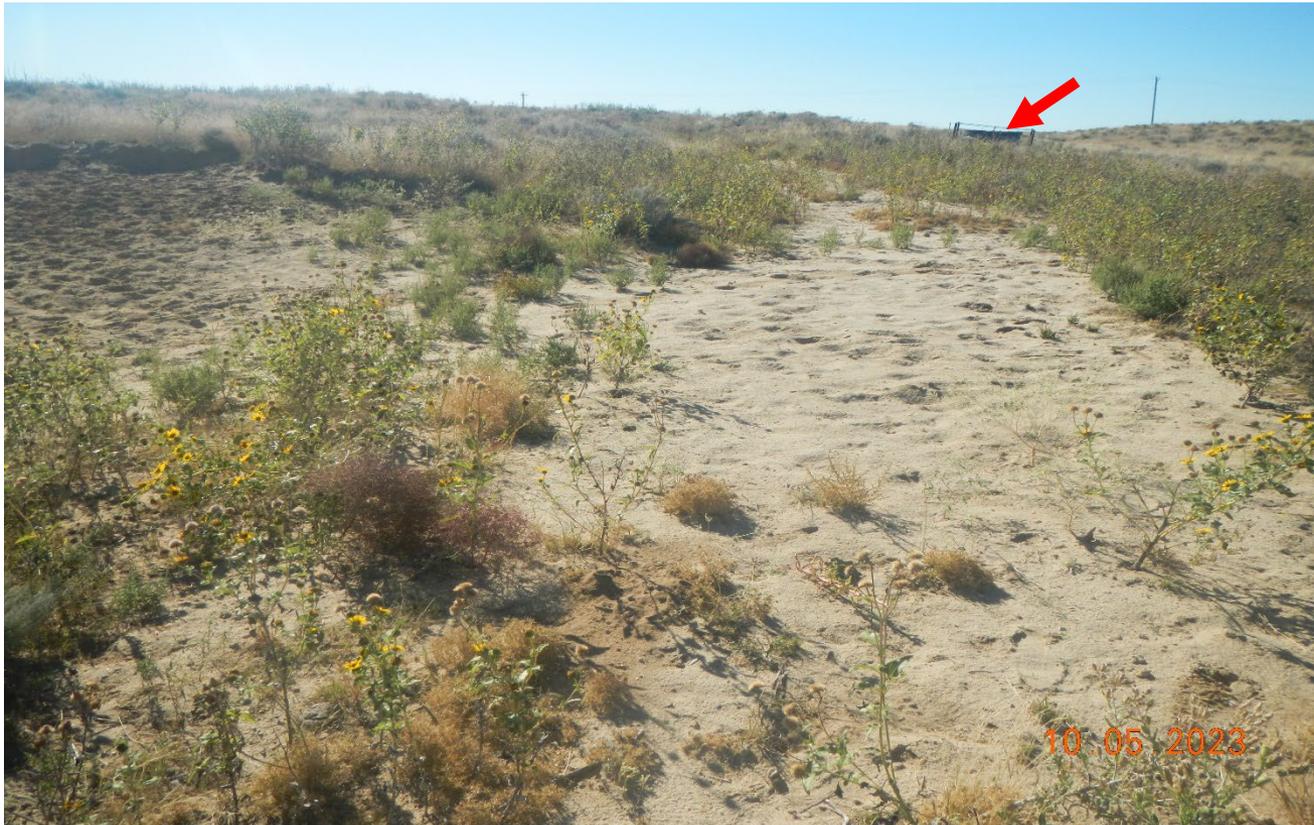
**Photo 8.** Facing southwest at the abandoned wellsite location. The sandy soils have not revegetated and need to be seeded and reclaimed. The red arrow points to the abandoned flowline cellar that needs to be removed.
