Inspection Photos

Location Name: TEP ROCKY MOUNTAIN LLC, FEDERAL-66S96W/33SESW

Location ID: 334862

Date: 10/5/2023

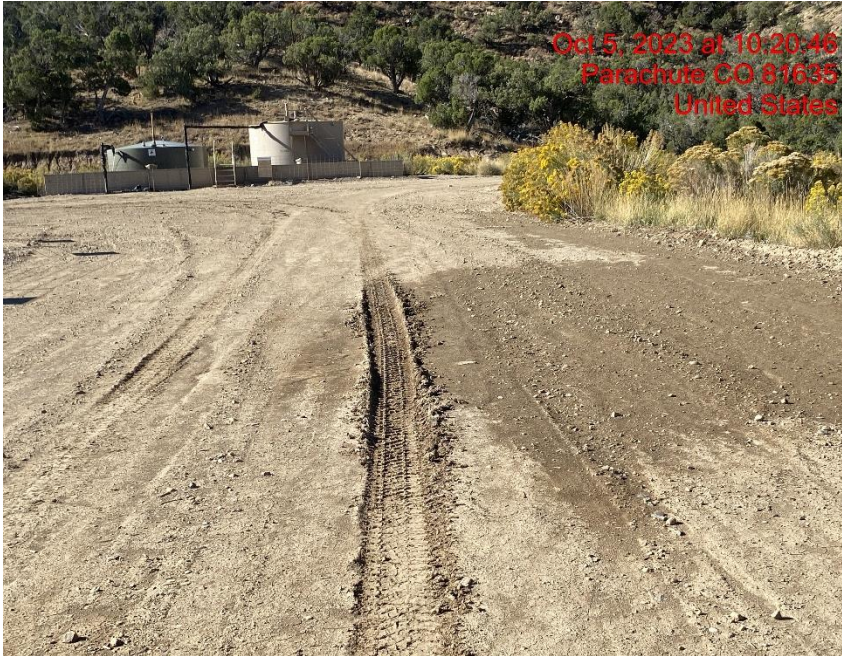
Location Lacks Stabilization – Photo #06834

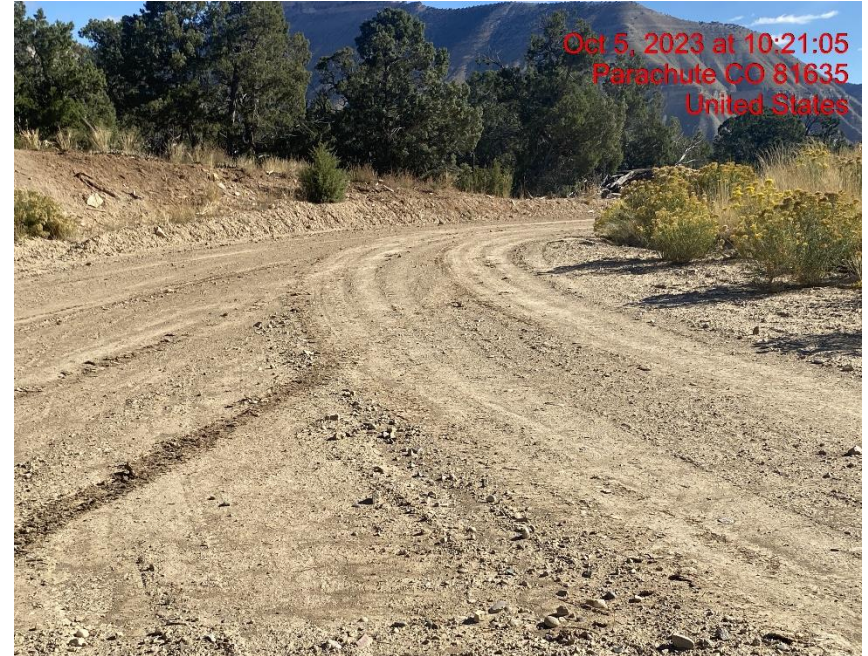
**Insufficient Vehicle Tracking BMPs at Location Entrance/Exit
– Photo #06835**

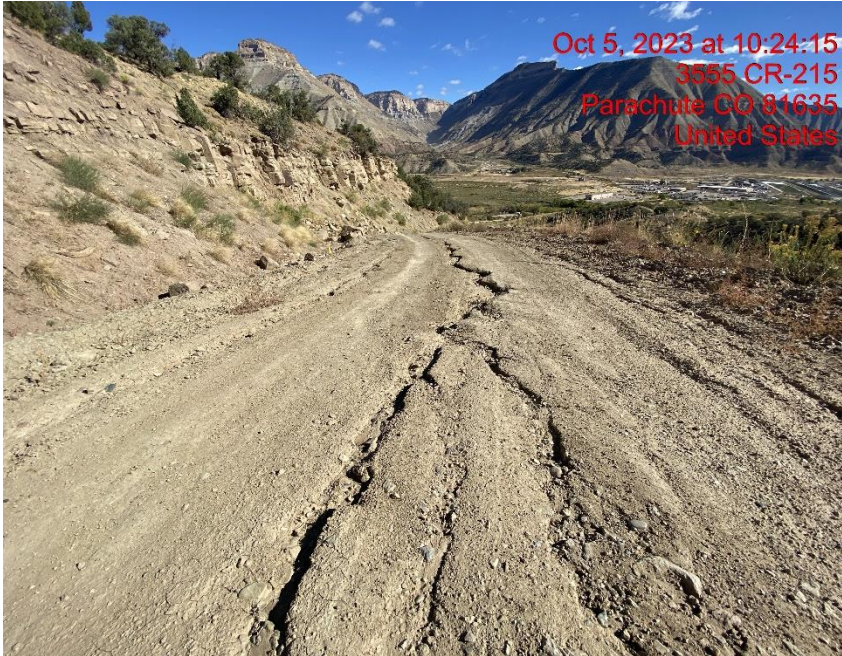
**Insufficient Erosion Controls/Rill Erosion on Lease Road –
Photo #06836**
