Caerus Piceance LLC  
Piceance Creek Unit-62S97W 2NESW  
Location ID: 335694

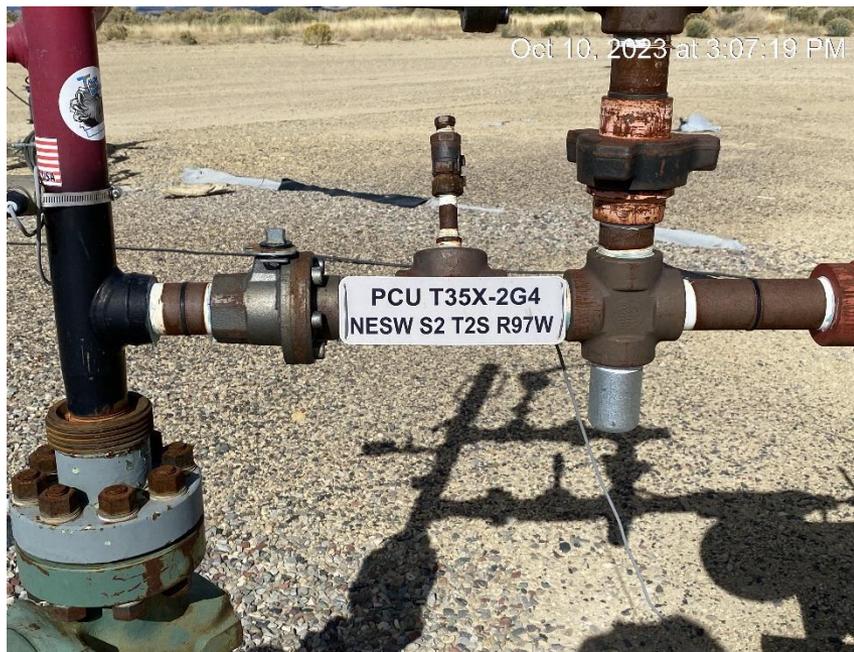
Wellhead sign missing required information

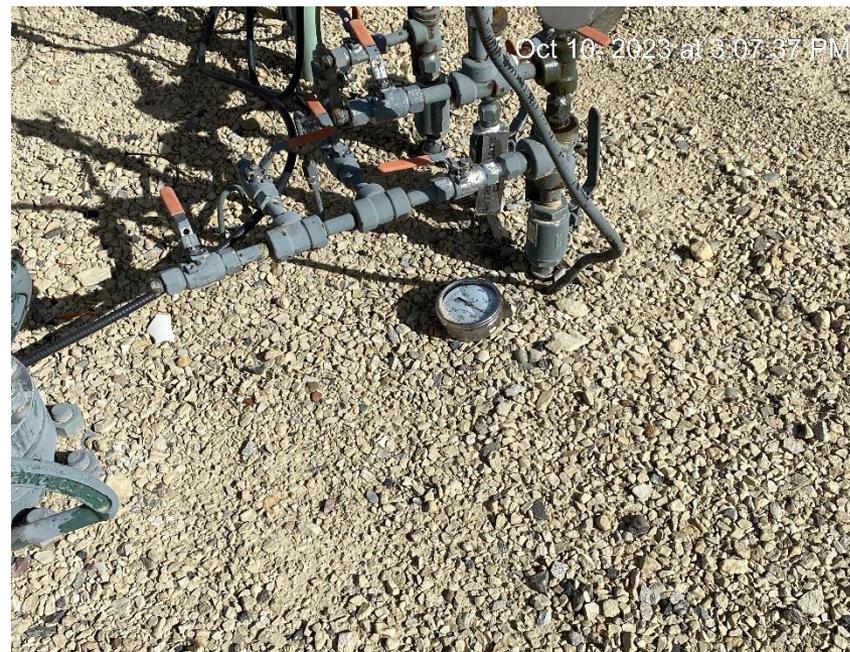
Debris

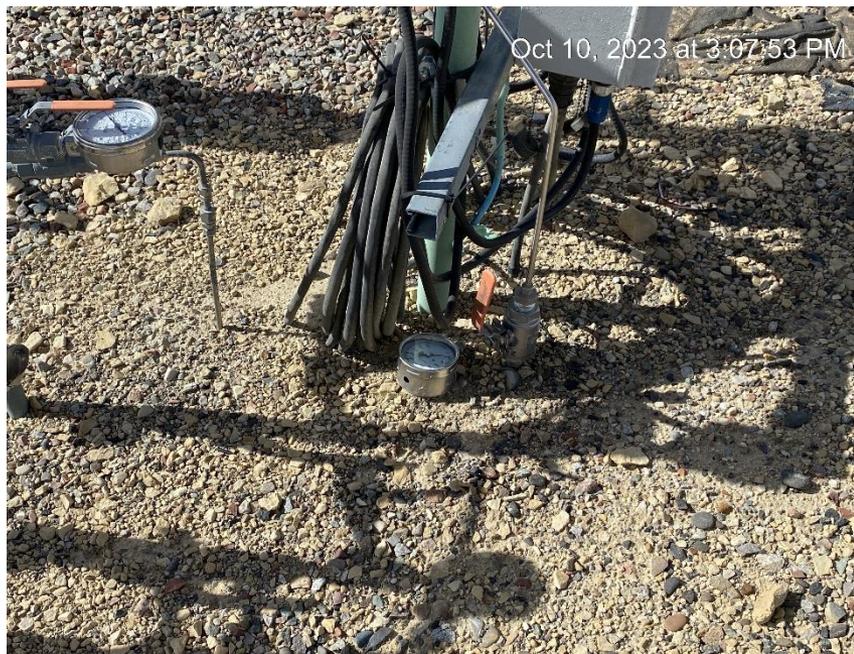
Debris

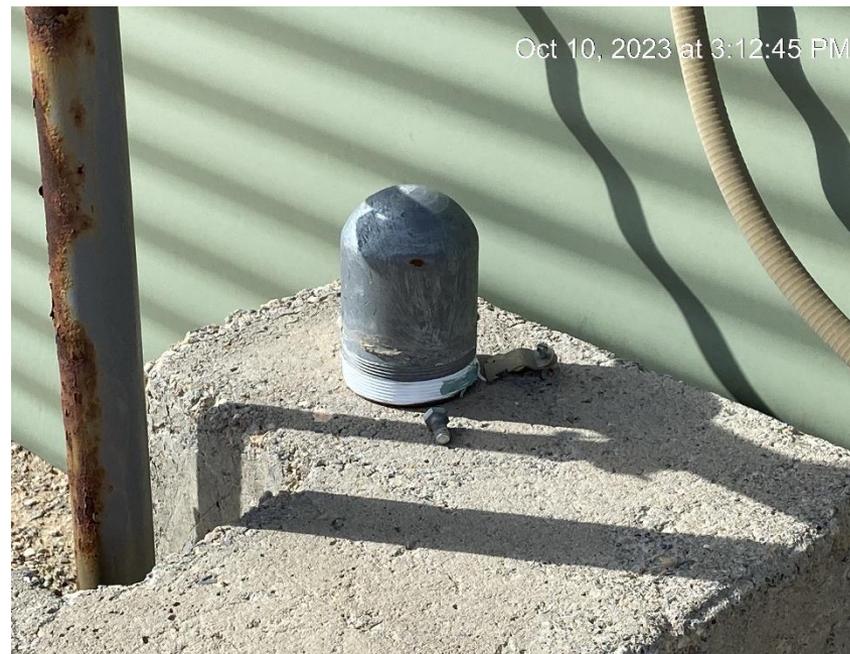
Debris

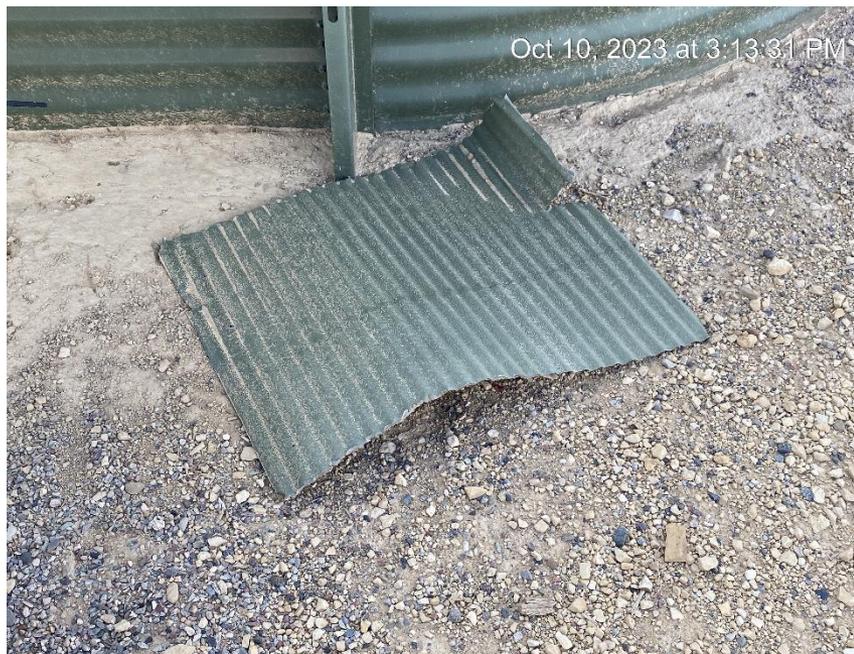
Debris

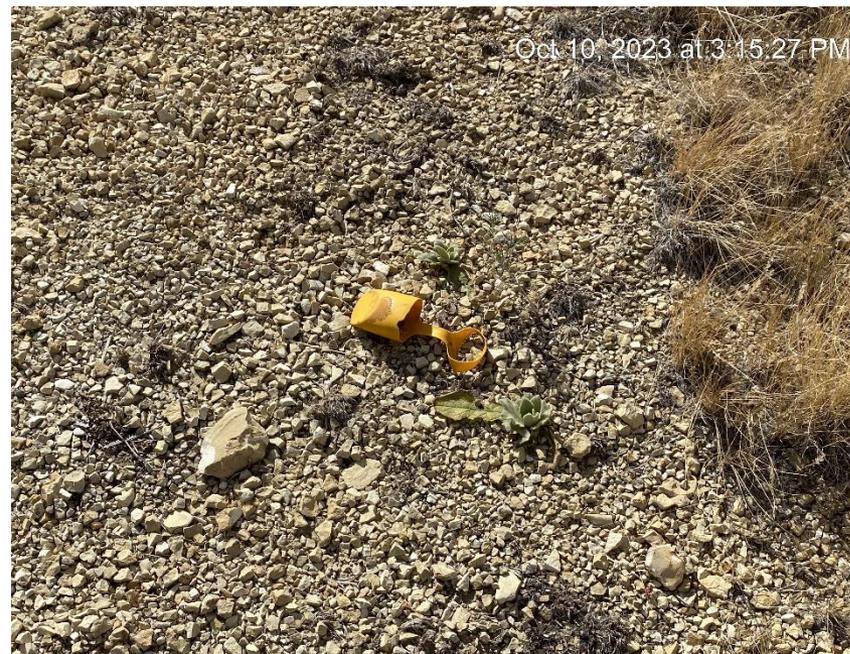
Debris

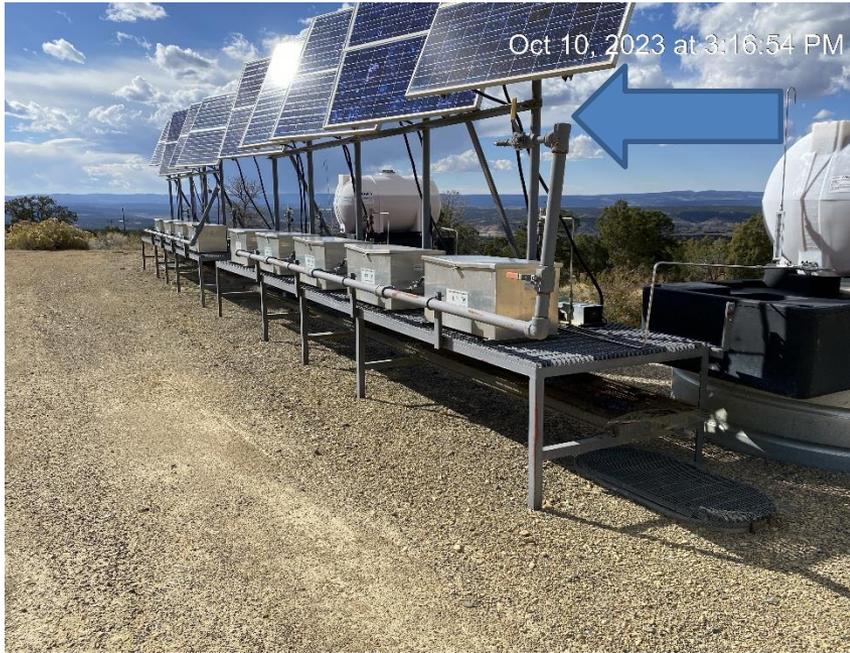
**Disconnected manifold open to wildlife**

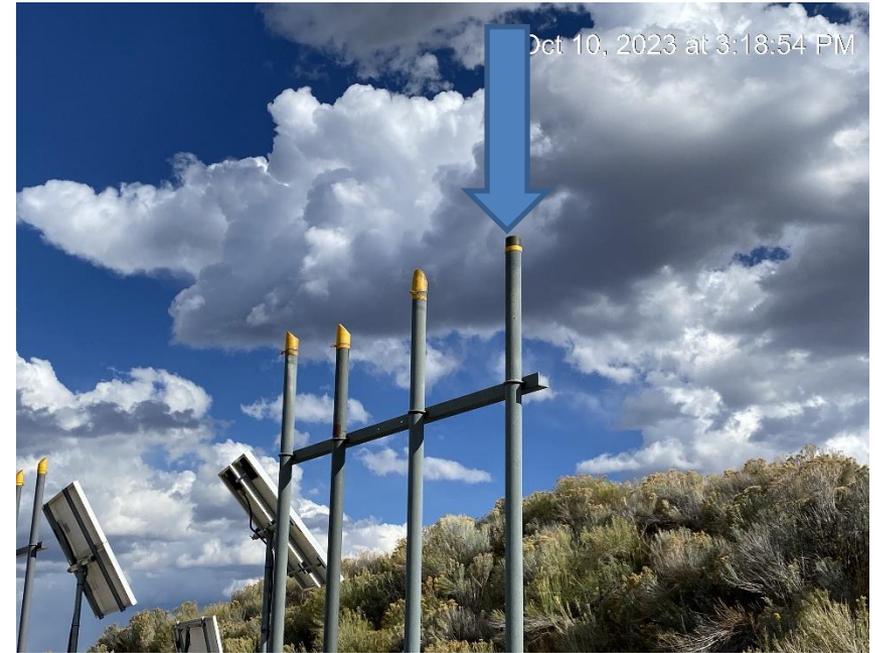
**Rain cap missing on riser**

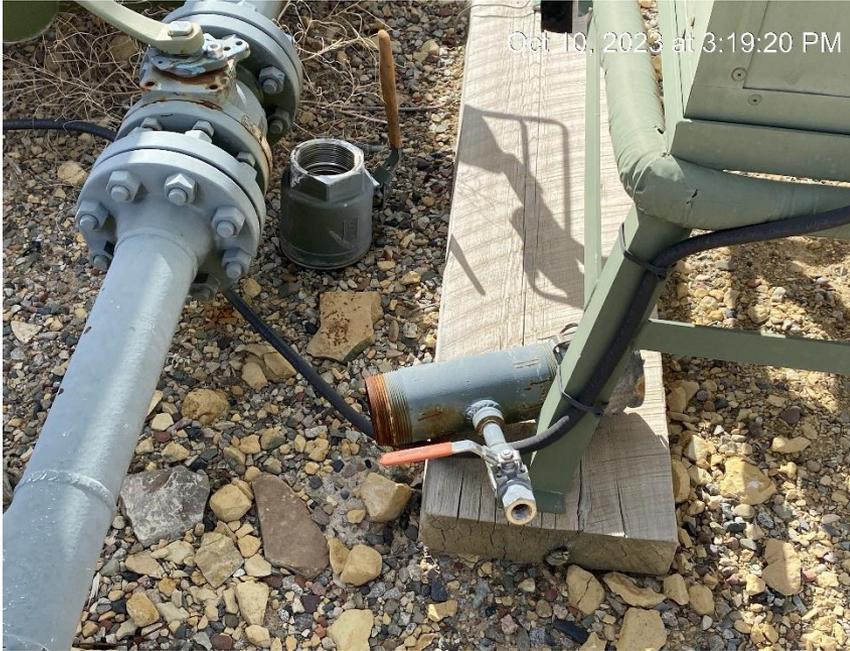
Debris

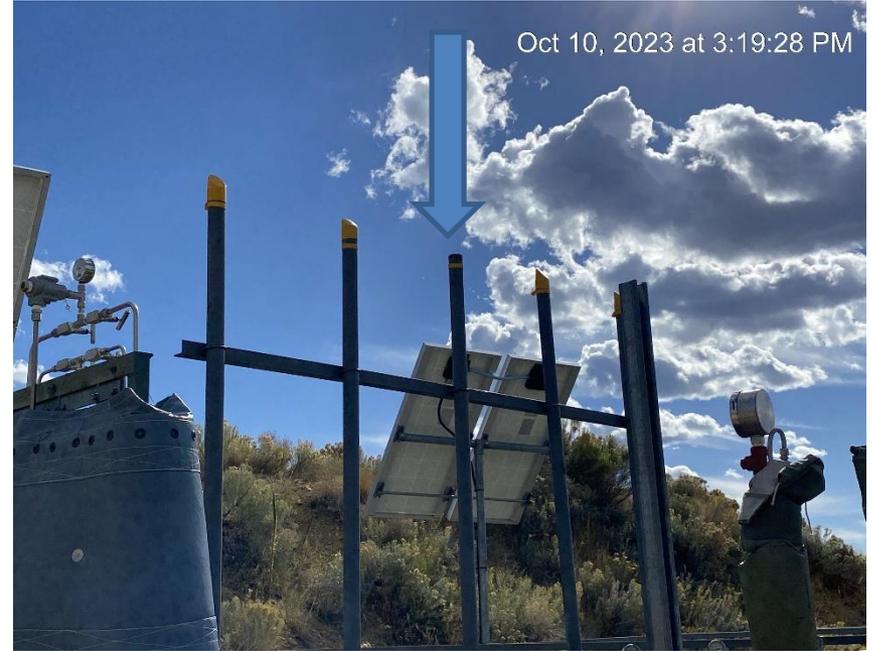
Rain cap missing on riser

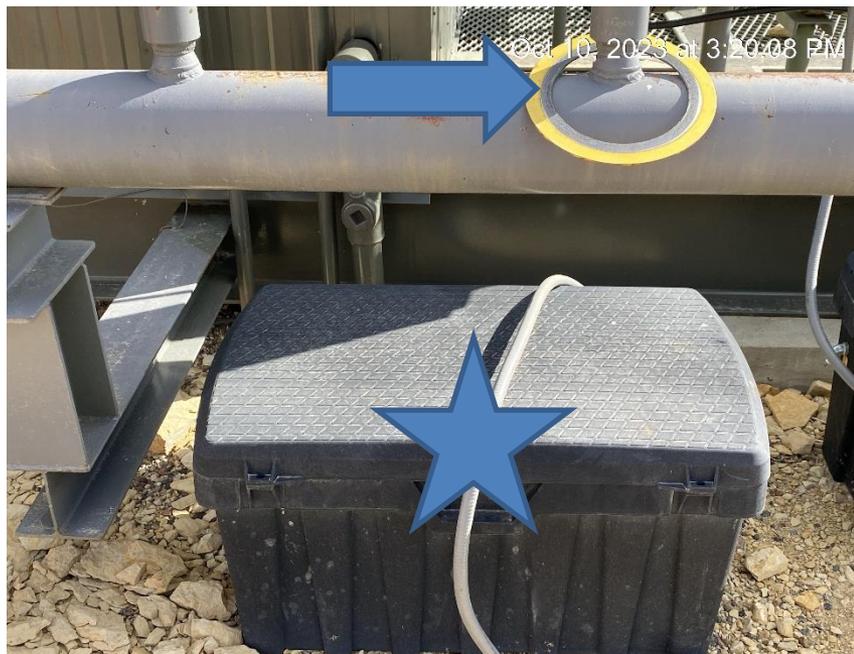
**Debris. Box is disconnected.**

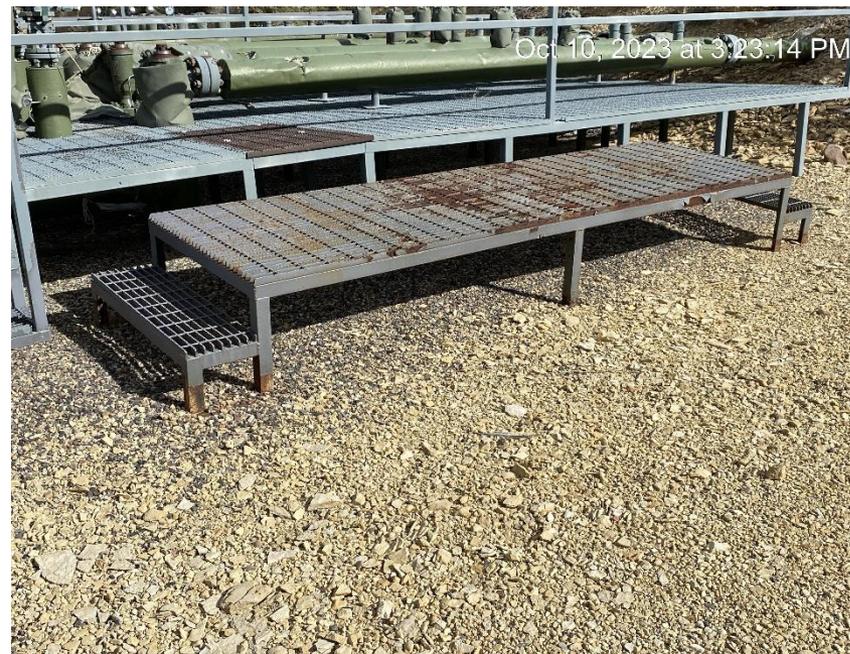
**Equipment not in use**

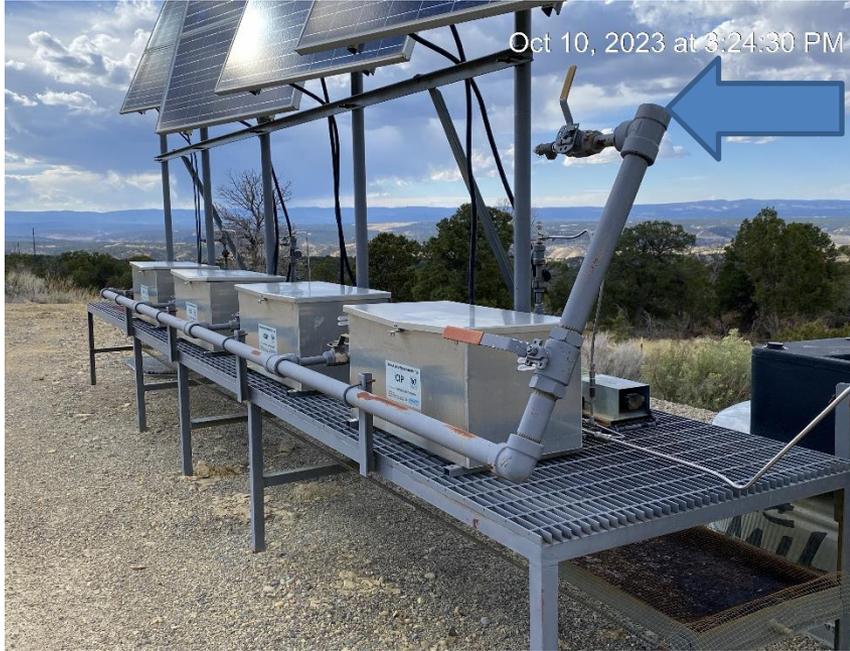
**Disconnected manifold open to wildlife**

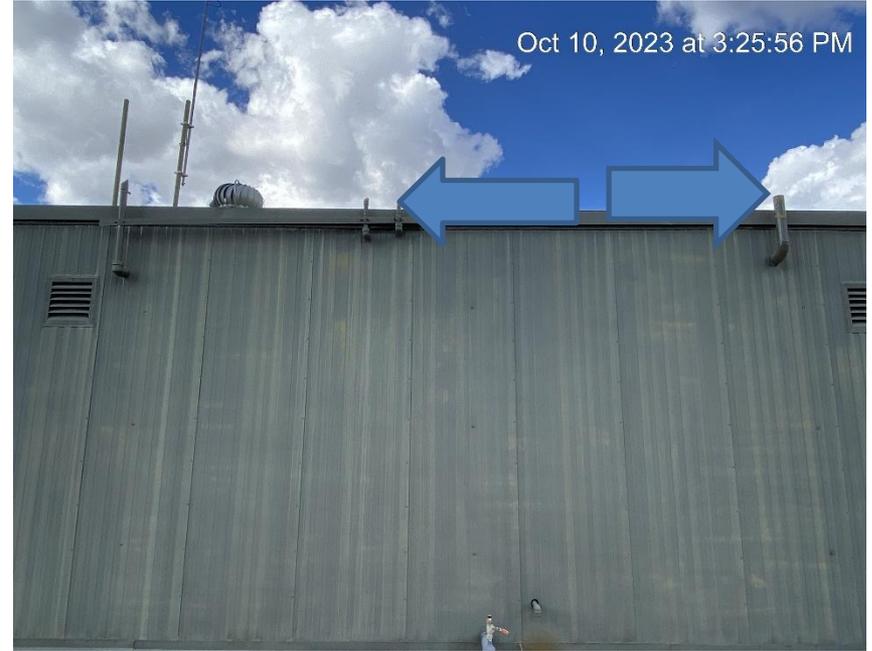
**Pressure relief risers missing rain caps**
