Interim Reclamation and Stormwater Inspection

Operator: H&M PETROLEUM CORPORATION - 10032

Location ID: 312324

Inspection Document #: 708200602

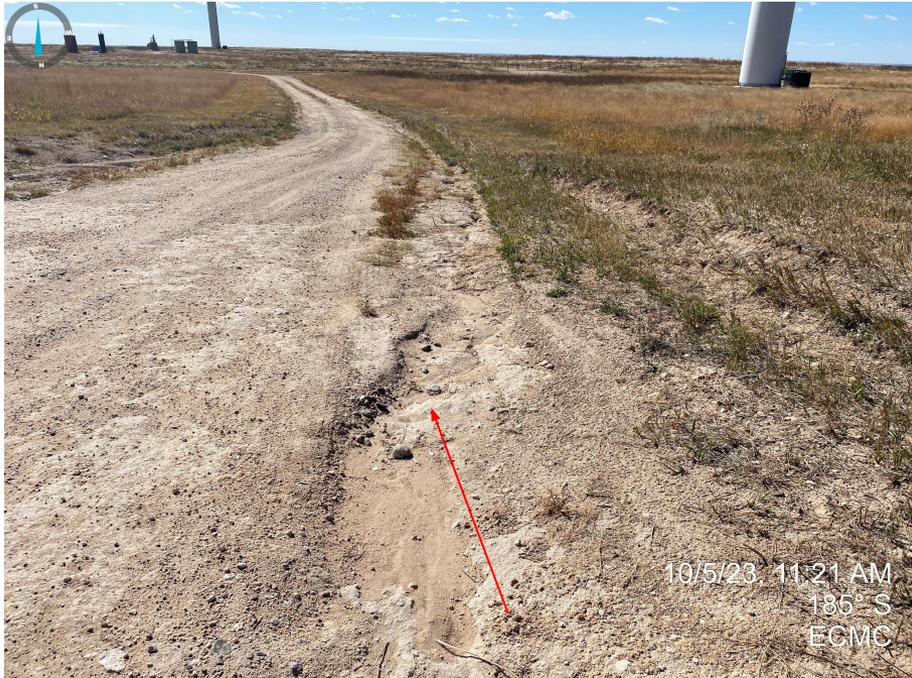
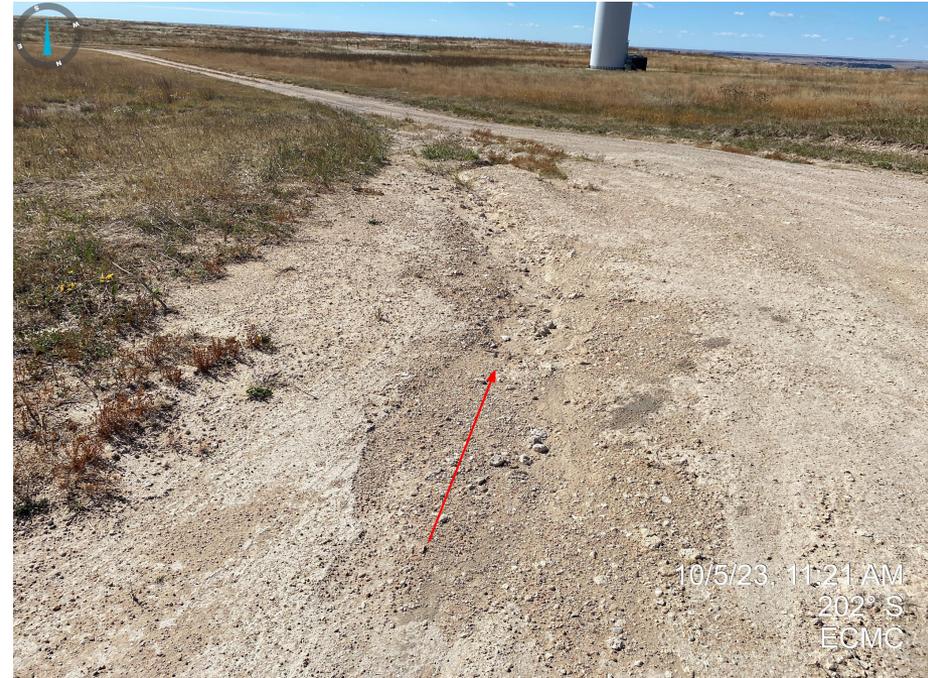
Photos 1 & 2. Erosion degradation occurring along the access road, south of the location.

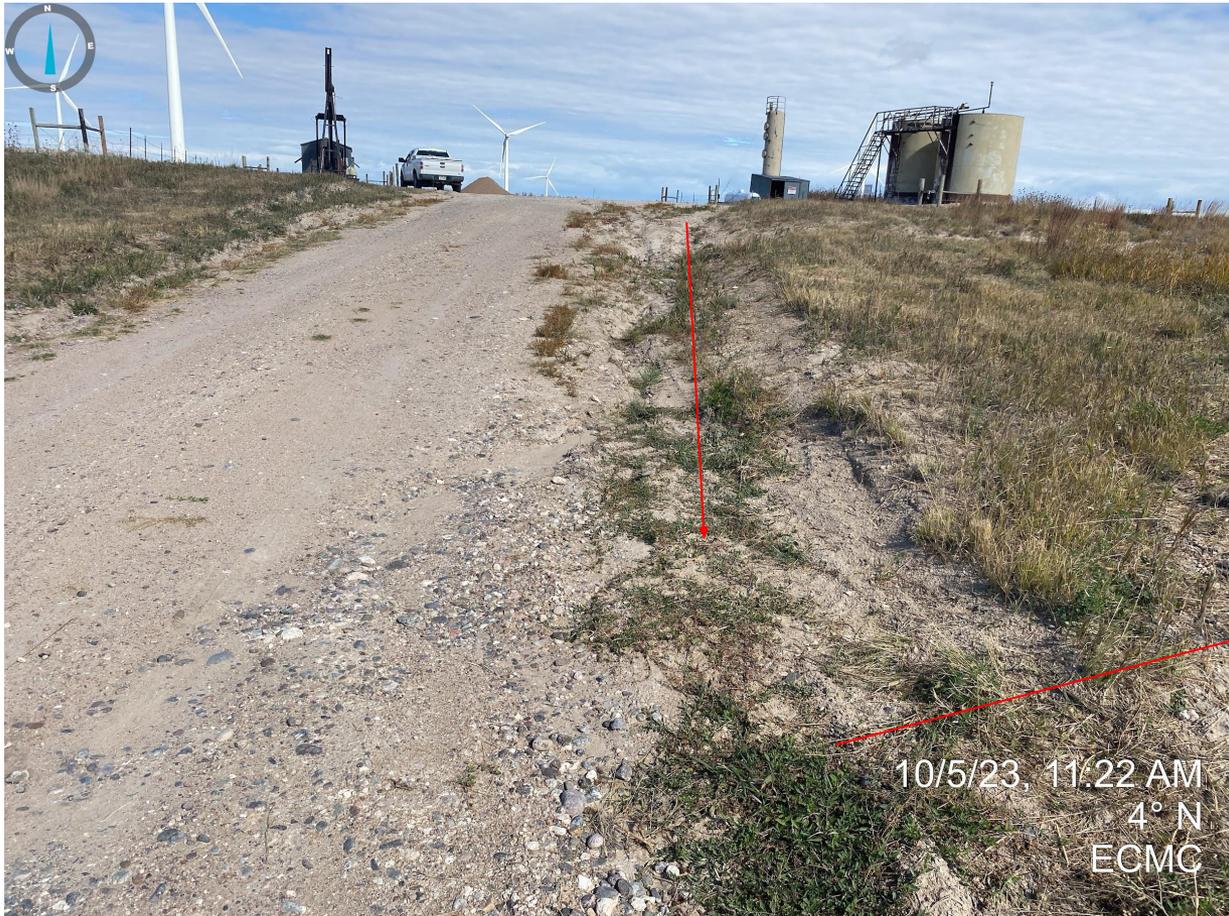
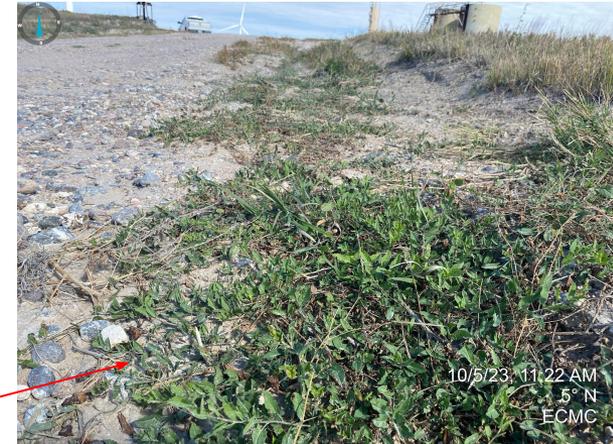
Photos 3 & 4. Continued from Photos 1 & 2; erosion degradation and Colorado List C Noxious Weed (field bindweed) observed.

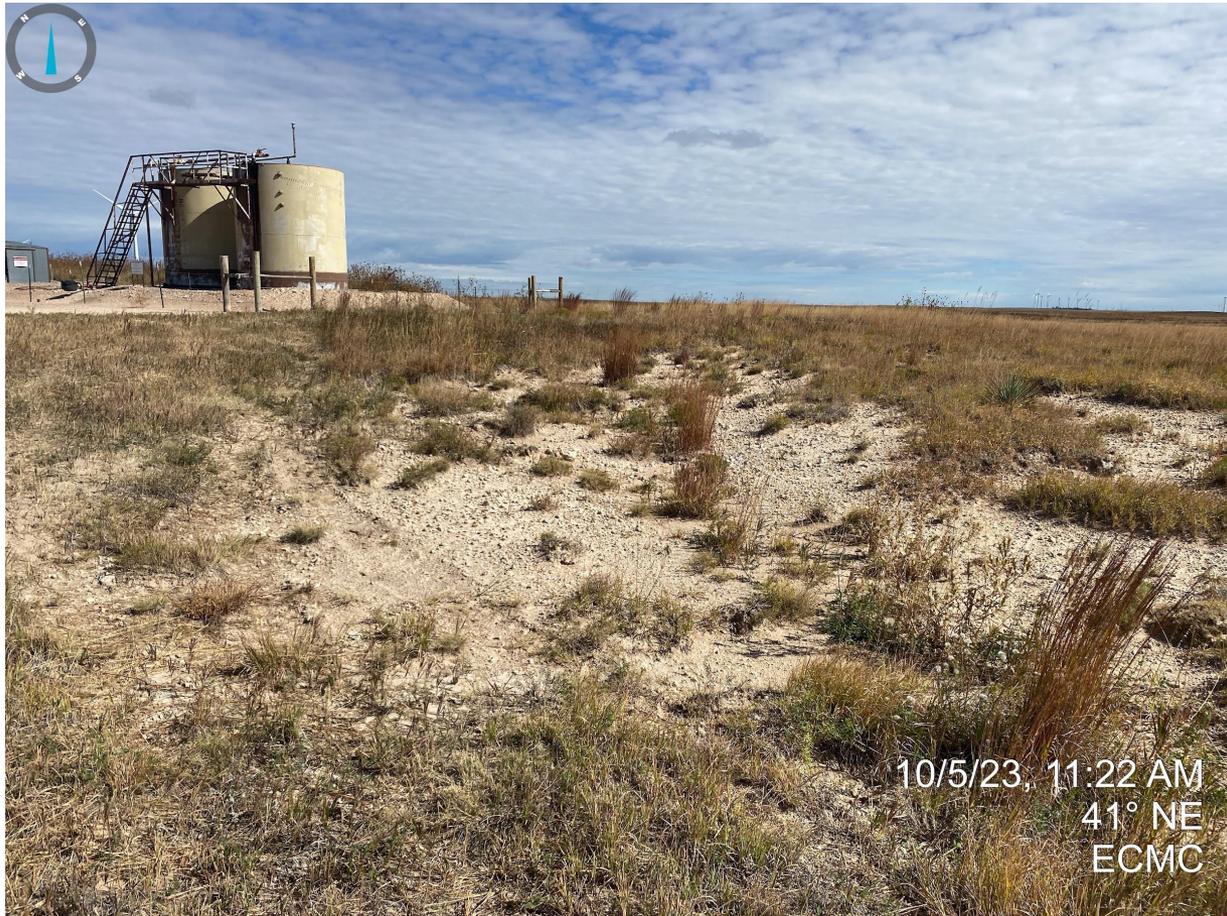
Photo 5. South of the location, within the interim area. Non-uniform vegetation cover resulting in areas of bare/exposed soils.

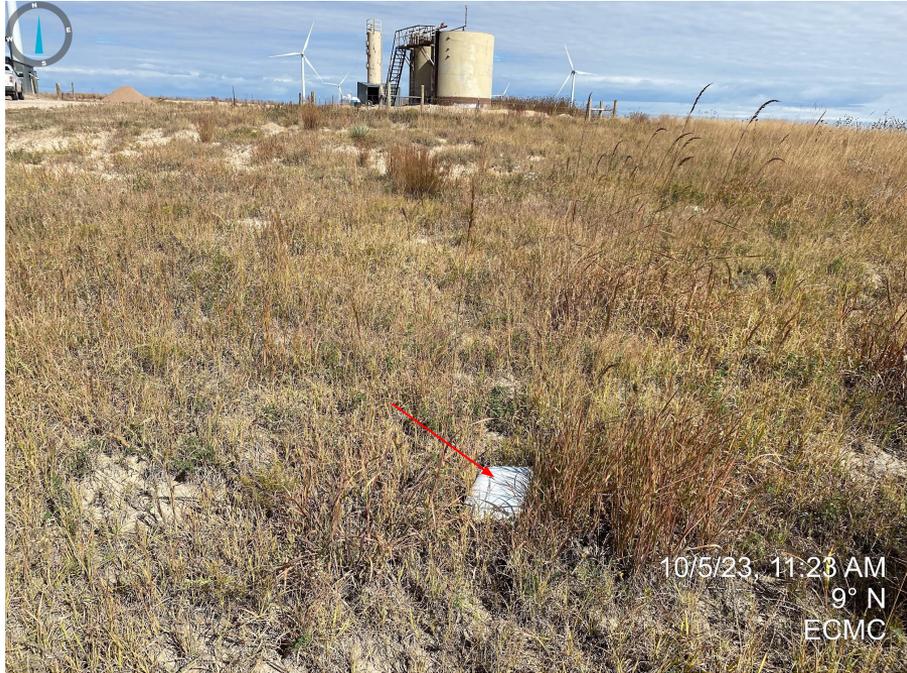
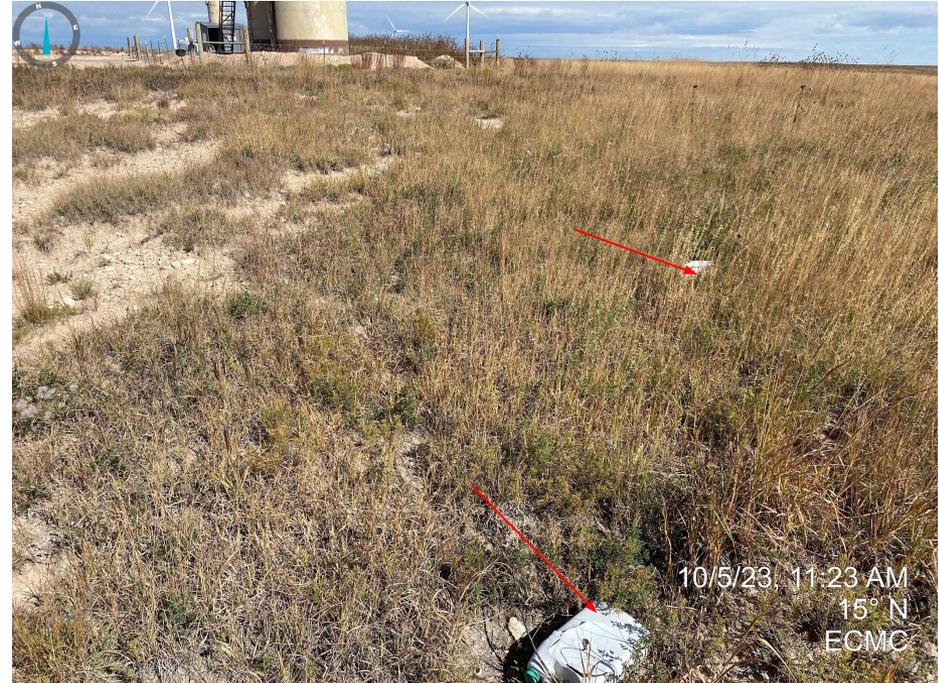
Photos 6 & 7. Trash (antifreeze bottles) observed on south side of location.

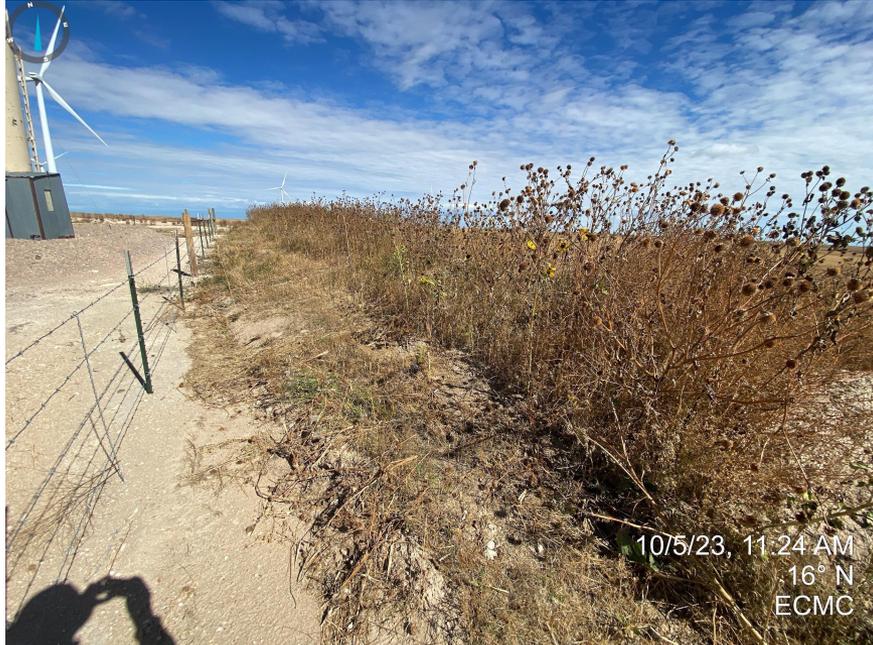
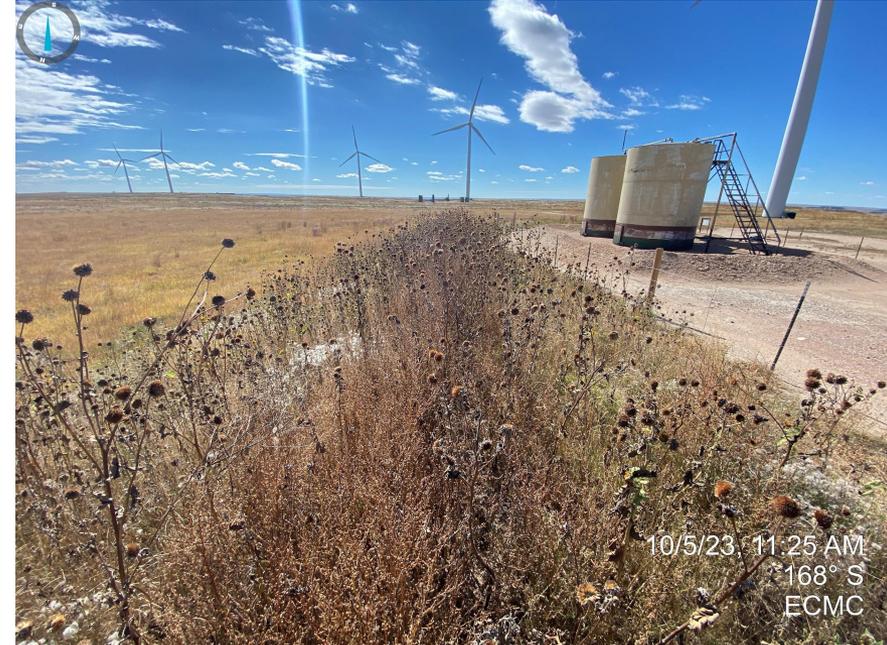
Photos 8 & 9. Topsoil stockpile on the east side of the location is predominantly annual forb (sunflower) and undesirable vegetation (japanese brome and russian thistle) was also observed. Longer term stabilization BMPs are required.

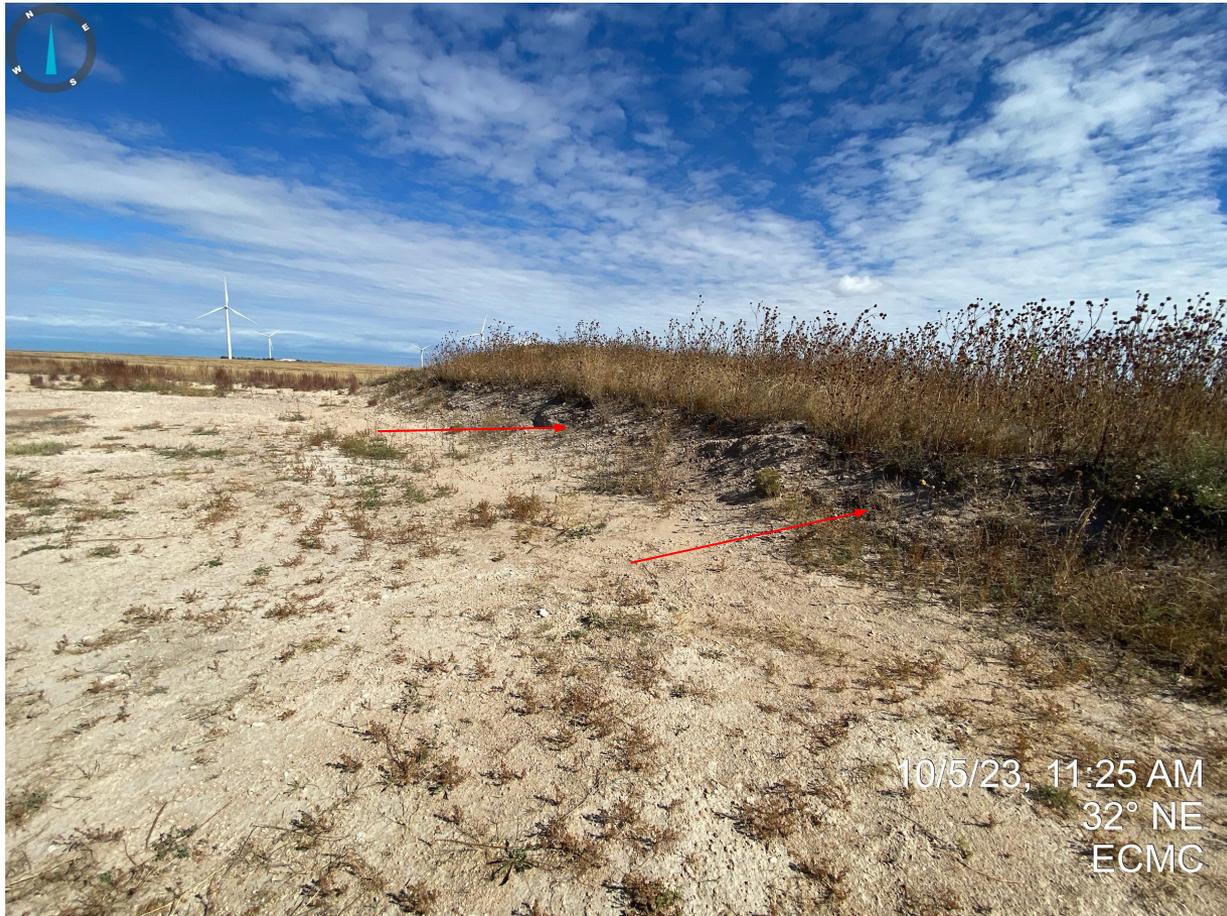
Photo 10. The western edge of the topsoil stockpile is not properly stabilized with evidence of wind/water erosion observed.

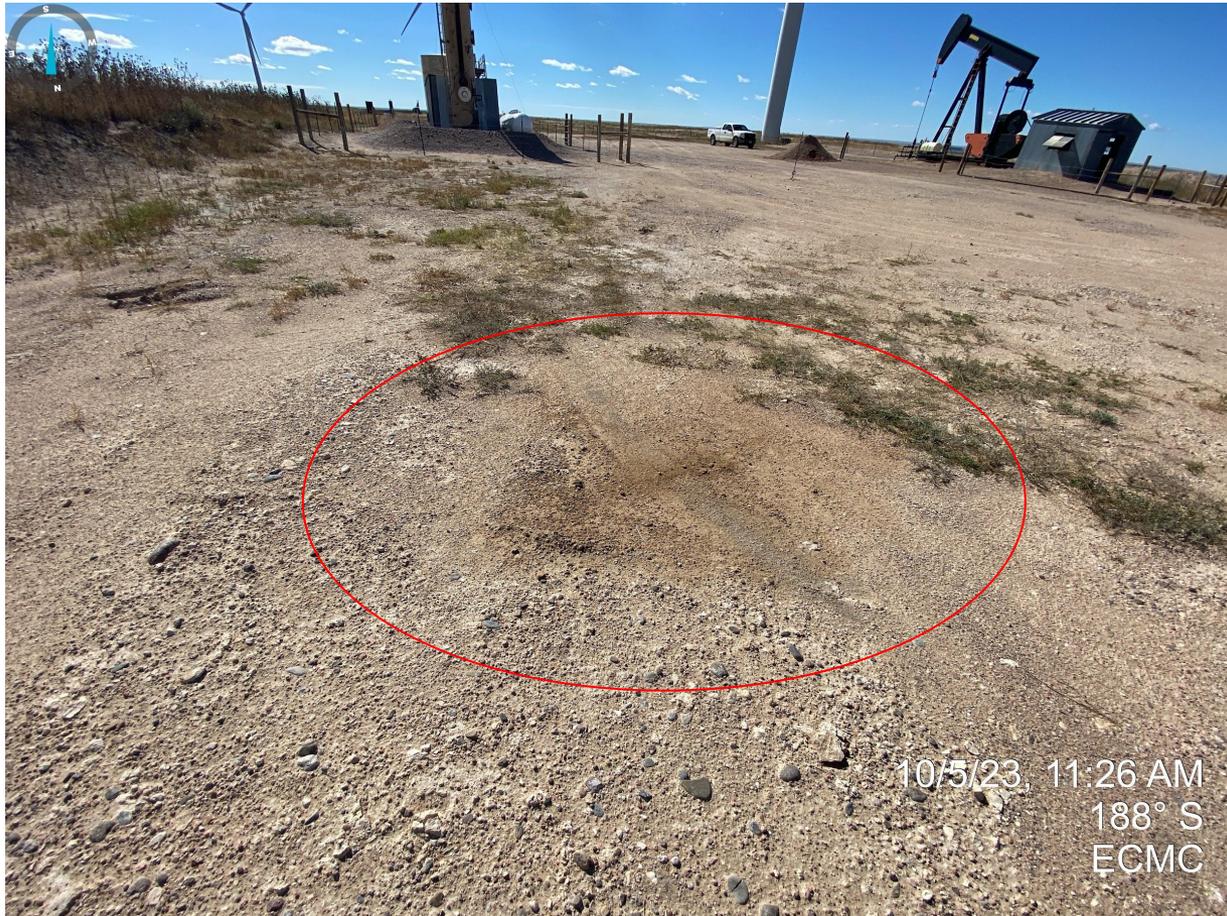
Photo 11. Stained soil observed on the northern portion of the production area.

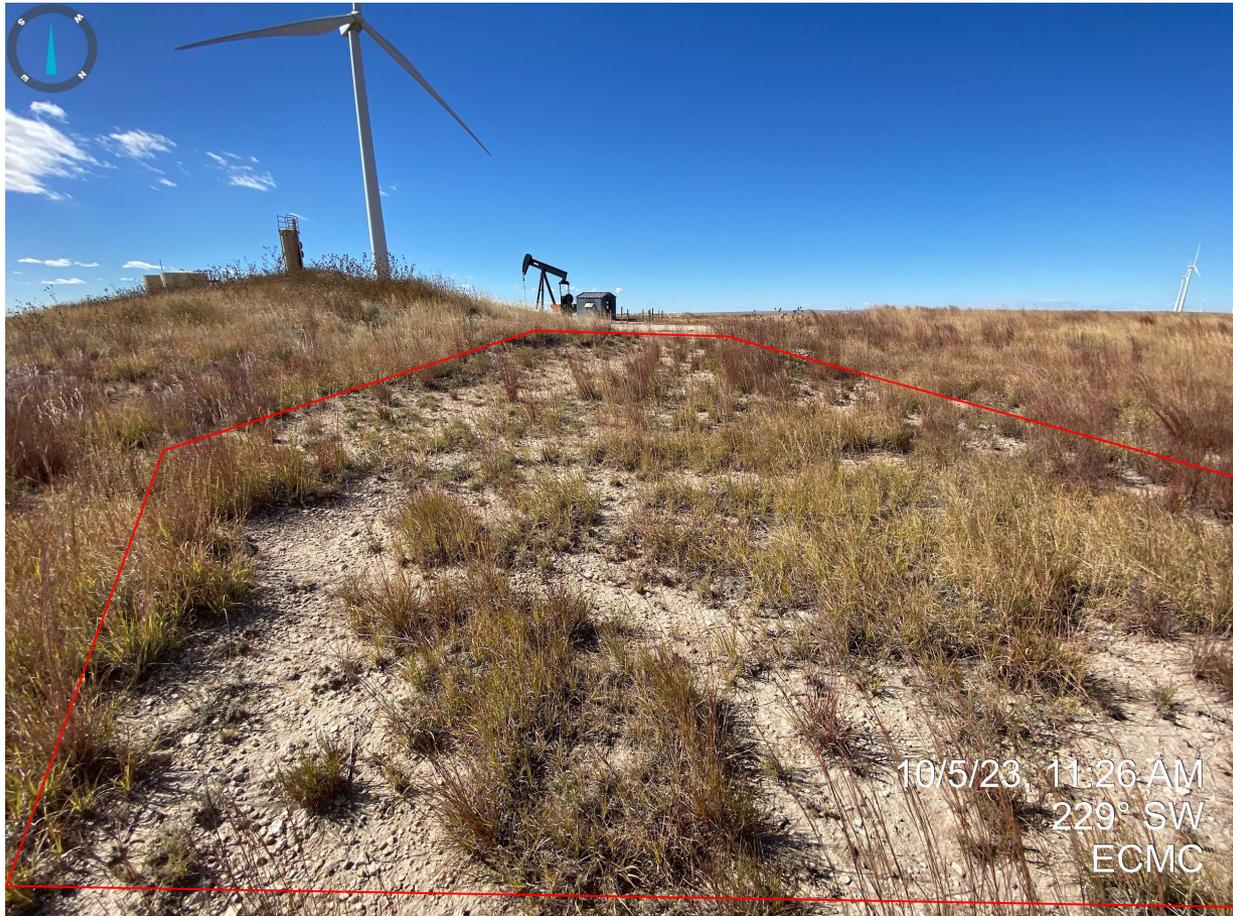
Photo 12. North of the location, within the interim area. Non-uniform vegetation cover resulting in areas of bare/exposed soils.

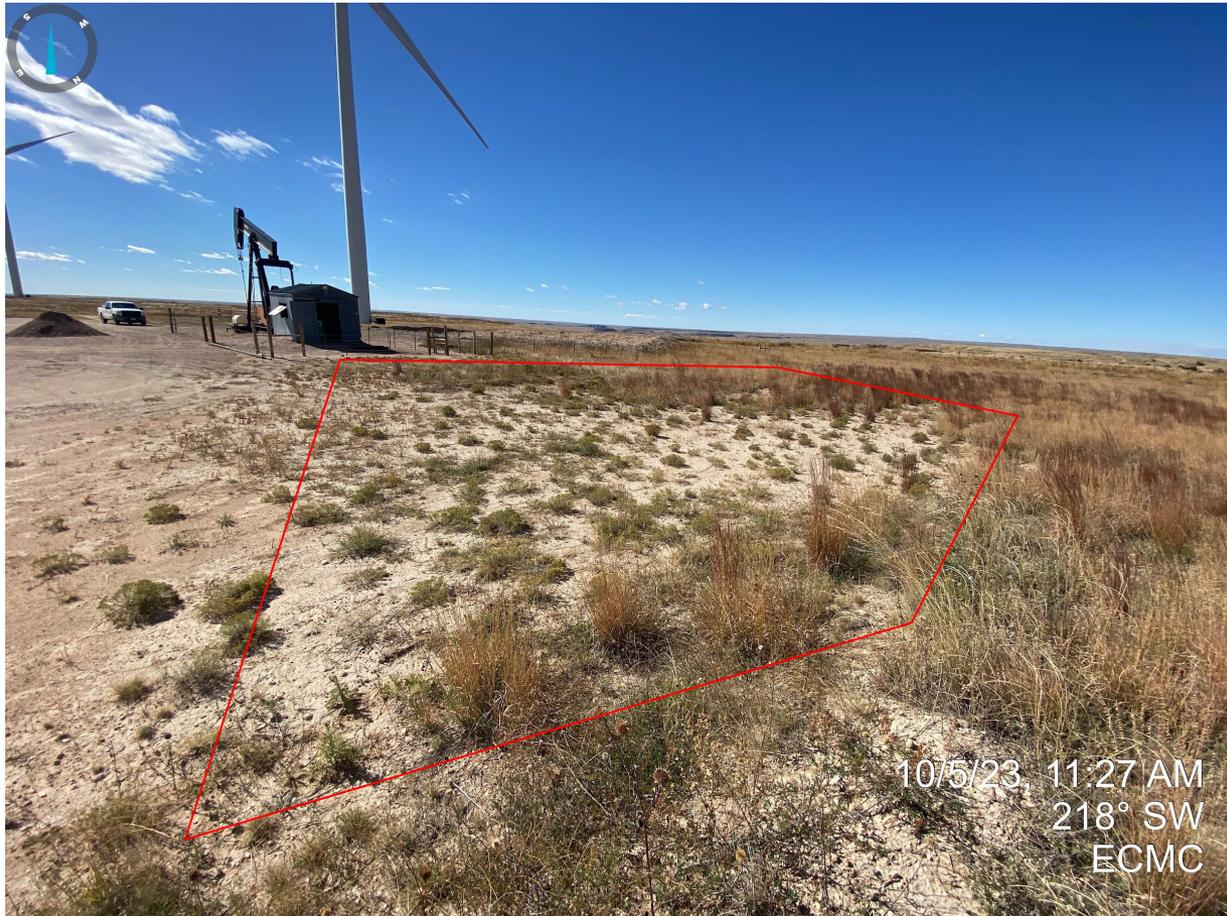
Photo 13. Northwestern portion of the interim area. Non-uniform vegetation cover resulting in areas of bare/exposed soils.

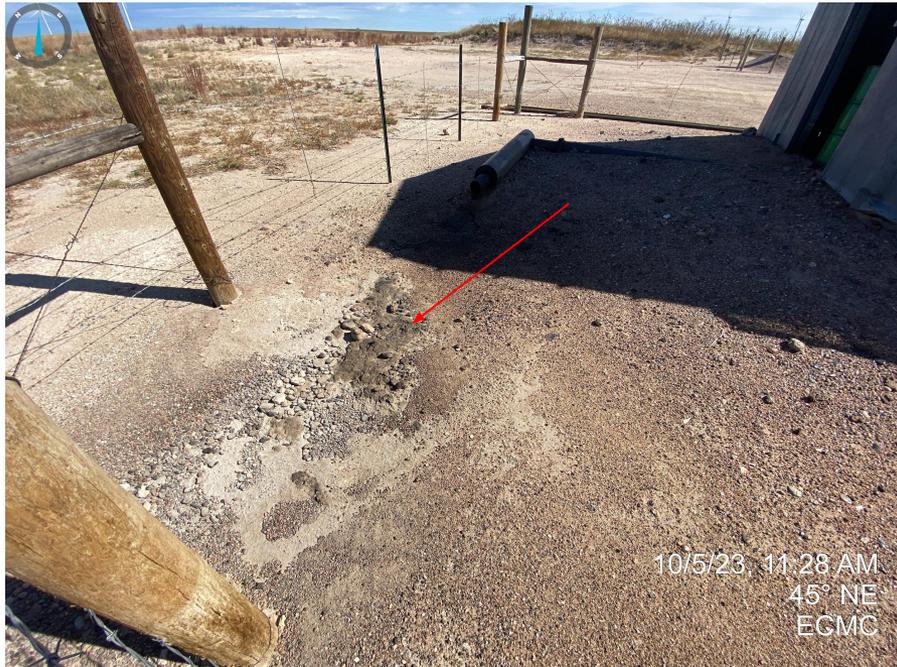
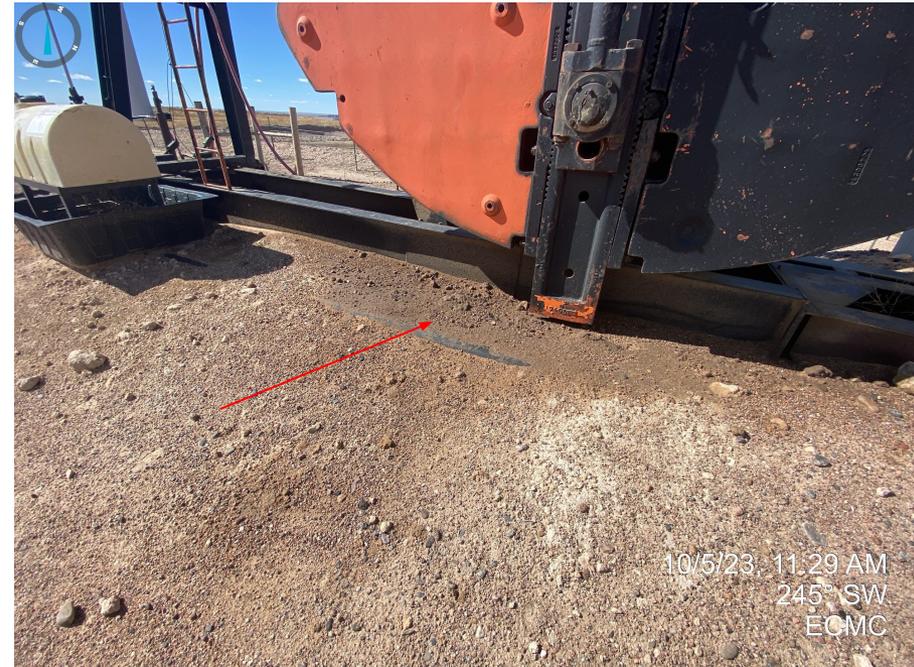
Photo 14 & 15. Stained soils observed around the pump jack unit.

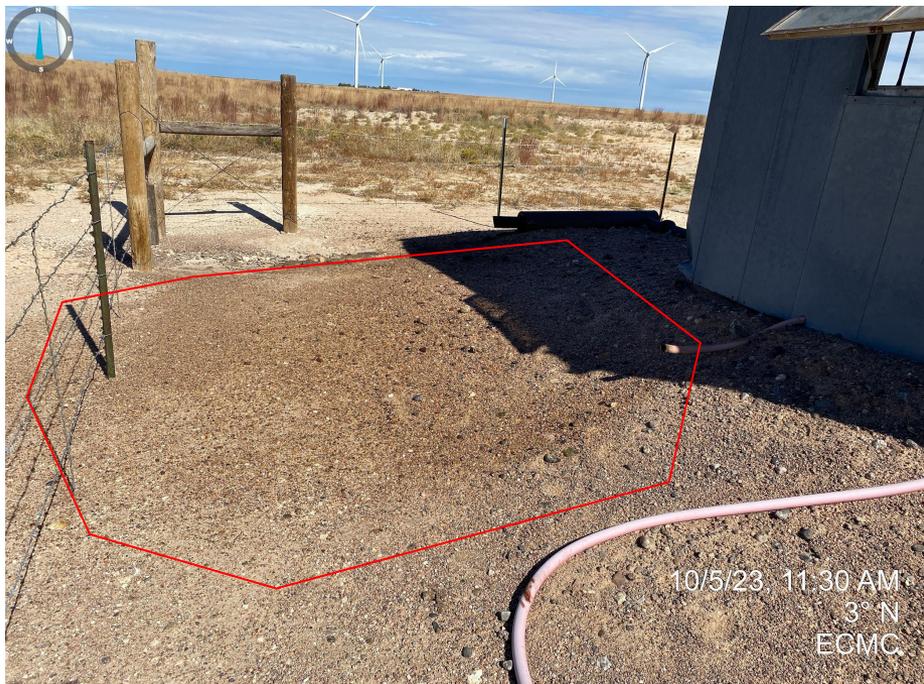
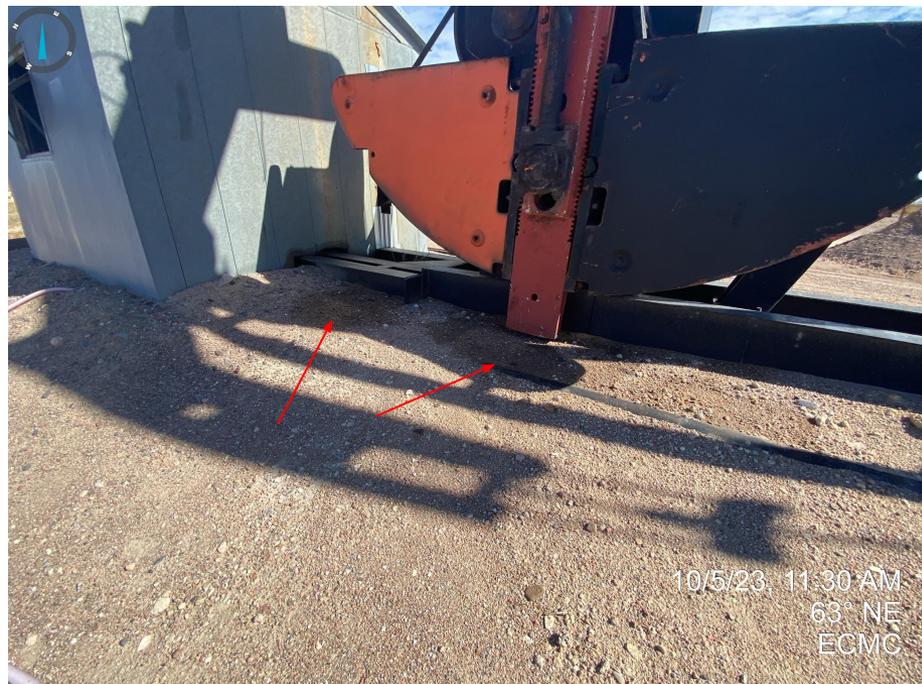
Photo 16 & 17. Oil sheen and stained soil observed around the pump jack.

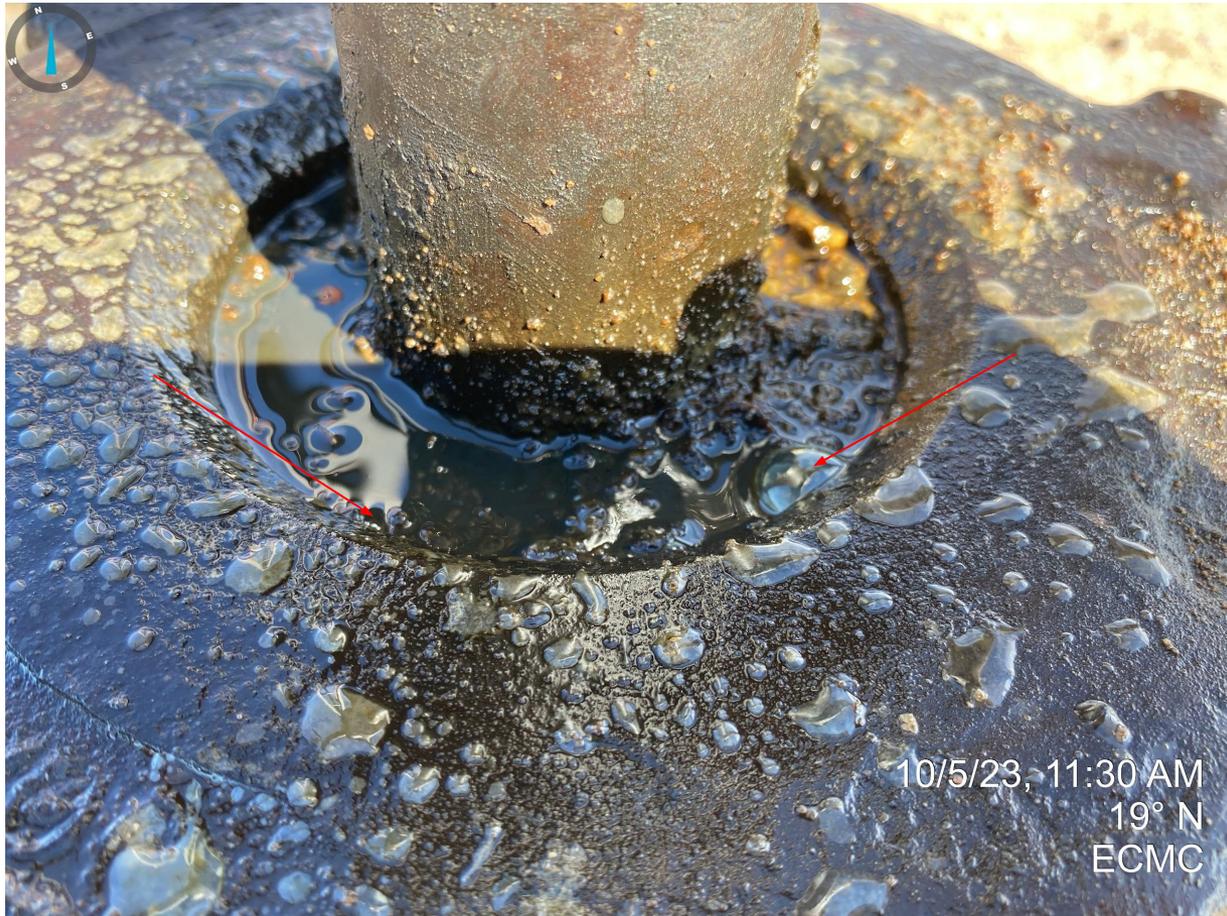
Photo 18. Audible and visual leak detected at wellhead/stuffing box hammer union.

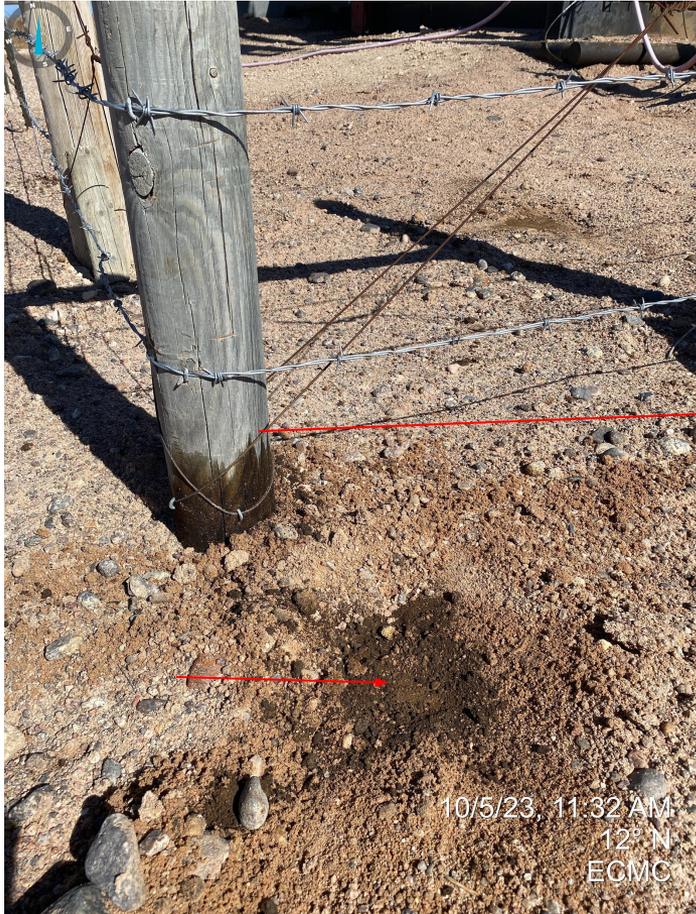
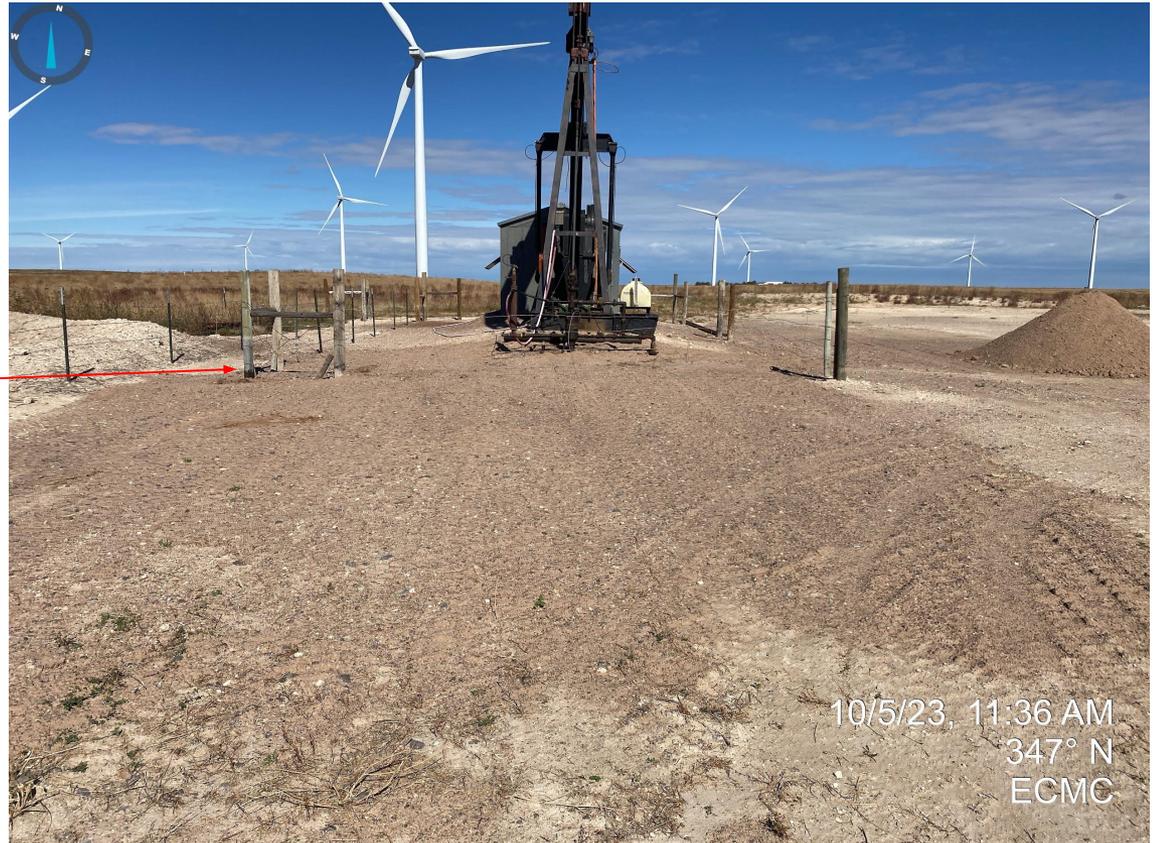
Photo 19 & 20. Apparent E&P waste discovered by the pump jack unit. Staff was unable to determine extent/volume of impacts and noted chemical odor from impacts below recent road base material application.

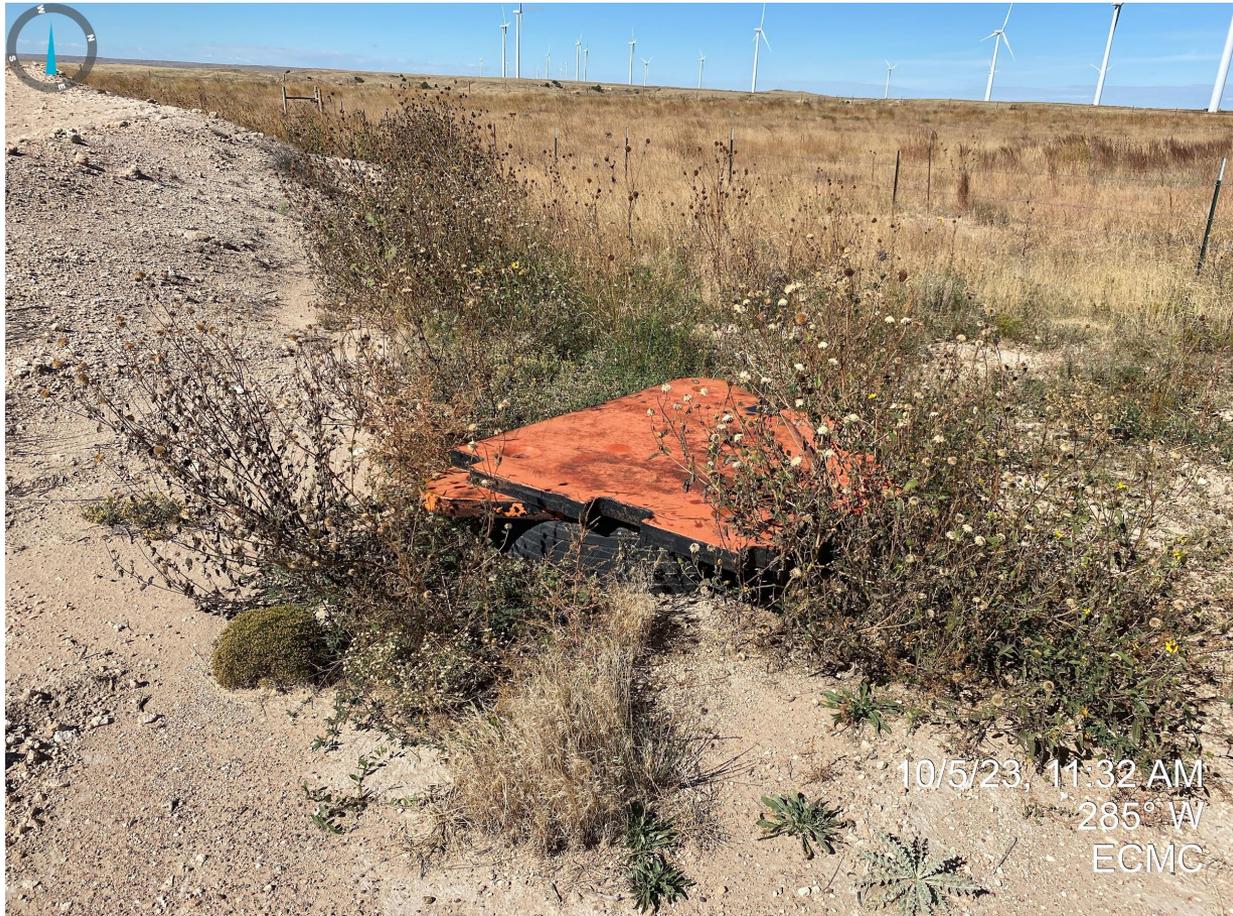
Photo 21. Unused equipment within pit area.

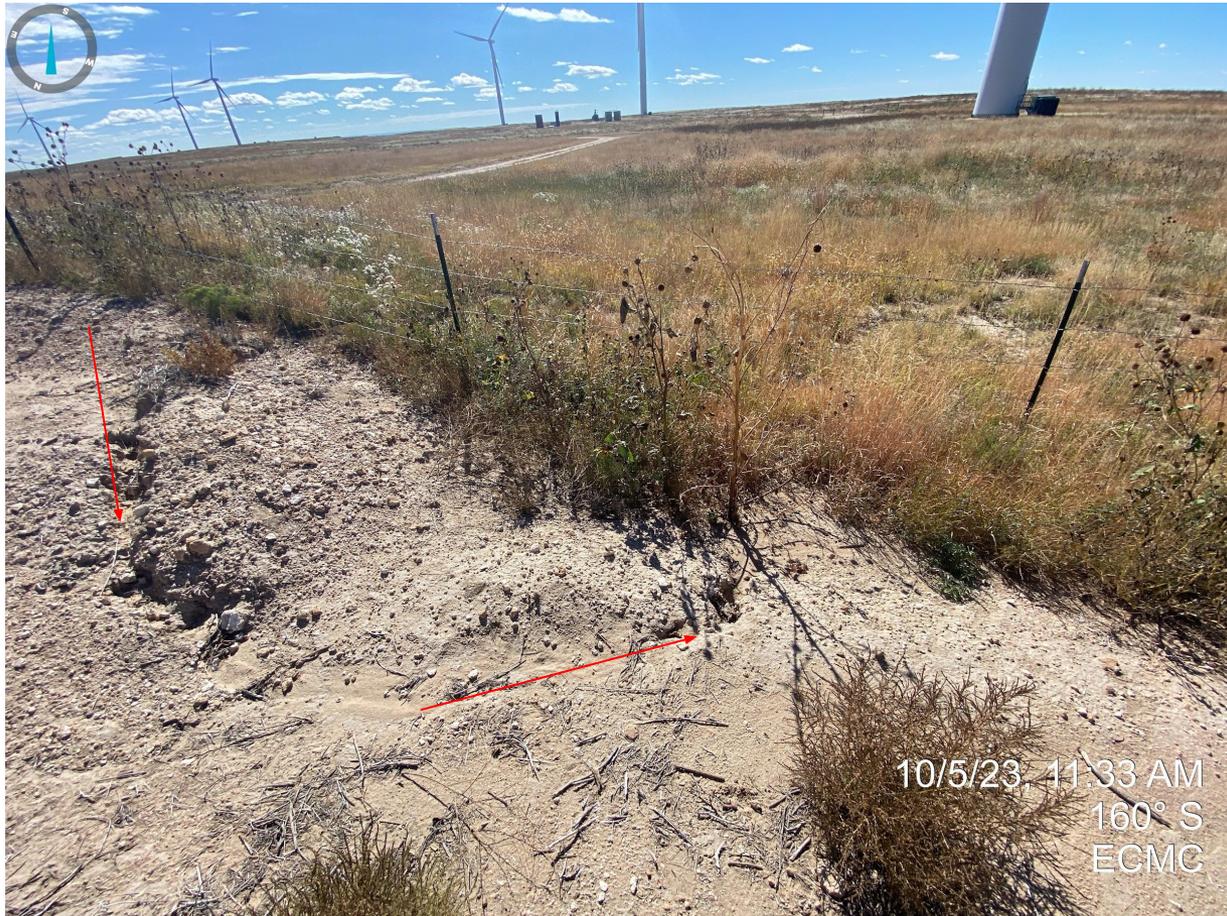
Photo 22. Erosion degradation occurring from the pit berms/walls.

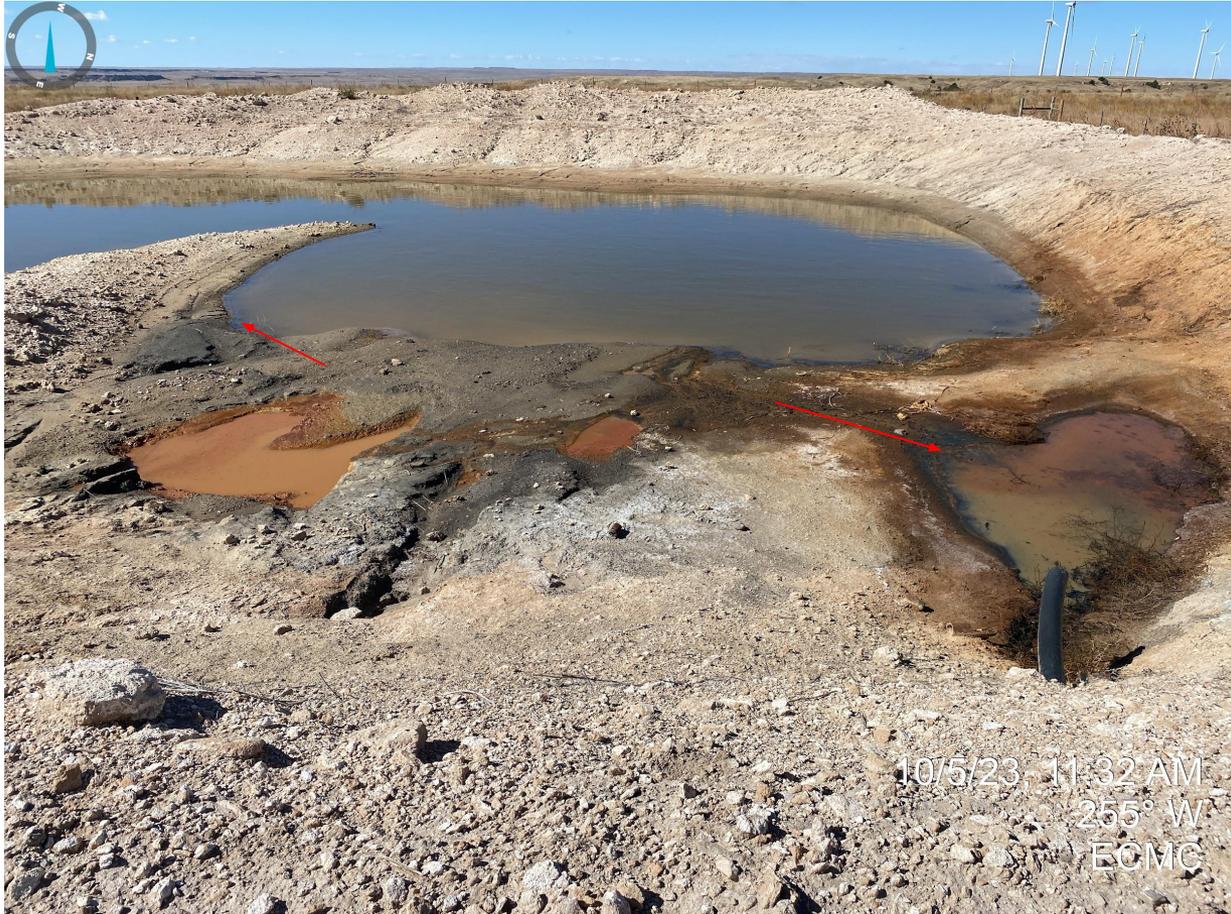
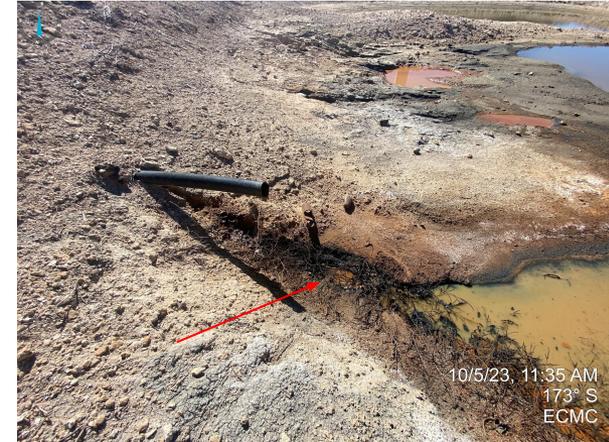
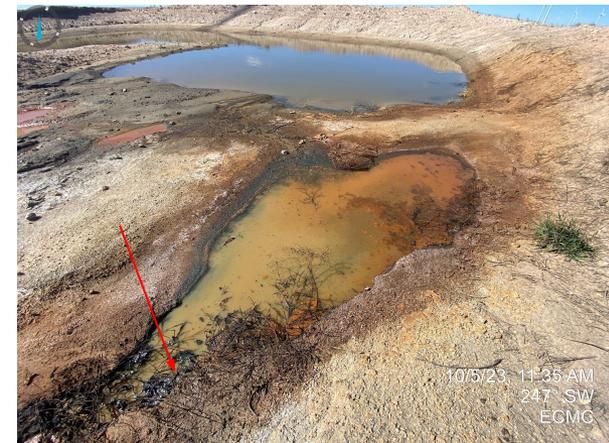
Photos 23-25. Hydrocarbon impacts observed within the pit.

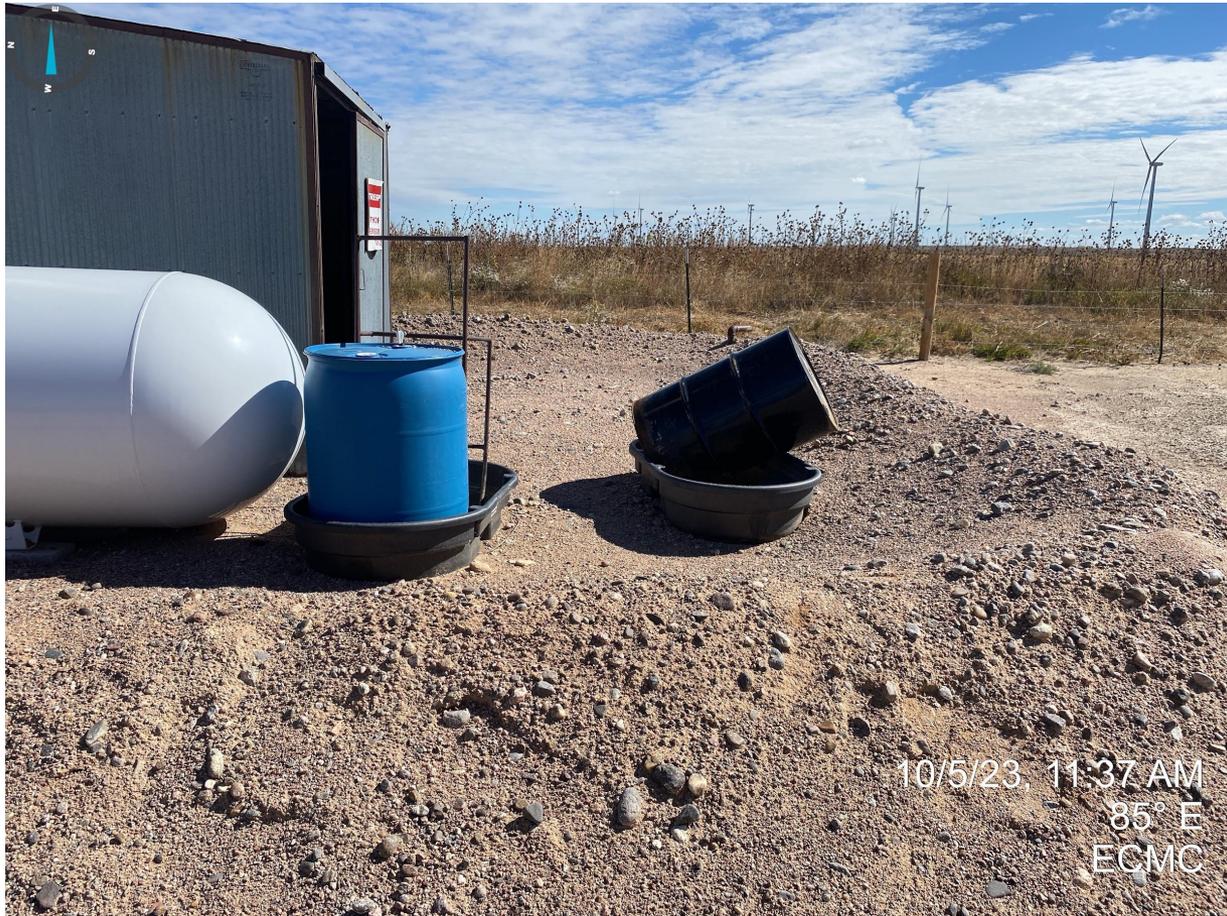
Photo 26. Unmarked/labeled drums within inadequate secondary containment, and no wildlife exclusion devices (e.g. netting) observed around secondary containment.

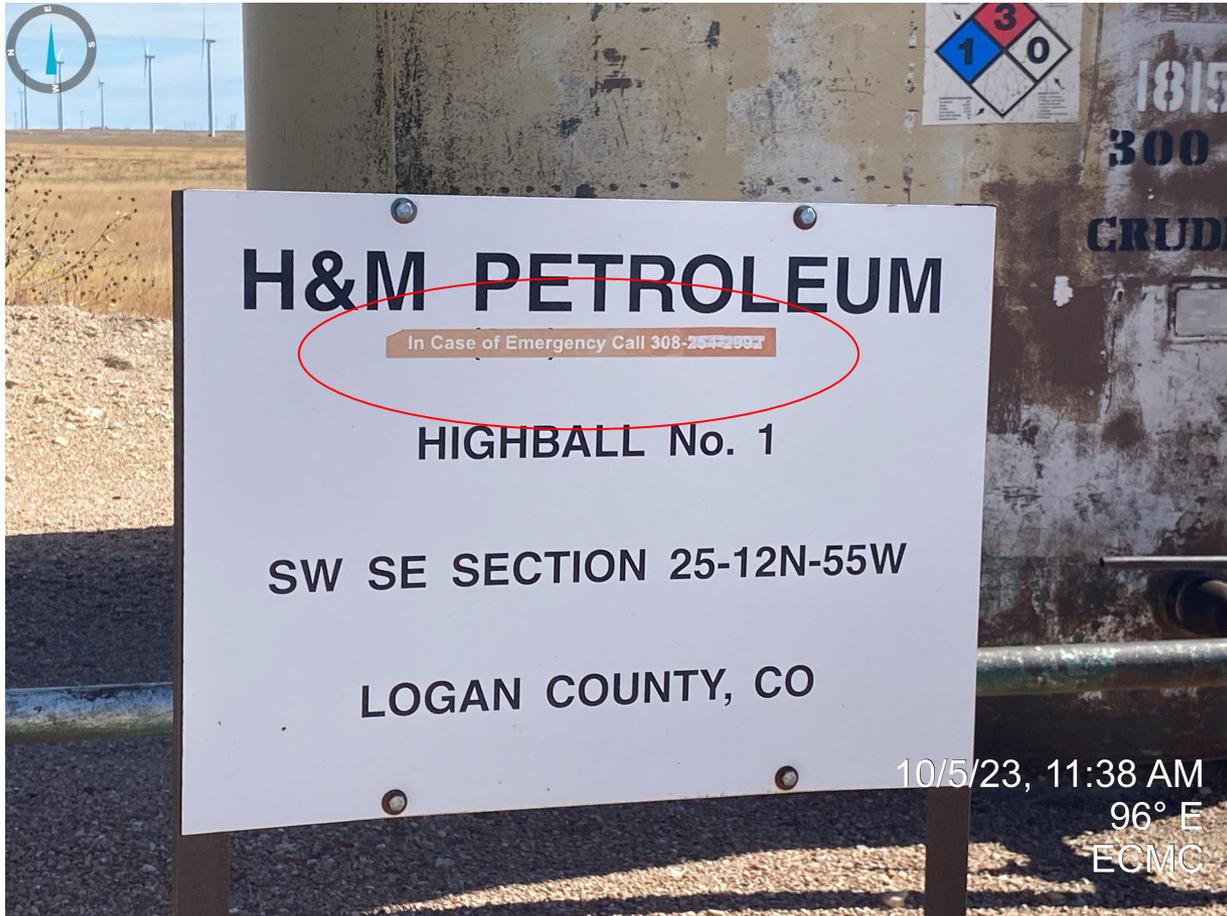
Photo 27. Emergency contact number not legible.
