Inspection Photos

Location Name: TEP ROCKY MOUNTAIN LLC, CHEVRON-66S96W/29SWNE

Location ID: 335298

Date: 10/12/2023

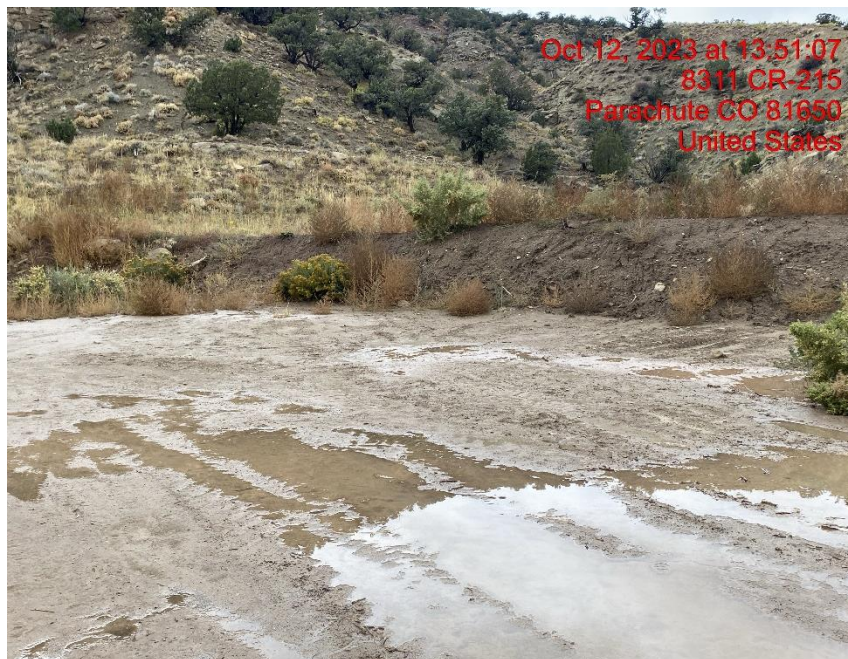
Location Lacks Stabilization – Photo #06895

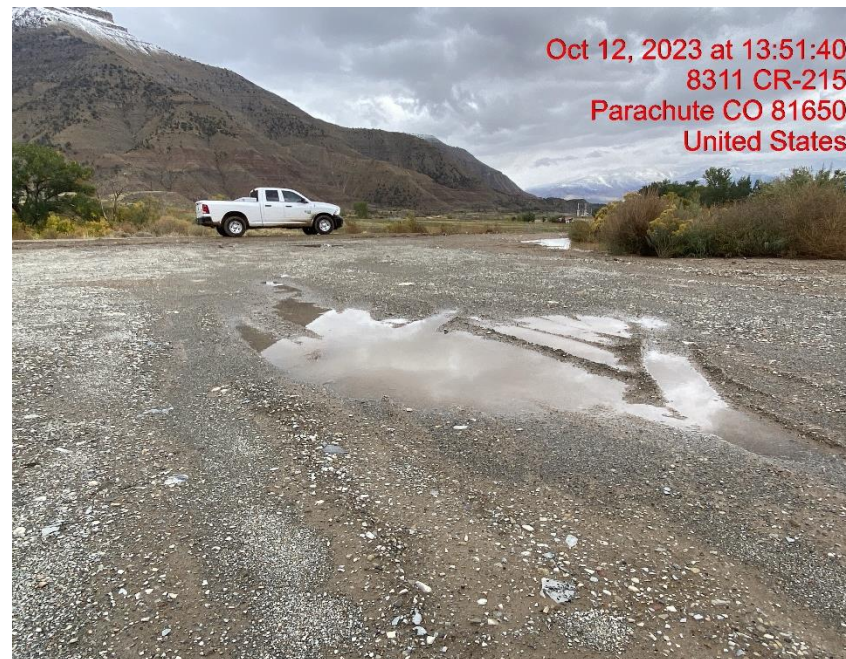
Location Lacks Stabilization – Photo #06897

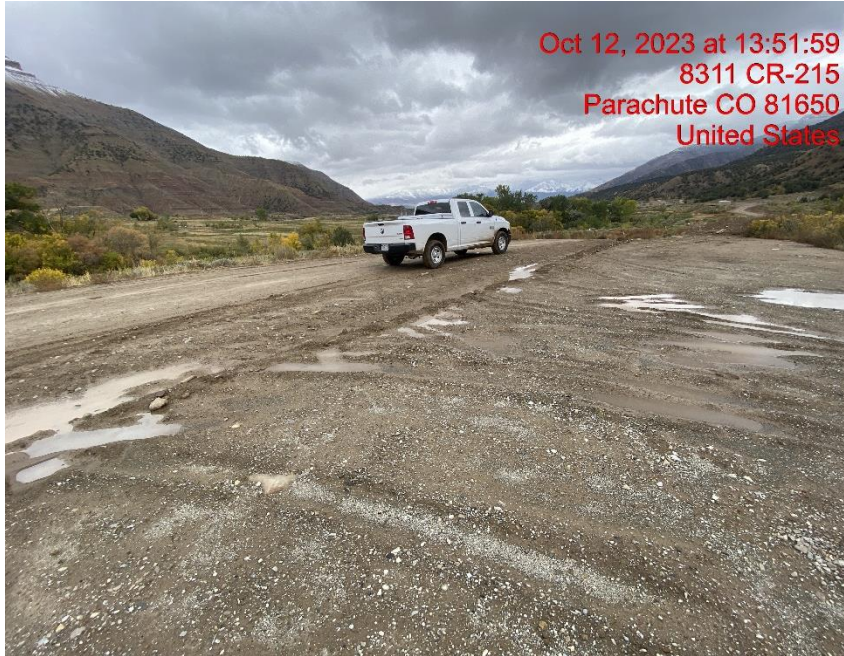
Insufficient Vehicle Tracking BMPs at Location Entrance/Exit
– Photo #06898
