Inspection Photos

Location Name: TEP Rocky Mountain LLC LAST DANCE 9-3 Pad

Location # 324247

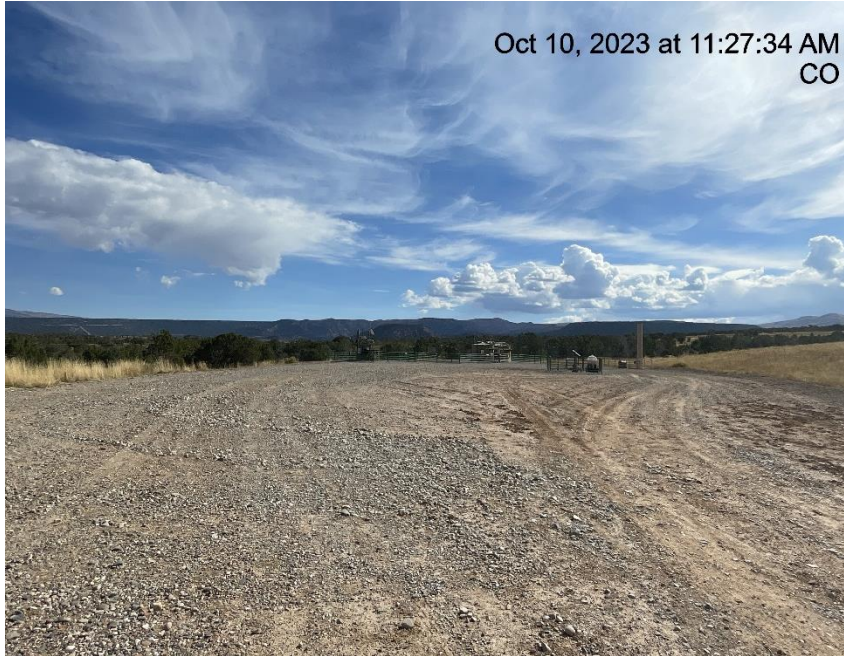
Photo # 2208 From entrance to location

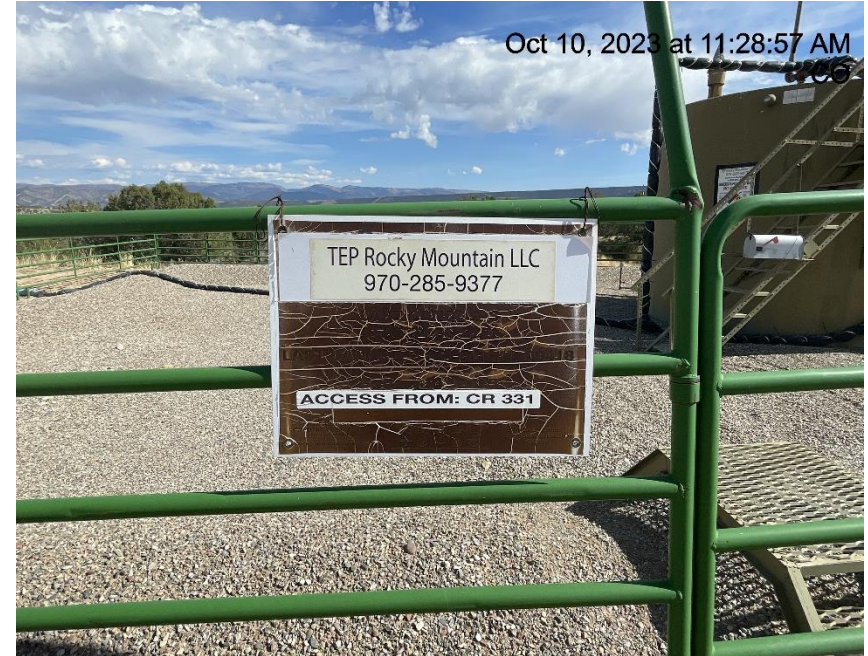
Photo # 2213 Battery sign weathered & illegible

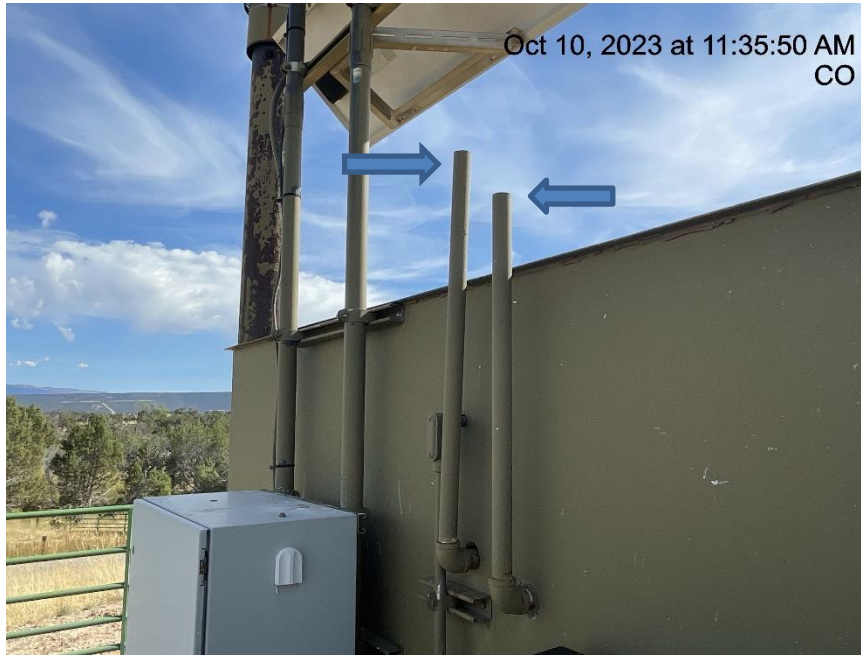
Photo # 2214 PRV & rupture disk vent lines lack caps

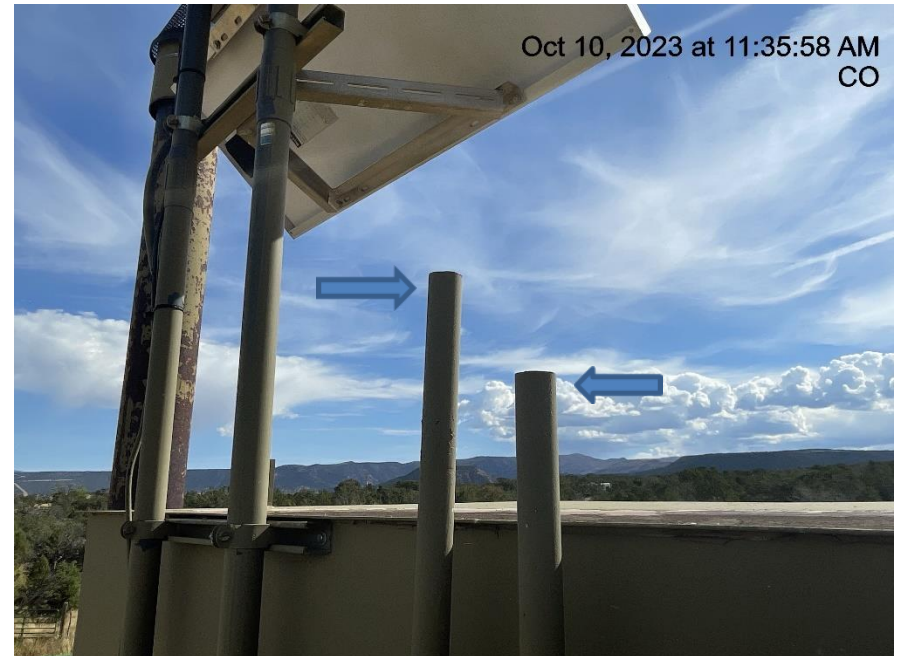
Photo # 2215 PRV & rupture disk vent lines lack caps

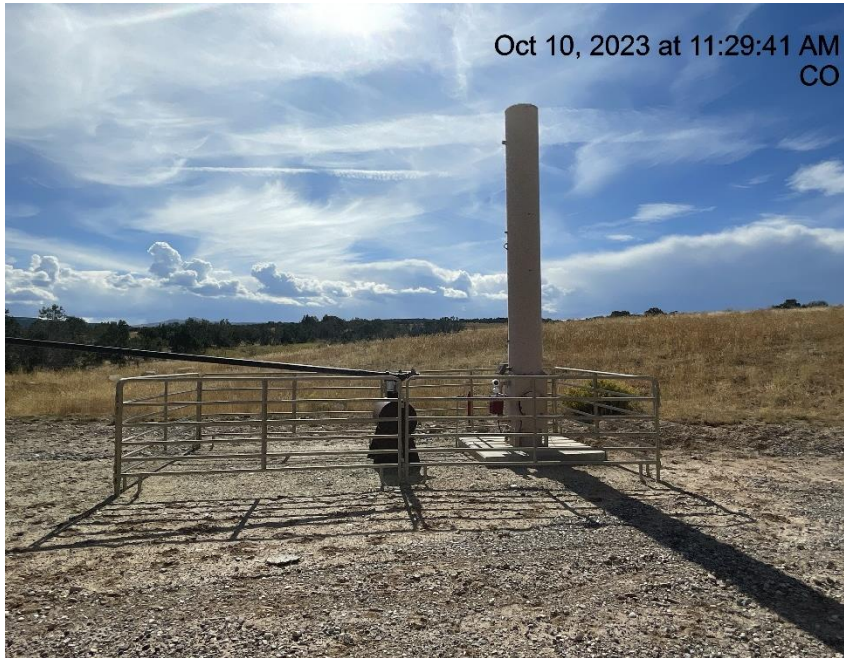
Photo # 2216 Unused equipment

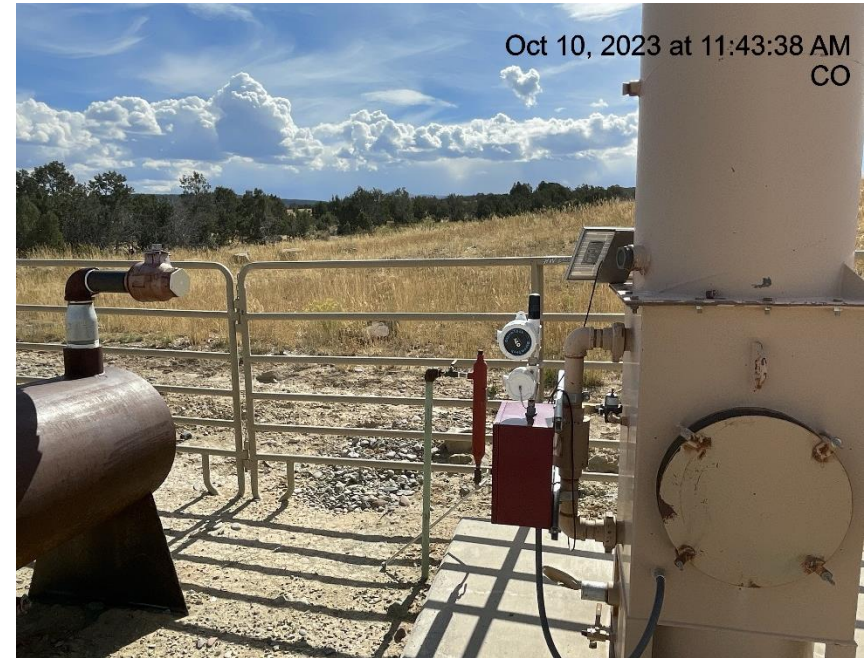
Photo # 2217 Unused equipment/ECD is disconnected

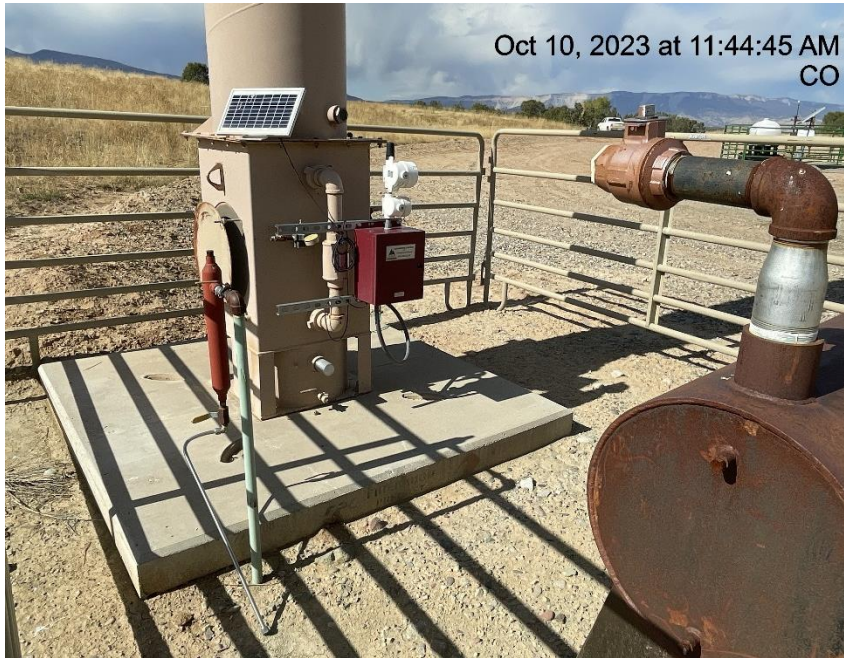
Photo # 2218 Unused equipment/ECD is disconnected
