# Inspection Photos

Loc: 324507

Operator: **OXY USA INC**

Inspection Date: 10/11/2023

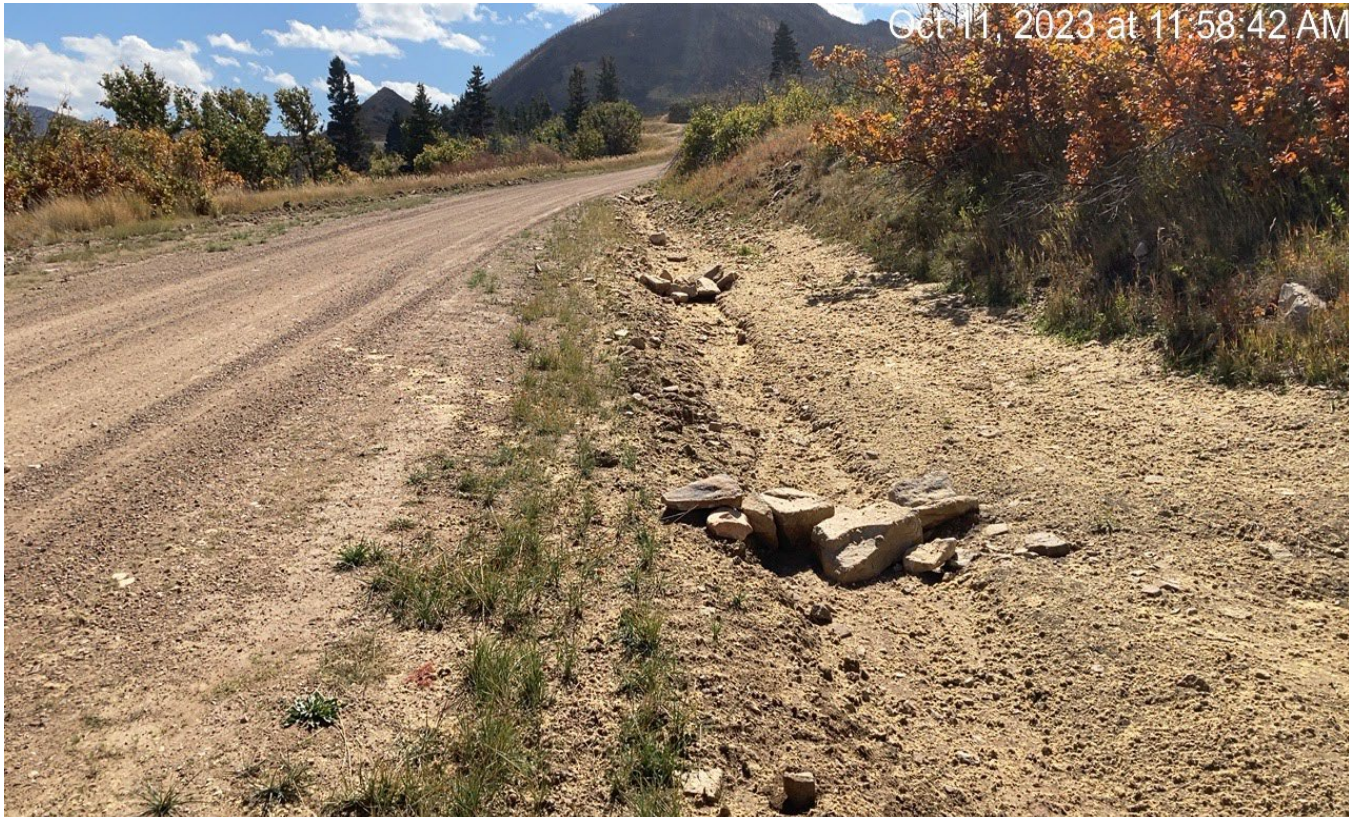
**Photo 1.** Facing southeast along the access road ascending the hill to the location. There has been recent work performed along the west side of the road.

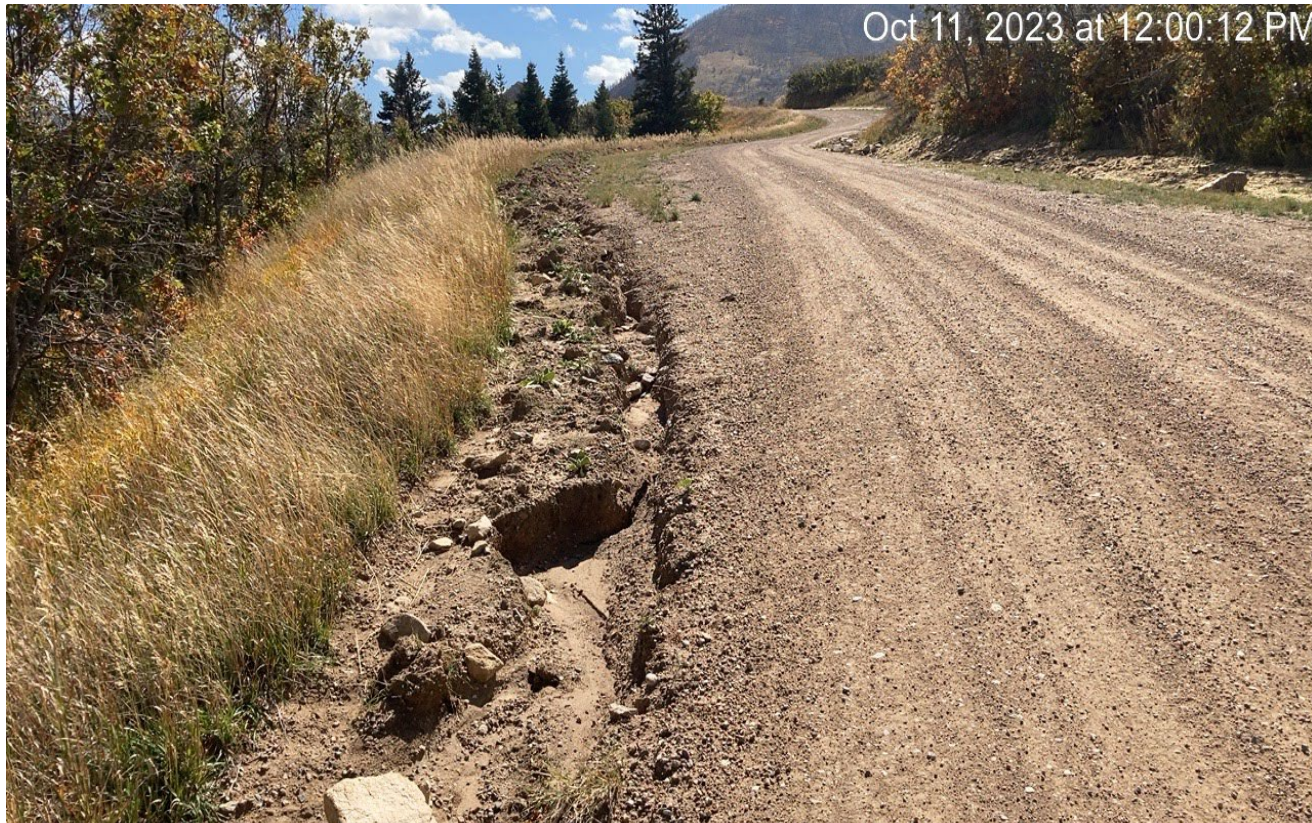
**Photo 2.** Facing southeast along the east side of the road. Grading has pushed out material into a berm which is not allowing stormwater to be diverted off the road.

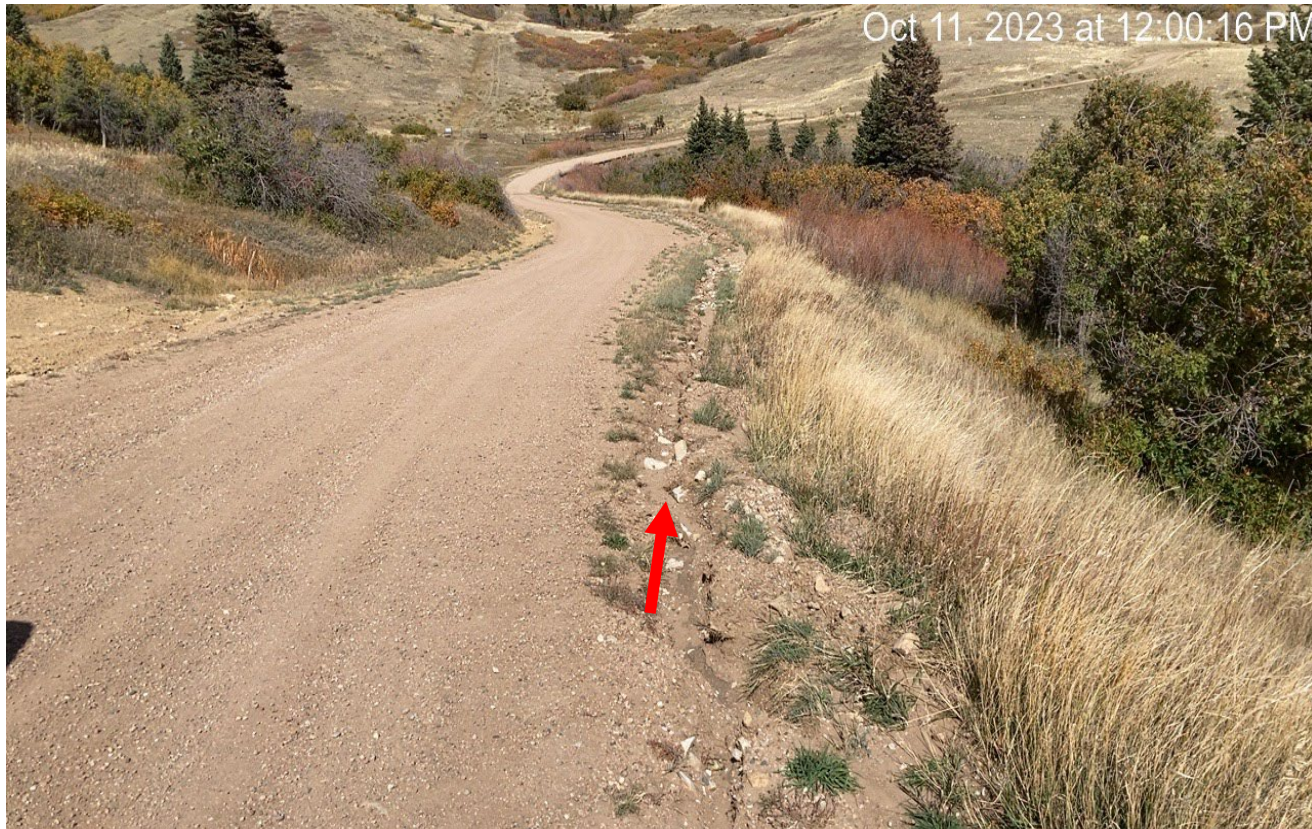
**Photo 3.** Facing northwest back down the access road. Grading has pushed out material into a berm which is not allowing stormwater to be diverted off the road. There is a long stretch of the road where stormwater will be directed down the road which will cause erosion.

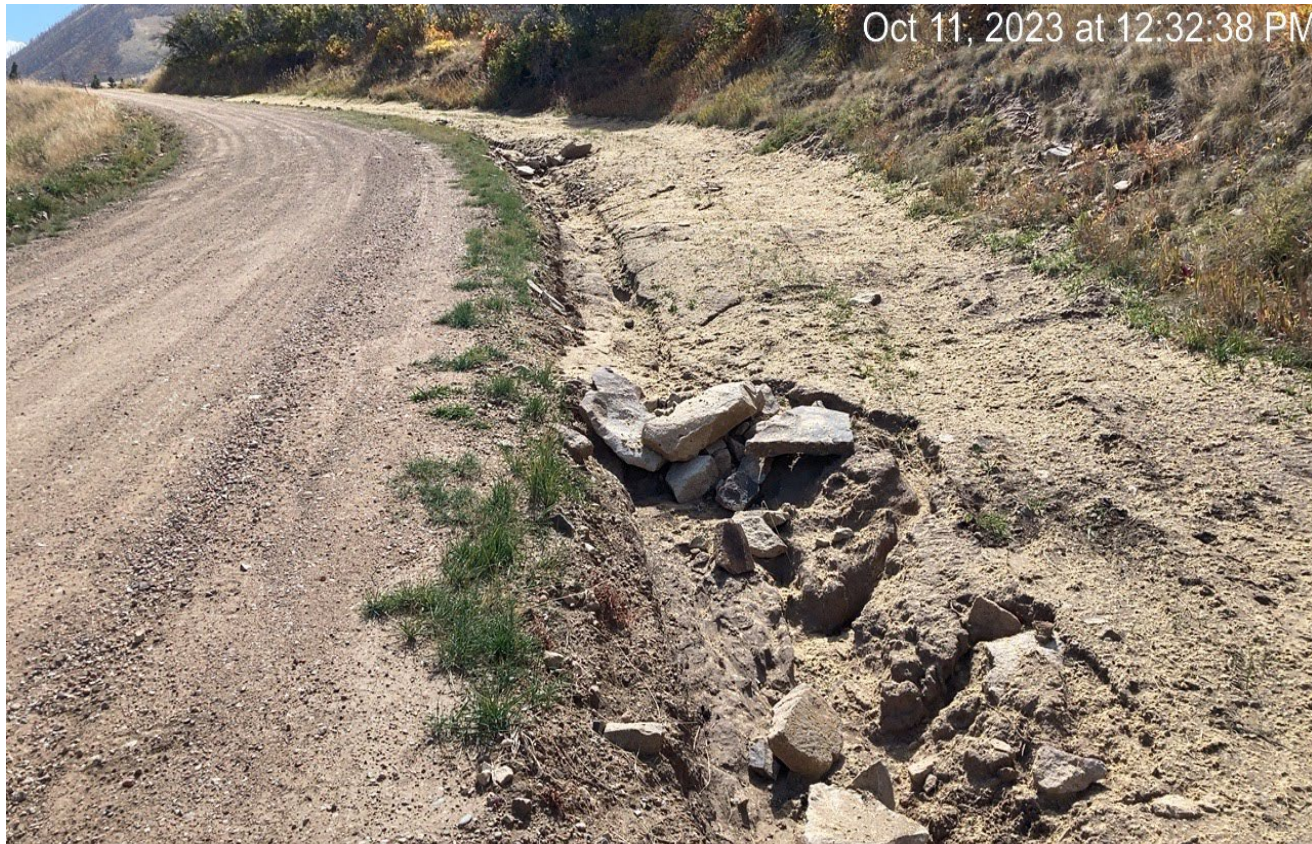
**Photo 4.** Facing southeast along the east side of the road. Some of the rock check dams installed have filled in with sediment and need maintenance. There was erosion observed underneath some of the rocks which were not properly constructed.

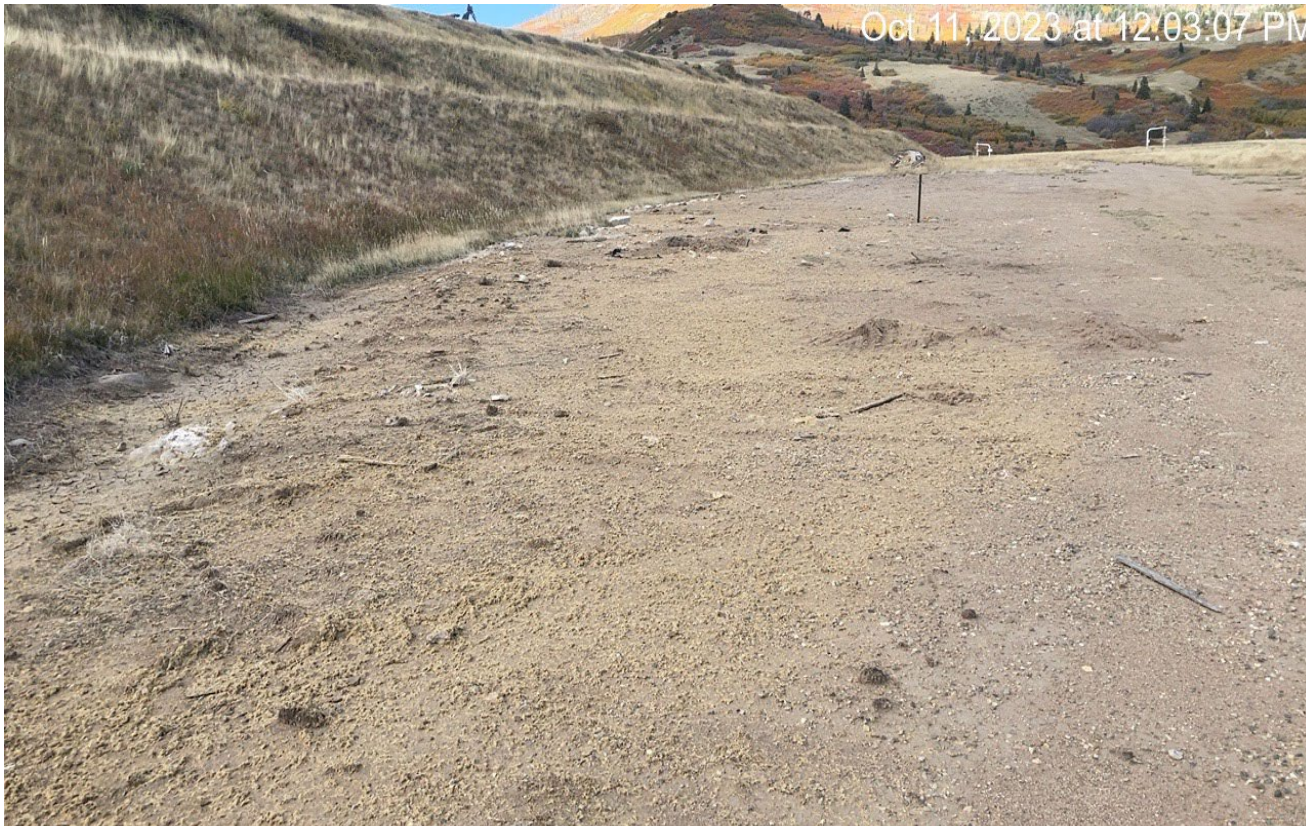
**Photo 5.** Facing northwest at the location.

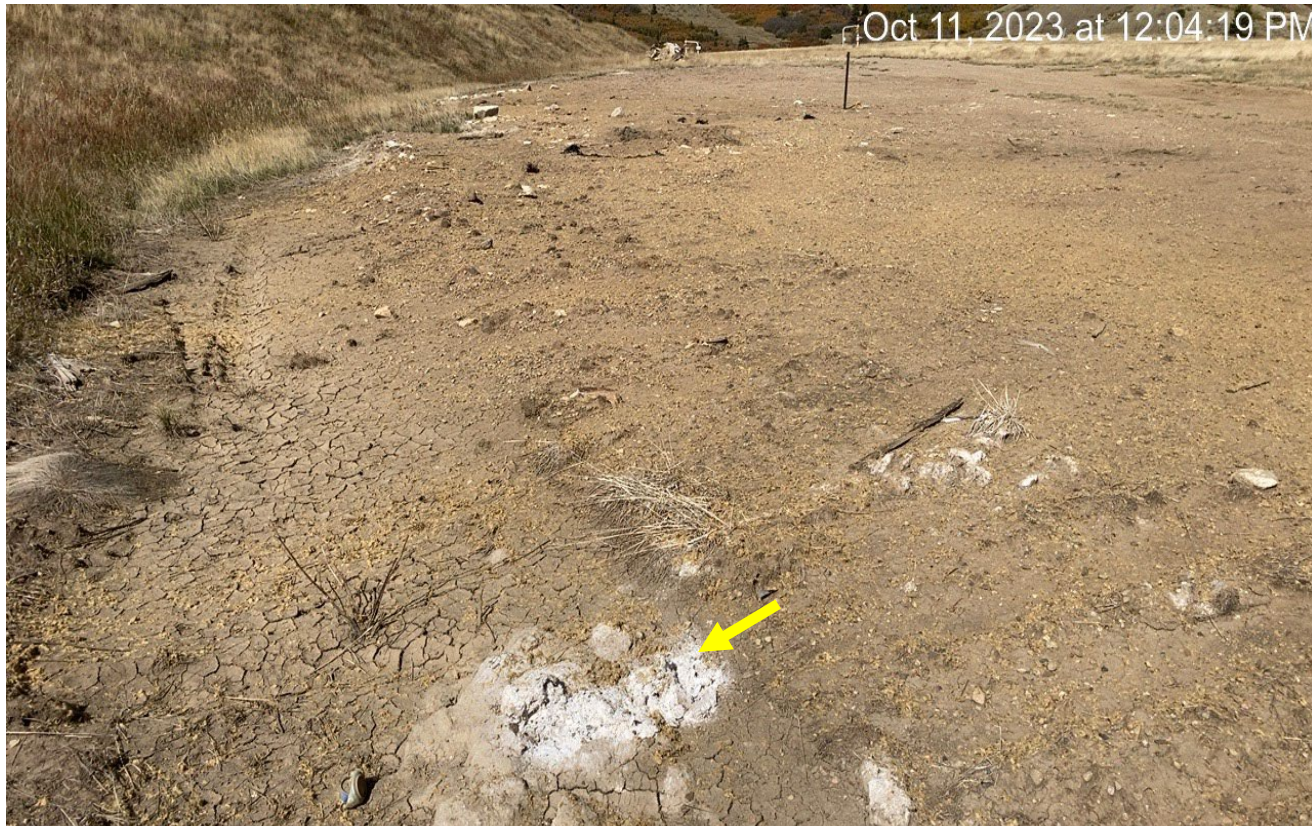
**Photo 6.** There is a white powder substance spill on the ground that needs to be cleaned up. Previous corrective action was not completed.

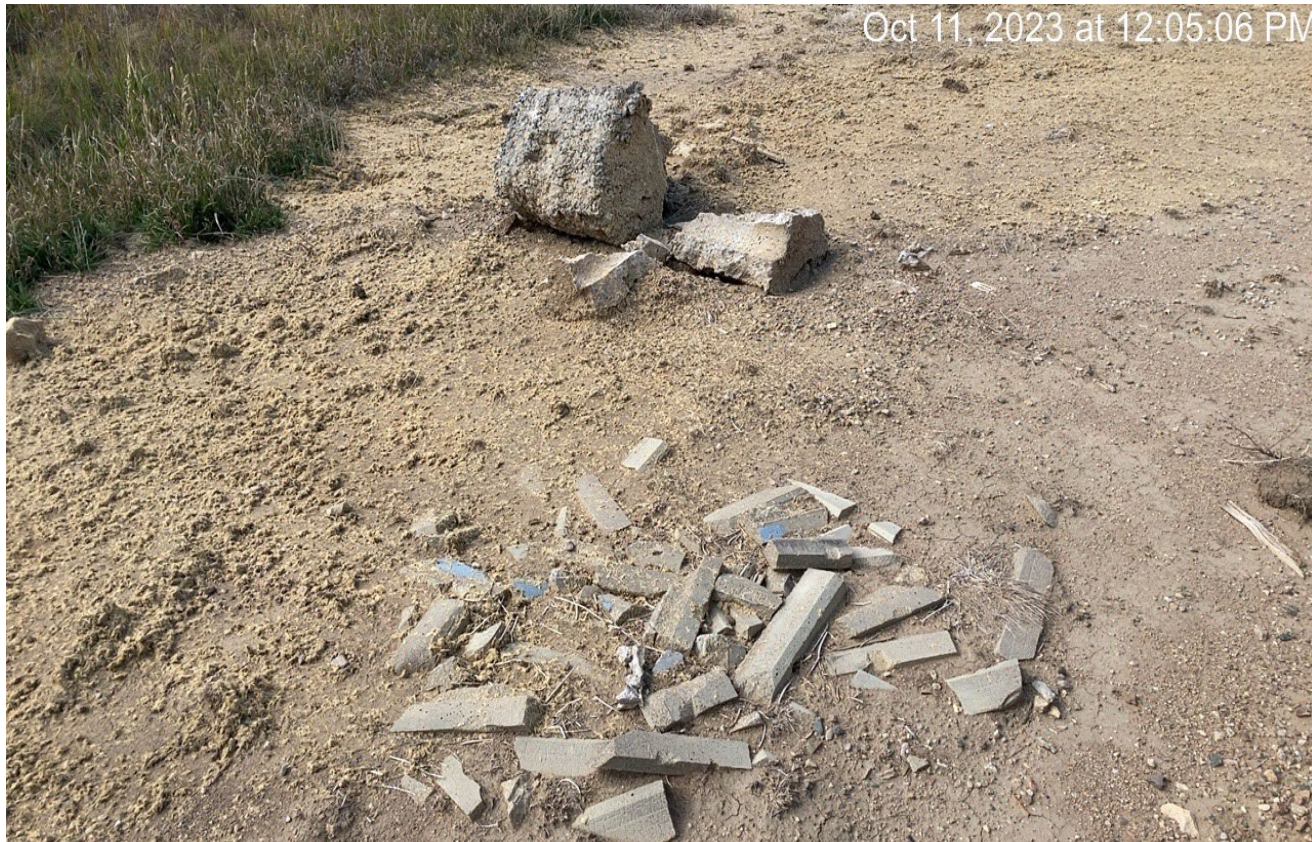
**Photo 7.** There is still cement debris that has not been removed.

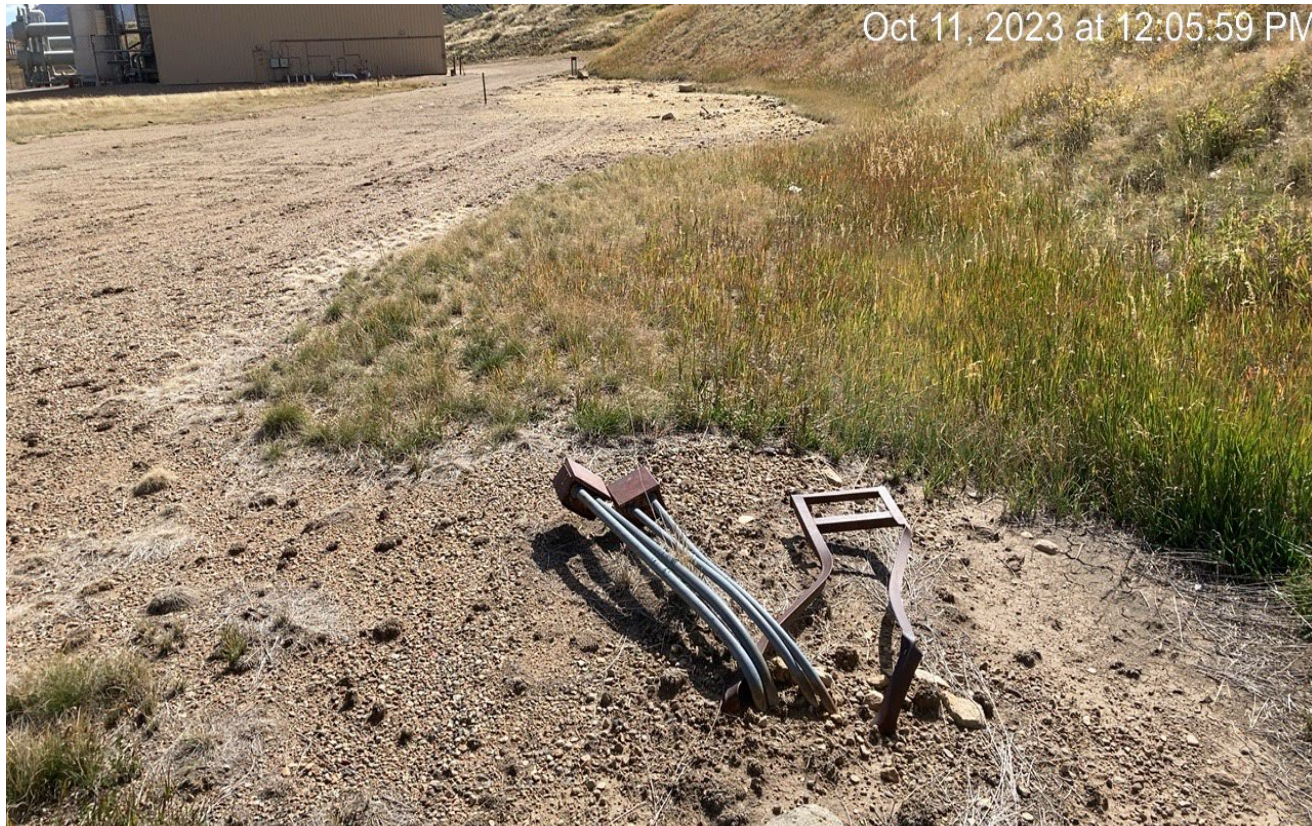
**Photo 8.** Facing back southeast at the location. There is a bent electric utility at this site that needs to be removed.
