# Interim Reclamation and Stormwater Inspection

Operator: CCRP OPERATING INC - #10665

Location ID: 455554

Location Name: True Ranch Fee/27 East

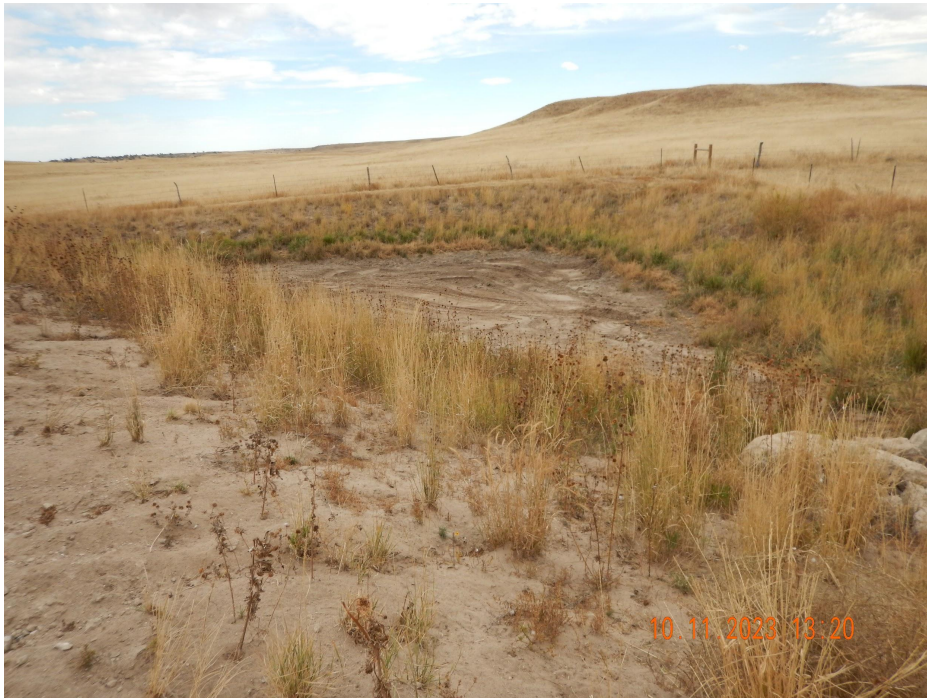
**Photo 1.** Photo taken from the southeastern location, facing Southeast. Photo illustrates the retention pond that is in proper functioning condition. No sediment discharge was observed from location.

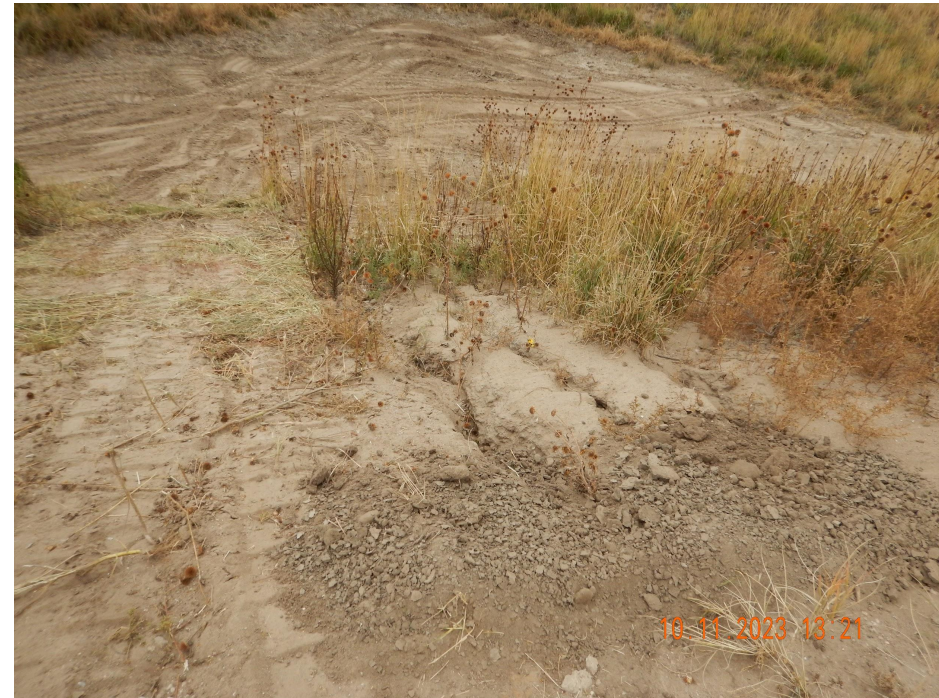
**Photo 2.** Photo taken from a section of the fill slope leading into the retention pond. Photo illustrates rill erosion that was partially repaired.

Note- filling in the rill erosion by itself will not be sufficient to stabilize the fill slope.

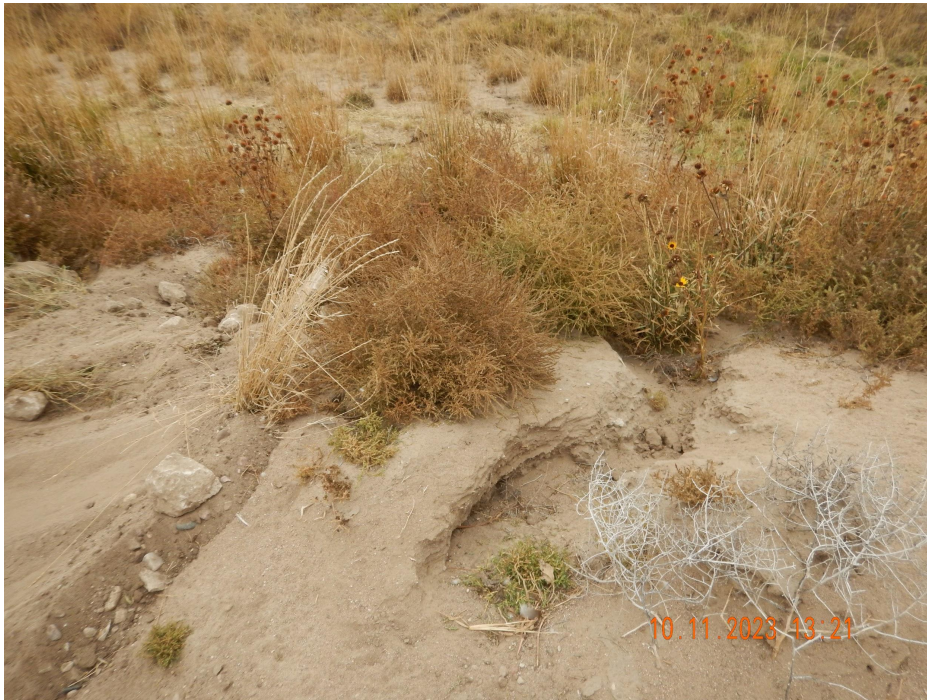
**Photo 3.** Photo taken from another section of fill slope, north of the retention pond. Photo illustrates rill erosion/gully erosion that needs repairs.

Note- filling in the rill/gully erosion by itself will not be sufficient to stabilize the fill slope.

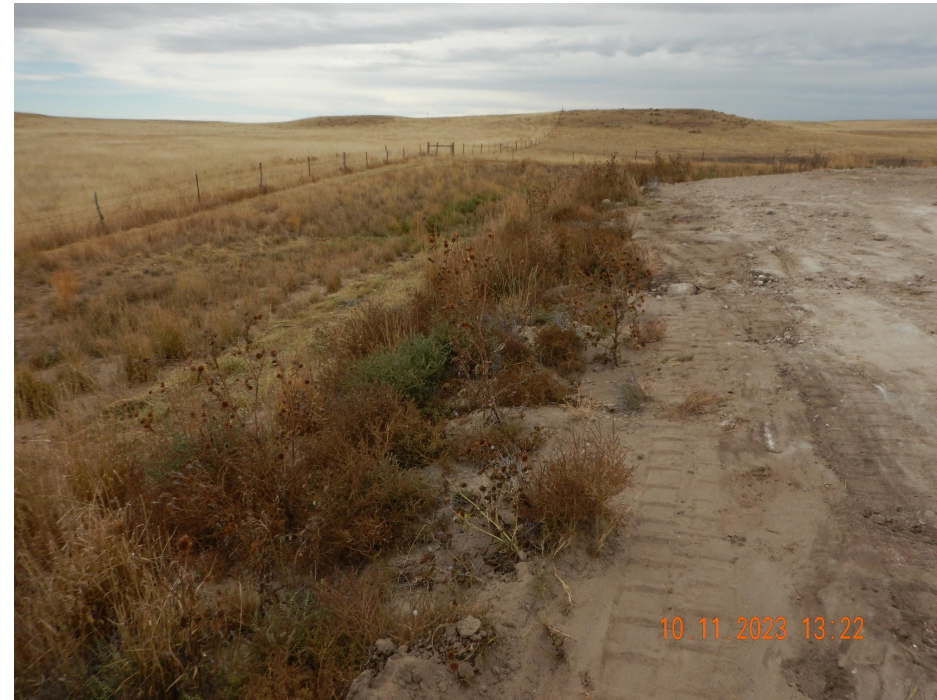
**Photo 4.** Photo taken from the eastern location, facing South. Photo illustrates Russian thistle (tumbleweed) that appears to be treated with herbicides. Since Russian thistle will likely break off and become weed debris, Operator will have to remove Russian thistle which can be accomplished through mechanical control.

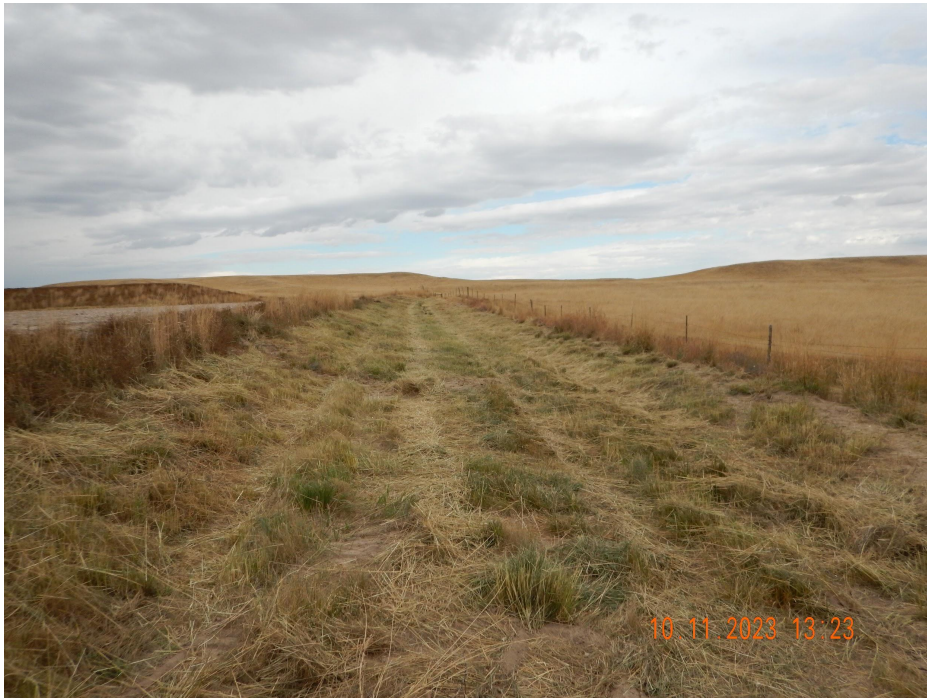
**Photo 5.** Photo taken from the eastern perimeter of location, facing North. Photo illustrates recent mowing operations.

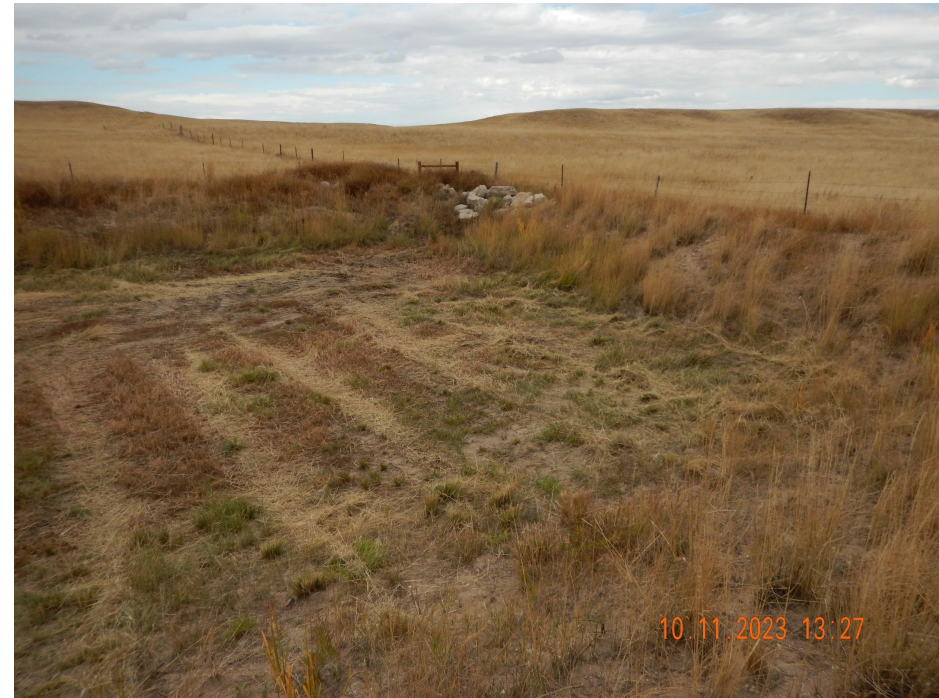
**Photo 6.** Photo taken from the northeastern location, facing Northeast. Photo illustrates the retention pond that is in proper functioning condition. No sediment discharge was observed from location.

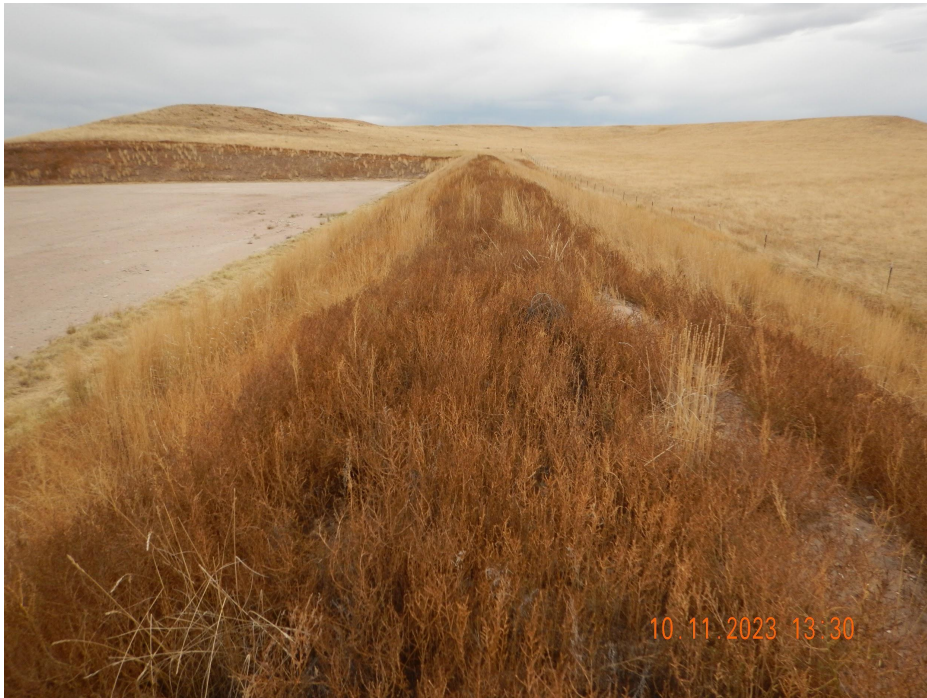
**Photo 7.** Photo taken from the topsoil stockpile, facing West. Photo illustrates Russian thistle growth that appears to be treated with herbicides. Much of the other perennial vegetation on the stockpile is introduced grass species not reflective of reference area conditions.

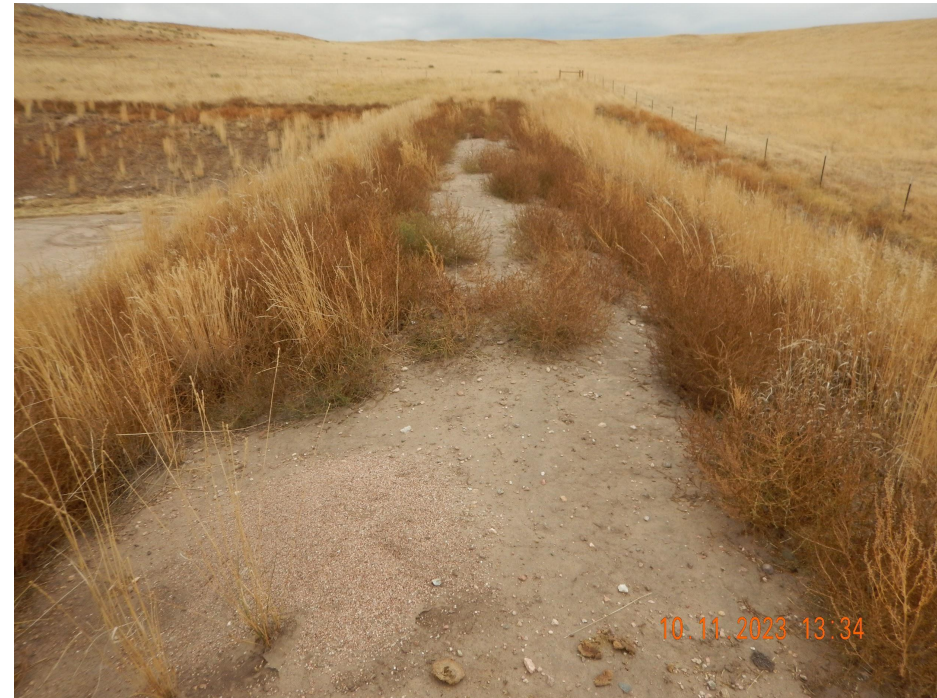
**Photo 8.** Photo taken from another portion of the topsoil stockpile, facing West. Photo illustrates bare areas that appears to be compacted.

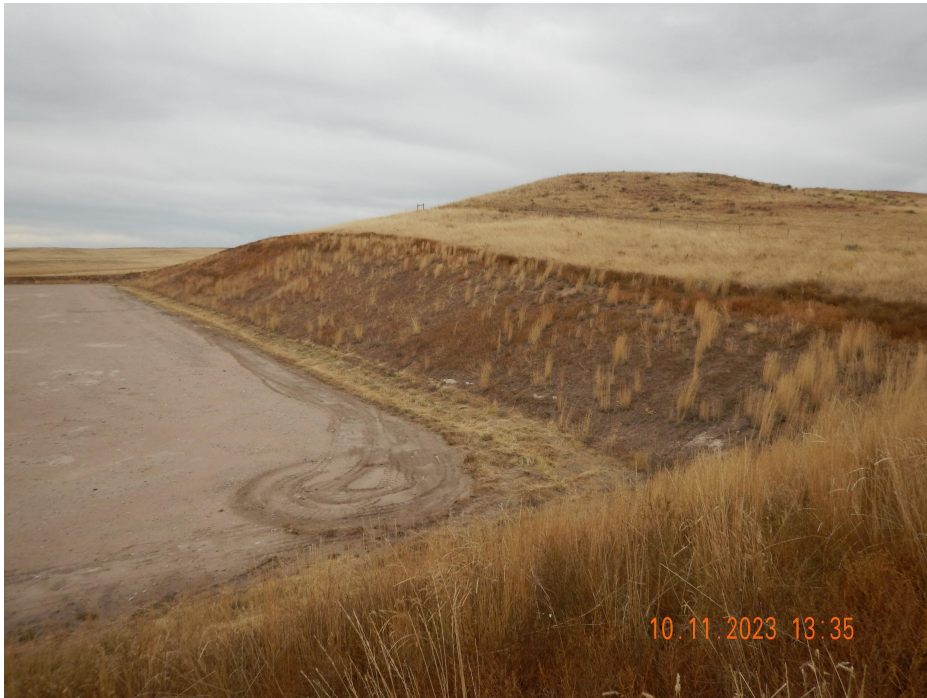
**Photo 9.** Photo taken from the topsoil stockpile, facing Southwest. Photo illustrates the western cut slope that has some perennial vegetation but introduced species.

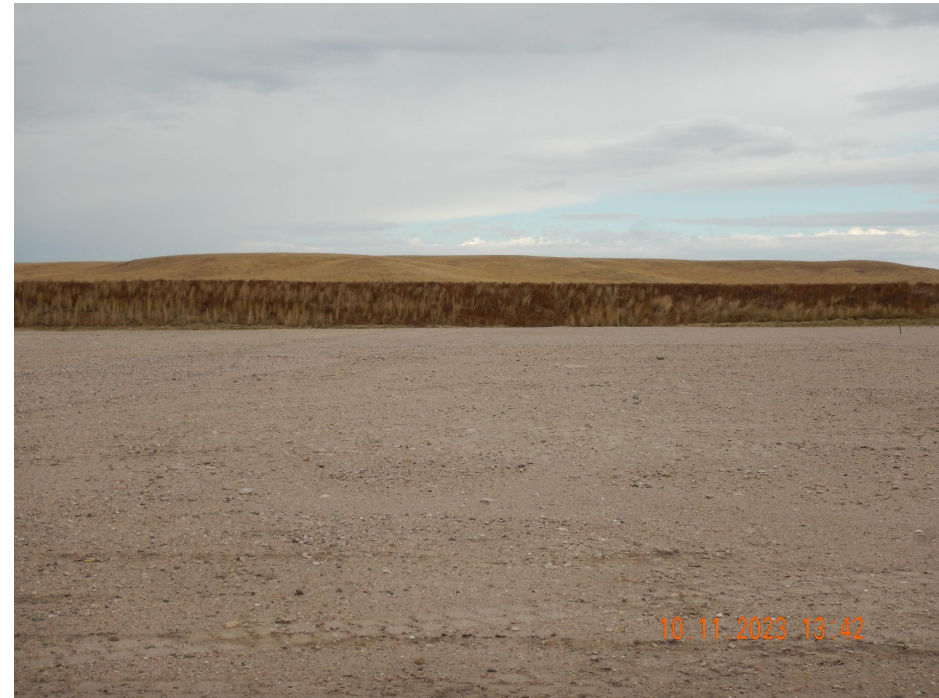
**Photo 10.** Photo taken from the southern location, facing North. Photo illustrates the south-facing side of the topsoil stockpile illustrating Russian thistle growth that appeared to be treated with herbicides.

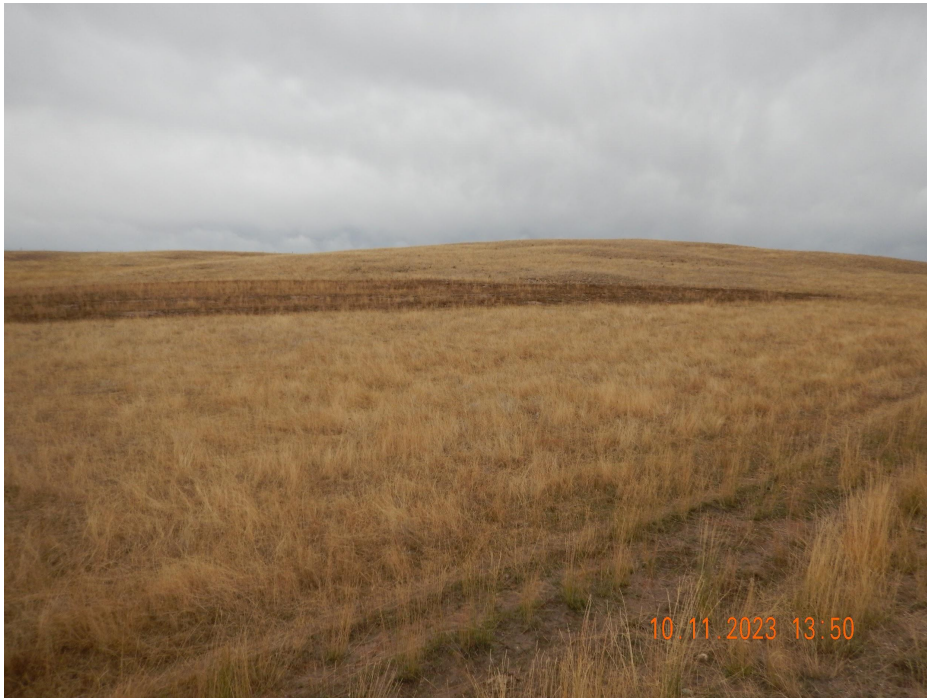
**Photo 11.** Photo taken along the portion of the access road where topsoil was salvaged from the access road, facing South. Refer to Photo 13 for an overview of the stockpiled location.

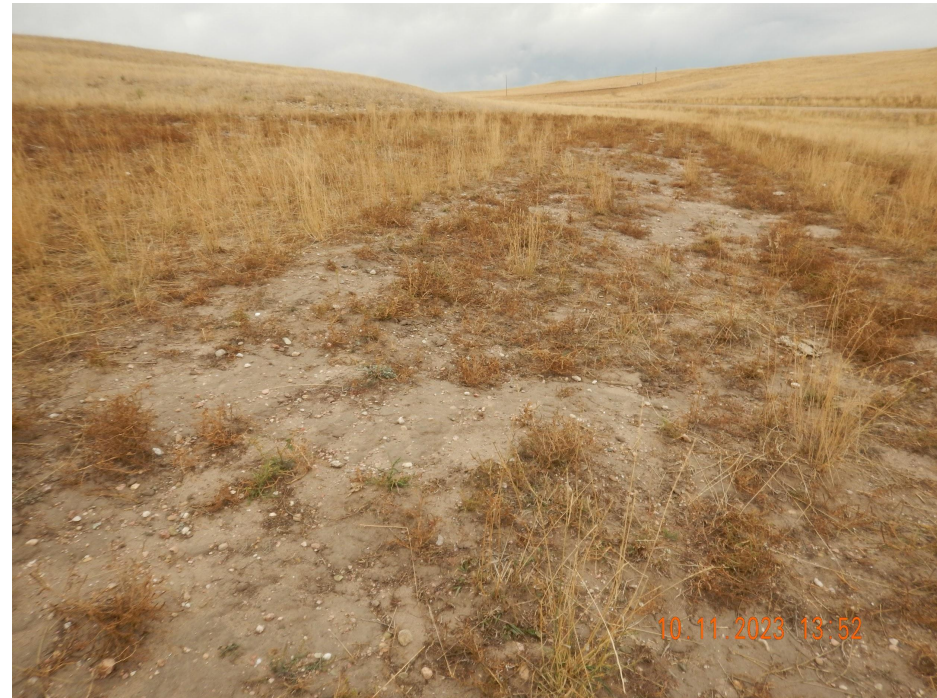
**Photo 12.** Photo taken from the topsoil stockpile location, facing West. Photo illustrates some desirable establishment and introduced grass species but also bare areas that are not reflective of reference areas. The area also appeared to be compacted.

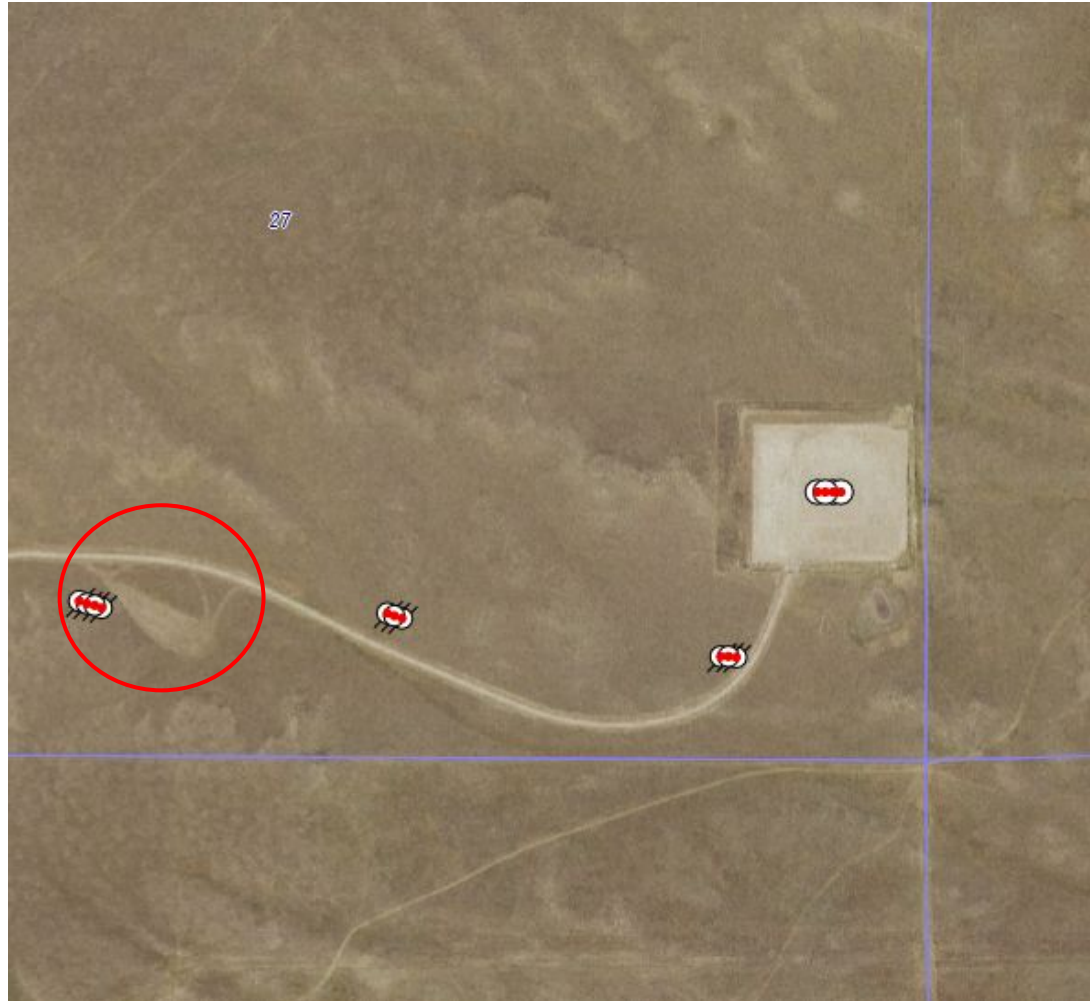
**Photo 13.** ECMC aerial imagery illustrates the topsoil stockpile area shown in Photos 11-12.
