Interim Reclamation and Stormwater Inspection

Operator: LONGS PEAK RESOURCES LLC- #10611

Location ID: 439459

Inspection Photos
Location Name: Motu East /2821-8CH
Location ID: 439459

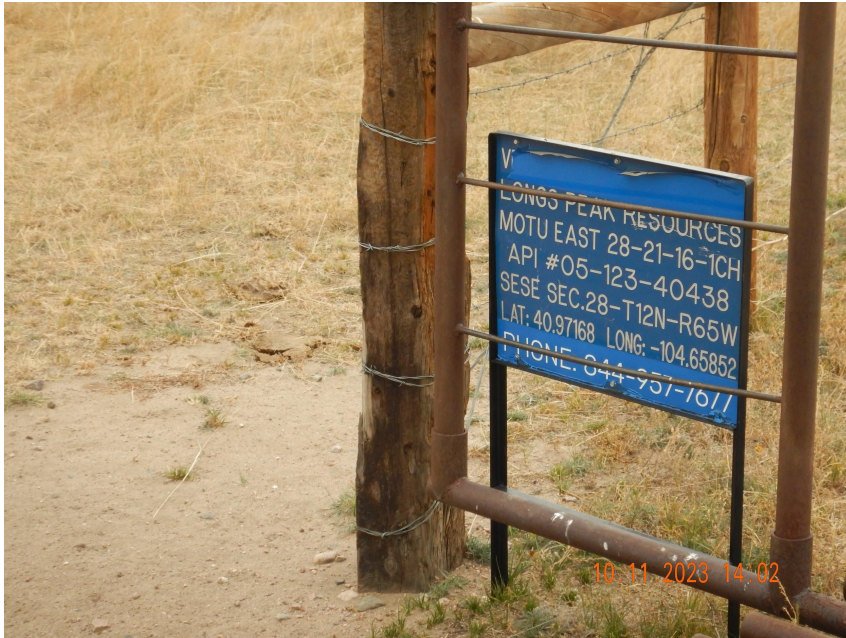
Photo 1. Photo taken from the entrance of location.
Photo illustrates Operator signage.

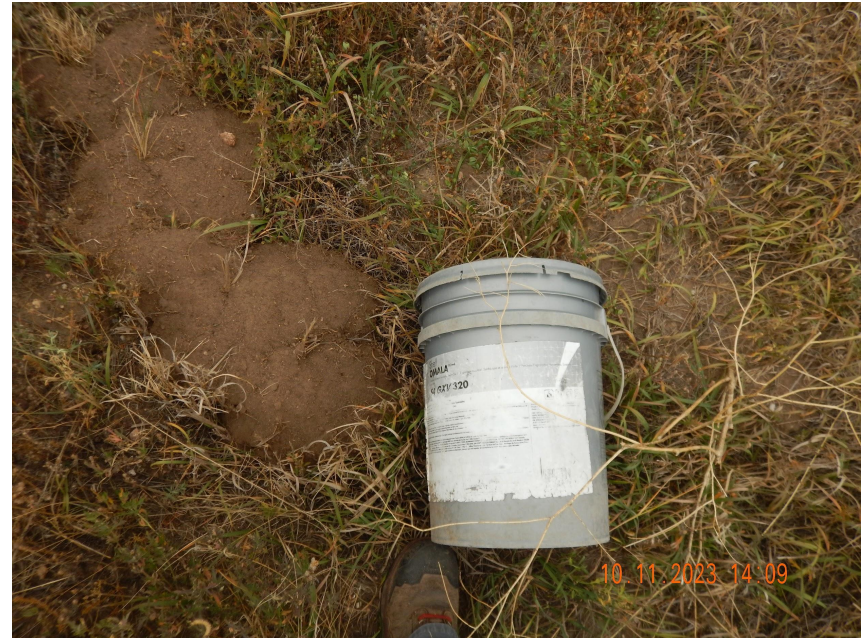
Photo 2. Photo taken from the southeastern location.
Photo illustrates trash that needs to be removed and properly disposed of. Trash was observed throughout the location and continues to be issue.

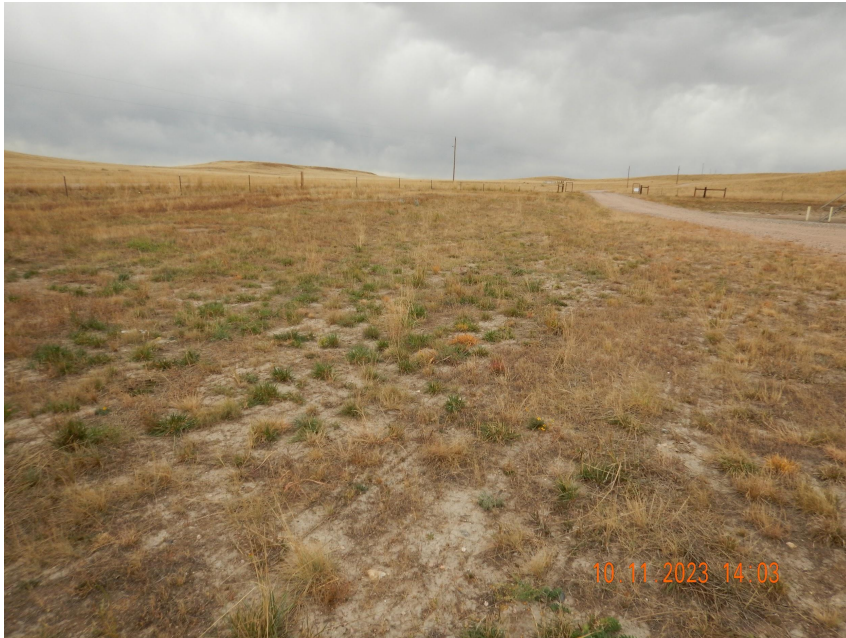
Photo 3. Photo taken from the southern interim reclamation area, facing West. Photo illustrates additional reclamation was performed and some desirable vegetation was observed and is in process of establishing.

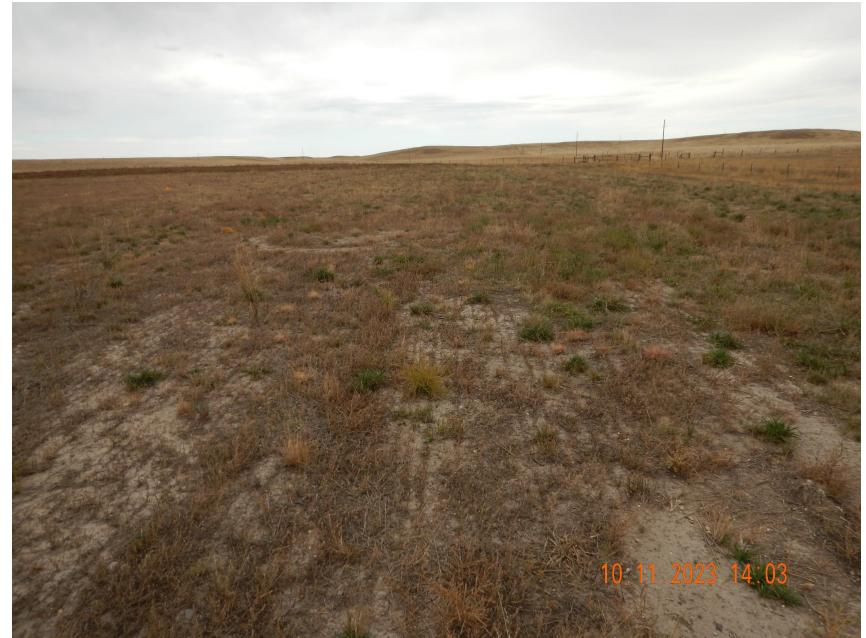
Photo 4. Photo taken from the southern interim reclamation area, facing East. See comments under Photo 3.

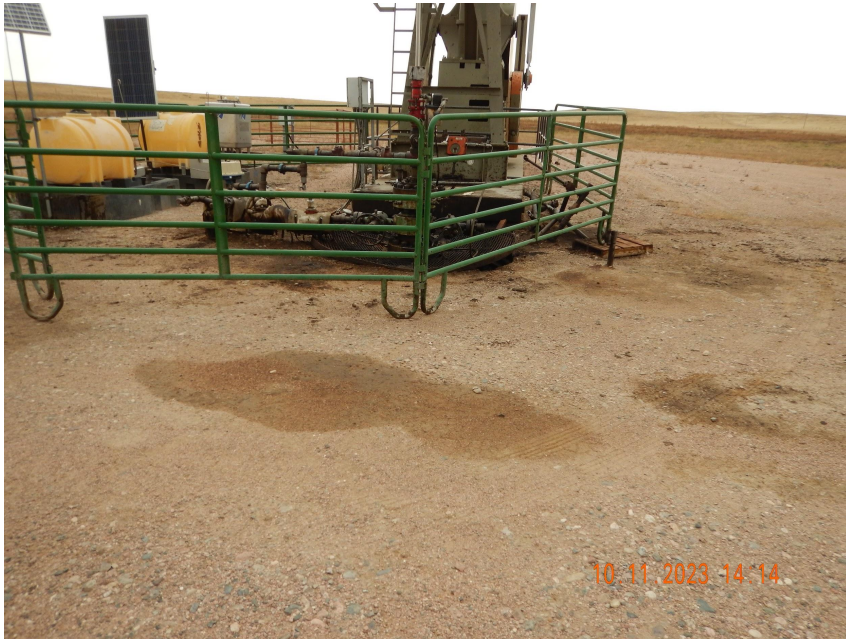
Photo 5. Photo taken from the wellhead. Photo illustrates stained soil around the wellhead and outside of the cattle guards.

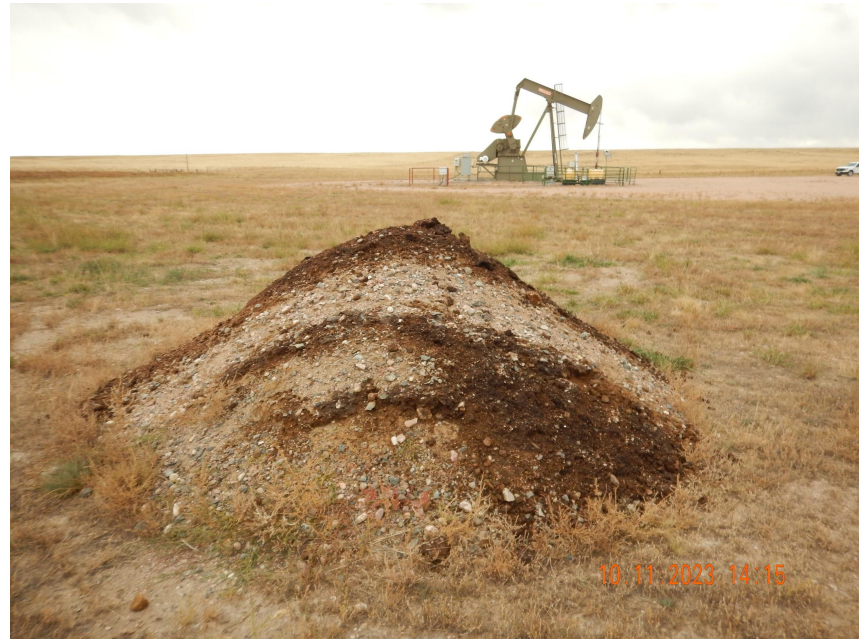
Photo 6. Photo taken from the interim reclamation area, facing South. Photo illustrates improper waste disposal and waste management.

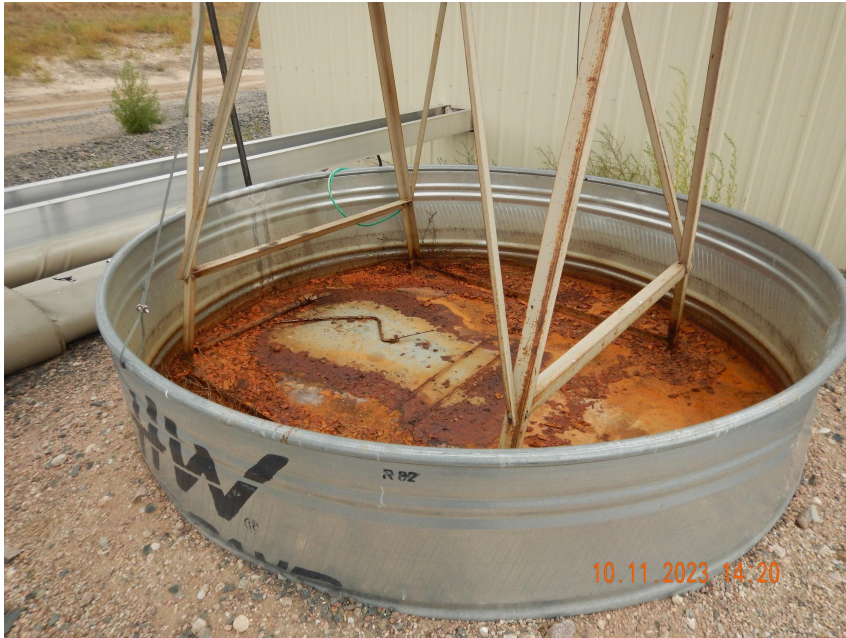
Photo 7. Photo taken of secondary containment which is missing wildlife protection (netting). Secondary containment is for coolant.

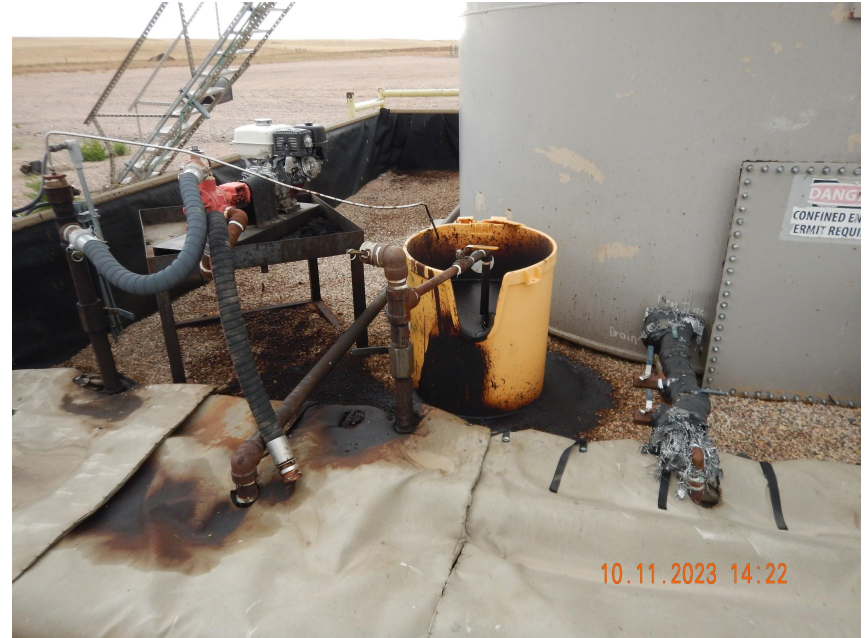
Photo 8. Photo taken from within the secondary containment. Stained soil/gravel needs to be removed, cleaned out and properly disposed of.

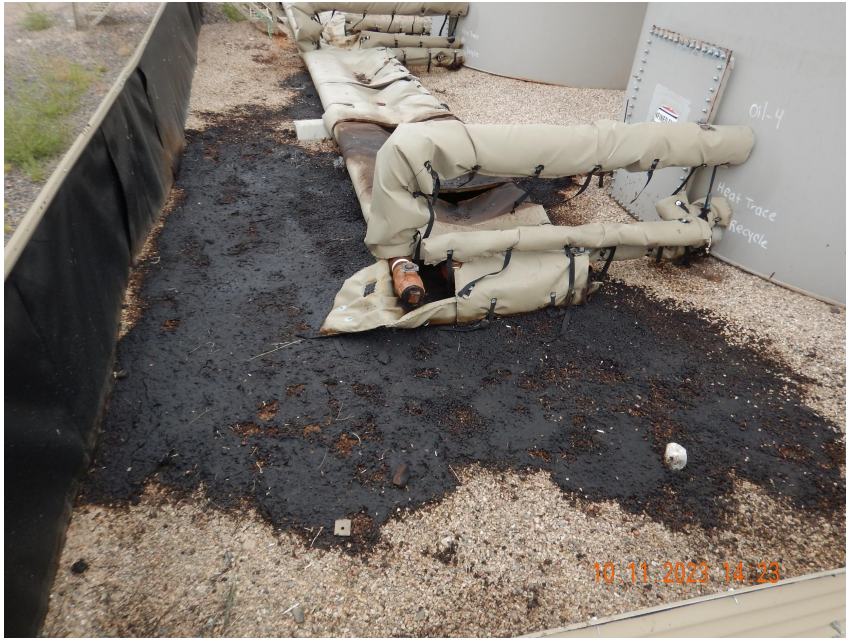
Photo 9. Photo taken from within the secondary containment. Stained soil/gravel needs to be removed, cleaned out and properly disposed of.

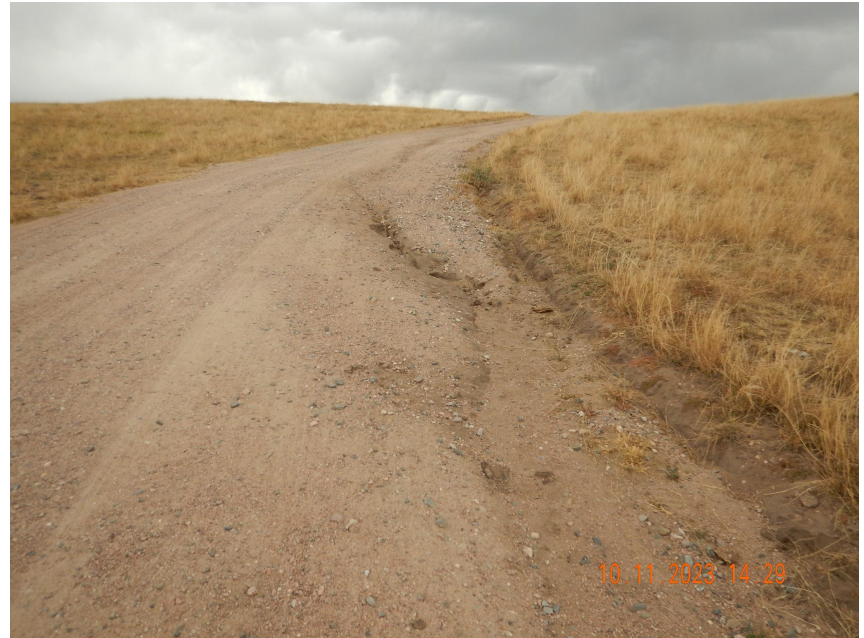
Photo 10. Photo taken along a portion of the access road, facing West. Photo illustrates rill erosion in need of repair.

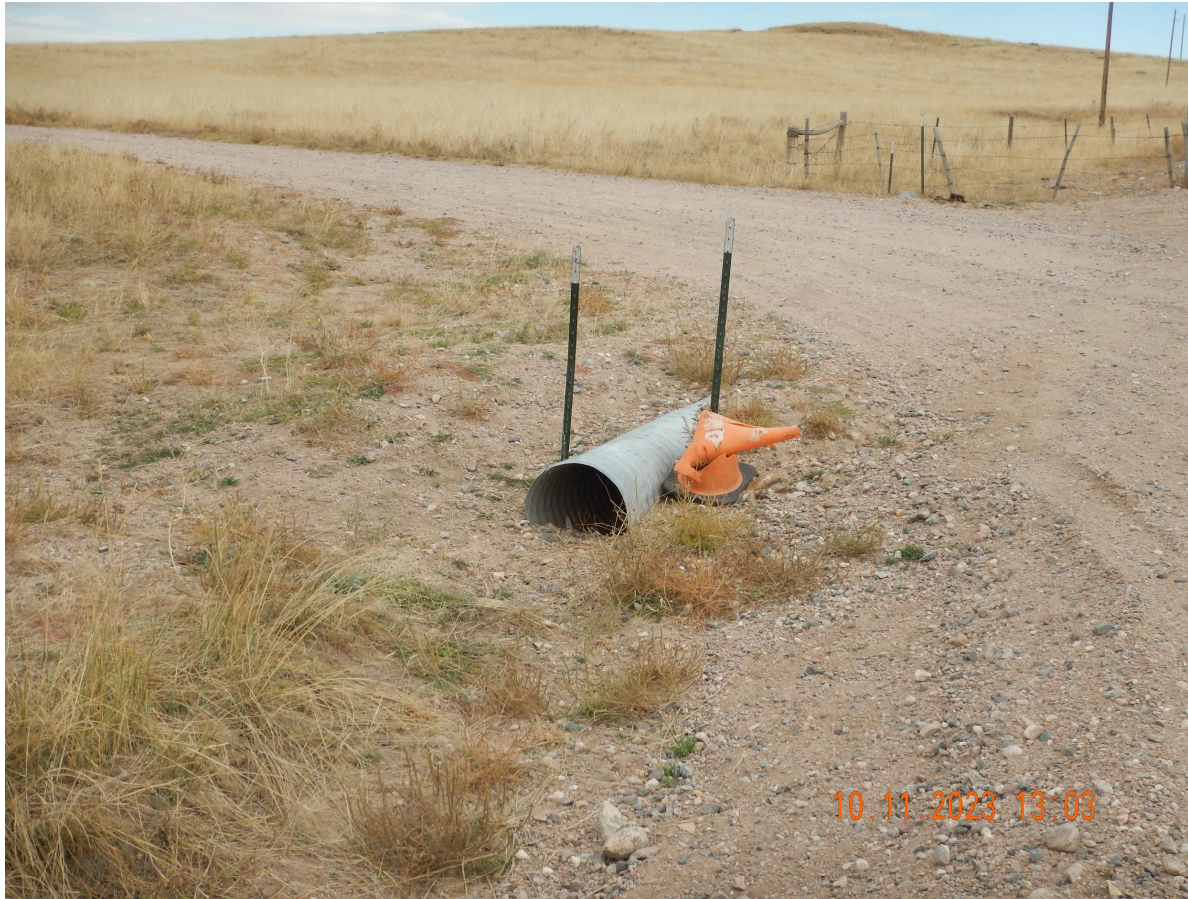
Photo 11. Photo taken from the entrance of location off CR 136. Photo illustrates culvert has been repaired.
