WELL NAME: JJ #1, API #: 043-05180, INSP. # 695108717

COLORADO
Energy & Carbon Management
Commission
Department of Natural Resources

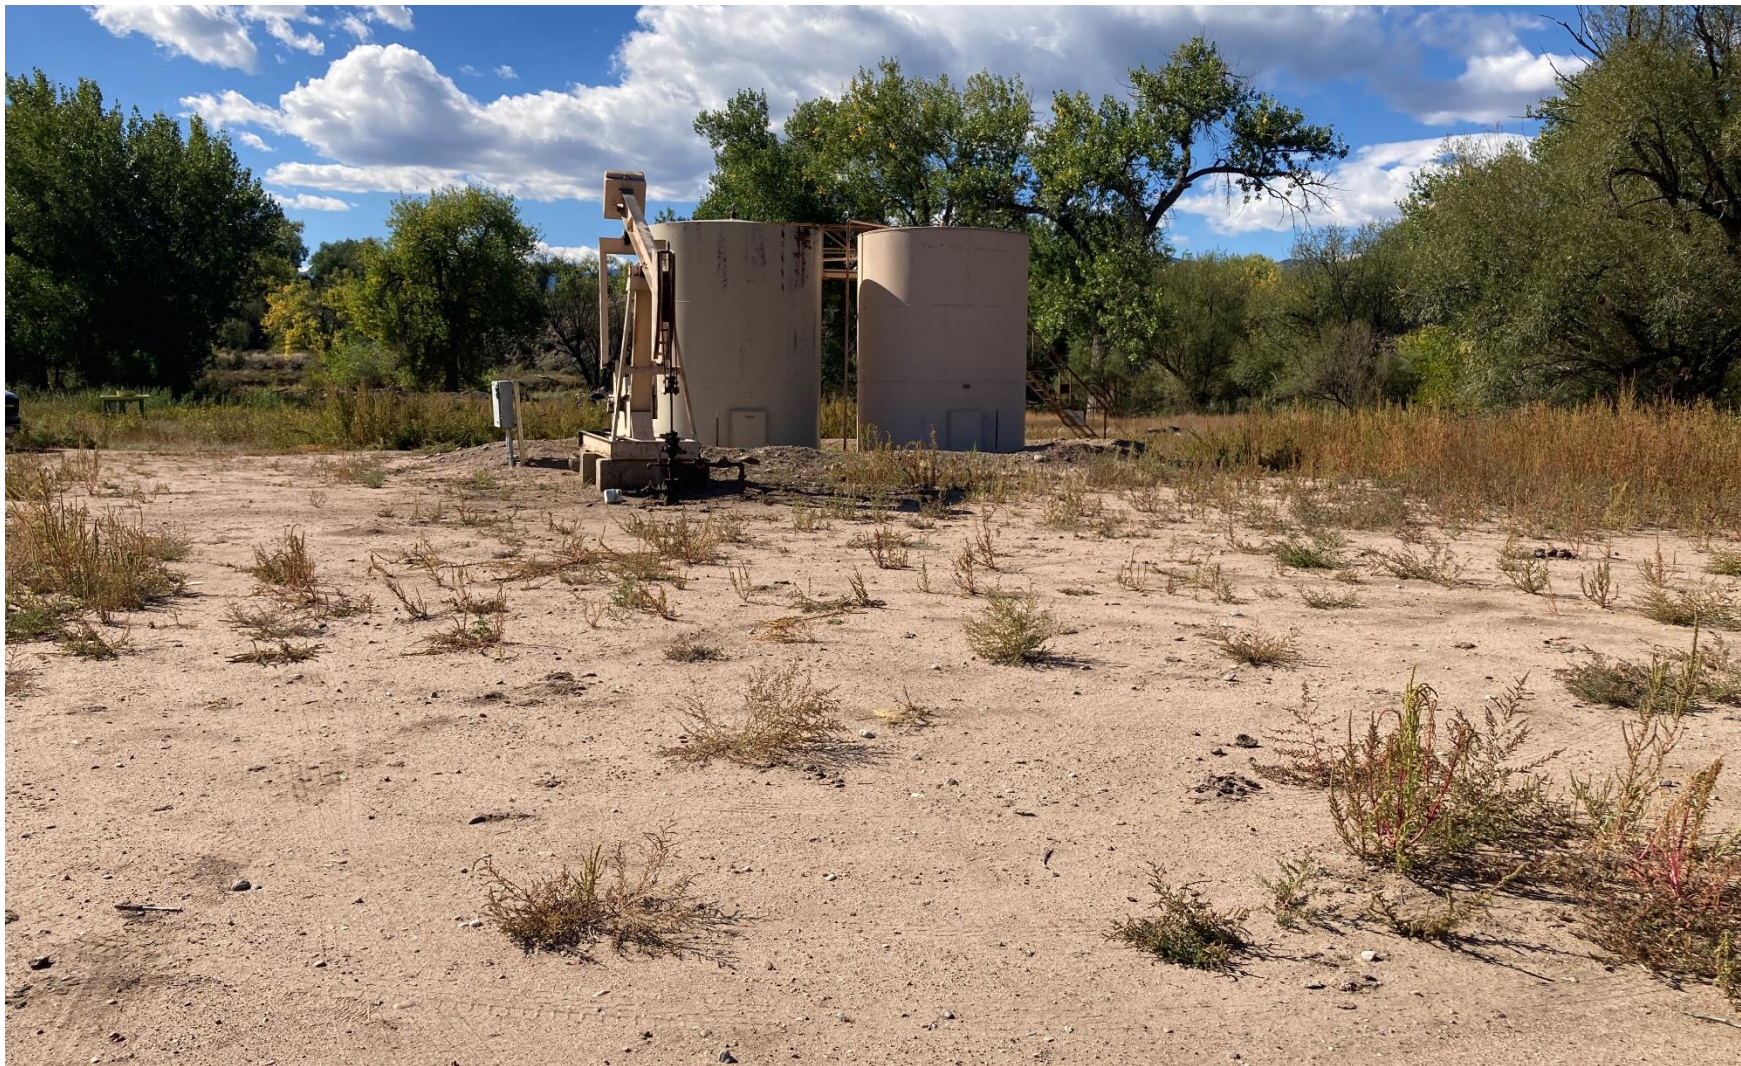
**PHOTO 2: WEEDS INSIDE ANCHORS NOT MAINTAINED. MAINTAIN ALL WEEDS INSIDE ANCHARS ON LOCATION PER RULE 606. CA
DATE 11-11-2023.**

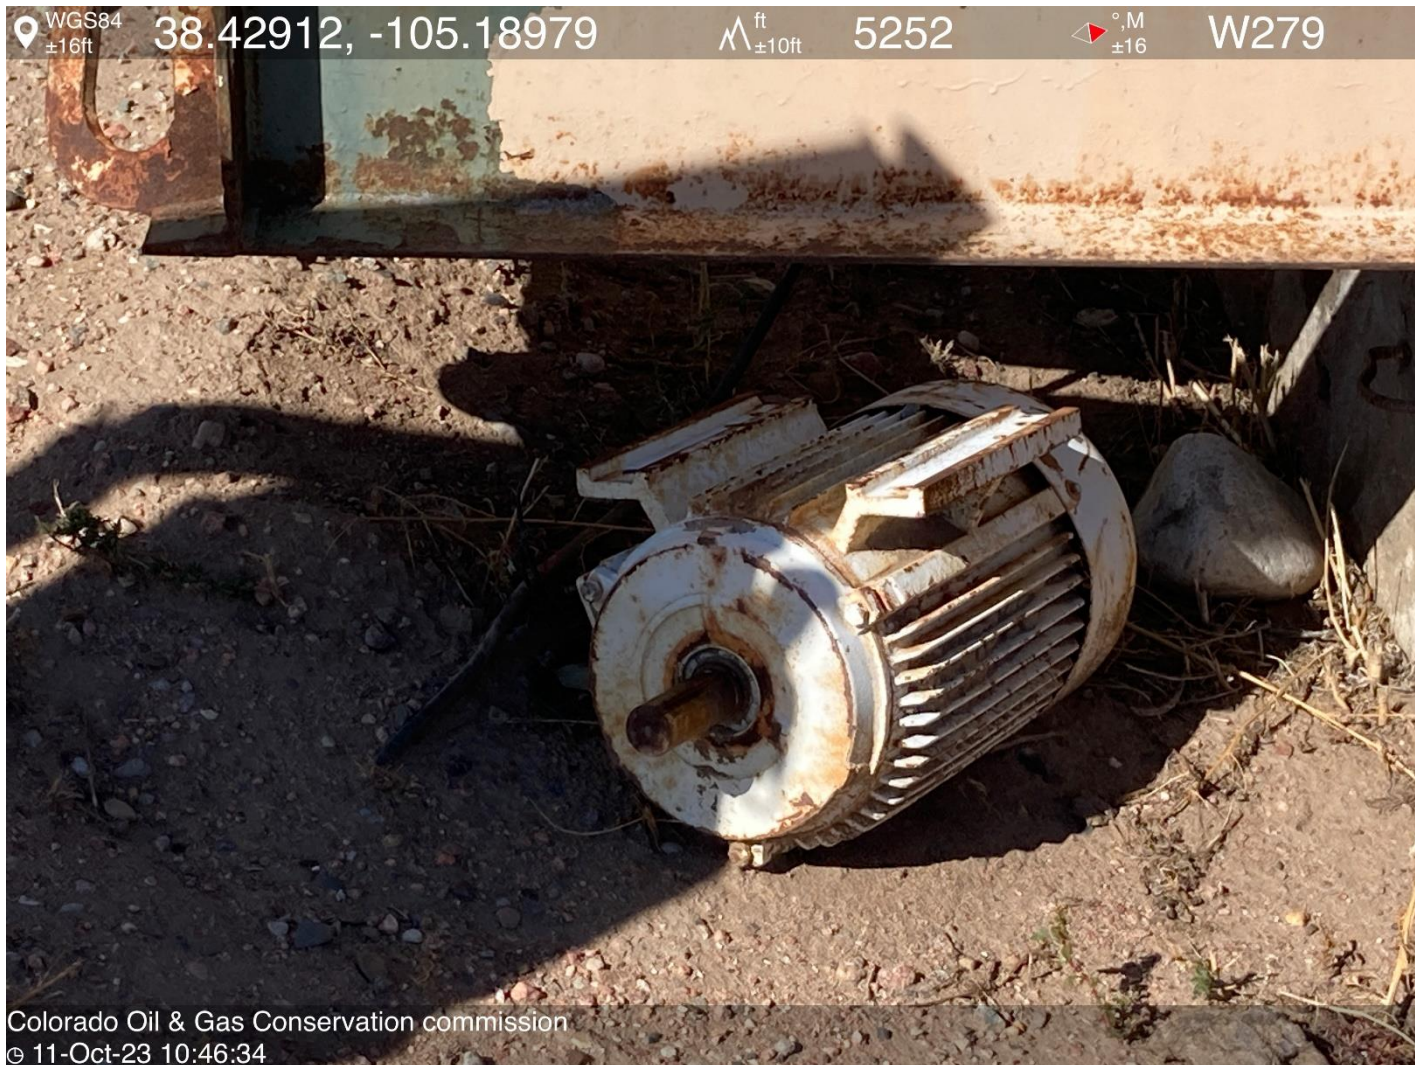
PHOTO 5: UNUSED EQUIPEMNT STORED ON LOCATION (ELECTRIC DRIVE MOTOR NEAR PUMP JACK). REMOVE UNUSED EQUIPMENT PER RULE 606. CA DATE 11-11-2023.

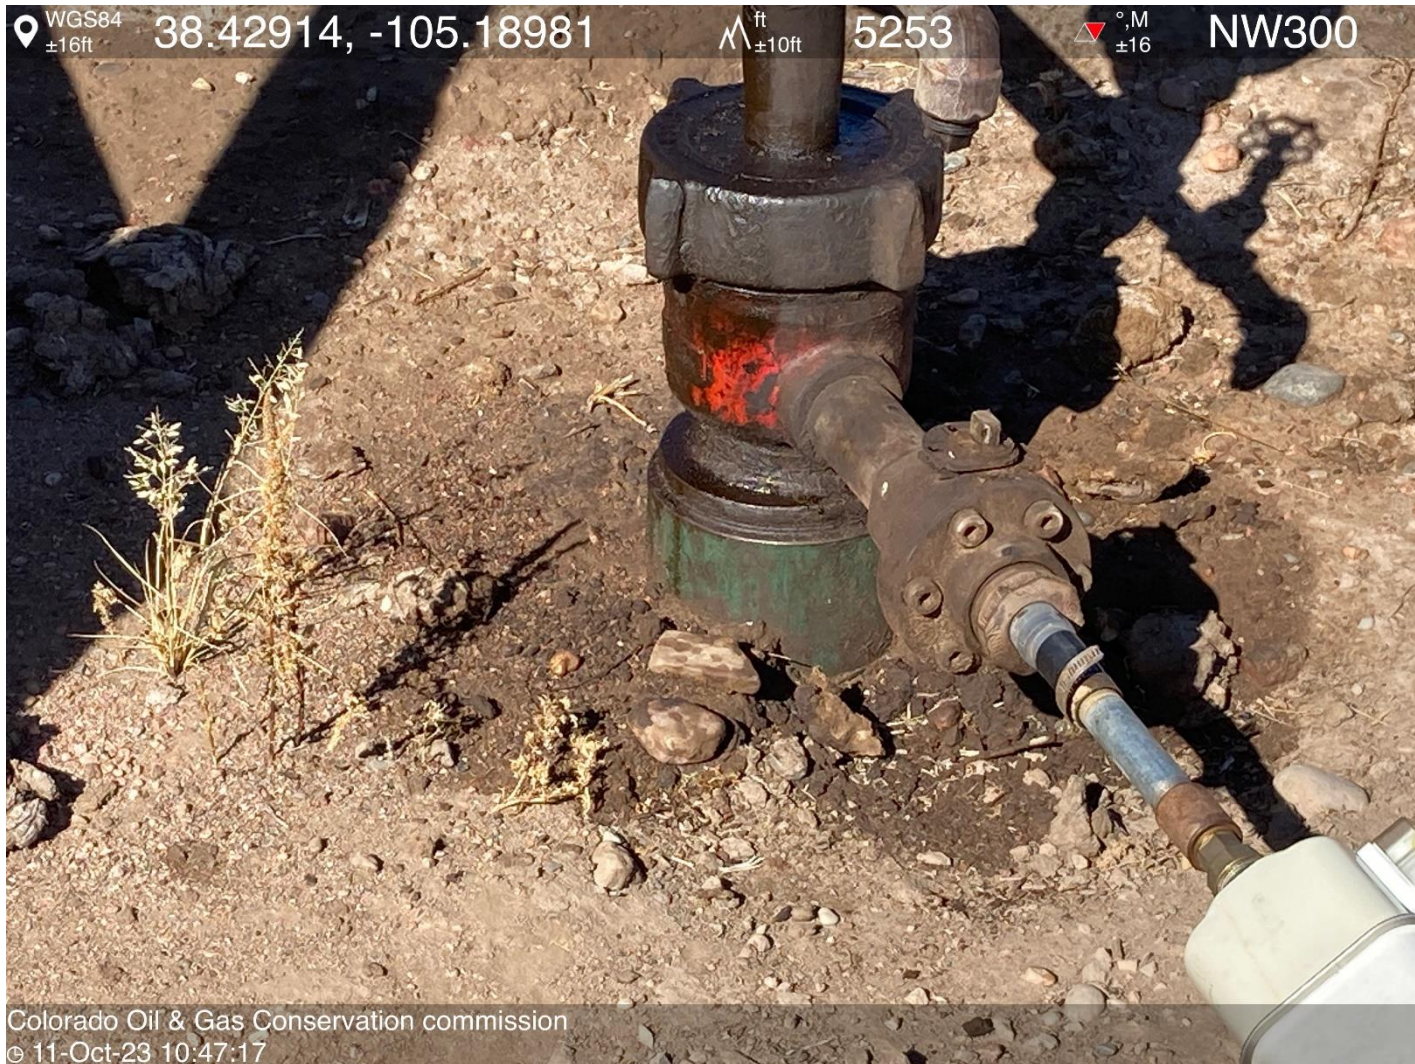
PHOTO 6: AREA OF IMPACTED SOIL AROUND WELLHEAD APPEARS TO BE FROM LEAKING POLISH ROD PACKING. Conduct maintenance on equipment, cleanup stained material and review self inspection processes. COMPLY WITH RULE 1002,(2).D. CA DATE 11-11-2023.

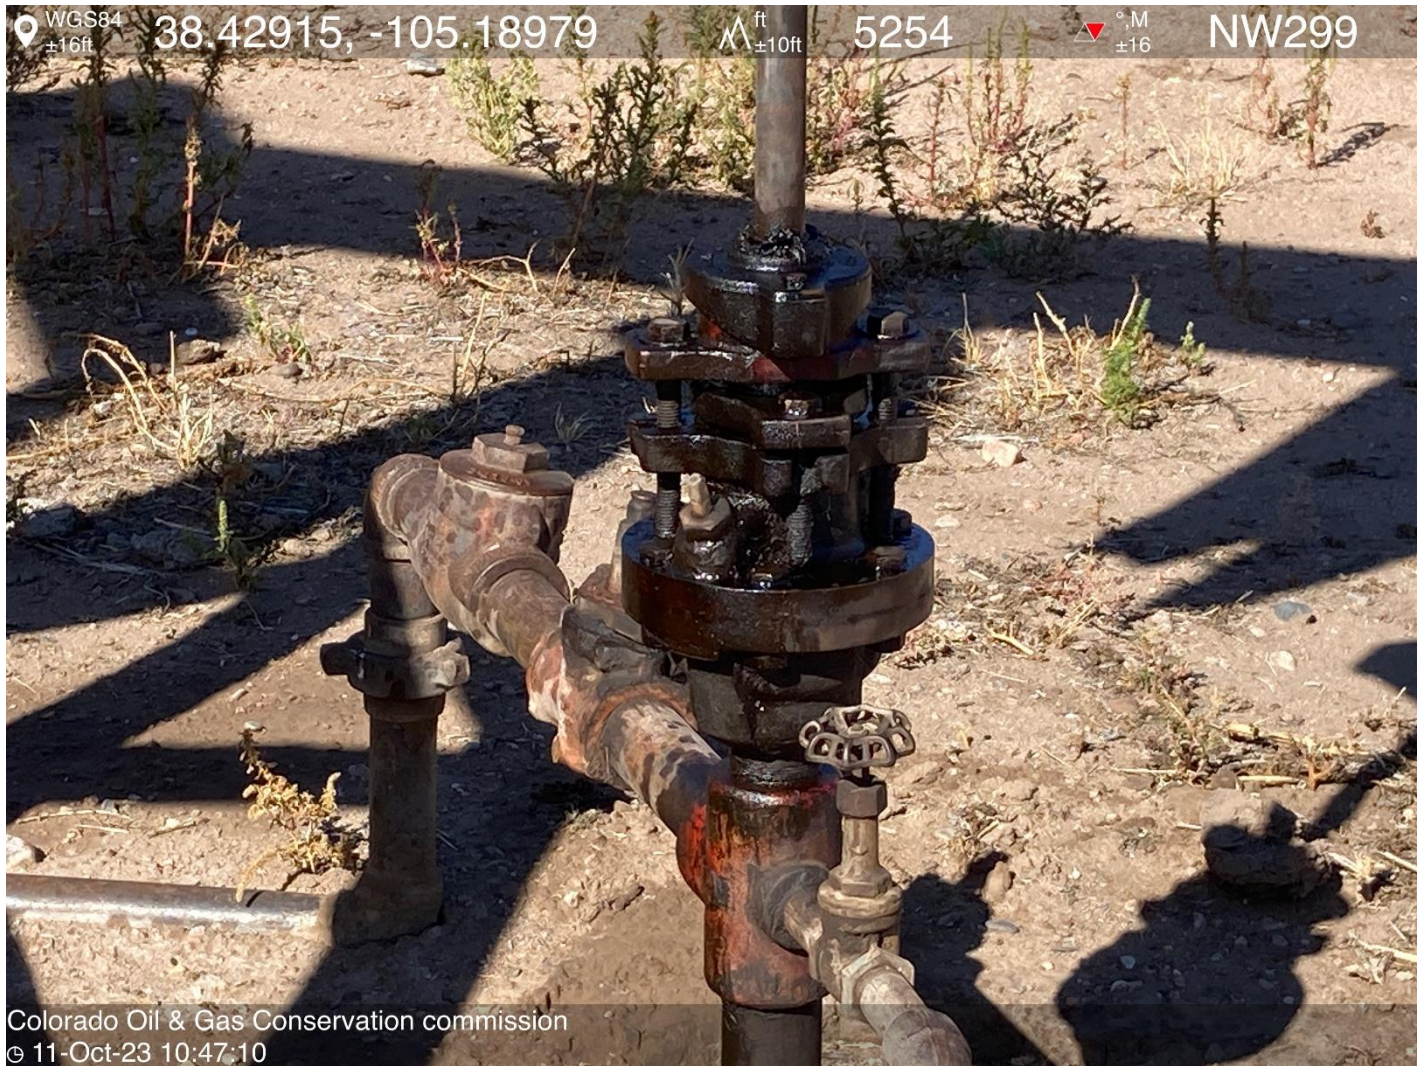
PHOTO 7: POLISH ROD PACKING LEAK. Securely fasten all valves, pipes, fittings, and Production Facilities to ensure good mechanical condition, inspect at regular intervals and maintain in good mechanical condition per Rule 608.e. Securely fasten all valves, pipes, fittings, and Production Facilities to ensure good mechanical condition, inspect at regular intervals and maintain in good mechanical condition per Rule 608.e. CA DATE 11-11-2023.

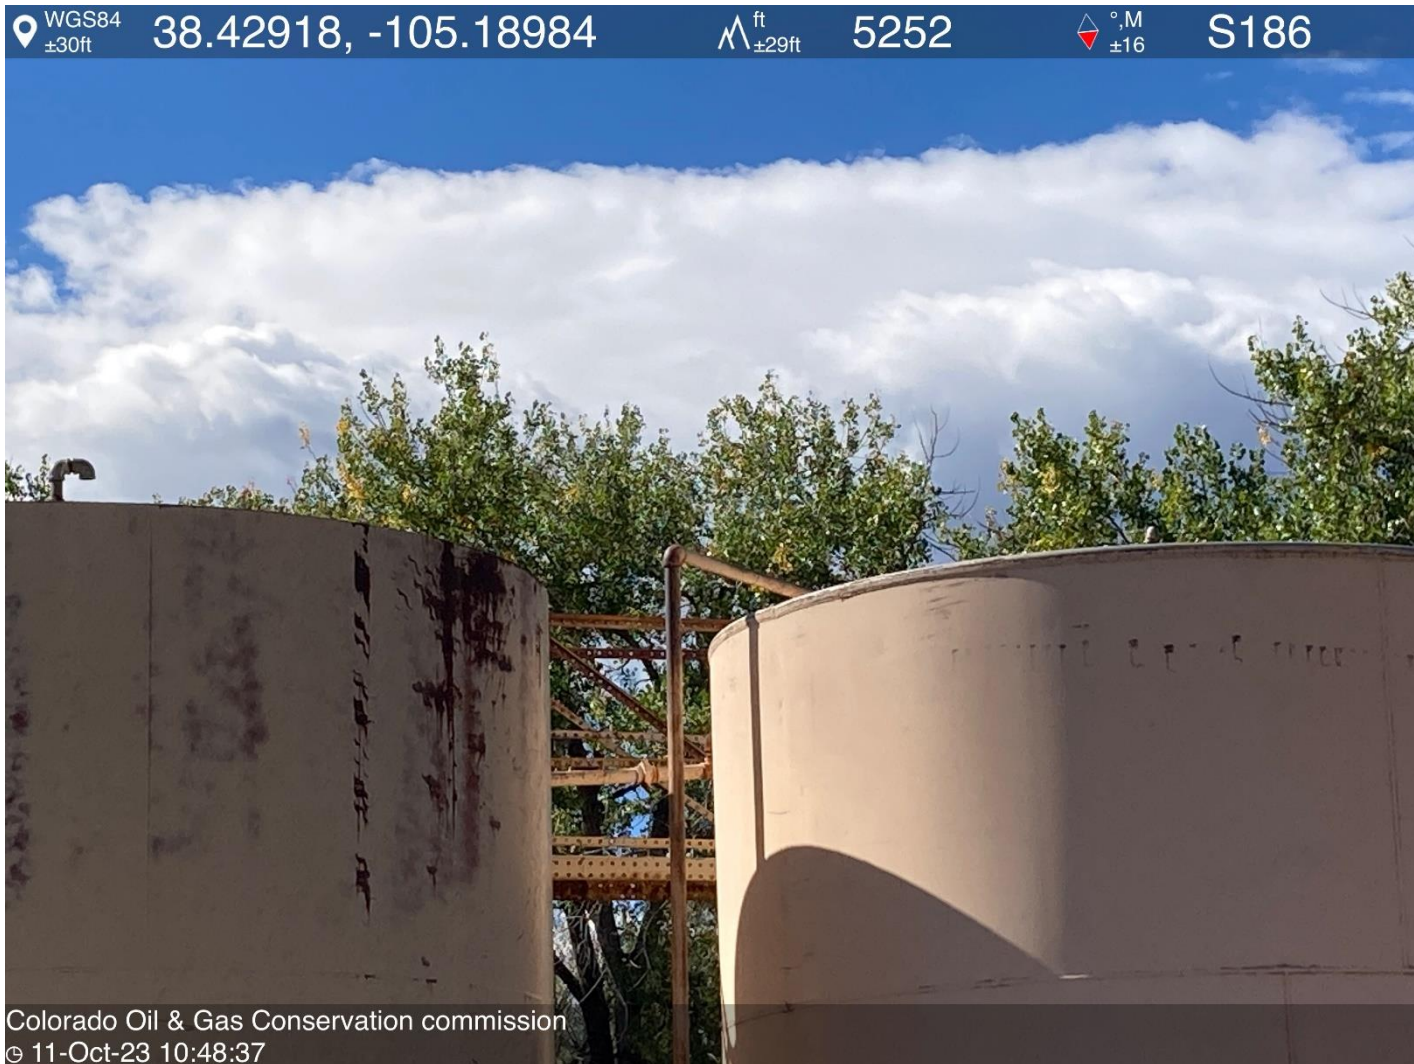
PHOTO 8: THERE IS A 2" PIPE ON THE JJ#2 TANK BATTERY OPENENDED AND NO PRESSURE RELIEF VALVE INSTALLED. Tanks will function as sealed and ventless with gas released only through a vapor control system or properly sized pressure relief valve. per Rule 608.a.(9). CA DATE 11-11-2023.

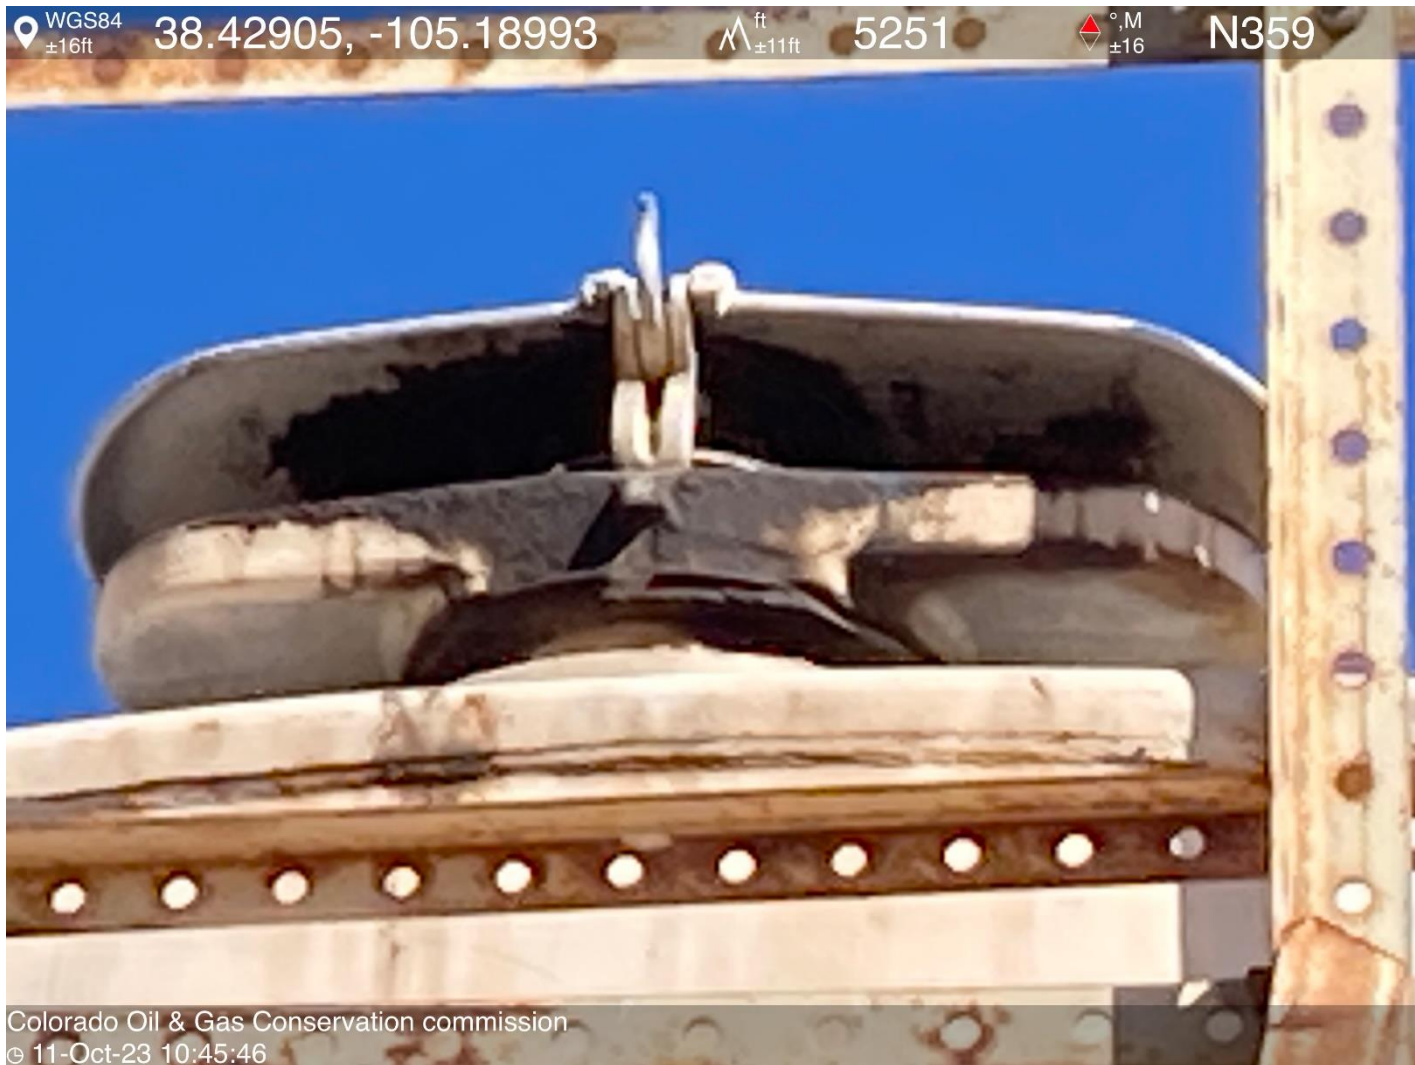
PHOTO 9: GAUGE HATCH OPEN OR NOT SEALED ON BOTH CRUDE OIL TANKS. Close and seal gauge hatches when not accessing tank per Rule 608.a.(9). THIS IS THE SECOND NOTICE FOR THIS CORRECTIVE ACTION IMMEDIATE ACTION IS REQUIRED.

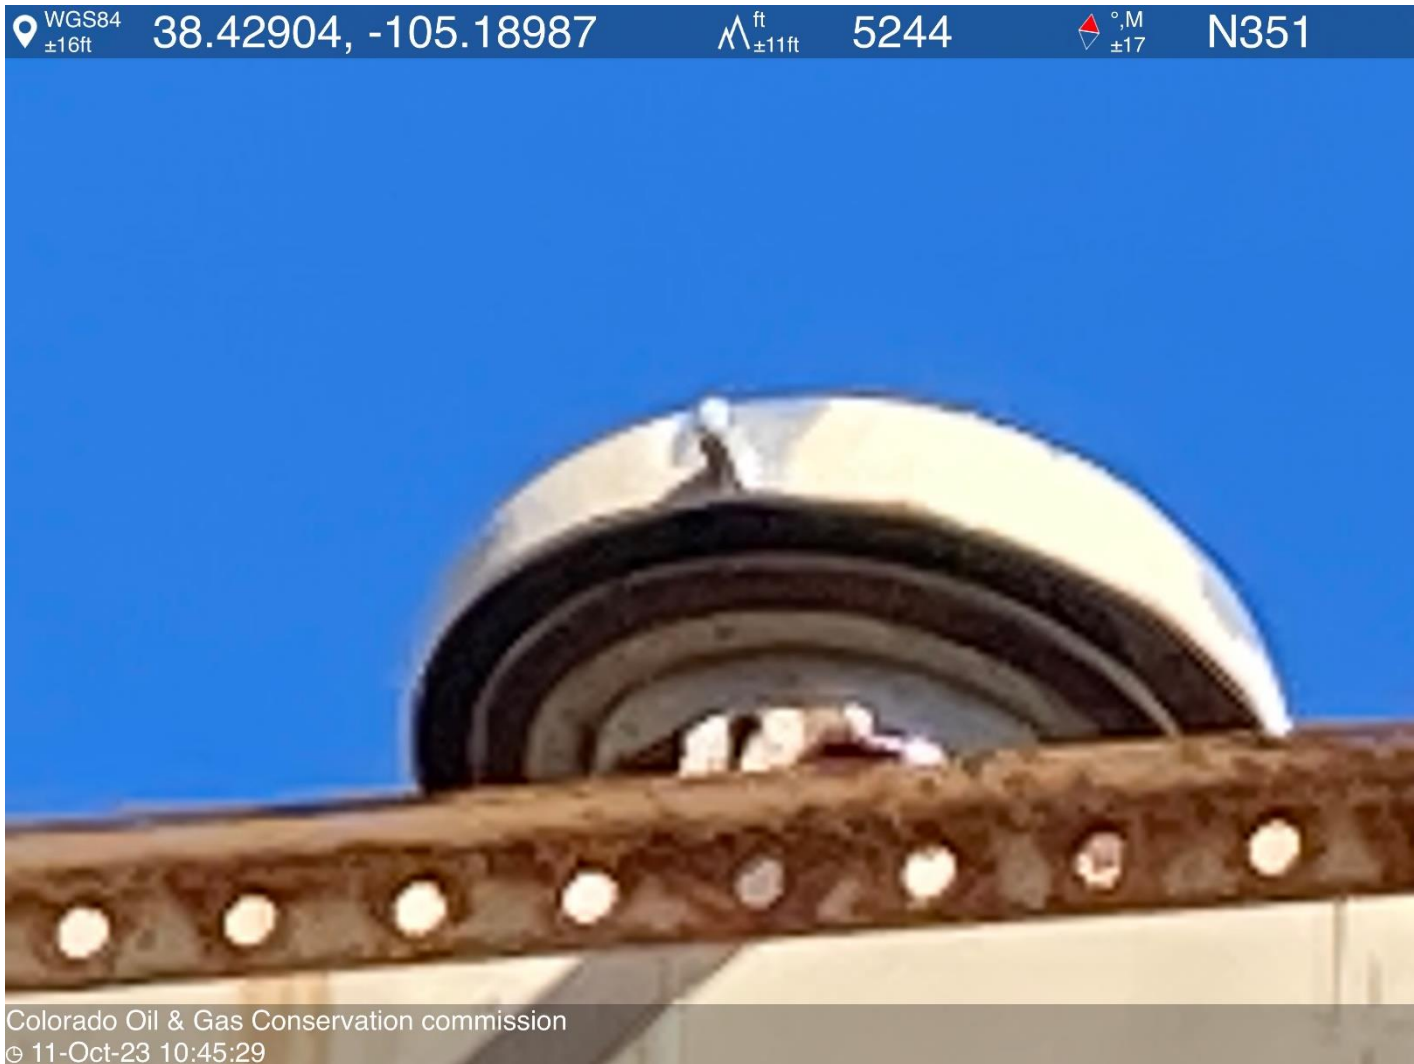
PHOTO 10: GAUGE HATCH OPEN OR NOT SEALED ON BOTH CRUDE OIL TANKS. Close and seal gauge hatches when not accessing tank per Rule 608.a.(9). THIS IS THE SECOND NOTICE FOR THIS CORRECTIVE ACTION IMMEDIATE ACTION IS REQUIRED.

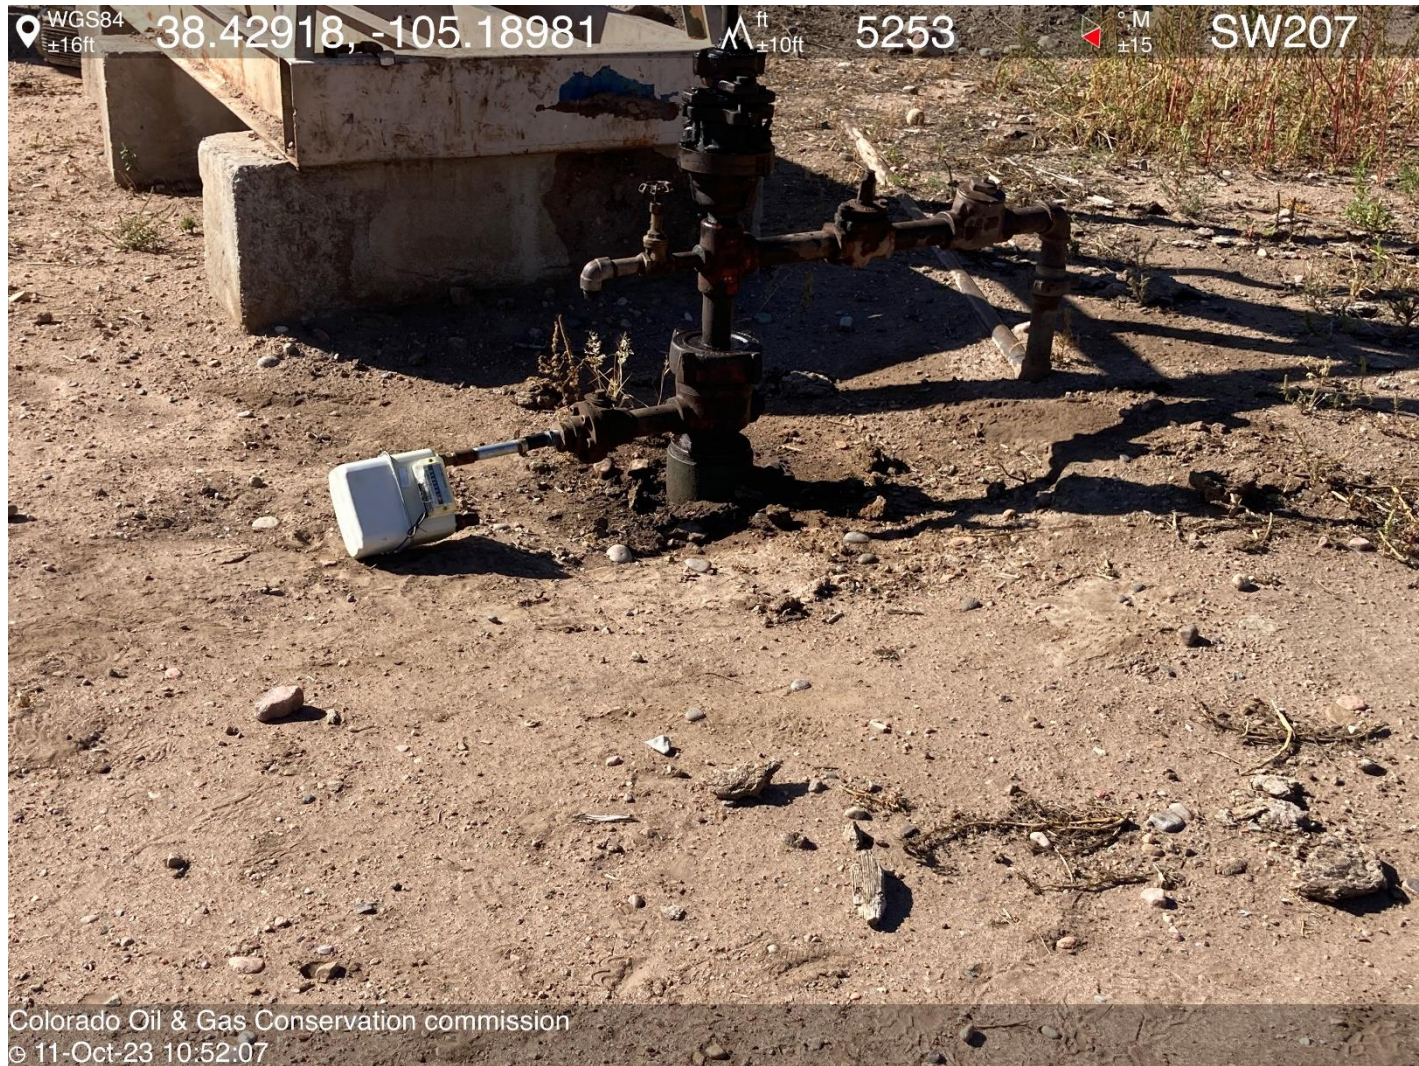
PHOTO 11: Bradenhead inaccessible or not visible. Install appropriate fittings to allow bradenhead visual inspection as per Rule 419.a.(1), (2). THIS IS THE SECOND NOTICE FOR THIS CORRECTIVE ACTION, IMMEDIATE ACTION IS REQUIRED.

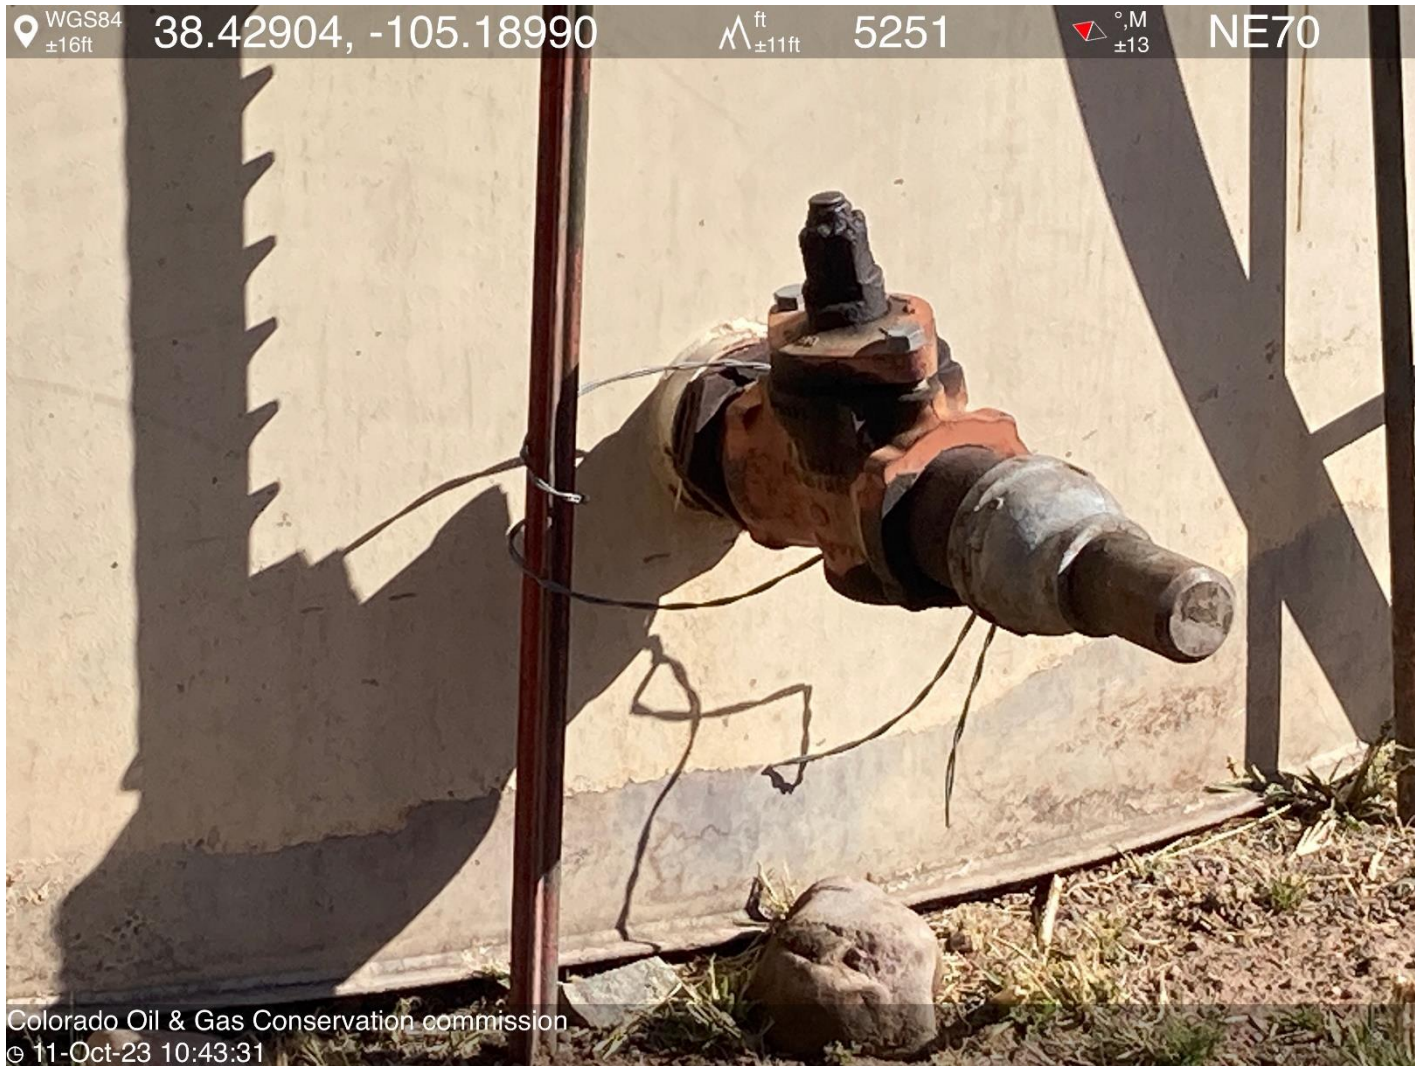
PHOTO 12: Equipment in geologic hazard area not anchored or inadequately anchored. Anchor equipment ensuring anchors are (engineered) to ensure the equipment will resist flotation, collapse, lateral movement, or subsidence per Rule 607. THIS IS THE SECOND NOTICE FOR THIS CORRECTIVE ACTION, IMMEDIATE ACTION IS REQUIRED. NOTE: PER RULE ANCHORING MUST BE ENGINEERED.

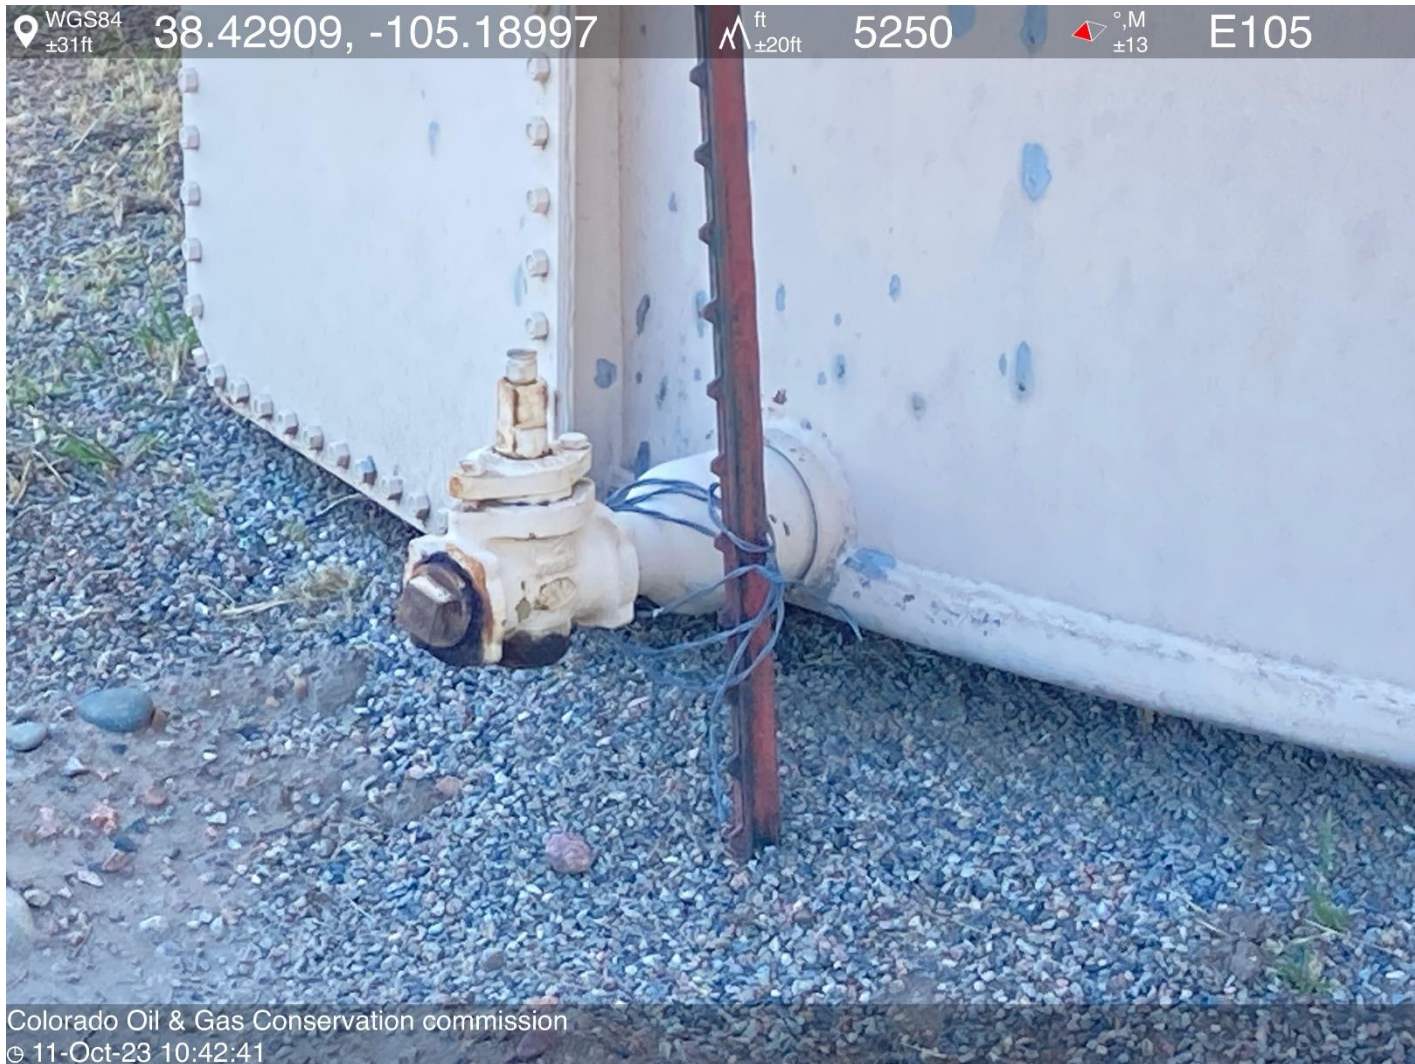
PHOTO 13: Equipment in geologic hazard area not anchored or inadequately anchored. Anchor equipment ensuring anchors are (engineered) to ensure the equipment will resist flotation, collapse, lateral movement, or subsidence per Rule 607. THIS IS THE SECOND NOTICE FOR THIS CORRECTIVE ACTION, IMMEDIATE ACTION IS REQUIRED. NOTE: PER RULE ANCHORING MUST BE ENGINEERED.

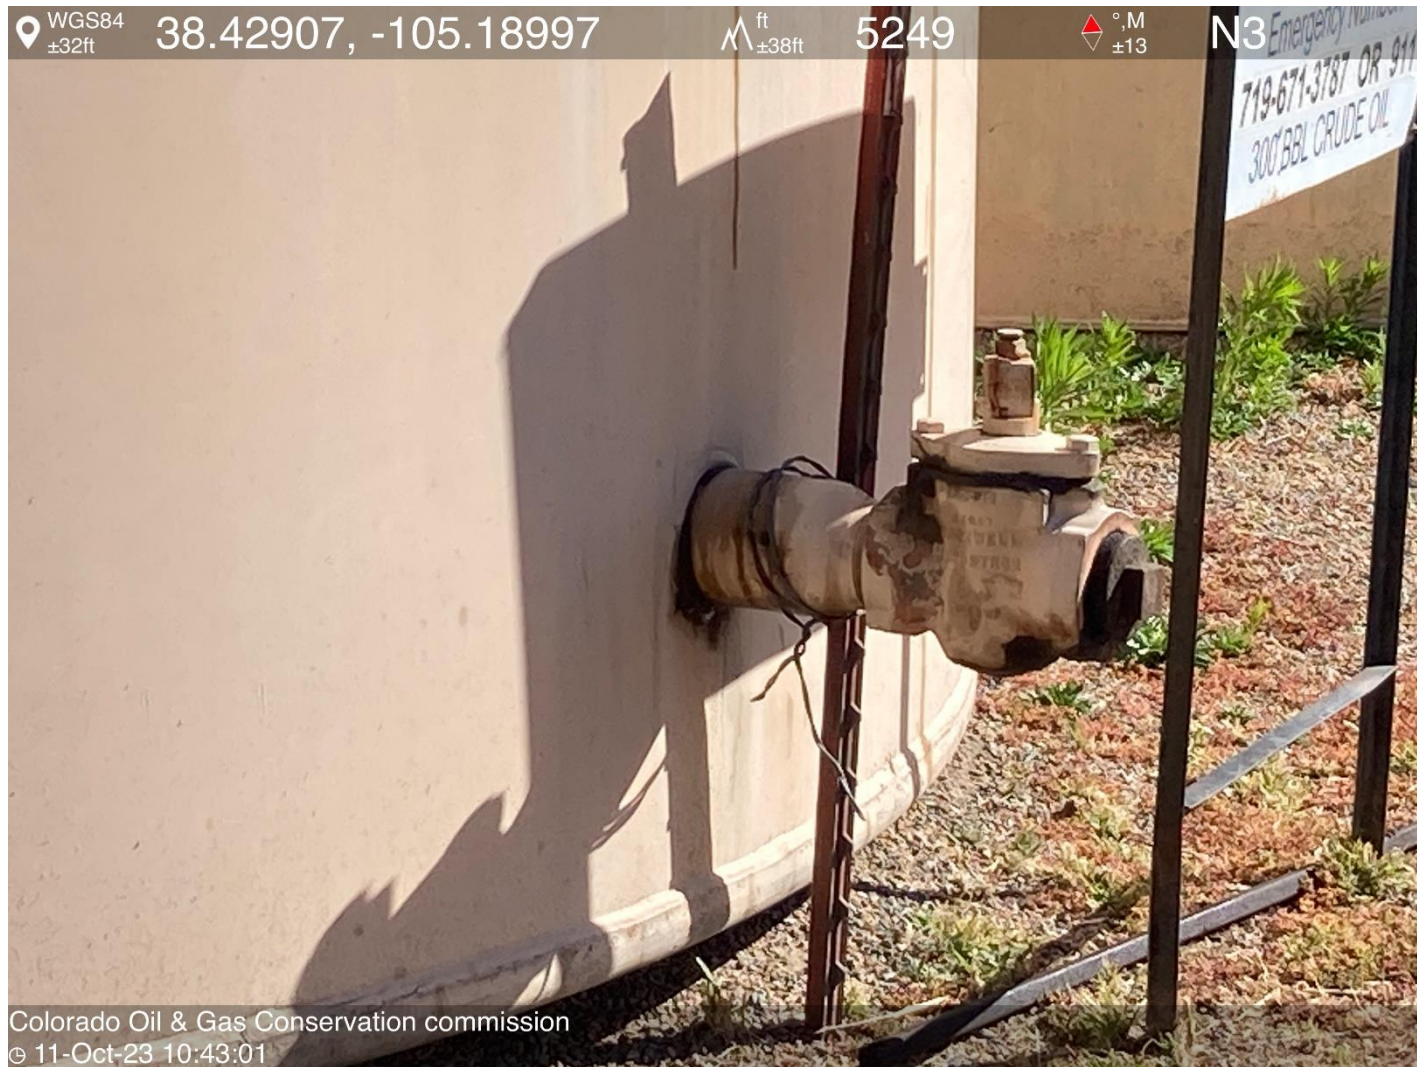
PHOTO 14: Equipment in geologic hazard area not anchored or inadequately anchored. Anchor equipment ensuring anchors are (engineered) to ensure the equipment will resist flotation, collapse, lateral movement, or subsidence per Rule 607. THIS IS THE SECOND NOTICE FOR THIS CORRECTIVE ACTION, IMMEDIATE ACTION IS REQUIRED. NOTE: PER RULE ANCHORING MUST BE ENGINEERED.

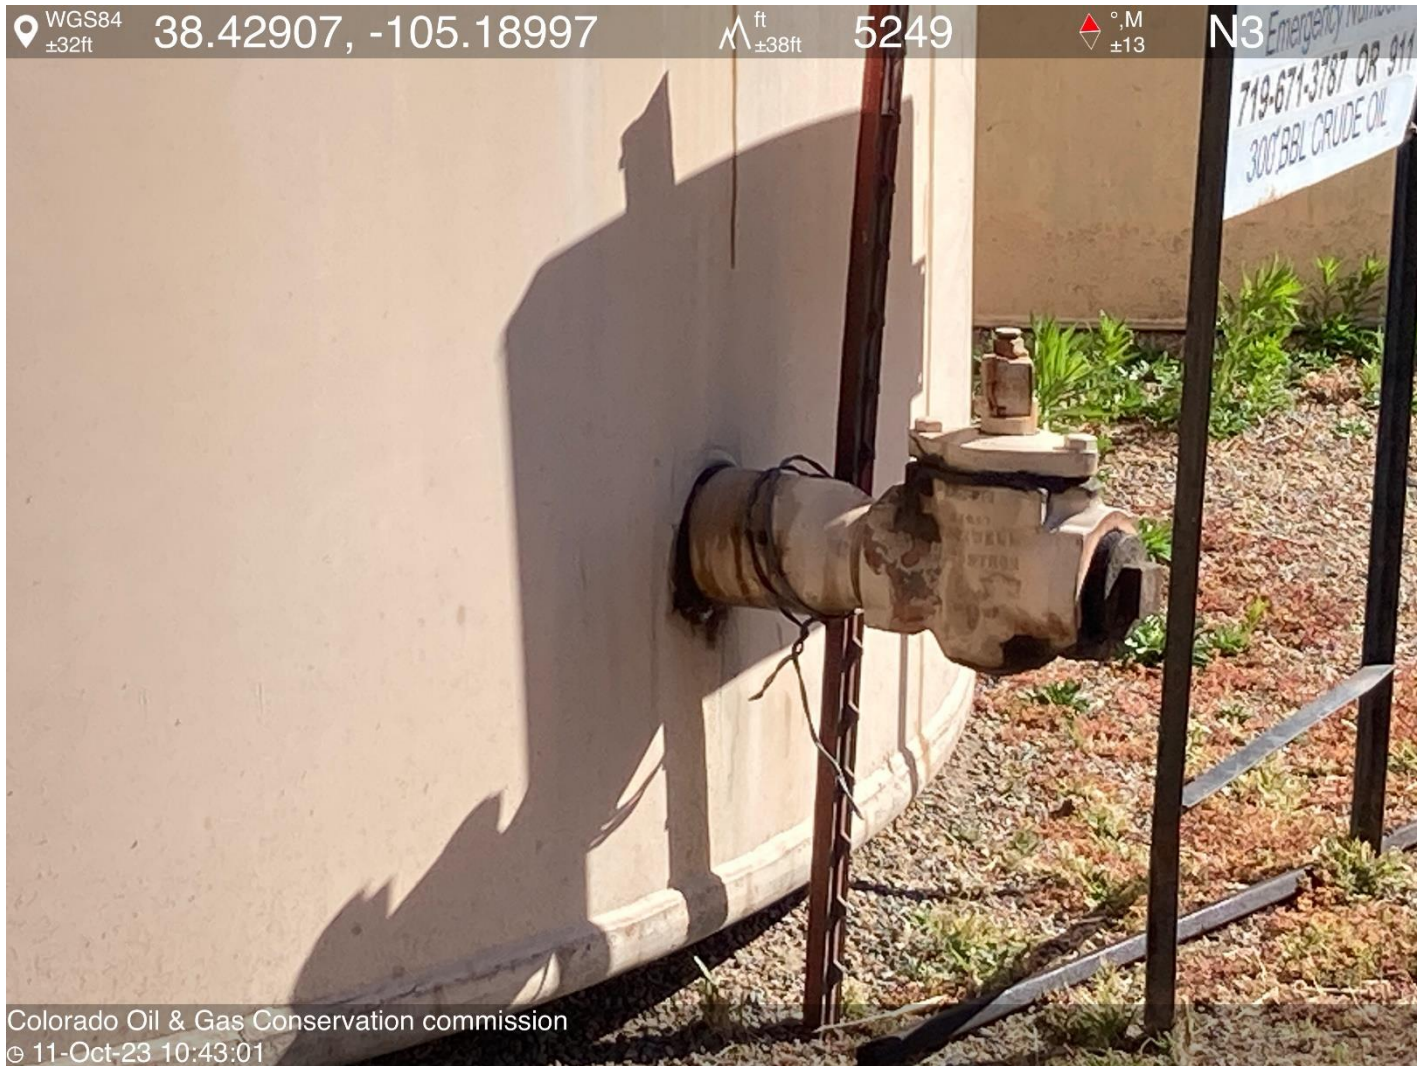
PHOTO 15: Equipment in geologic hazard area not anchored or inadequately anchored. Anchor equipment ensuring anchors are (engineered) to ensure the equipment will resist flotation, collapse, lateral movement, or subsidence per Rule 607. THIS IS THE SECOND NOTICE FOR THIS CORRECTIVE ACTION, IMMEDIATE ACTION IS REQUIRED. NOTE: PER RULE ANCHORING MUST BE ENGINEERED.
