# Construction and Stormwater Inspection

Operator: BISON IV OPERATING LLC- 10670

Location ID: 477204

Inspection Photos  
Location Name: Ancona/Pad  
Location ID: 477204

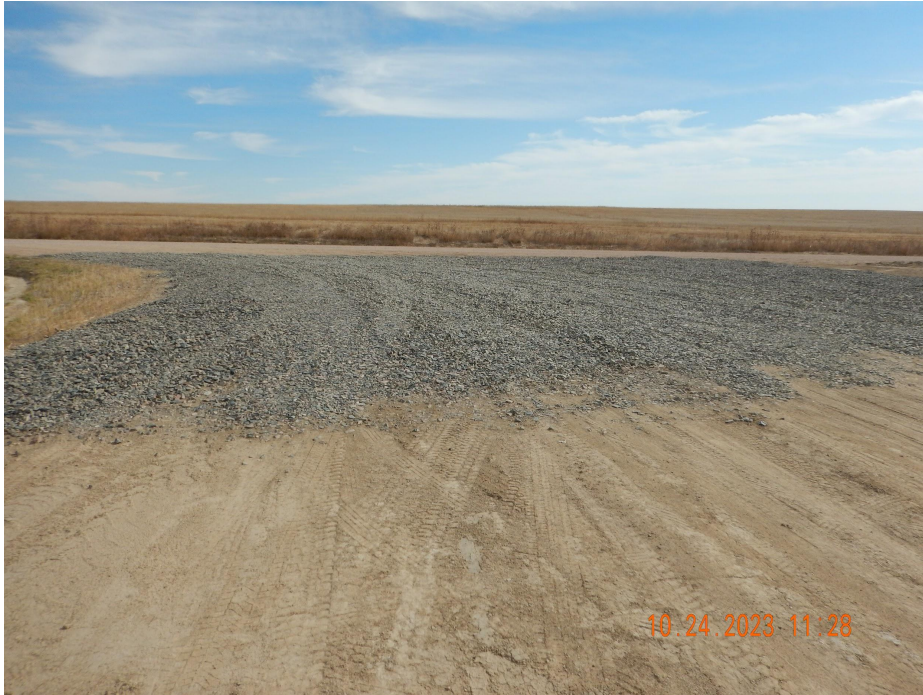
**Photo 1.** Photo taken from the entrance of location, facing East. Photo illustrates a tracking device BMP installed. At the time of this inspection, the BMP was in proper functioning condition.

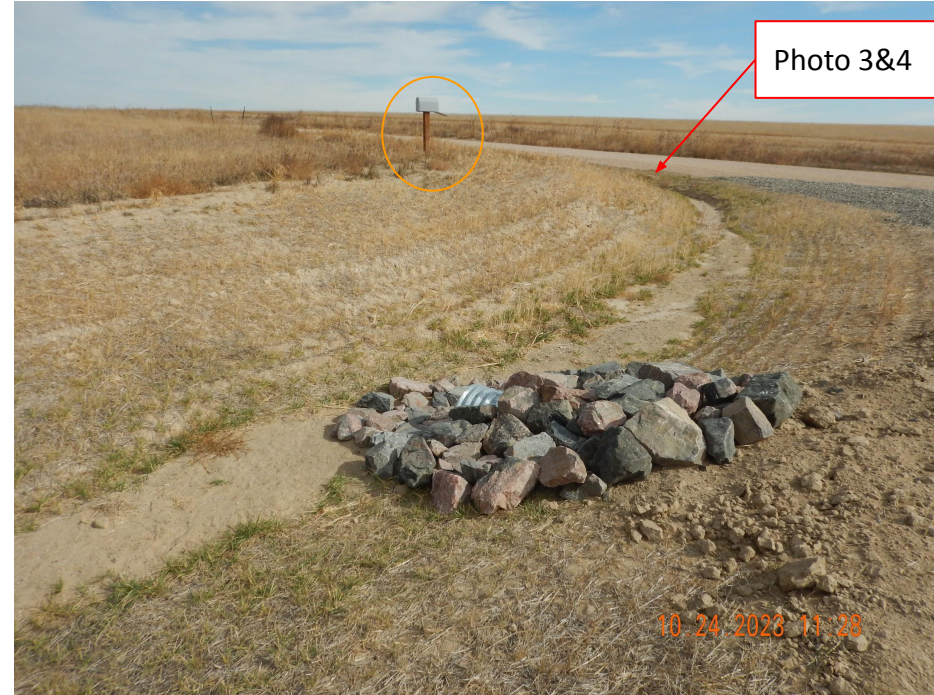
**Photo 2.** Photo taken from the entrance of location, facing Northeast. Photo illustrates inlet culvert protection. However, there was erosion observed along the roadside ditch area.

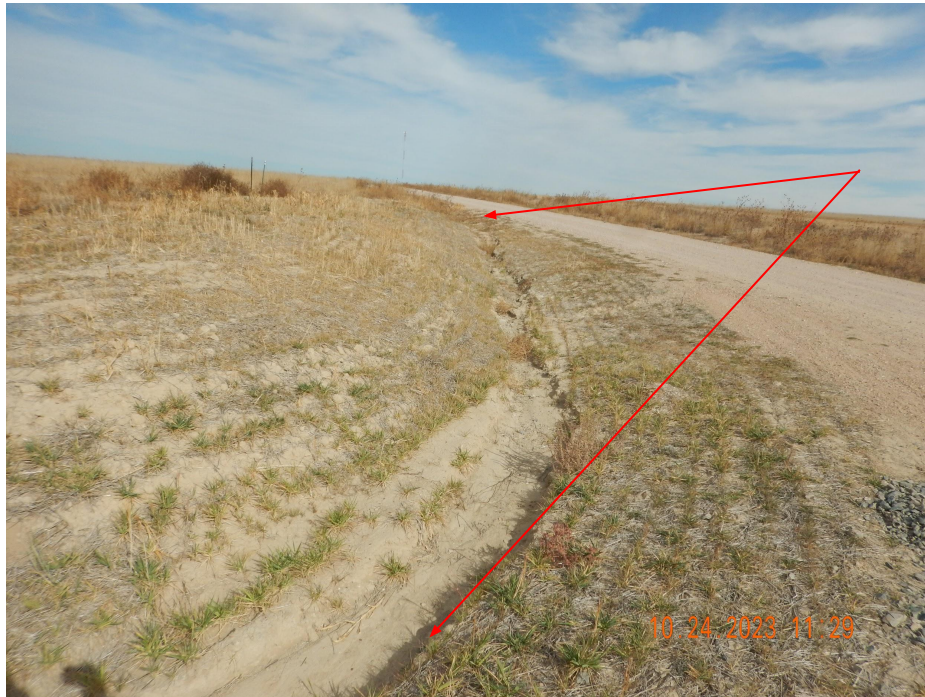
**Photo 3.** Photo taken from the entrance of location, facing North. Photo illustrates stormwater erosion which needs additional BMPs and repairs.

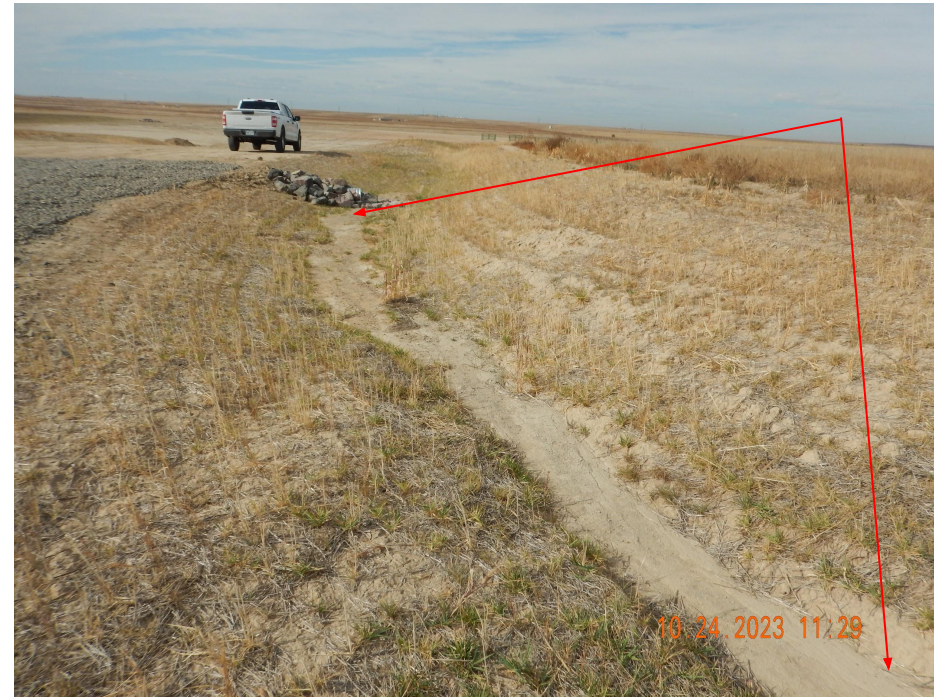
**Photo 4.** Photo taken from Photo 3, facing West. Photo illustrates sediment accumulation in the roadside ditch areas.

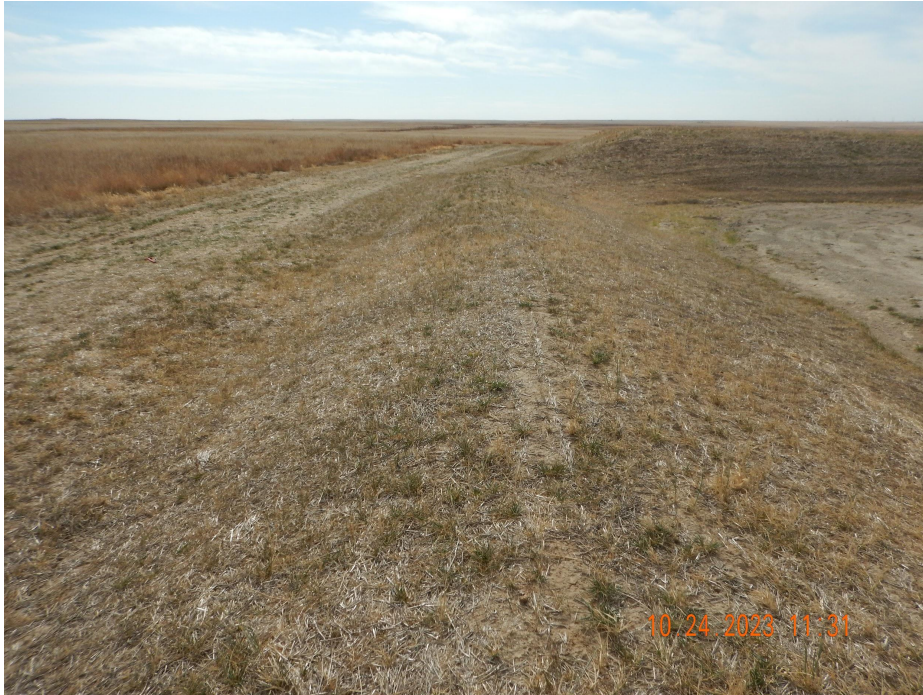
**Photo 5.** Photo taken from the southeastern perimeter of location, facing South. Photo illustrates desirable vegetation establishment which is in process of meeting vegetation requirements.

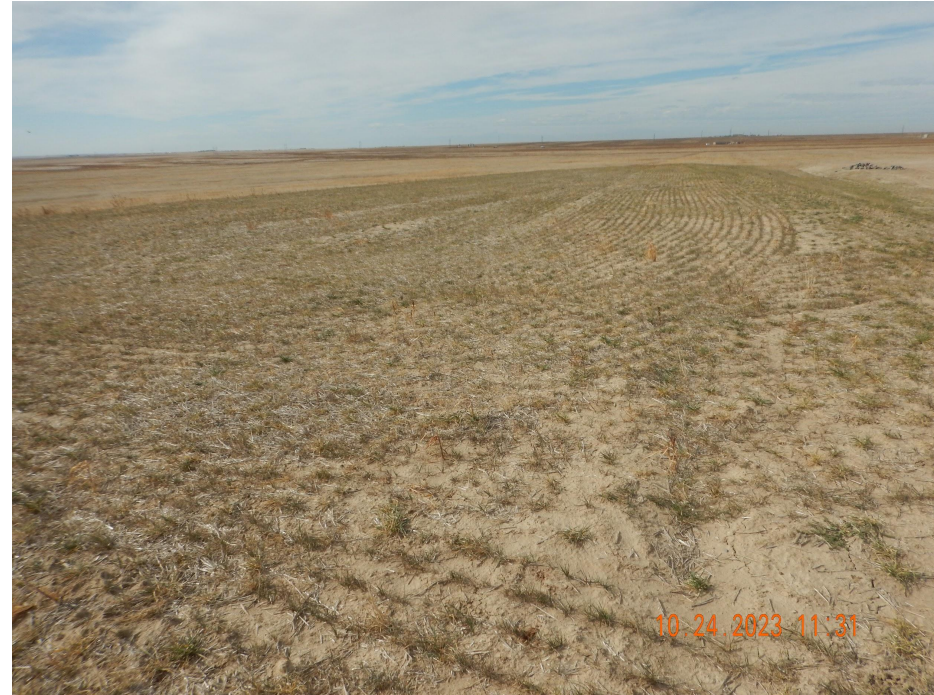
**Photo 6.** Photo taken from the topsoil stockpile, facing West. Photo illustrates desirable vegetation establishment which is in process of meeting vegetation requirements.

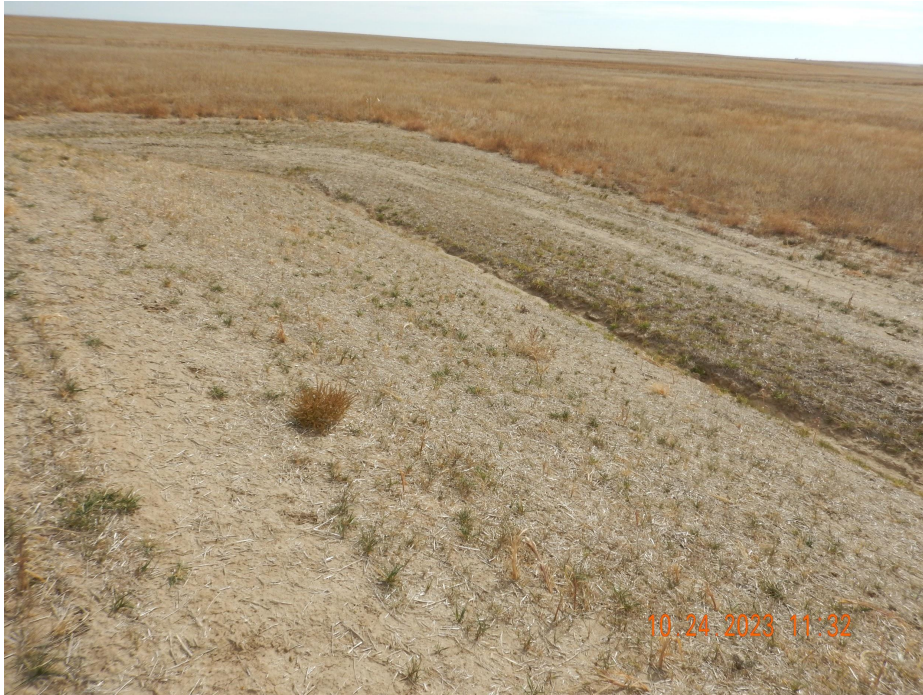
**Photo 7.** Photo taken from the southeastern location on the topsoil stockpile, facing Southeast. Photo illustrates Operator has installed a perimeter ditch BMP in response to the previous corrective action.

Photo illustrates some erosion in the ditch BMP that needs additional stabilization and repair. Sediment accumulation is shown in Photo 8.

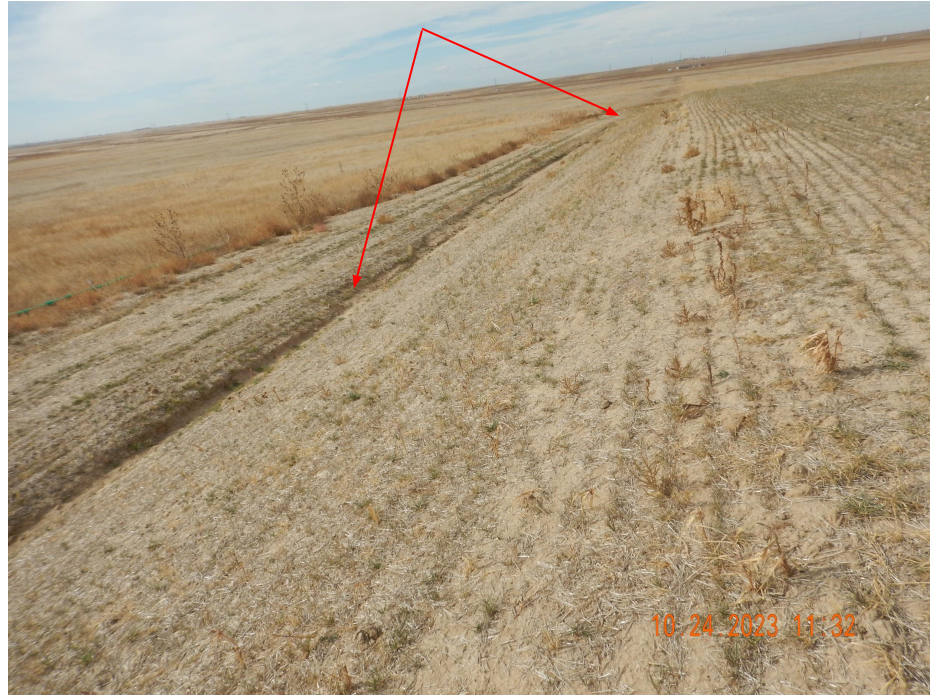
**Photo 8.** Photo taken from the southeastern location on the topsoil stockpile, facing West. See comments under Photo 7.

Filtrexx wattle BMP has also been installed in addition to the ditch BMP. Sediment accumulation is evident from the ditch BMP that needs additional stabilization.

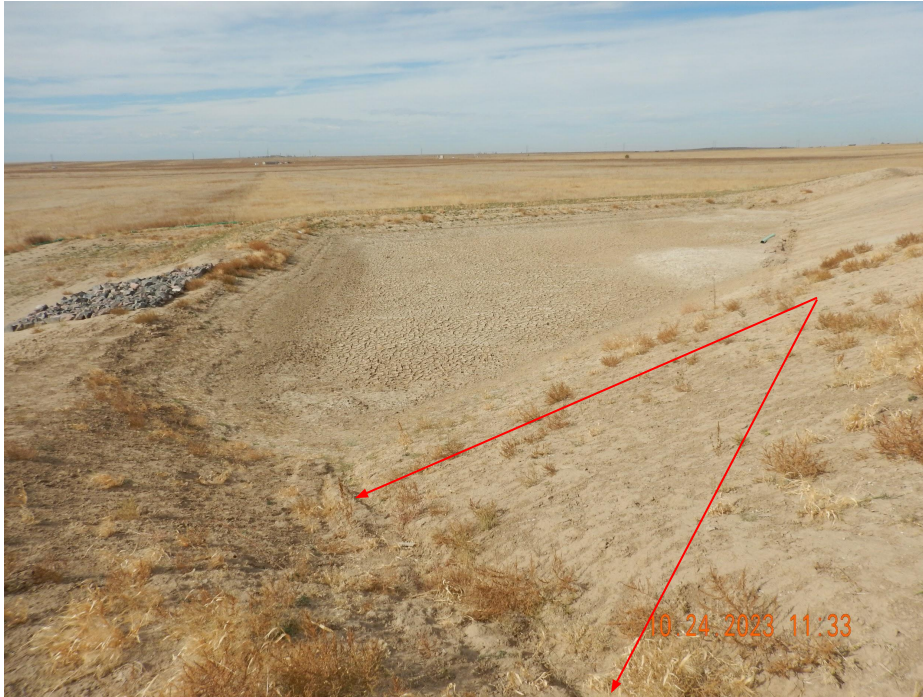
**Photo 9.** Photo taken from the southwestern portion of the location, facing West. Photo illustrates a detention area that is in proper functioning condition.

Note- there is some rill erosion going into the detention area needing additional stabilization. Filtrexx wattle BMP has also been installed along the western perimeter of the location.

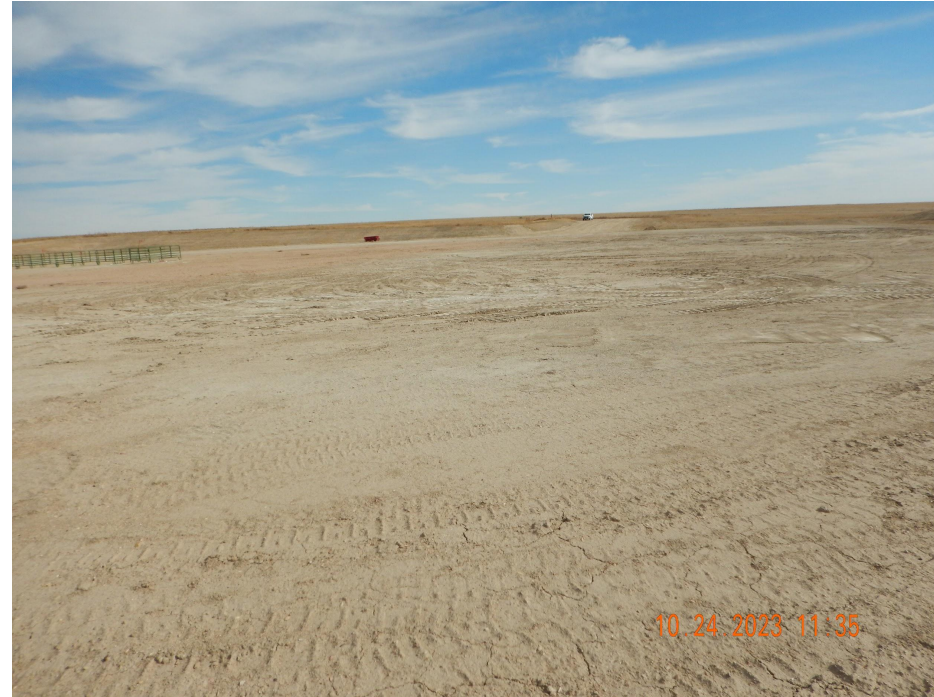
**Photo 10.** Photo taken from southwestern location, facing East. Photo illustrates the well pad surface. Operator has added additional stabilization around the wellheads but the remainder of the well location may need additional stabilization during drilling operations depending on time of the year.
