# Construction and Stormwater Inspection

Operator: MDS ENERGY DEVELOPMENT LLC - 10814

Location ID: 477495

Inspection Photos  
Location Name: Daffy Pad  
Location ID: 477495

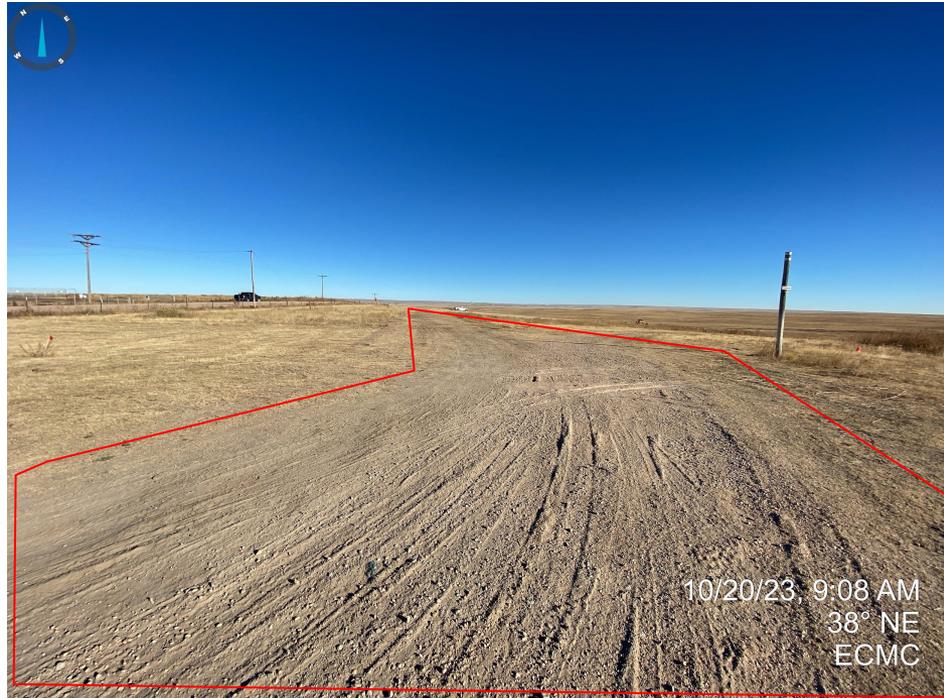
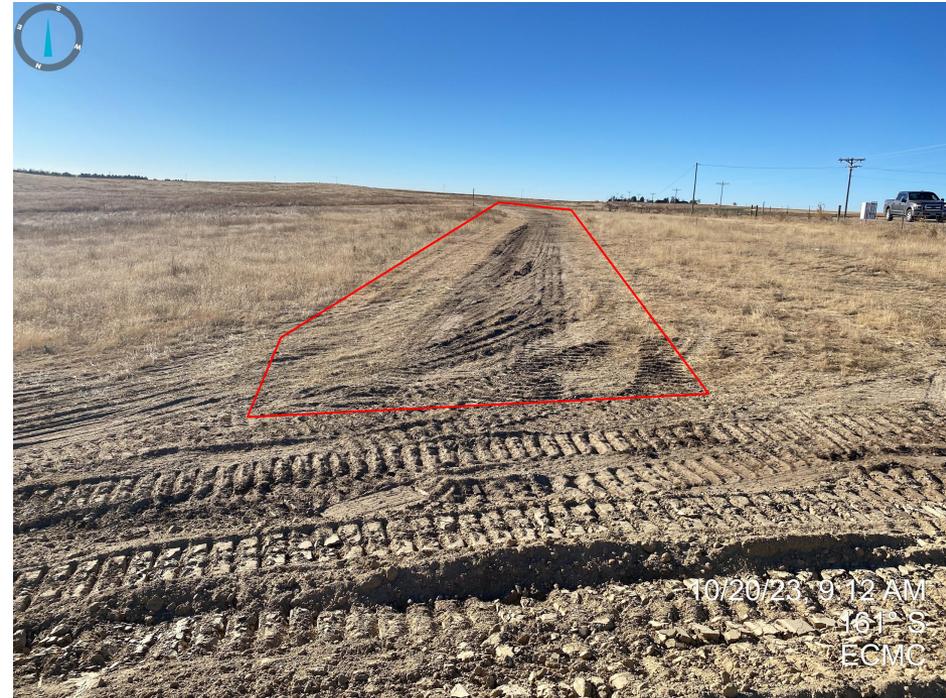
**Photos 1 & 2.** Previously used access roads, south of the new access road, have been disturbed by vehicle and construction activities. These disturbances will need to be reclaimed per the 1000 series rules.

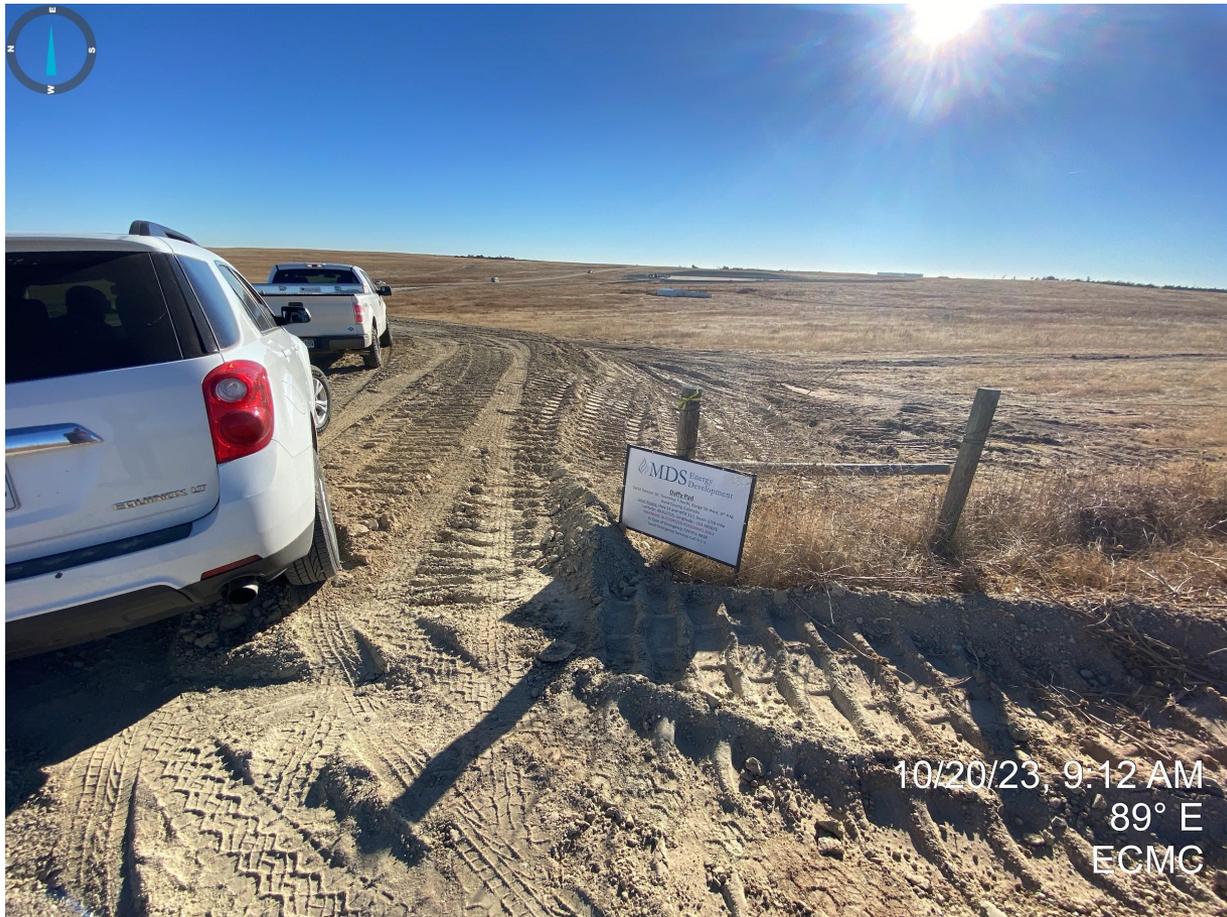
**Photo 3.** Location signage posted at the entrance to the location, previously required by a corrective action.

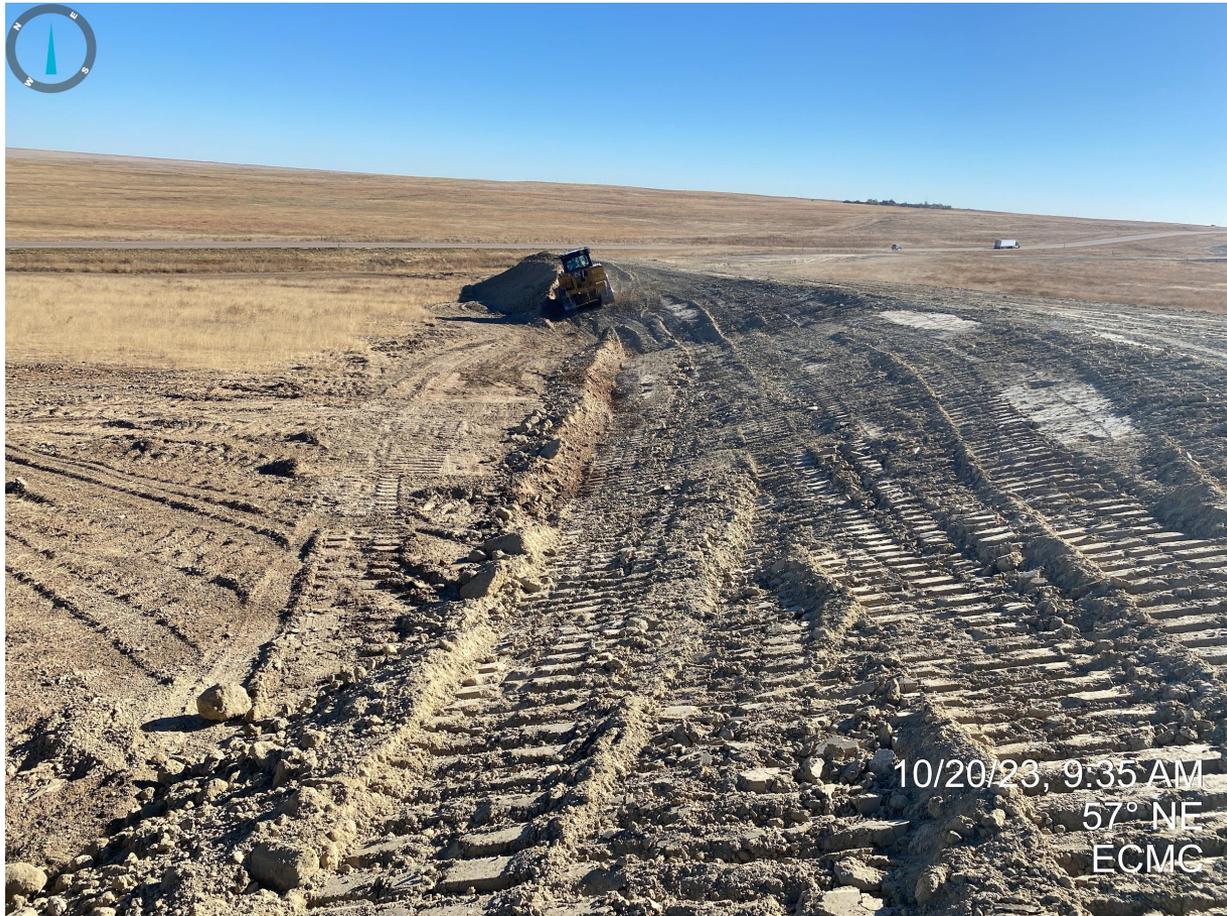
**Photo 4.** Taken from the new location entrance. Photo illustrates fine grading of the new access road. Also pictured, equipment tracking is parallel to the slope. Additional stabilization techniques (e.g. seeding/mulching) should be implemented to protect the soils from wind and water erosion degradation. .

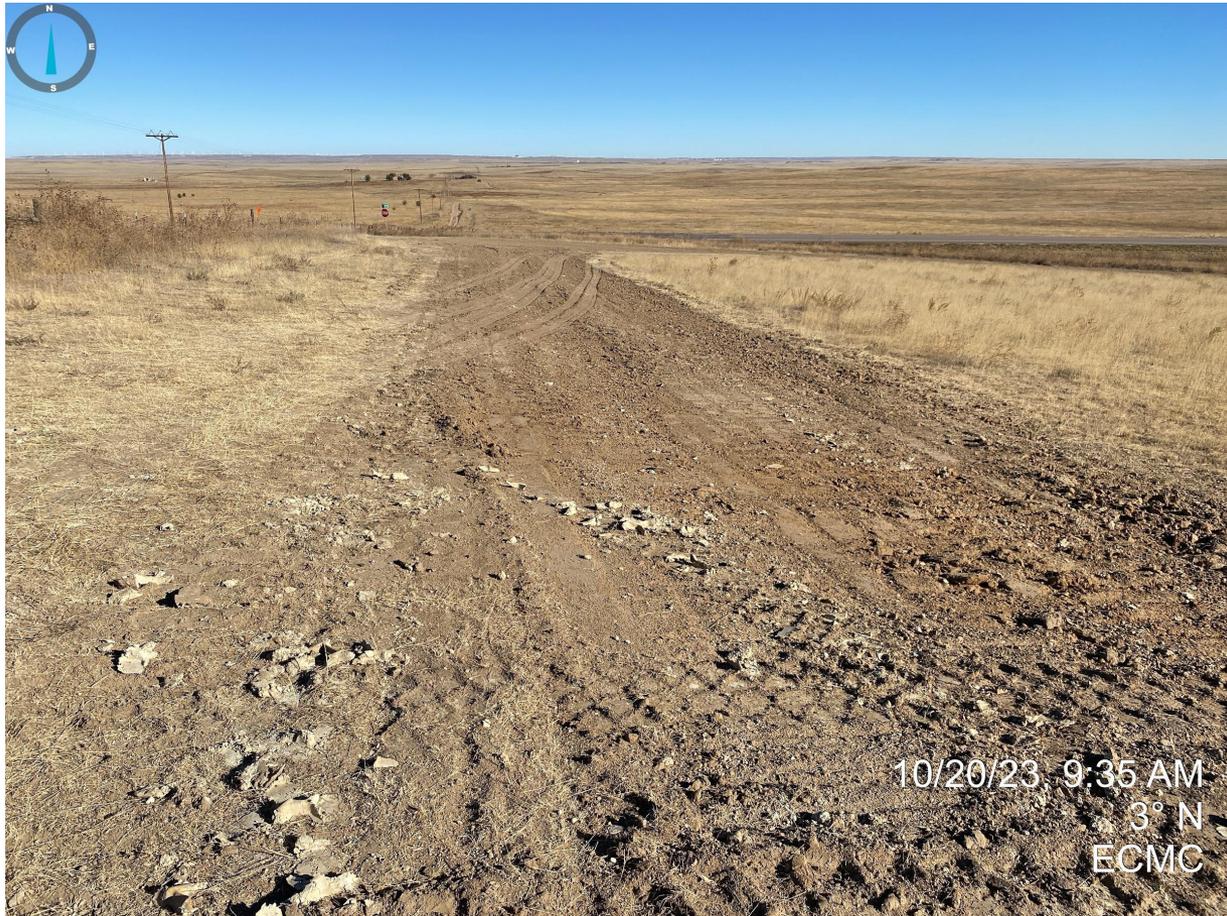
**Photo 5.** Taken north of the new entrance/access road. Photo illustrates a portion of the former access road that has had topsoil added for subsequent reclamation. Onsite Operator representative informed Staff that topsoil salvaged from the new access road was redistributed throughout the former access road. Soils pictured here are not properly stabilized against wind/water erosion degradation.

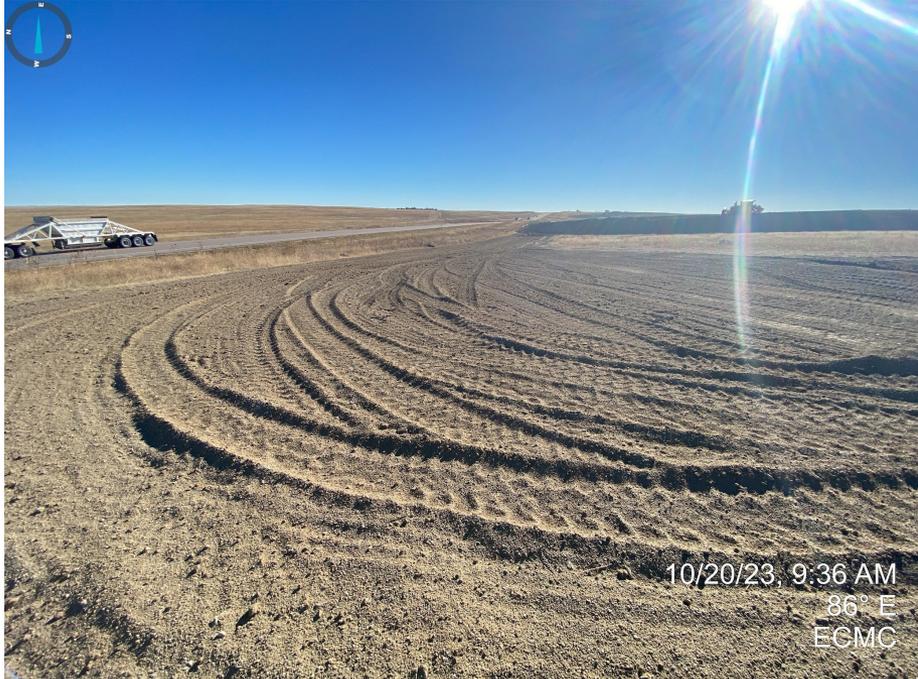
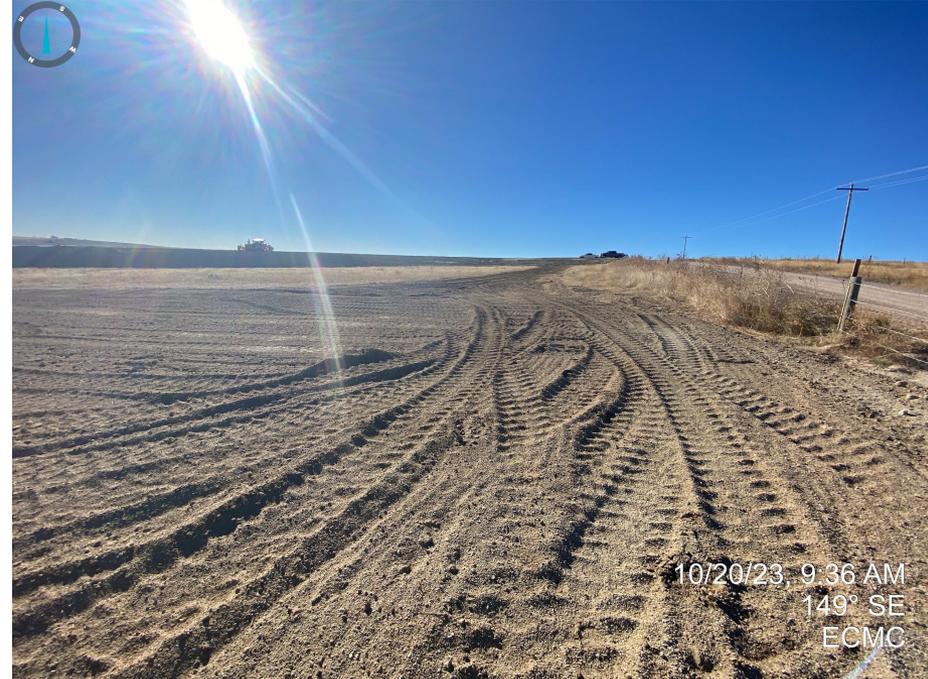
**Photos 6 & 7.** Taken near the northwest corner of the former access road. See comments in Photo 5.

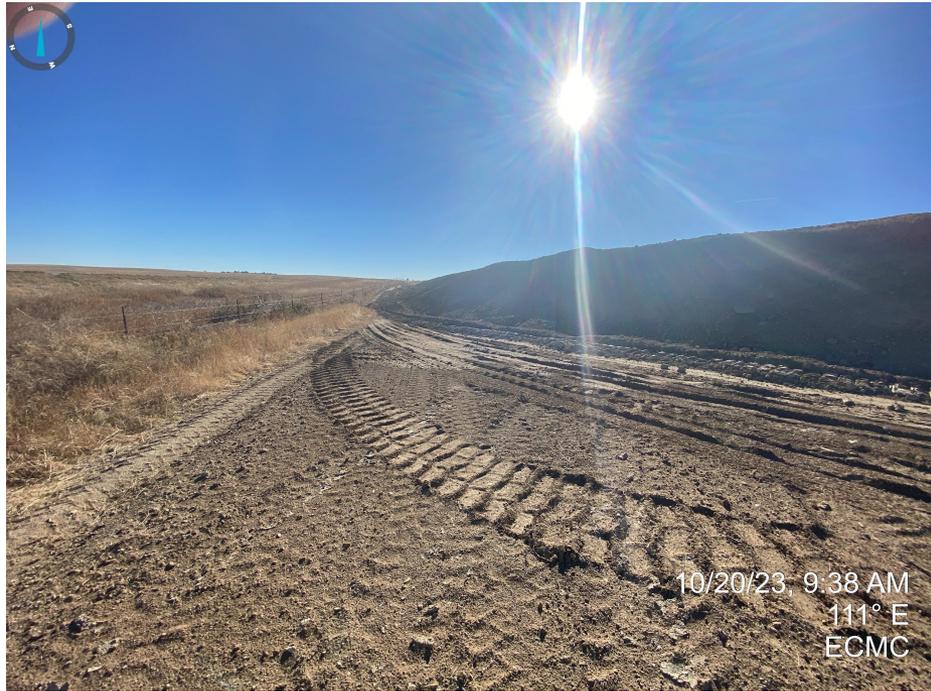
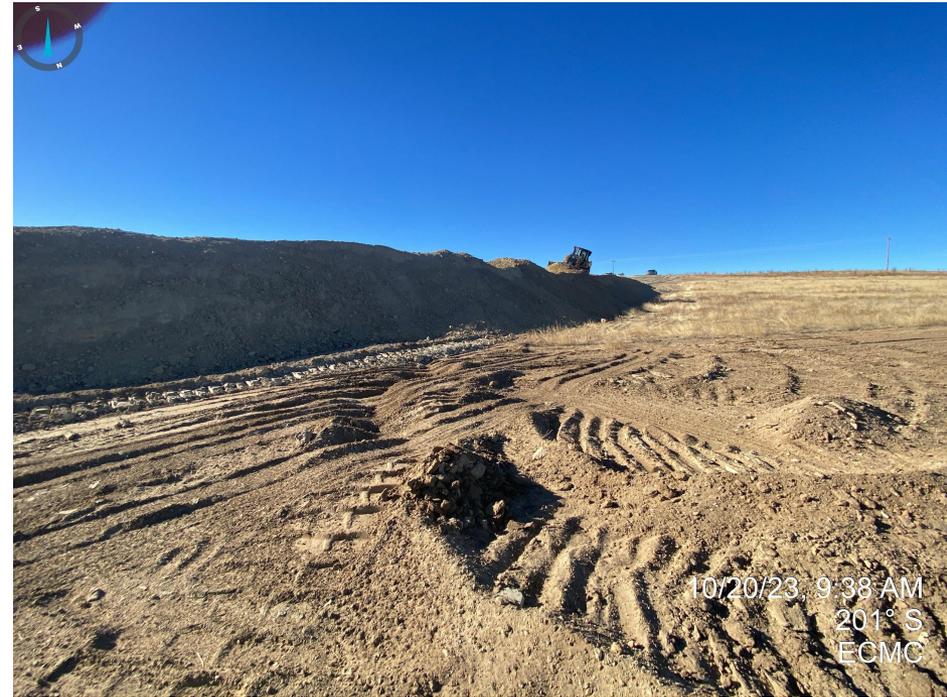
**Photos 8 & 9.** Taken from the former access road, north of the new access road. See comments in Photo 5.

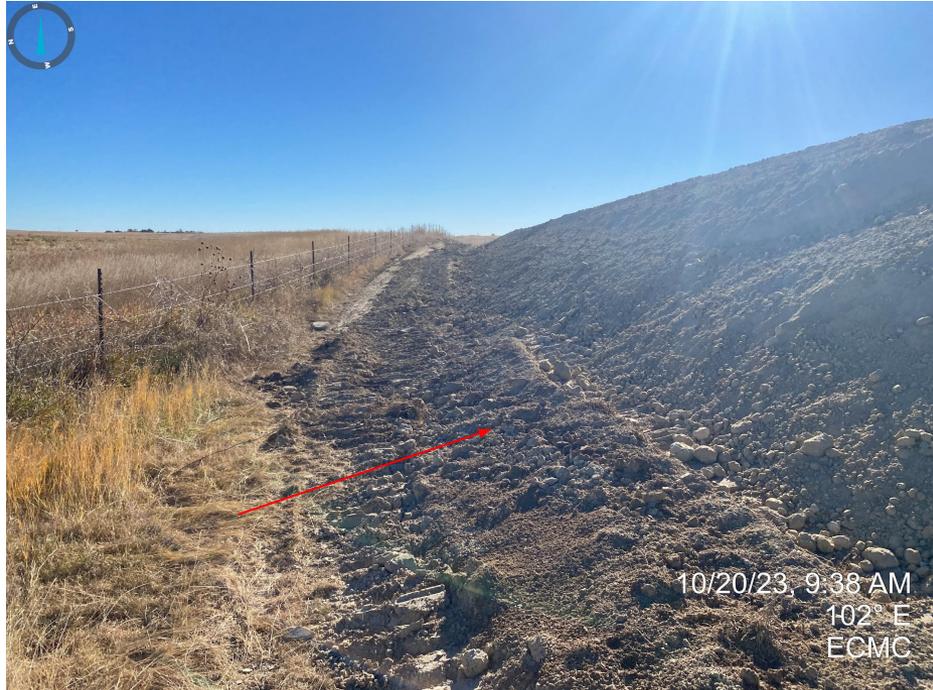
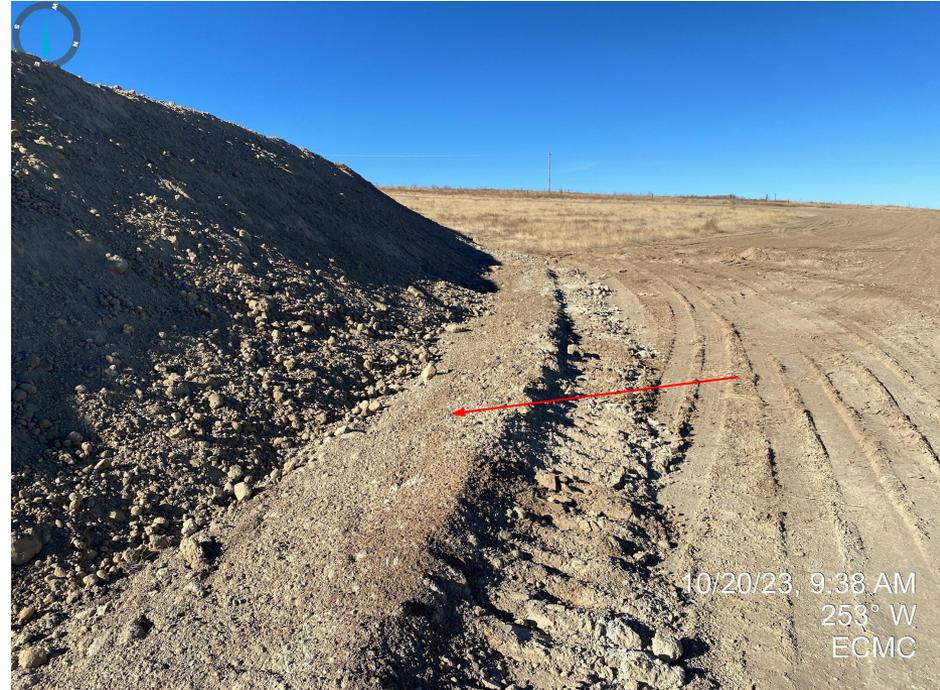
**Photos 10 & 11.** Taken from the northernmost portion of the new access road. Photo illustrates unconsolidated material within the new access road. Additional stormwater control measures/BMPs should be implemented to ensure that sediment migration does not impact adjacent areas, or travel off location.

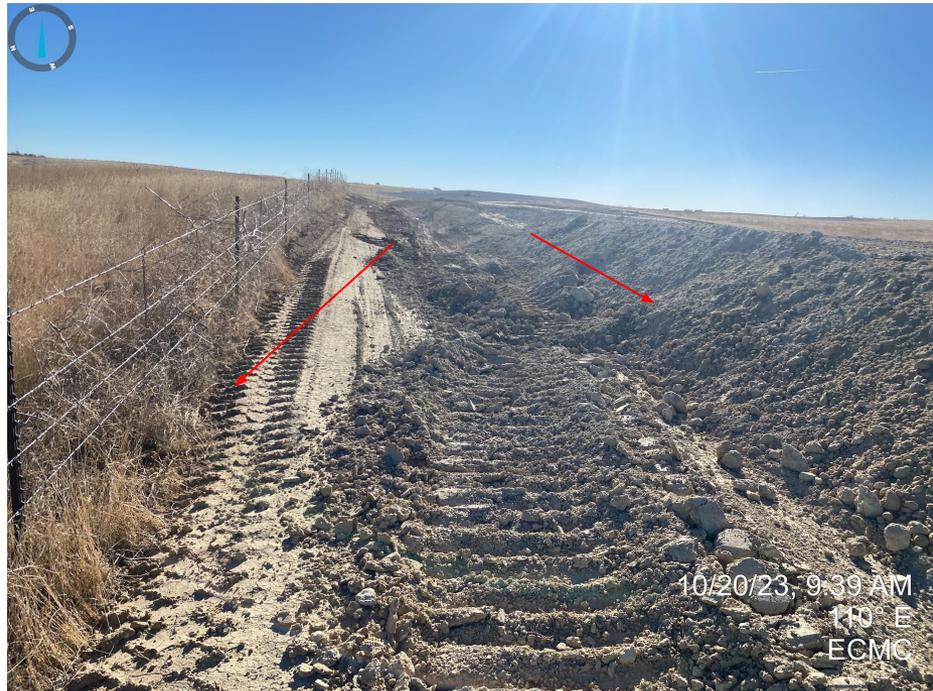
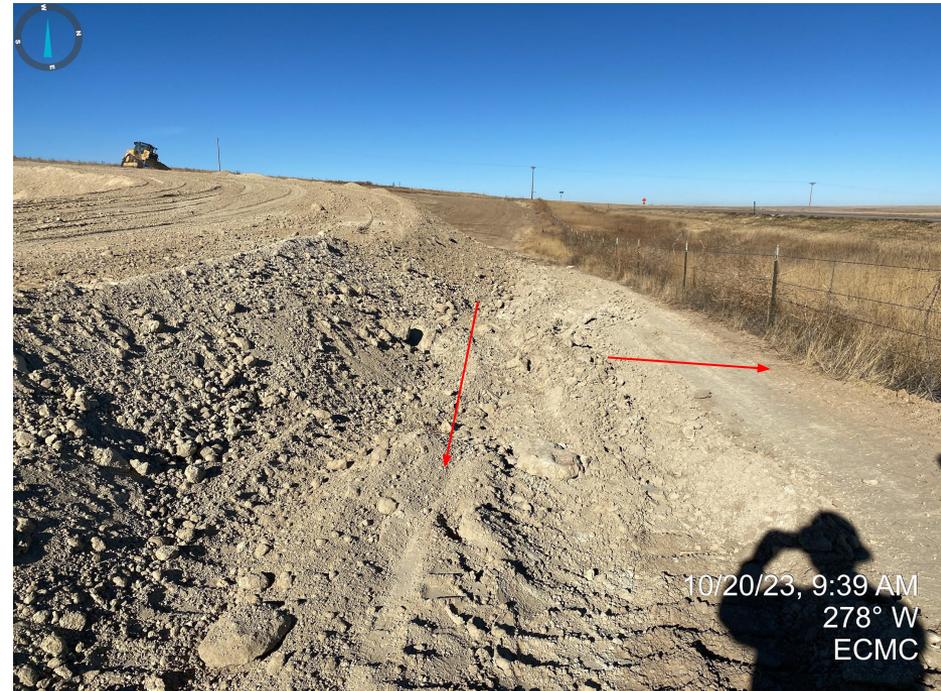
**Photos 12 & 13.** Continued from Photos 10 & 11. Unconsolidated material and the absence of perimeter stormwater control measures/BMPs.

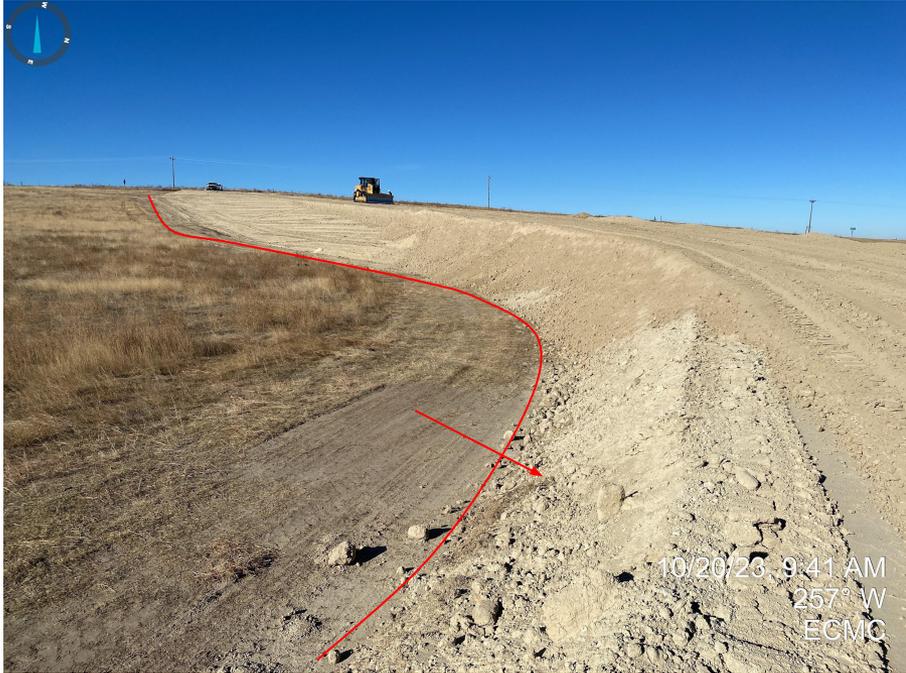
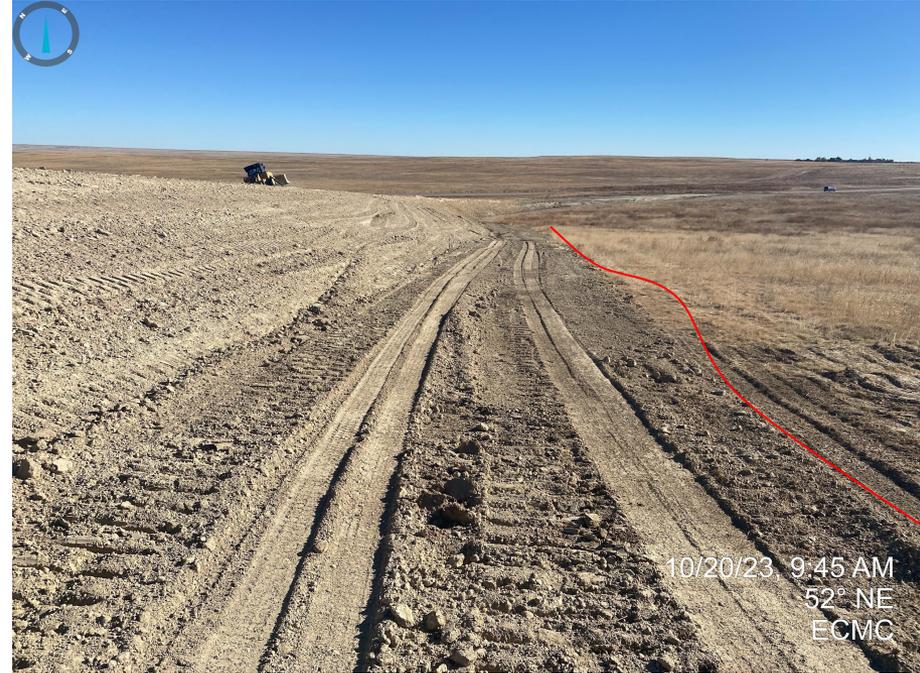
**Photos 14 & 15.** Taken from the south side of the new access road. Unconsolidated material (red arrow) and the absence of perimeter stormwater control measures/BMPs (red line).

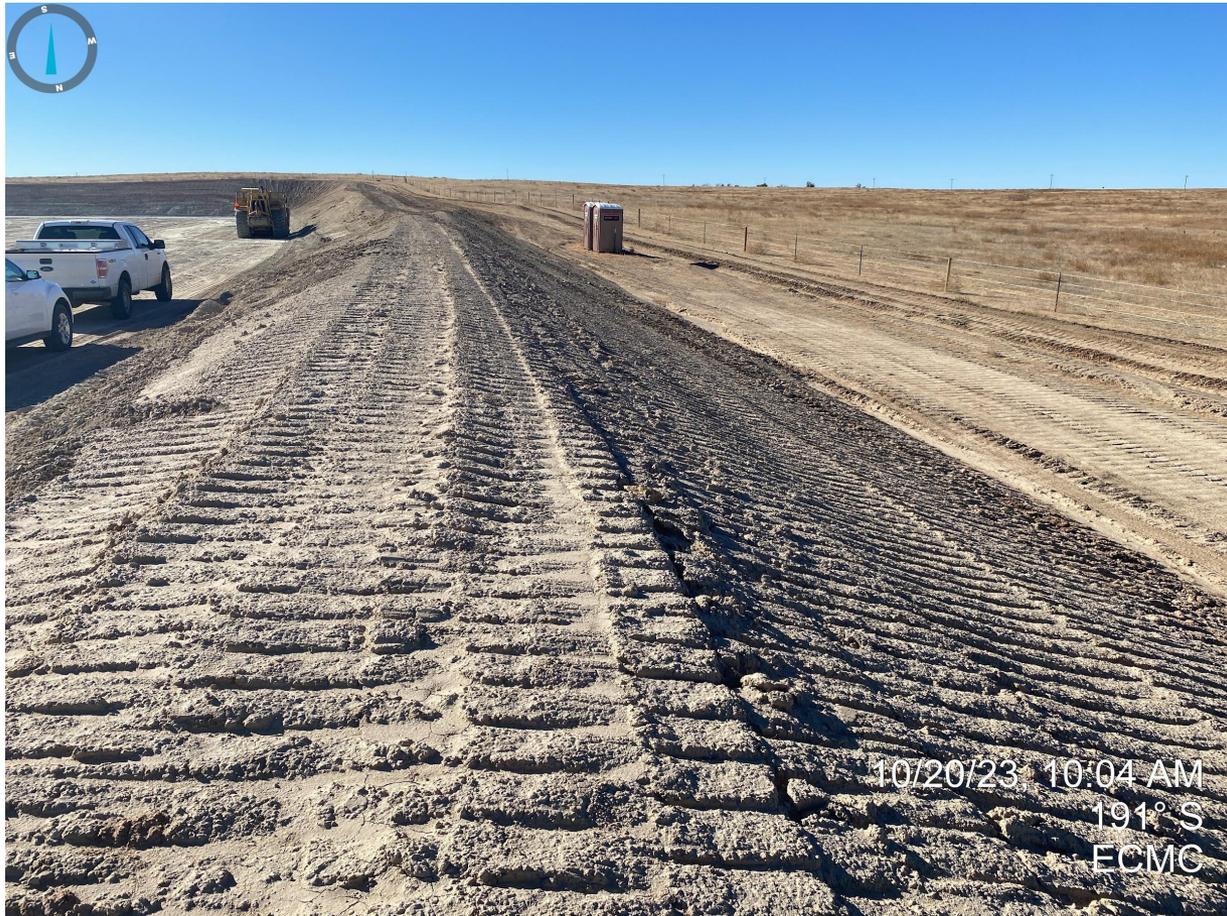
**Photo 16.** Taken from the northwest corner of the location. Photo illustrates that equipment tracking is parallel to the slope.

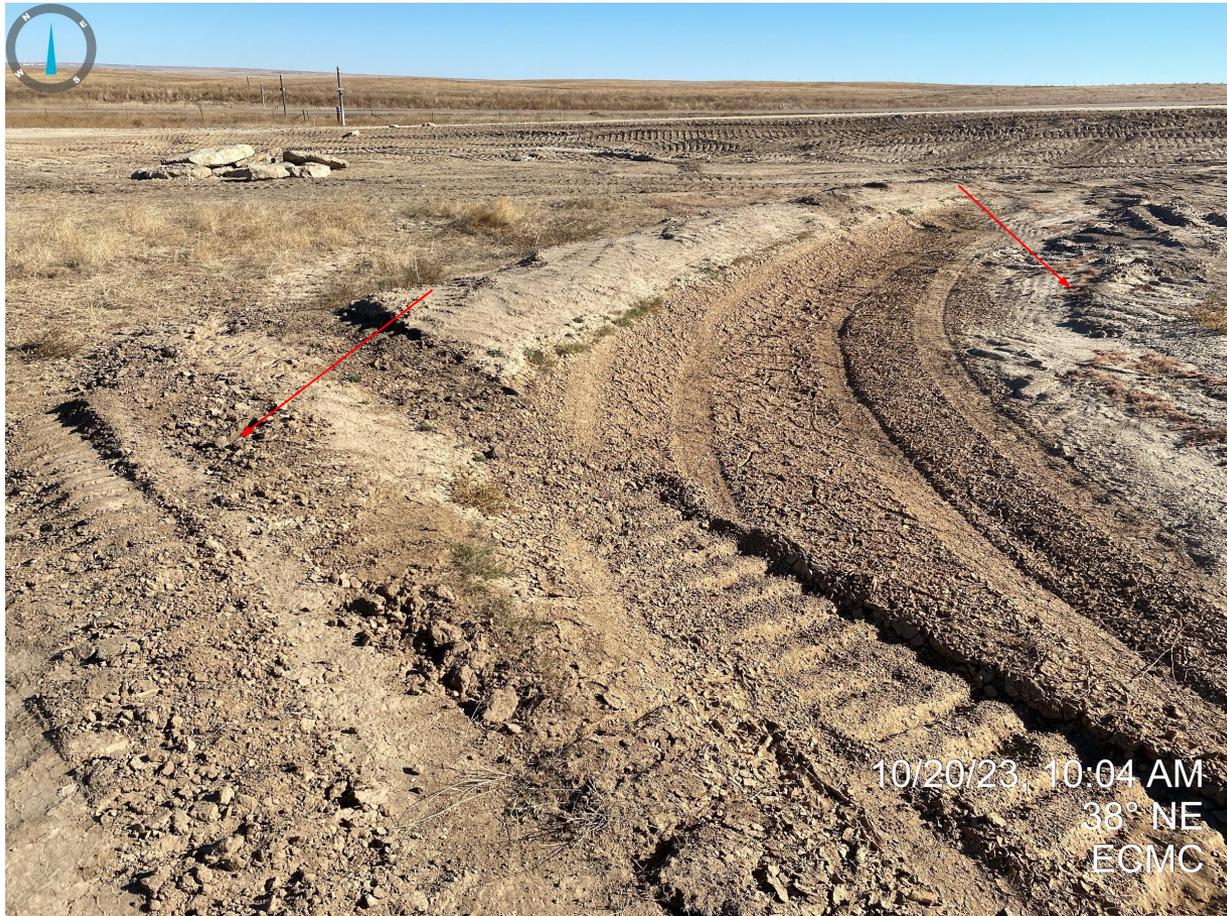
**Photo 17.** Taken from the northwest corner of the location. Photo illustrates that the perimeter stormwater ditch is comprised of unconsolidated material and is not properly stabilized. Additional repairs/maintenance is required.

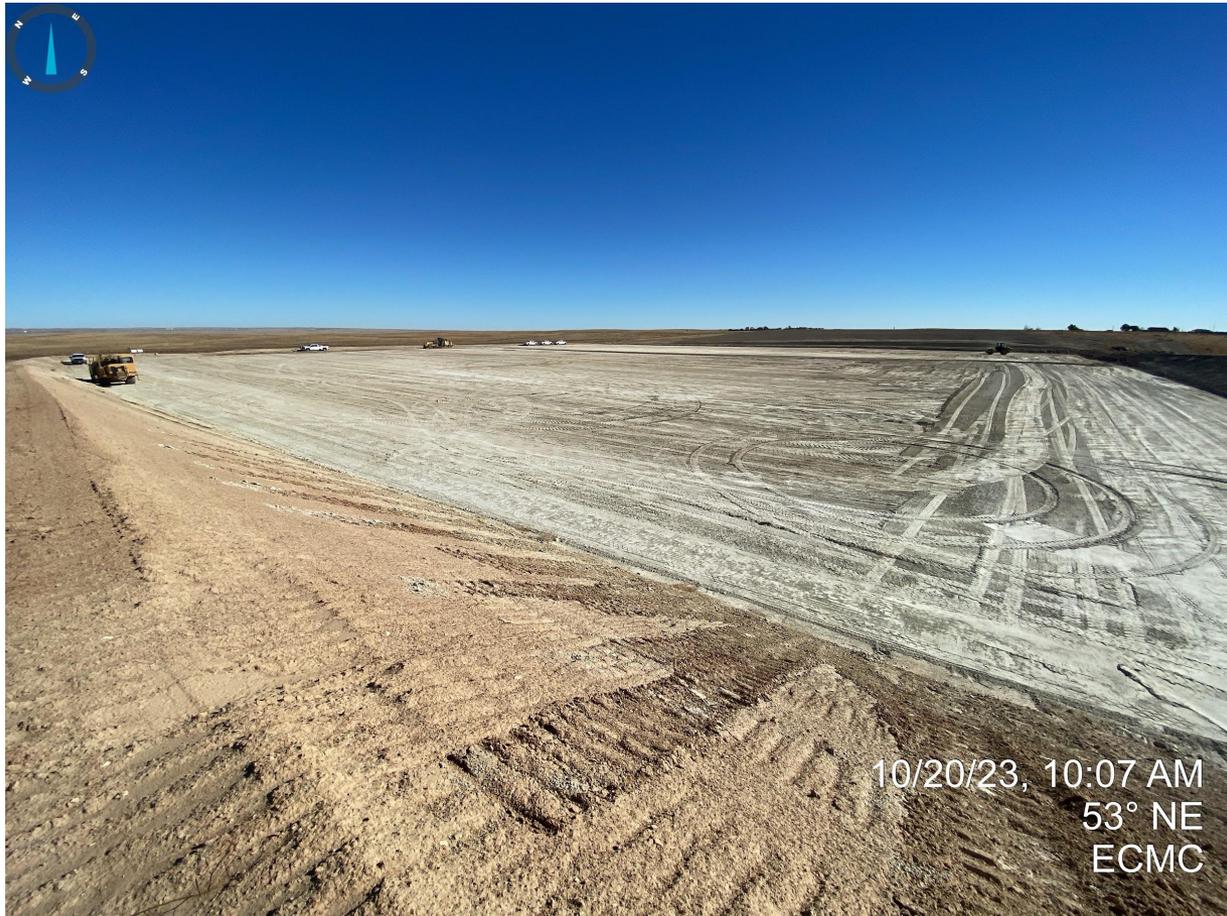
**Photo 18.** Overview of the production pad, taken from the southwest corner. Onsite crews informed staff that fill material was removed from the production pad and used for the new access road construction.

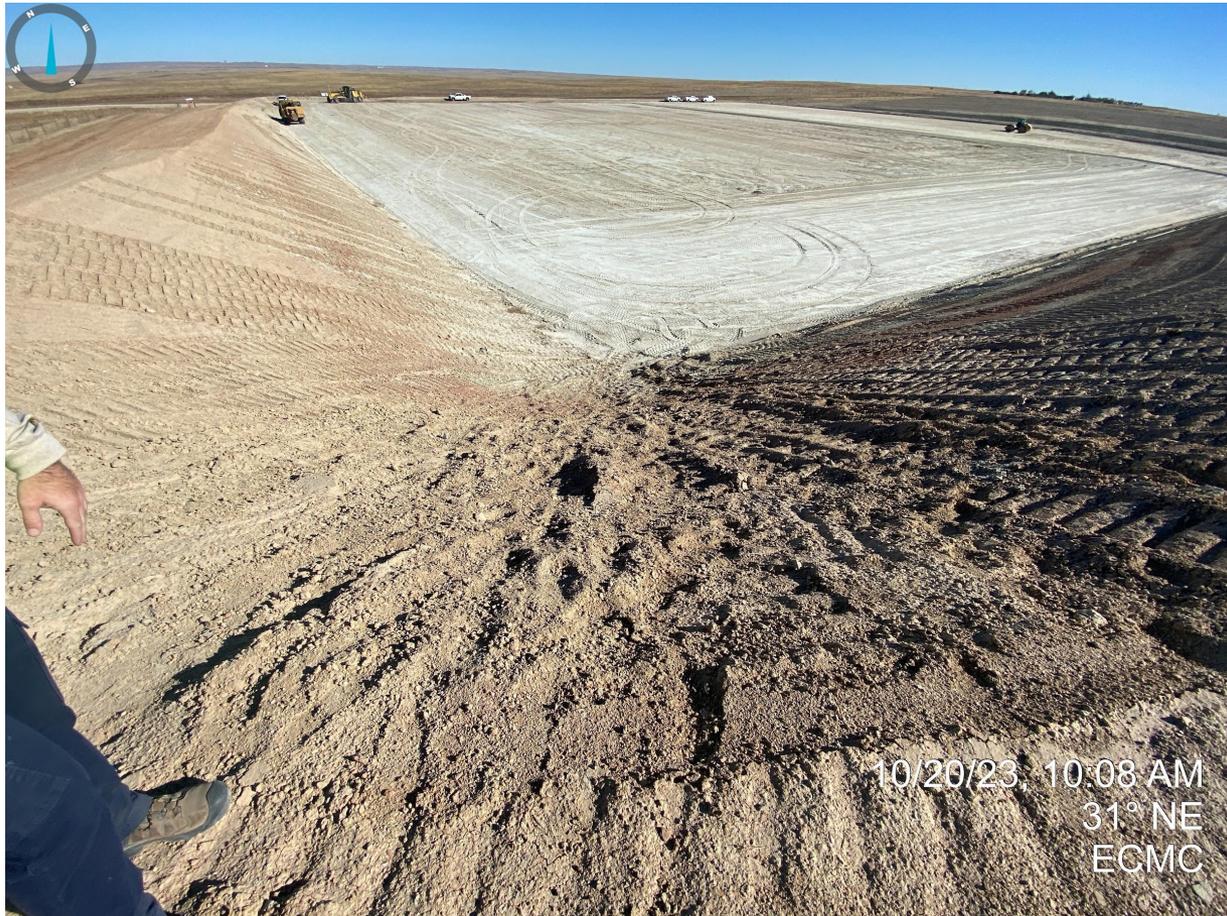
**Photo 19.** Taken from the southwest corner of the production area. Photo illustrates that some erosion degradation has been repaired since previously documented. Additional stormwater control measures/soil stabilization is required due to the steep topography and probability of further erosion degradation.

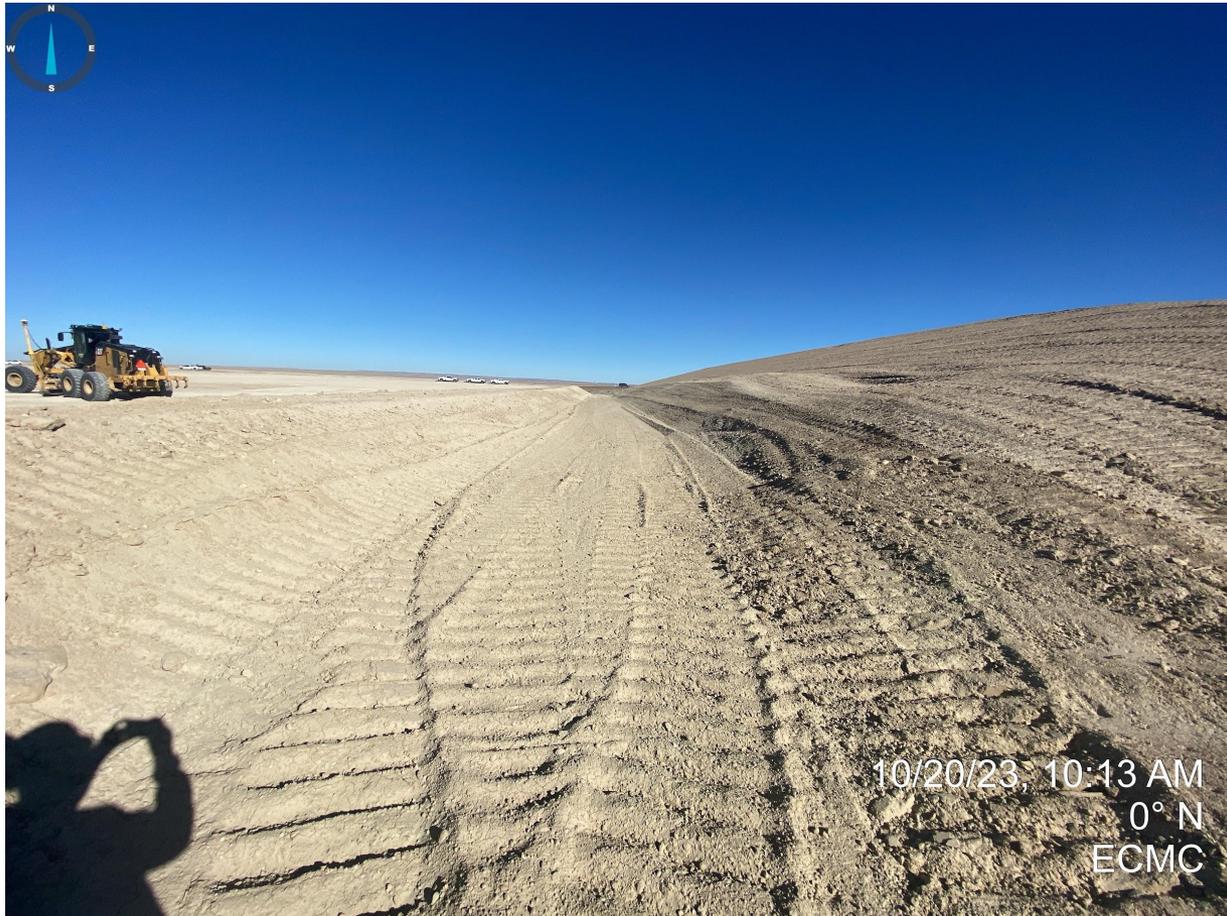
**Photo 20.** Taken from the southeastern portion of the production pad. Photo illustrates the absence of stormwater controls/BMPs within the stormwater ditch that would help to reduce the velocity of stormwater.

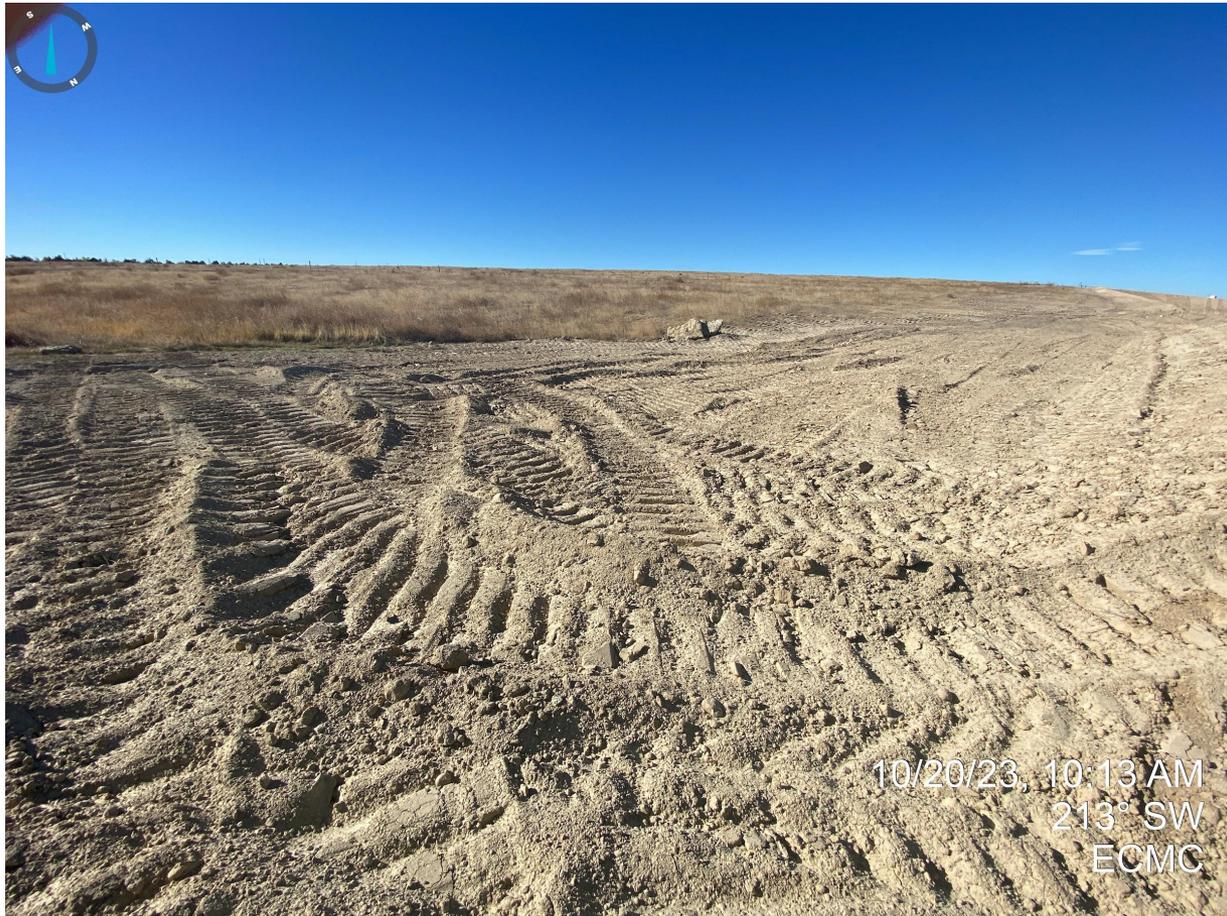
**Photo 21.** Unstabilized soils observed southeast of the production pad.

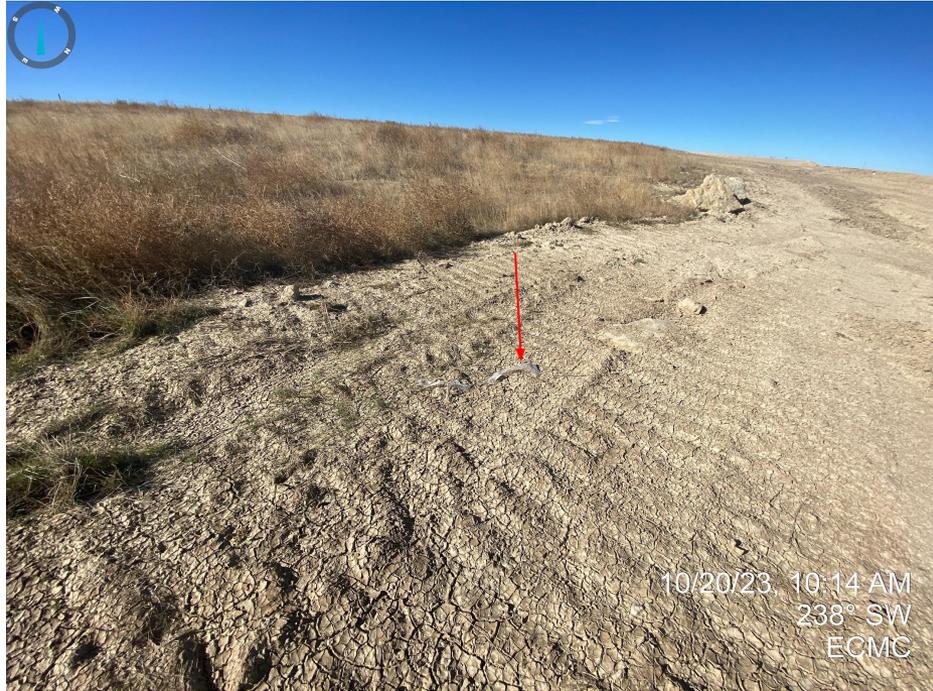
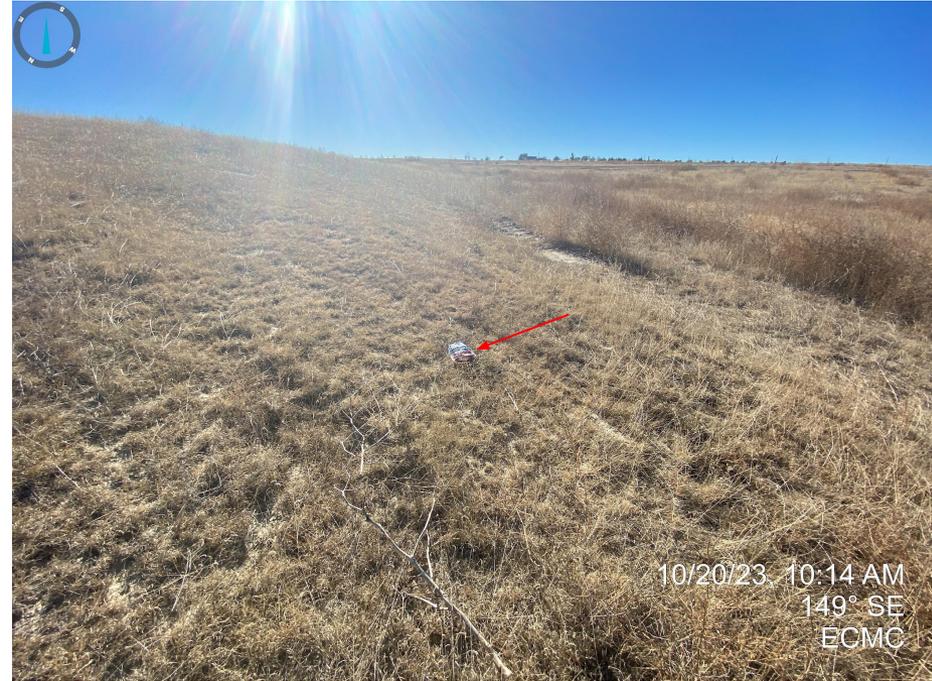
**Photos 22 & 23.** Trash observed on the southeast portion of the location. The Operator shall self inspect the entire location and remove any trash to ensure that it does not blow off onto adjacent lands.

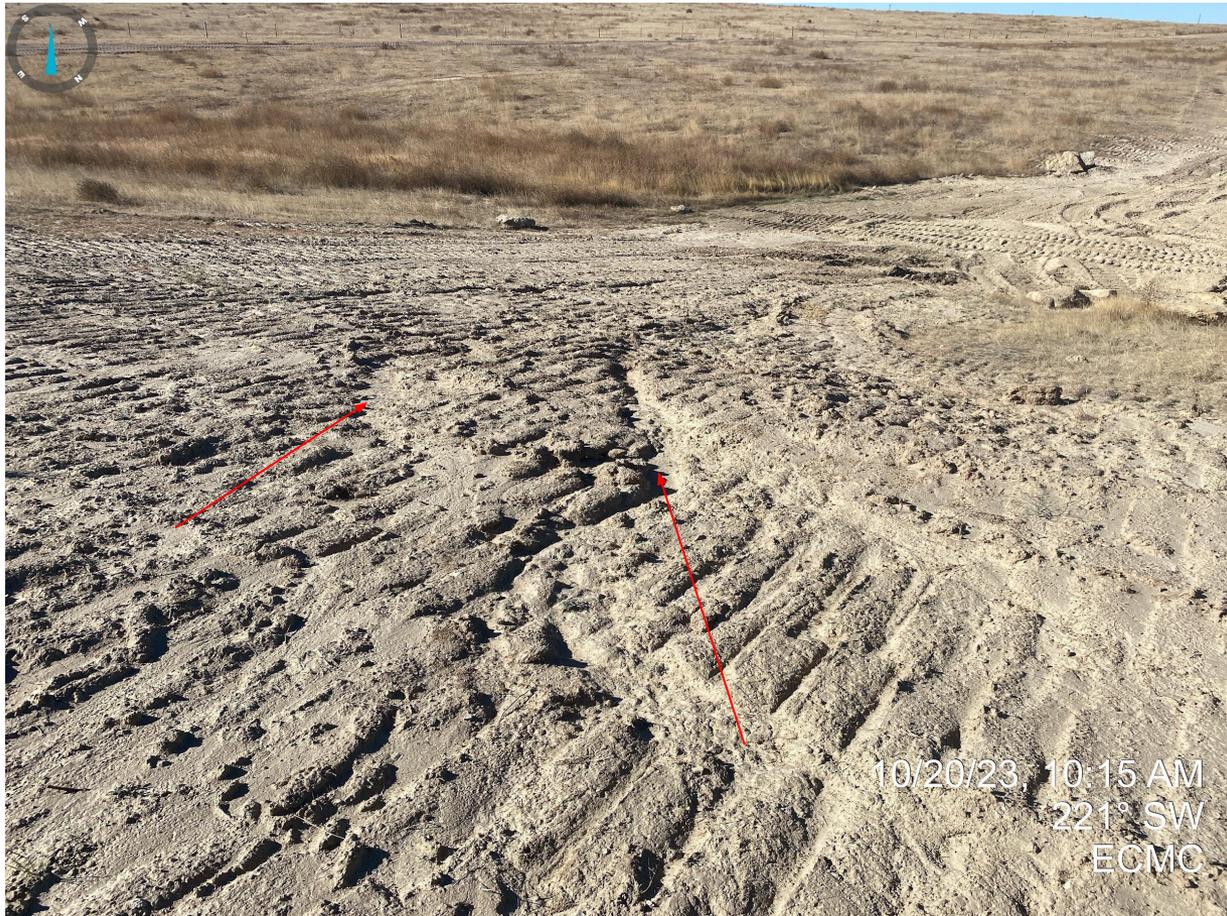
**Photo 24.** Erosion degradation observed on the south end of the topsoil stockpile. This was previously documented in the last inspection (Doc #708200543) and does not appear to have been repaired. No additional stormwater controls/BMPs were observed.

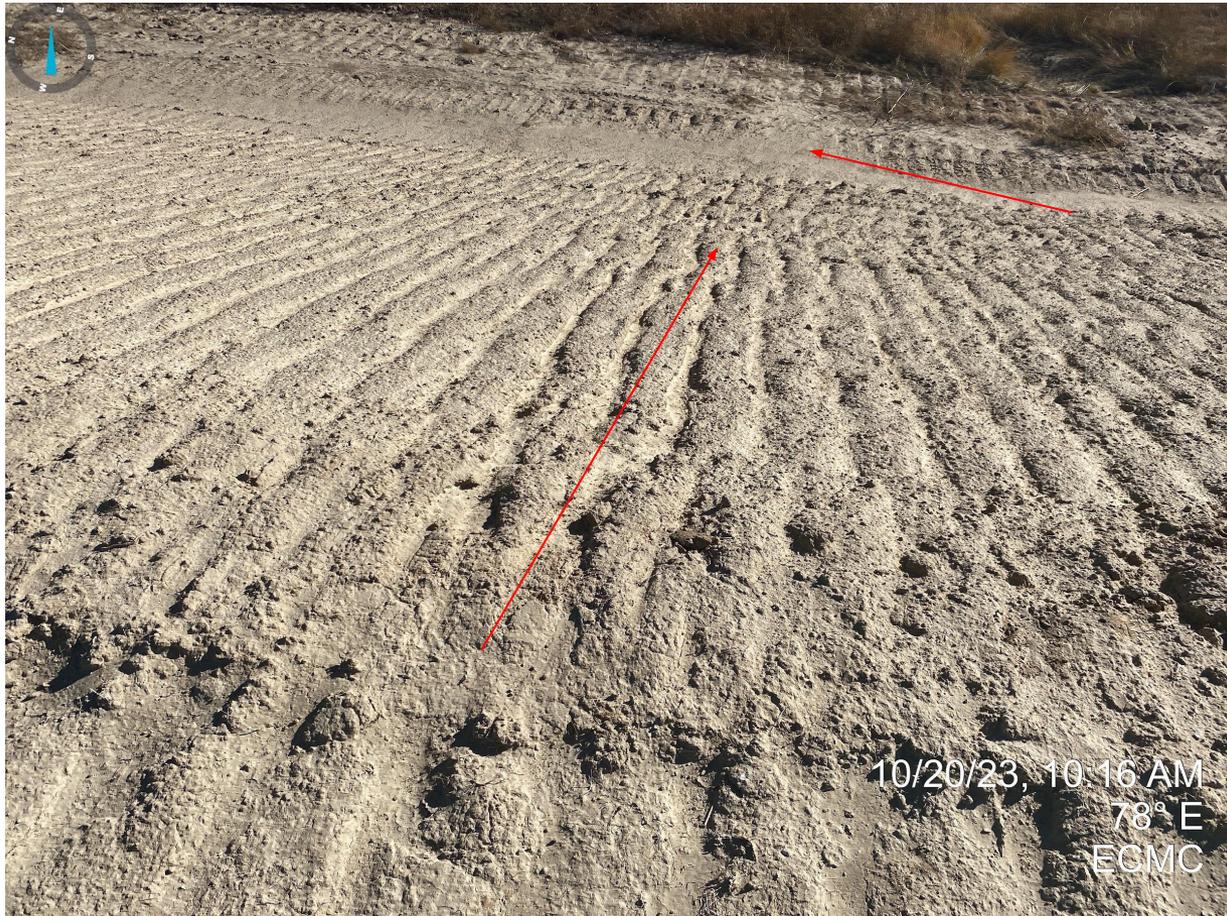
**Photo 25.** Erosion degradation (e.g. rilling) observed on the east side of the topsoil stockpile. Evidence of sediment deposition and absence of perimeter stormwater controls around the stockpile.
