# Construction and Stormwater Inspection

Operator: MDS ENERGY DEVELOPMENT LLC - 10814

Location ID: 477495

Inspection Photos  
Location Name: Daffy Pad  
Location ID: 477495

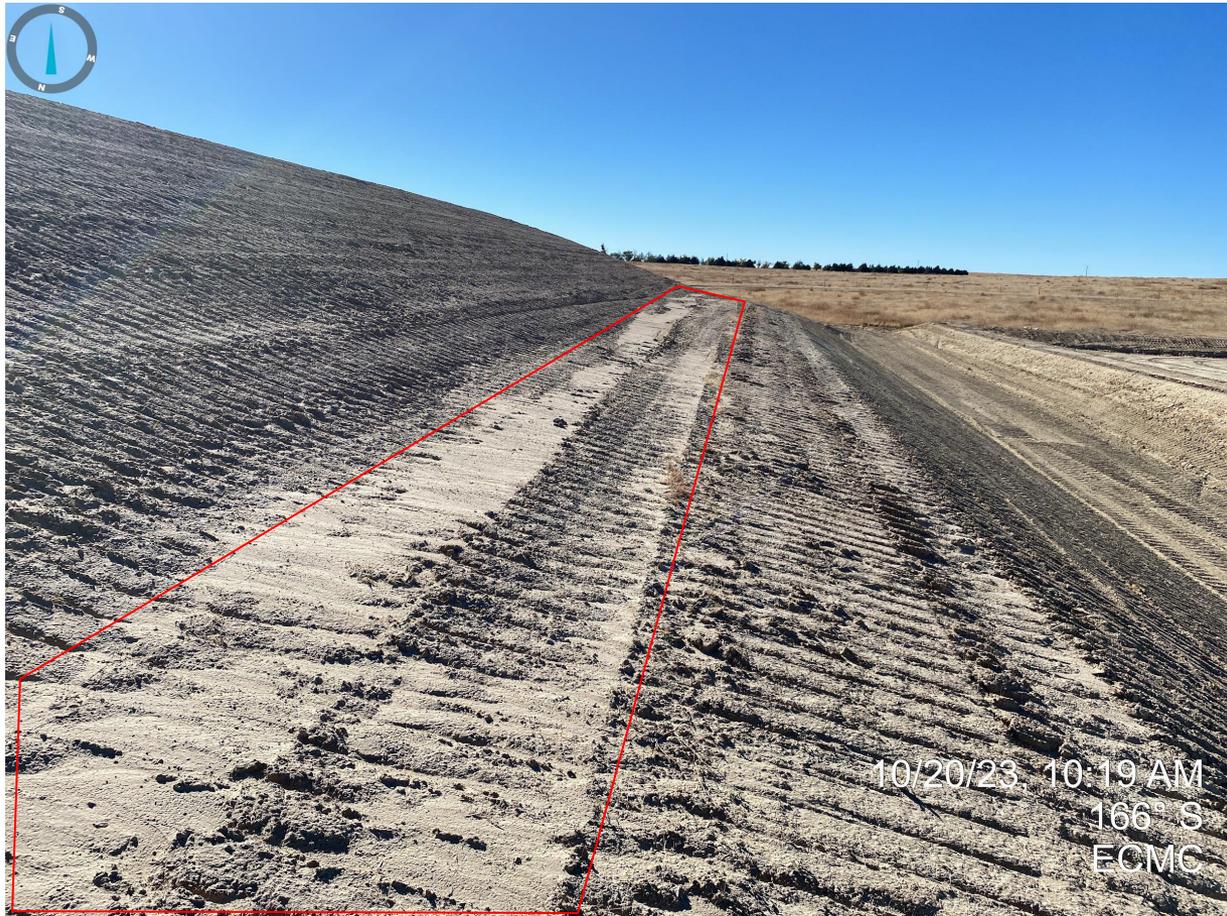
**Photo 26.** Taken from the east side of the topsoil stockpile. Photo illustrates evidence of sediment transport/deposition from improper temporary tracking and no apparent stormwater controls/BMPs to prevent topsoil from migrating into the adjacent stormwater ditch. Additional perimeter controls are required to prevent erosion degradation.

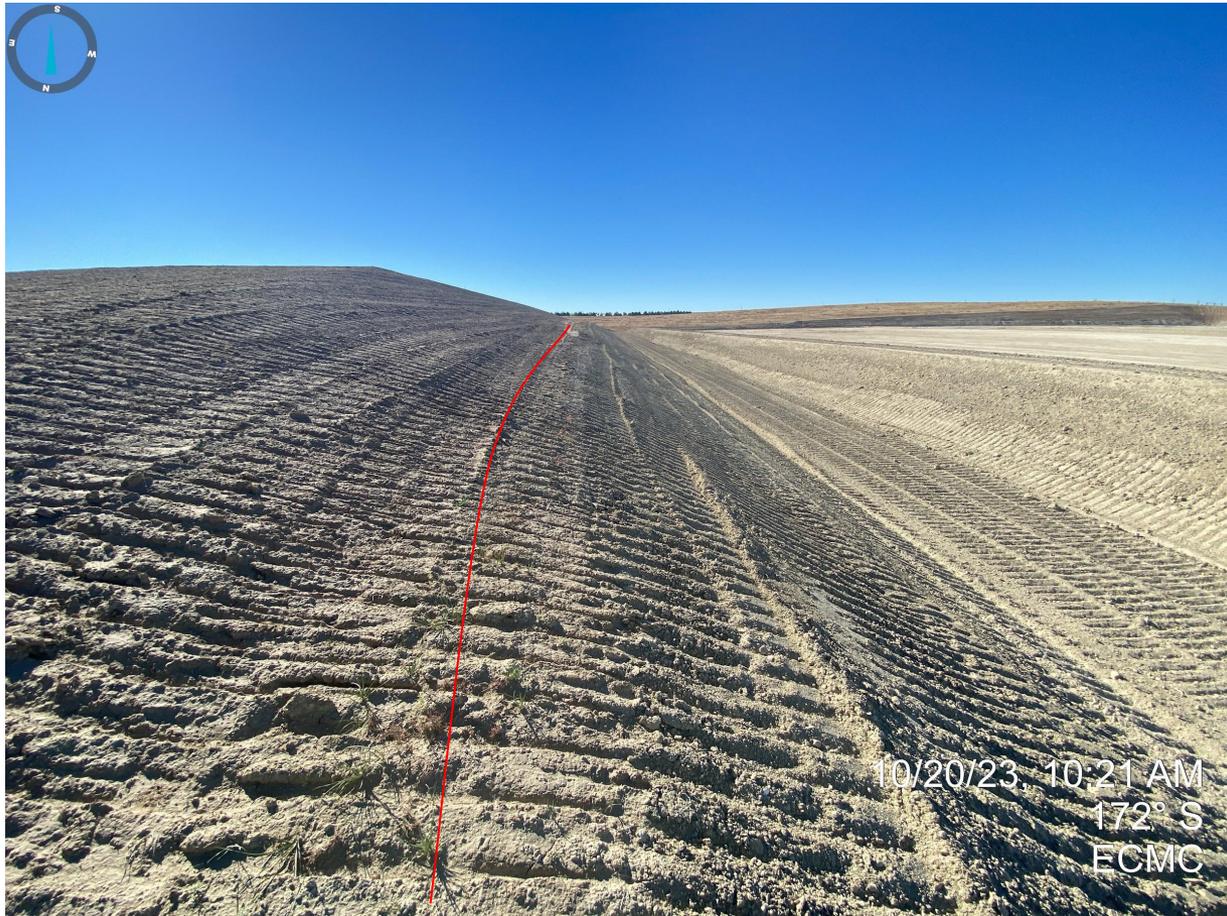
**Photo 27.** Continued from Photo 26, towards the northern end of the topsoil stockpile.

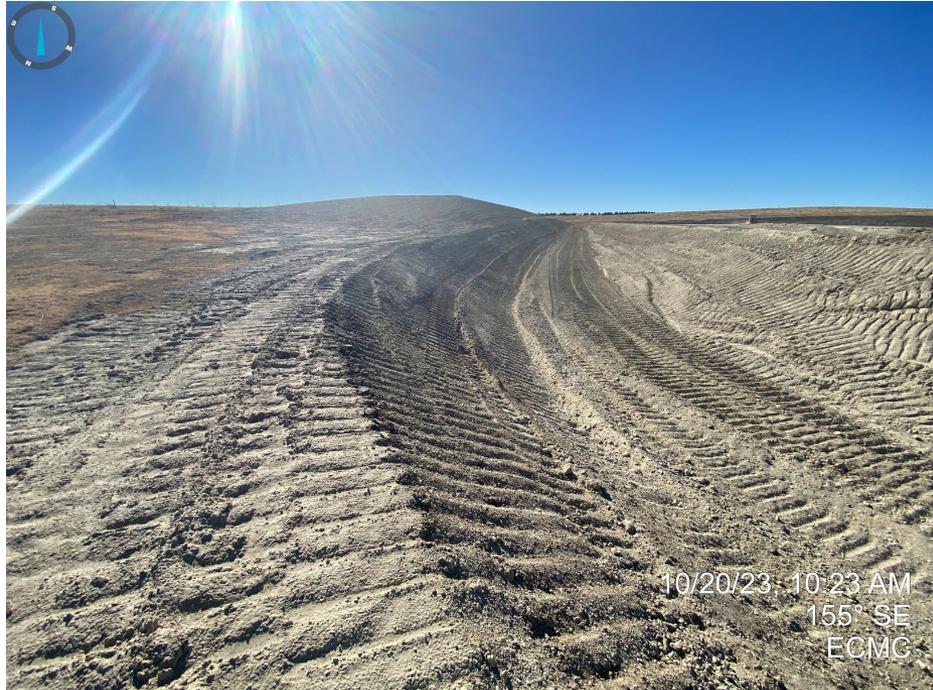
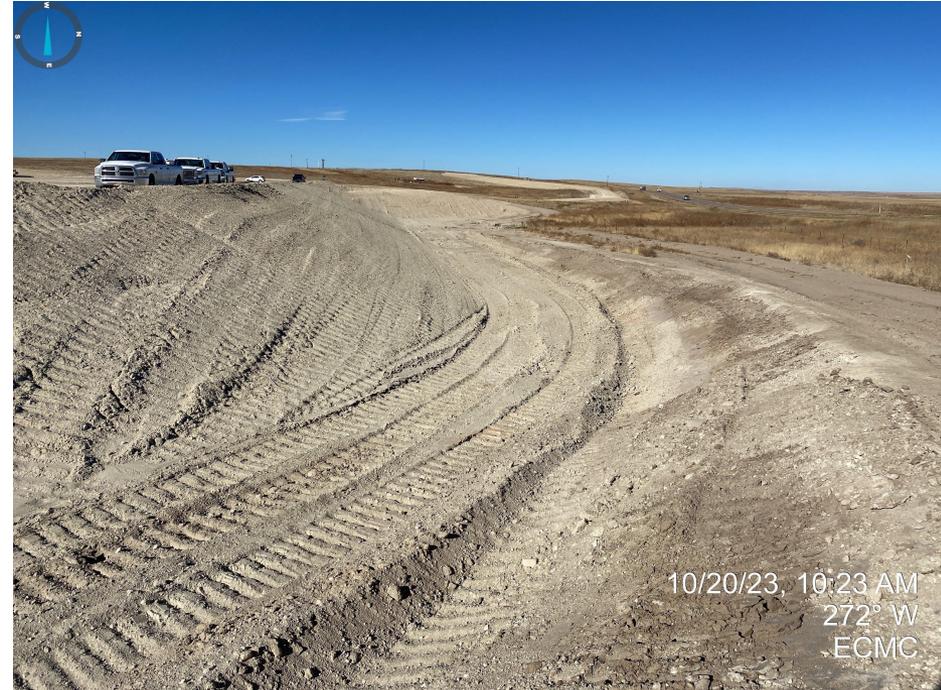
**Photos 28 & 29.** Erosion degradation repaired on the northeast corner of the production pad. Equipment tracking is parallel to the slope and soils remain unstabilized.

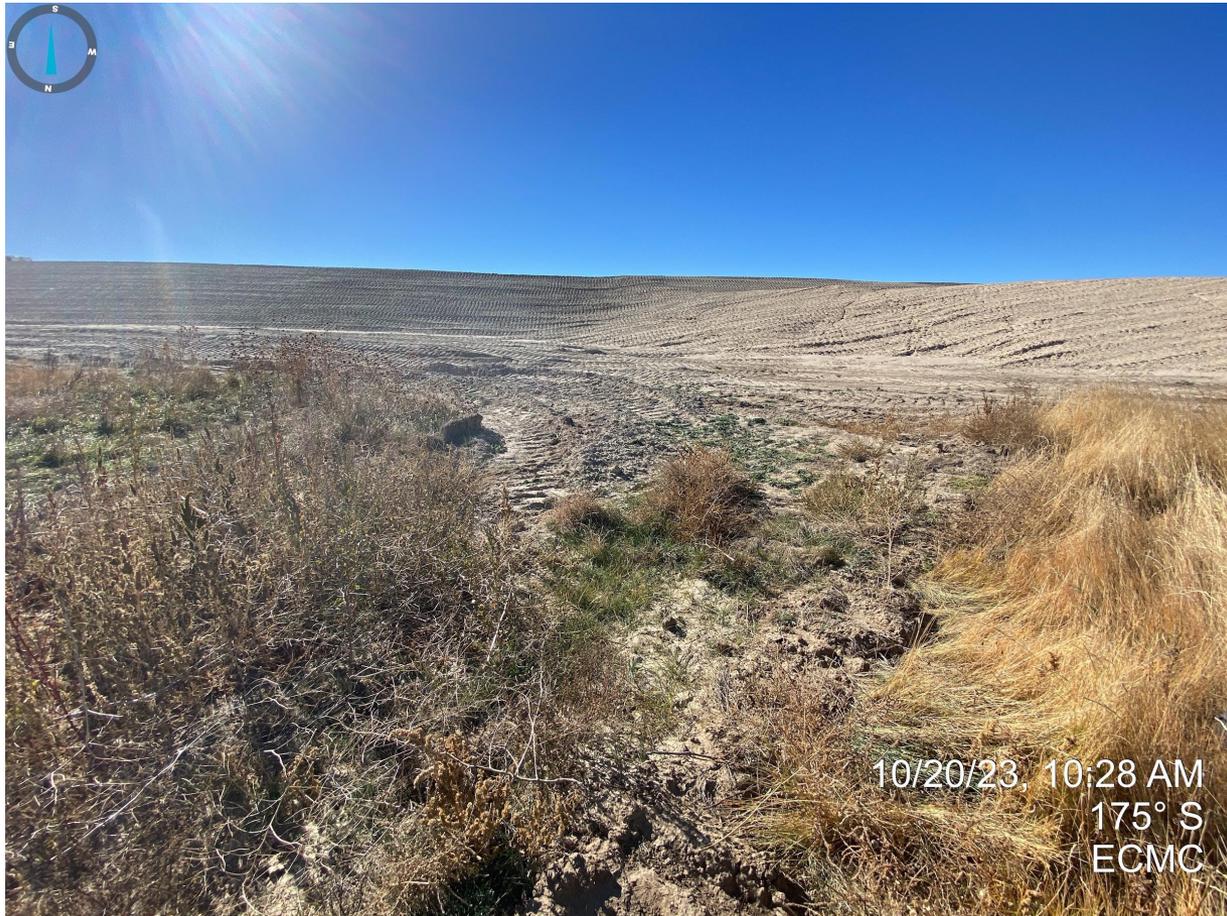
**Photo 30.** Erosion degradation previously documented does not appear to have been repaired, and no additional stormwater control measures observed that would prevent/manage stormwater from exiting off location into adjacent areas. Additional and more robust control measures are required as much of the stormwater from the location could potentially collect in this low spot.

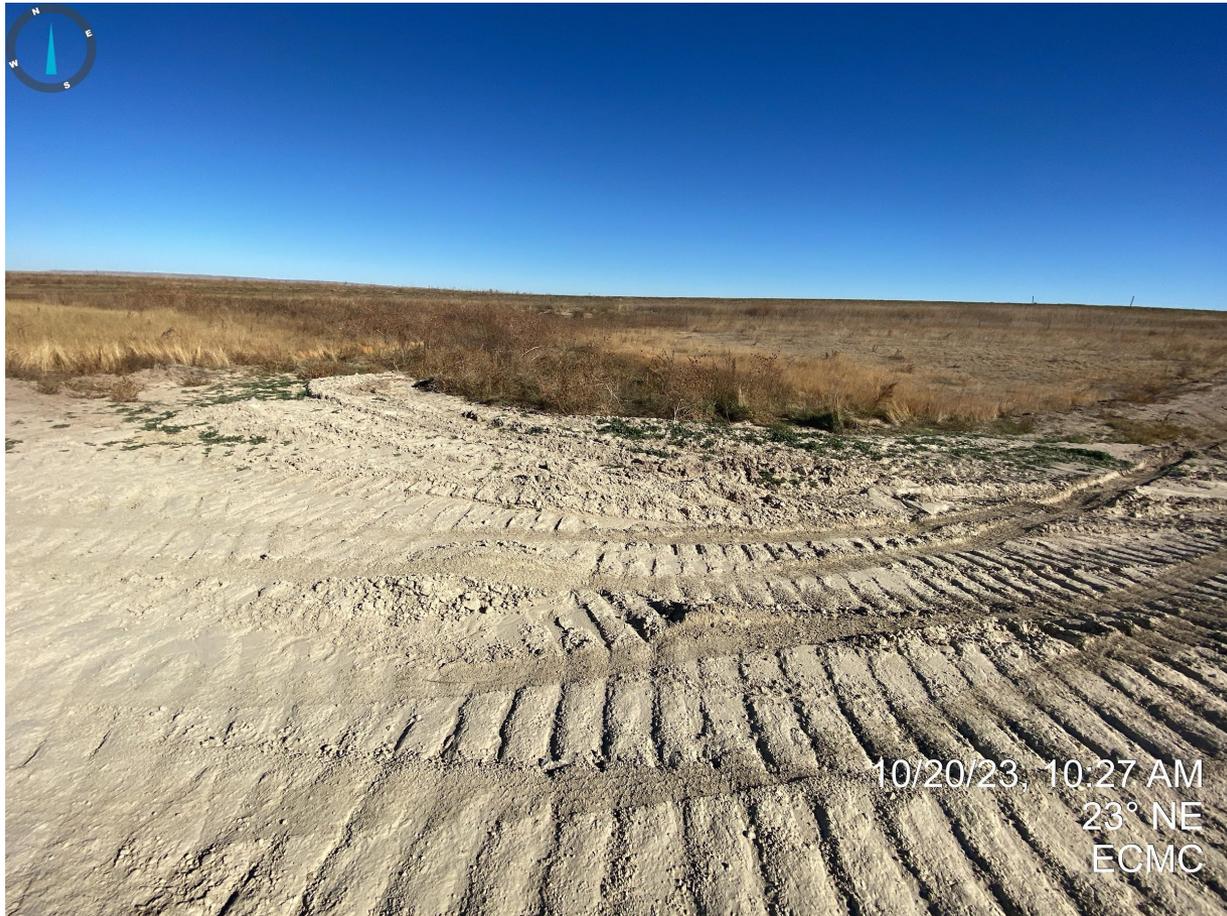
**Photo 31.** Continued from Photo30, taken from the northern/center portion of the location. No apparent stormwater control measures observed.
