Inspection Photos
Location: Drill Site 3
Facility ID: 333348

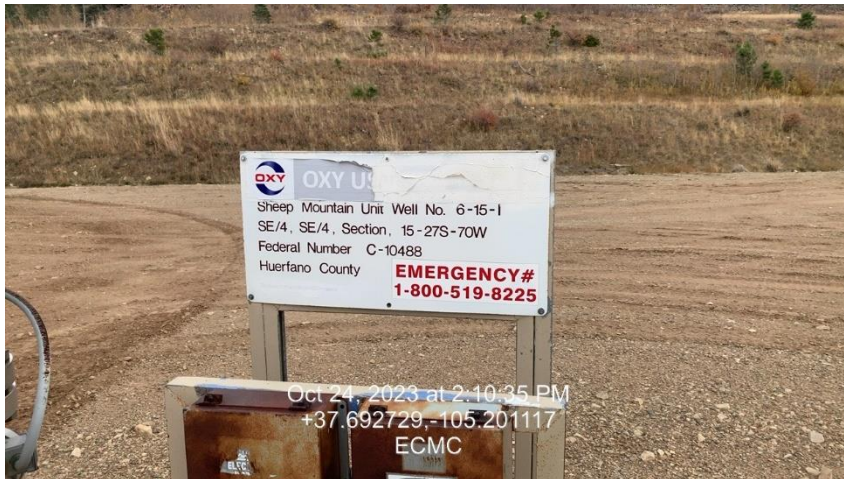
Photo 1 –Wellhead Placard SMU 6-15-I

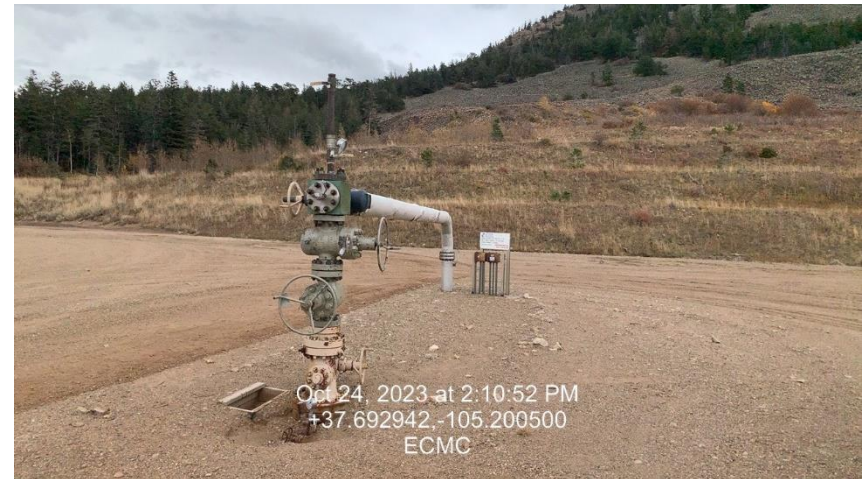
Photo 2 – Spill Remediation # 31510, Spill ID # 484278

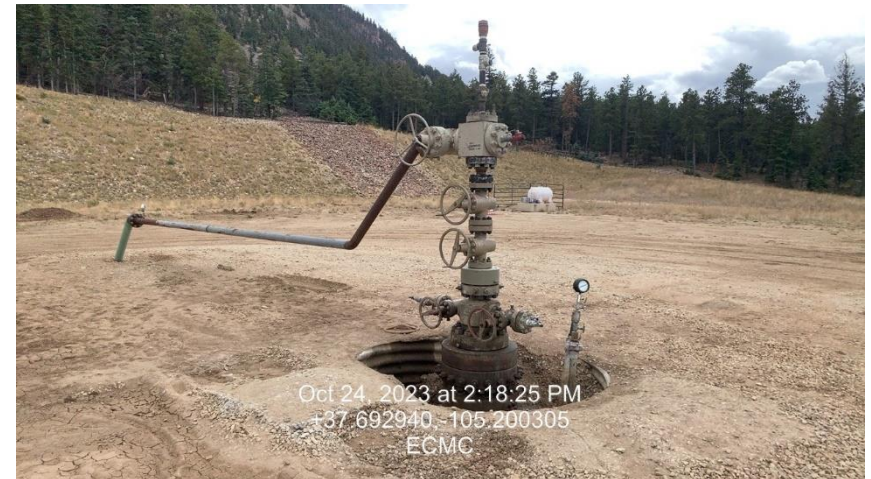
Photo 4 – SMU 4-23-L No well placard at Wellhead

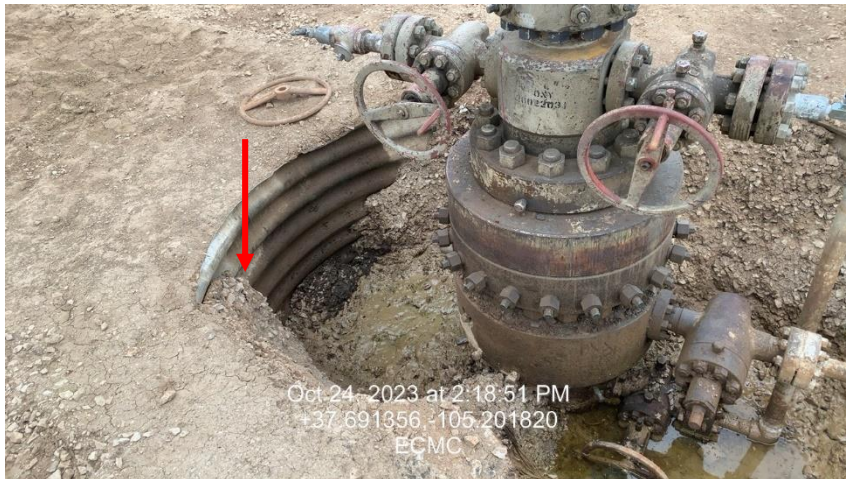
Photo 5 – 4-23-L Oil Stained soil

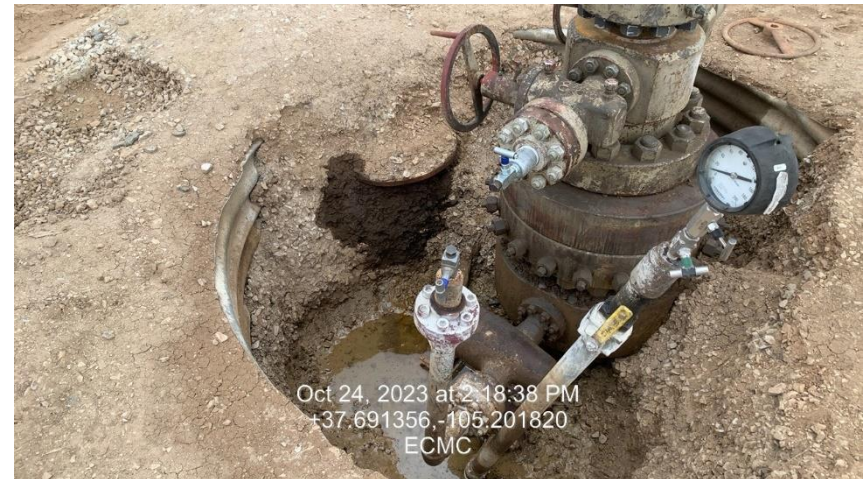
Photo 6 – 4-23-L Oil Stained soil

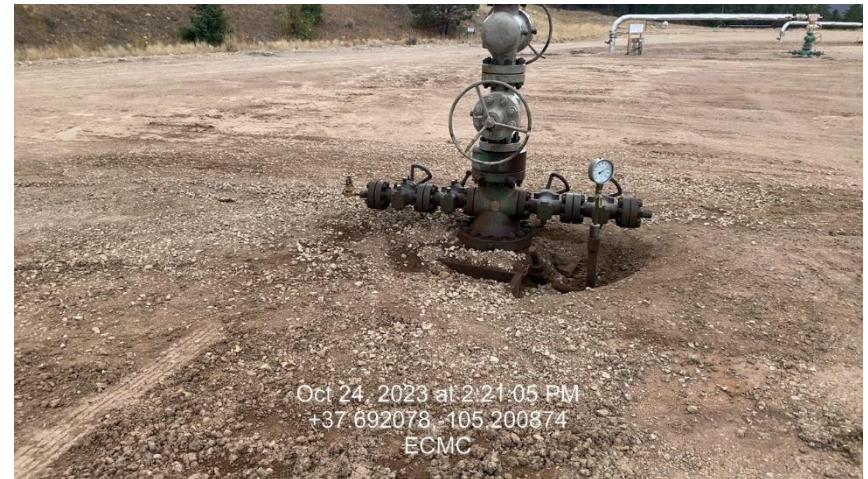
Photo 8 – 3-23-D Wellhead

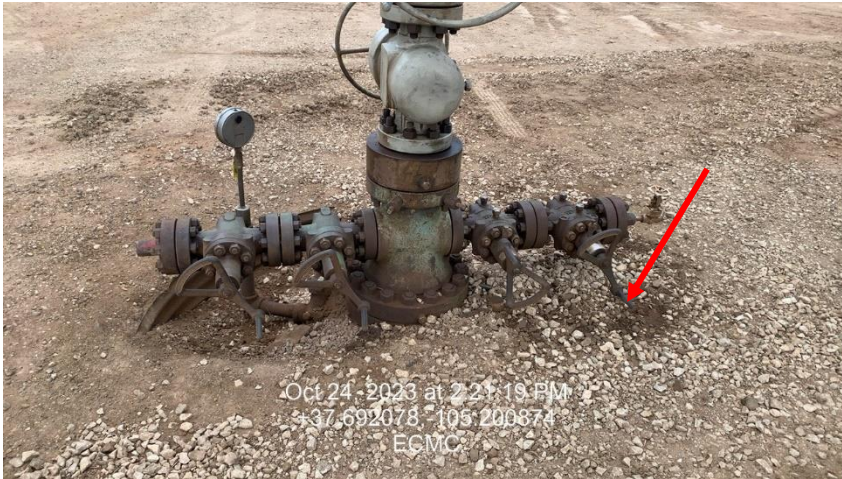
Photo 9 – 3-23-D Oil Stained Soil

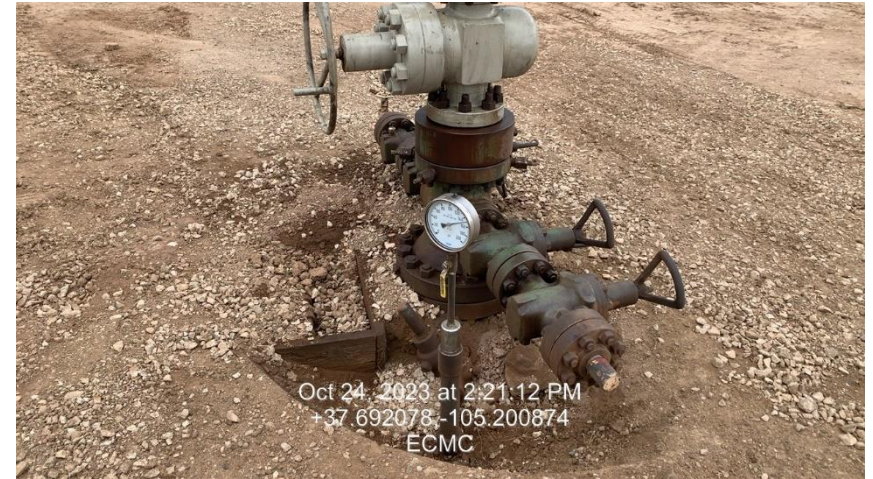
Photo 10 – 3-23-D Oil Stained Soil
