Inspection Photos  
Location: Drill Site  
Facility ID: 334553

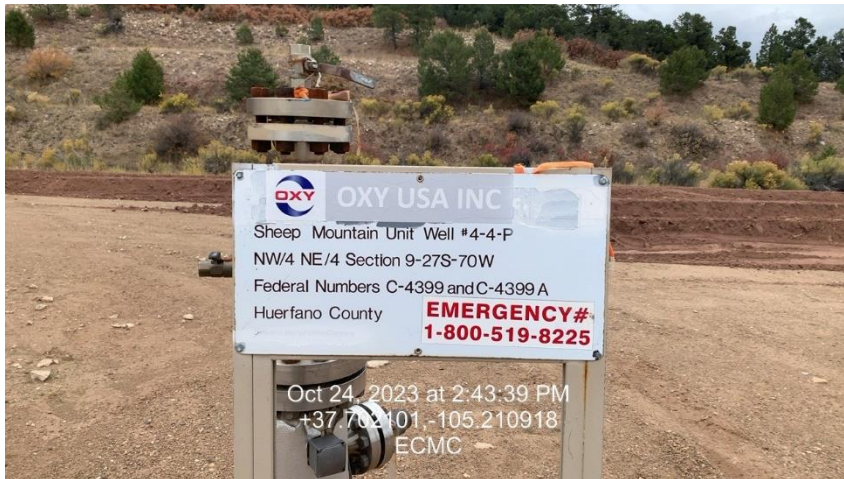
Photo 1 –Wellhead Placard SMU 4-4-P P&A  
Wellhead

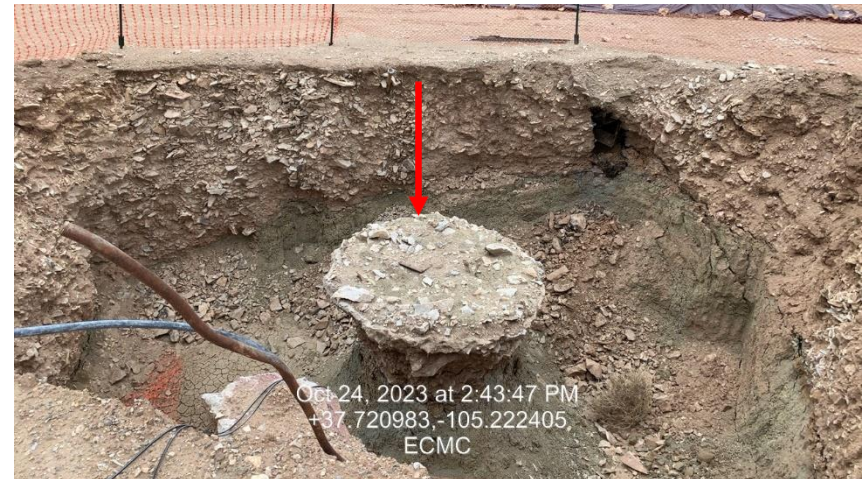
Photo 2 – SMU 4-4-P Cemented Wellhead,  
Remediation # 24086

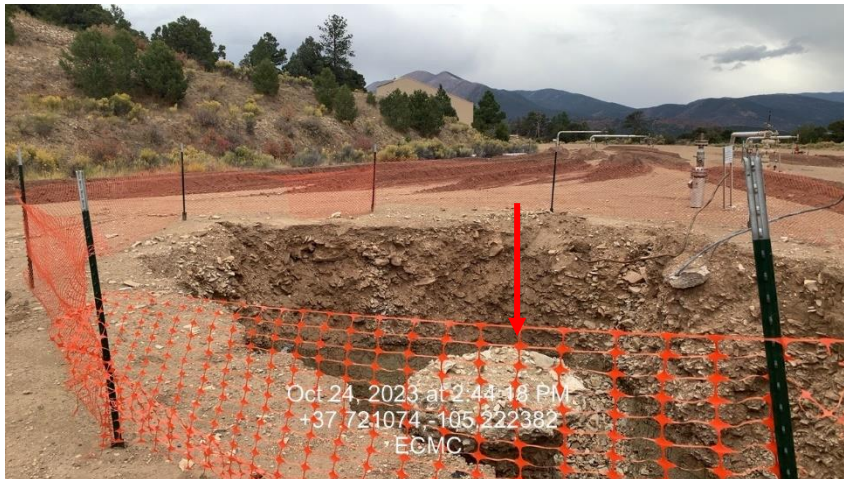
**Photo 3 – SMU 4-4-P Cemented Wellhead,  
Remediation # 24086**

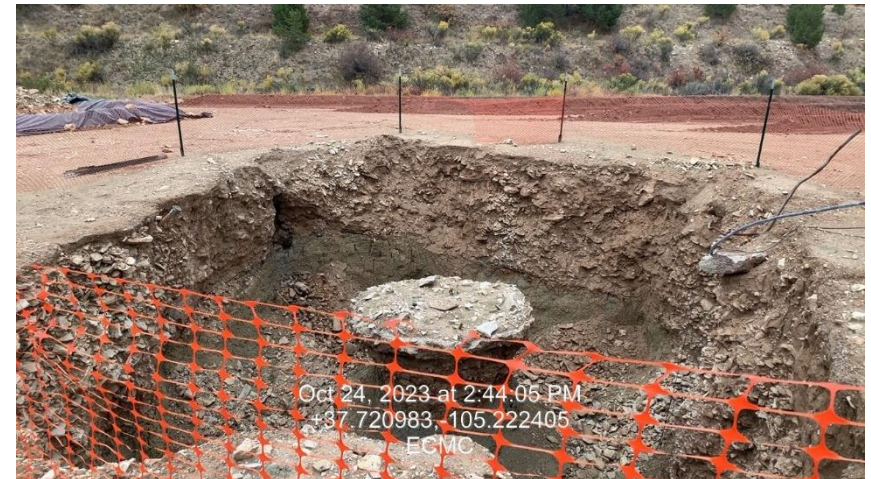
**Photo 4 – SMU 4-4-P Cemented Wellhead,  
Remediation # 24086**

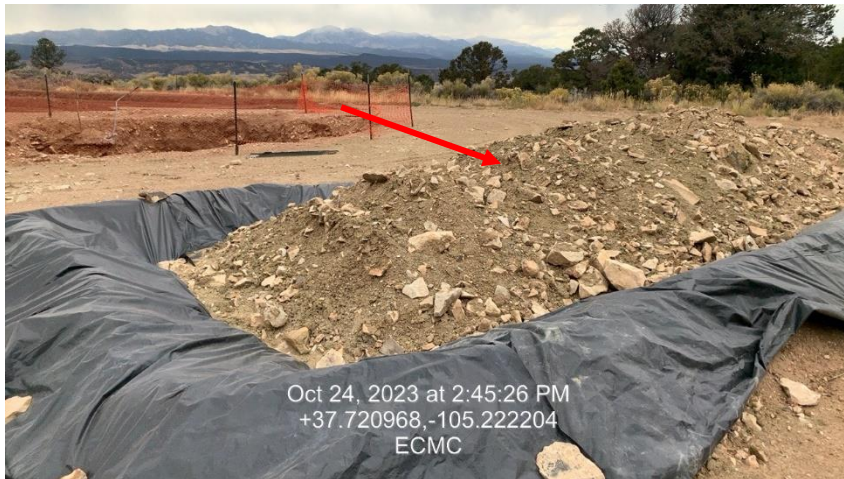
**Photo 5 – Contaminated Soil**

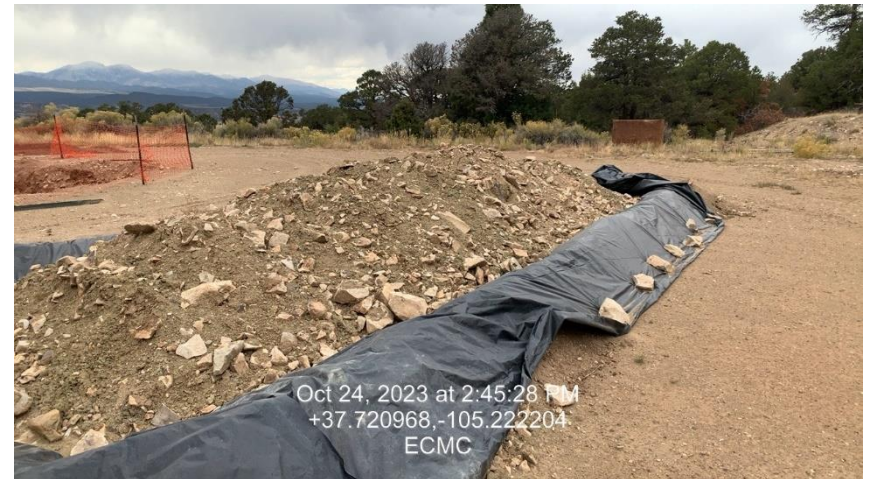
**Photo 6 – Contaminated Soil**

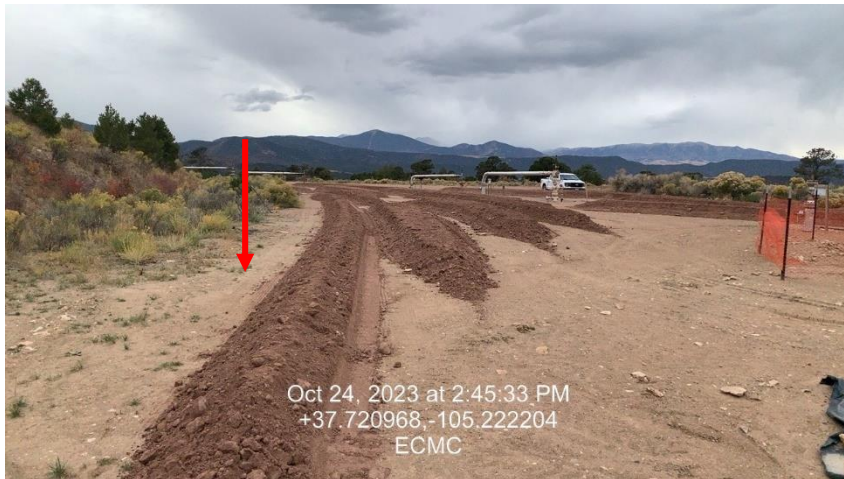
**Photo 7 – Stockpiled backfill material**

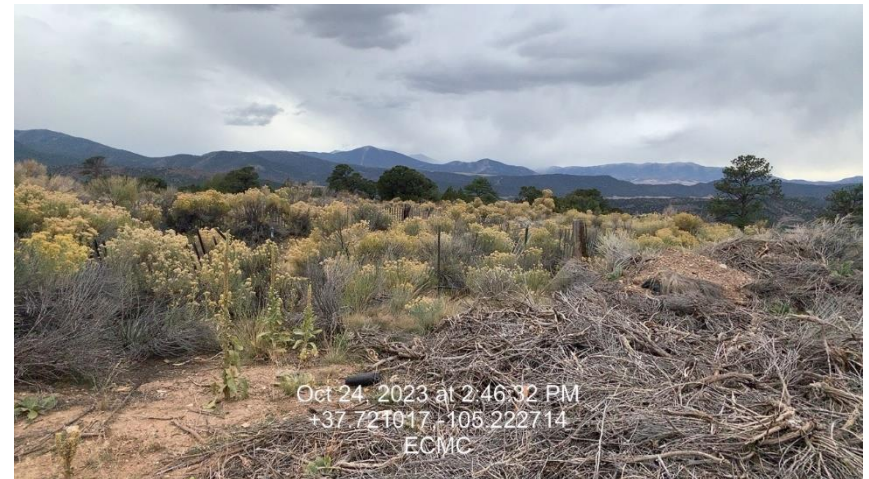
**Photo 8 – Drill Site 1 South Pit Facility 483528;  
Remediation # 28196**

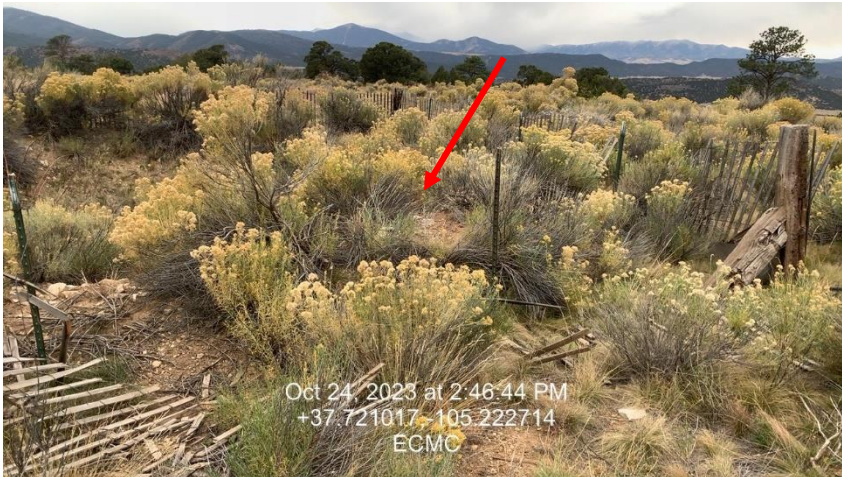
**Photo 9 – Drill Site 1 South Pit Facility 483528 Fence  
in disrepair**

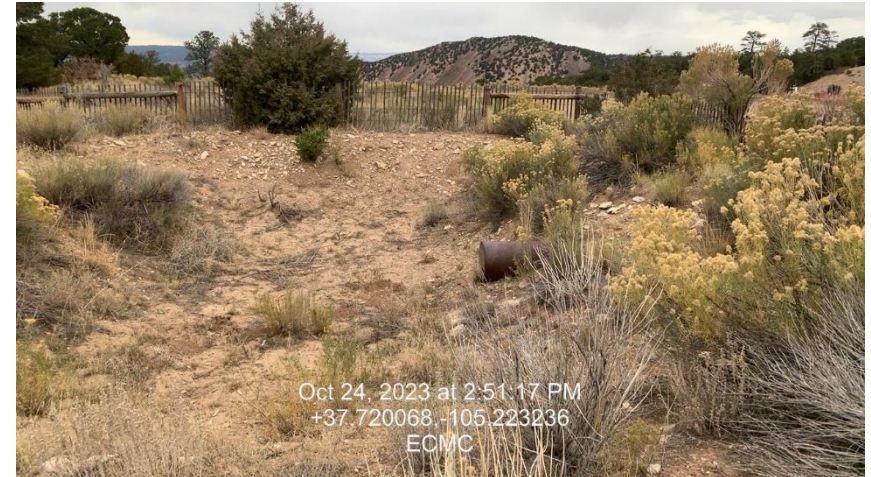
**Photo 10 – Drill Site 1 North Pit Facility ID 483530;  
Remediation # 28194**
