Inspection Photos
Location: Larissa 32-35
Facility ID: 422584
to Flashback Deep 22-27
Location ID 309260

**Energy & Carbon Management
Commission**

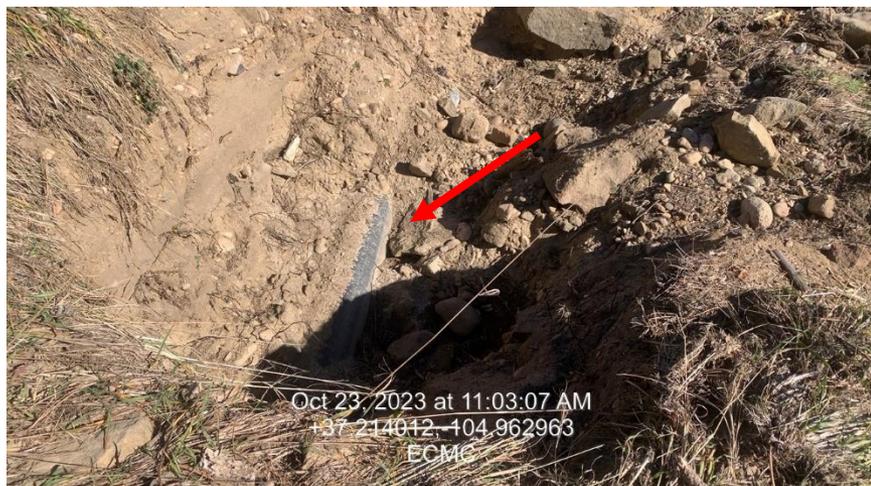
**Photo 1 –Exposed Gathering Line @ 37.214012;
-104.962963 Box Canyon Creek Crossing**

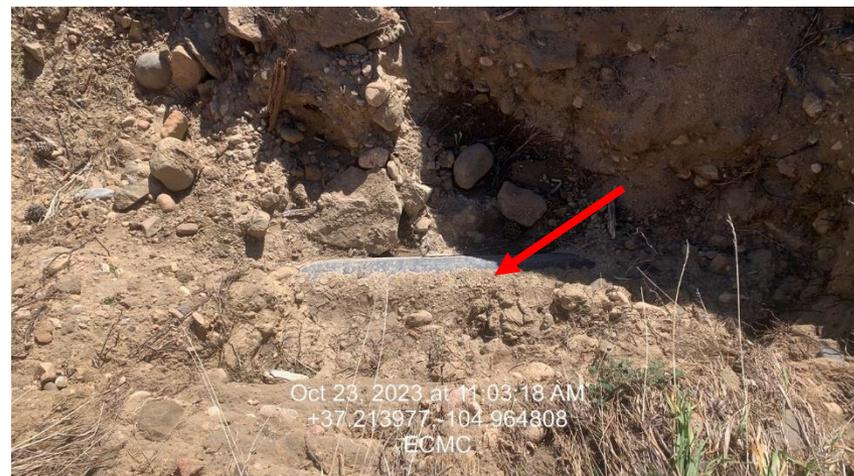
Photo 2 – Exposed Gas Gathering Line

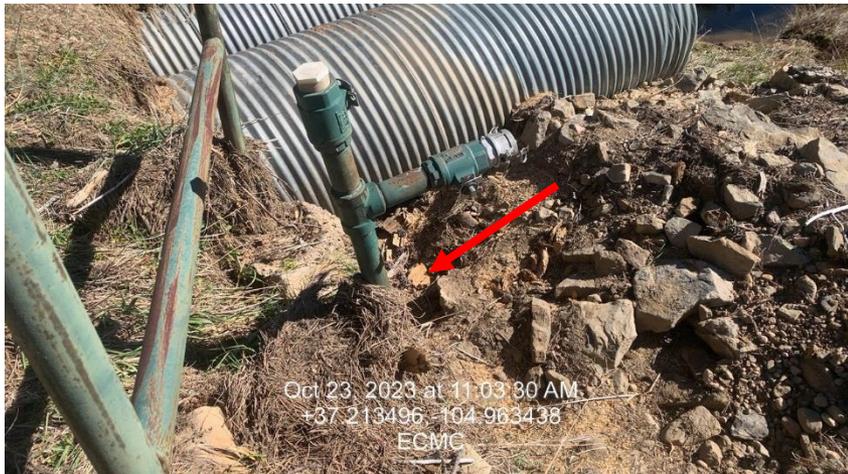
Photo 3 – Erosion and buildup debris around Drip

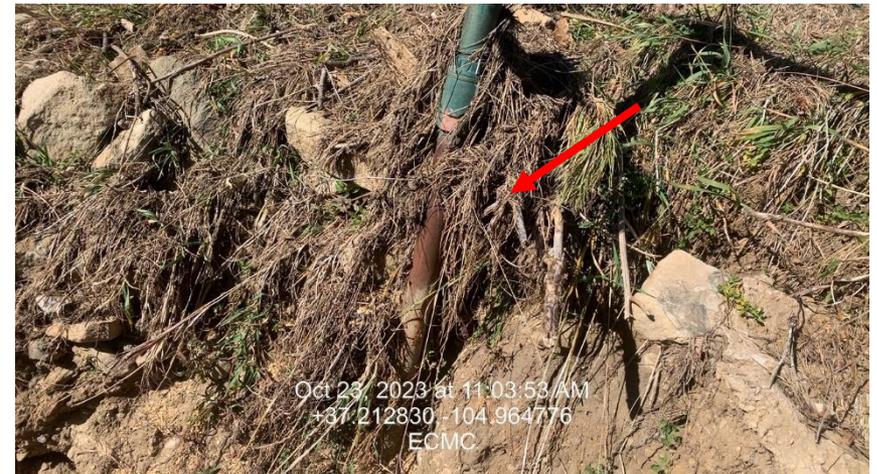
Photo 4 – Erosion and buildup debris around Drip

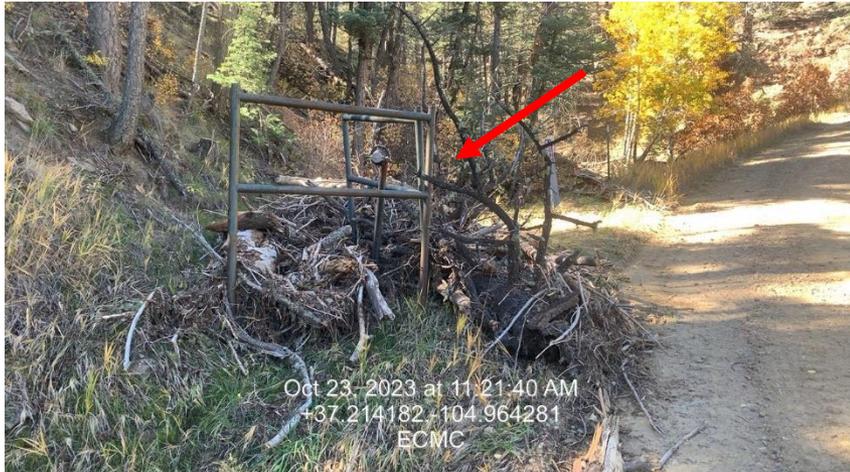
Photo 5 – Debris buildup around drop from storm event

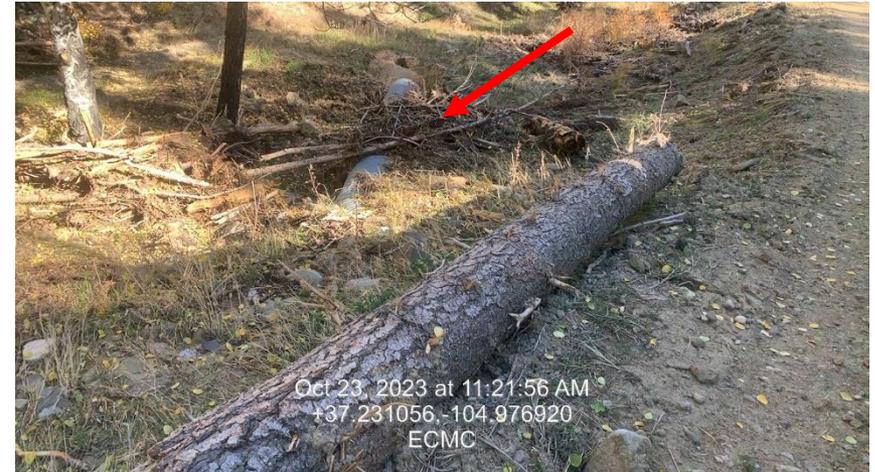
Photo 6 – Area starting to wash, loose debris from storm event

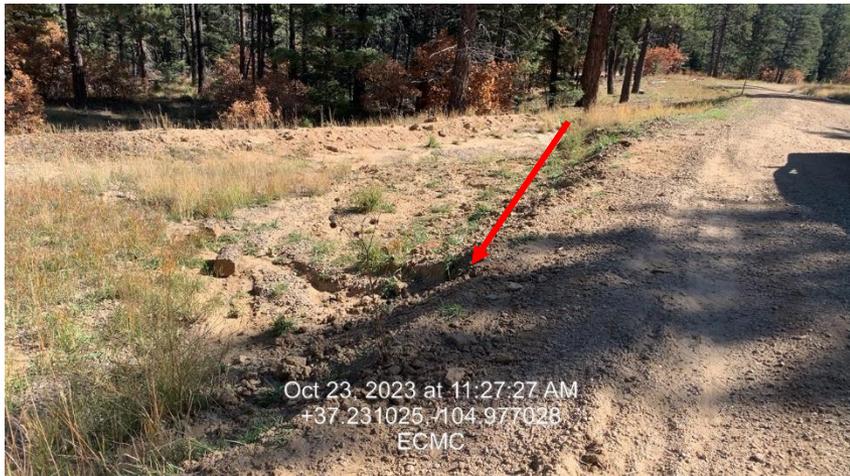
Photo 7 – Fill slope of road starting to wash.

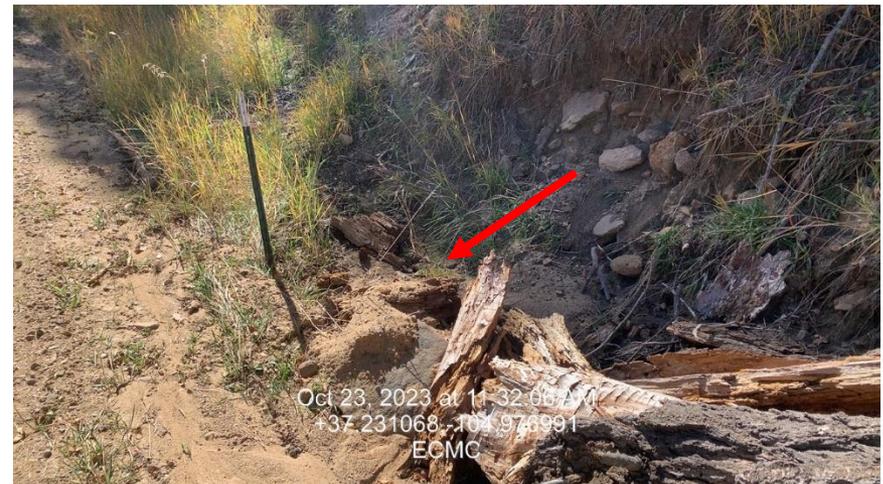
Photo 8 – Plugged Culvert

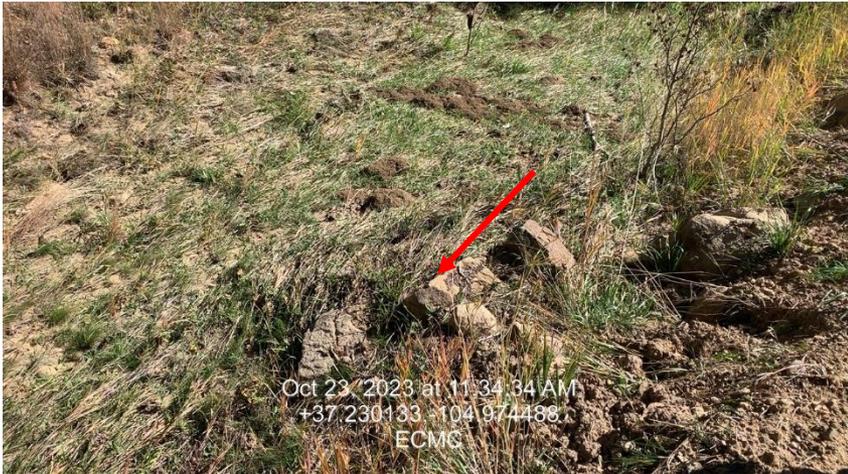
Photo 9 – Plugged Culvert

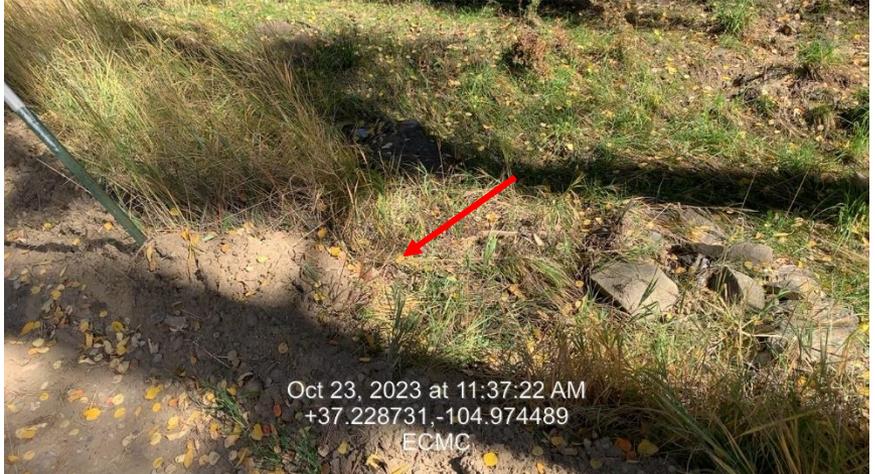
Photo 10 – Plugged Culvert

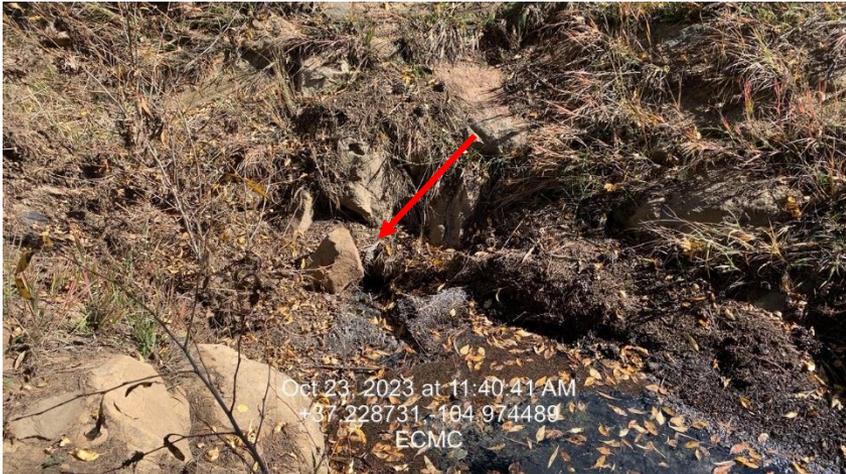
Photo 11 – Half Plugged Culvert

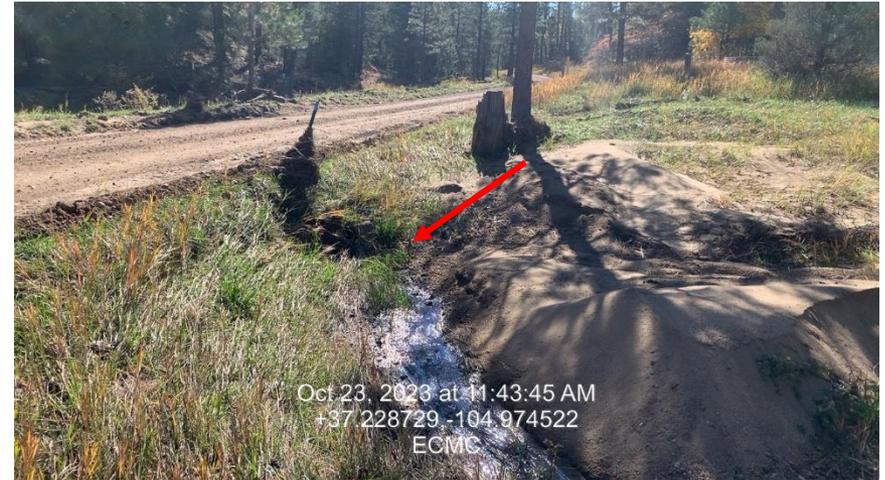
Photo 12 – Half Plugged Culvert, Loos sediment at inlet of culvert

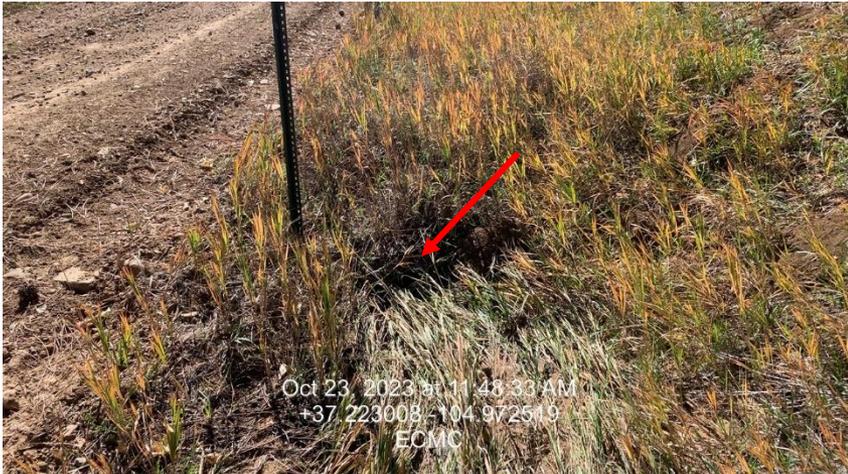
Photo 13 – Half Plugged Culvert

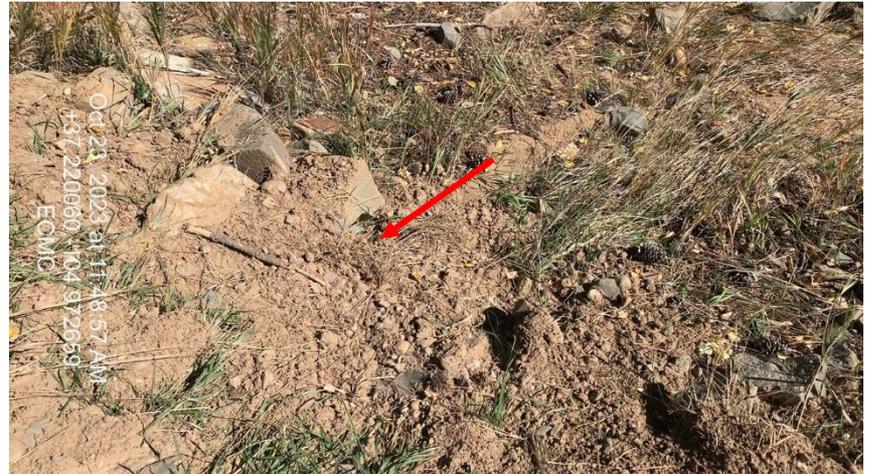
Photo 14 – Plugged Culvert

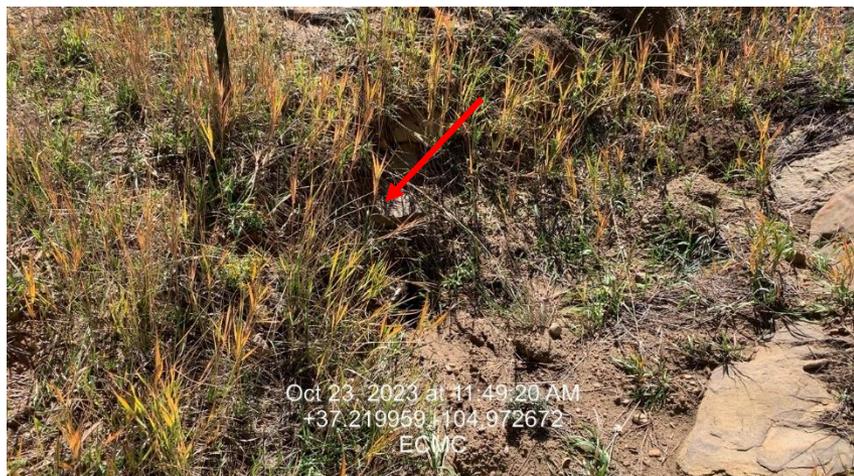
Photo 15 – Half Plugged Culvert

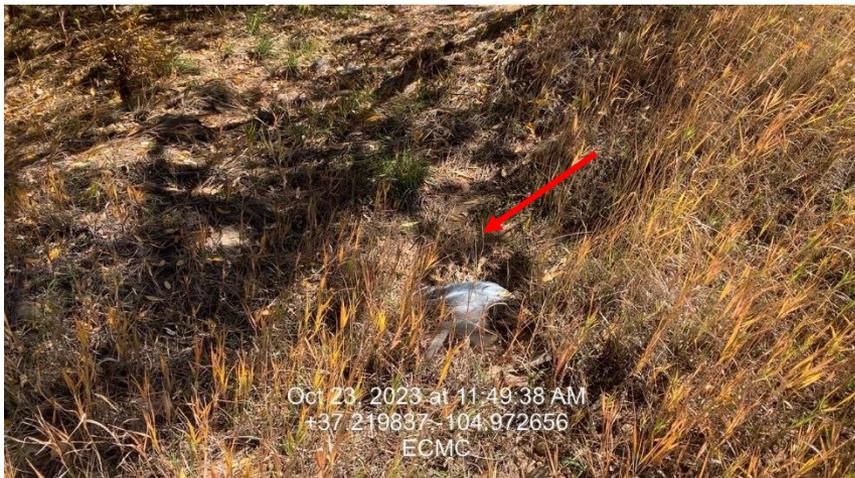
Photo 16 – Half Plugged Culvert

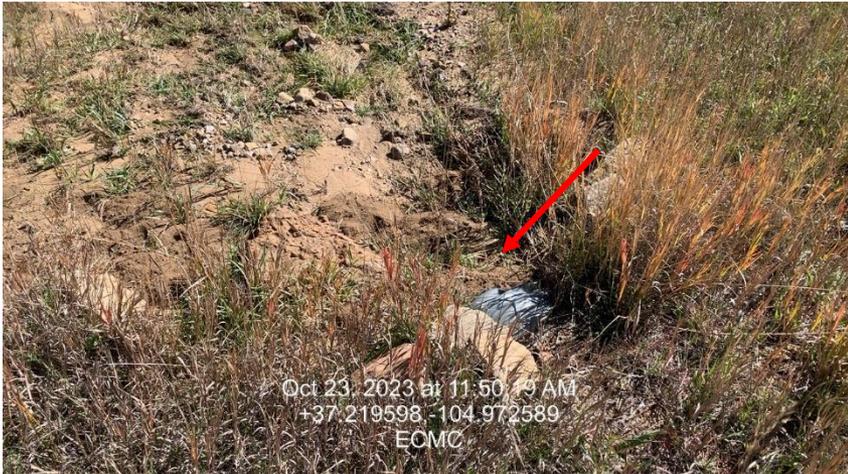
Photo 17 – Half Plugged Culvert

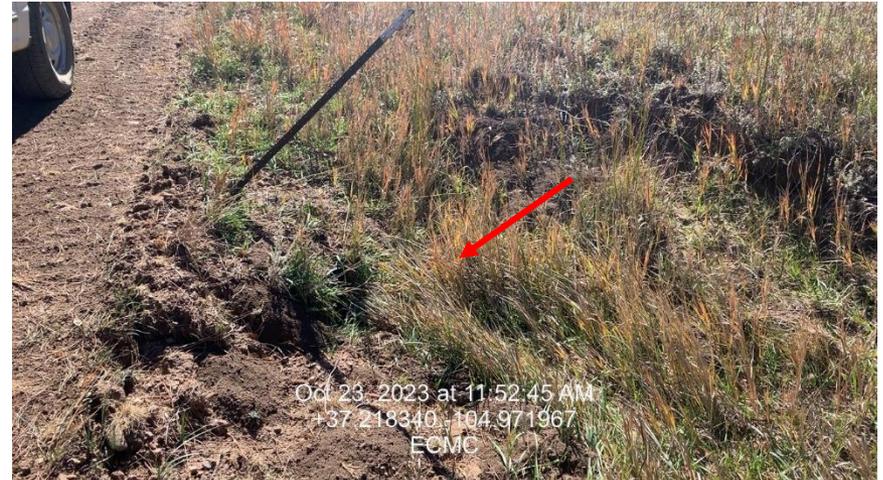
Photo 18 – Plugged culvert

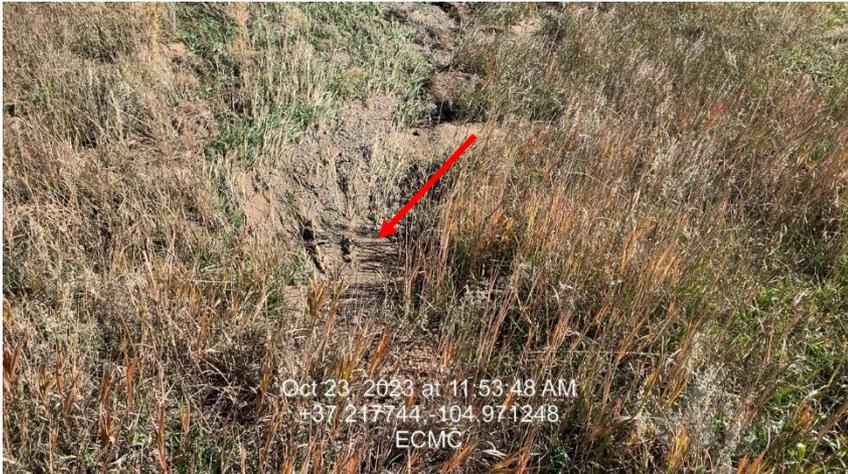
Photo 19 – Plugged culvert

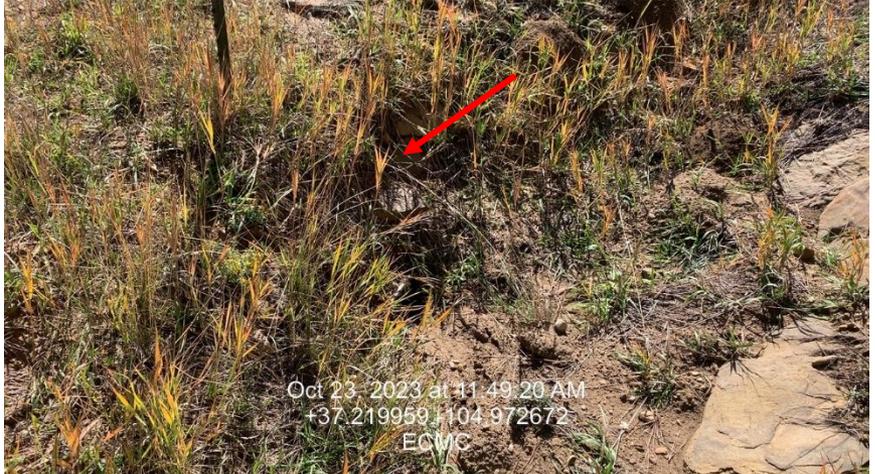
Photo 20 – Plugged culvert

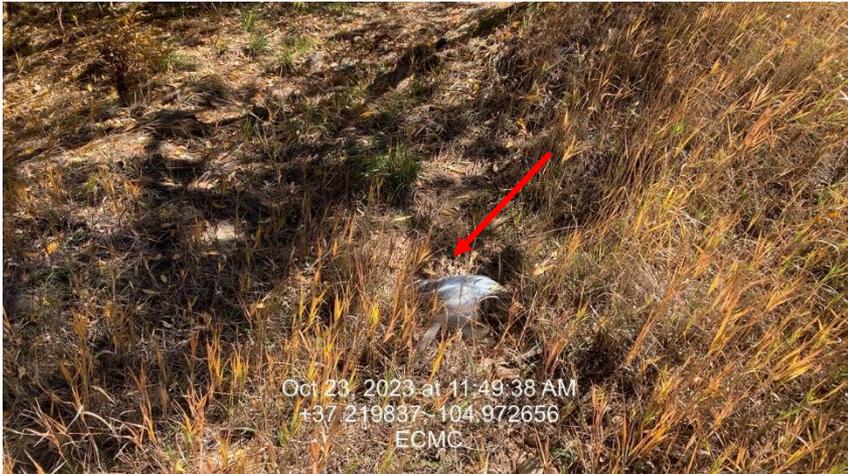
Photo 21 – Half Plugged Culvert

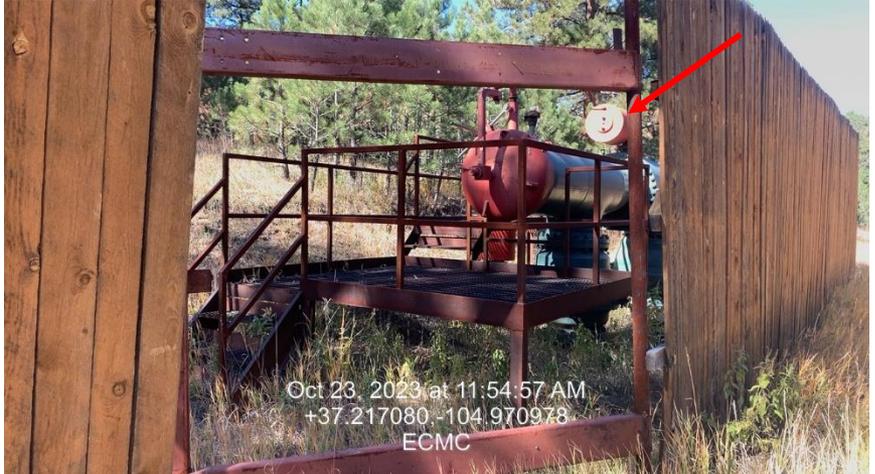
Photo 22 – Fencing around Equipment in disrepair

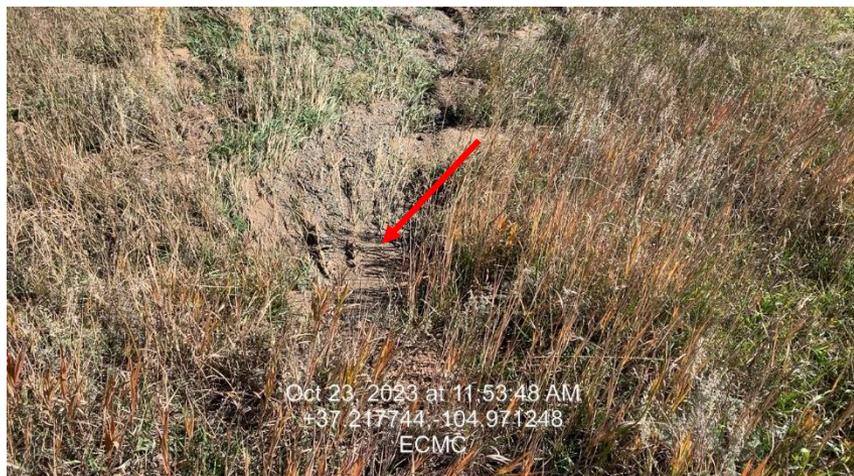
Photo 23 – Plugged culvert

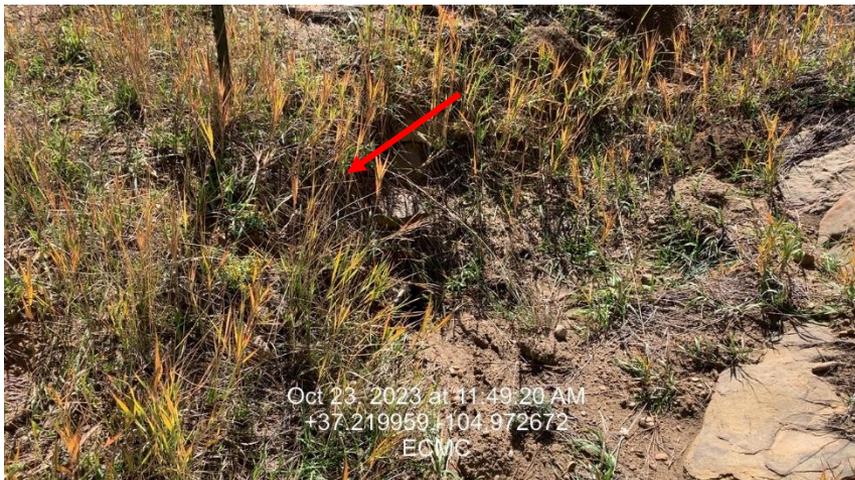
Photo 24 – Plugged culvert

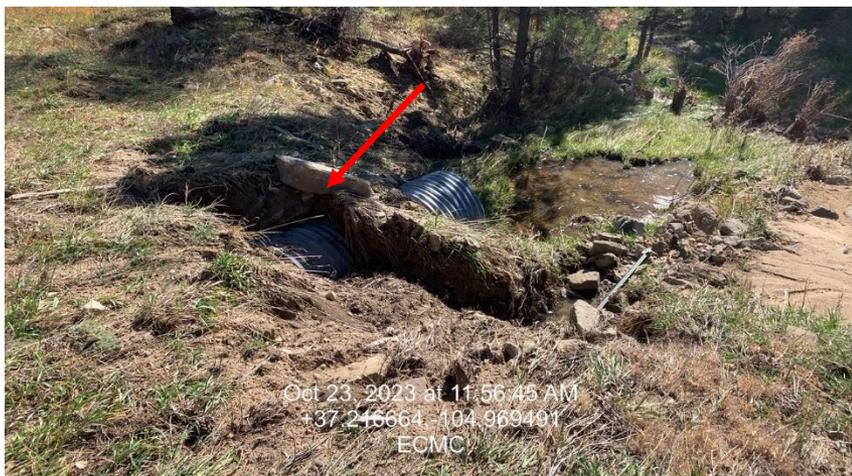
Photo 25 – Erosion, Outlet of culvert

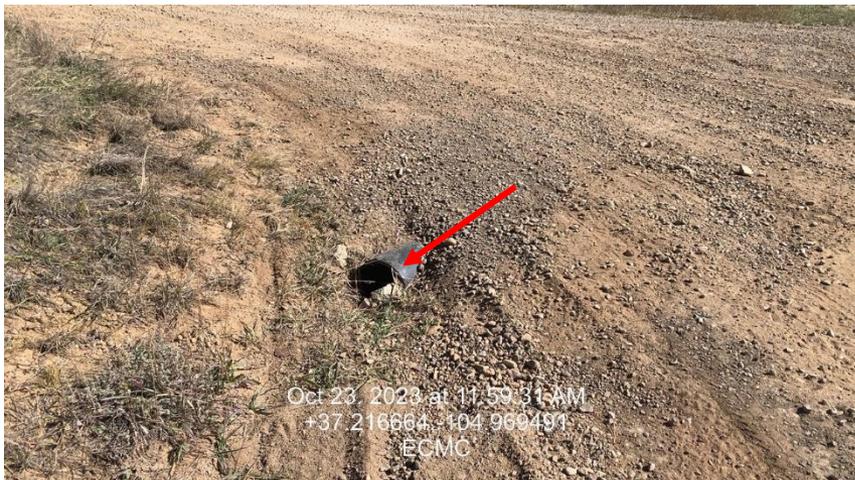
Photo 26 – Half Plugged Culvert

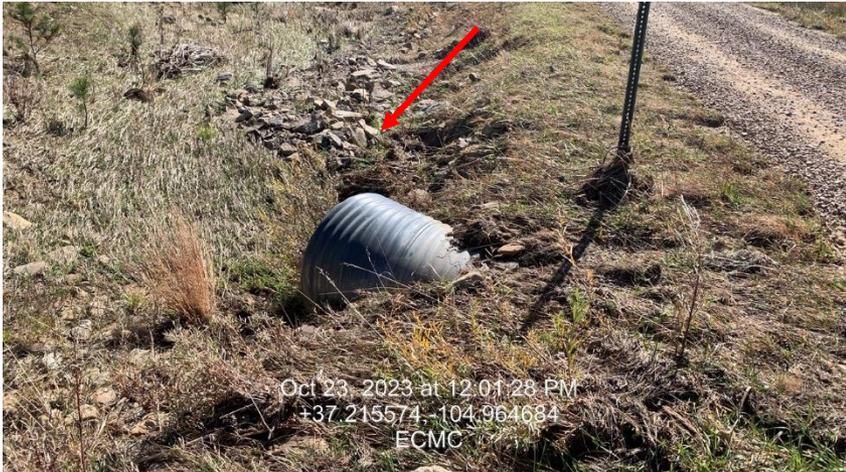
Photo 27 – Erosion, Outlet of culvert
