Construction and Stormwater Inspection

October 24, 2023

Operator: BISON IV OPERATING LLC- 10670

Location ID: 470933

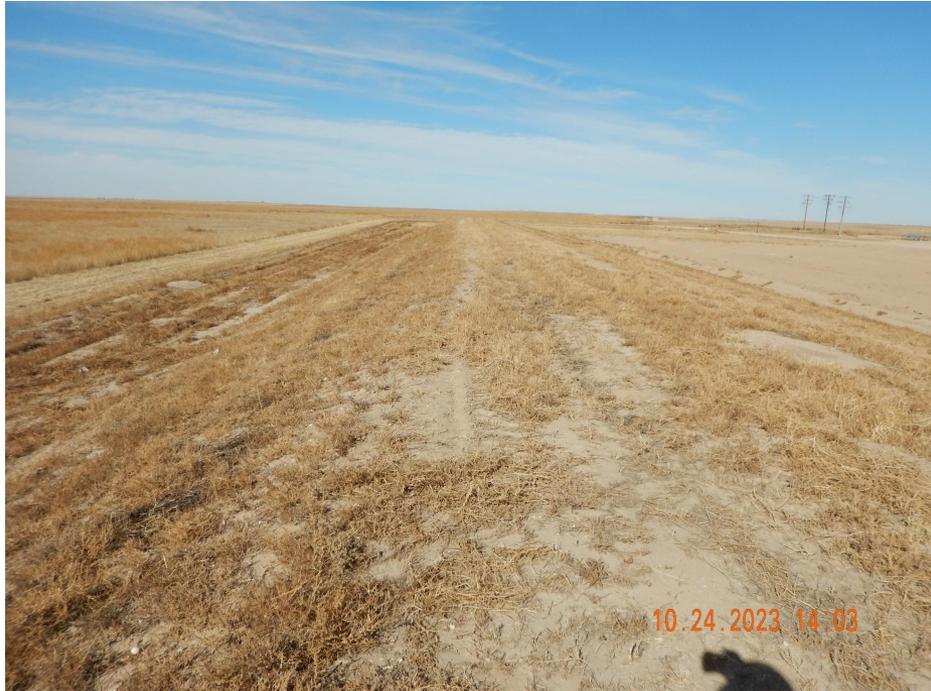
Photo 1. Photo taken from the southwestern location on the topsoil stockpile, facing North. Photo illustrates the stockpile has predominantly annual weedy growth with some desirable plant growth.

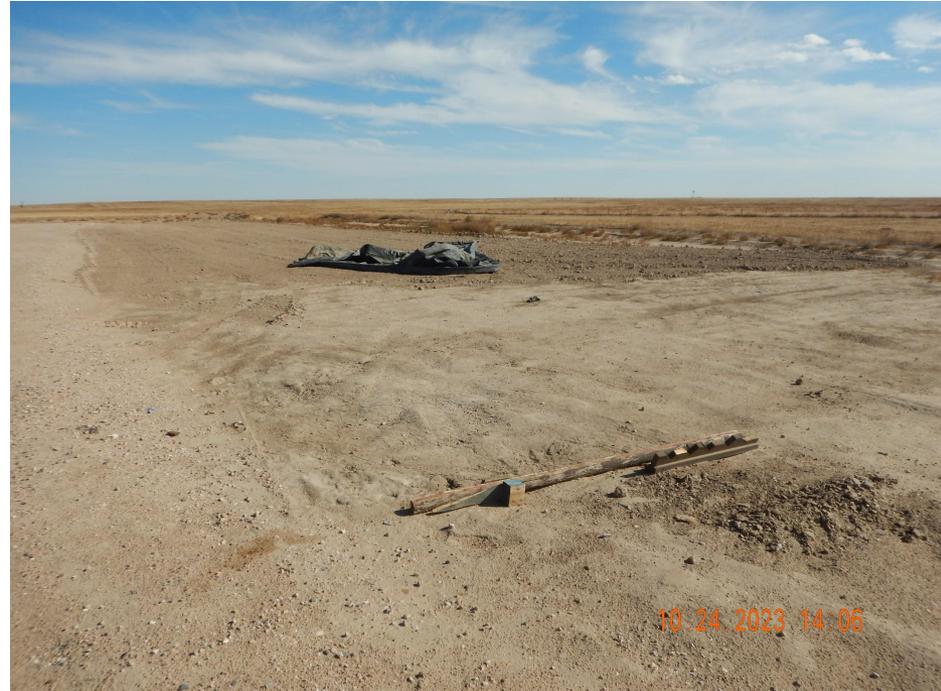
Photo 2. Photo taken from the southern location, facing East. Photo illustrates trash.

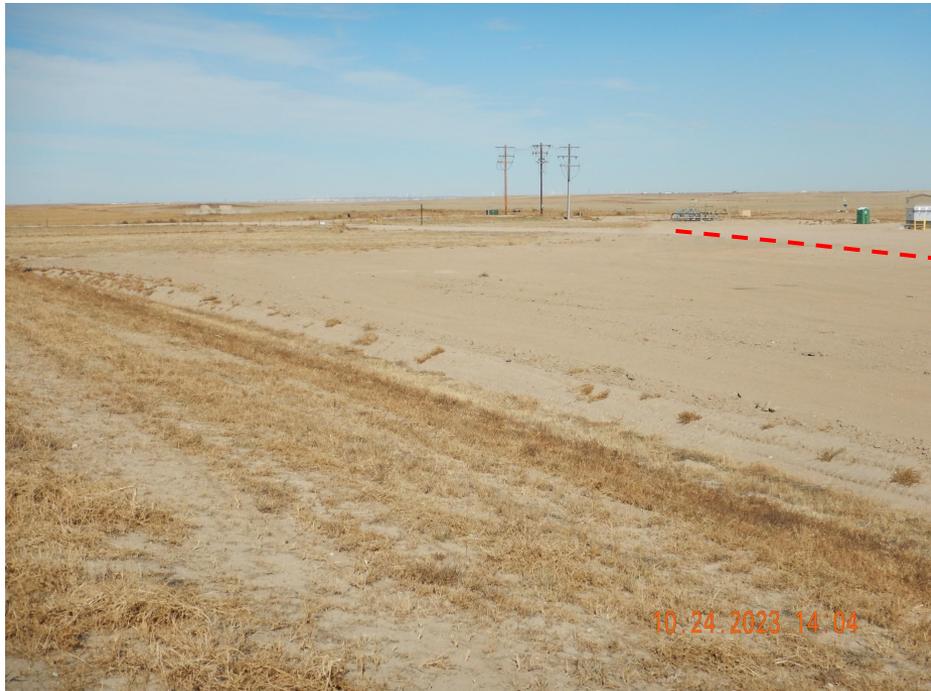
Photo 3. Photo taken from the southwestern location on the topsoil stockpile, facing Northeast. Photo illustrates interim reclamation appears to be in-process, left of the red-dashed line.

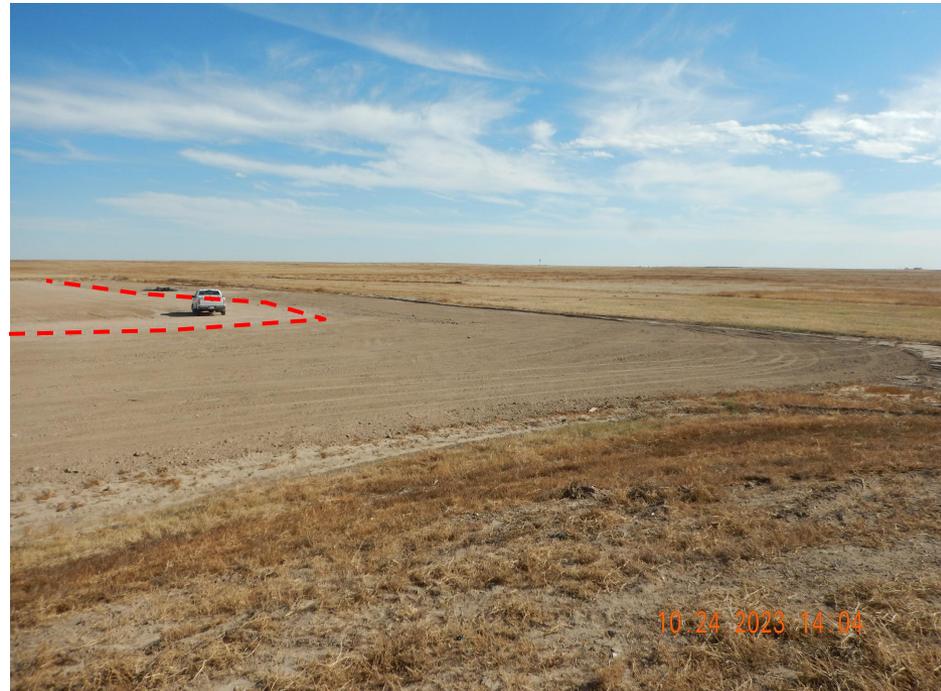
Photo 4. Photo taken from the southwestern location on the topsoil stockpile, facing Southeast. Photo illustrates interim reclamation appears to be in-process, right of the red-dashed line.

Note- oily waste has been cleaned up.

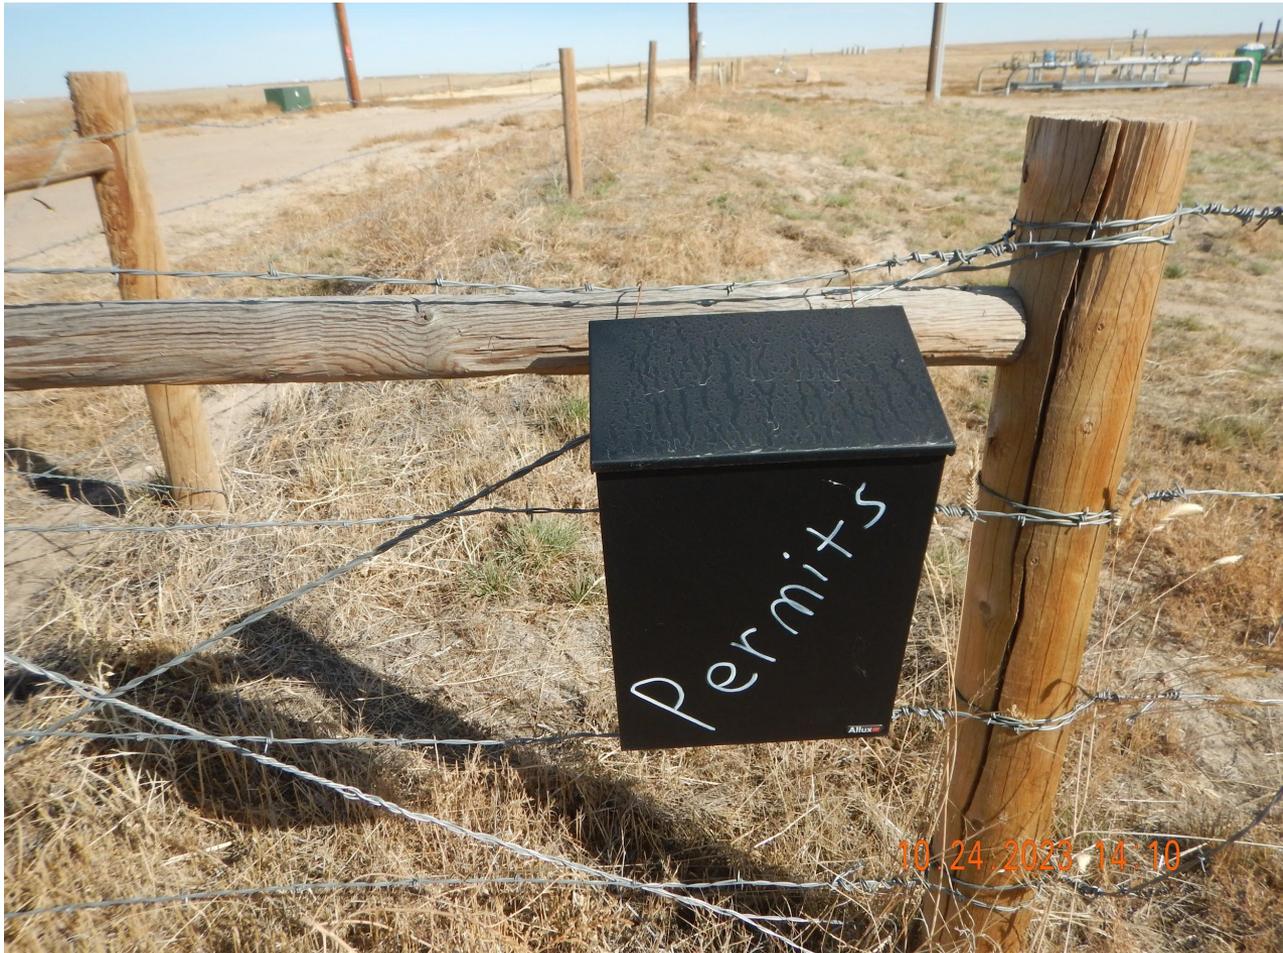
Photo 5. Photo taken from the entrance of location, facing East. Photo illustrates the permit box with the Form 2A on location.

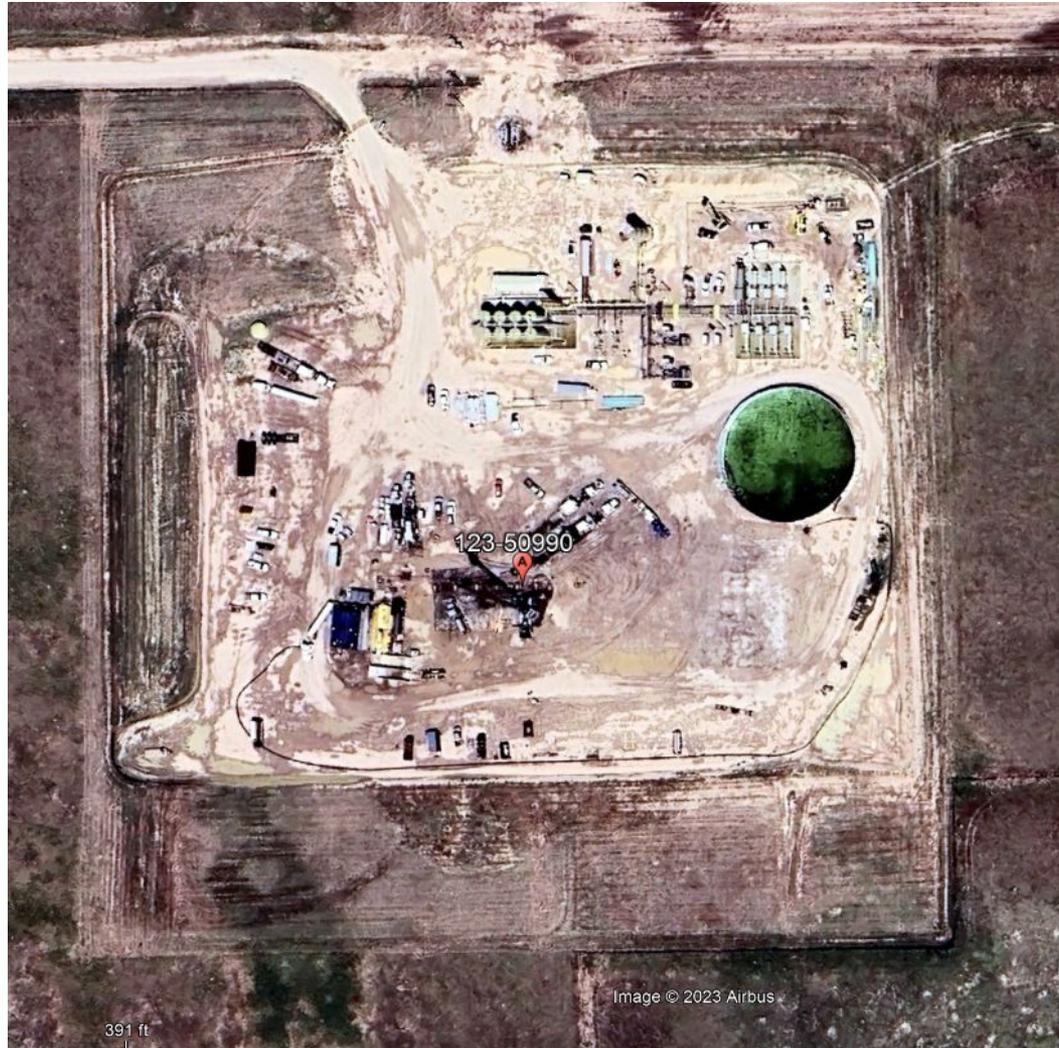
Photo 6. Google Earth aerial imagery from 8/2/2023. Operator has constructed a retention area along the southeastern perimeter; however, a significant amount of stormwater is draining to the southwestern location without sufficient stormwater BMPs.

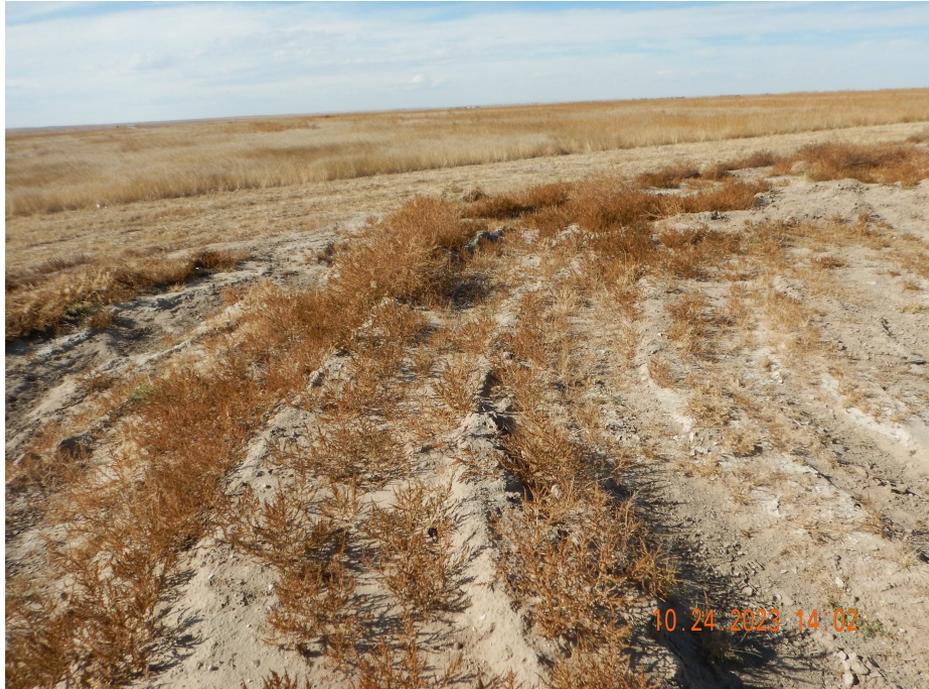
Photo 7. Photo taken from the southwestern location facing West. Photo illustrates that there was not a sufficient response to install stormwater BMPs to prevent sediment laden stormwater from discharging off location. The ditch and berm by itself is not sufficient and it has not been constructed with good engineering practices.

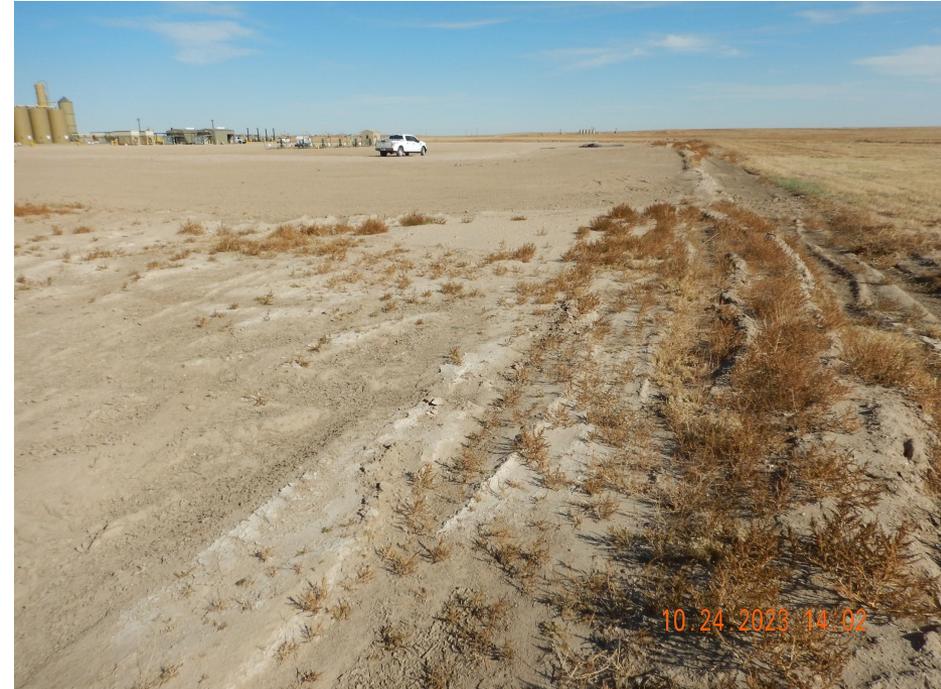
Photo 8. Photo taken from the southwestern location facing East. See comments under Photo 7.
