Storm Water Management and Erosion control
Location Name: TEP ROCKY MOUNTAIN LLC SAVAGE PA 21-9 Pad
Location ID: 324452

**Location Overview: Location is within High
Priority/Density/Black Bear Habitat areas. Location is within
Rule 411a Surface Water External Buffer. Location is within
close proximity to Rule 411.b Generalized External Buffer.**

Section/Township/Range: 9 7S95W

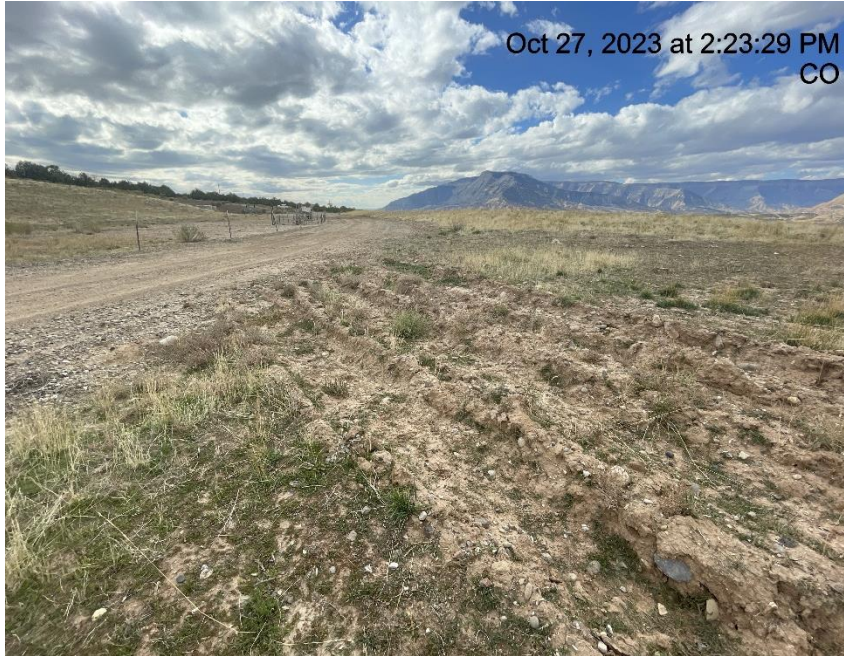
Photo # 4688 Failure to minimize surface disturbance

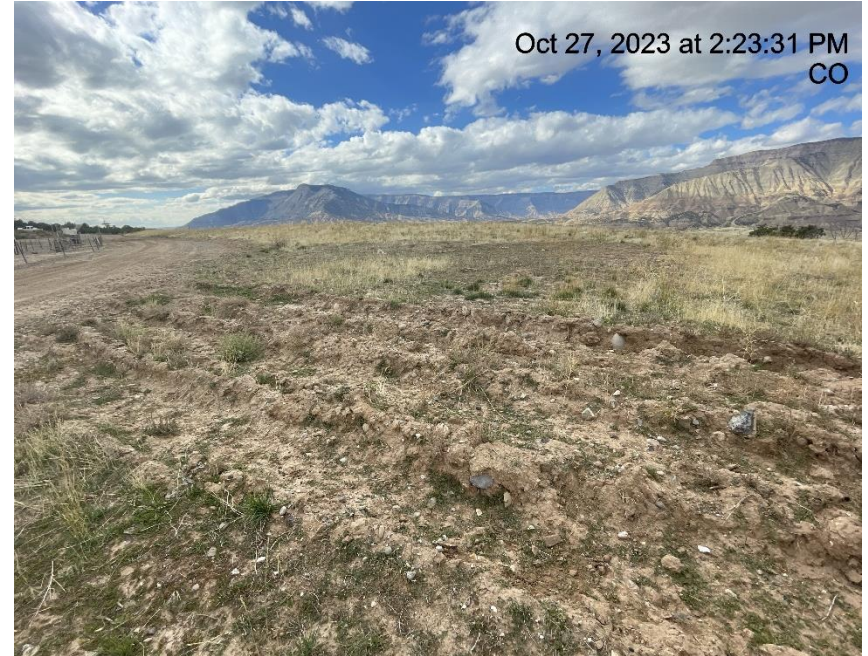
Photo # 4689 Failure to minimize surface disturbance

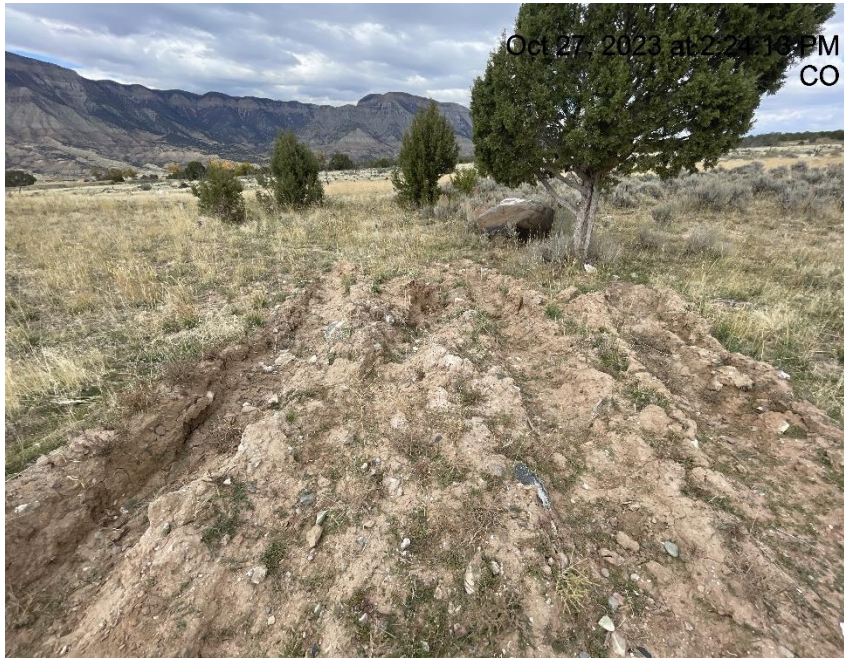
Photo # 4690 Failure to minimize surface disturbance

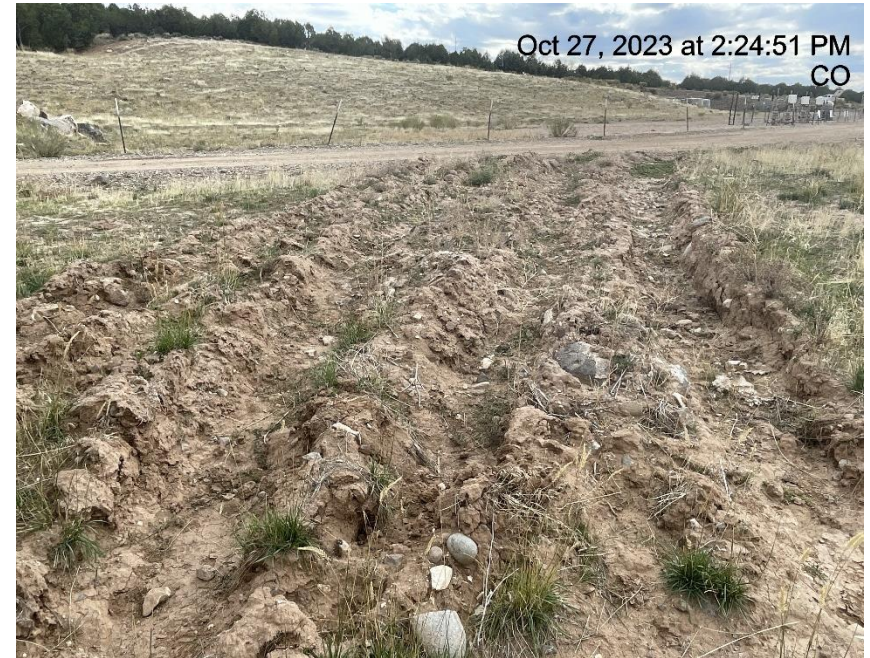
Photo # 4691 Failure to minimize surface disturbance

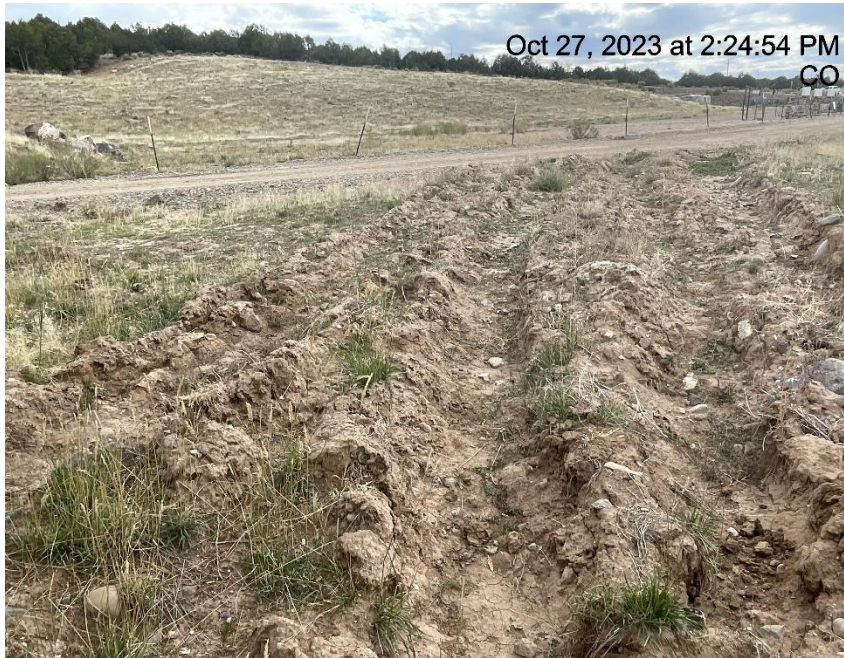
Photo # 4692 Failure to minimize surface disturbance

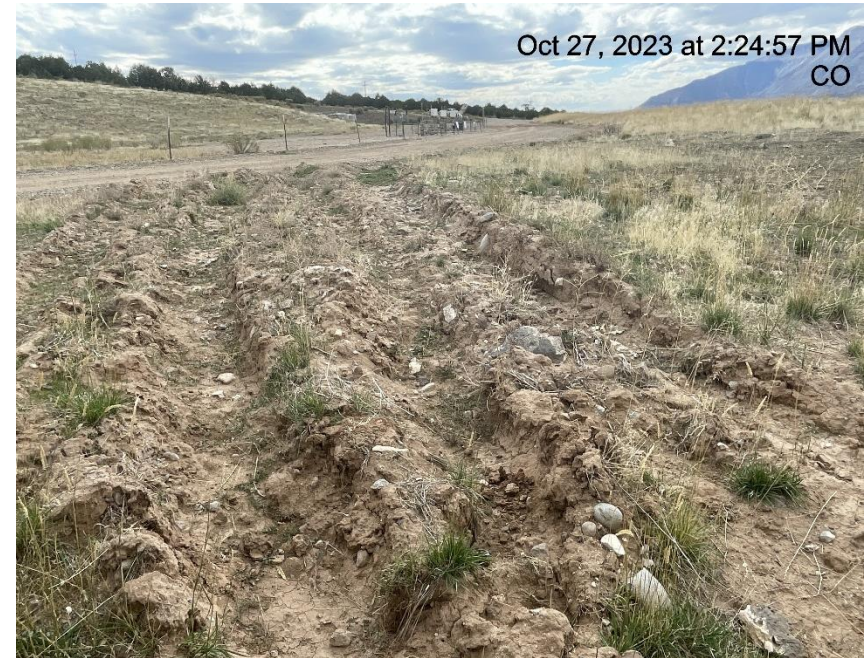
Photo # 4693 Failure to minimize surface disturbance

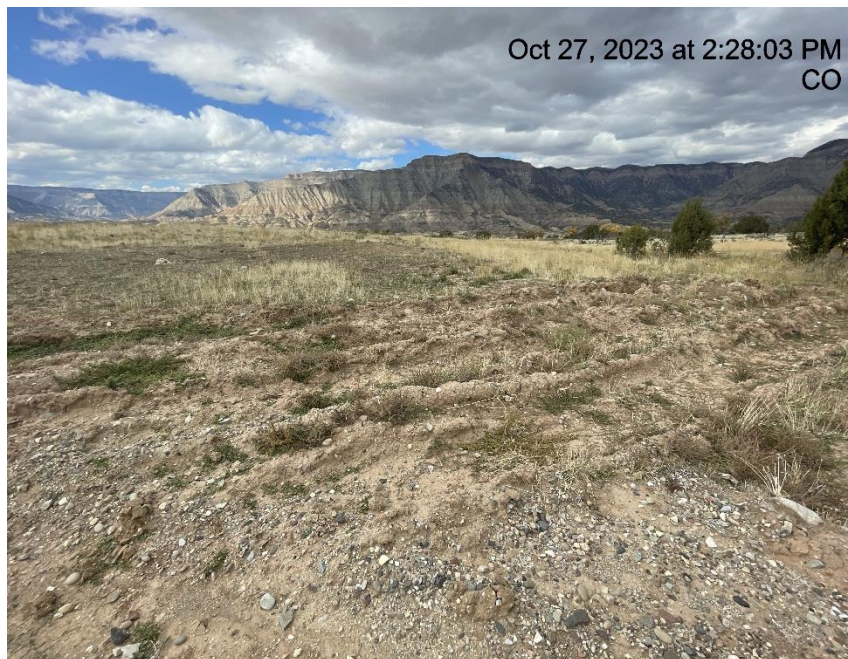
Photo # 4694 Failure to minimize surface disturbance

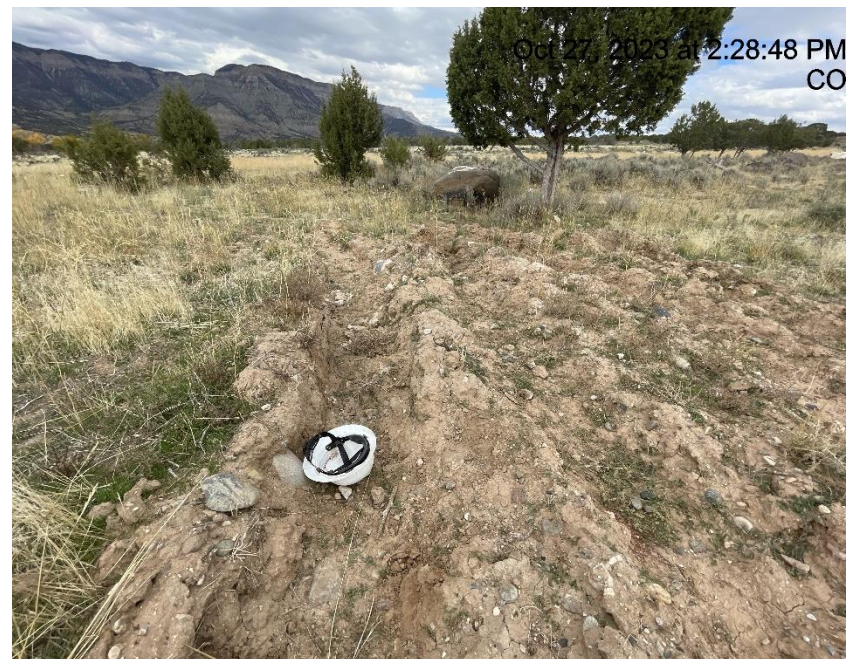
Photo # 4695 Failure to minimize surface disturbance

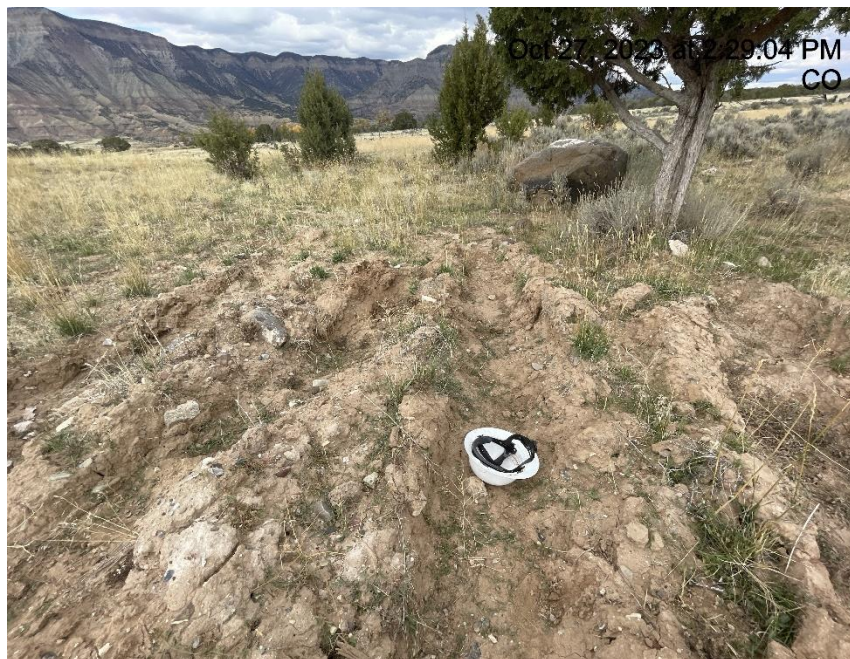
Photo # 4696 Failure to minimize surface disturbance

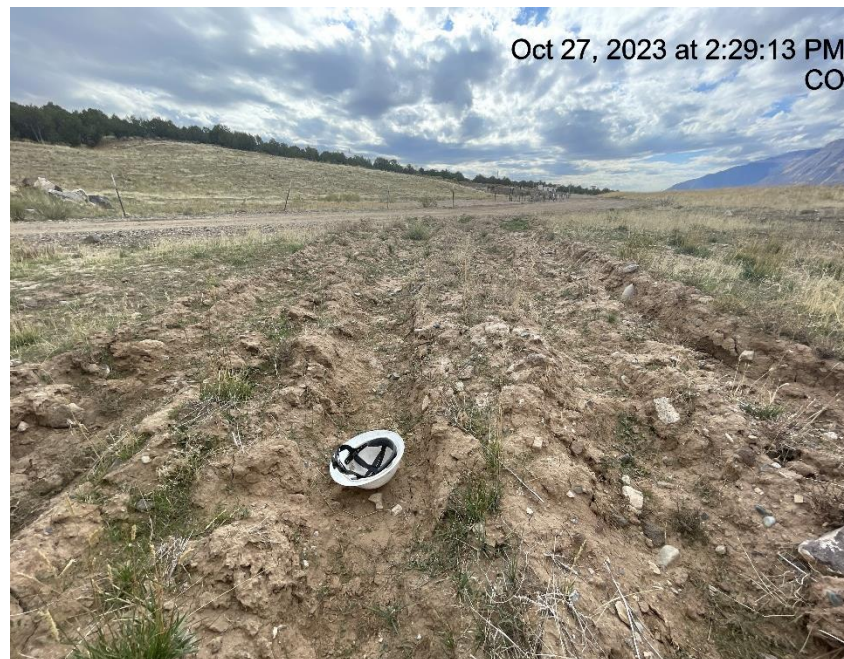
Photo # 4697 Failure to minimize surface disturbance

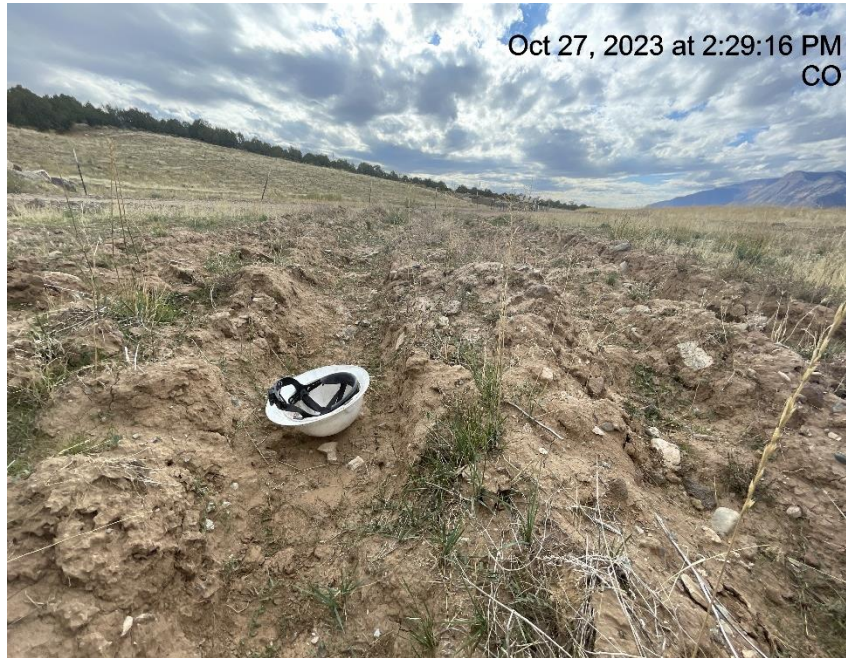
Photo # 4698 Failure to minimize surface disturbance

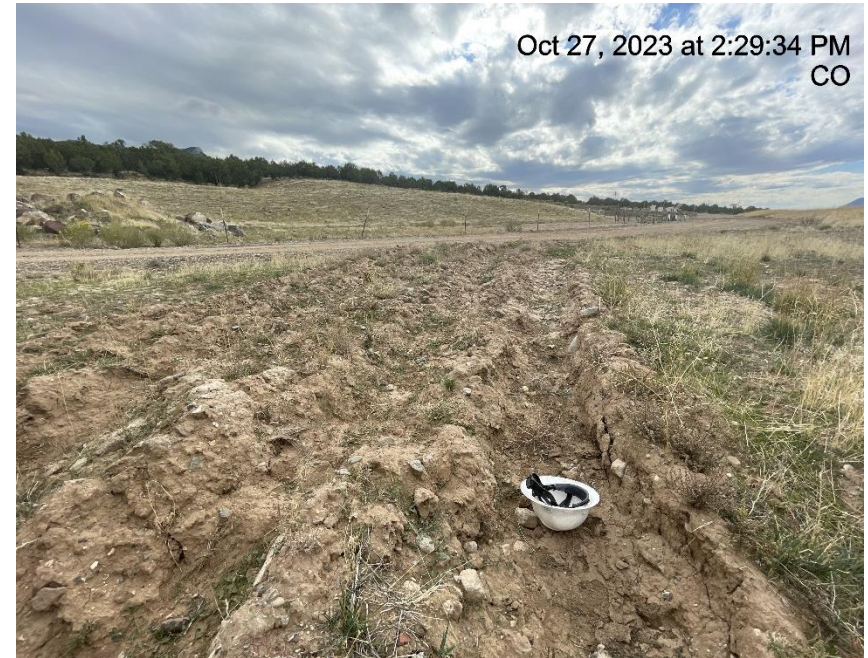
Photo # 4699 Failure to minimize surface disturbance

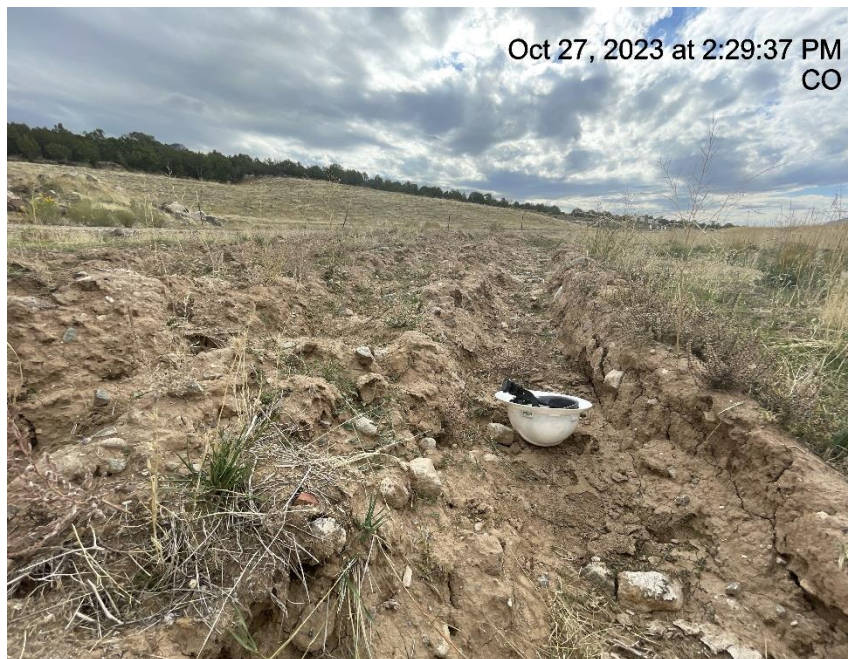
Photo # 4700 Failure to minimize surface disturbance

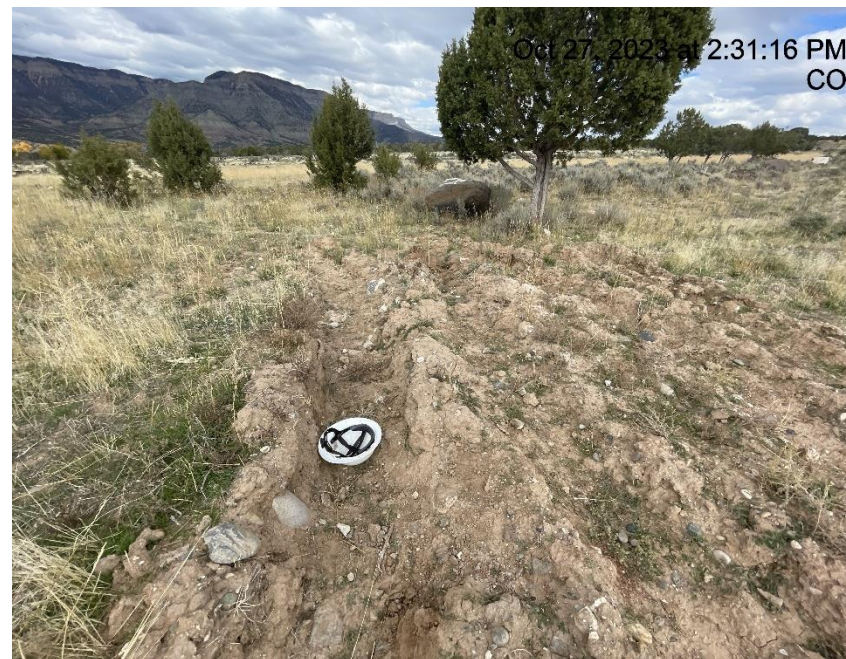
Photo # 4701 Failure to minimize surface disturbance

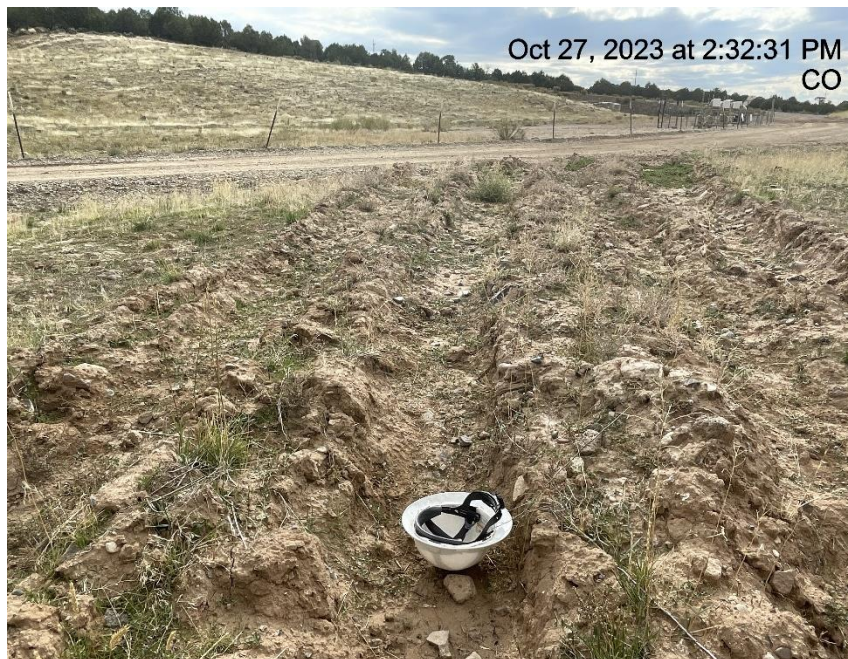
Photo # 4702 Failure to minimize surface disturbance

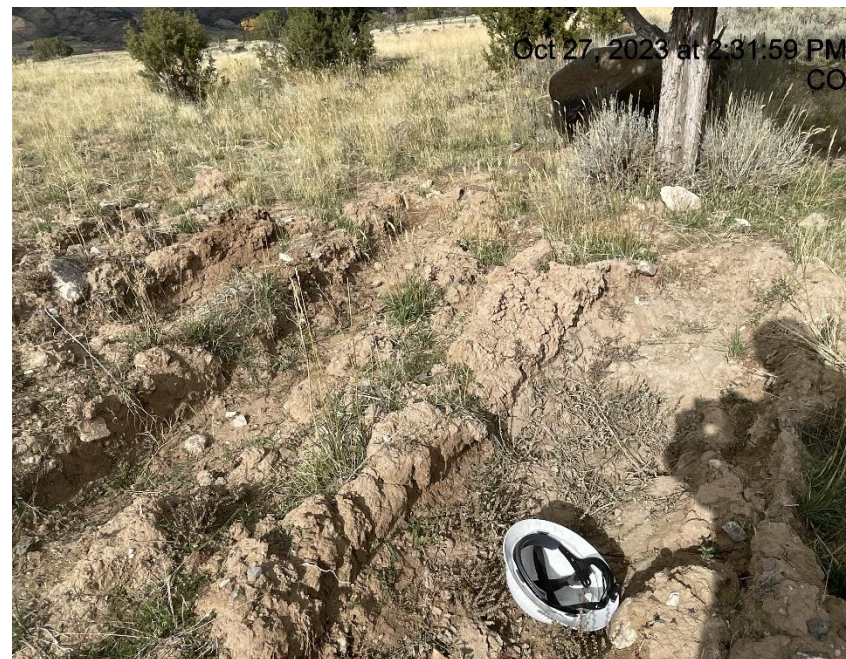
Photo # 4703 Failure to minimize surface disturbance

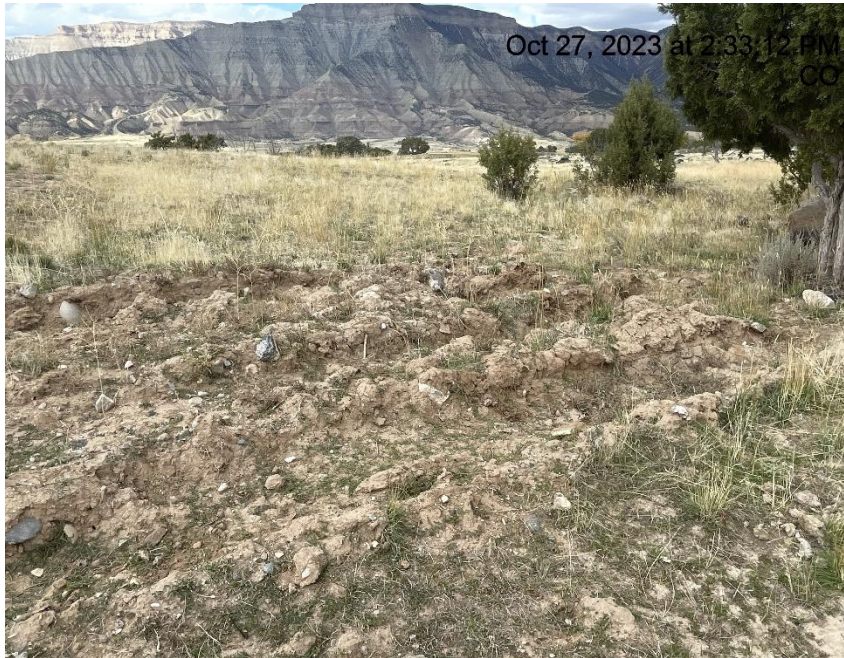
Photo # 4704 Failure to minimize surface disturbance

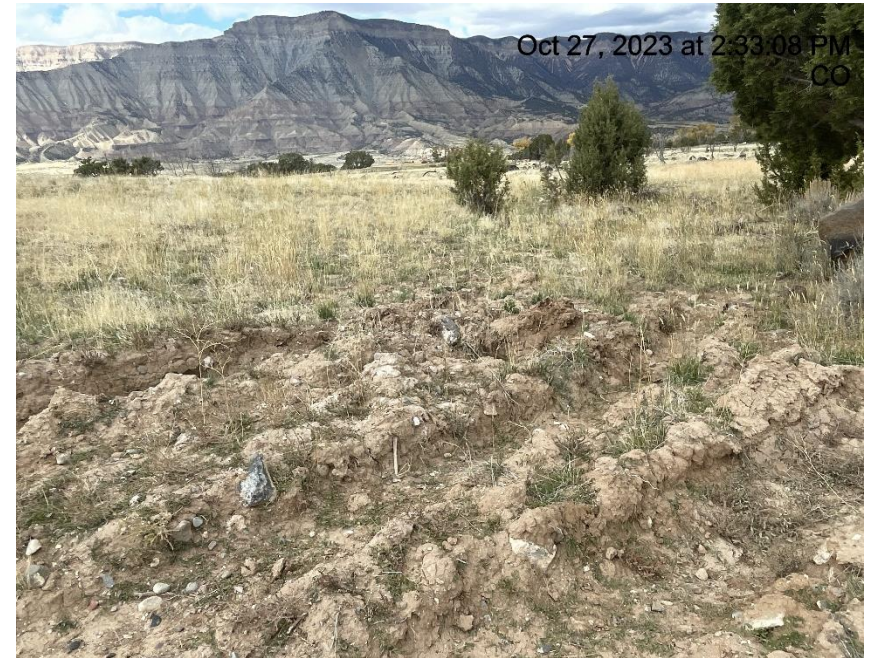
Photo # 4705 Failure to minimize surface disturbance

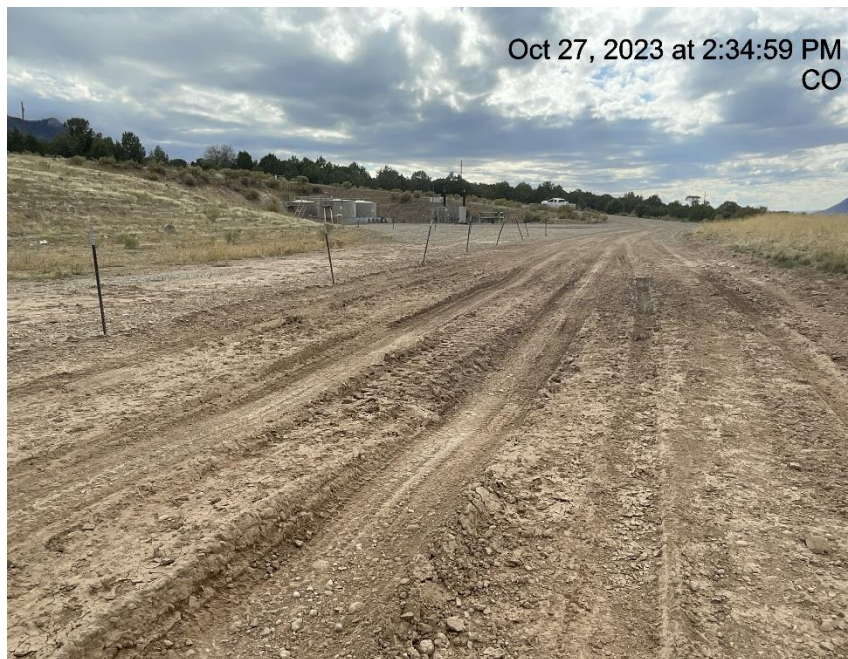
Photo # 4706 Lack of stabilization/compaction/insufficient BMP's

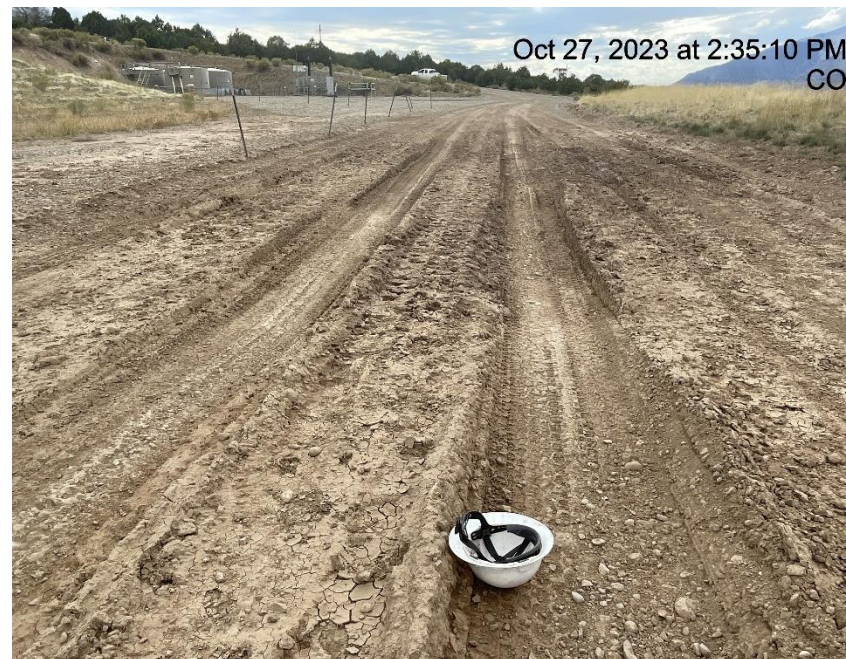
Photo # 4707 Lack of stabilization/compaction/insufficient BMP's

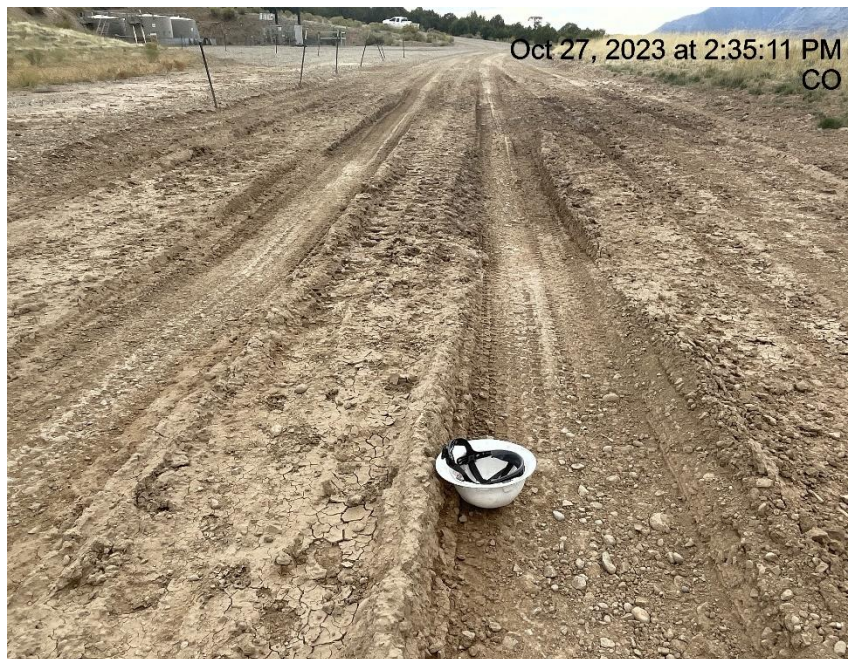
Photo # 4708 Lack of stabilization/compaction/insufficient BMP's

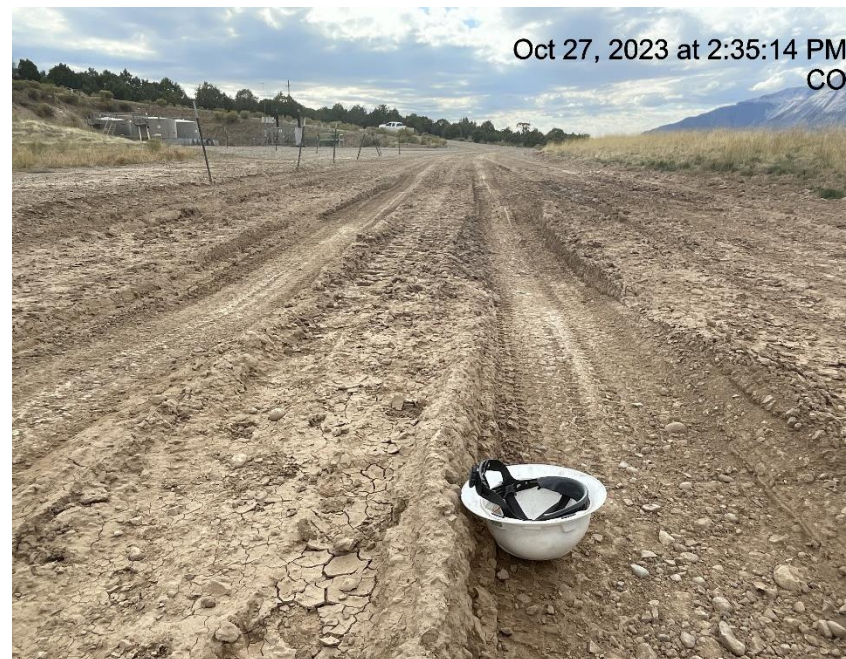
Photo # 4709 Lack of stabilization/compaction/insufficient BMP's

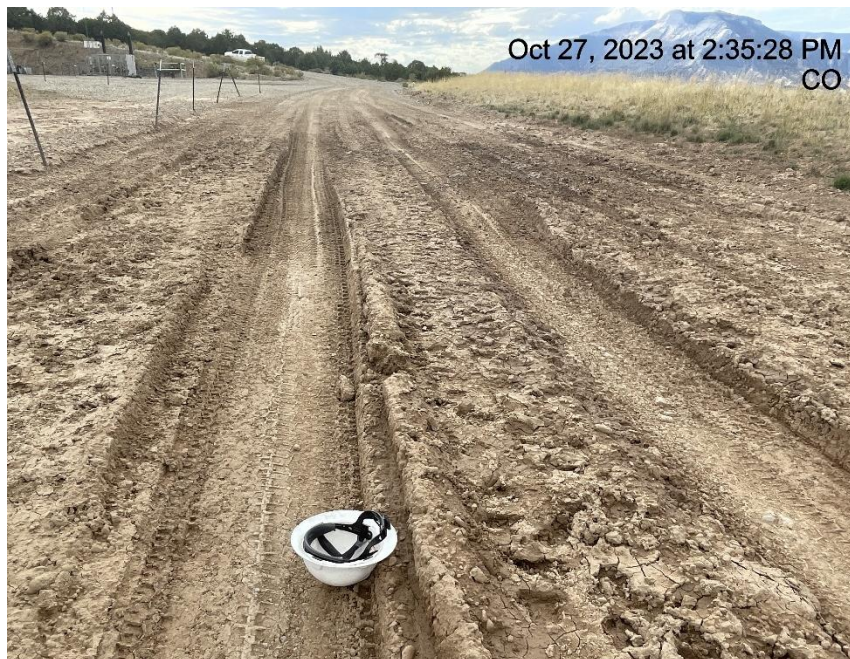
Photo # 4710 Lack of stabilization/compaction/insufficient BMP's

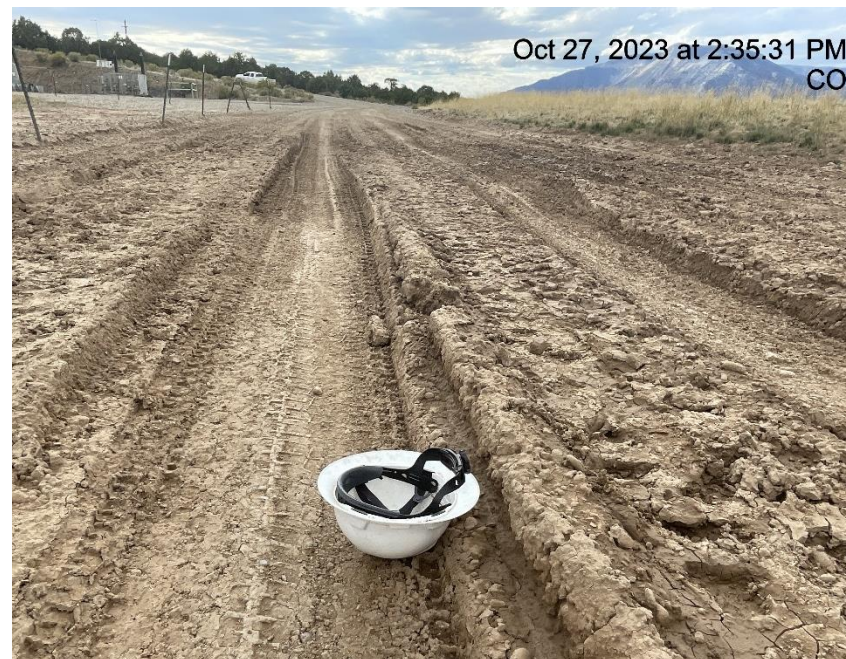
Photo # 4711 Lack of stabilization/compaction/insufficient BMP's

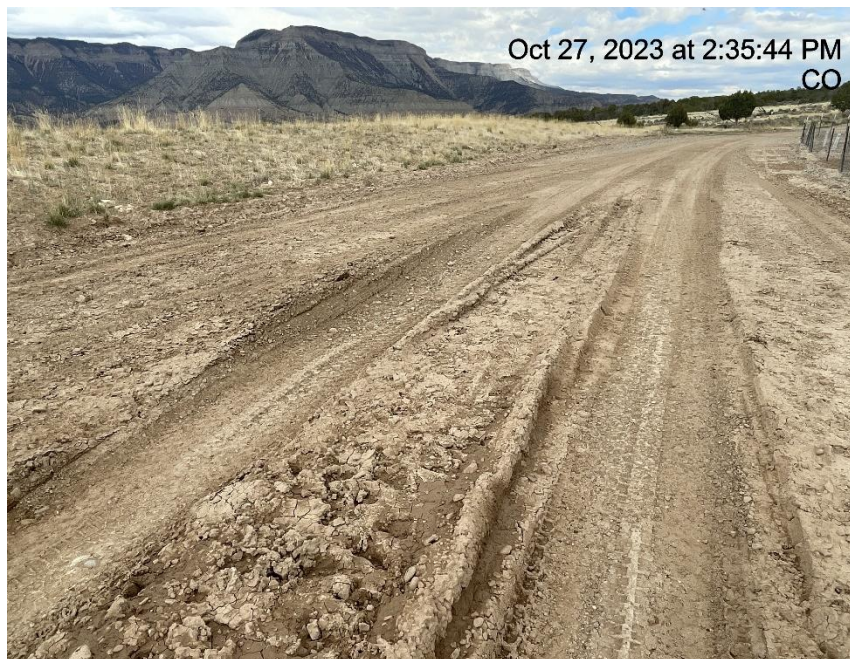
Photo # 4712 Lack of stabilization/compaction/insufficient BMP's

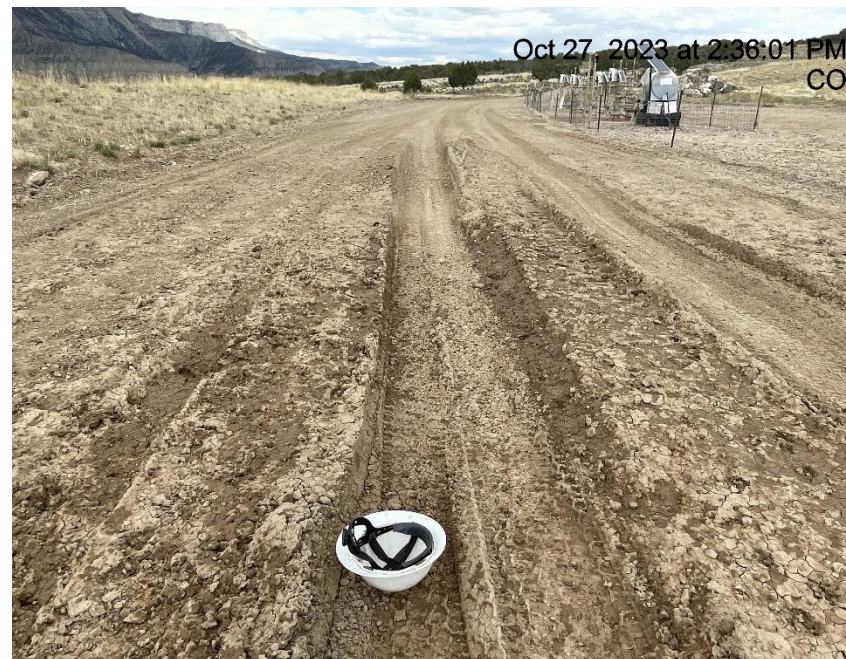
Photo # 4713 Lack of stabilization/compaction/insufficient BMP's

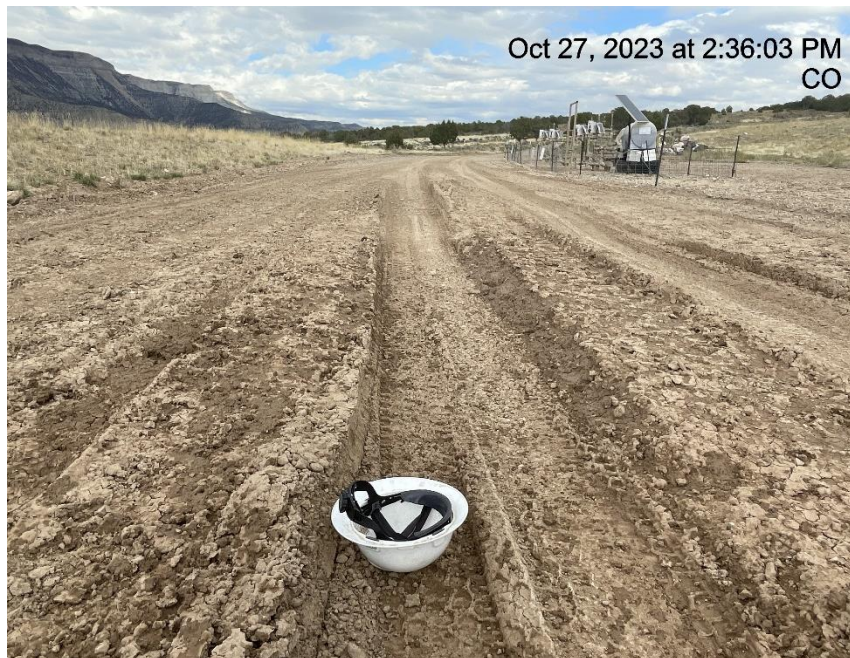
Photo # 4714 Lack of stabilization/compaction/insufficient BMP's

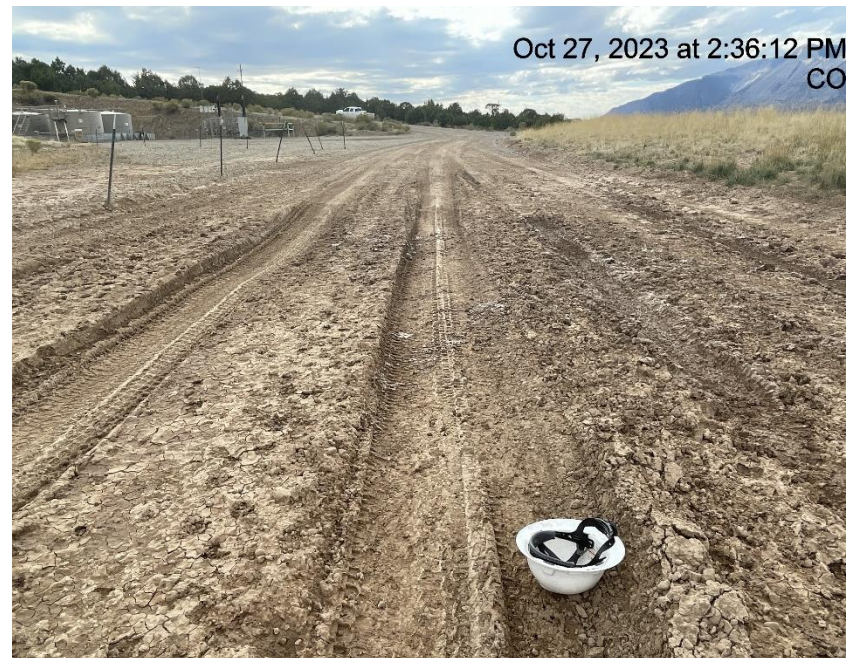
Photo # 4715 Lack of stabilization/compaction/insufficient BMP's

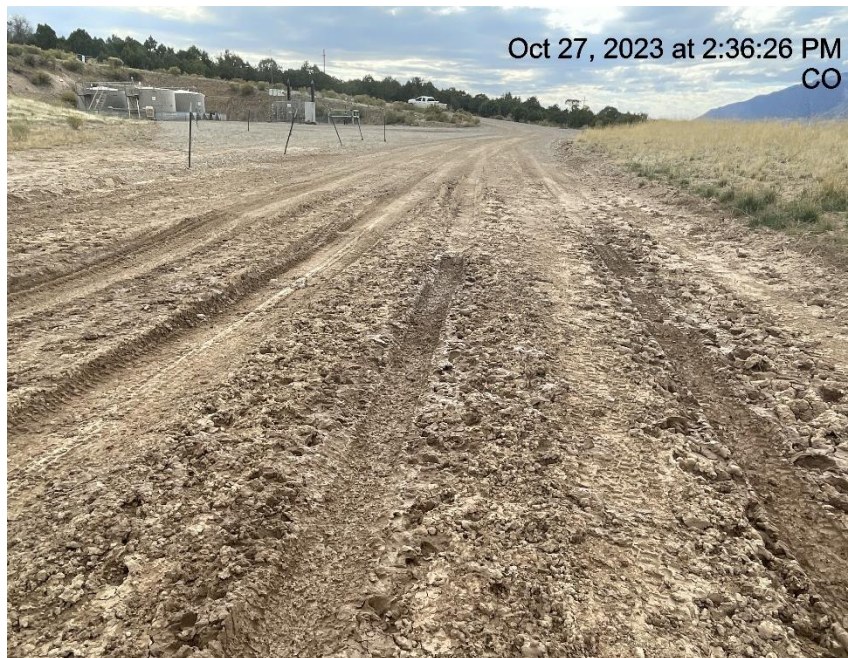
Photo # 4716 Lack of stabilization/compaction/insufficient BMP's

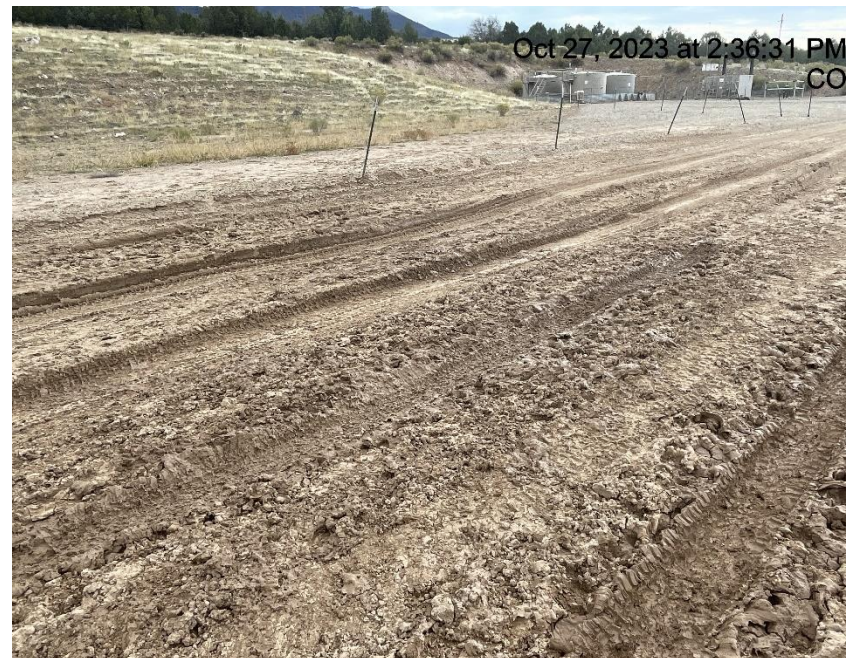
Photo # 4717 Lack of stabilization/compaction/insufficient BMP's

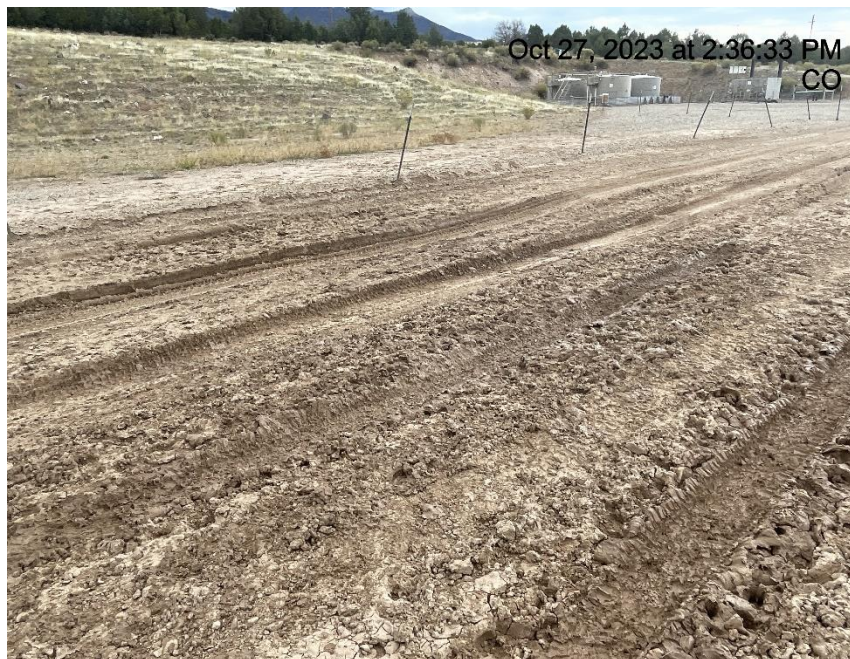
Photo # 4718 Lack of stabilization/compaction/insufficient BMP's

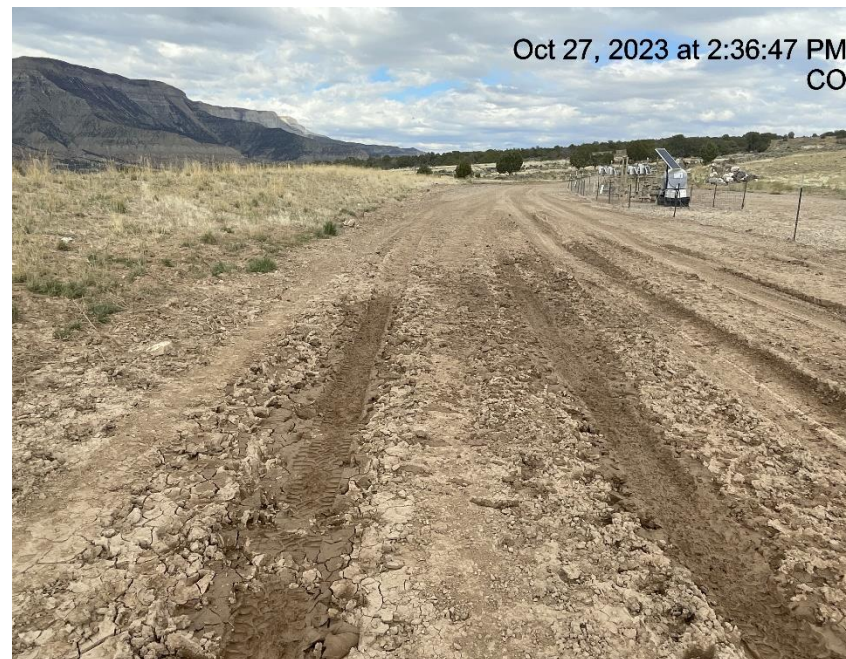
Photo # 4719 Lack of stabilization/compaction/insufficient BMP's

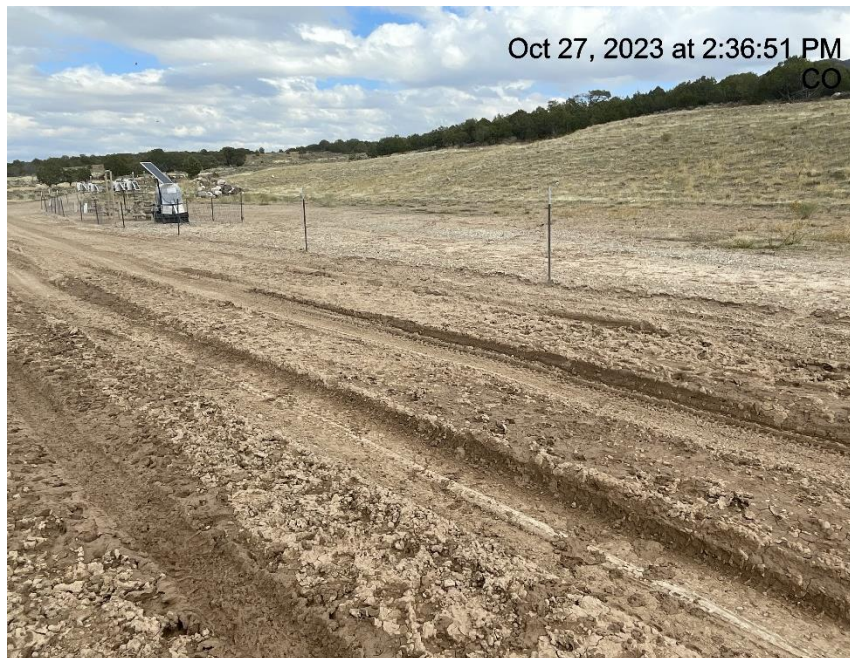
Photo # 4720 Lack of stabilization/compaction/insufficient BMP's

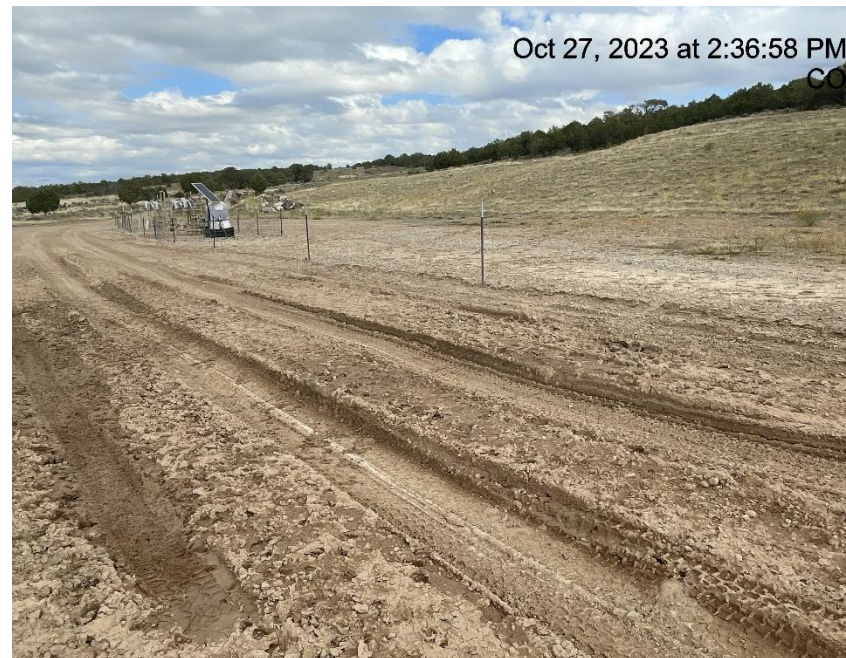
Photo # 4721 Lack of stabilization/compaction/insufficient BMP's

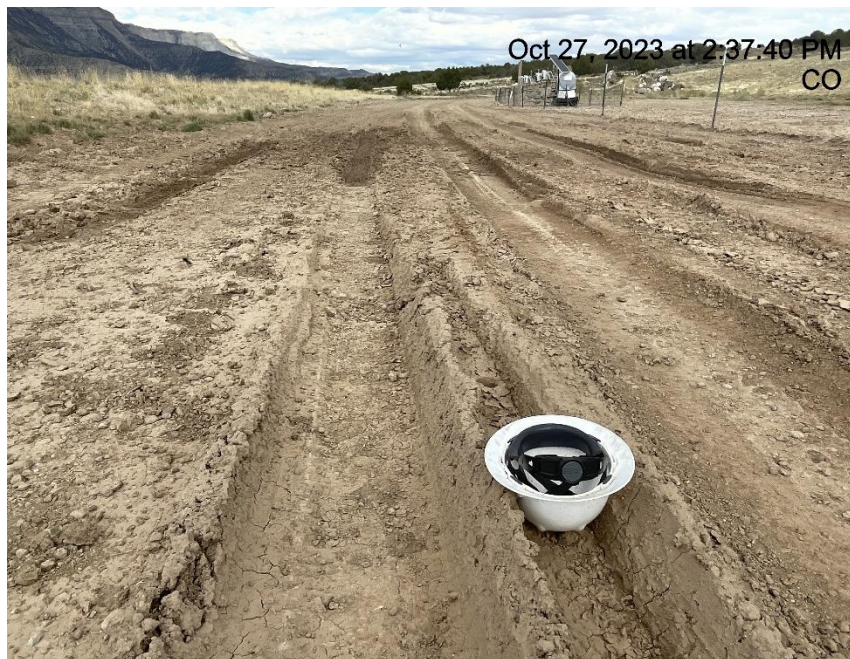
Photo # 4722 Lack of stabilization/compaction/insufficient BMP's

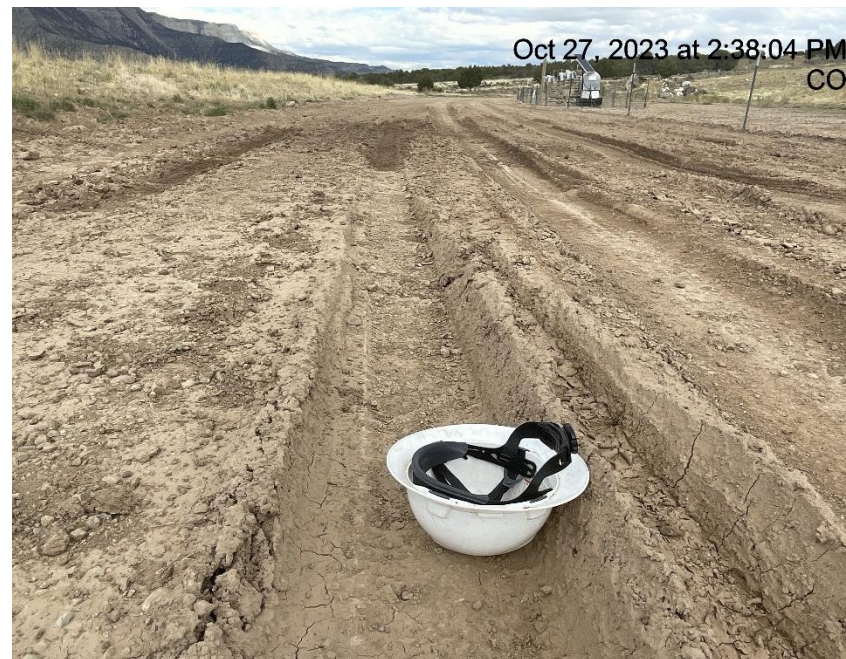
Photo # 4723 Lack of stabilization/compaction/insufficient BMP's
