Final Reclamation and Stormwater Inspection

Date: 10/17/2023

Operator: Fundare Resources Operating Company
LLC - 10773

Location ID: 330673

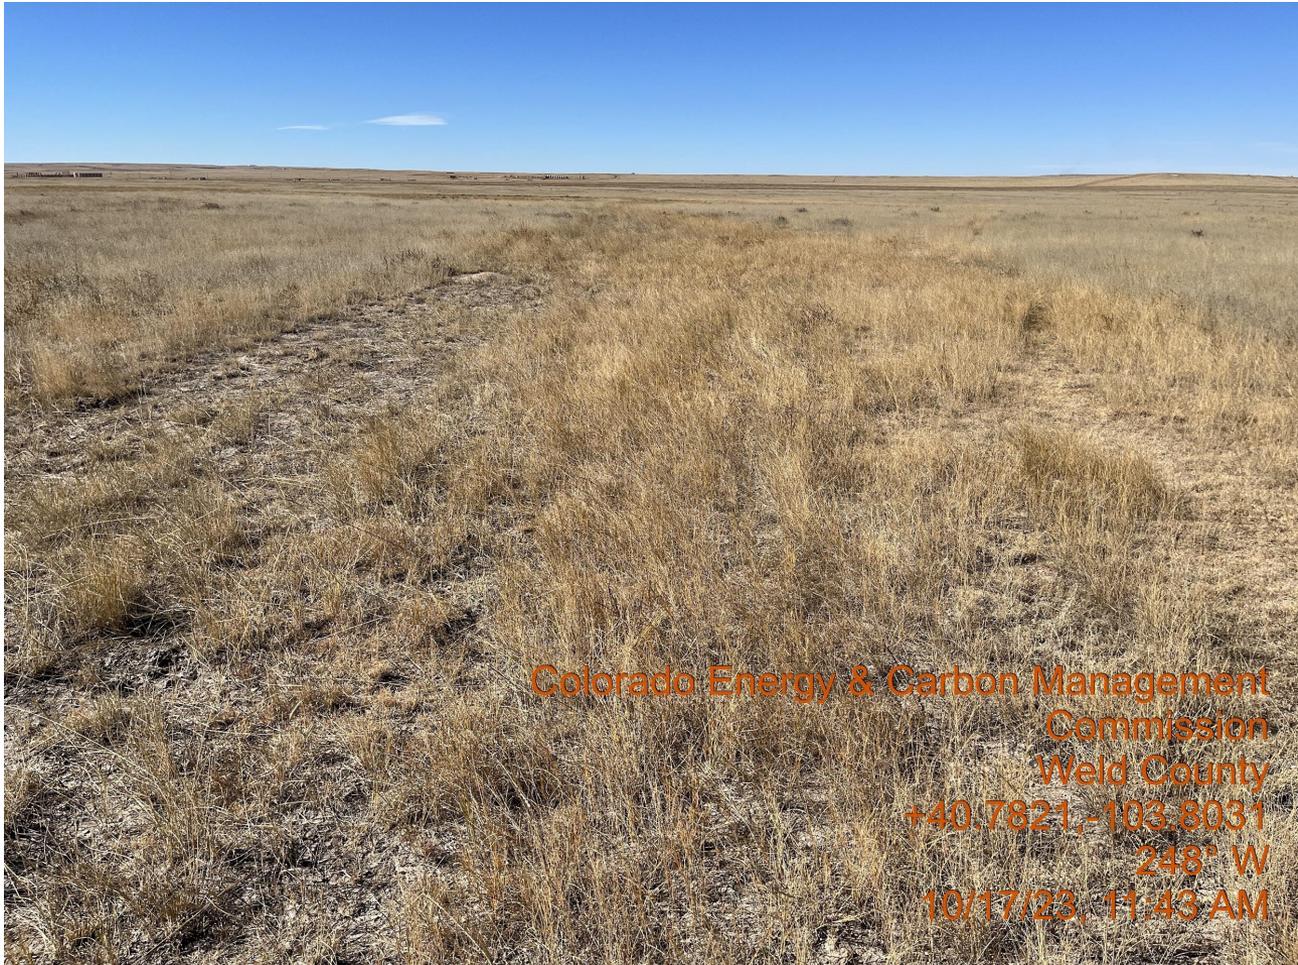
Photo 1. Photo taken from the Eastern access road facing West. Representative photo of the access road to the well locations. The access road outline was still apparent, i.e. not dominated by blue grama.

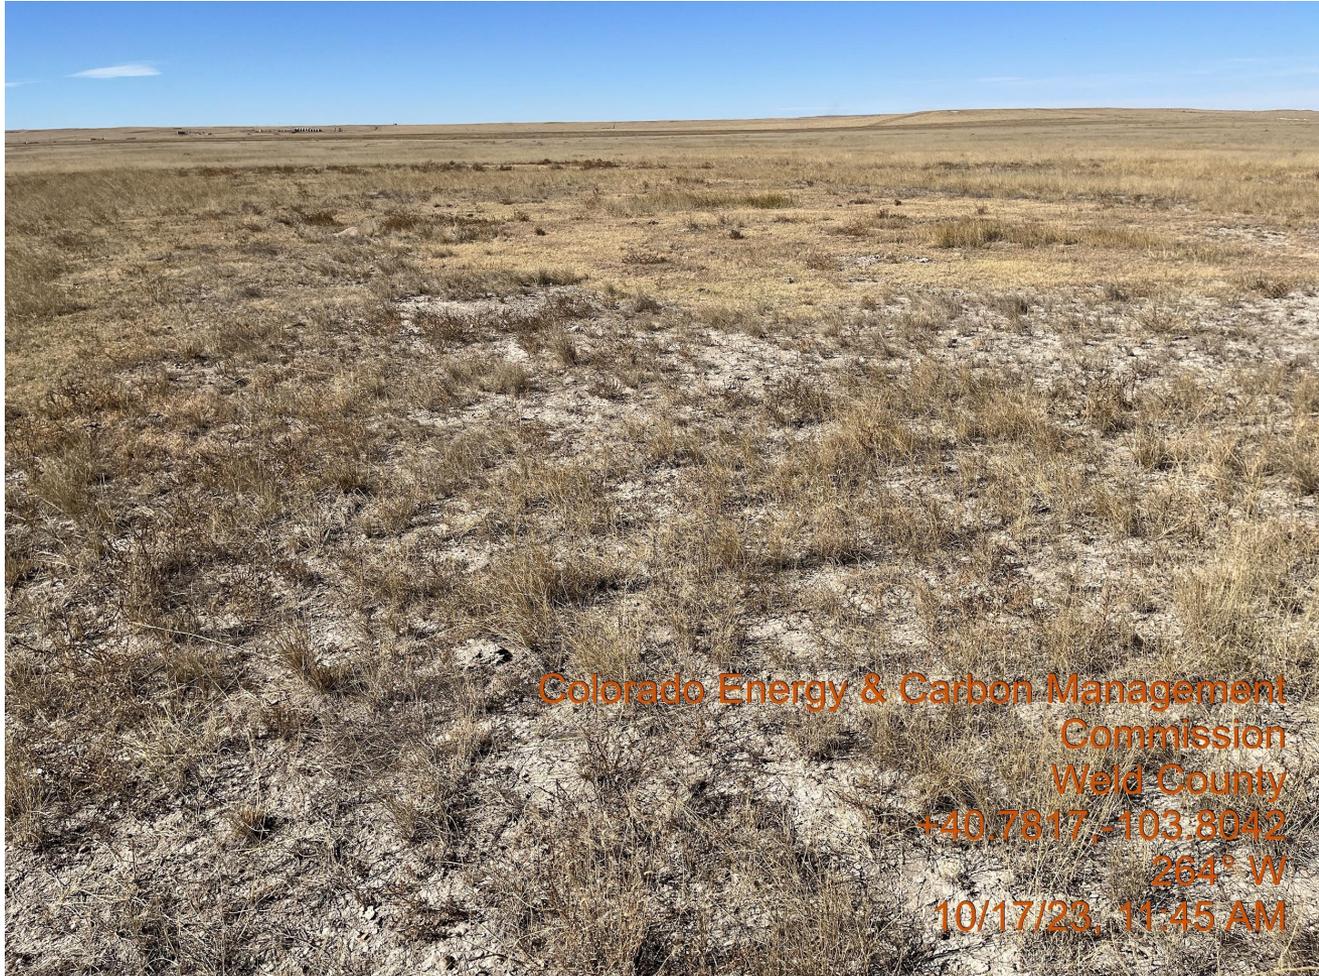
Photo 2. Photo taken from the East side of the well location facing West. The photo illustrates that the facility outline is still apparent on the landscape being dominated by bare soil, western wheatgrass and russian thistle.

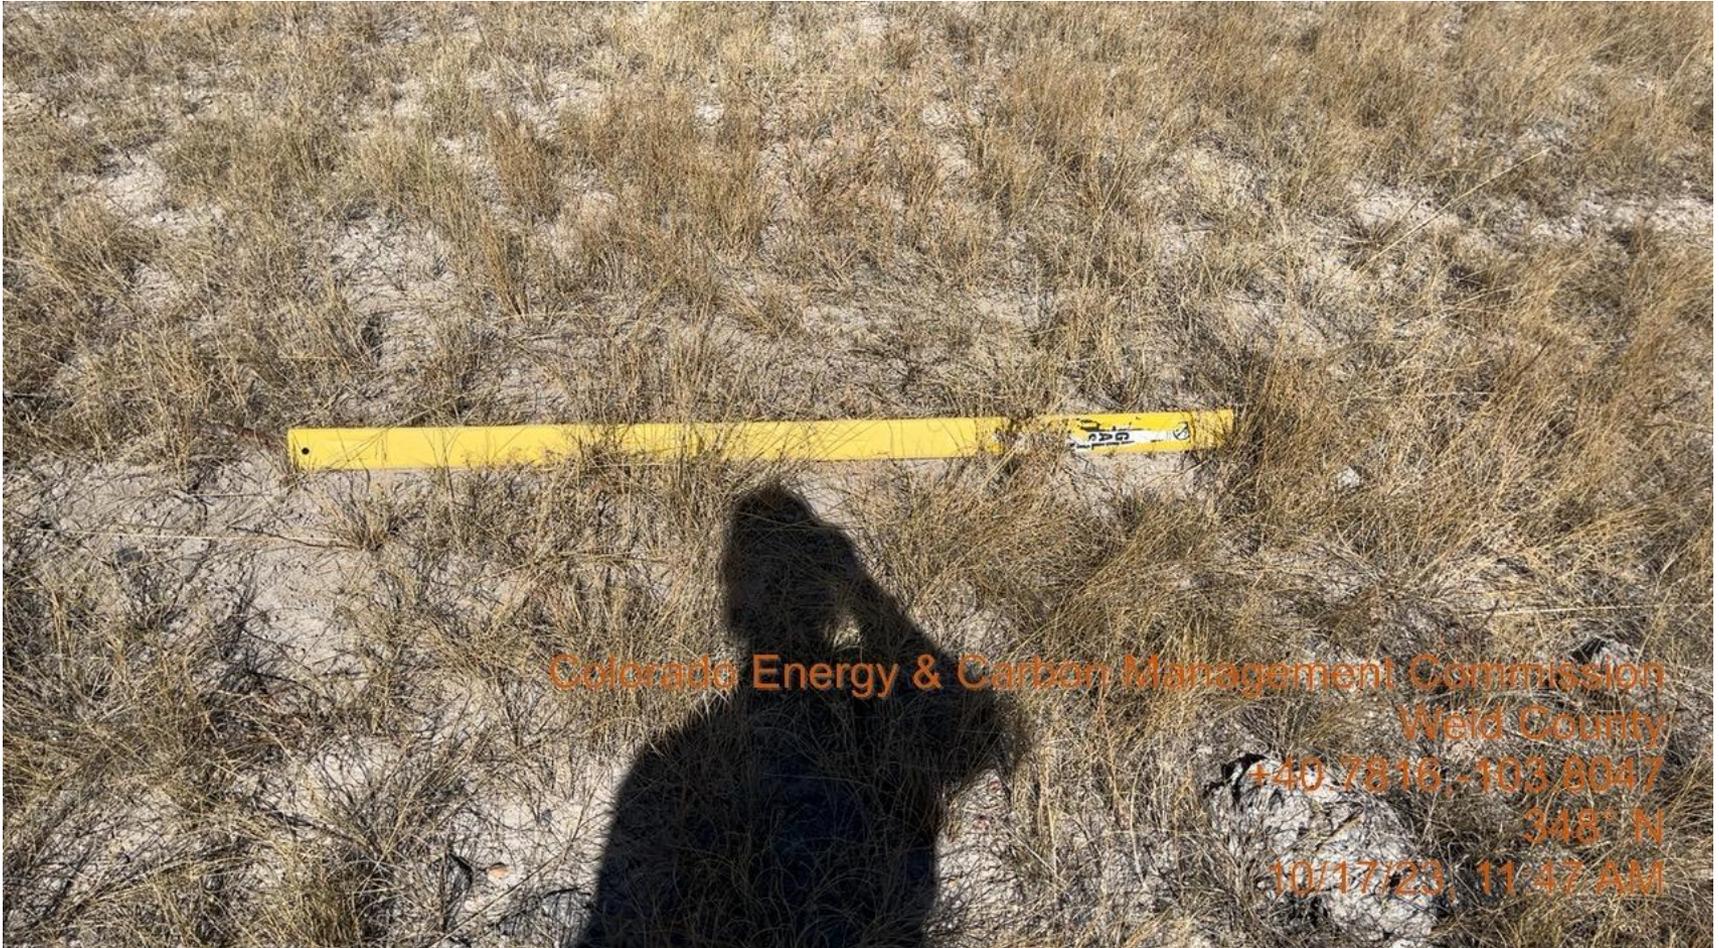
Photo 3. Photo taken from the well location facing North. The photo illustrates representative debris spread across the location.

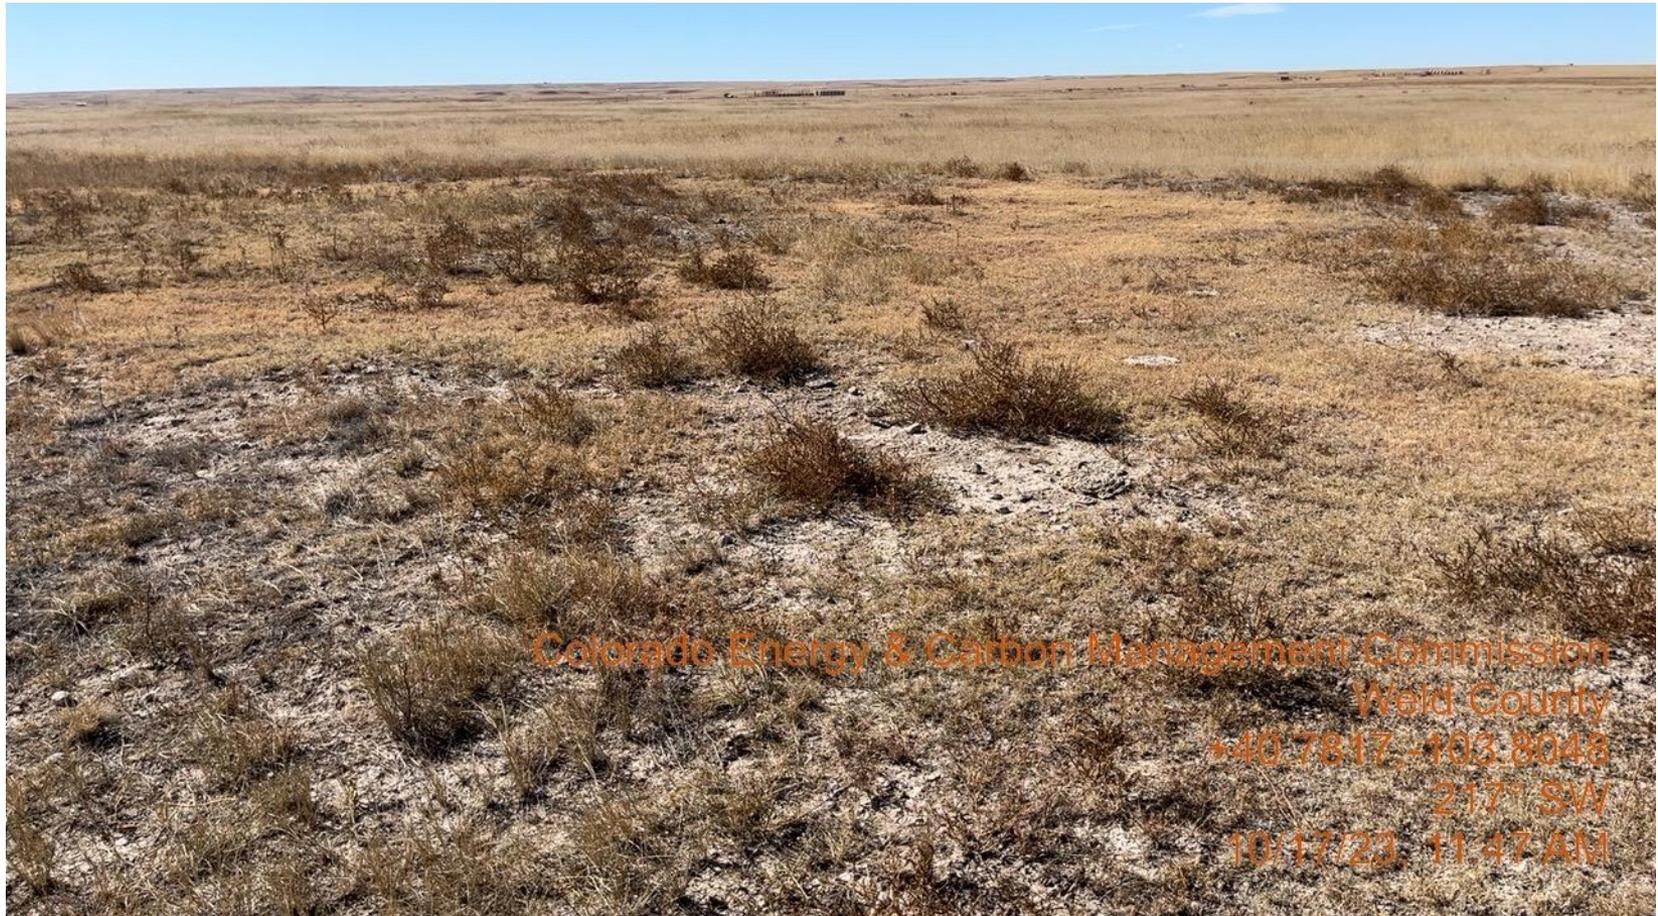
Photo 4. Photo taken from the well location facing Southwest. The photo illustrates russian thistle and kochia growing abundantly onsite as well as bare soil.

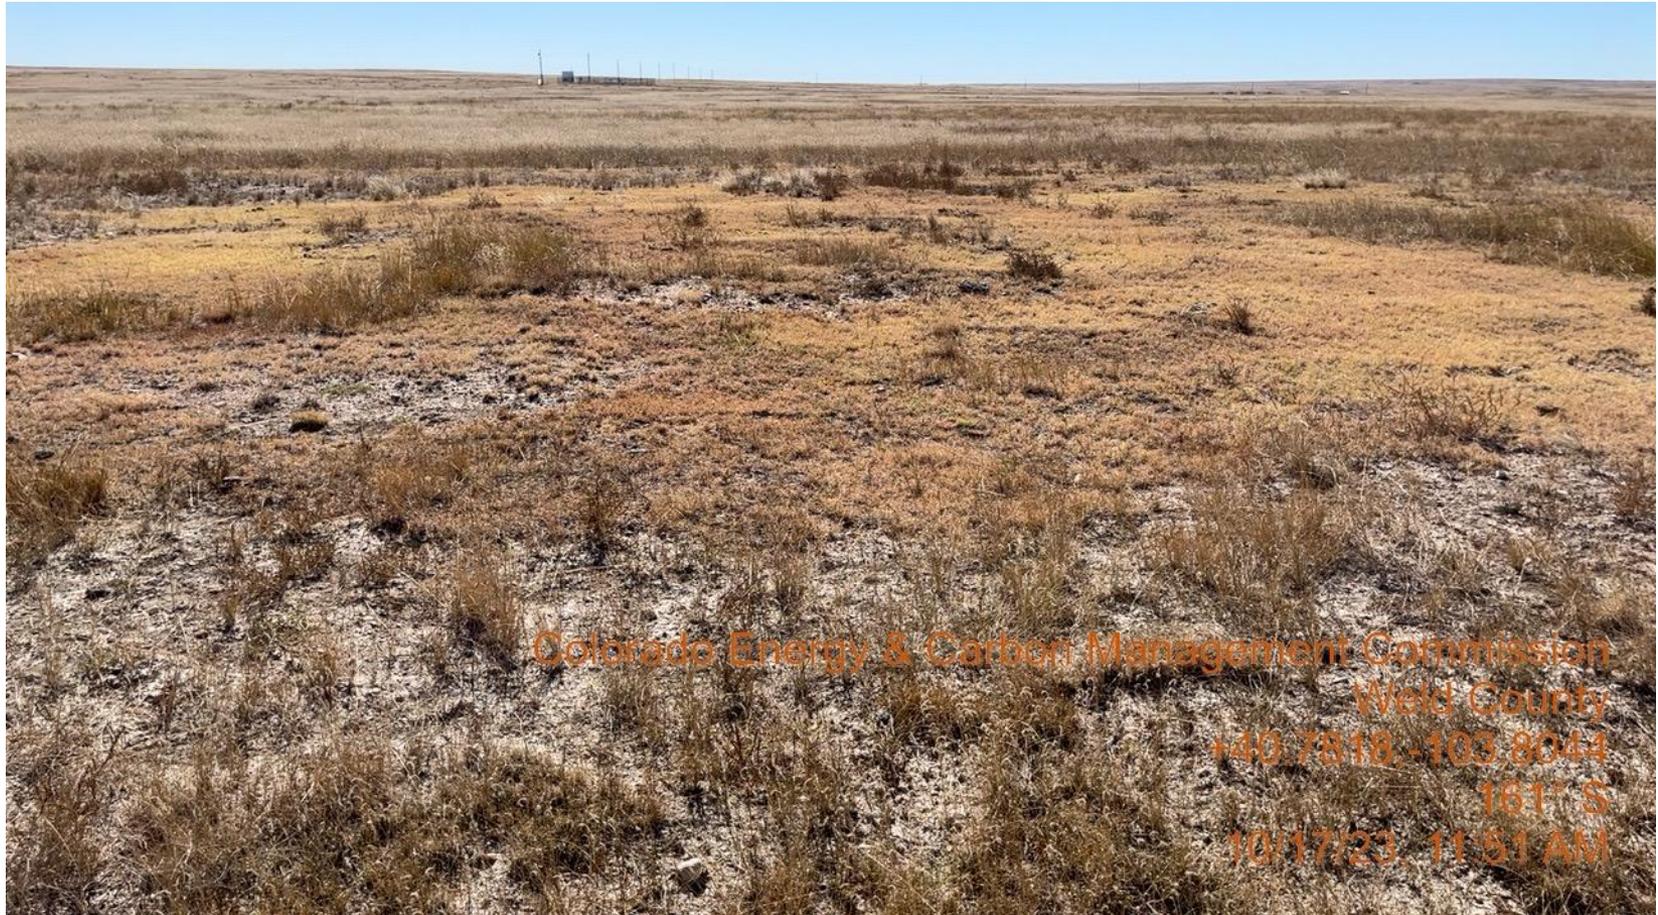
Photo 5. Photo taken at the well location facing South. The photo illustrates the tank battery area is dominated by saltgrass and bare soil.

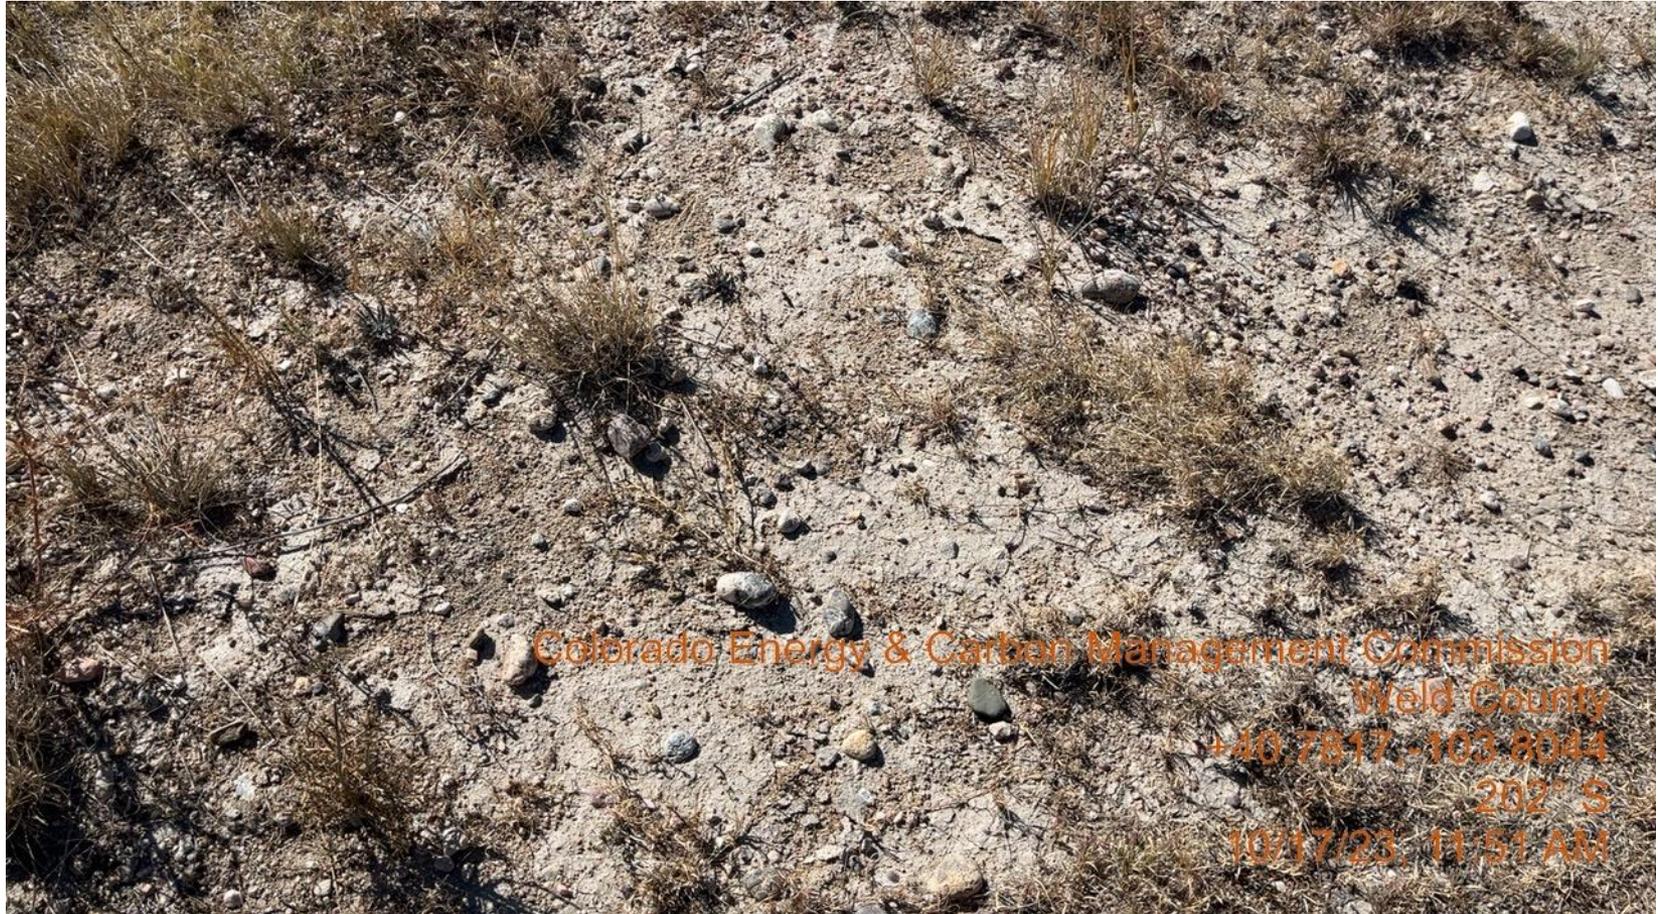
Photo 6. Photo was taken on the well location facing South. The photo illustrates there is not uniform vegetative cover on the location representative of reference areas.

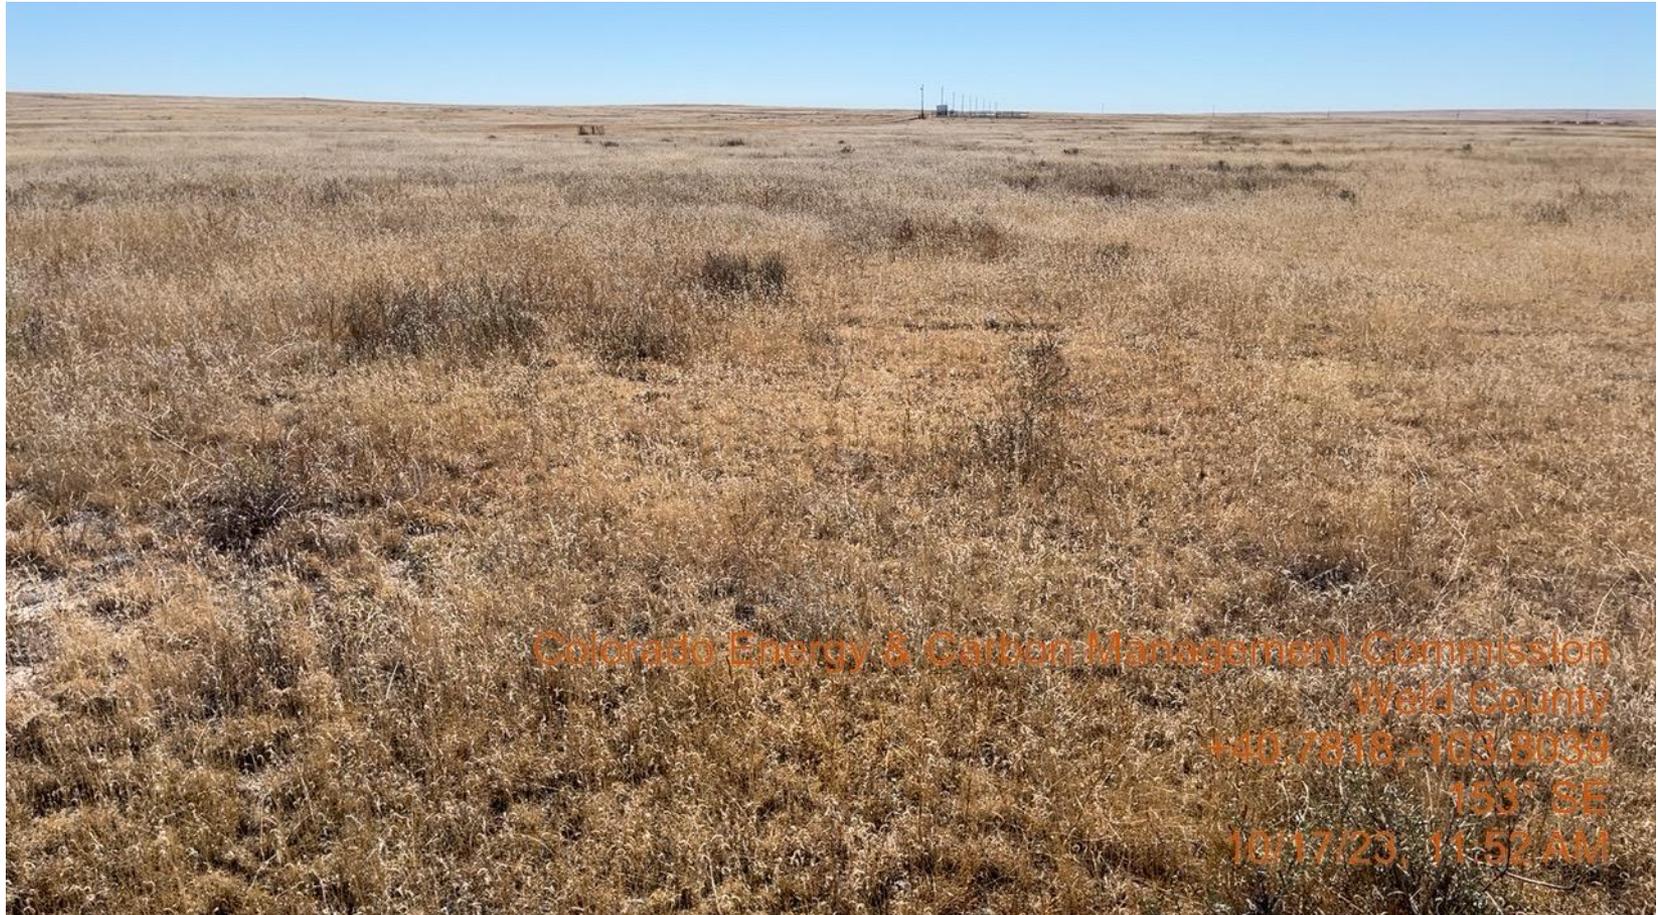
Photo 7. Reference photo was taken on the well location facing off the location Southeast. The photo illustrates blue grama dominated rangeland with pockets of four-winged saltbush.
