Interim Reclamation and Stormwater Inspection

Date: 10/26/2023

Operator: FUNDARE RESOURCES OPERATING
COMPANY LLC - 10773

Inspection Photos
Location Name: Horsetail 30H Pad
Location ID: 445579

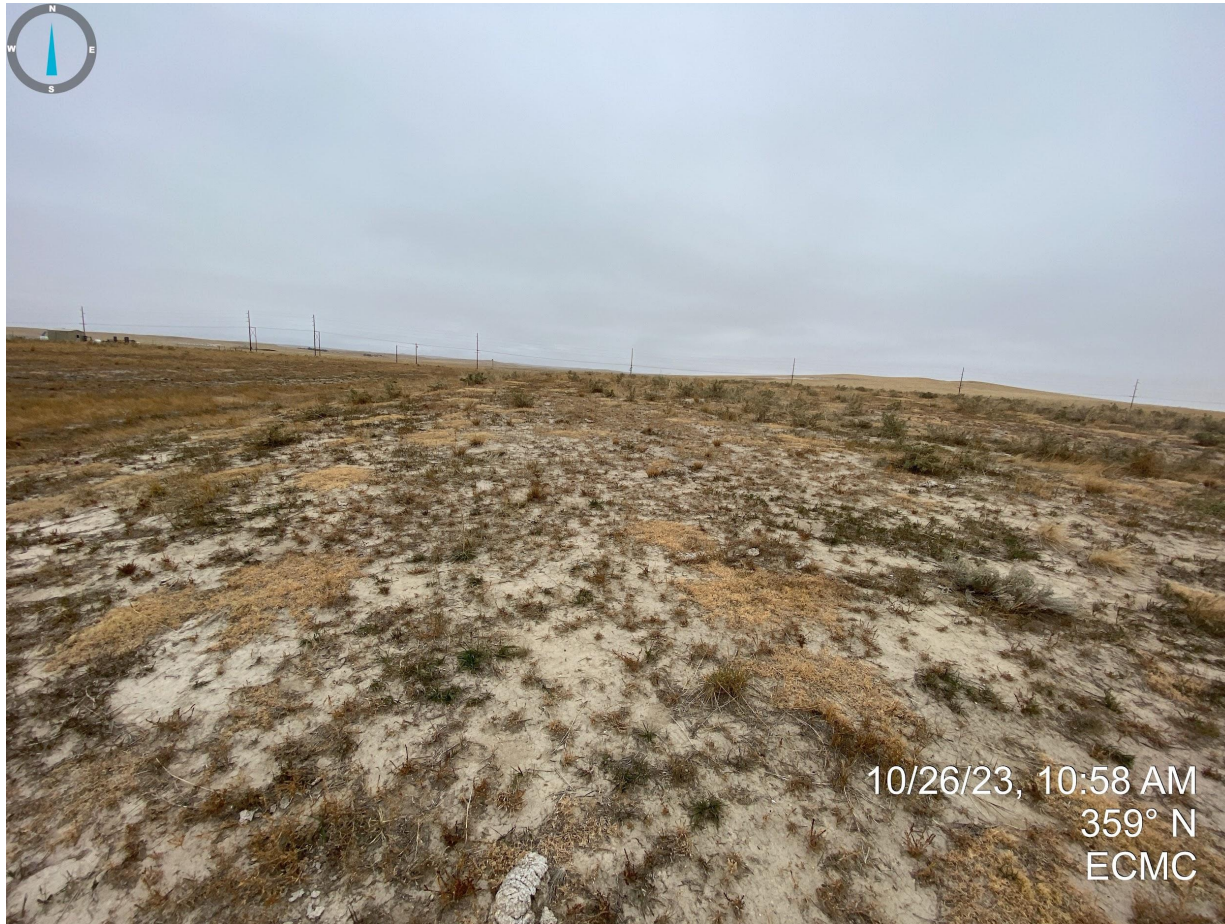
Photo 1. Taken from the eastern side of the location at the southern portion of the topsoil stockpile. Photo illustrates that the topsoil stockpile is not progressing towards Rule 1003 standards with non-uniform vegetative cover resulting in bare and exposed soils. Undesirable vegetation (e.g. kochia and russian thistle) was also observed throughout.

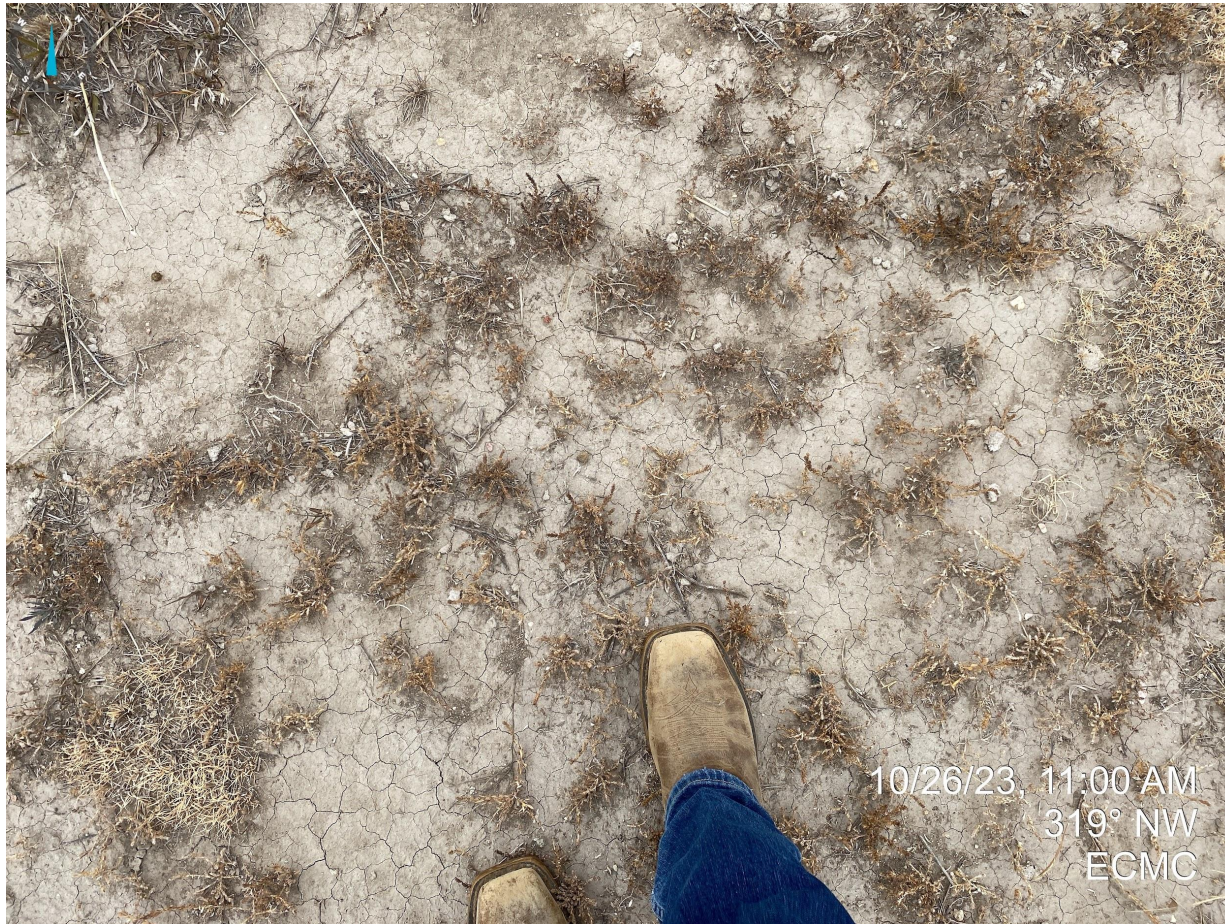
Photo 2. Close up photo of the topsoil stockpile.

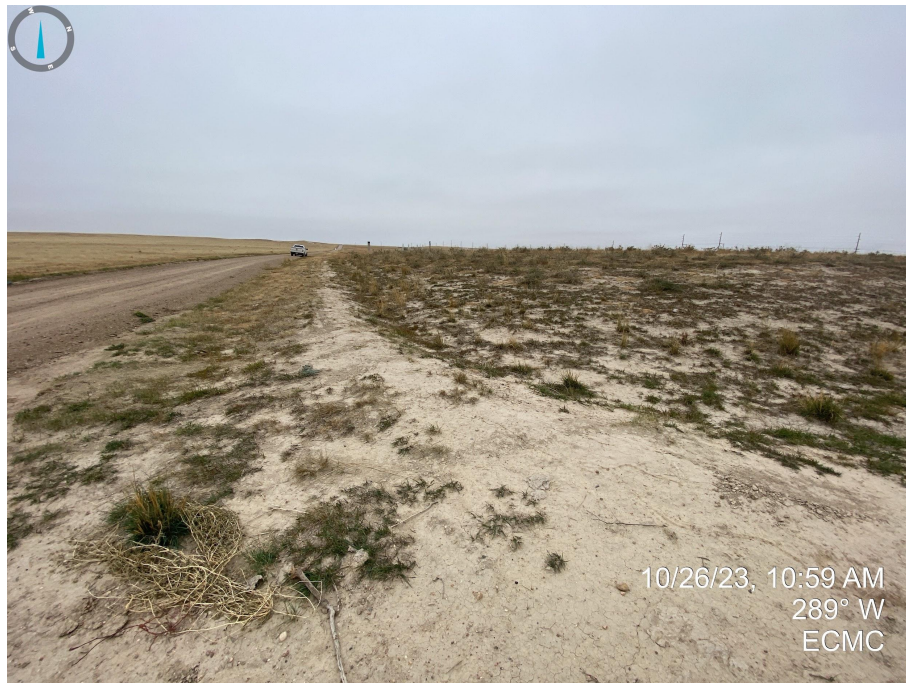
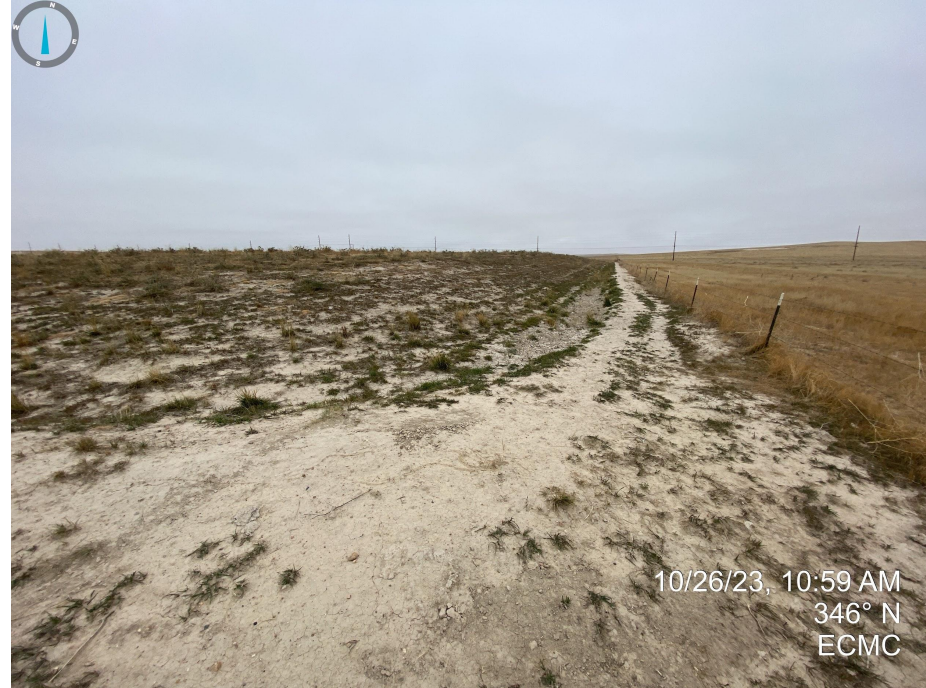
Photos 3 & 4. Taken from the southeast corner of the location, near the topsoil stockpile. Photo illustrates that soils are not properly stabilized as evidenced by non-uniform vegetative cover.

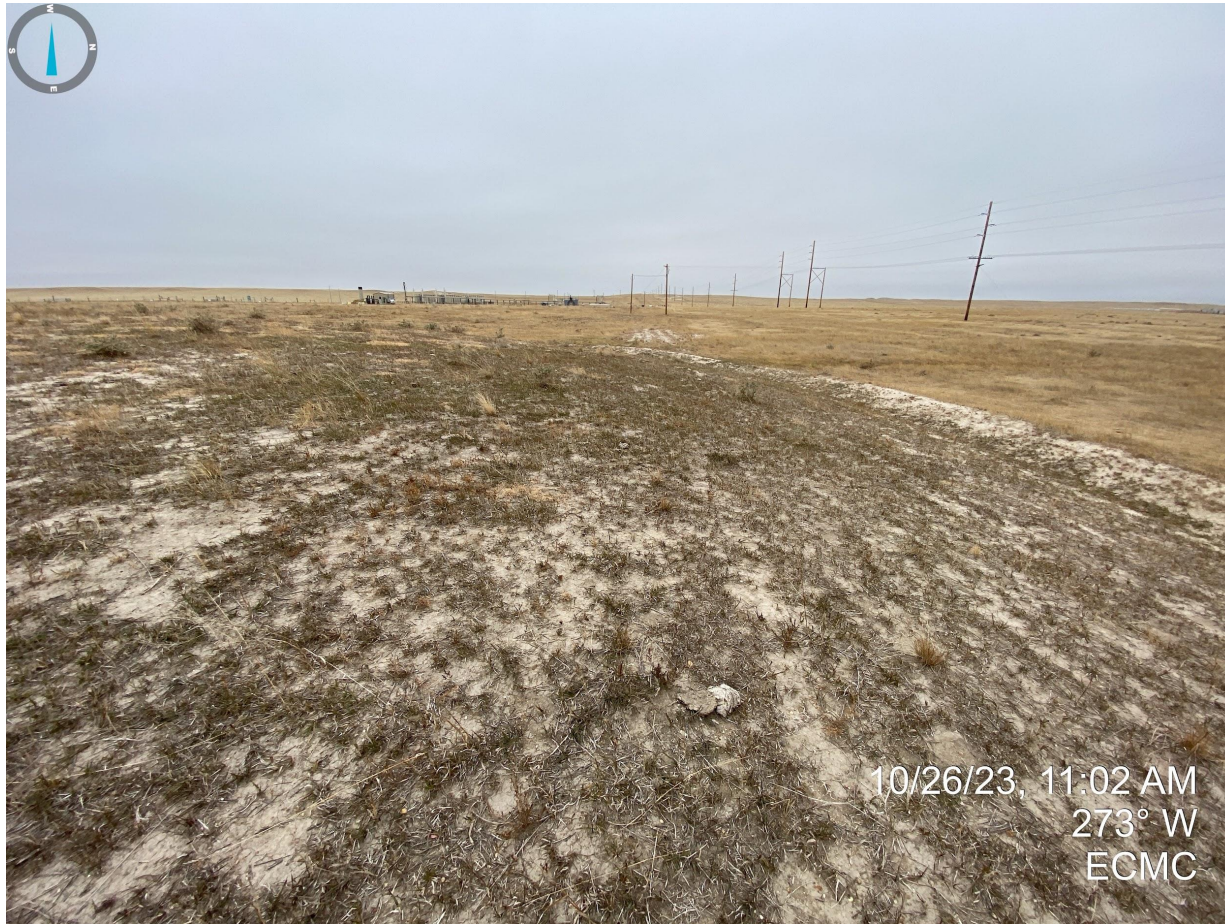
Photo 5. Taken from the northern portion of the topsoil stockpile. See comments in Photo 1.

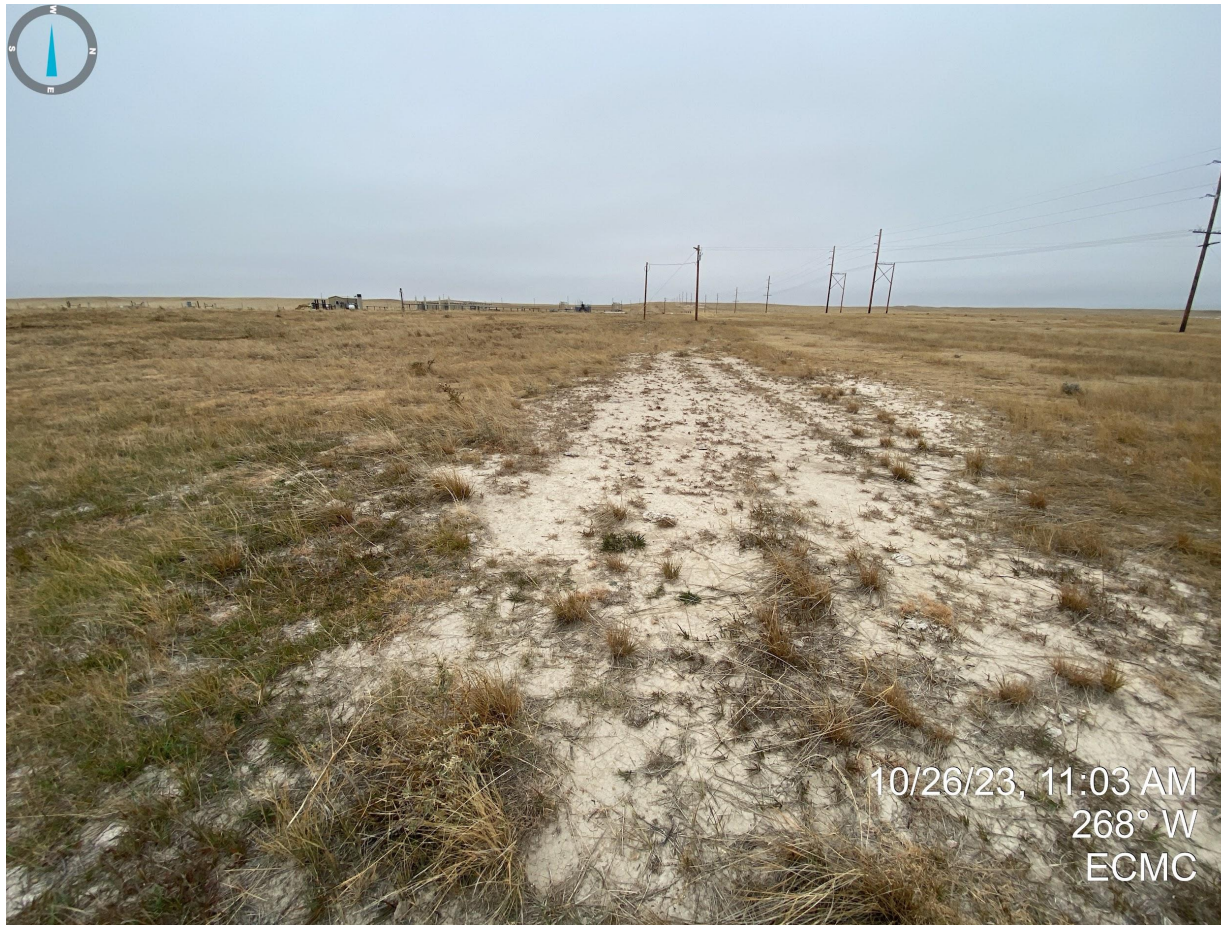
Photo 6. Taken from the northern portion of the location. Photo illustrates an area of non-uniform vegetative cover resulting in bare/exposed soils.

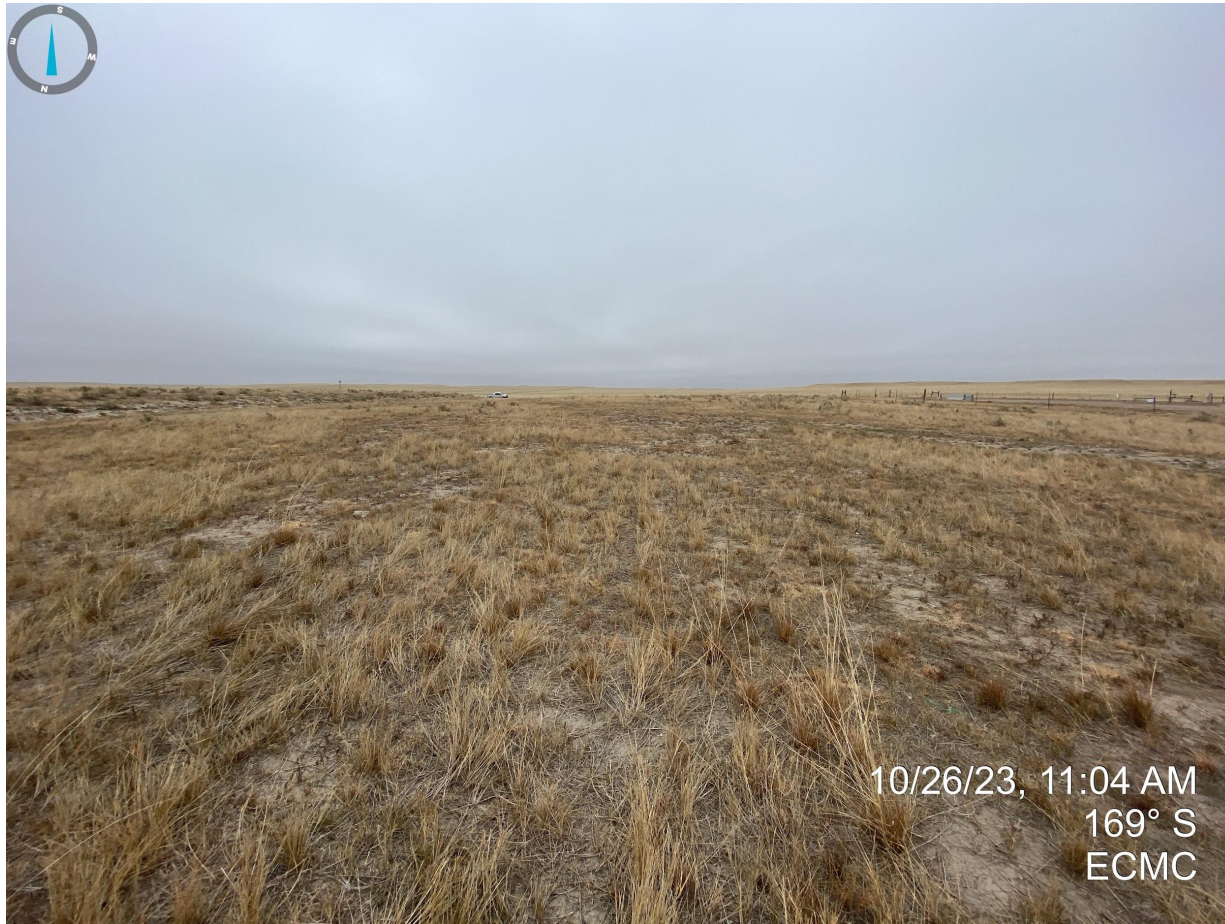
Photo 7. Taken from the northern portion, between the topsoil stockpile and the well location. Photo illustrates that portions of the interim reclaimed areas are progressing towards Rule 1003 with desirable species present (blue grama, western wheat, etc).

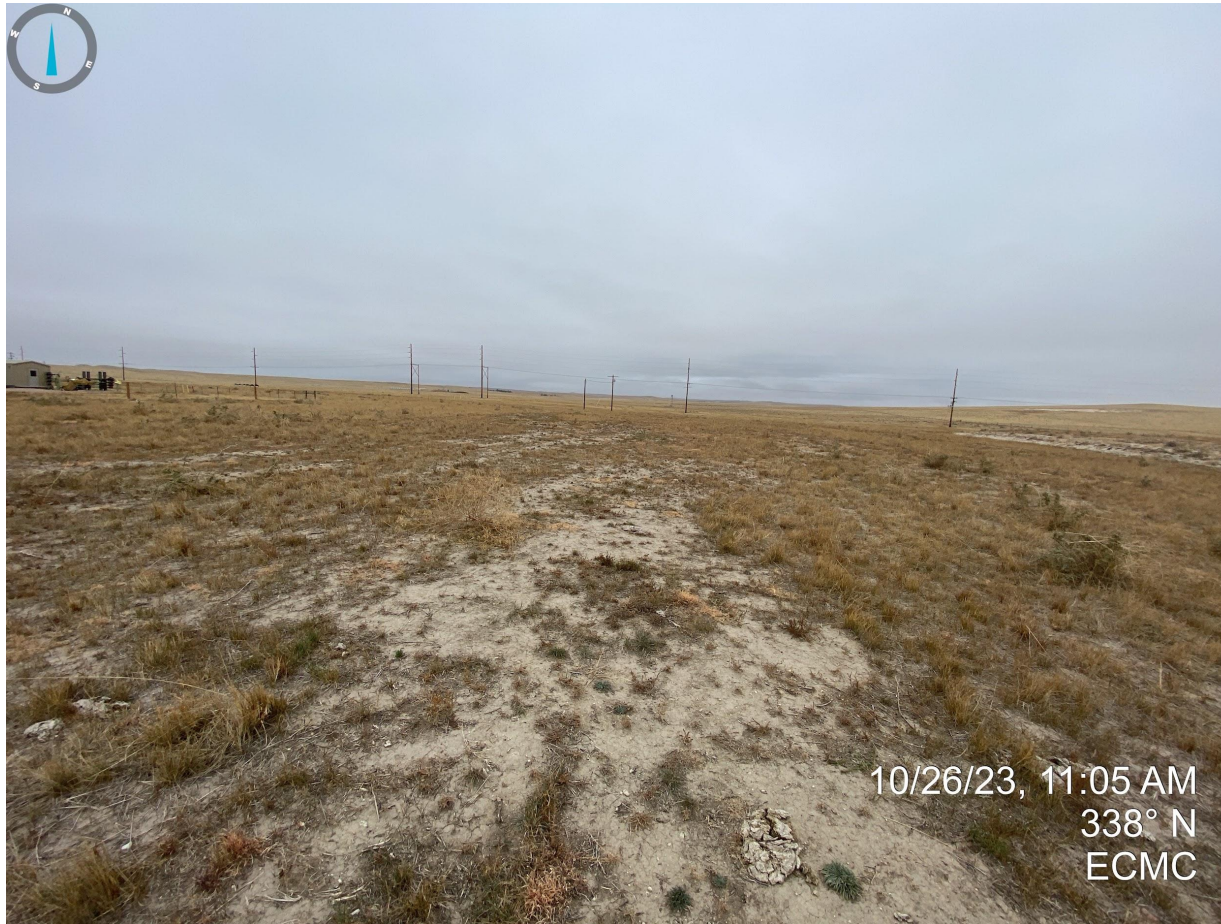
Photo 8. Taken from the southern/middle portion of the interim reclaimed area, between the topsoil stockpile and the well location. Photo illustrates that exposed soils are present. Additional revegetation activities are required.

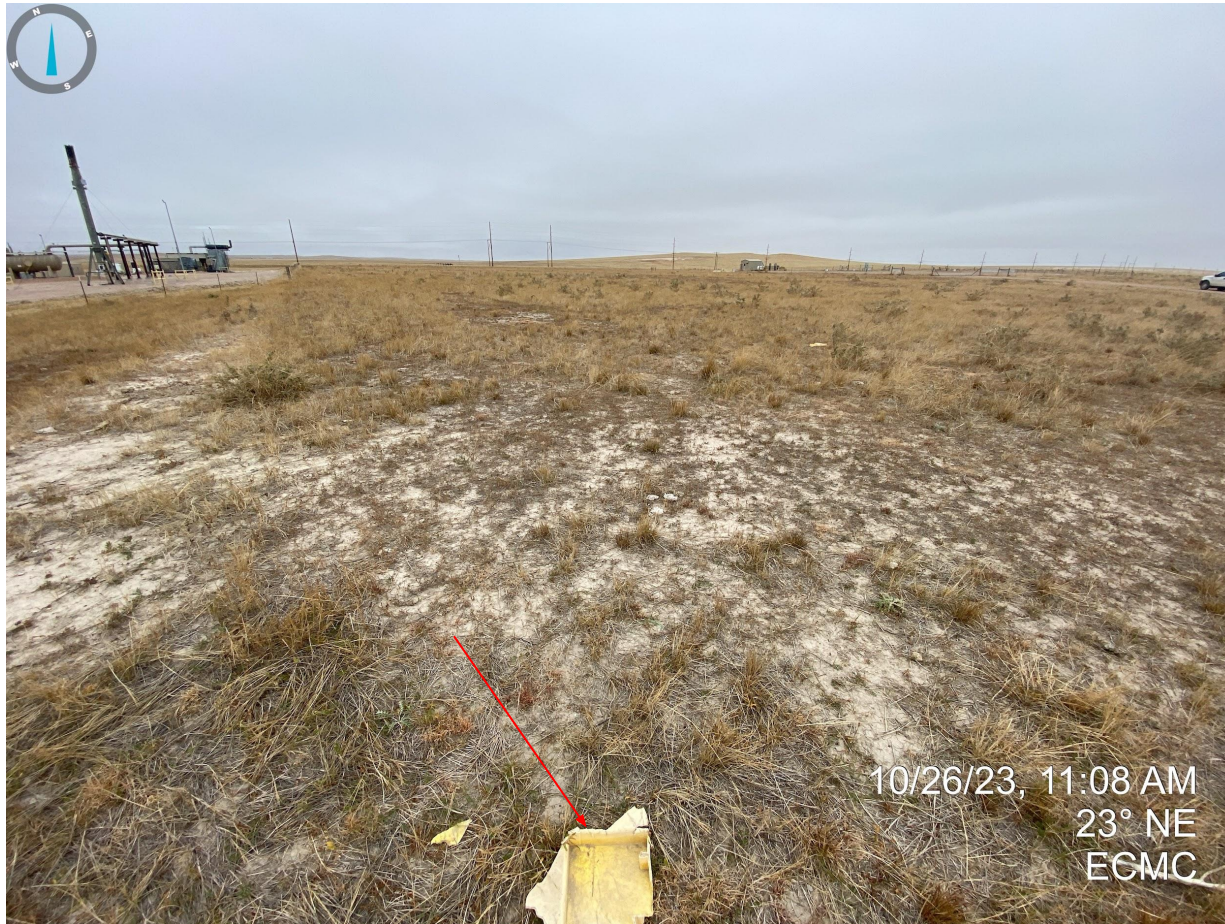
Photo 9. Taken from the western side of the location. Non-uniform vegetative cover resulting in bare soils and trash/debris present.

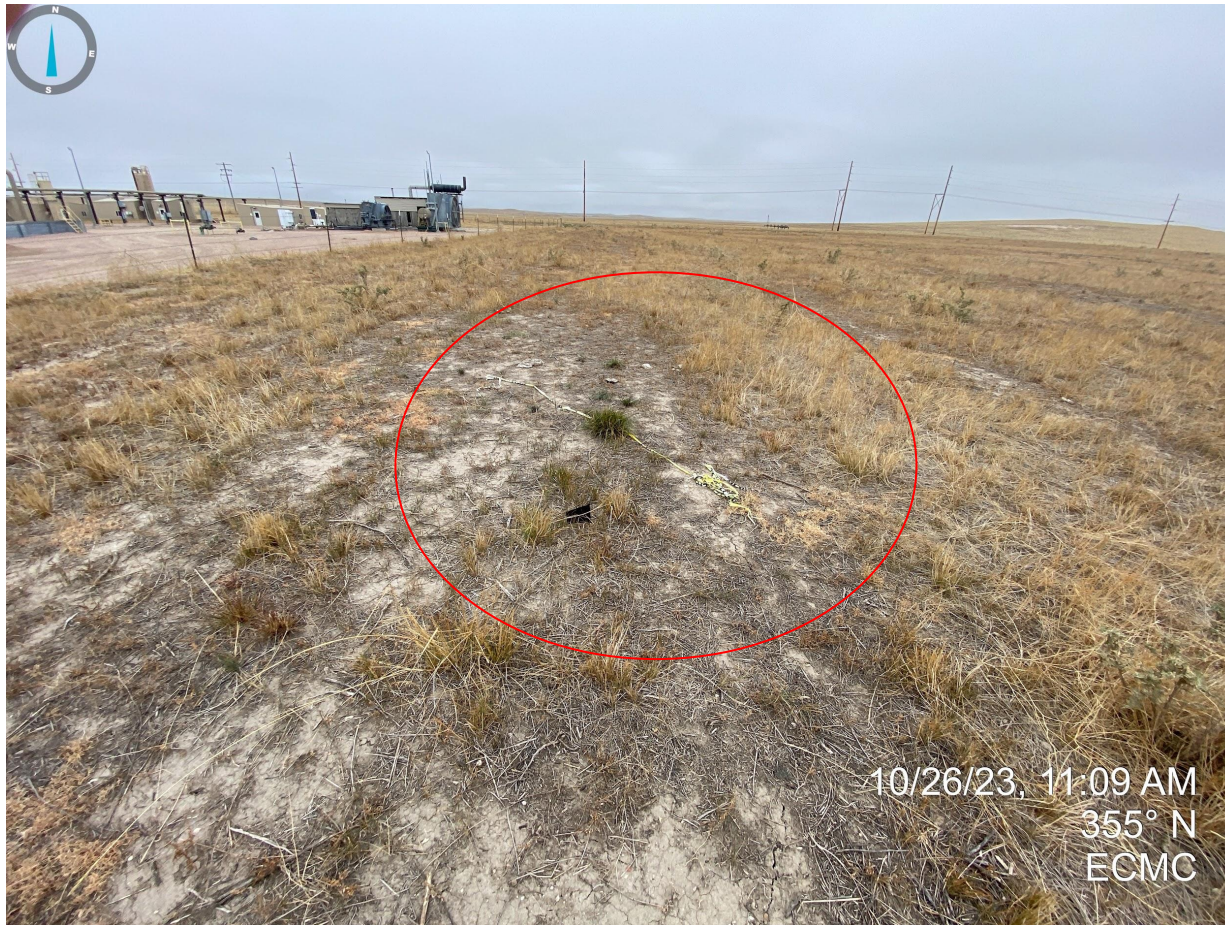
Photo 10. Western side of the location, see comments in Photo 9.

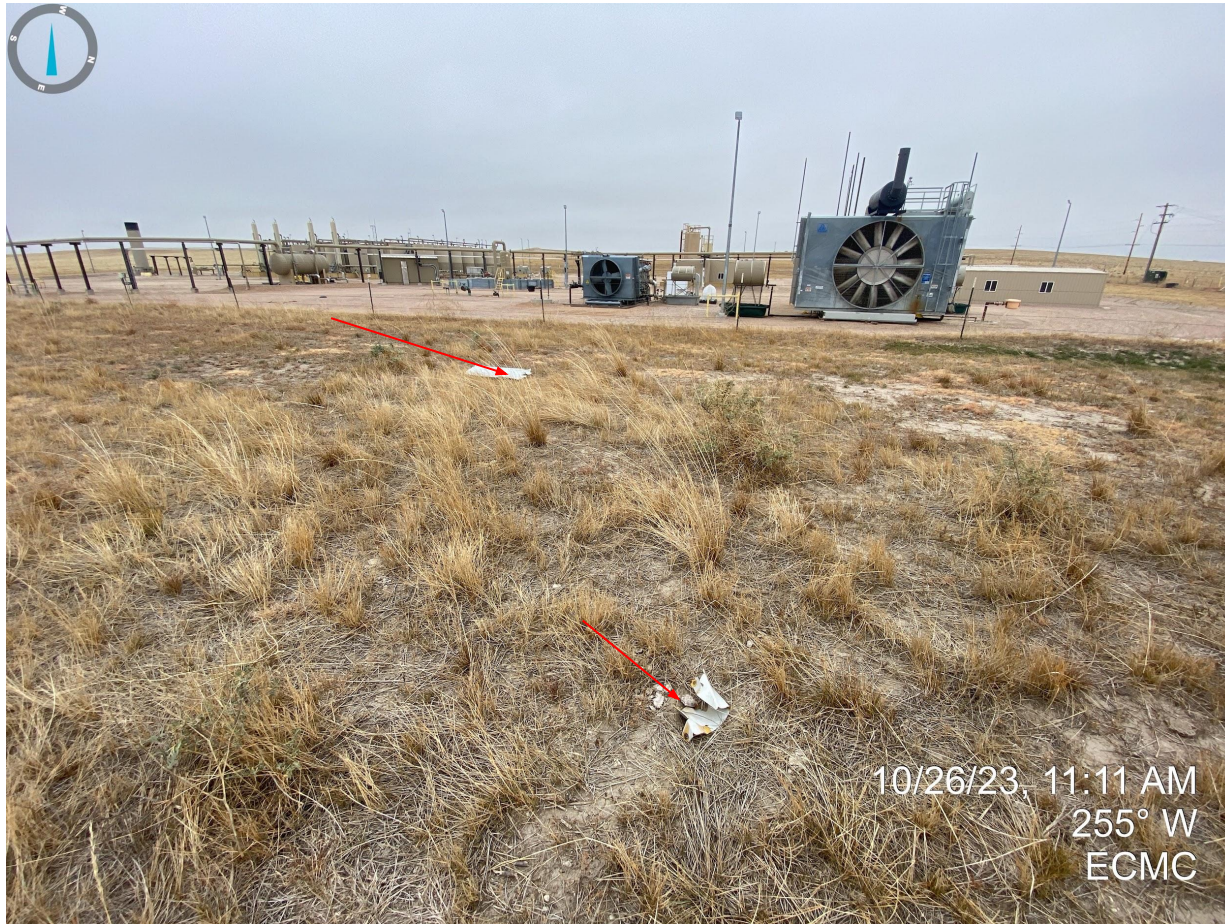
Photo 11. Western side of the location, see comments in Photo 9.

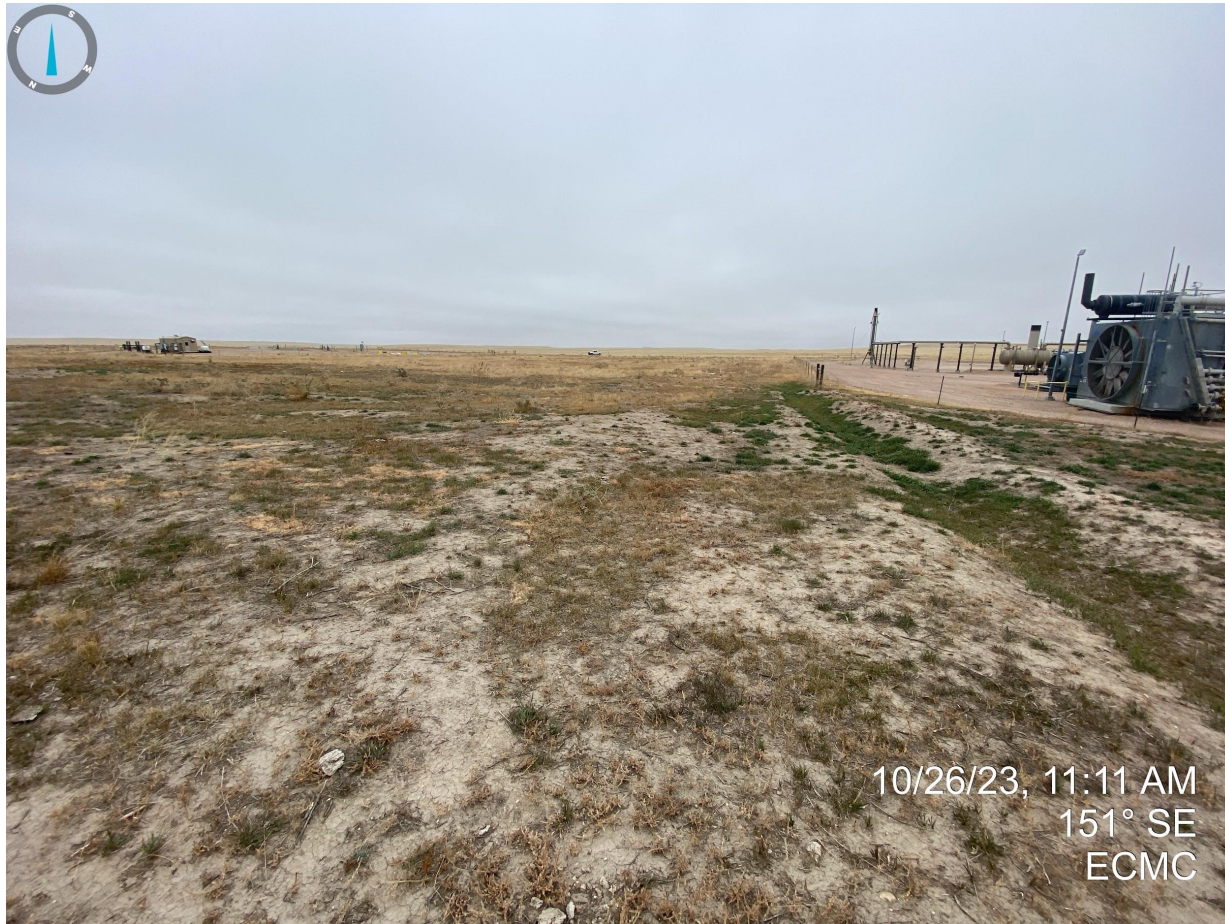
Photo 12. Northwest side of the location, see comments in Photo 9.

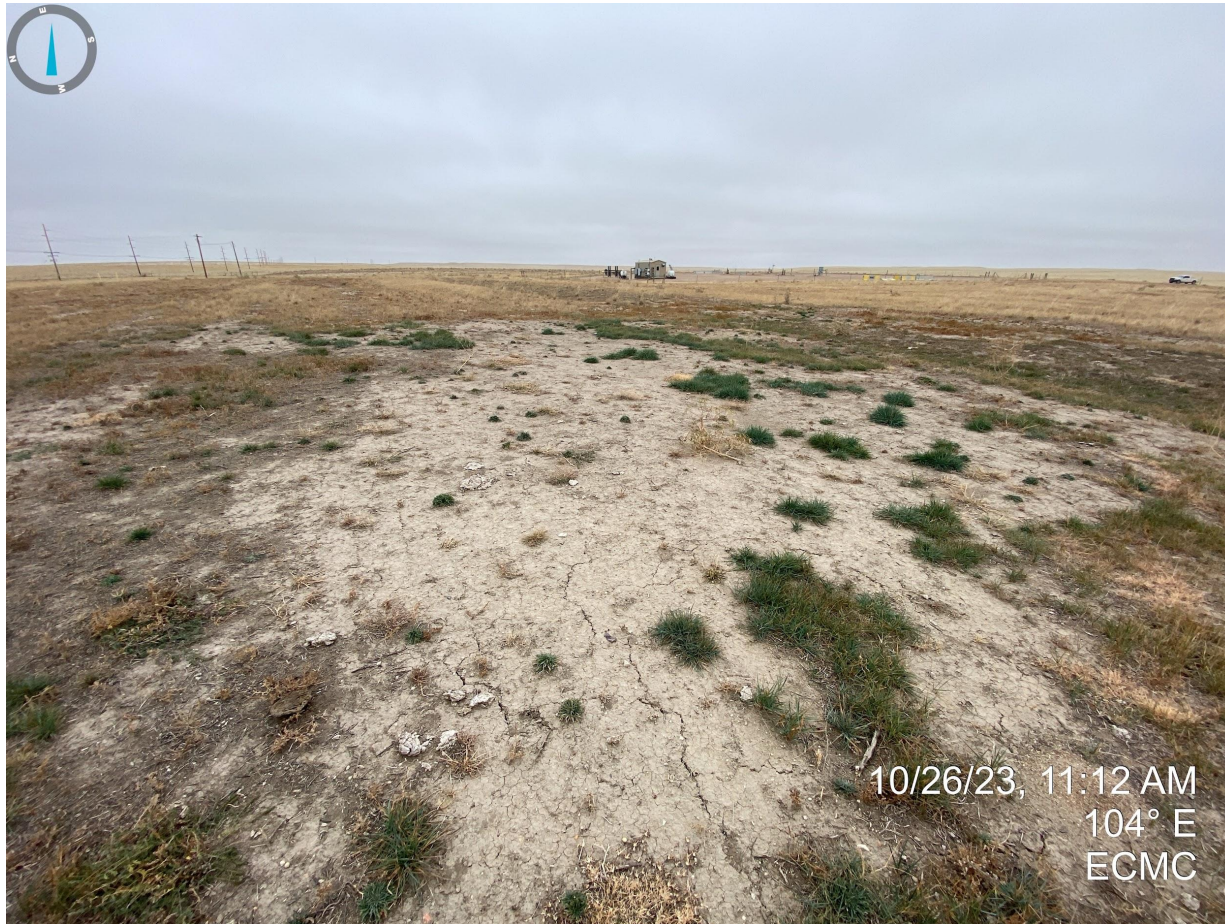
Photo 13. Taken from the northwest corner of the location. Evidence of bare and exposed soils.

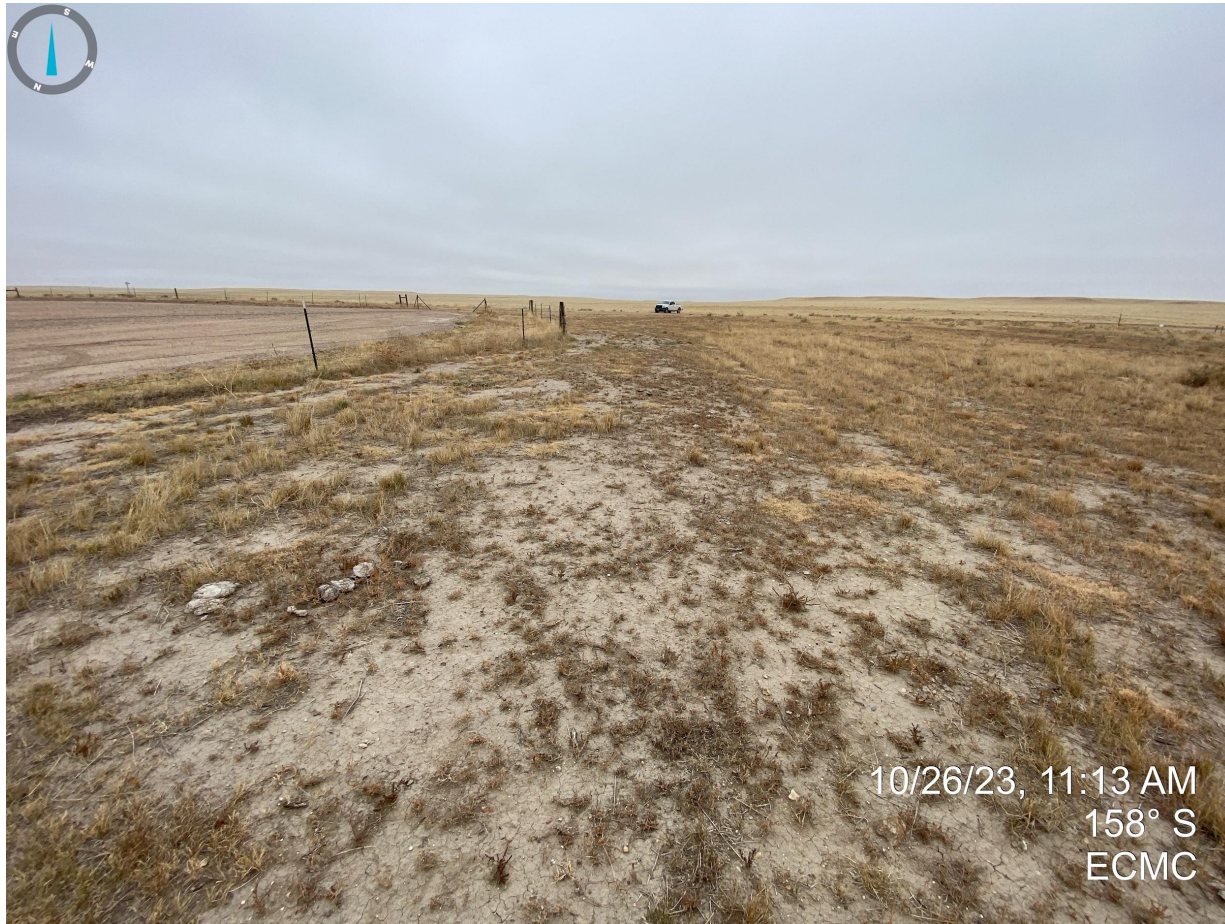
Photo 14. Taken from the west side of the well location. Photo illustrates that exposed soils are present. Additional revegetation activities are required.

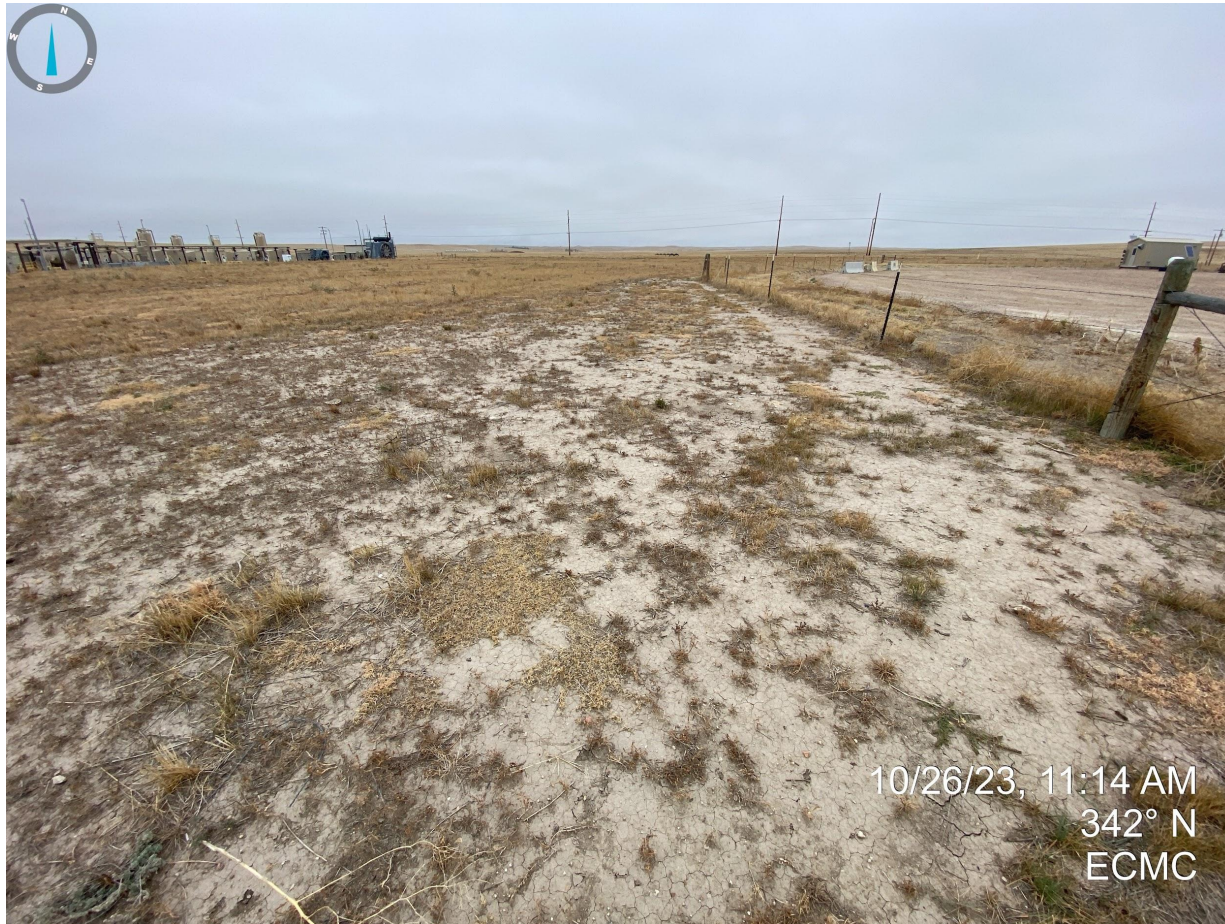
Photo 15. See comments in Photo 14.

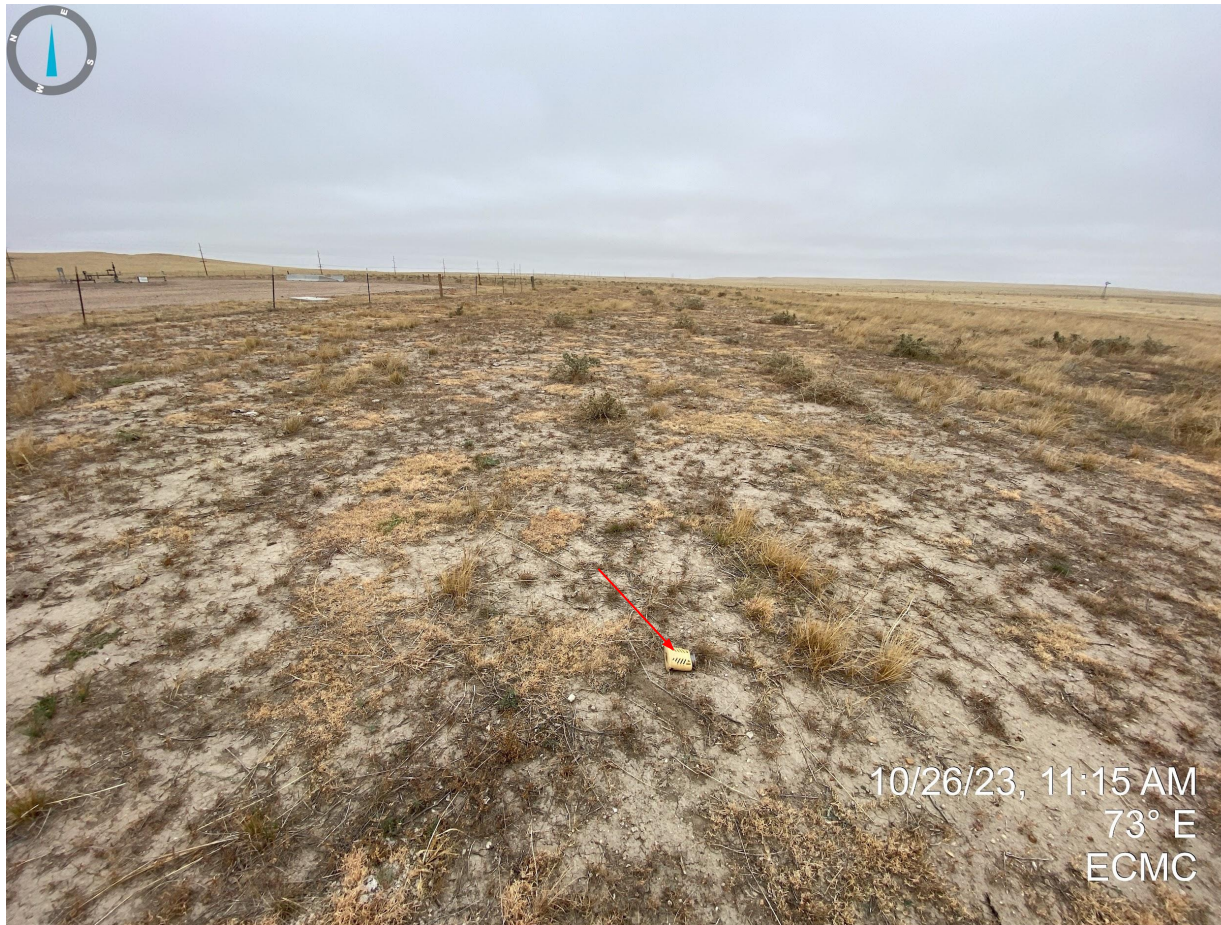
Photo 16. Taken south of the well location. Photo illustrates that exposed soils are present. Additional revegetation activities are required. Also pictured, trash/debris (red arrow).

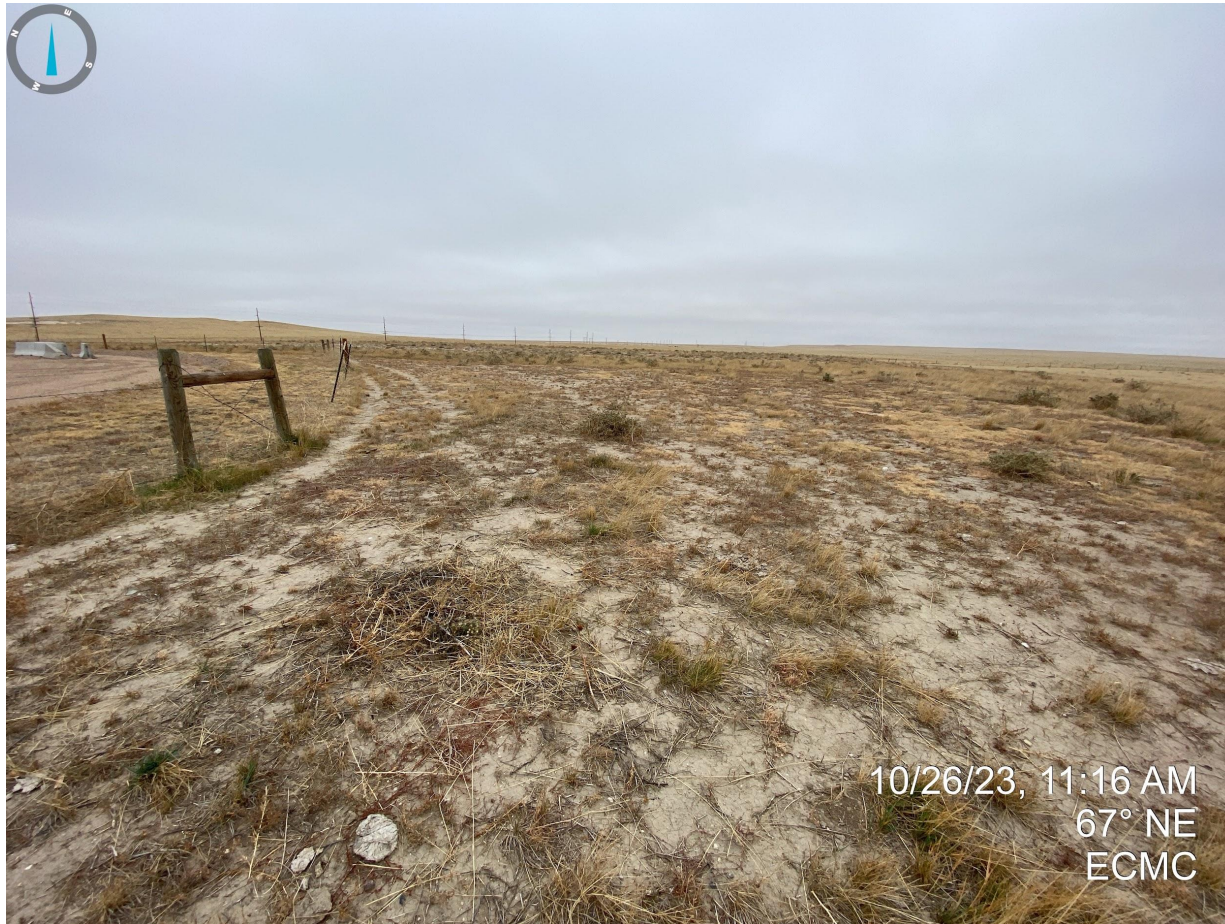
Photo 17. Continued from Photo 16. See comments in previous photo.

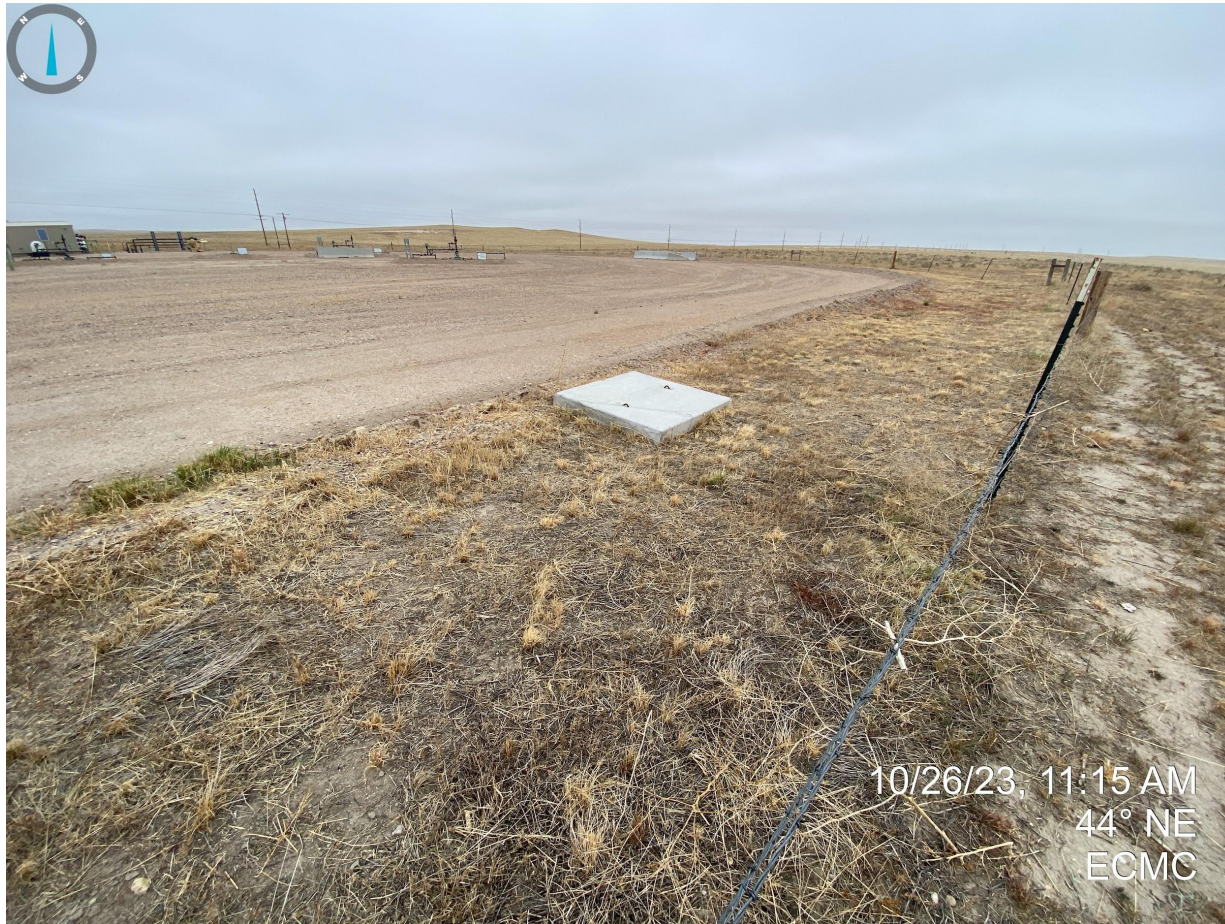
Photo 18. Concrete foundation does not appear to be in use and must be removed per Rule 606.

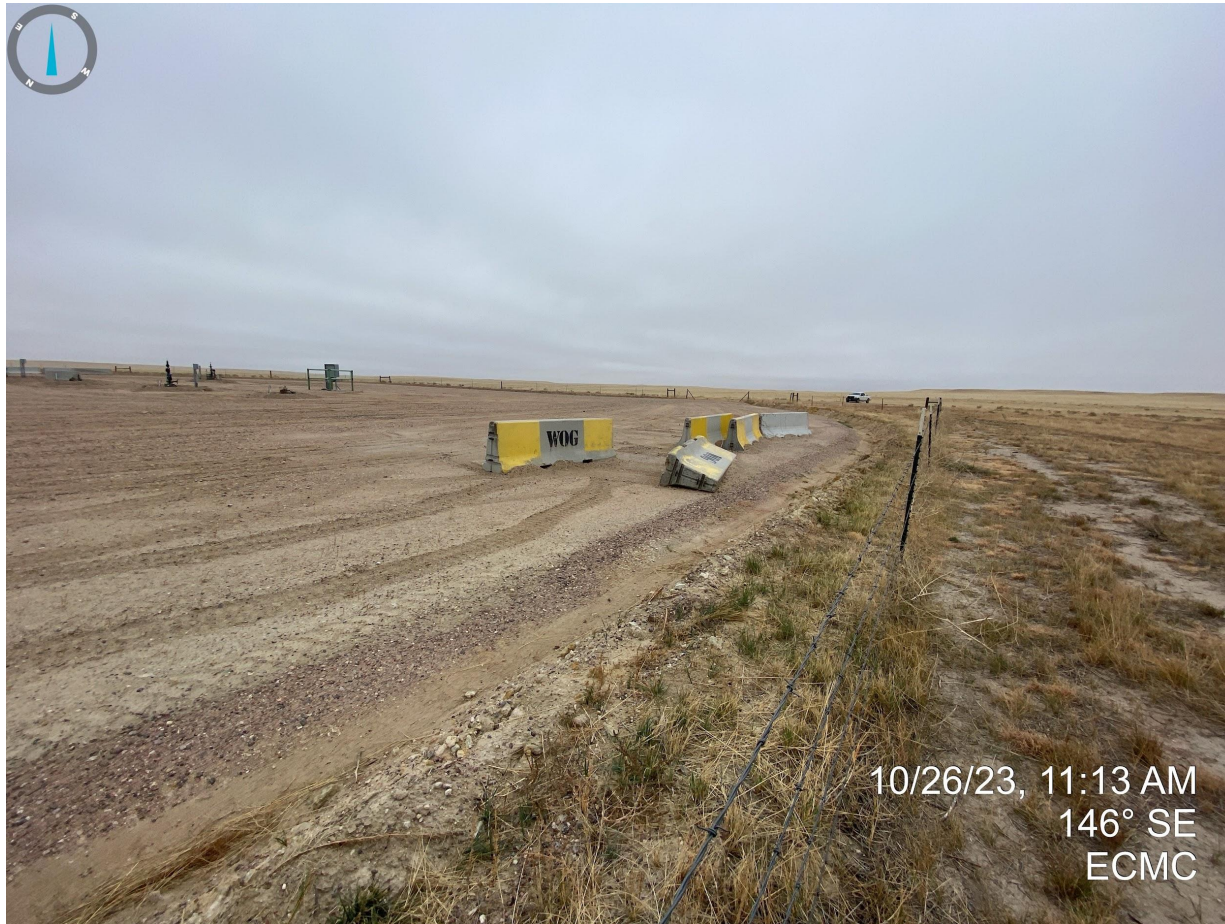
Photo 19. Jersey barriers on the well location do not appear to be in use and must be removed per Rule 606.
