## Inspection Photos

Location Name: CAERUS PICEANCE LLC GMR 9-3C (C9W) Pad

Location #: 334615

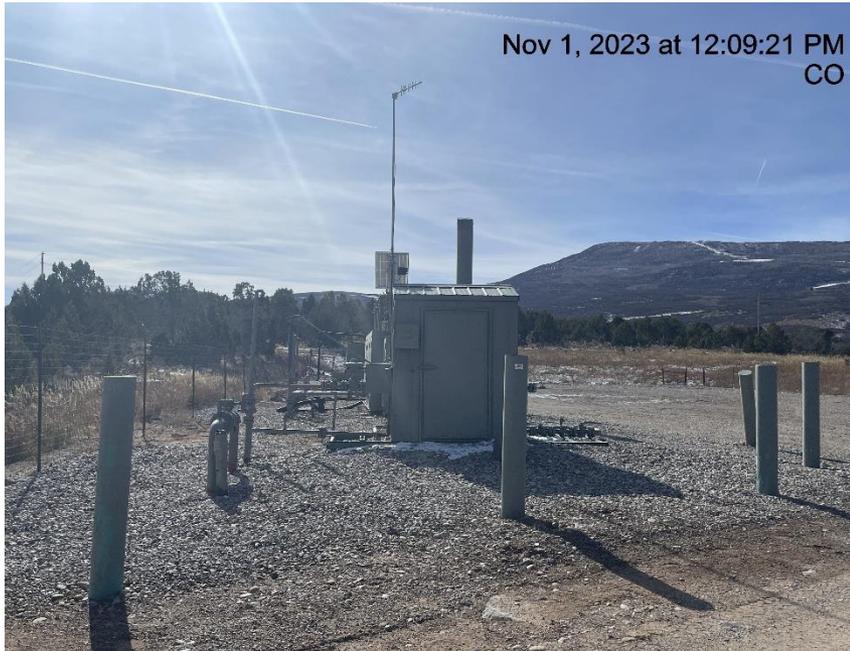
Photo # 4984 From entrance to location

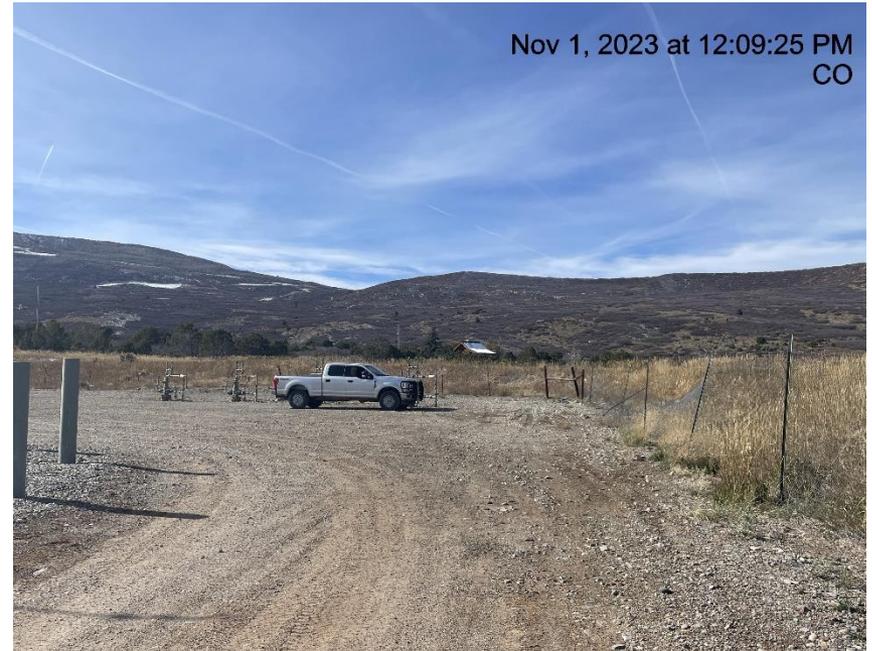
Photo # 4985 From entrance to location

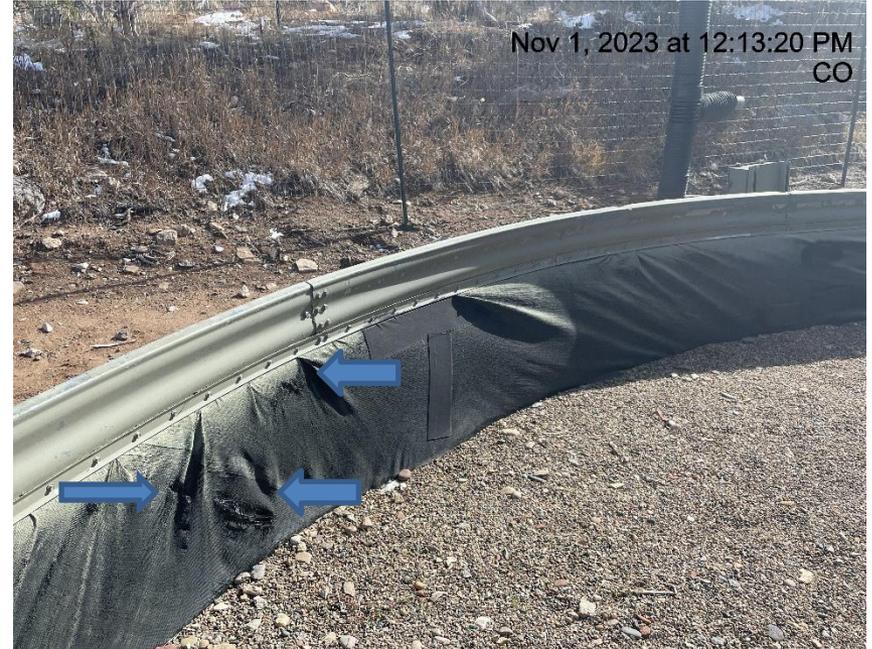
Photo # 4991 Holes in liner/liner needs maintenance

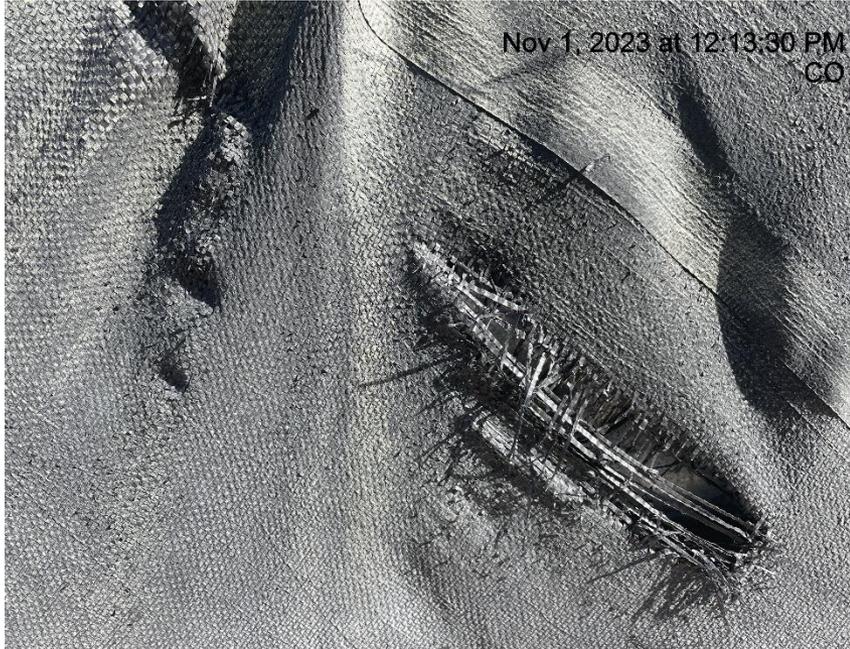
**Photo # 4992 Holes in liner/liner needs maintenance**

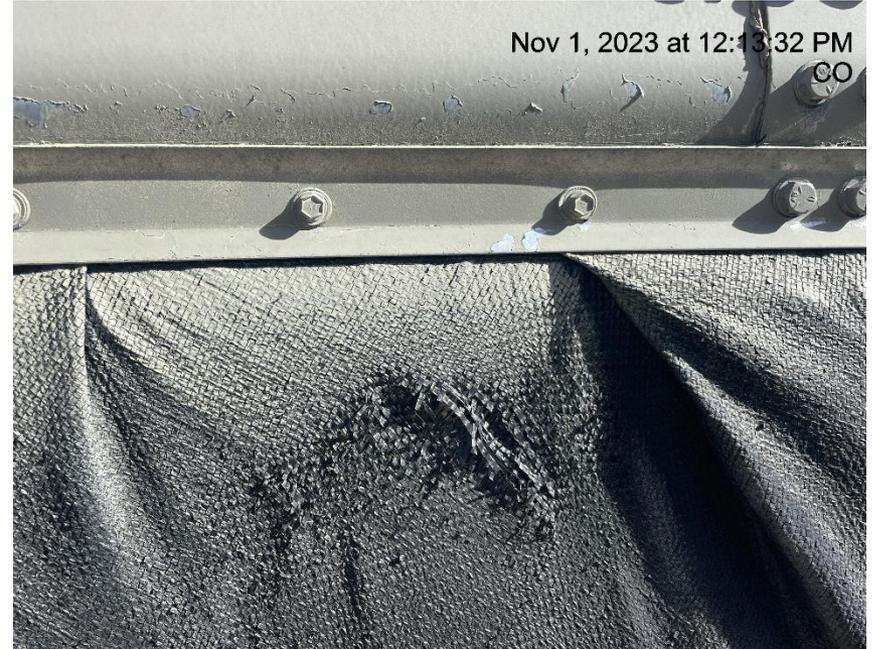
**Photo # 4993 Hole in liner/liner needs maintenance**
