Inspection Photos

Location Name: TEP Rocky Mountain LLC RMV 207-20 Pad

Location # 324102

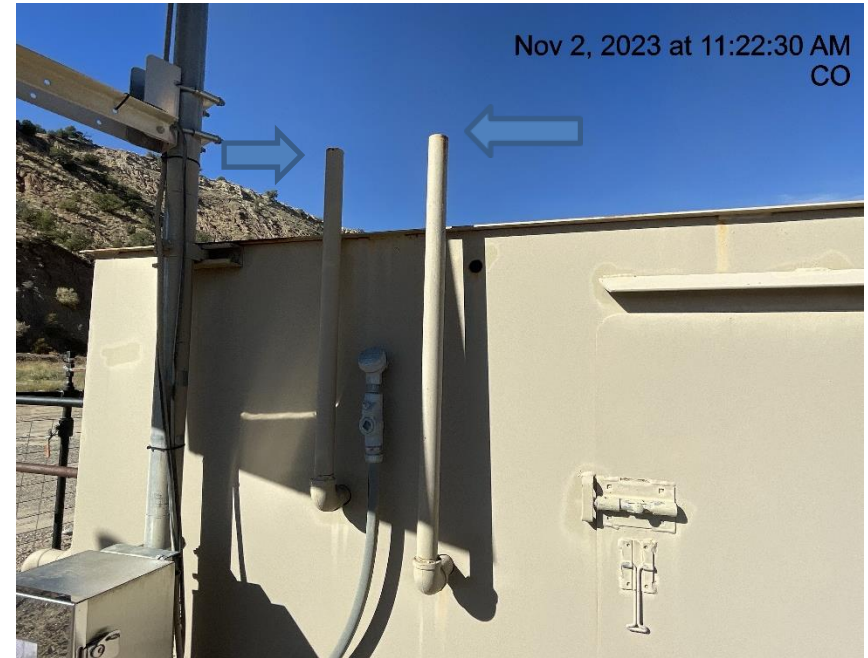
Photo # 5169 PRV & Rupture disc vent lines lack caps

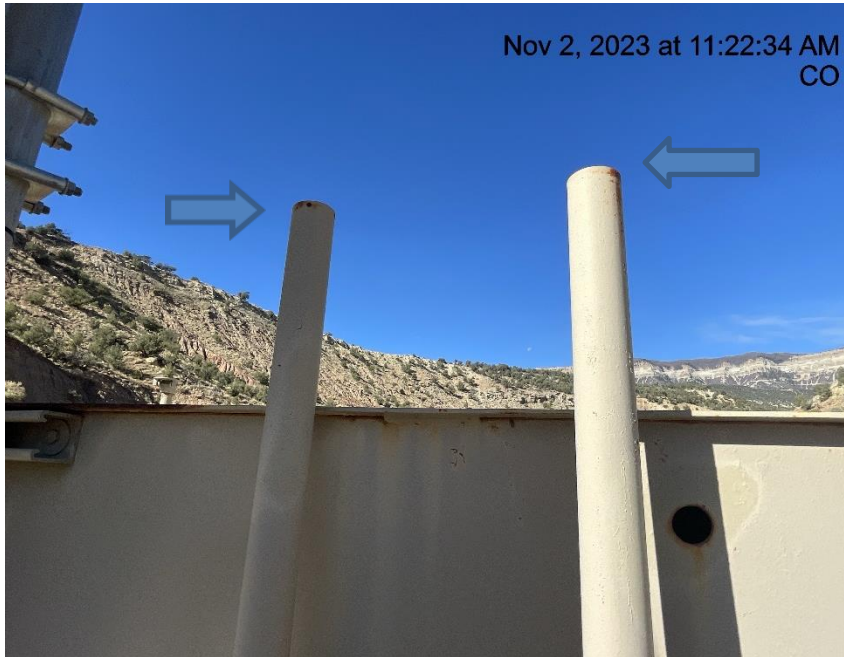
Photo # 5170 PRV & Rupture disc vent lines lack caps
